National Transportation Safety Board

DCA22MA193

MATERIALS LABORATORY

Factual Report 23-022 Elevator

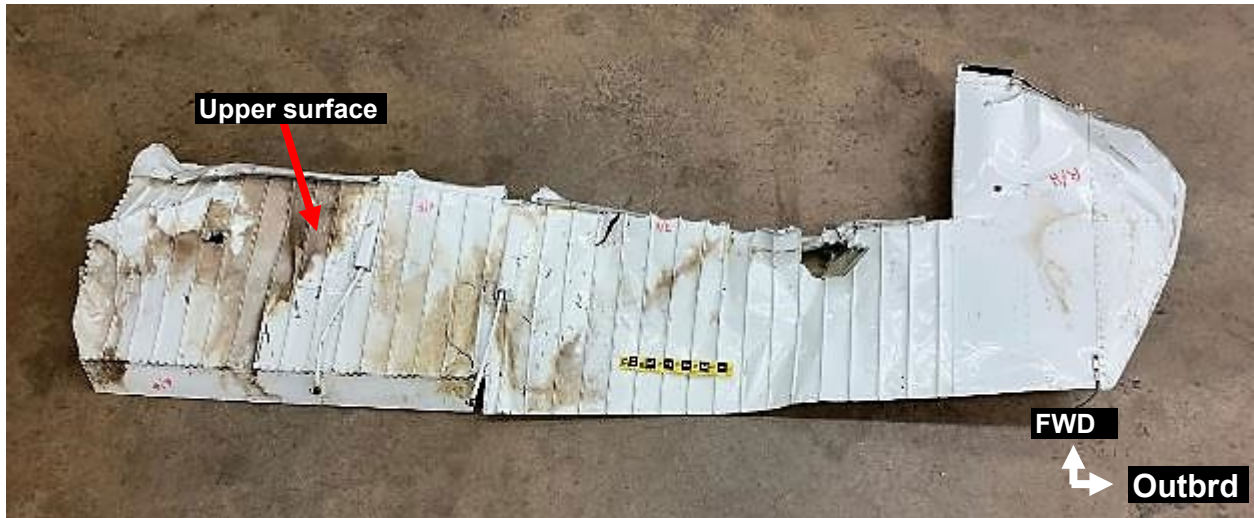
The right elevator was mostly intact but damaged. The right elevator servo tab was intact and remained installed. The two servo tab actuating rods remained attached to the tab at the aft ends and were fractured through the forward rod ends about 22 inches forward of the aft attach points. A section of the inboard root rib about 12 inches long was torn from the right elevator. The center and outboard bearing blocks remained attached to the right elevator forward spar. The center bearing was separated, and the outboard bearing remained installed.

Figure 1. As-received right hand right elevator assembly showing the upper surface.

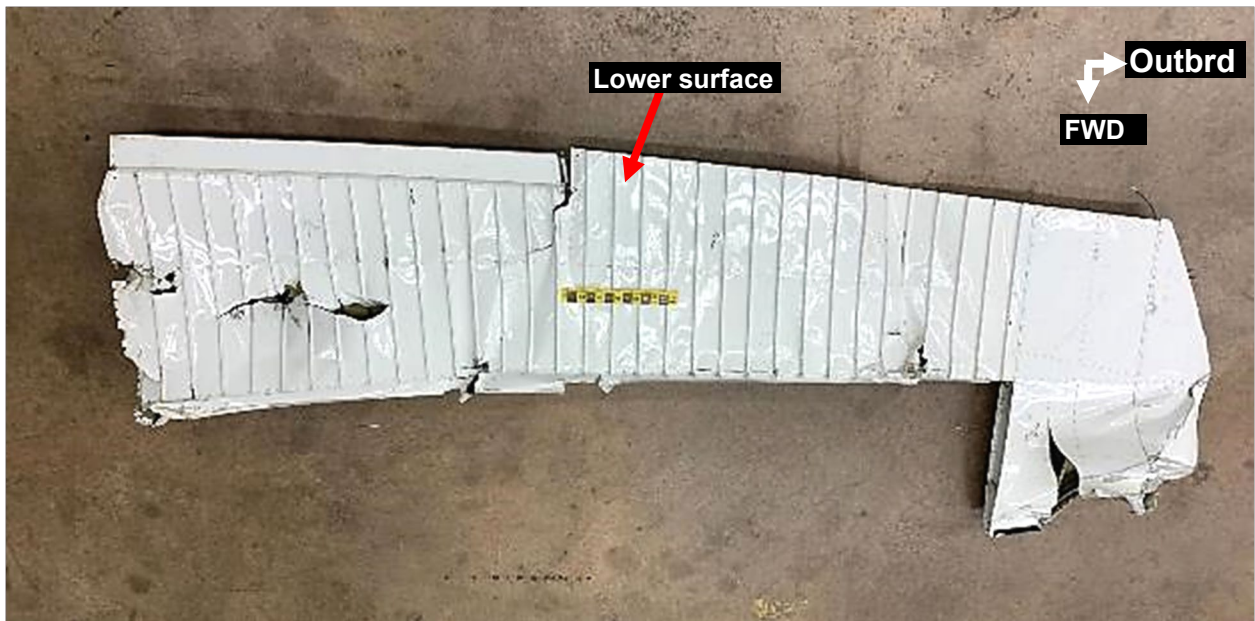
Figure 2. As-received right elevator assembly showing the lower surface.

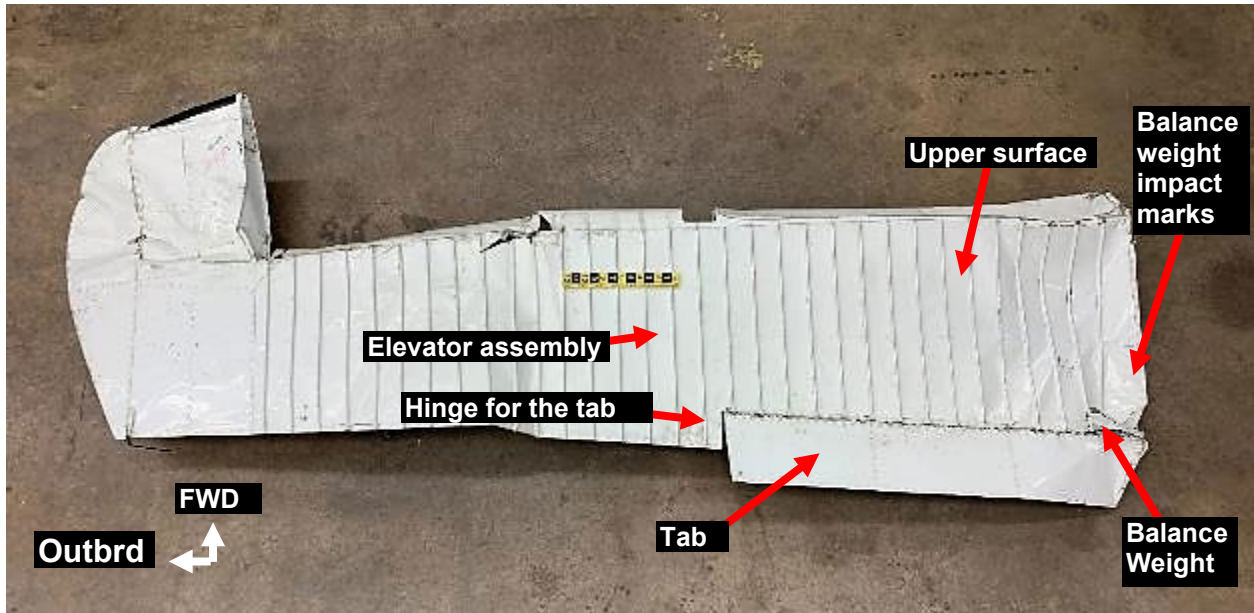
Figure 3. As-received left elevator assembly showing the upper surface. Close-up view of impact marks are shown in figure 16.

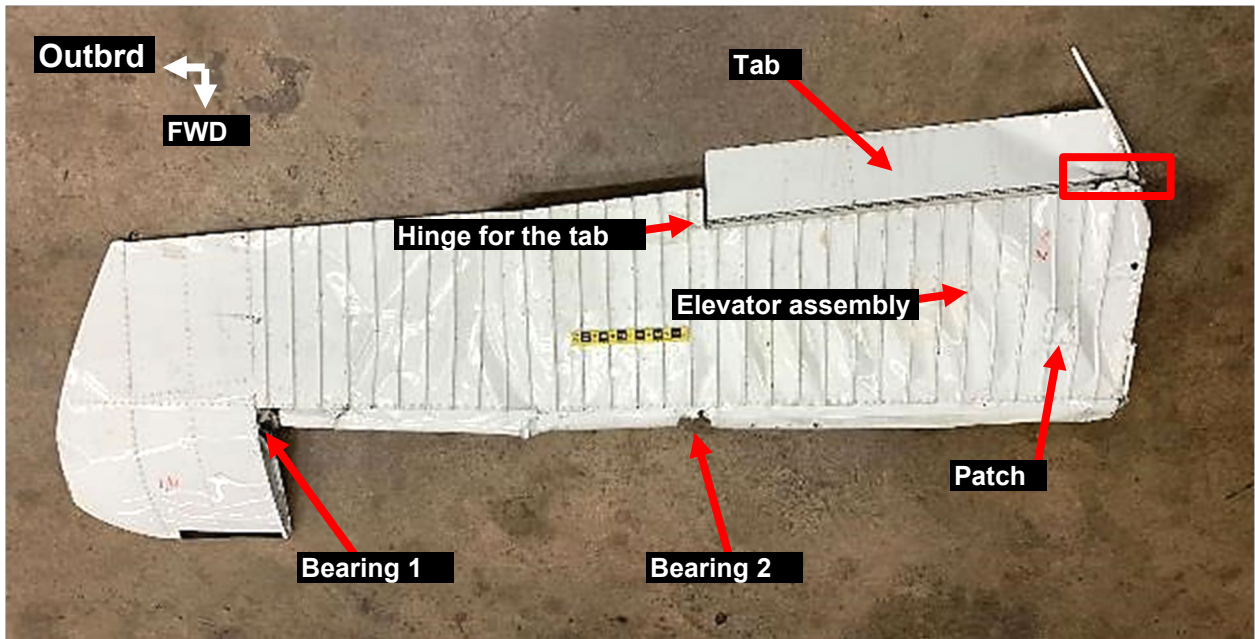
The left elevator was mostly intact but damaged. The left elevator trim tab was intact and remained installed. The trim tab control rod remained attached at the forward and aft ends but was fractured about 6 inches aft of the forward end. The center and outboard bearing blocks remained attached to the left elevator forward spar with the bearings installed. The hinge pin and outboard horizontal stabilizer hinge block remained installed in the outboard elevator bearing. The lower surface of the left elevator contained approximately a 4.9 inches by 4.4 inches repair patch that was located approximately 6 inches from the inboard end and approximately 7 inches from the front spar. The upper surface of the left elevator contained a repair doubler (approximately 11.5 inches long by 1.5 inches wide) coincident with the attach area of the inboard end of the auxiliary spar.

Figure 4. As-received left elevator assembly showing the lower surface. Three cracks were found at the inboard end of the auxiliary spar in the area enclosed by the red square.

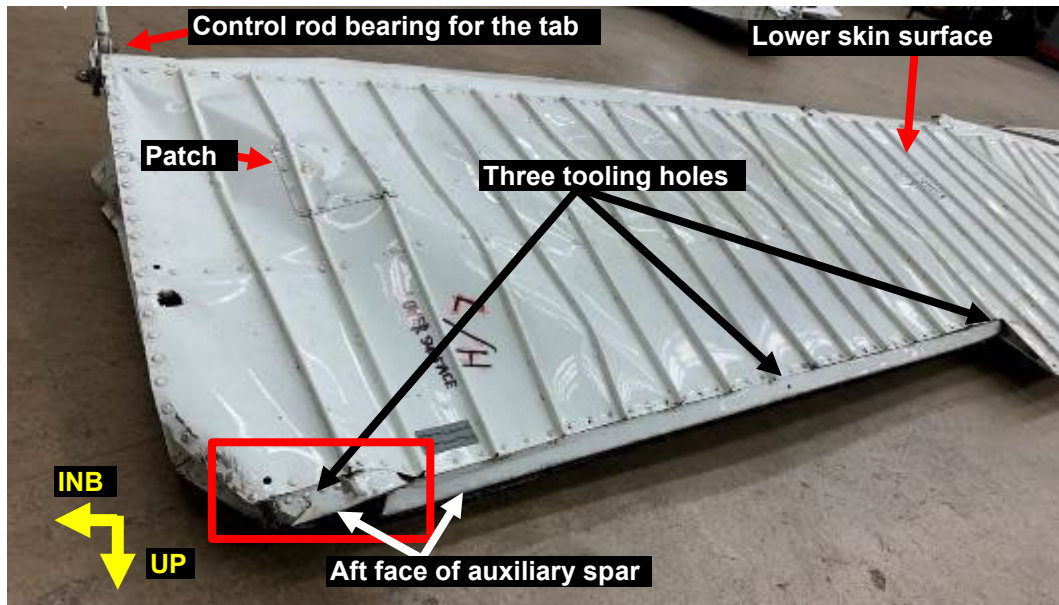
Examination of the left elevator assembly revealed the inboard end of the auxiliary spar contained three cracks (see figures 5 through 9). The three cracks were arbitrarily referred to as cracks "1", "2", and "3". Cracks "1" and "3" were located in the same area that contained a 2-inch long repair doubler (installed at the inboard end on the forward face of the auxiliary spar). Crack "1" extended from the inboard tooling hole to the inboard end of the auxiliary spar. The length of crack "1" measured approximately 0.8 inches. Crack "2" extended nearly vertically through the entire cross section of the auxiliary spar about 4 inches from the inboard end. Crack

Figure 5. Inboard end of the auxiliary spar for the left elevator that contained three cracks (shown after the tab was disassembled from the elevator). The 3 cracks were found in the area enclosed by a red box.

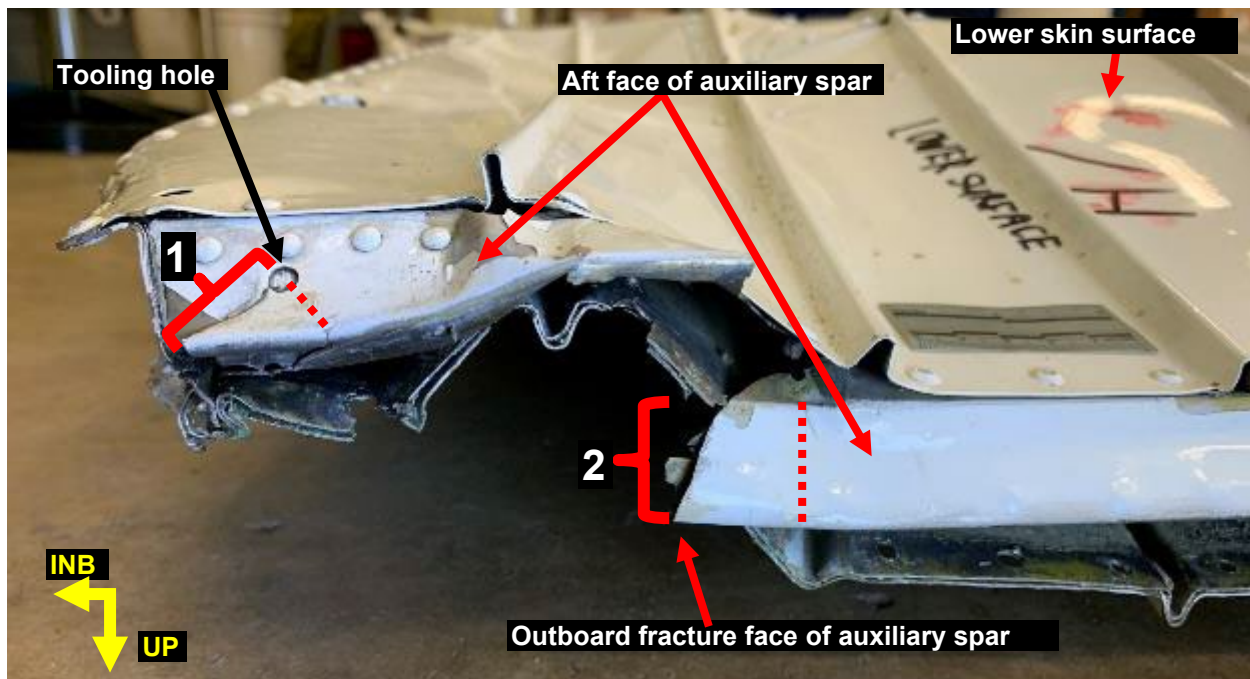
Each crack had two fracture faces. At least one fracture face of each crack was examined by bench binocular microscope and scanning electron microscope (SEM), after the fracture faces were cut out of the spar. The cut areas are indicated by dashed lines in figures 6 through 9. Other views of the inboard end of the auxiliary spar are shown in figures 10 and 11. The excised fracture faces were ultrasonically cleaned with Alconox, a commercial detergent.

Figure 6. View looking forward at the auxiliary spar for the left elevator, shown after the tab was disassembled. Cracks "1" and "2" are shown.

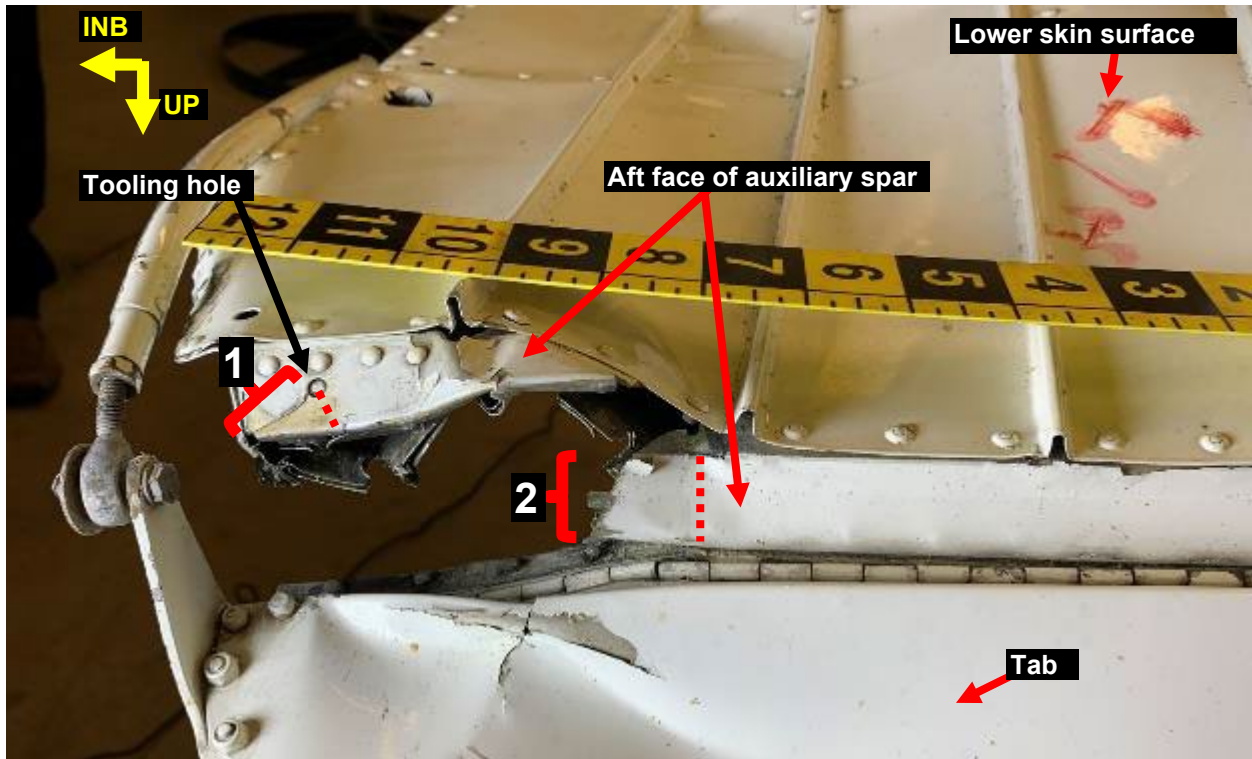
Figure 7. Another view looking forward at the auxiliary spar of the left elevator prior to removing the tab.

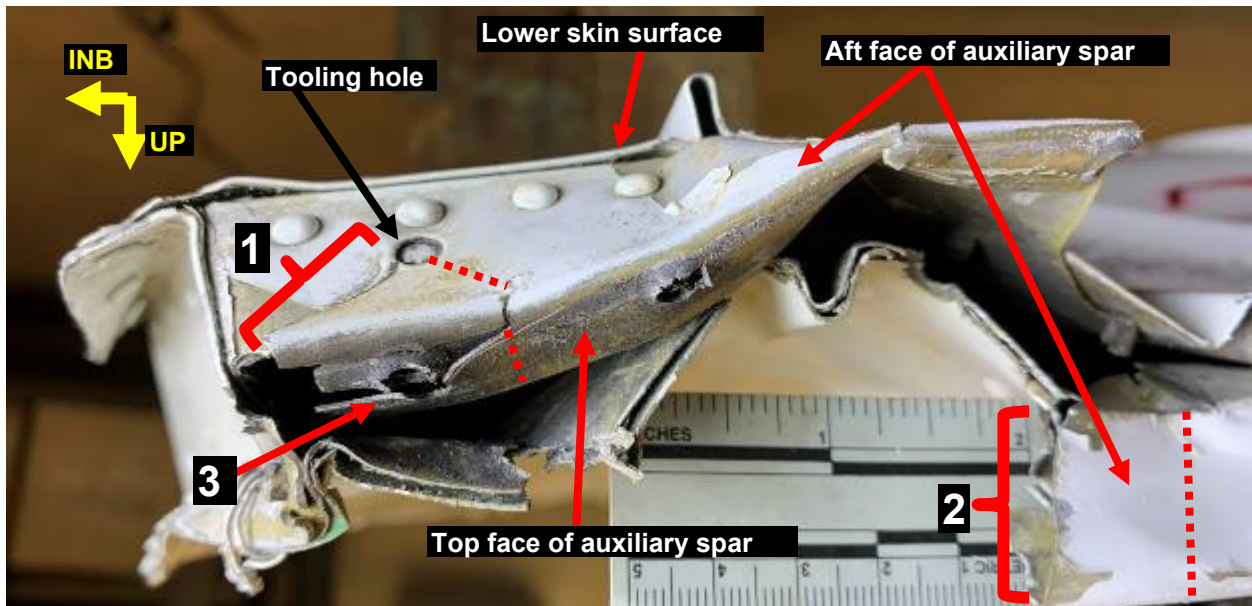
"3" intersected a rivet hole on the top flange of the auxiliary spar. The total length of crack "3" measured approximately 1 inch.

Figure 8. Another view looking forward at the auxiliary spar for the left elevator, after the tab was removed, showing cracks "1", "2" and "3".

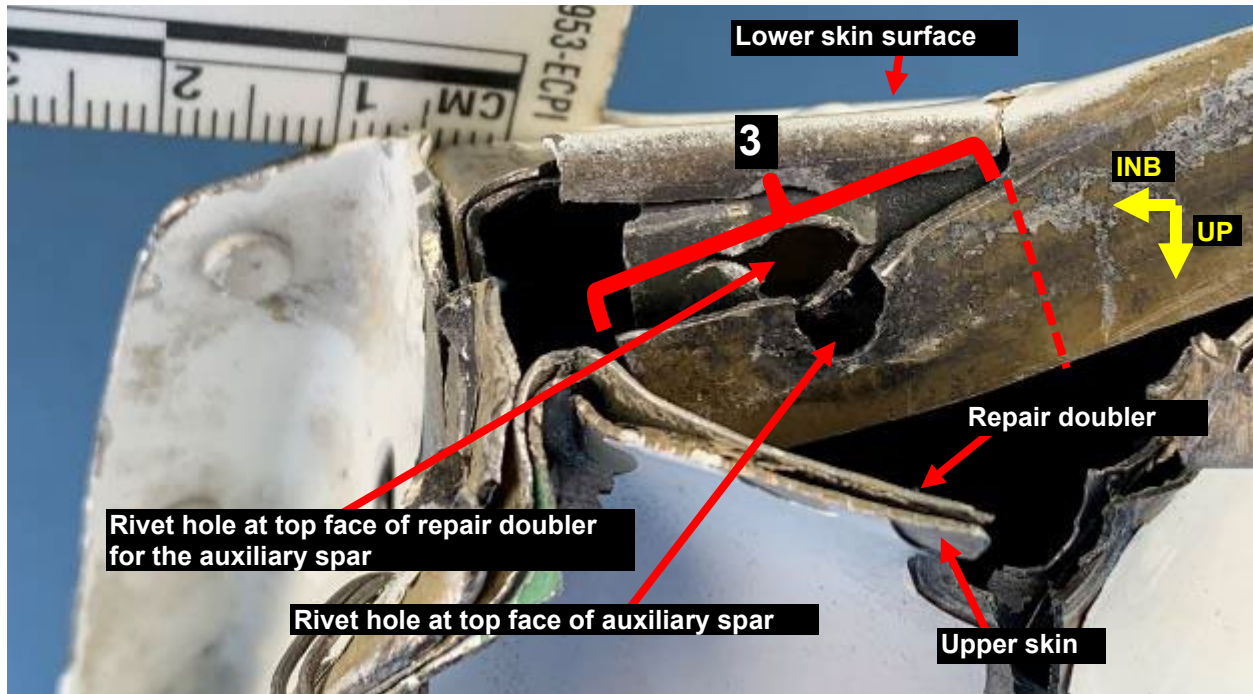
Figure 9. Another view looking forward at the auxiliary spar for the left elevator, after the tab was removed.

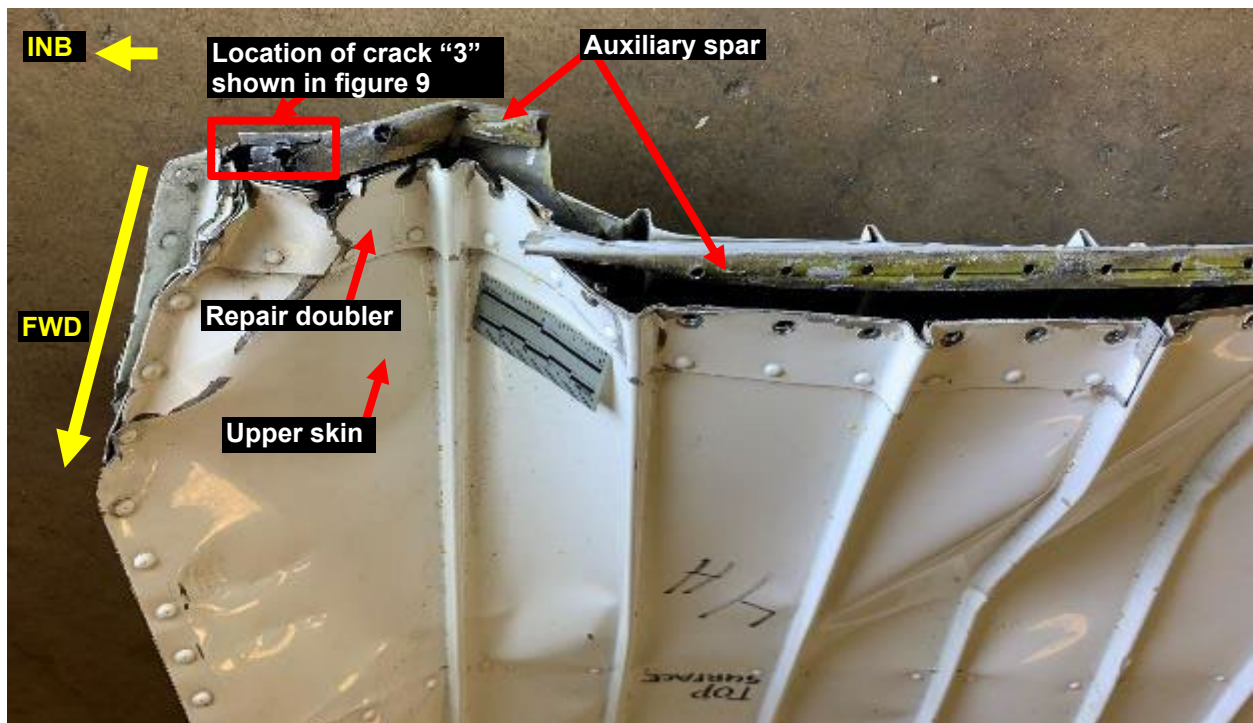
Figure 10. View looking forward and up at the auxiliary spar for the left elevator, after the tab was removed, showing a repair doubler at the inboard end.

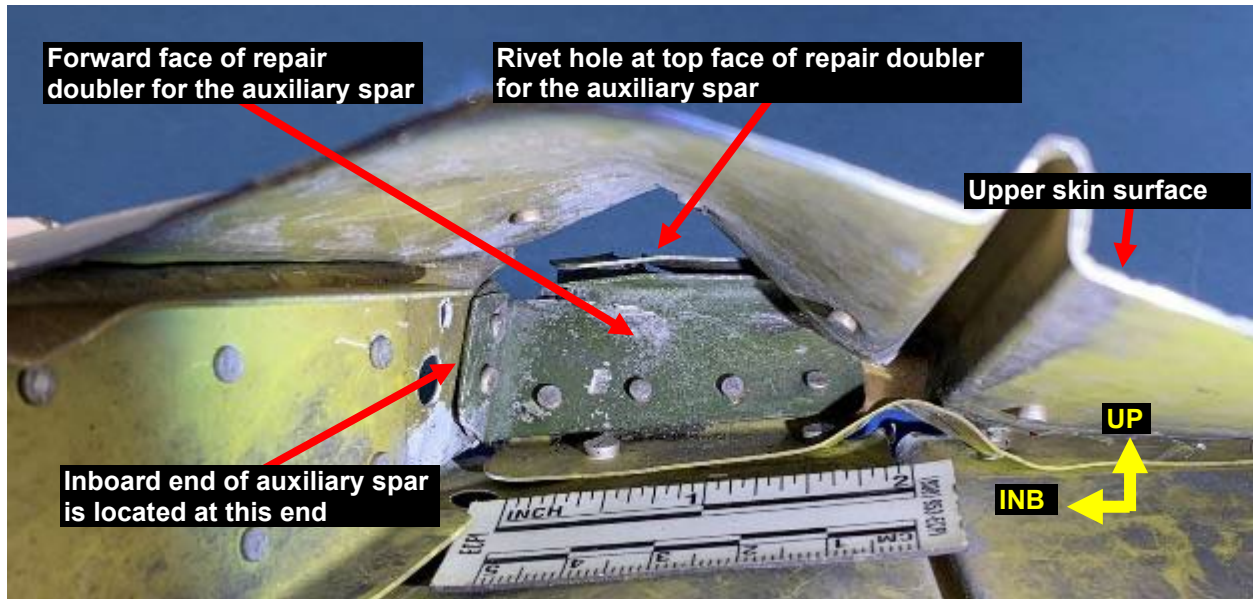
Figure 11. View looking aft at the inboard end of the auxiliary spar after the tab was disassembled showing a repair doubler in the area that coincided with fatigue cracks "1" and "2".

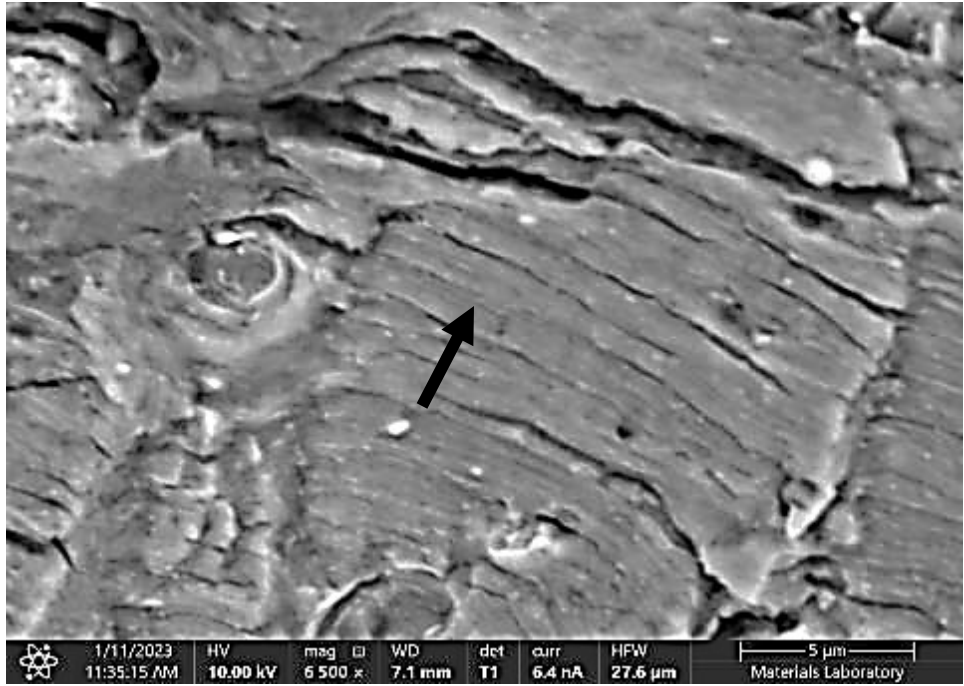
SEM examination of the outboard fracture face of crack "1" revealed the majority of the fracture face contained mechanical damage that resulted from relative movement between mating fracture faces. Isolated areas of the fracture face at the inboard end contained evidence of crack arrest fracture features, typical of fatigue cracking, that emanated from the aft side of the auxiliary spar. Typical fatigue striations are shown in figure 12. The origin of the fatigue cracking was obliterated due to mechanical damage.

Figure 12. SEM image of fatigue cracking on the fracture face of crack "1". Arrow indicates general direction of fatigue crack propagation.

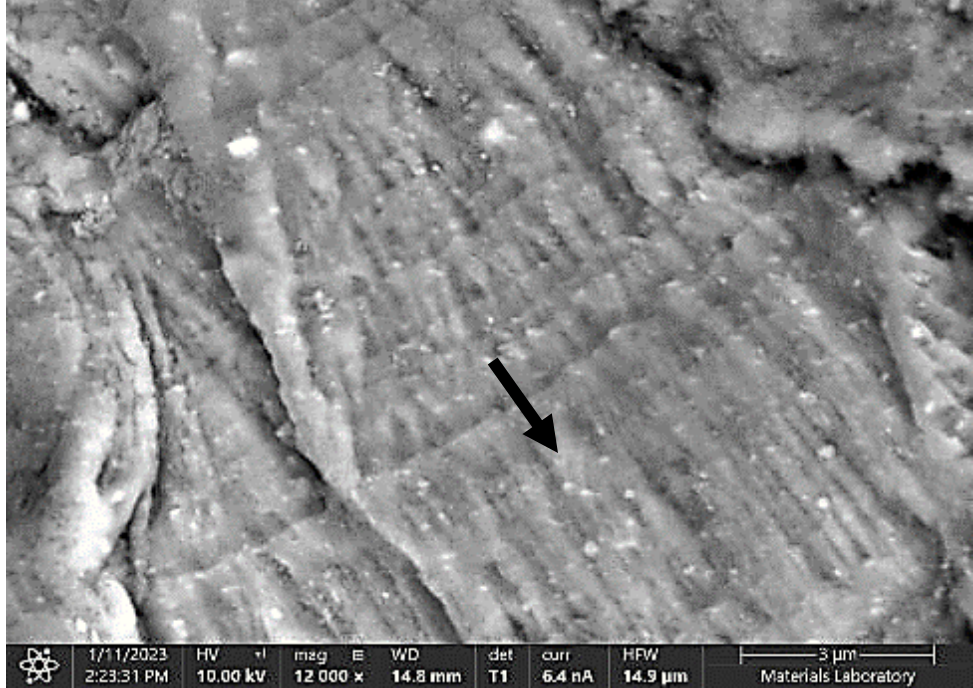
SEM examination of the forward fracture face of crack "3" revealed the majority of the fracture face contained mechanical damage that resulted from relative movement between mating fracture faces and exhibited evidence of dirt on the fracture face. The fracture face was further cleaned with a chromic acid solution that removed dirt and debris from the fracture face.¹ Isolated areas of the fracture face at the inboard end contained evidence of crack arrest fracture features, typical of fatigue cracking, that emanated from the upper side of the auxiliary spar. Typical fatigue striations are shown in figure 13. The origin of the fatigue cracking was obliterated due to mechanical damage.

Figure 13. SEM image of fatigue cracking on the fracture face of crack "3". Arrow indicates general direction of fatigue crack propagation.

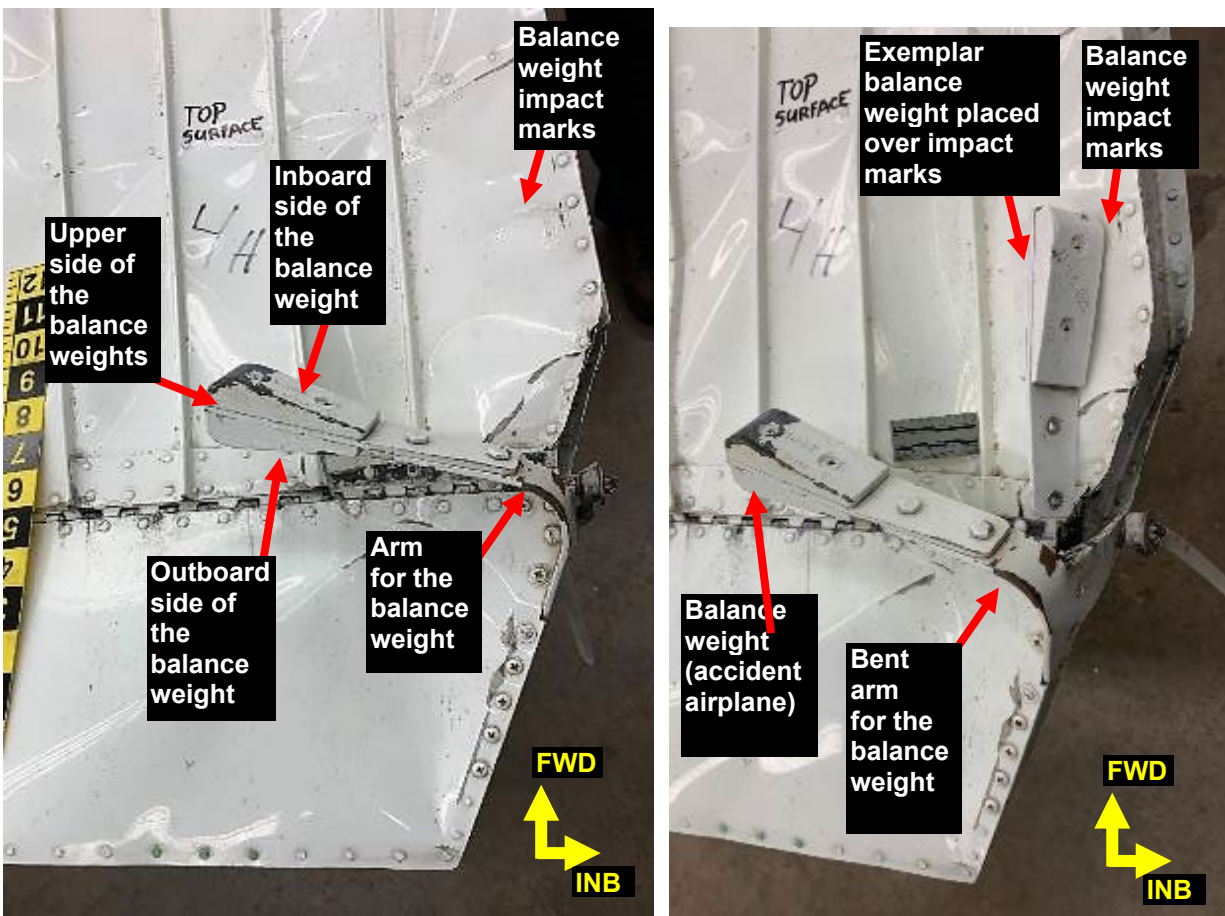
The inboard end of the left elevator contained two balance weights that were attached to an arm that extended from the elevator (see figures 14 and 15). One weight was attached to the inboard side of the arm and another was attached the outboard side of the arm. The inboard weight was stamped part number "C3-TE-15 13A" and stamped "12 OZ", where "OZ" indicated weight in ounces. The outboard weight for the accident elevator was stamped part number "C3-TE-15 15A" and stamped "11.2 OZ". The white paint was missing (had peeled off) from the forward inboard side of the inboard balance weight. Impact marks from the balance weights were found on the upper surface of the elevator (see figure 16). An exemplar balance weight was placed above the impact marks. The upper surface of the elevator contained what appeared to be at least four adjoining impact marks that corresponded to the outline of the bottom side of the exemplar balance weight.

Figure 14. View of the upper inboard surface of the left elevator showing the inward bent arm and attached weight from the accident airplane (left side of page); and an exemplar balance weight that was placed on top of the impact marks (right side of page). The outline of the impact marks resembled the outline of the exemplar balance weight (see figures 15 and 16).

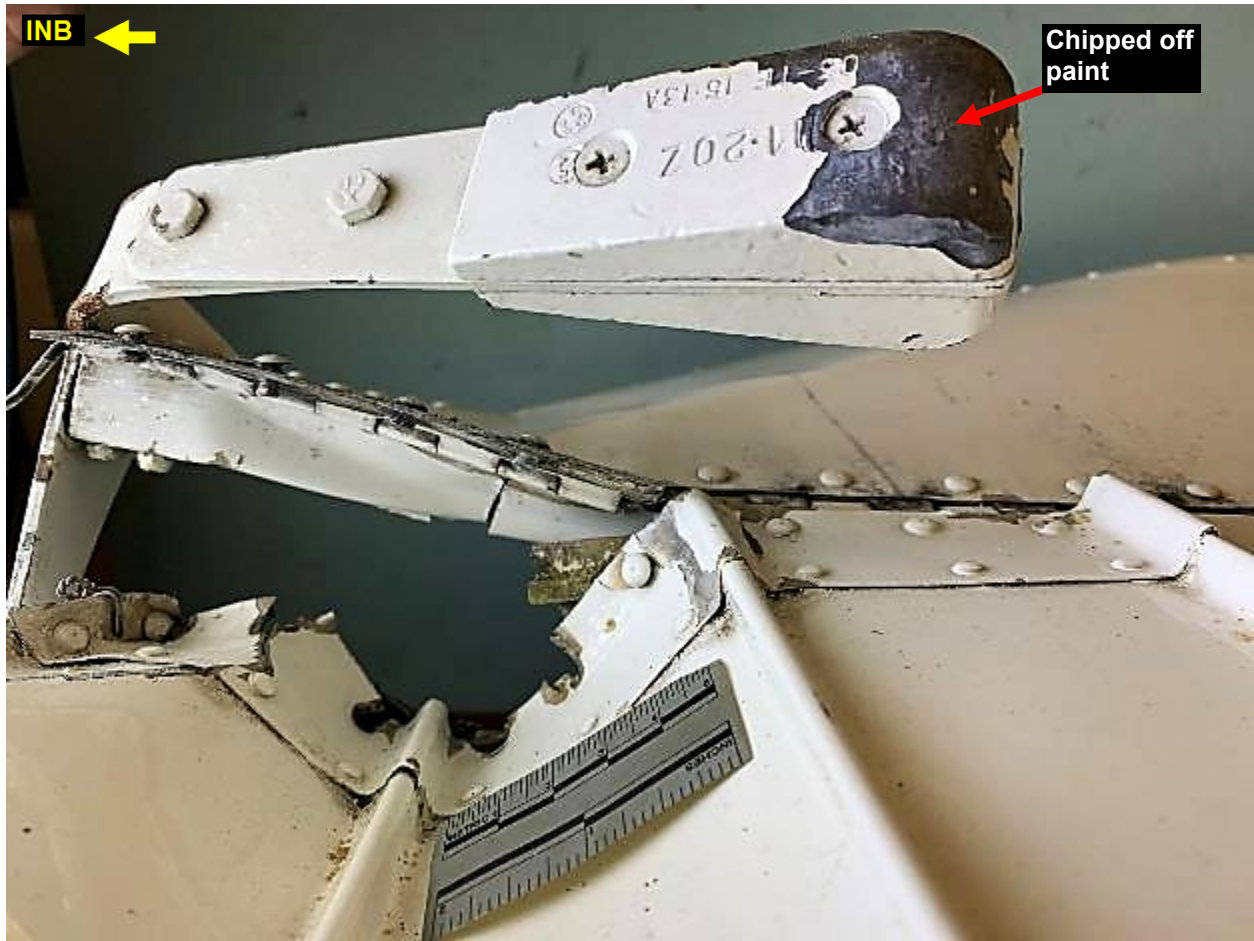
Figure 15. View of the lower side of the balance weights from the accident airplane.

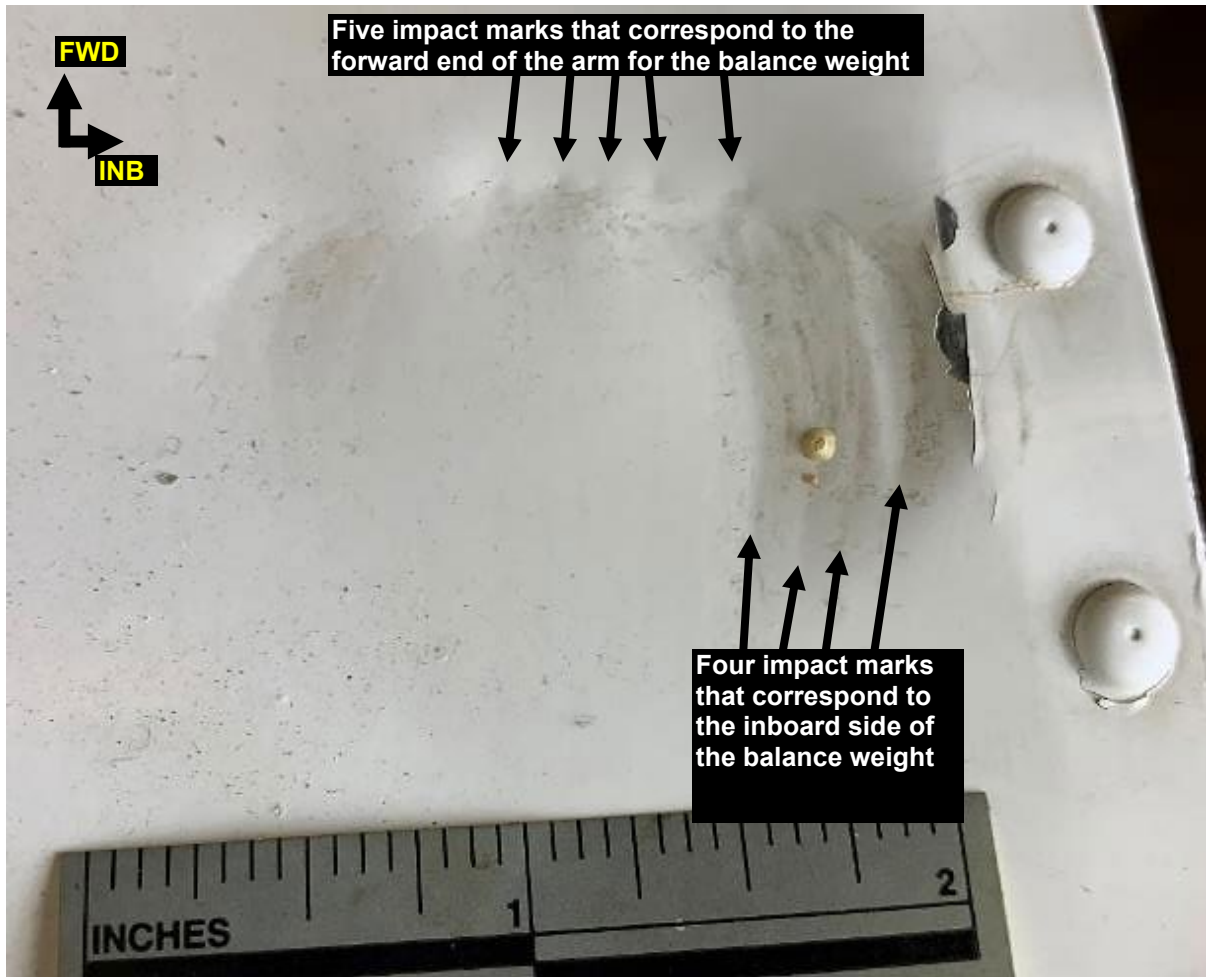
Figure 16. Close-up view of impact marks found at the upper face at the inboard end of the left elevator that resembled the outline of the exemplar balance weight.

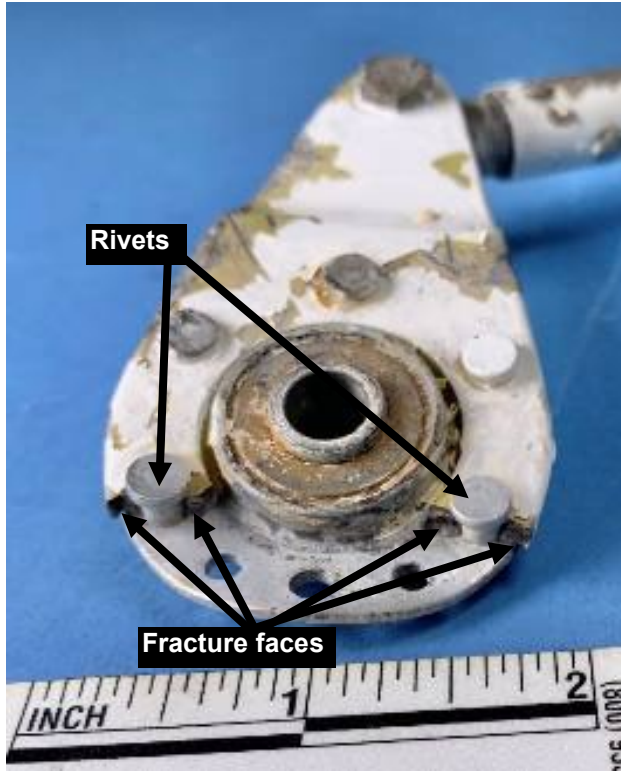
The left elevator tab control rod bellcrank from the forward inboard end of the elevator (see figure 5) was removed. The upper arm of the bellcrank contained a fracture that intersected two rivets (see figure 17). The fracture faces were ultrasonically cleaned in Alconox, a commercial detergent. Bench binocular microscope examination of the fracture faces on the arm portion revealed coarse fracture features on slant planes consistent with overstress separation, with no evidence of fatigue cracking.

Figure 17. Control rod bellcrank that was disassembled from the forward inboard end of the tab for the left elevator.
