# National Transportation Safety Board

DCA22MA193

## **MATERIALS LABORATORY**

Factual Report 23-023

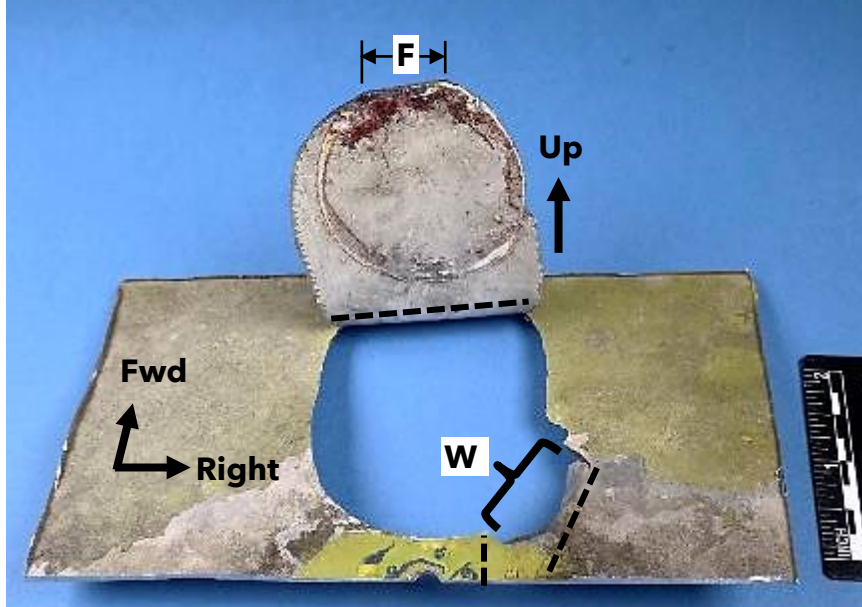
Figures 1 through 6 show photographs of the as-received lower skin panel section from the horizontal stabilizer, with the exception of figure 3(b) which shows a photograph that was taken after cleaning. The panel, about 6.5 inches long and 3.5 inches wide, was cut from the horizontal stabilizer and contained a puncture with the ruptured flap portion that was deformed up. A 1.3 inch portion of the puncture, in the area indicated by bracket "W" in figures 1, 2, and 4, exhibited a deformed curved pattern that was consistent with the shape and size of the barrel outer diameter. The curved pattern contained deformation consistent with the barrel portion pressing toward the right and against the panel. The portion of the flap that remained attached to the panel was located on the forward side of the flap. The length of the flap in the forward-aft orientation measured approximately 2.6 inches and the width in the left-right orientation of the flap measured approximately 2.3 inches.

The flap and panel portions were cut along the areas indicated by dashed lines in figure 1, to facilitate X-ray energy dispersive spectroscopy (EDS) analysis of the fracture faces. The flat panel portion was specified as an aluminum alloy, whereas the lock wire was specified as carbon steel spring wire that was to be coated with cadmium or zinc. EDS analysis was performed on the aluminum panel fractures to determine whether cadmium or zinc was transferred to the aluminum fracture faces. EDS analysis of the flap and panel in areas that contained gouge or mechanical damage revealed no evidence of cadmium or zinc elemental peaks.

**Figure 1.** Lower skin panel section from the horizontal stabilizer in the as-received condition that contained a puncture with a ruptured flap portion that was deformed up. Green painted surface represents the top surface of the panel whereas the white painted surface represents the bottom face. "Fwd" indicates forward.

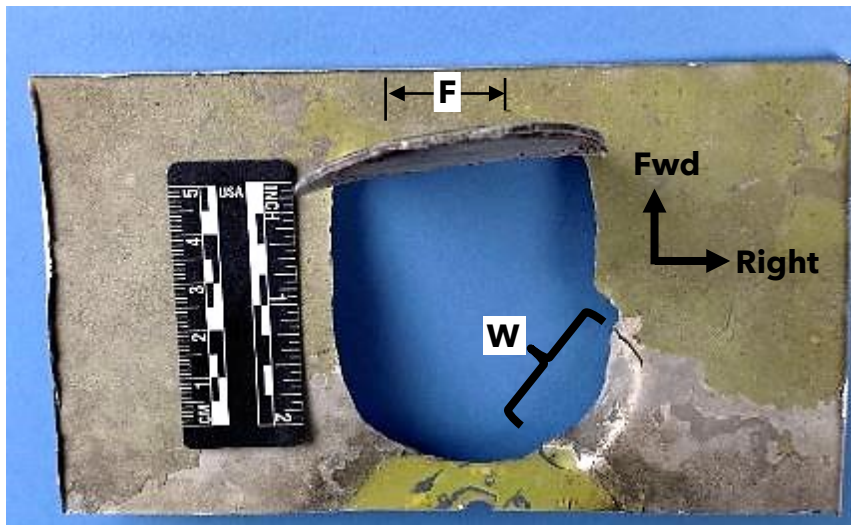
**Figure 2.** View looking down at the lower skin panel section from the horizontal stabilizer, in the as-received condition. Green painted surfaces represent the top surface of the panel.

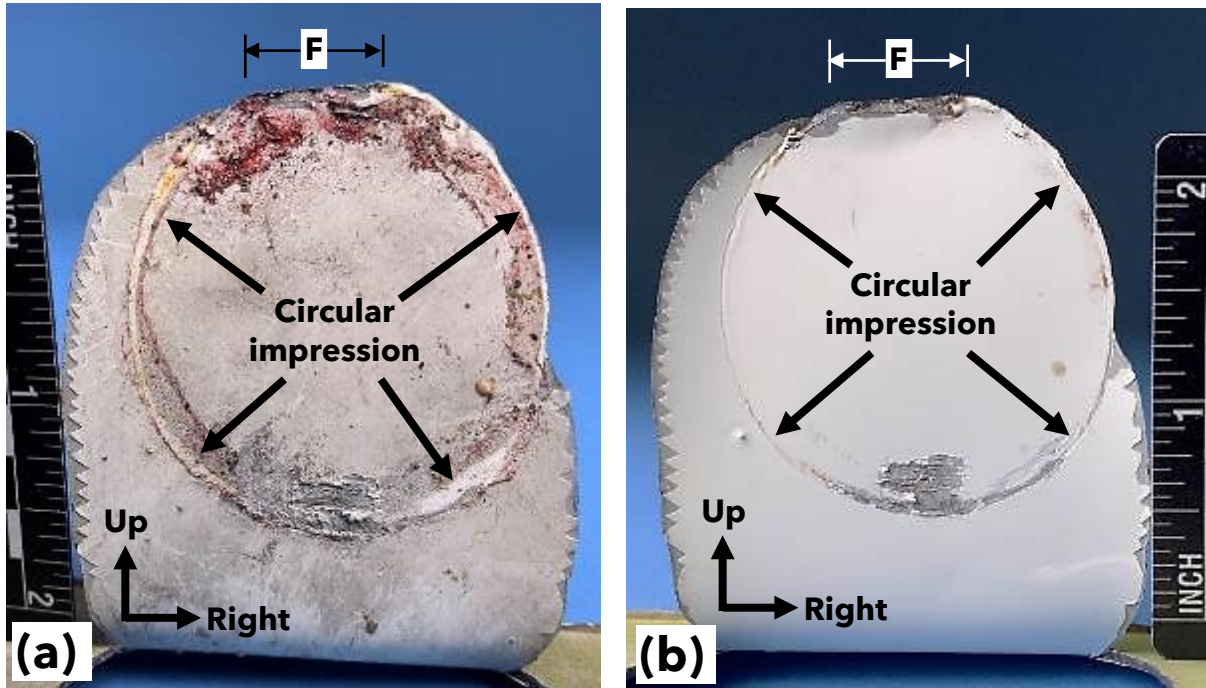
Examination of the bottom surface of the panel (white painted side) revealed evidence of a circular impression that was located within the flap portion, see figure 3. In several areas of the impression the paint layer had fractured and exposed the bare metal surface. The outer diameter portion of the impression in the left-right orientation measured approximately 1.85 inches, consistent with the specified nominal outer diameter of the barrel portion of the stabilizer (1.85 inches). The outer diameter of the impression mark in the forward-aft orientation measured approximately 1.98 inches. The bottom surface of the flap in areas all around the impression mark and within the impression mark was covered with translucent red grease. The forward side of the flap in an isolated area indicated by arrows "H" in figure 4 contained circular dent marks consistent with the forward end of the barrel impacting the flap.

**Figure 3.** View looking at the bottom surface of the ruptured flap portion in the (a) as-received condition and (b) after cleaning with detergent showing a circular impression.

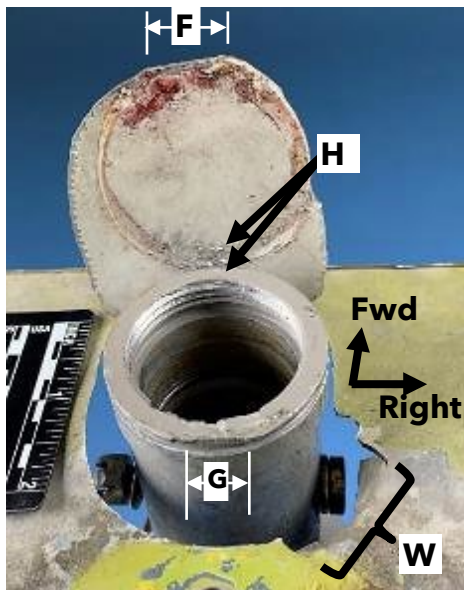
**Figure 4.** View looking down and forward at the lower skin panel for the horizontal stabilizer, in the as-received condition, with the barrel portion of the horizontal stabilizer actuator inserted into the open end of the ruptured flap portion. Green painted surfaces represent the top surface of the panel.

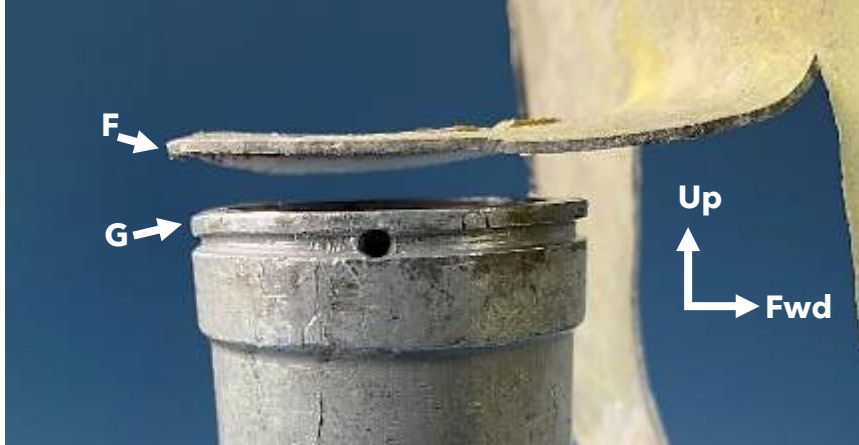
**Figure 5.** Side view of the flap portion with the top face of the barrel facing the bottom of the flap. The outer surface of the barrel at the aft end, in the area indicated by arrow "G", and the aft end of the flap, in the area indicated by arrow "F", exhibited downward deformation. Areas indicated by arrows "F" and "G" in this figure correspond to areas between arrows having the same letter designations in other figures of this report. In this figure, the barrel portion of the horizontal actuator was not inserted into the open end of the ruptured flap portion.

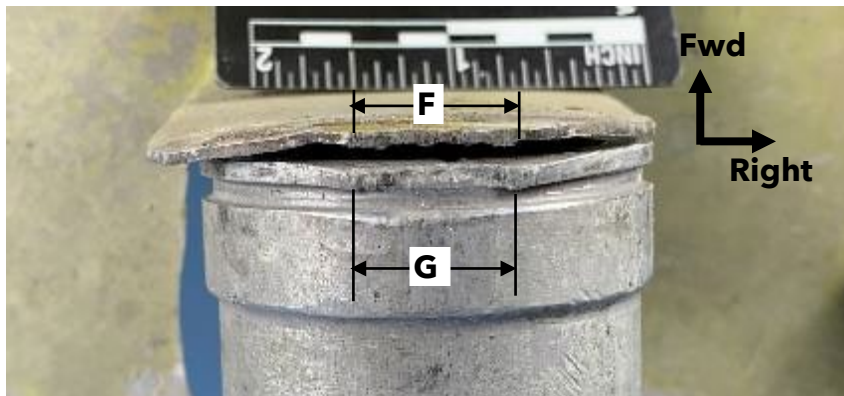
Bench binocular microscope examination of the flap portion revealed the fracture face exhibited coarse features on a slant plane consistent with overstress separation, with no evidence of a pre-existing crack, such as a fatigue crack. The fracture face contained a straight (flat) length portion at the aft end of the flap that measured approximately 1.2 inches, in the areas indicated by arrows "F" in figures 1 through 6. The aft end of the barrel also contained a 1.2 inches straight (flat) length portion, in the area indicated by arrows "G" in figures 4 through 6, that coincided with the straight flat length portion "F". The deformation found in the 1.2-inches flat areas are consistent with barrel portion pushing up and through the bottom panel.

**Figure 6.** Side view of the flap portion looking down with the barrel portion pressing against the bottom face of the flap showing the straight (flat) length portion of the fracture at the aft end of the flap, area between arrows "F", and corresponding flat length portion of the fracture on the barrel, area between arrows "G". In this figure, the barrel portion of the horizontal actuator was not inserted into the open end of the ruptured flap portion.
