# National Transportation Safety Board

ERA23LA041

## **MATERIALS LABORATORY**

Factual Report 23-031

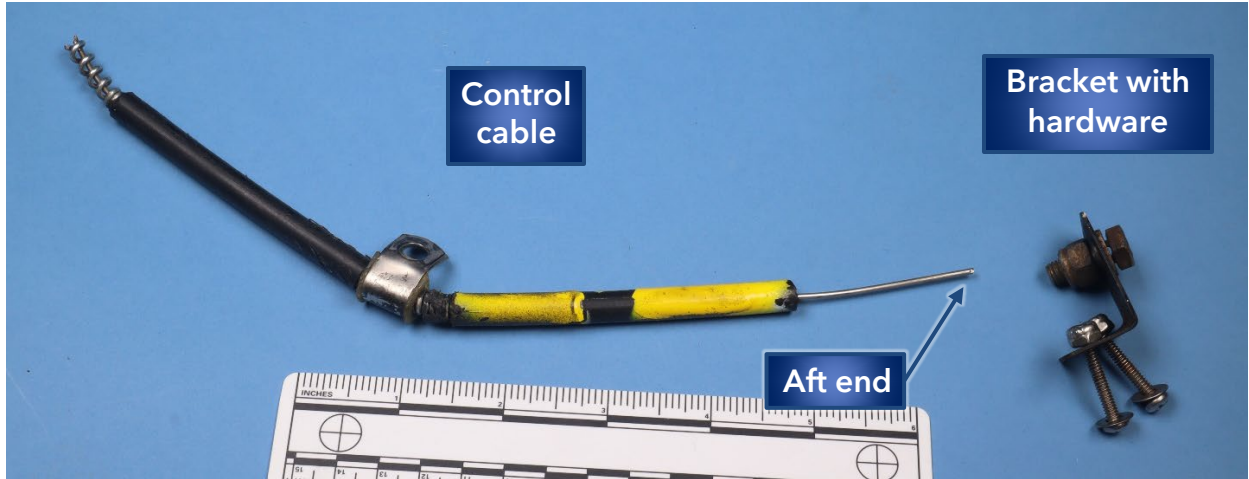
An overall view of the submitted components are shown in figure 1. The aft end of the elevator trim control cable was separated from the attachment bolt on the corresponding attachment bracket. The forward end of the cable piece had been cut from the remainder of the cable, and a clamp remained attached next to a bend in the cable. The trim control cable attachment bracket had been disassembled from the trim tab, and the attaching hardware remained loosely assembled on the bracket. Hardware for attaching the cable to the bracket was intact on the bracket, which was also intact.

**Figure 1.** Elevator trim control cable piece and trim tab attachment bracket with associated hardware as received.

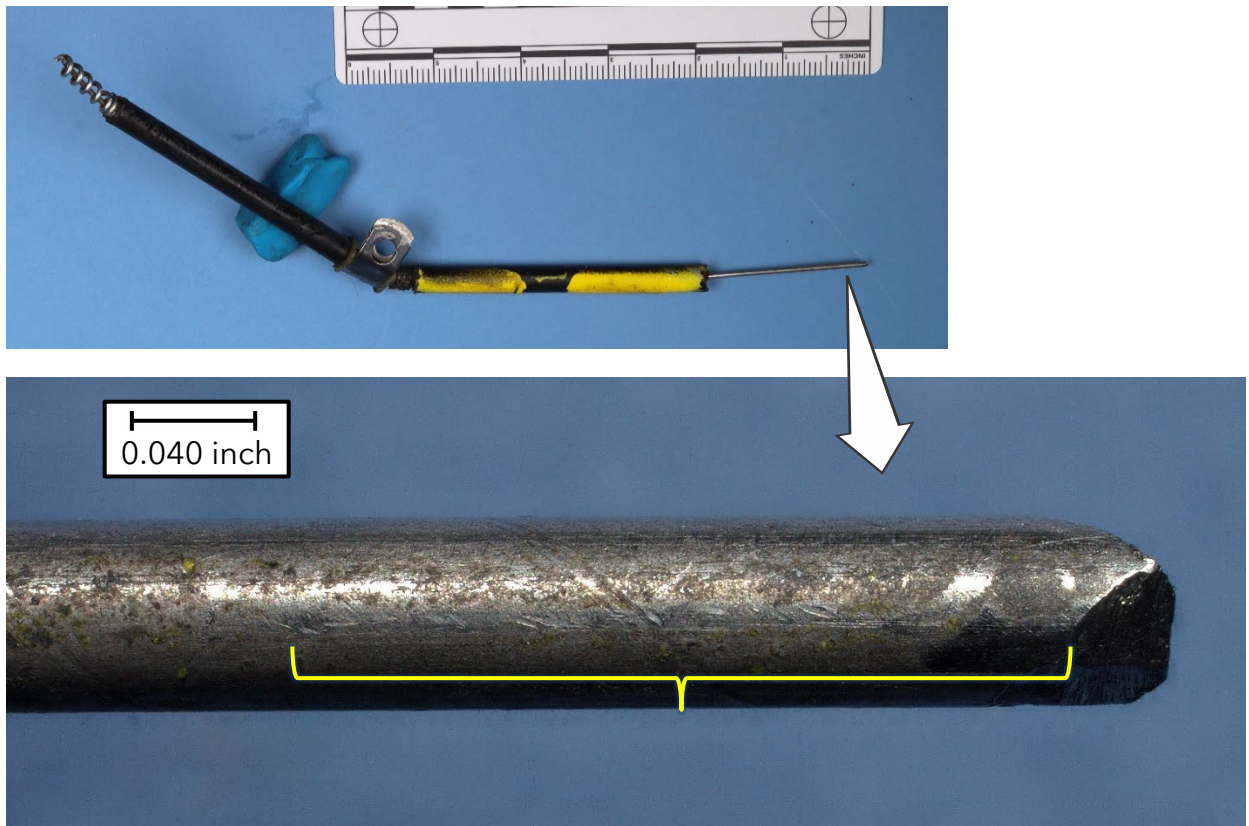
Sliding contact marks were observed on the surface of the cable near the aft end as indicated with a bracket in figure 2. The cable was rotated from the view in figure 1 by lifting the forward end of the piece off the table toward the camera to orient the sliding contact marks to face the camera in figure 2. As evident in this view, the sliding contact marks were located on a side of the cable that was closer to the inside radius of the bend.

**Figure 2.** Another view of the aft end of the control cable piece (upper image) with a closer view (lower image) showing sliding contact marks as indicated with a bracket.

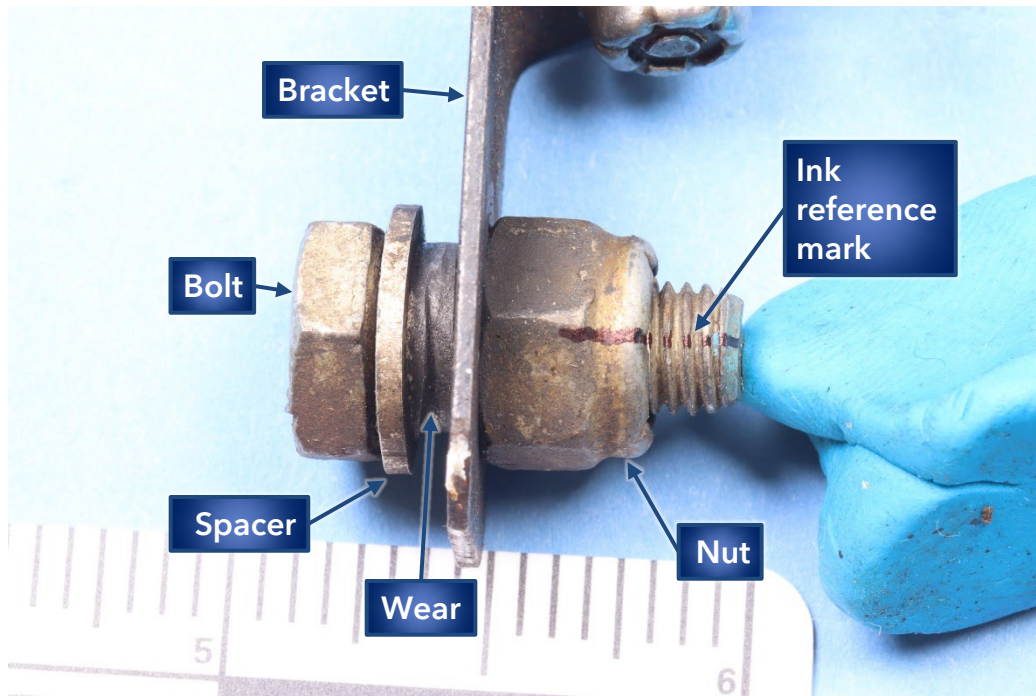
A closer view of the elevator trim control cable attachment hardware on the bracket is shown in figure 3. The hardware consisted of a bolt, nut, and spacer. The hat-shaped spacer consisted of a larger-diameter "brim" and a smaller-diameter "body". The spacer moved freely on the bolt grip between the bolt head and the nut, and the body slid easily into a hole for the spacer body in the bracket. The side of the spacer body was worn as indicated in figure 3 consistent with contact with the corresponding hole in the bracket.

Next, the bolt threads and the nut were marked in ink as indicated in figure 3 to note the relative positions of the nut and the bolt. Before disassembling the cable attachment hardware, the nut was initially rotated in the tightening direction. The nut rotated about 10 degrees, and the rotation was stopped due to rapidly increasing resistance. The nut was then removed from the trim control cable attachment bolt to facilitate further examination of the bolt and the cable contact faces on the spacer. On the bolt, the thread runout area adjacent to the grip appeared rubbed consistent with contact with the nut threads.

**Figure 3.** Close view of the trim tab control cable attachment hardware on the trim tab bracket.

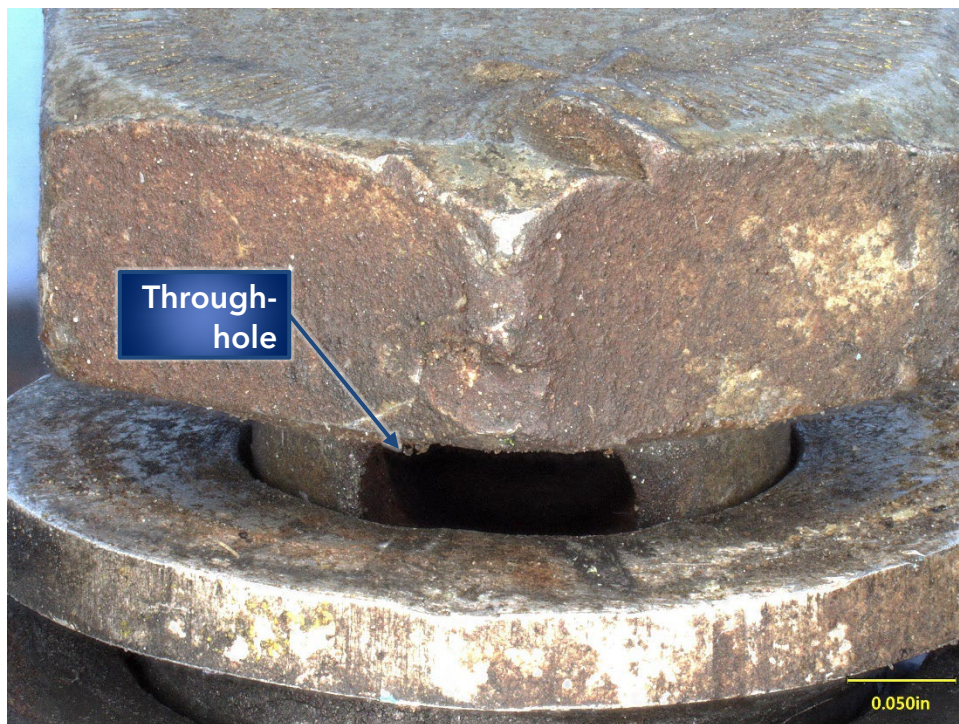
The spacer body was slid into the hole in the bracket until the spacer contacted the nut, revealing a through-hole in the shank under the bolt head as shown in figure 4. The spacer and bracket were then moved toward the bolt head, revealing the bolt shank adjacent to the clamping face of the nut. Only the smooth grip portion of the bolt shank was revealed, and no exposed threads were observed adjacent to the nut clamping face.

**Figure 4.** View of the through-hole in the shank of the trim tab attachment bolt with the spacer positioned against the nut.

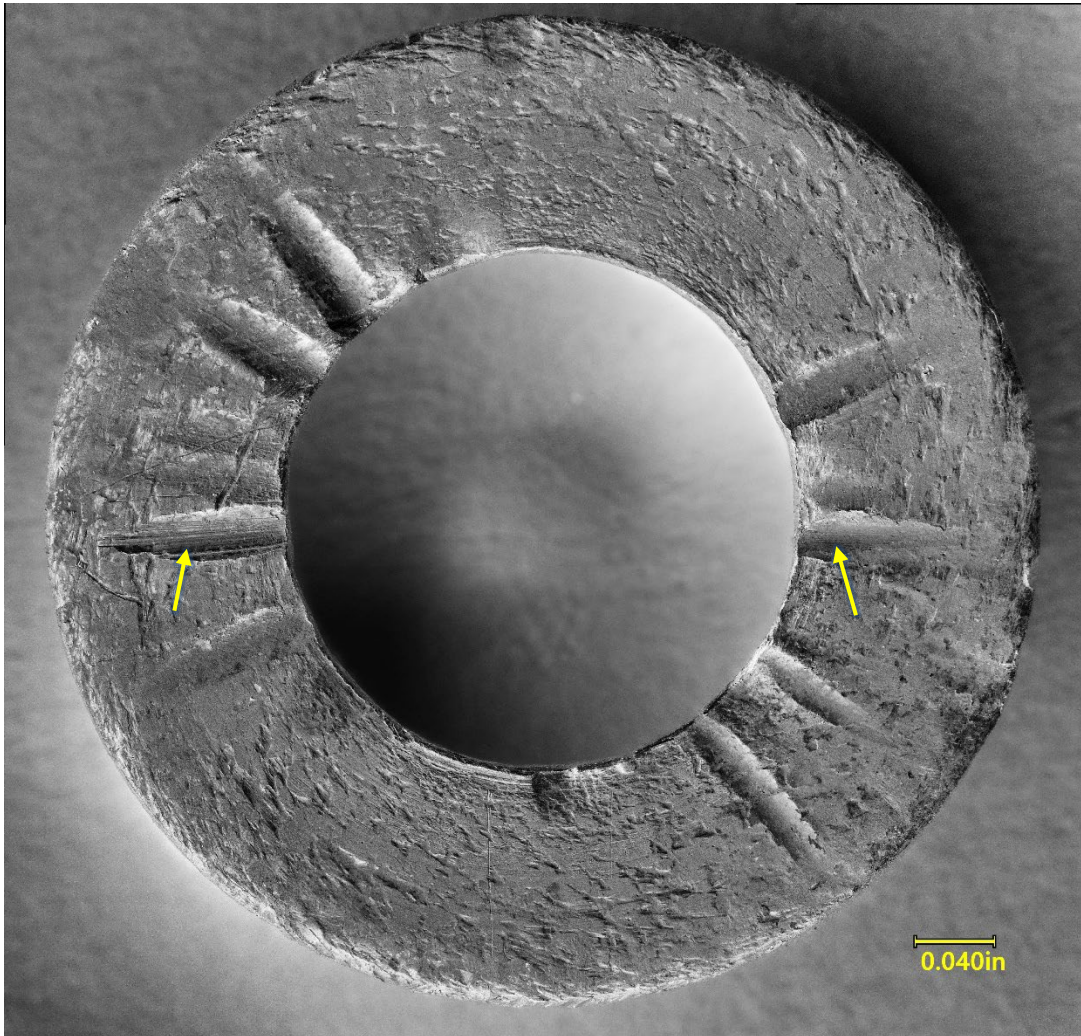
The spacer surfaces were partially covered with greasy black deposits. After an initial examination under an optical stereomicroscope, the spacer was dipped in a beaker of acetone and cleaned using an ultrasonic cleaner. A view of the cleaned contact faces of the spacer is shown in figure 5. The image shown in figure 5 is a montage of obtained in shadow mode and stitched together using a Keyence VHX-7000 optical microscope.

As shown in figure 5, multiple impressions were observed around the circumference of the contact face consistent with cable contact from multiple assembly positions. All but two of the impressions had relatively smooth surfaces consistent with static contact with the cable. The two impressions as indicated with arrows in figure 5 had radially-oriented sliding contact marks consistent with the cable sliding against the spacer. The two impressions with sliding contact marks were located on opposite sides of the spacer, consistent with a single installation position.

**Figure 5.** Elevator trim control cable contact face of the spacer after disassembly and cleaning obtained using a Keyence VHX-7000 optical microscope in shadow mode. Arrows indicate two impressions with sliding contact marks.
