# National Transportation Safety Board

ENG22LA004

## **MATERIALS LABORATORY**

Factual Report 23-047

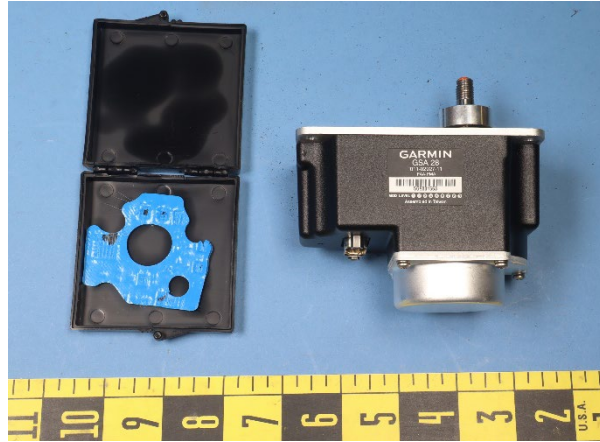
An overall view of the submitted Garmin GSA 28 servo actuator, serial number 5G9001953, is shown in figure 1. The servo actuator circuits had previously been tested and disassembled at a Garmin facility where the blue thermal pad had been removed to facilitate a visual examination. Testing showed motor current measurements were out of range.

**Figure 1.** Overall view of the submitted servo with a separate box containing the blue thermal pad.

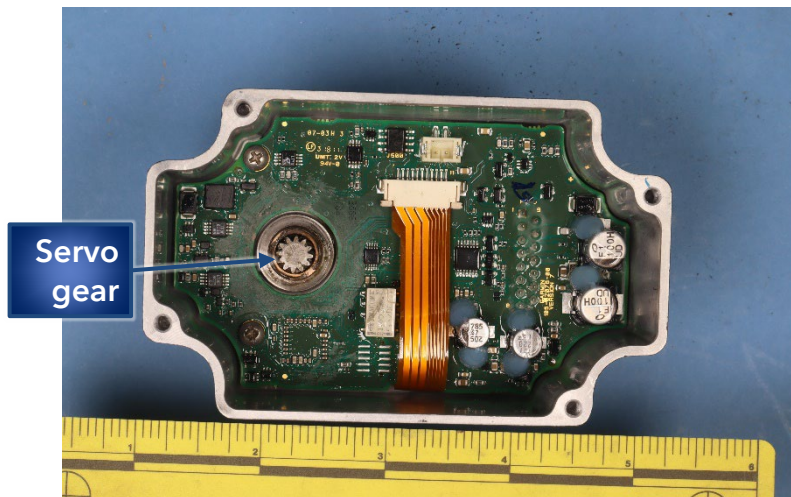
**Figure 2.** Circuit board after removing the cover plate. The resistors shown in figure 3 were located on the opposite side of the circuit board.

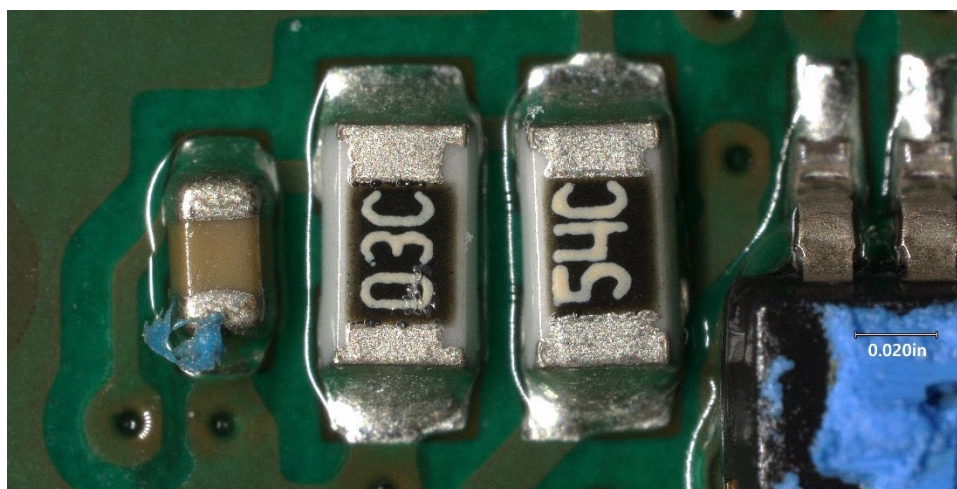
Resistors identified by Garmin as associated with the motor current circuit are shown in figure 2. Semi-spherical growths consistent with sulfuration were observed at the edges of the resistor film as shown with unlabeled arrows in figure 3.<sup>1</sup> The resistors were located close to the servo gears, and similar indications of sulfuration damage were observed on other resistors on the circuit board that were also located close to the servo gears. The growths appeared to be absent from resistors located at the opposite end of the circuit board.

**Figure 3.** Resistors in the faulty motor circuit as identified by Garmin representatives.

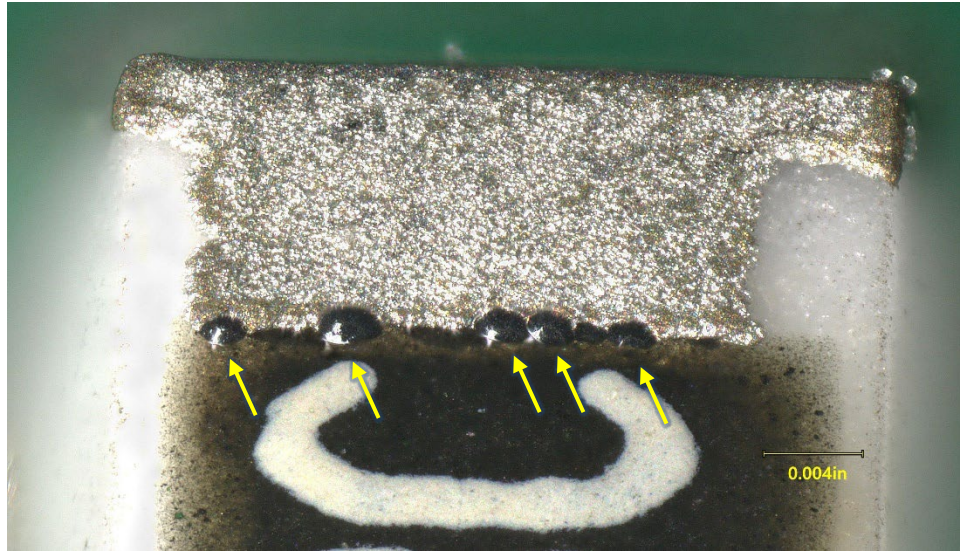
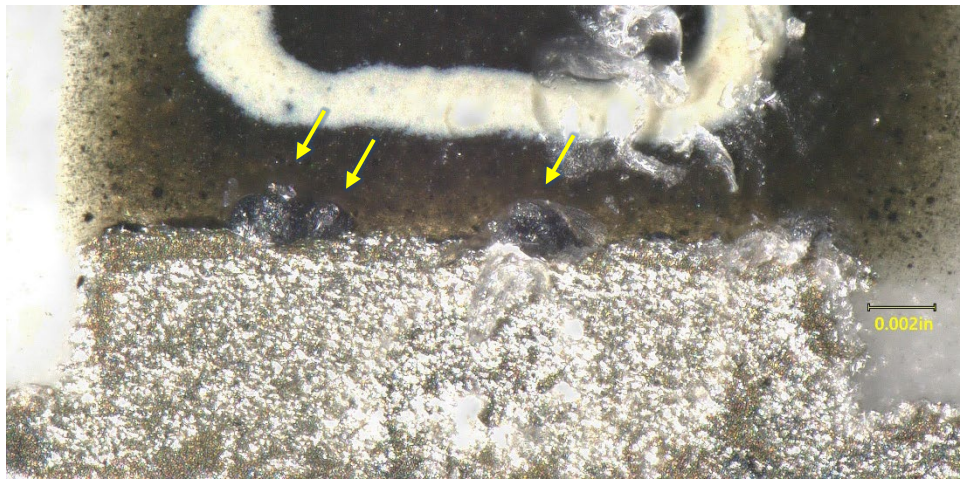
<sup>1</sup> Sulfuration of resistors is a condition where silver electrodes on the resistor react with sulfur gas to form sulfides, which can degrade the connection and destroy the resistor.

The subject servo actuator had a serial number that was within the range of numbers affected by Garmin Service Bulletin (SB) 2063, Rev. B issued May 6, 2020. Garmin had identified premature failures due to sulfuration in the subject servo actuators, which had prompted the issuance of the SB. The stated purpose of the SB was to identify and replace failed servo actuators, and compliance was recommended at the next scheduled maintenance opportunity.

**Figure 4.** Semi-spherical growths at the contact edges of the resistor labeled 03C consistent with sulfuration damage.

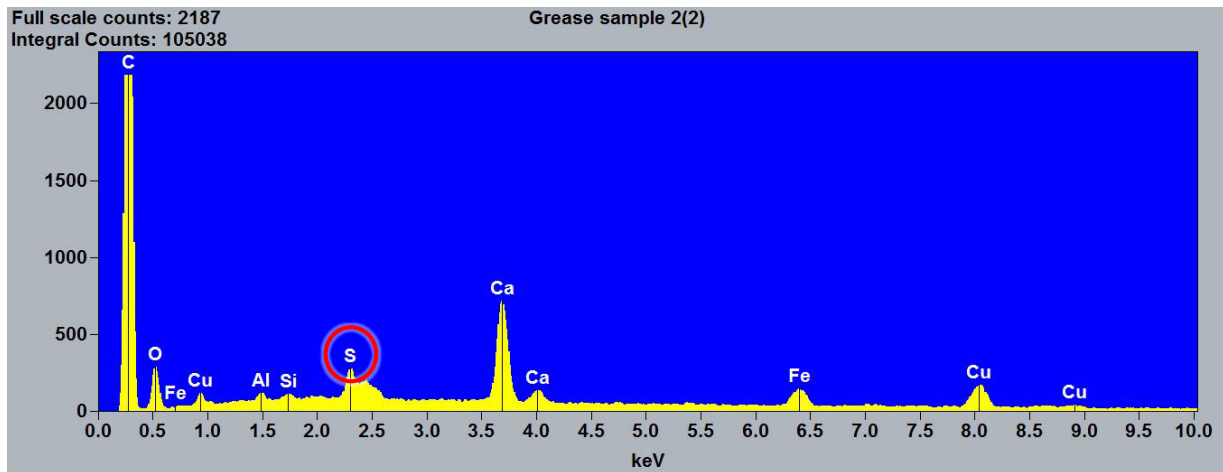
A sample of grease was collected from the servo gears and was analyzed using energy-dispersive x-ray spectroscopy (EDS). The resulting spectrum is shown in figure 5 was analyzed using a 30 kV accelerating voltage. A peak associated with sulfur was observed as shown circled in figure 5.

**Figure 5.** EDS spectrum of a grease sample from the servo showing a sulfur peak.
