# National Transportation Safety Board

WPR22FA361

## **MATERIALS LABORATORY**

Factual Report 23-054

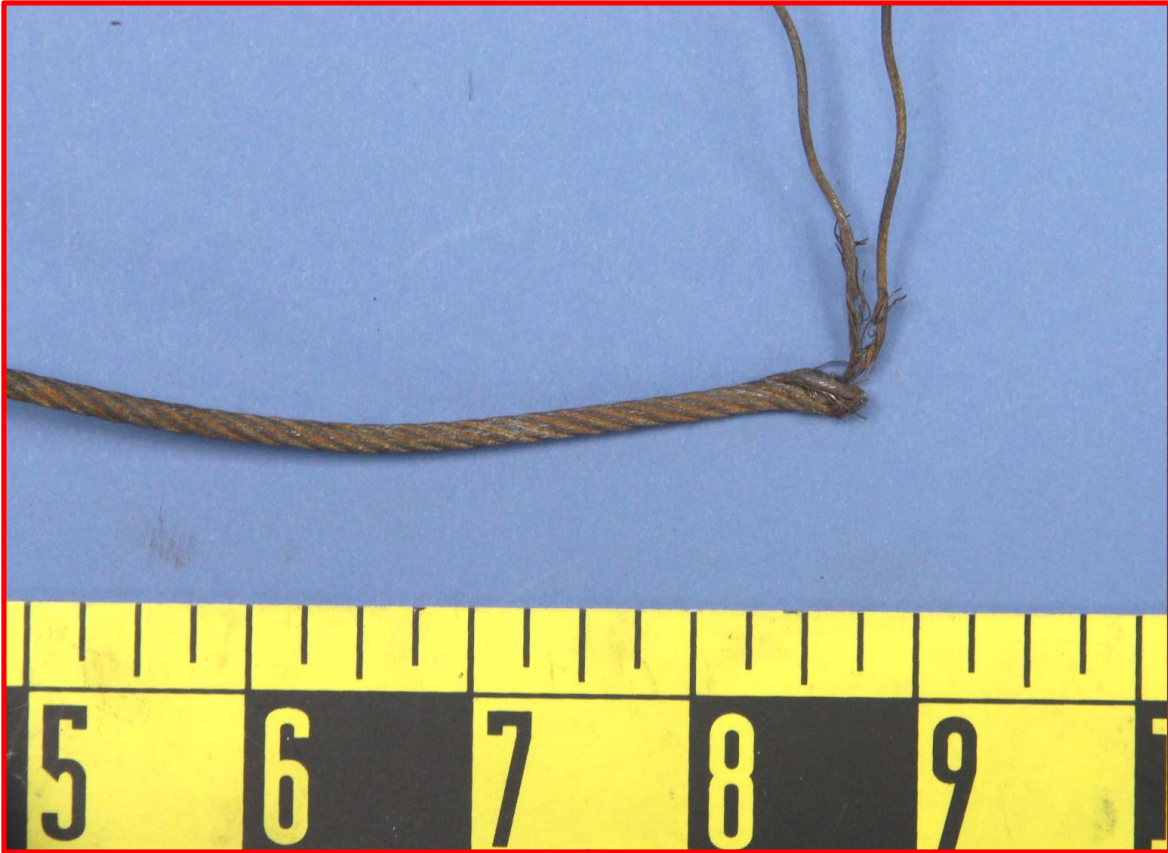
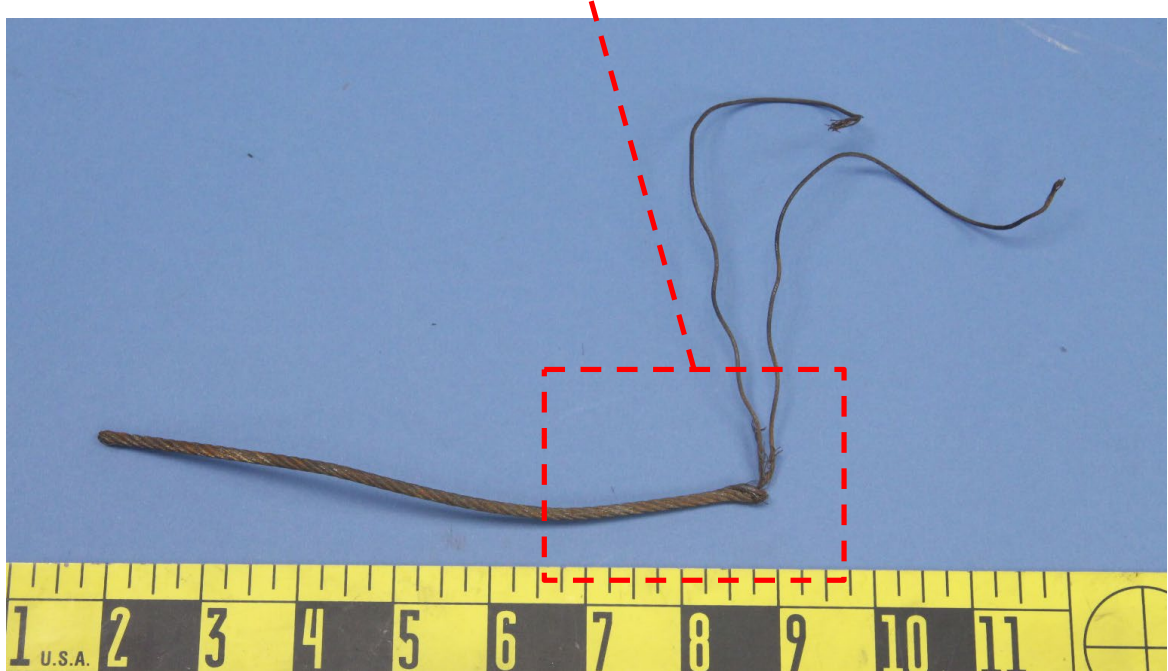
A portion of control cable was submitted for examination. Figure 1 shows that most of the cable was still bundled and had separated approximately 8 inches from the cut end. Two strands had unwound from the overall cable and extended an additional 5 inches, as shown in Figure 4.

**Figure 1.** An overall photo of the submitted portion of cable is shown in the bottom. A close-up photo showing the separated still bundled end of the cable is shown in the top.

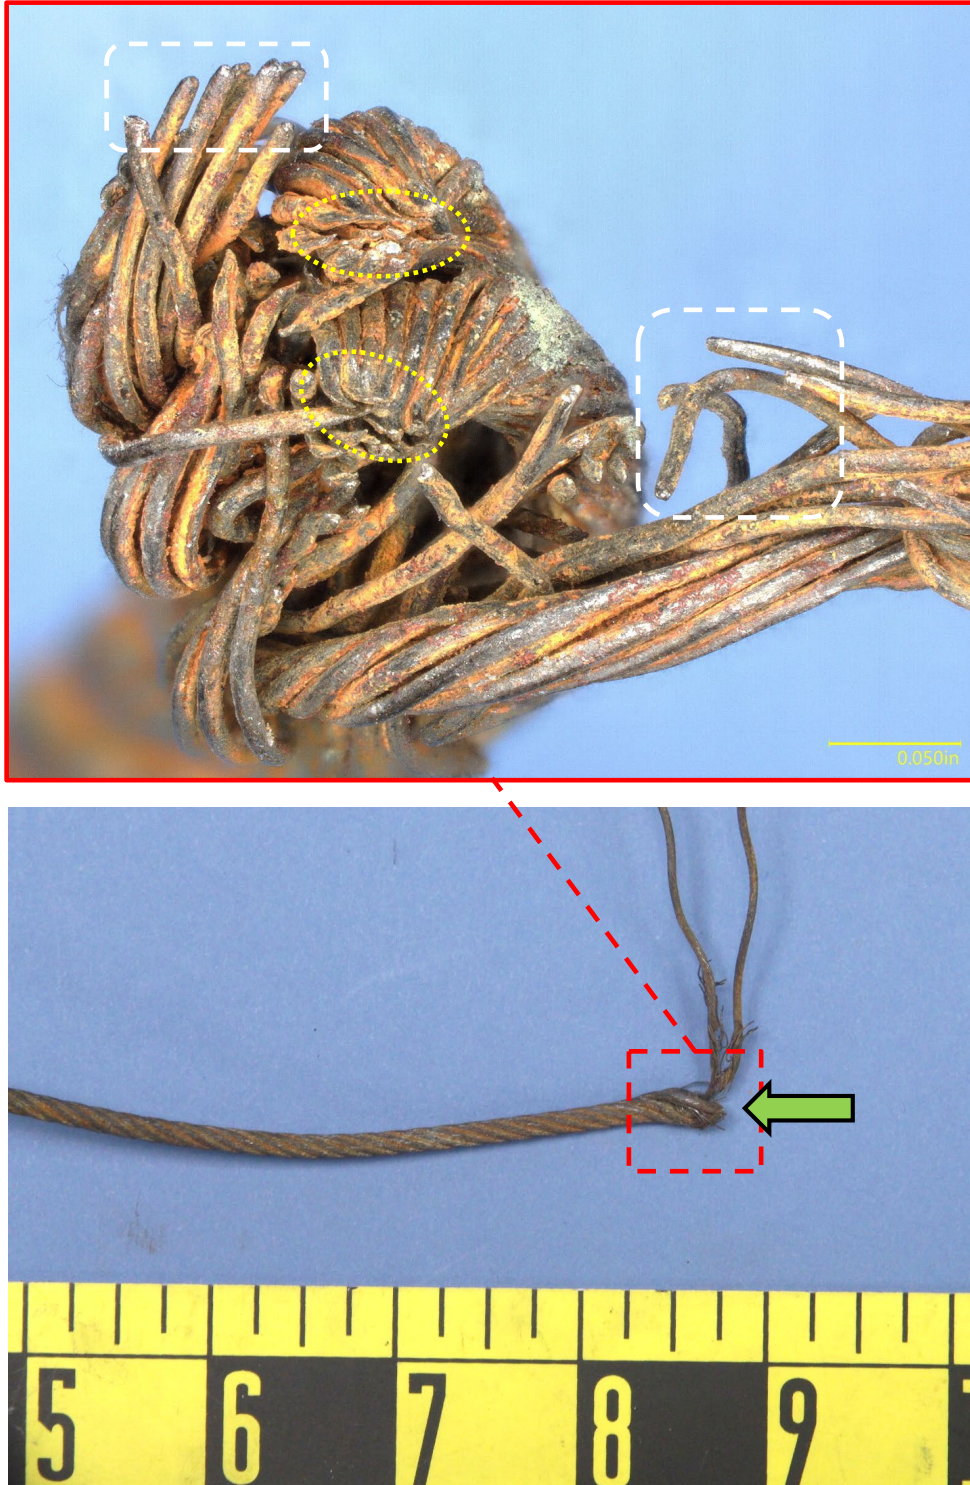
The separated wire ends throughout the entire length of the cable were examined using a 5x to 50x magnification stereo microscope. Digital microscope images of wire fracture surfaces at the still bundled segment of cable are shown in Figures 2 and 3. Digital microscope images of wire fracture surfaces at the ends of the unwound strands are shown in Figures 5 and 6.

The remaining wires had cup-and-cone like fracture surfaces accompanied by adjacent necking of the wire cross-section (indicated by white dashed lines in Figure 2 and white arrows in Figures 3, 5, and 6), which is consistent with overstress separation.

**Figure 2.** A close-up photo showing the separated still bundled end of the cable is shown in the bottom. A digital microscope image of the separated still bundled end of the cable looking in the direction of the green arrow is shown in the top. The yellow dotted lines encircle separated wire ends that had thinned and the white dashed lines indicate separated wire ends with cup-and-cone fractures.

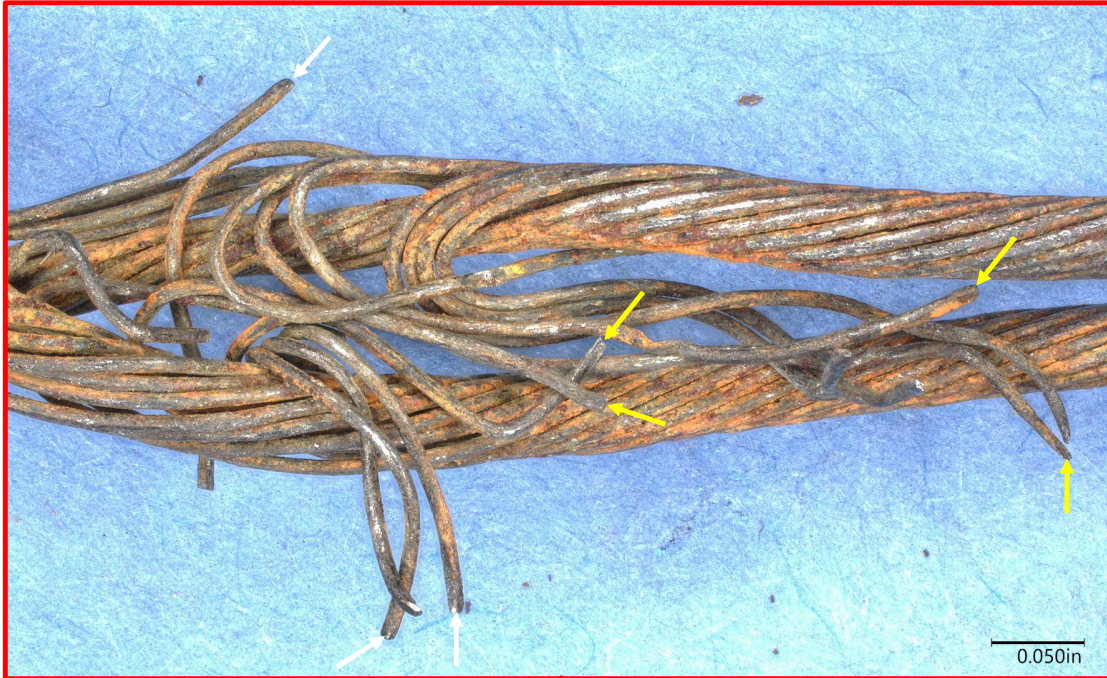
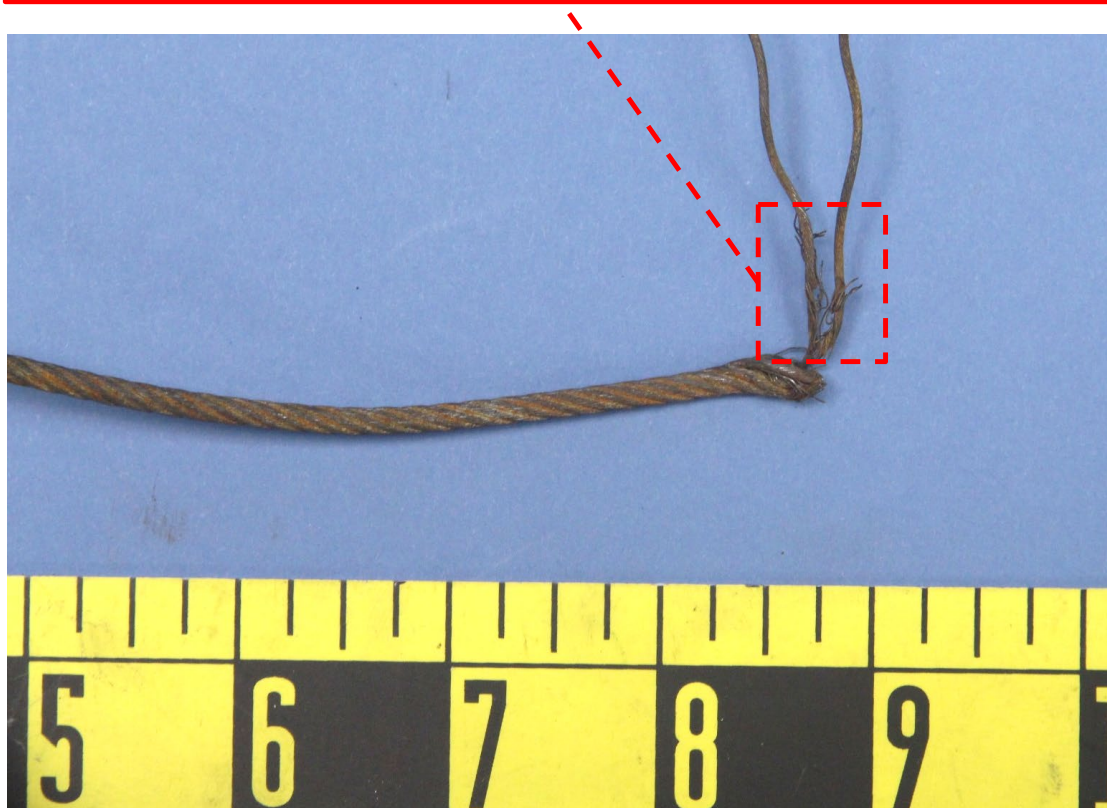
There were flat, elongated, angular fracture surfaces on the ends of many of the wires (indicated by yellow arrows in Figures 3, 5, and 6). The angular fracture surfaces had rub marks and the cross-sections of the wires adjacent to the separations had thinned. At the separated end of the still bundled segment of cable the thinned wires were still grouped together into strands, as indicated by the yellow dotted circles in Figure 2. The orientation and characteristics of the fractured wire ends is consistent with between-strand wear and subsequent overstress separation.

**Figure 3.** A close-up photo showing the separated still bundled end of the cable is shown in the bottom. A digital microscope image of the unwound strands with wires that separated from the still bundled end of the cable is shown in the top. The yellow arrows point to separated wire ends that had thinned and the white arrows point to separated wire ends with cup-and-cone fractures.

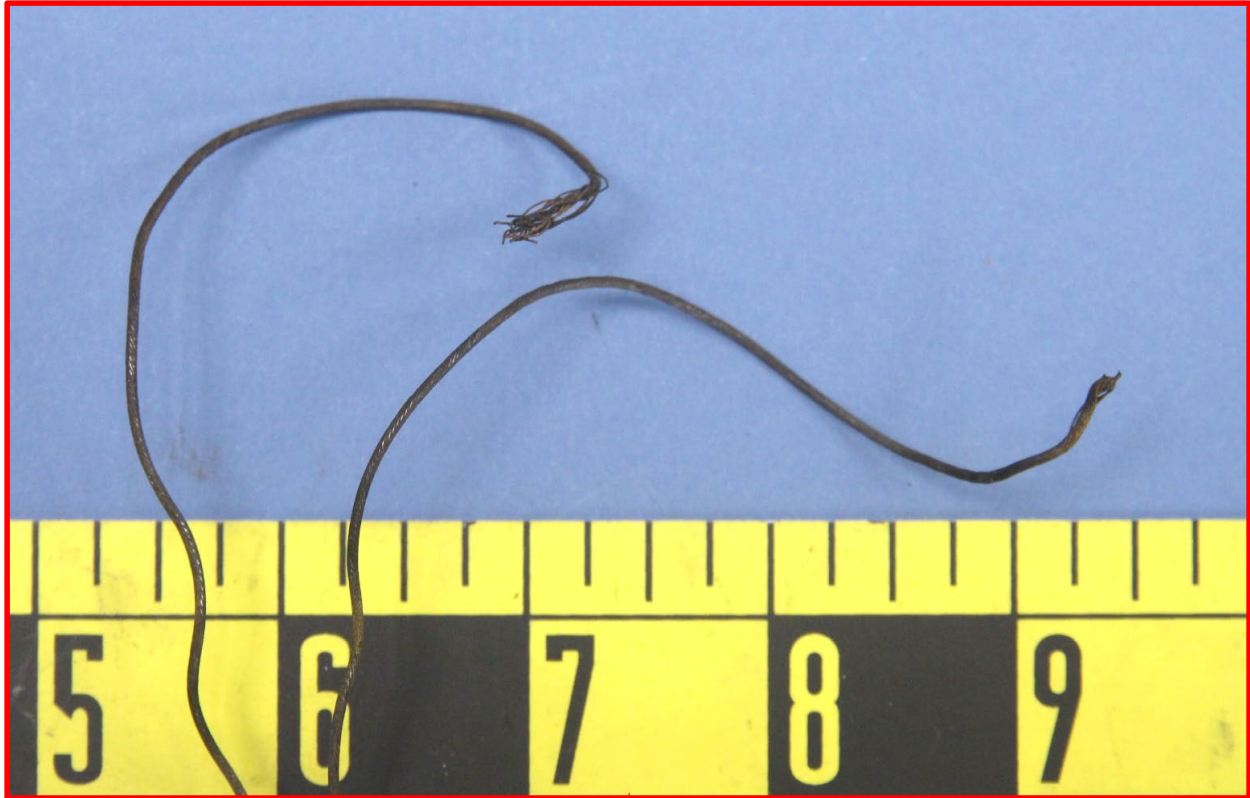
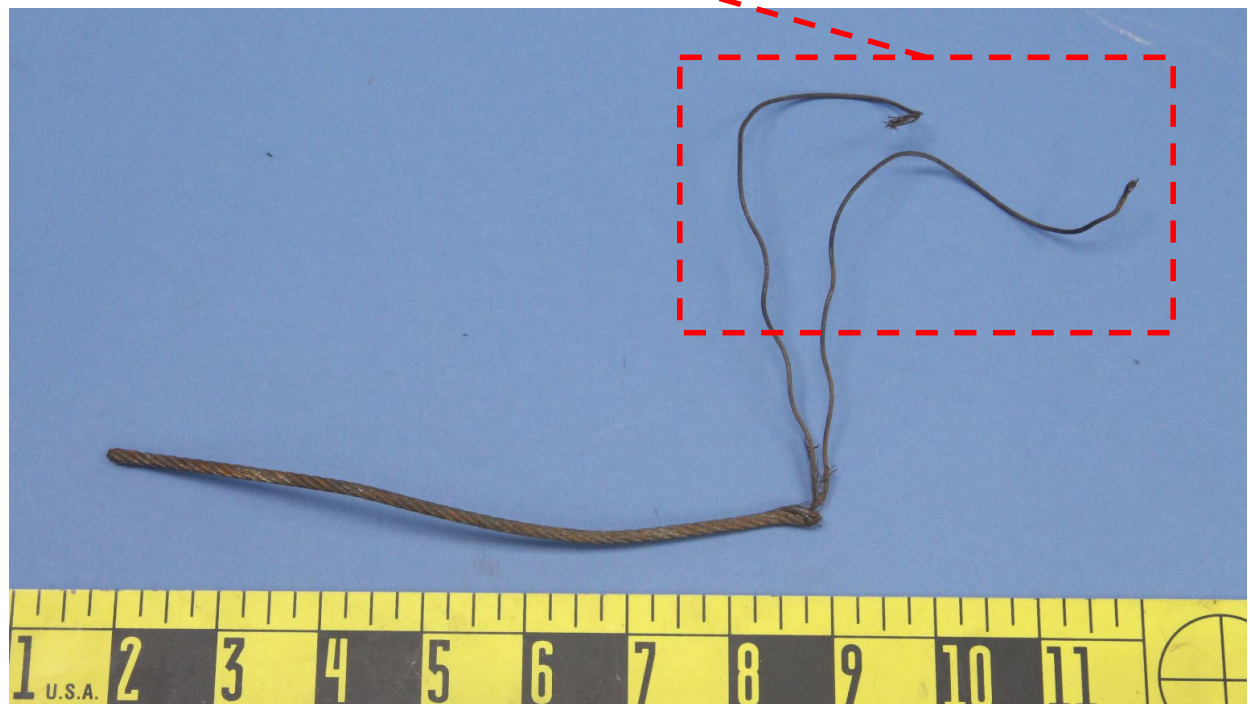
**Figure 4.** An overall photo of the submitted portion of cable is shown in the bottom. A close-up photo showing the unwound strands of the cable is shown in the top.

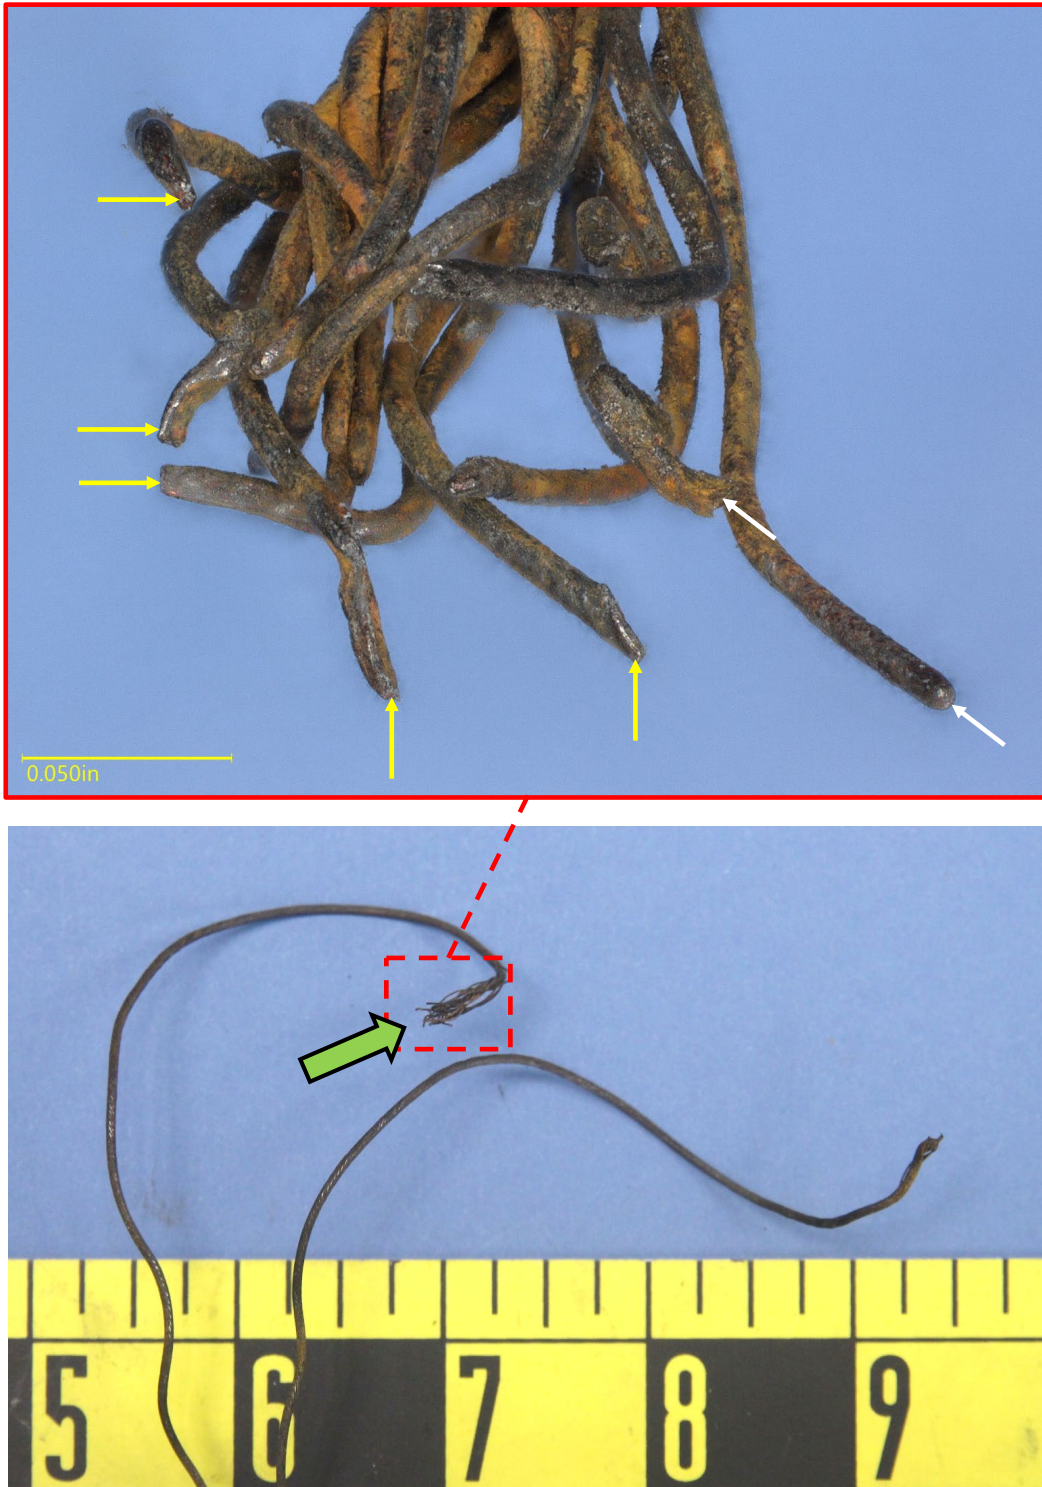
**Figure 5.** A close-up photo showing the unwound strands of the cable is shown in the bottom. A digital microscope image of the strand looking in the direction indicated by the green arrow is shown in the top. The yellow arrows point to separated wire ends that had thinned and the white arrows point to separated wire ends with cup-and-cone fractures.

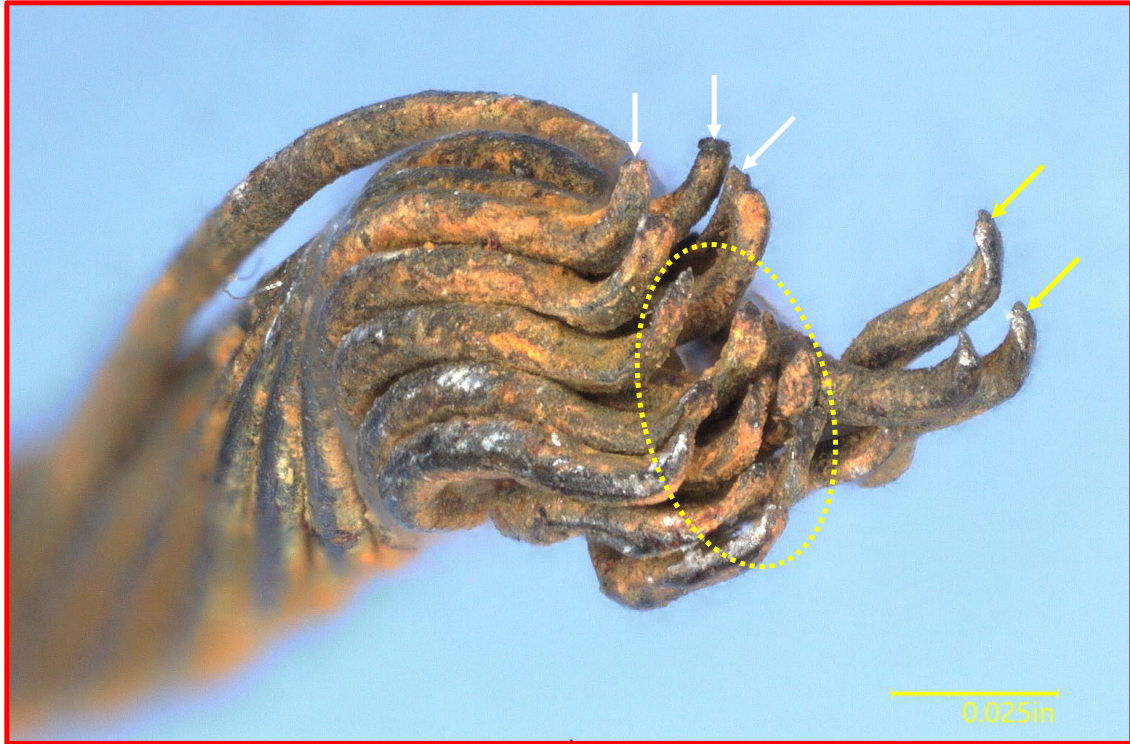
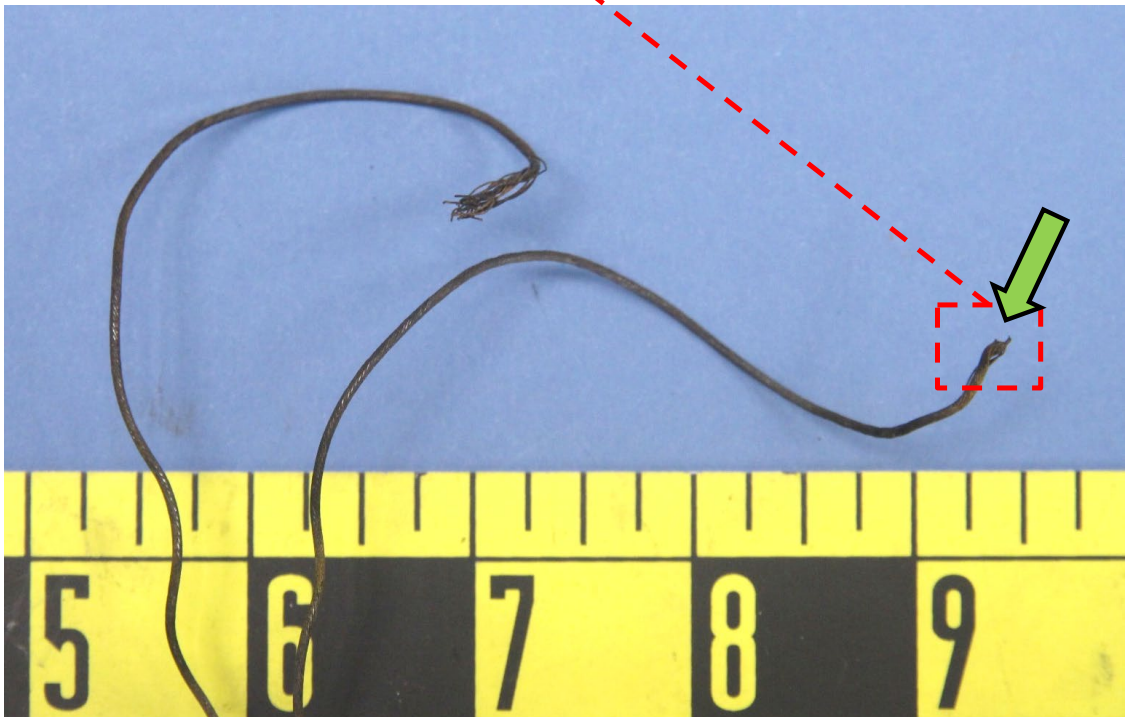
**Figure 6.** A close-up photo showing the unwound strands of the cable is shown in the bottom. A digital microscope image of the strand looking in the direction indicated by the green arrow is shown in the top. The yellow dotted line encircles and the yellow arrows point to separated wire ends that had thinned and the white arrows point to separated wire ends with cup-and-cone fractures.
