National Transportation Safety Board

CEN23LA107

MATERIALS LABORATORY

Factual Report 23-076

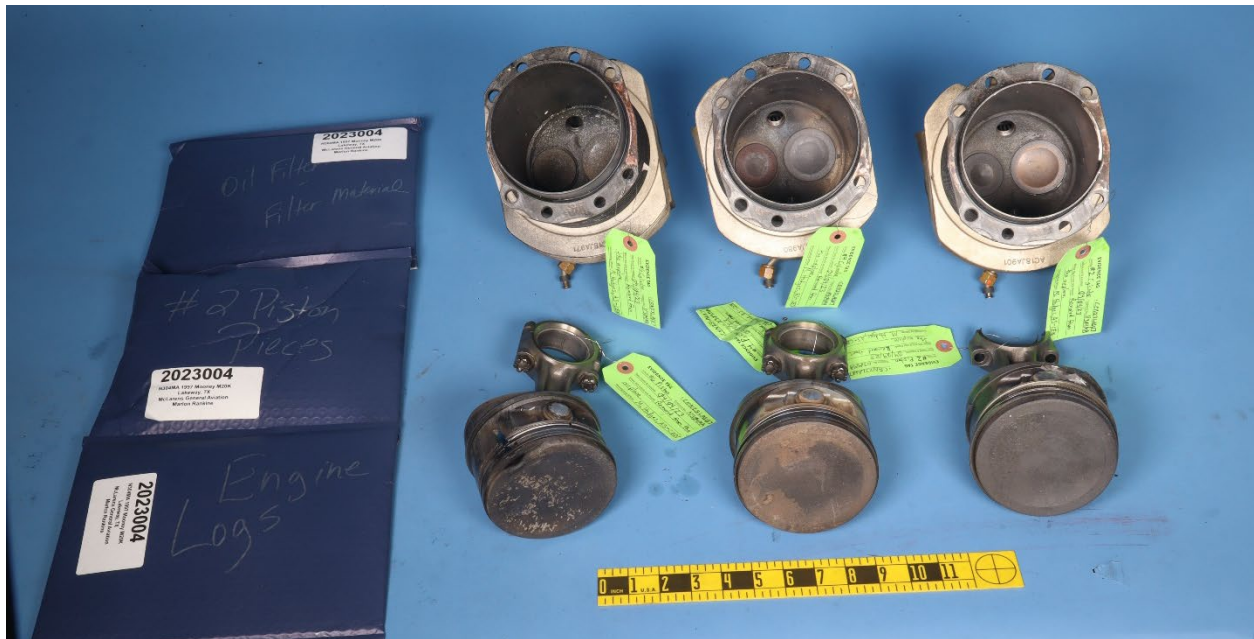
Figure 1 shows the parts submitted to the Materials Laboratory for examination. These parts included cylinders, pistons, and connecting rods from the #2, 4, and 6 positions, as well as logbooks and various debris collected from the engine.

Figure 1. The piston assemblies and cylinders from the #2, 4, and 6 positions, with miscellaneous debris and small remnants.

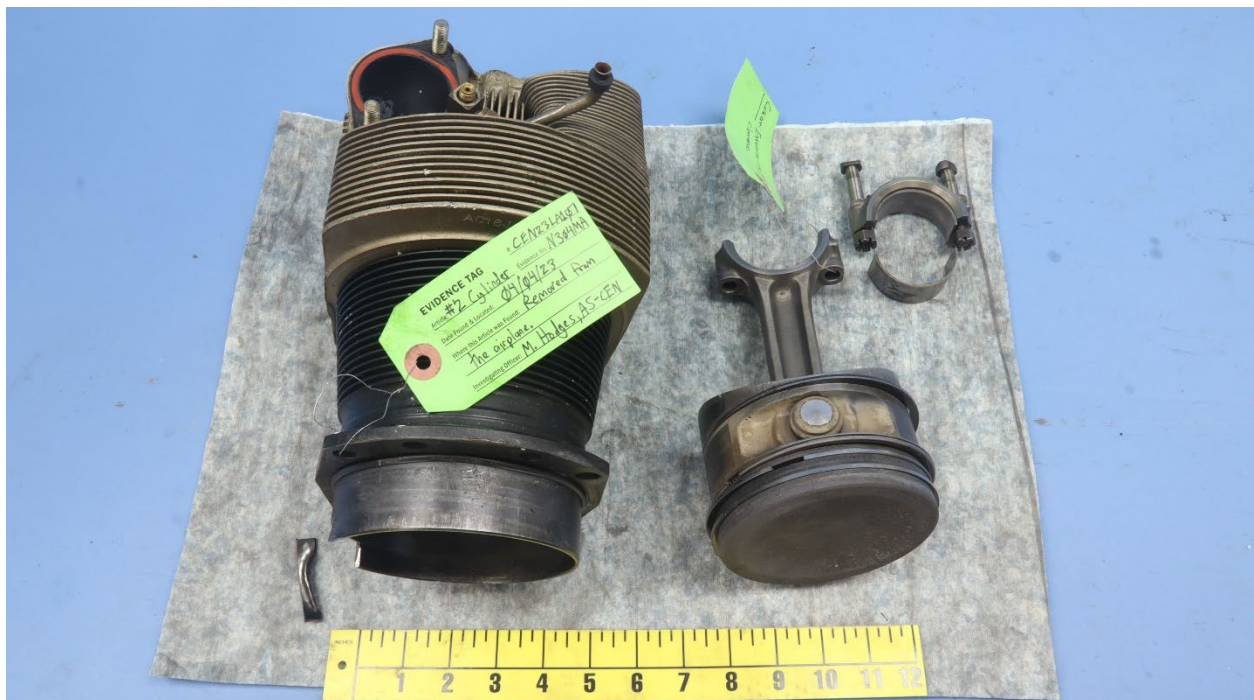
Figure 2 illustrates the components received from the #2 engine position—these included the cylinder assembly, piston assembly with connecting rod, and a section of the cylinder barrel. As with all the cylinders submitted in this case, the upper housing had been removed prior to receipt. The upper components are shown in Figure 3, illustrating the rockers, retainers, and the underlying springs and valves. There were no visible indications of damage in these component surfaces.

Figure 2. The cylinder and the piston with connecting rod from the #2 position. The connecting rod had been partially disassembled, and a section of the cylinder skirt had been removed.

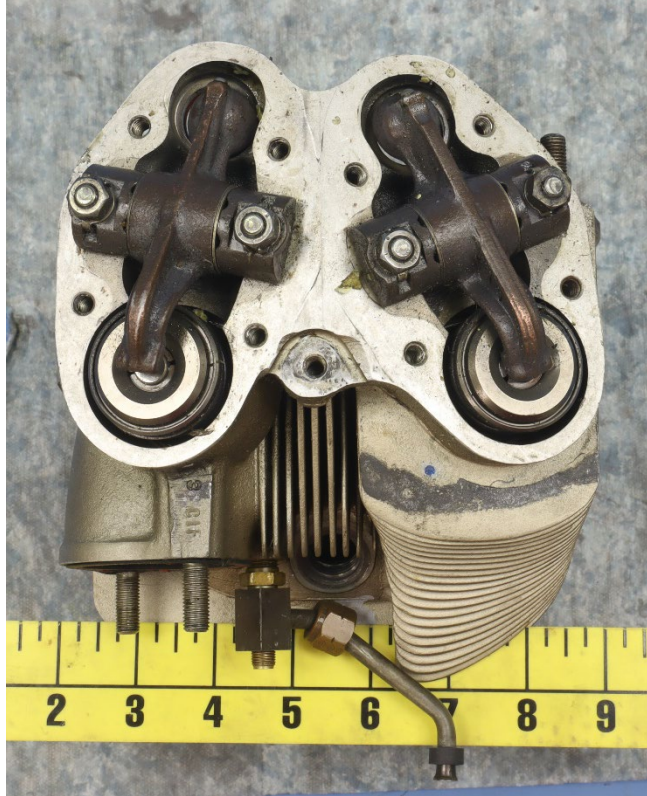
Figure 3. View of the top of the #2 cylinder, showing the rockers and retainers.

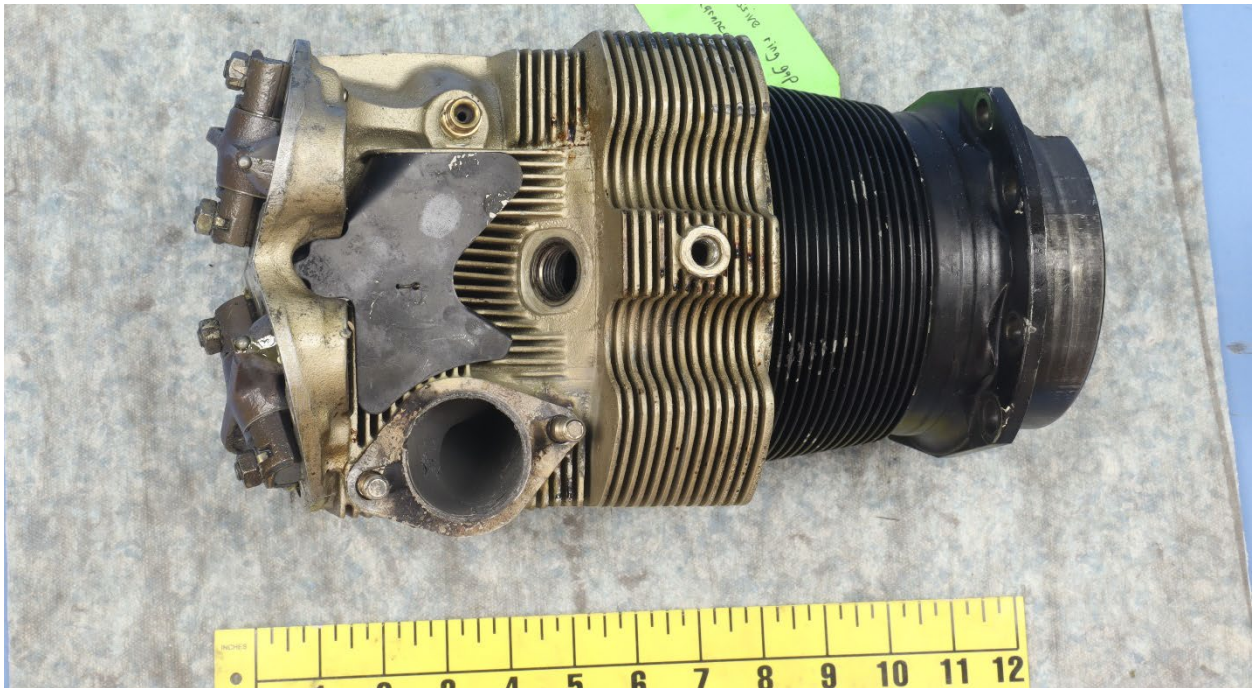
Figures 4 and 5 show the other exterior surfaces of the #2 cylinder assembly. There were no indications of deformation to the cooling fins or overheating, such as discoloration or deposits on the exterior. Figure 6 shows the interior of the #2 cylinder, the crown, and the faces of the intake and exhaust valves as received. This view shows the larger intake valve face on the left, colored brownish-tan with darker edges, and the smaller exhaust valve face on the right, showing a darker color and a rougher surface, consistent with adherence of combustion deposits.

Figure 4. View of the exhaust port side of the #2 cylinder, as received.

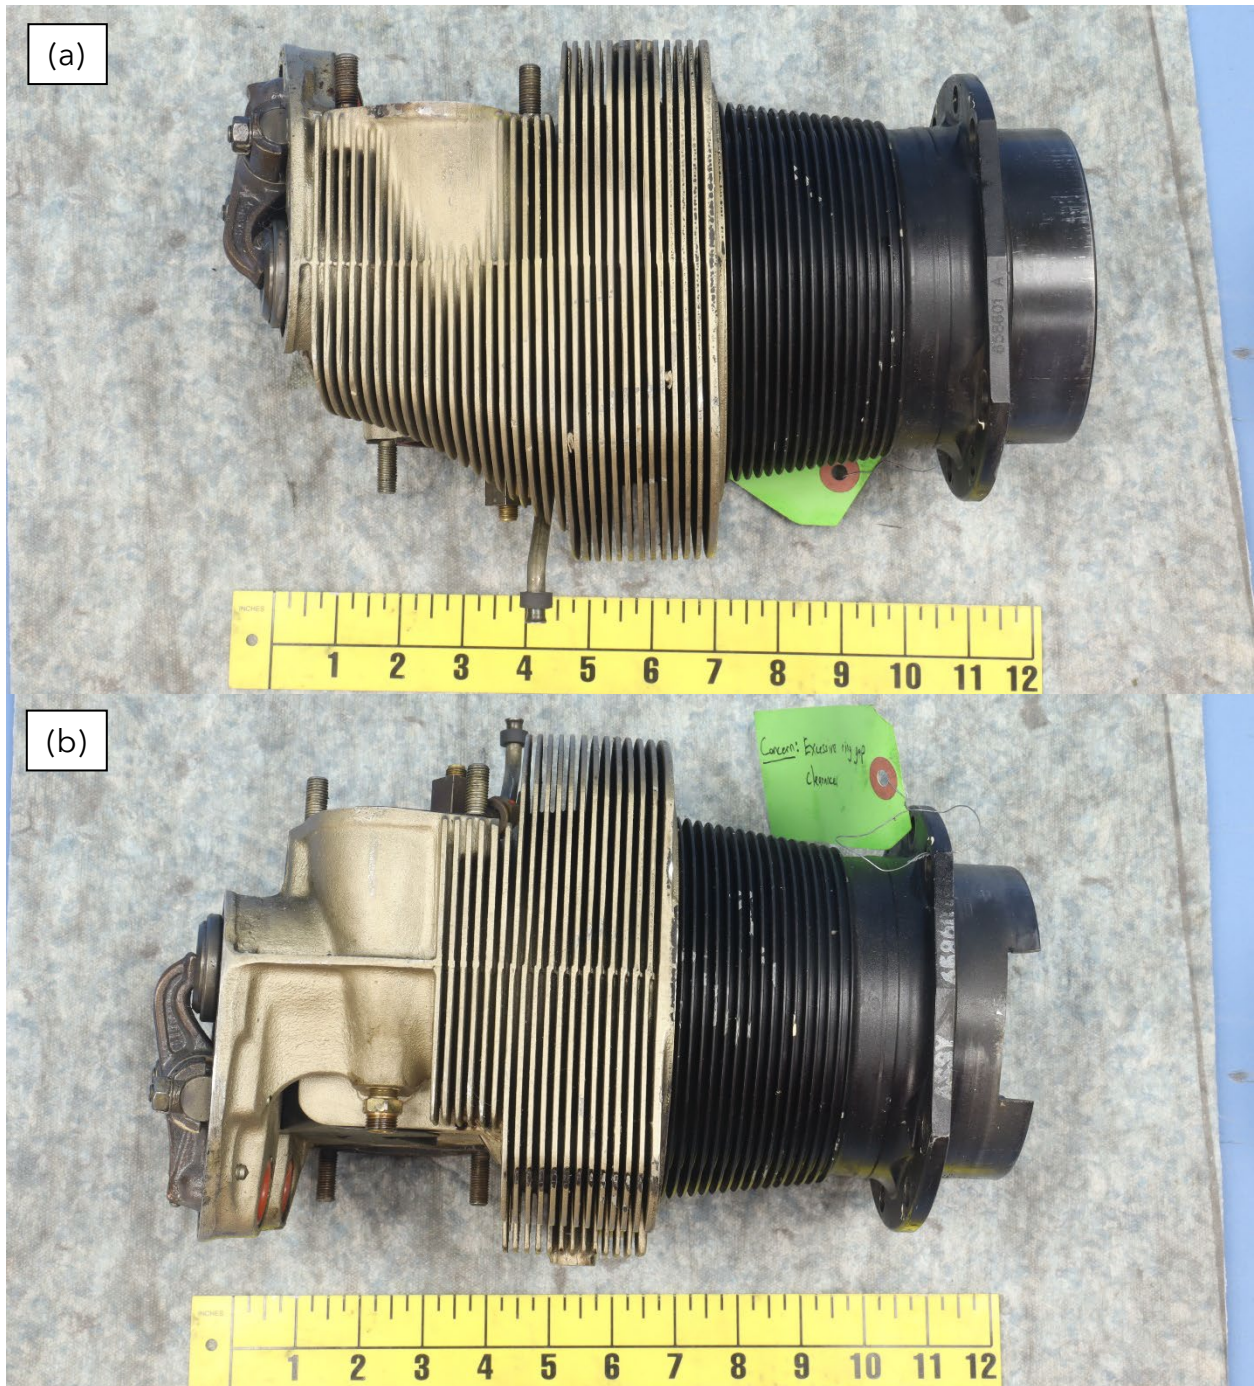
Figure 5. Opposite view of the sides of the #2 cylinder exterior.

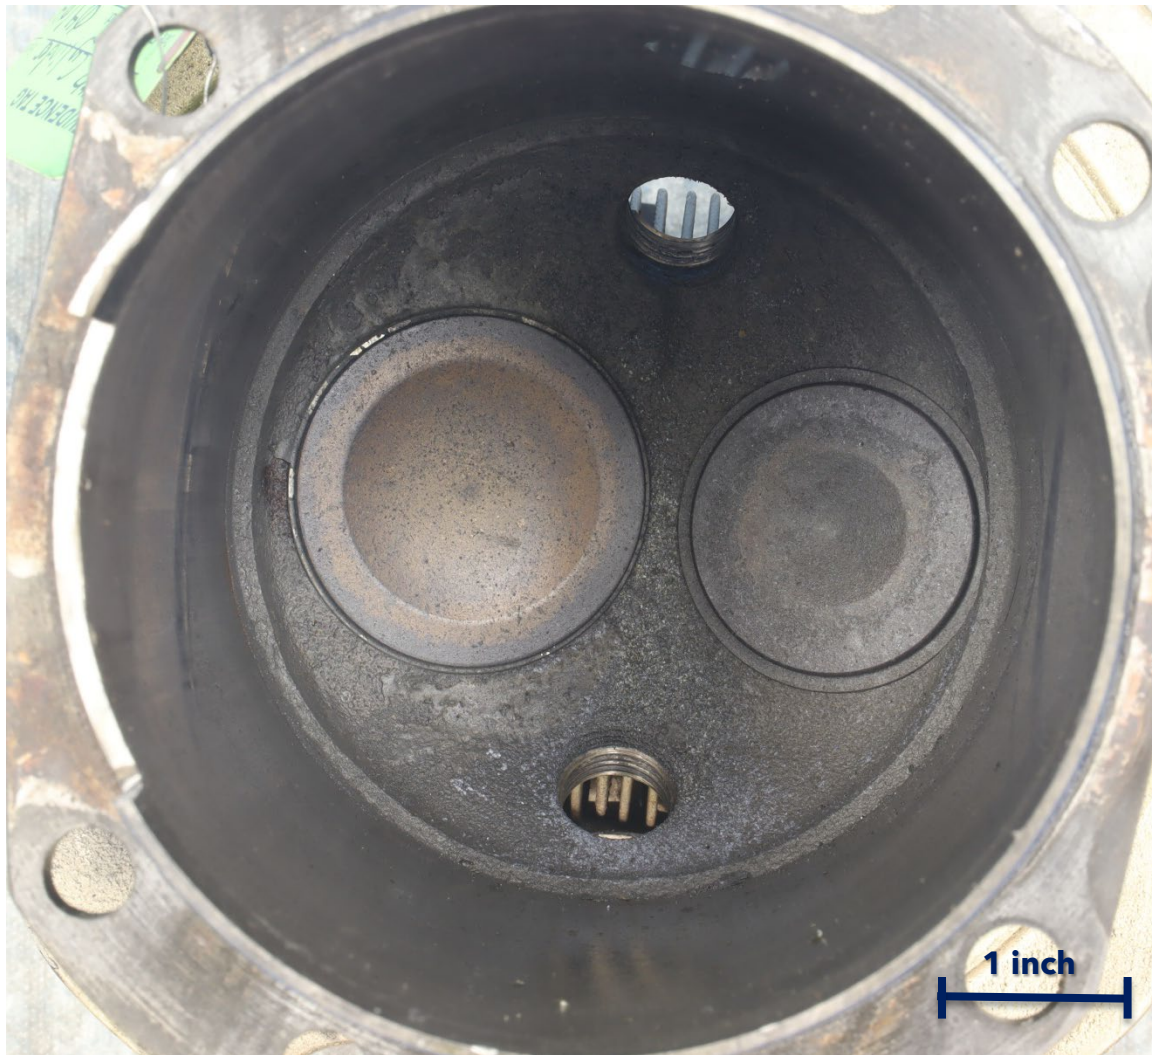
These deposits were present along the cylinder crown surface, particularly around the lower spark plug hole in Figure 6. There were indications of erosion and material loss just below the intake valve seat in the lower left in the figure, as exemplified by the lighter color in the figure. In addition, the opposite sides of the cylinder barrel surfaces exhibited parallel wear streaks along the direction of the piston actuation (on the left and right sides of the bore in Figure 6).

Figure 6. The interior of the #2 cylinder, showing the crown and valve faces.

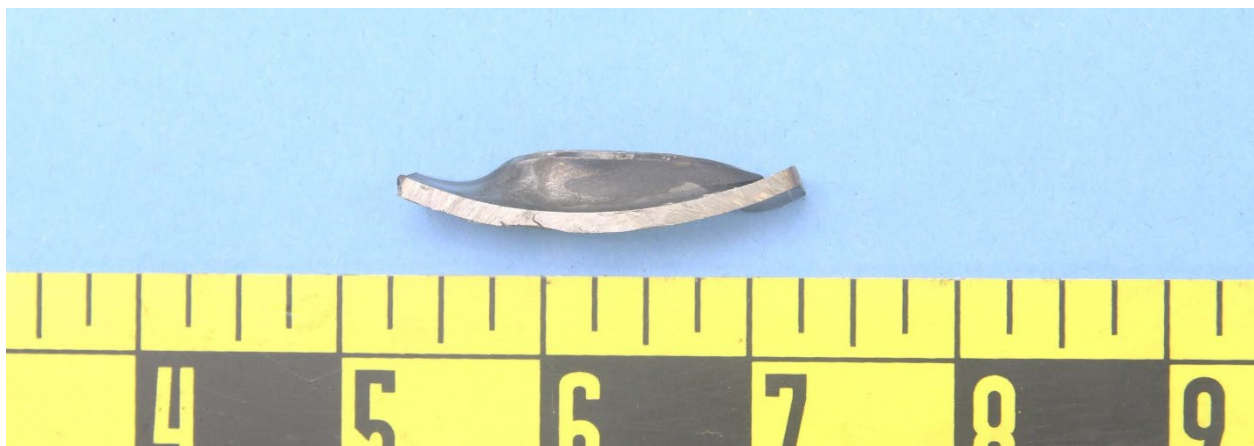
Figure 7 shows the section of the cylinder that had been sectioned from the rest of the barrel. This piece exhibited plastic deformation, consistent with an inward direction. The plastic deformation indicated batter, consistent with impacts against an adjacent metallic component.

Figure 7. View of the piece sectioned from the #2 cylinder skirt.

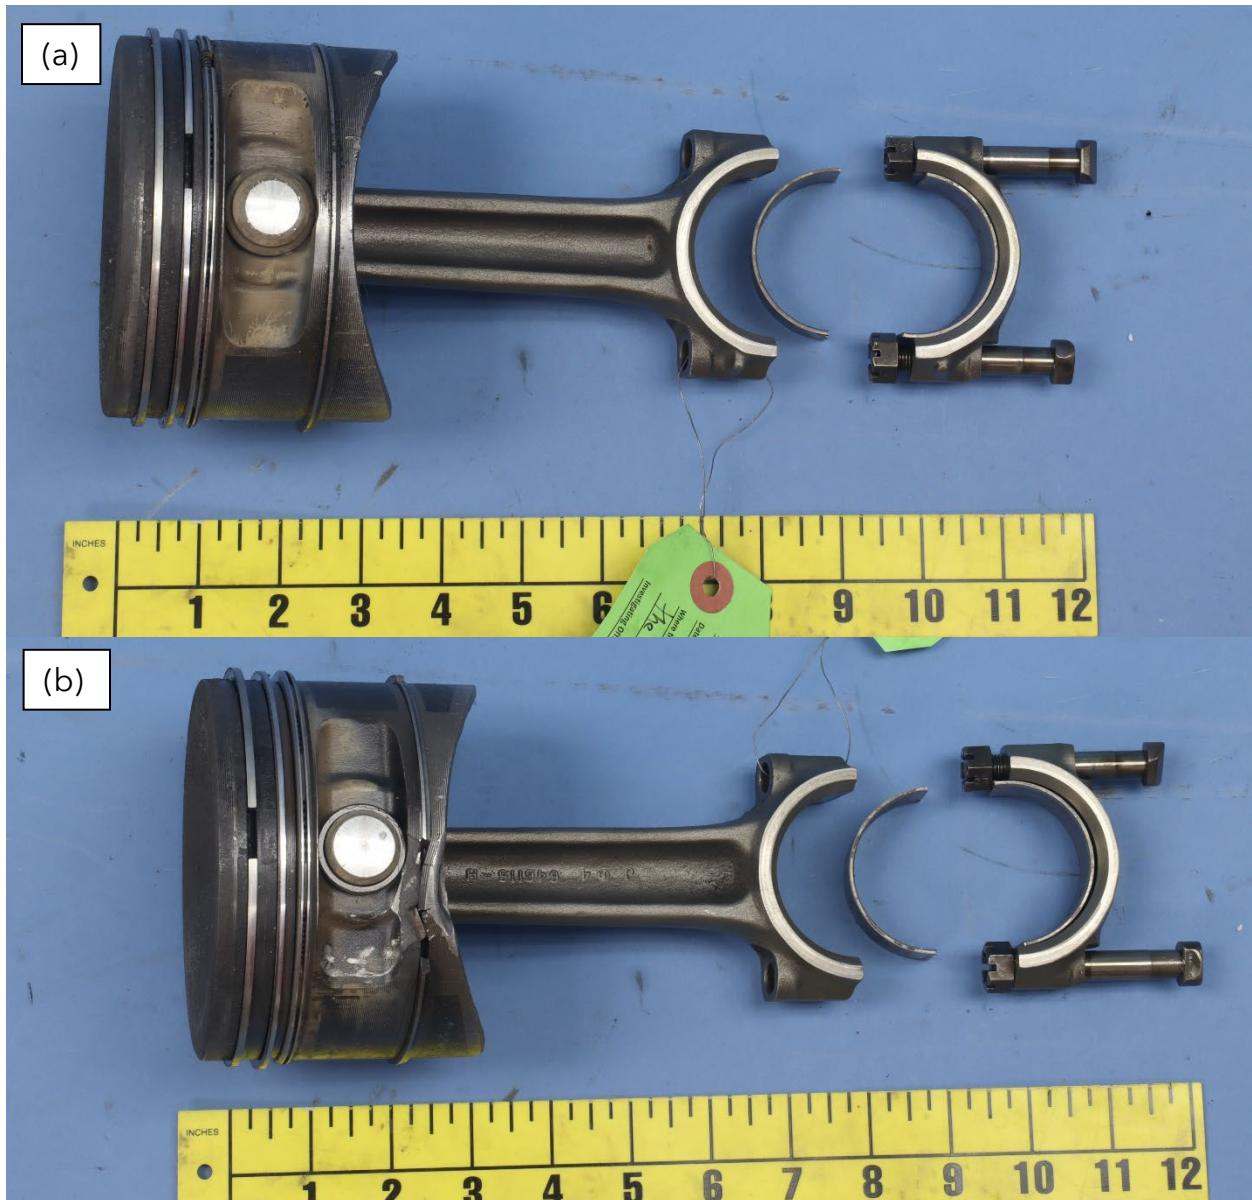
Figure 8 shows the piston assembly from opposite sides, as received. While the connecting rod was still affixed to the piston via the pin, the cap and bearings had been disassembled from the rest of the connecting rod. One of the flanges of the connecting rod exhibited minor indentation (Figure 8a) but was otherwise unblemished. The sides of the piston, as exemplified in Figure 8b, show indications of upward plastic deformation near one of the ends of the piston pin.

Figure 8. View of the opposite side of the #2 piston and connecting rod assemblies.

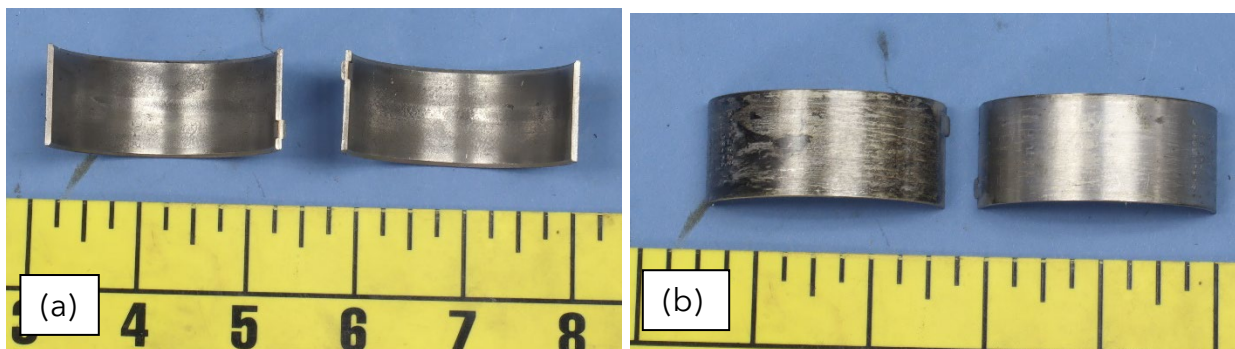
Figure 9 shows the condition of the connecting rod bearings. The bearings exhibited circumferential streaking consistent with rotational motion against the crankshaft journal. The wear pattern on the bearing interior surfaces revealed a center area of smoother, more reflective material flanked with opposite areas of rougher, duller surfaces.

Figure 9. Views of the (a) interior and (b) exterior surfaces of the conrod bearings.

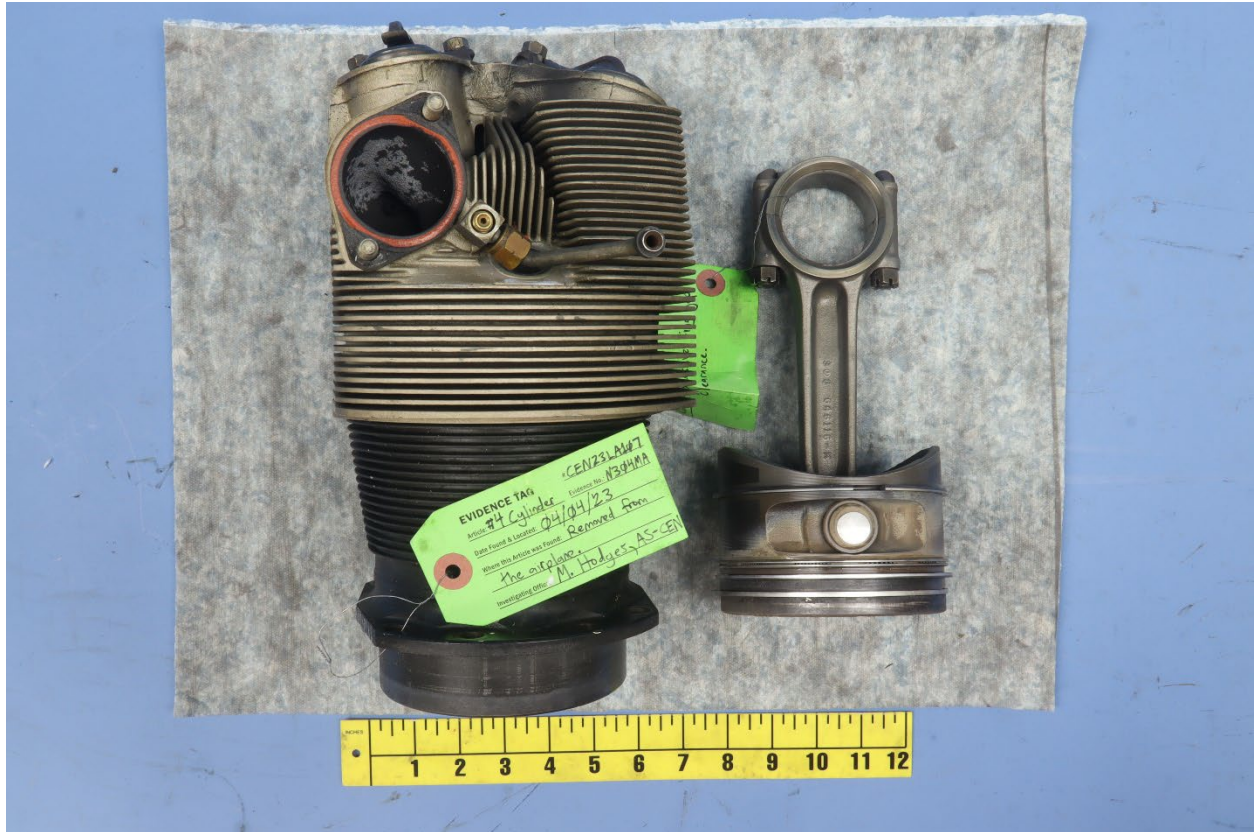
Figure 10 shows the components from the #4 position—a cylinder and piston assembly. Figures 11 and 12 show the exterior of the cylinder, which exhibited little visual indication of damage outside of nicks in the paint. The opened housing area is

Figure 10. The #4 cylinder, piston and connecting rod assemblies, as received.

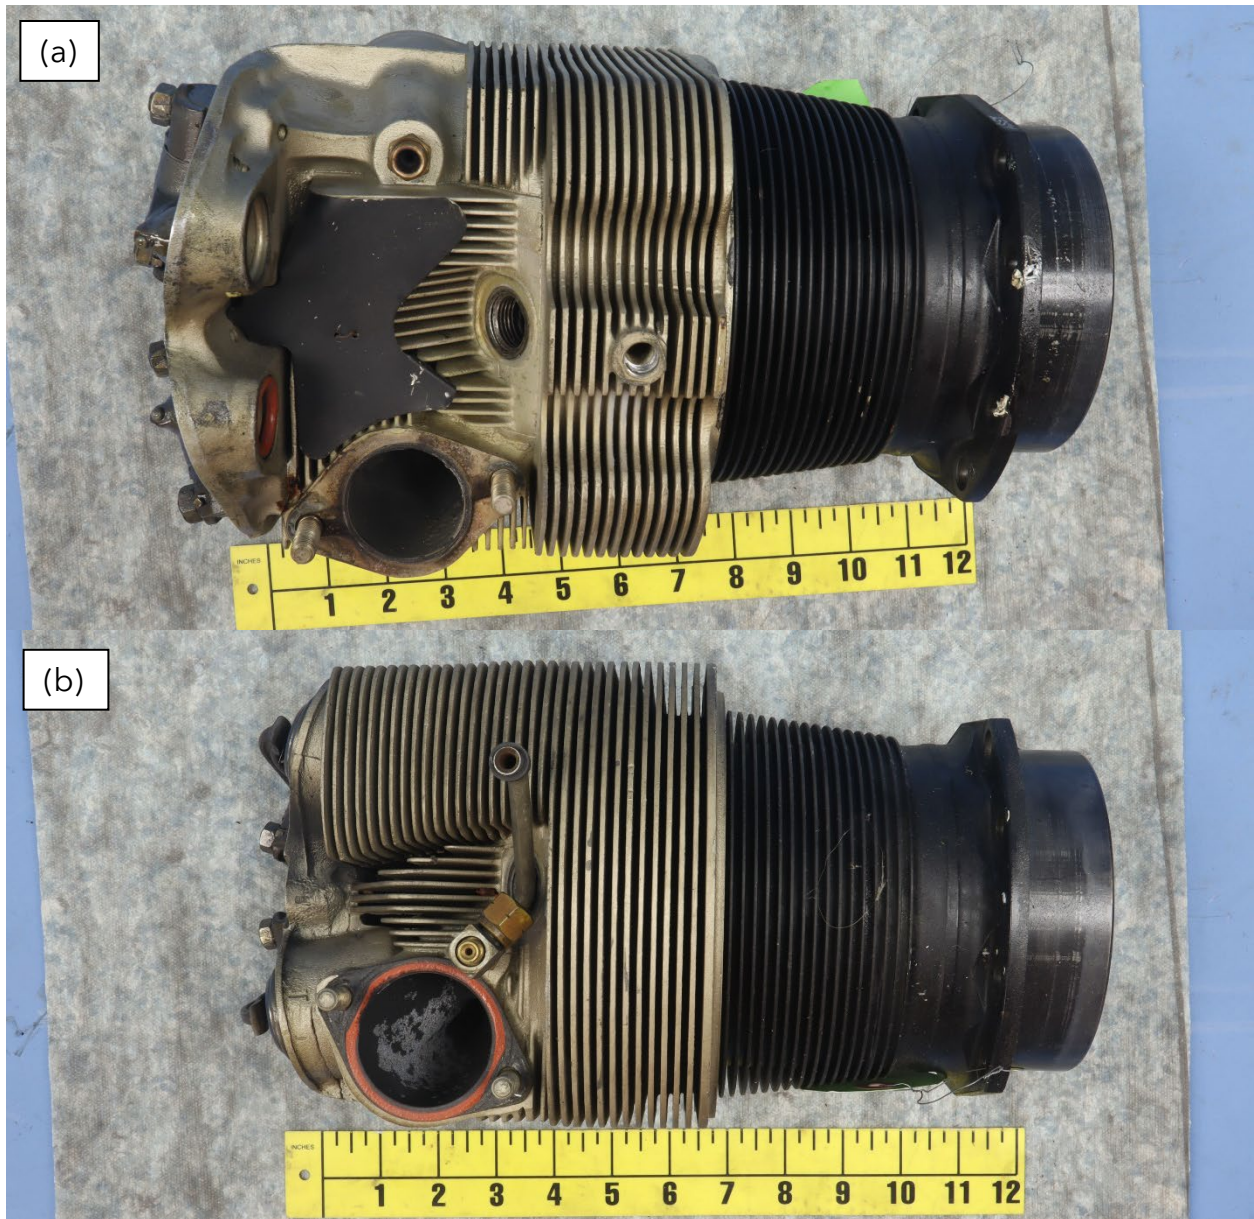
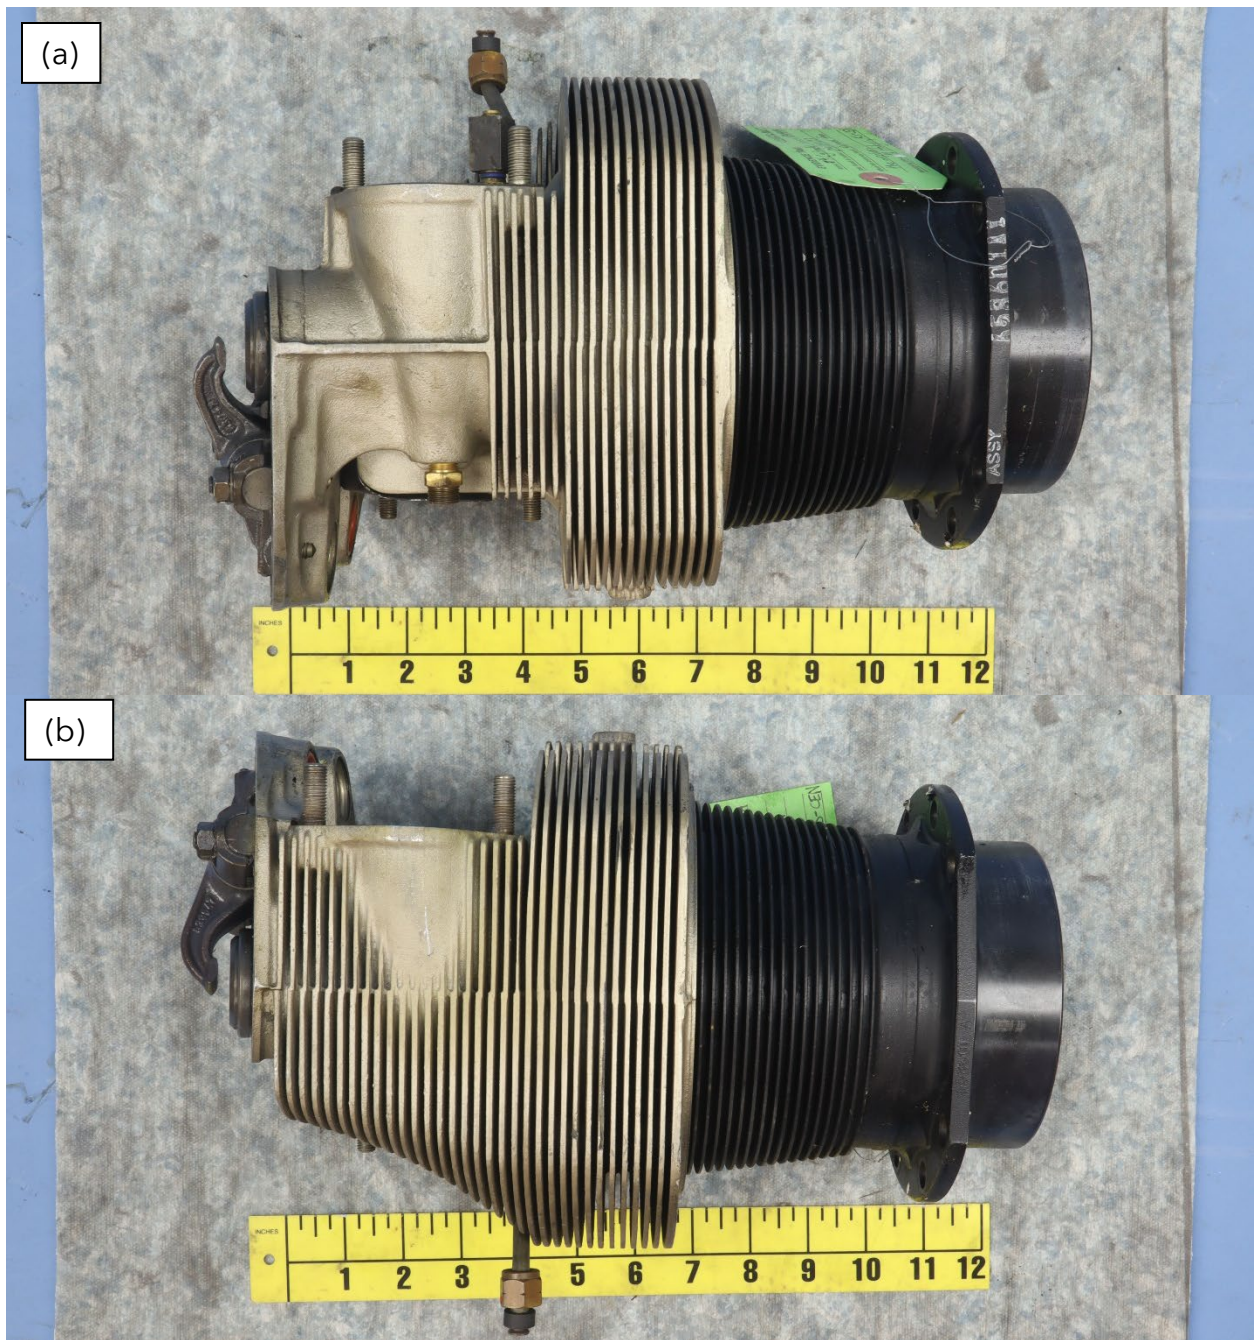
Figure 11. Opposite views of the #4 cylinder from (a) exhaust and (b) intake port sides.

Figure 12. View of the other two sides of the #4 cylinder, as received.

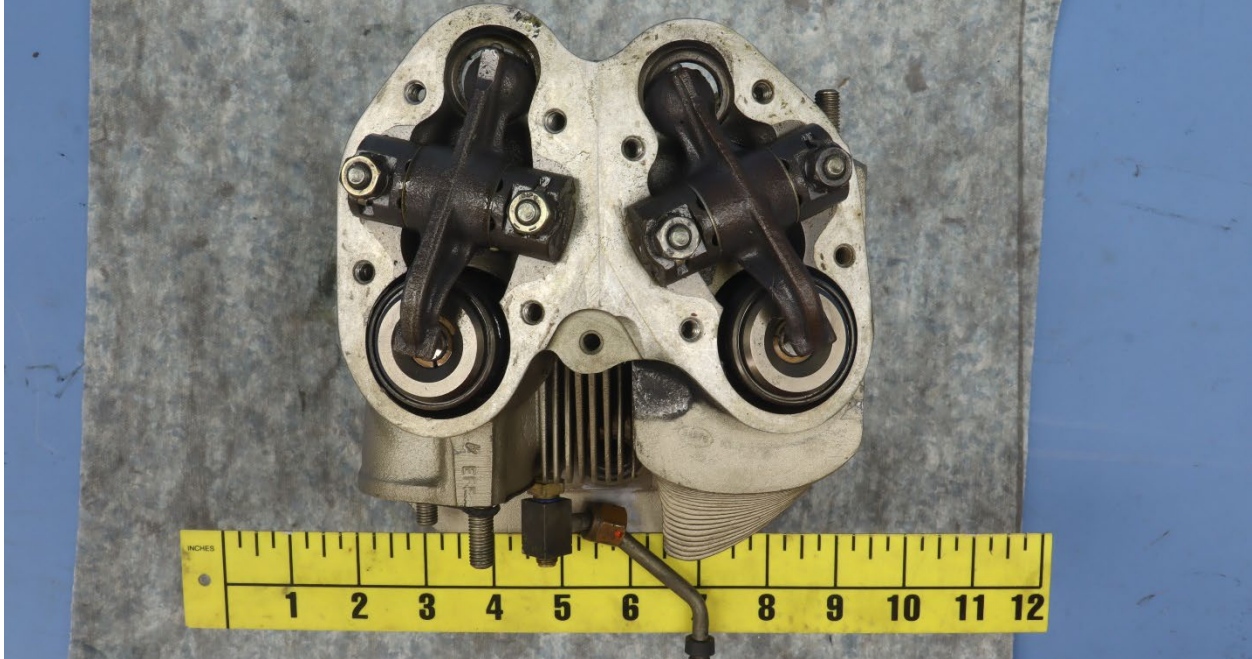
shown in Figure 13, revealing the internal rockers and other components, which were absent visual indications of impact damage or deformation.

Figure 13. View of the top of the #4 cylinder, as received, showing the rockers and retainers.

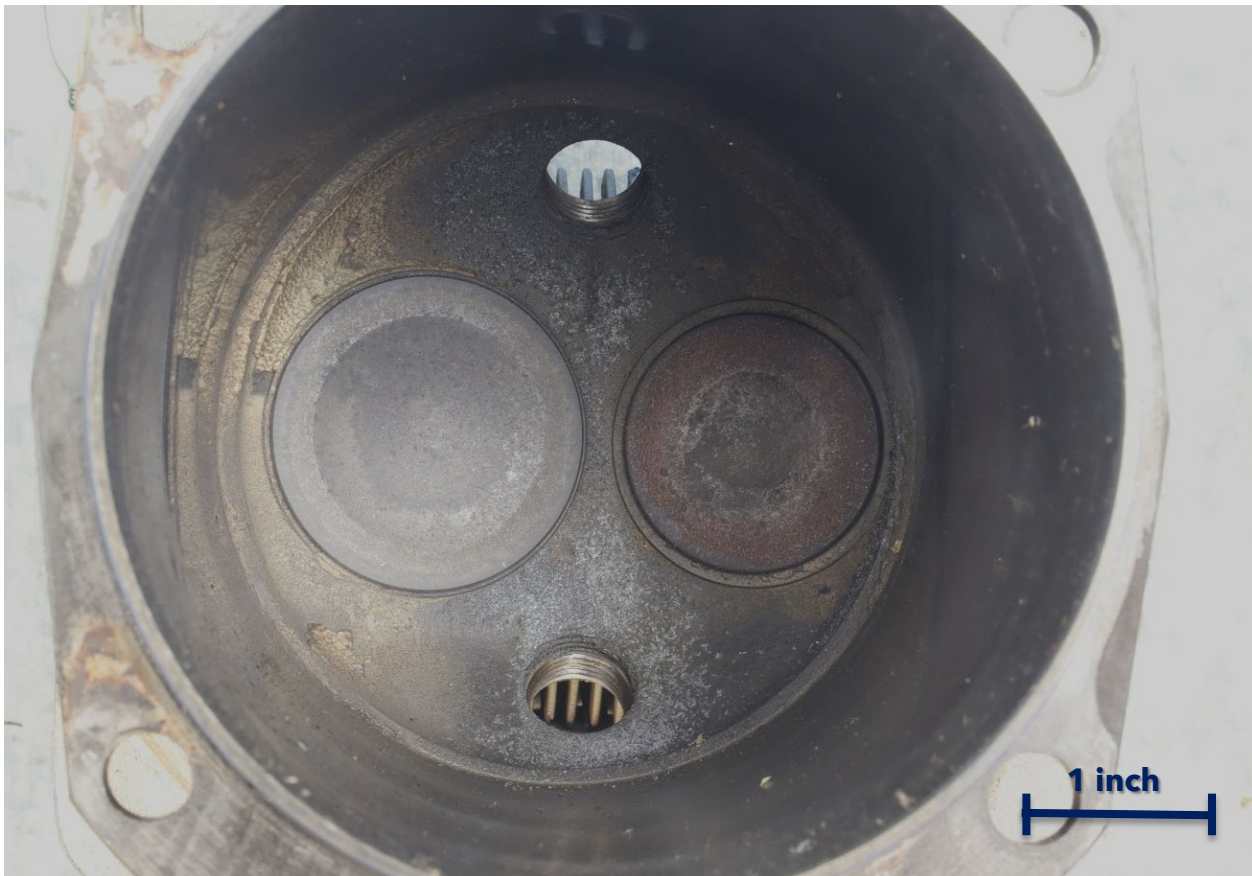
Figure 14 shows the interior of the cylinder. The face of the intake valve exhibited a dull gray color, and the smaller exhaust valve face displayed a central dark area with an outer band of maroon-brown coloring consistent with combustion deposits. In addition, white and tan combustion deposits were present along the crown's surface, with the white deposits mainly located around the spark plug holes. In the lower left of Figure 14, some of the deposits had spalled from the cylinder interior surface.

Figure 14. View of the interior of the #4 cylinder, showing the crown and valve faces.

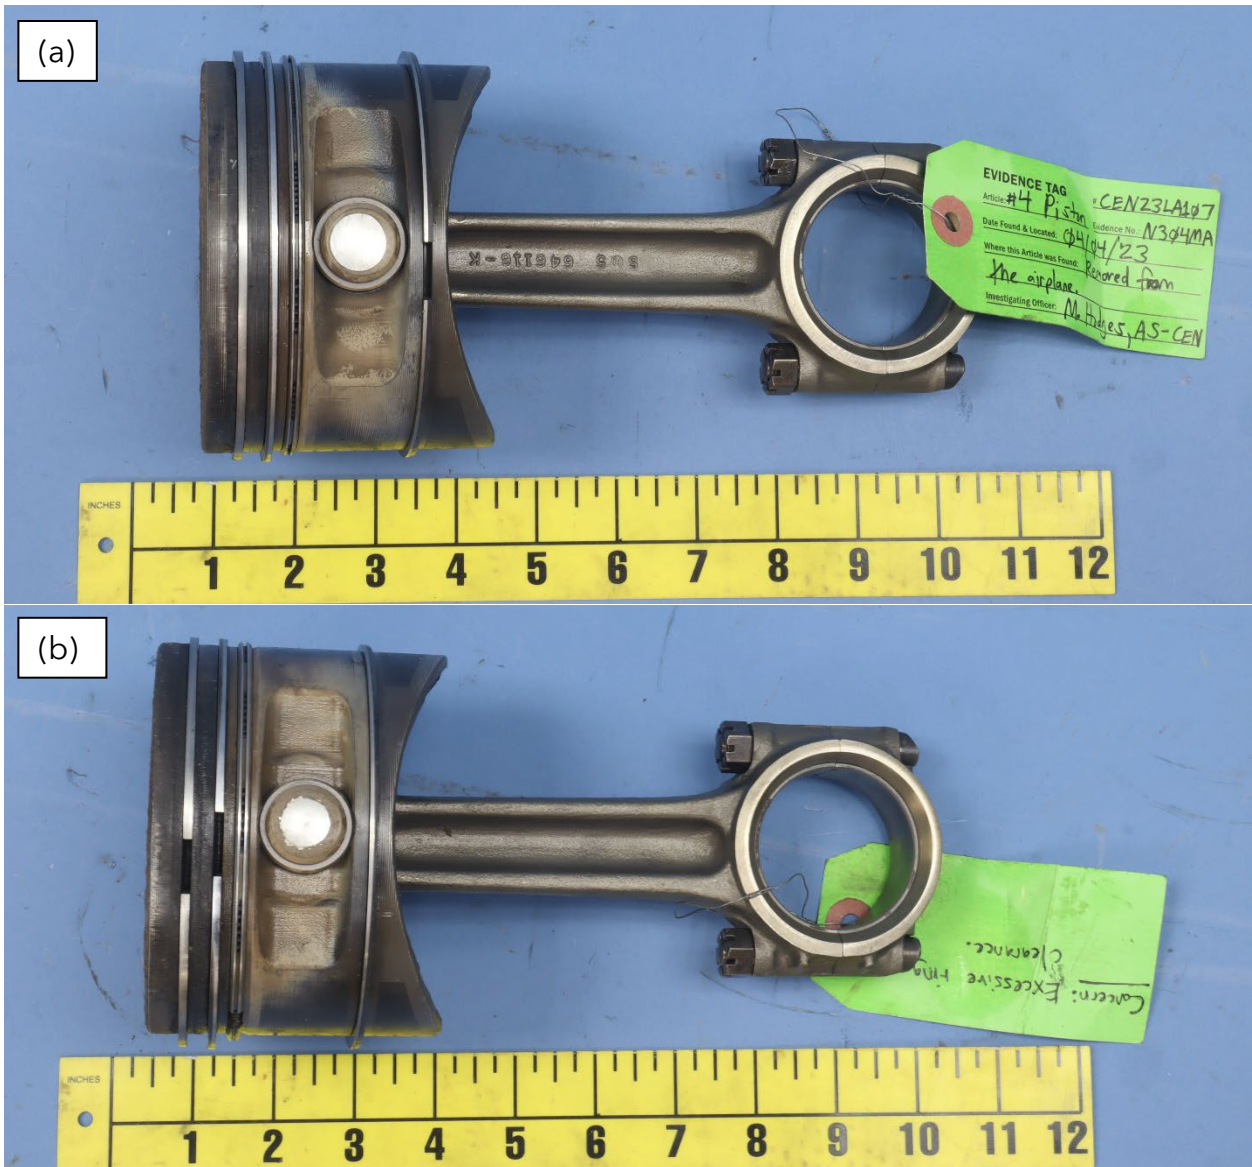
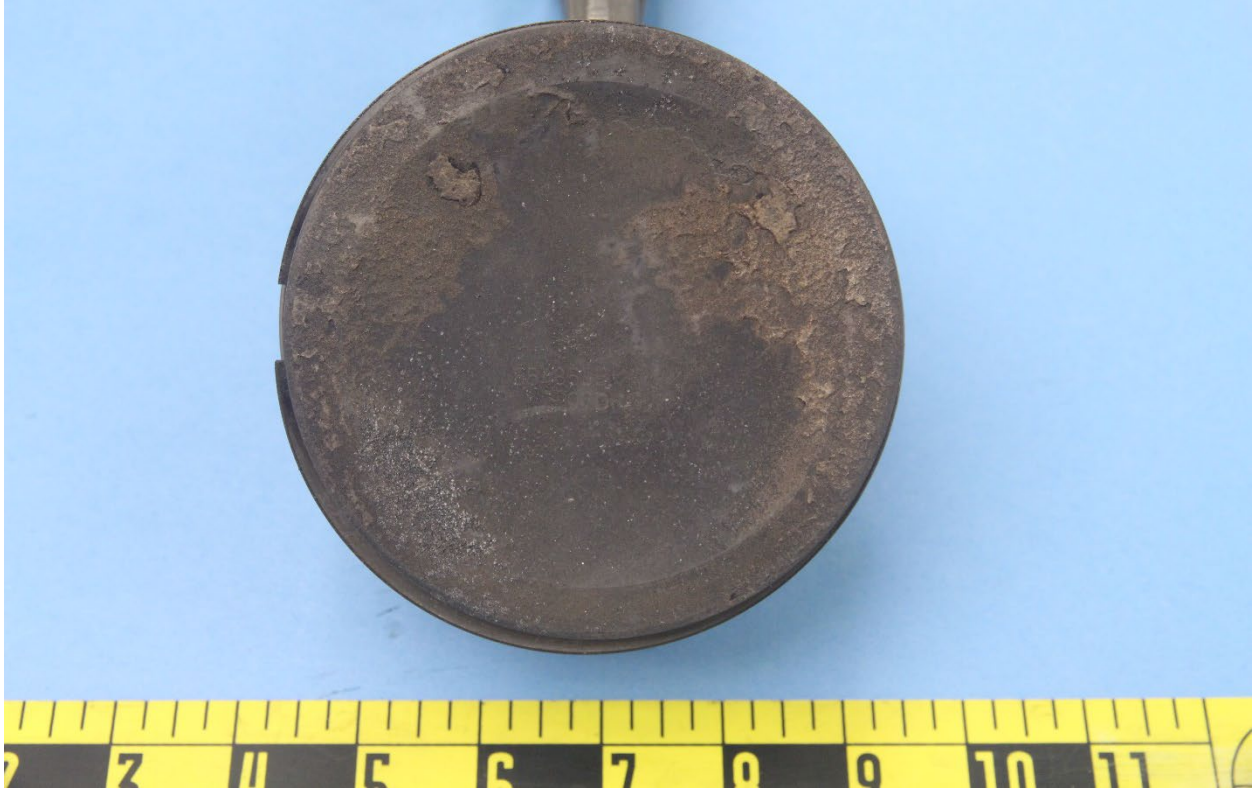
Figure 15 shows opposite views of the piston assembly. The connecting rod, cap, and bearings were still attached and assembled. There were no indications of damage to the outside skirt of the piston or the connecting rod components. However, the crown of the piston, shown in Figure 16, illustrates the heavy deposits present on that surface. The deposits were thick enough to exhibit large protruding chunks, with the one in the upper right consistent with the spalled material on the cylinder in Figure 14. The deposit pattern on the piston matched that of the corresponding cylinder crown and valve faces shown in Figure 14.

Figure 15. Opposite views of the #4 piston and connecting rod assembly.

Figure 16. View of the deposits on the #4 piston crown.

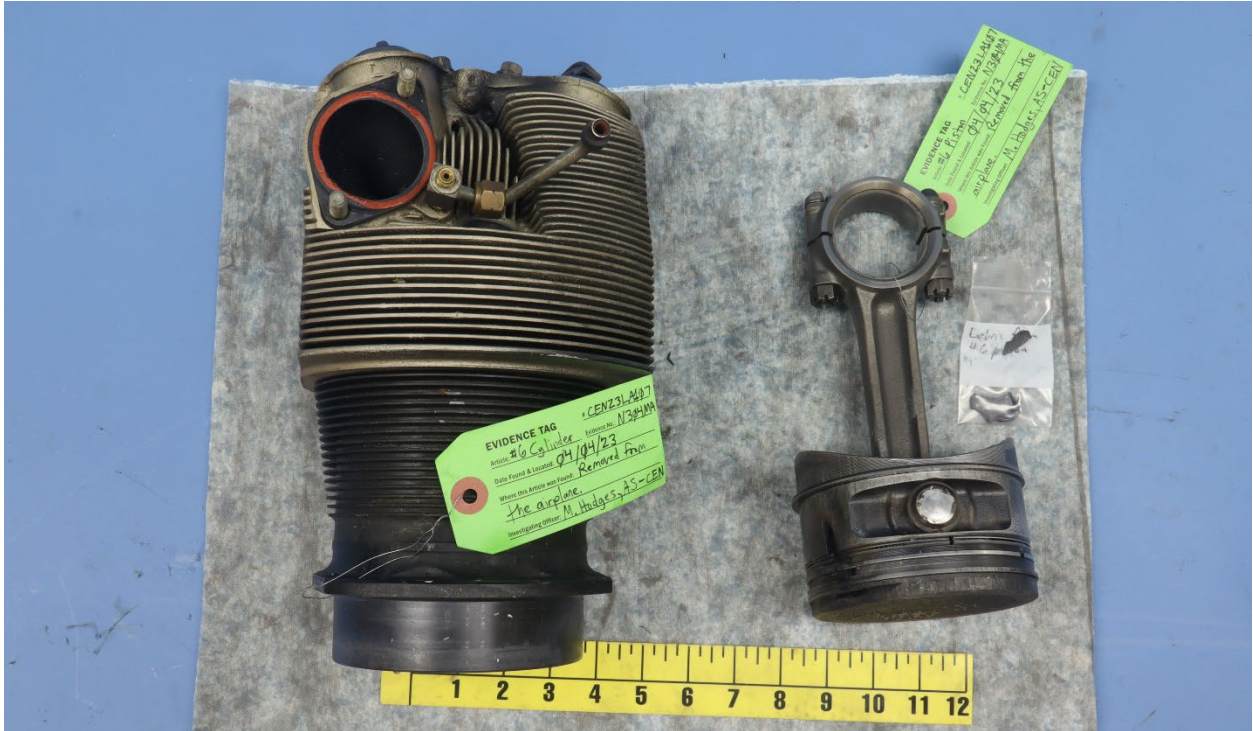
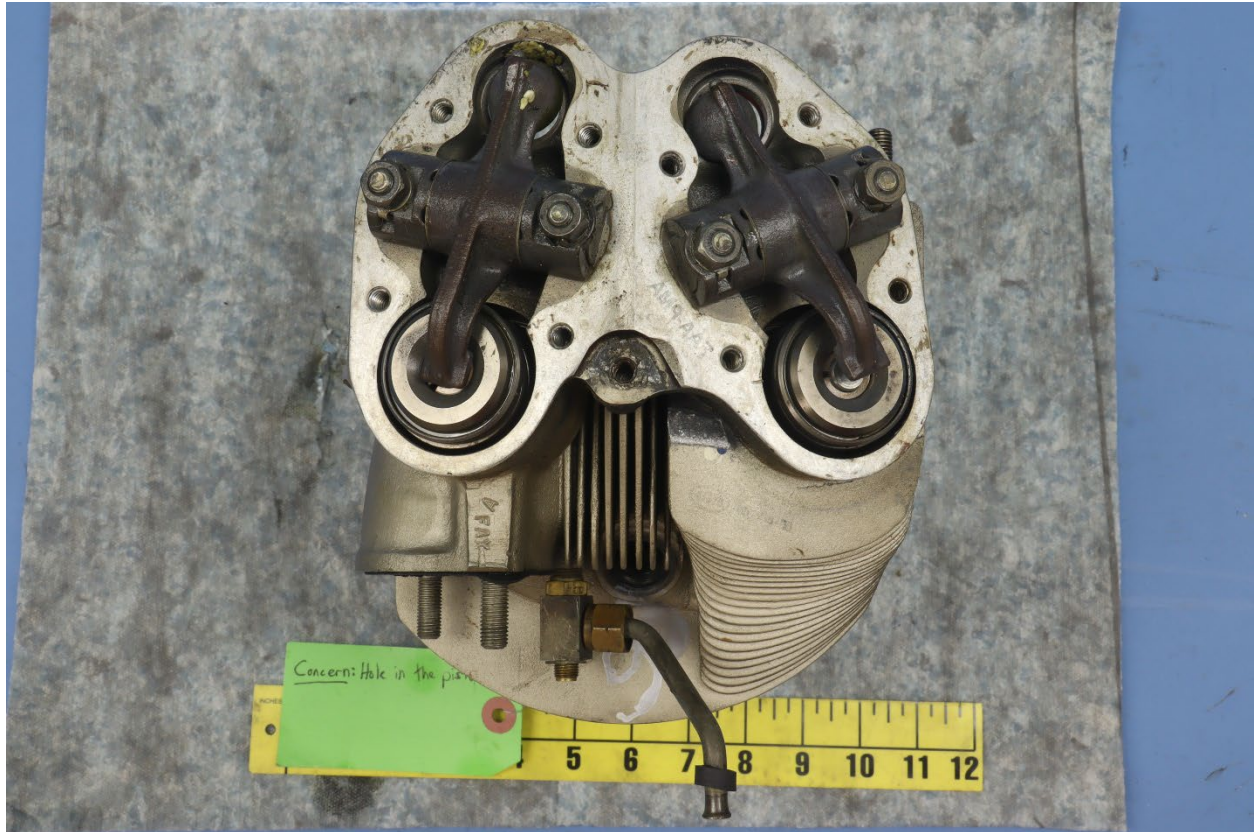
Figure 17 shows the components from the #6 position of the engine—the cylinder and piston assemblies along with several pieces of debris from the piston. Figure 18 shows the exposed upper portion of the cylinder assembly, revealing the rockers, retainers, and other components in this space. Figures 19 and 20 illustrate the other exterior surfaces of the cylinder assembly. Of note was the downward plastic deformation and partial fracture of the upper six cooling fins on the intake port side of the cylinder (see Figures 19b and 20b).

Figure 17. The #6 cylinder and piston assemblies, as received.

Figure 18. View of the opened top of the #6 cylinder showing the rockers and retainers.
