National Transportation Safety Board

CEN23LA107

MATERIALS LABORATORY

Factual Report 23-076

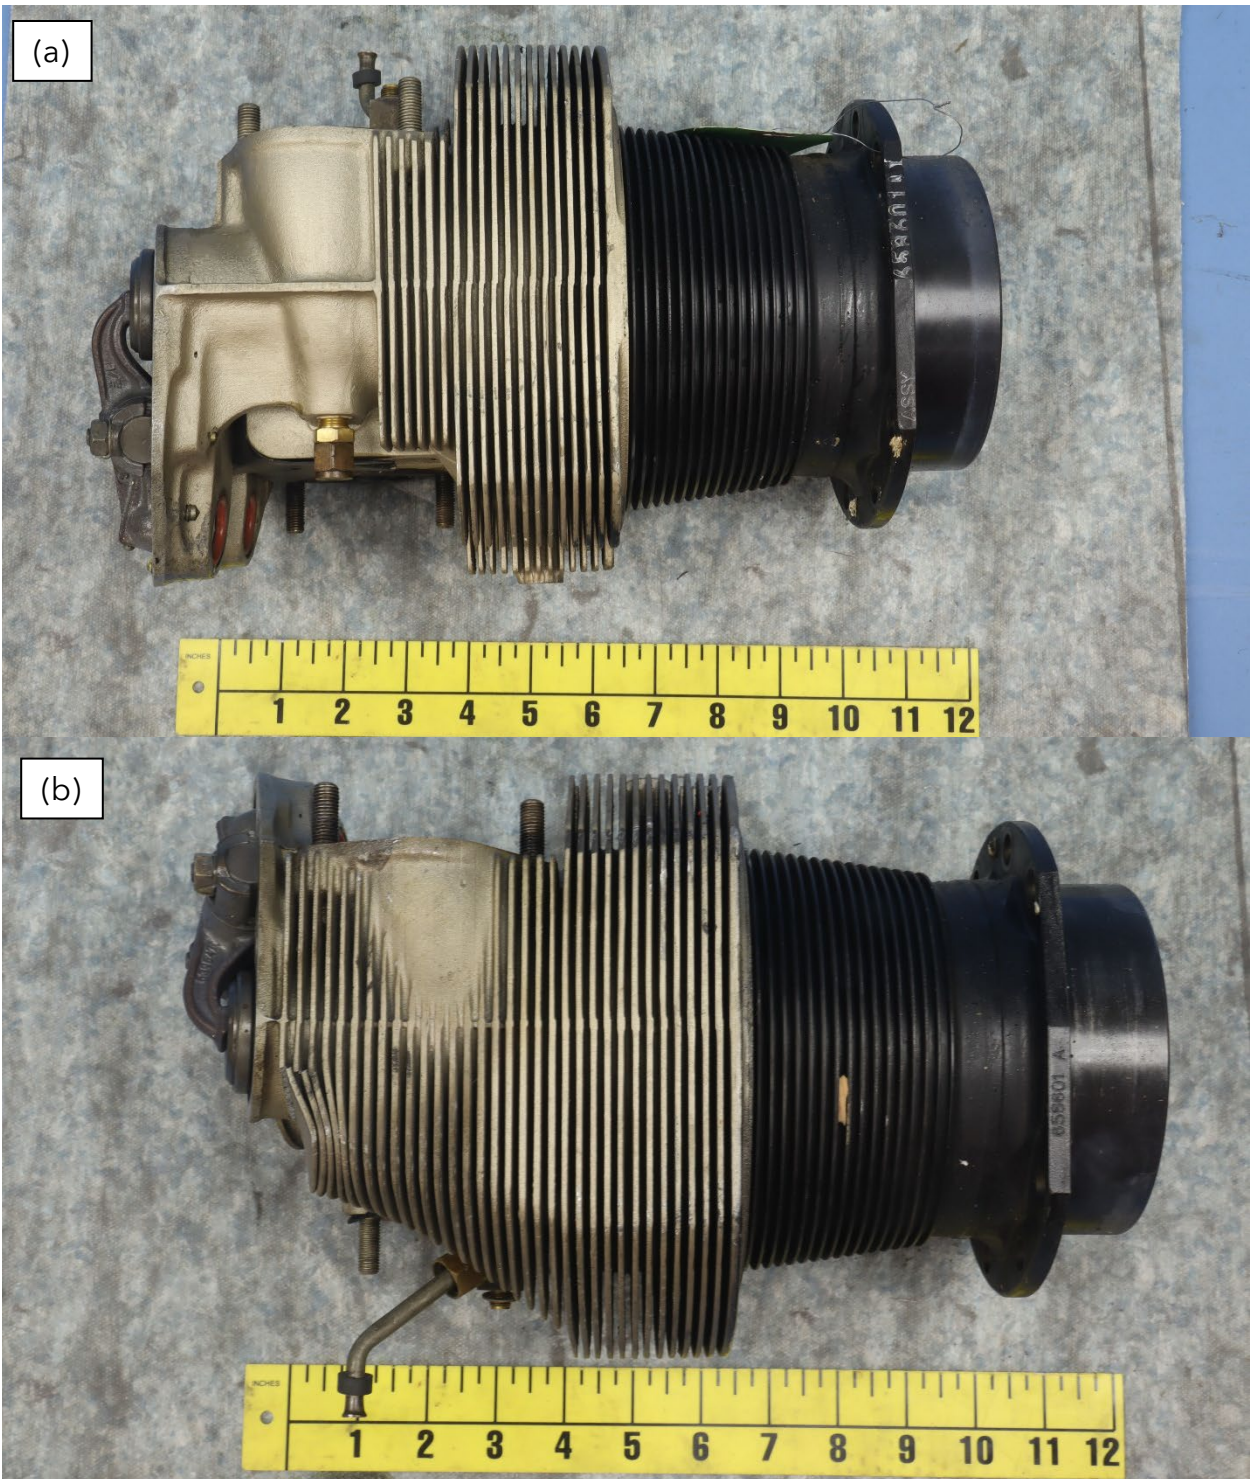
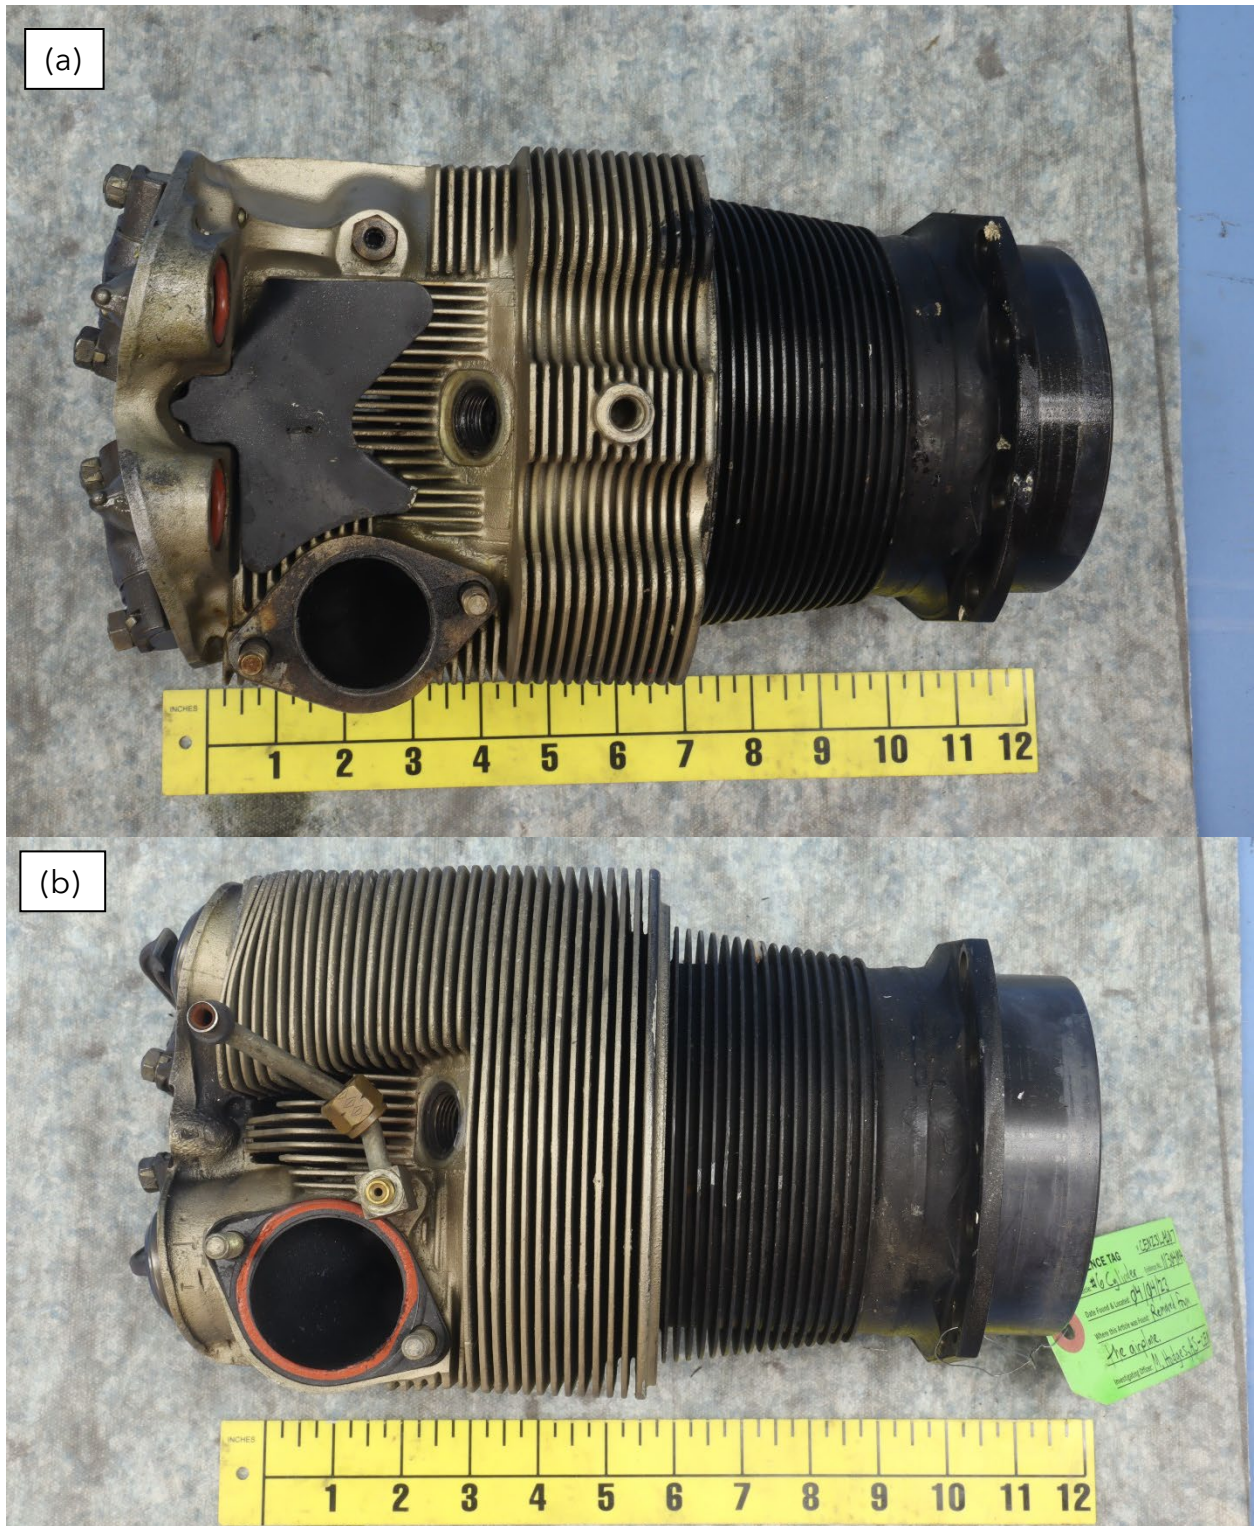
Figure 17 shows the components from the #6 position of the engine—the cylinder and piston assemblies along with several pieces of debris from the piston. Figure 18 shows the exposed upper portion of the cylinder assembly, revealing the rockers, retainers, and other components in this space. Figures 19 and 20 illustrate the other exterior surfaces of the cylinder assembly. Of note was the downward plastic deformation and partial fracture of the upper six cooling fins on the intake port side of the cylinder (see Figures 19b and 20b).

Figure 19. Opposite views of the two sides of the #6 cylinder, as received.

Figure 20. Opposite views of the #6 cylinder from (a) exhaust and (b) intake port sides.

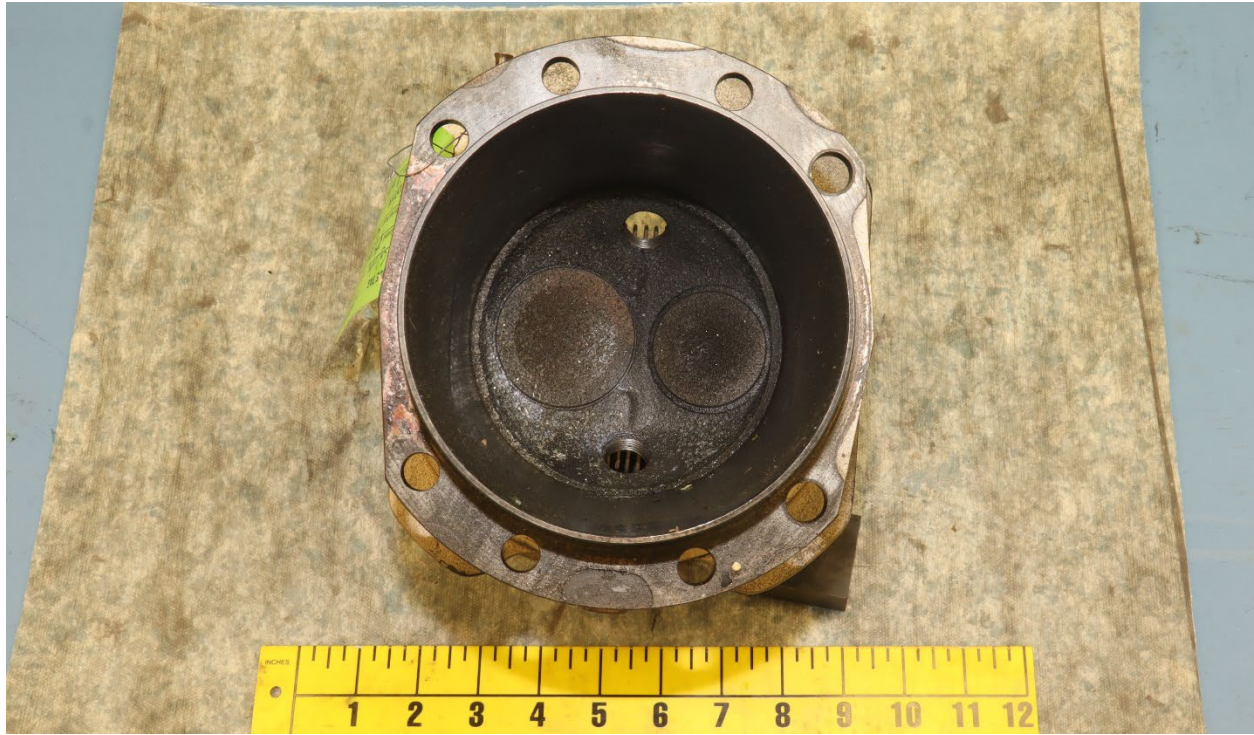
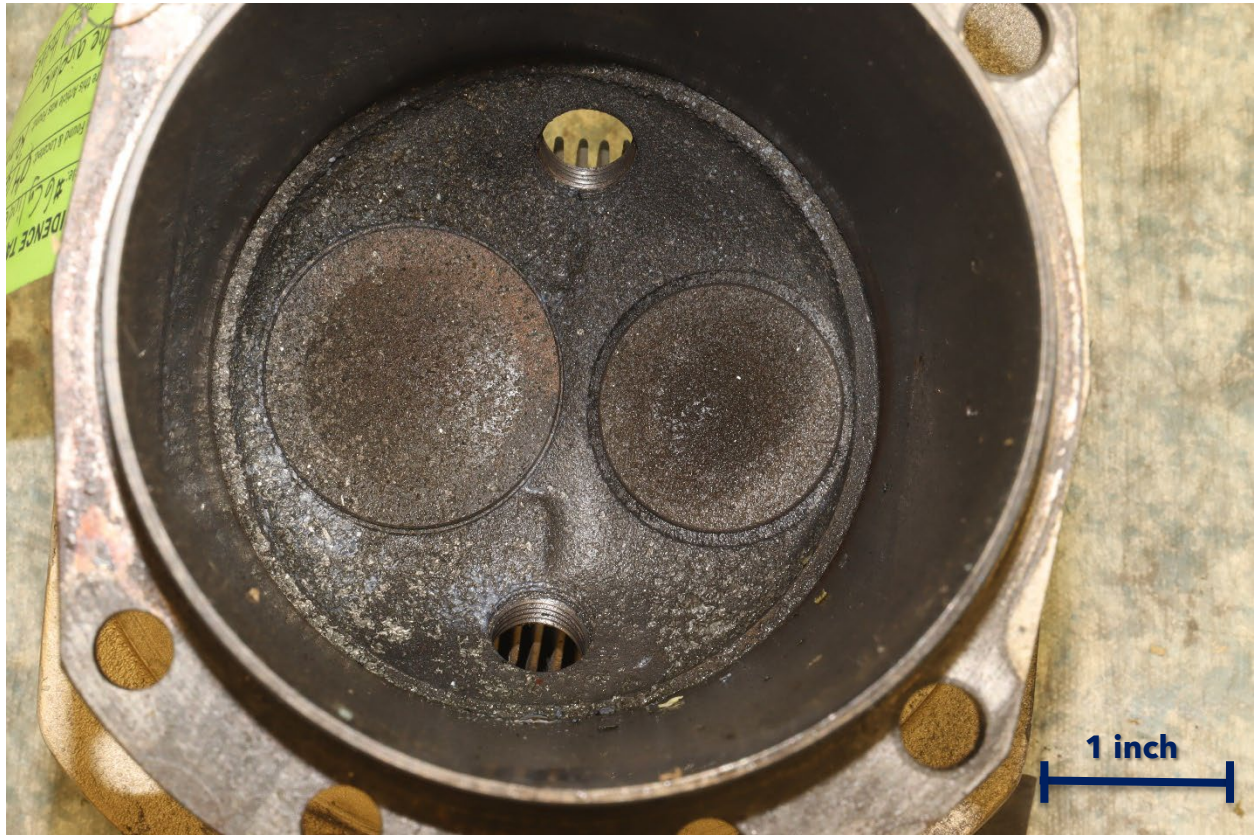
Figures 21 and 22 show the interior of the cylinder, which illustrates the condition of the crown and valve face surfaces. Similar to the surfaces of the other two cylinders, there were indications of combustion deposits on many of the surfaces in Figure 22. However, the #6 cylinder also exhibited a surface sheen of oil, along with adherent fines consistent with metal wear abrasives. In addition, the cylinder crown exhibited two hourglass-shaped divots or depressions between the two valve seats. These divots were located next to the spark plug holes, as illustrated in Figure 23 after removing the valves. The valve seat periphery of the exhaust valve contained the same combustion deposits as the rest of the cylinder crown surface. However, the intake valve seat perimeter was absent of such deposits. There were no visible cracks in the edges of either valve seat.

Figure 21. View of the interior of the #6 piston cylinder, as received.

Figure 22. Closer view of the crown and valve faces of the #6 cylinder, as received.

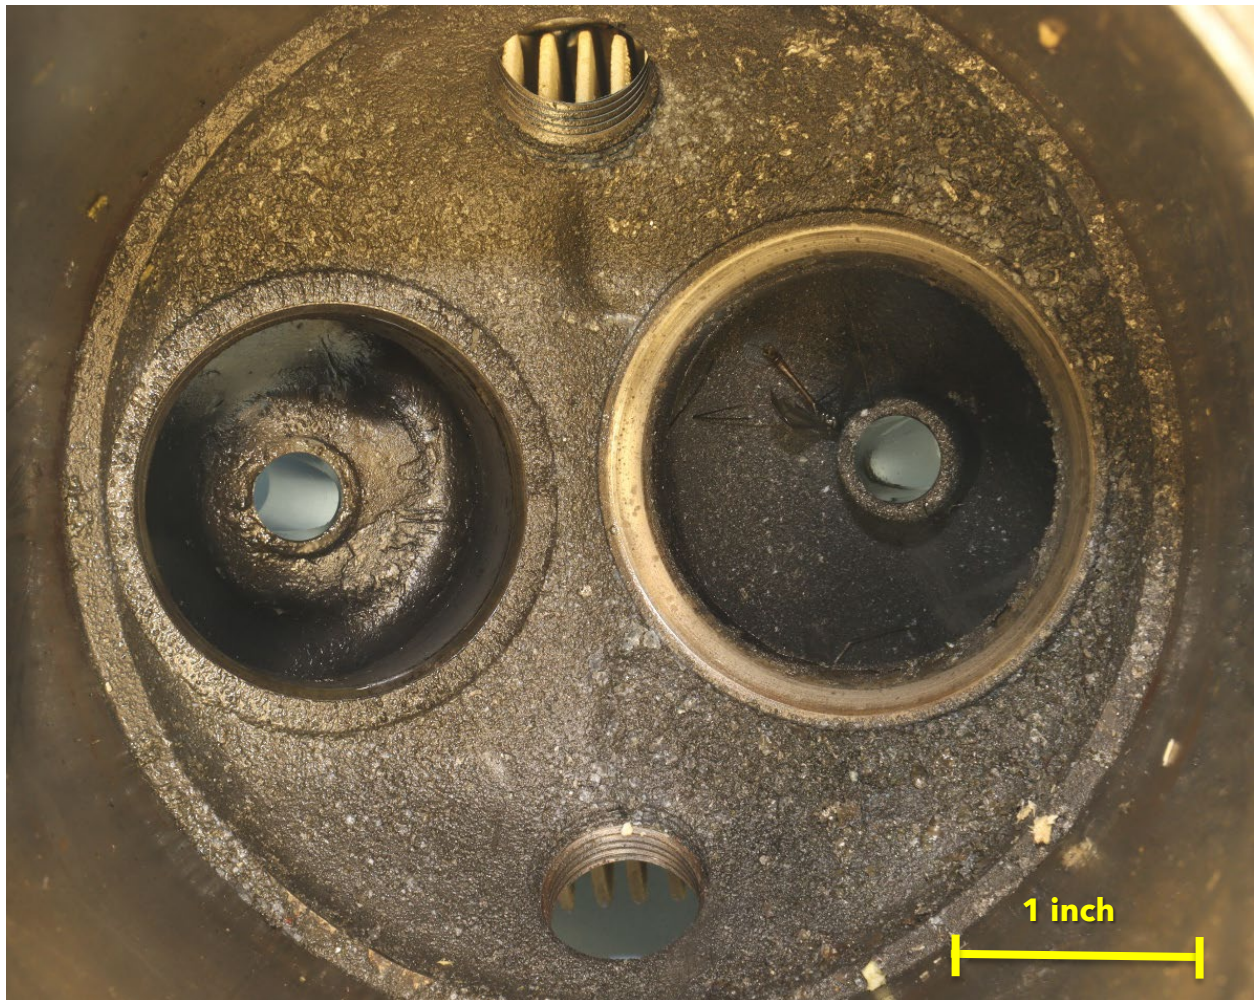
Figure 23. View of the #6 cylinder crown after removal of the valves, showing the condition of the seats.

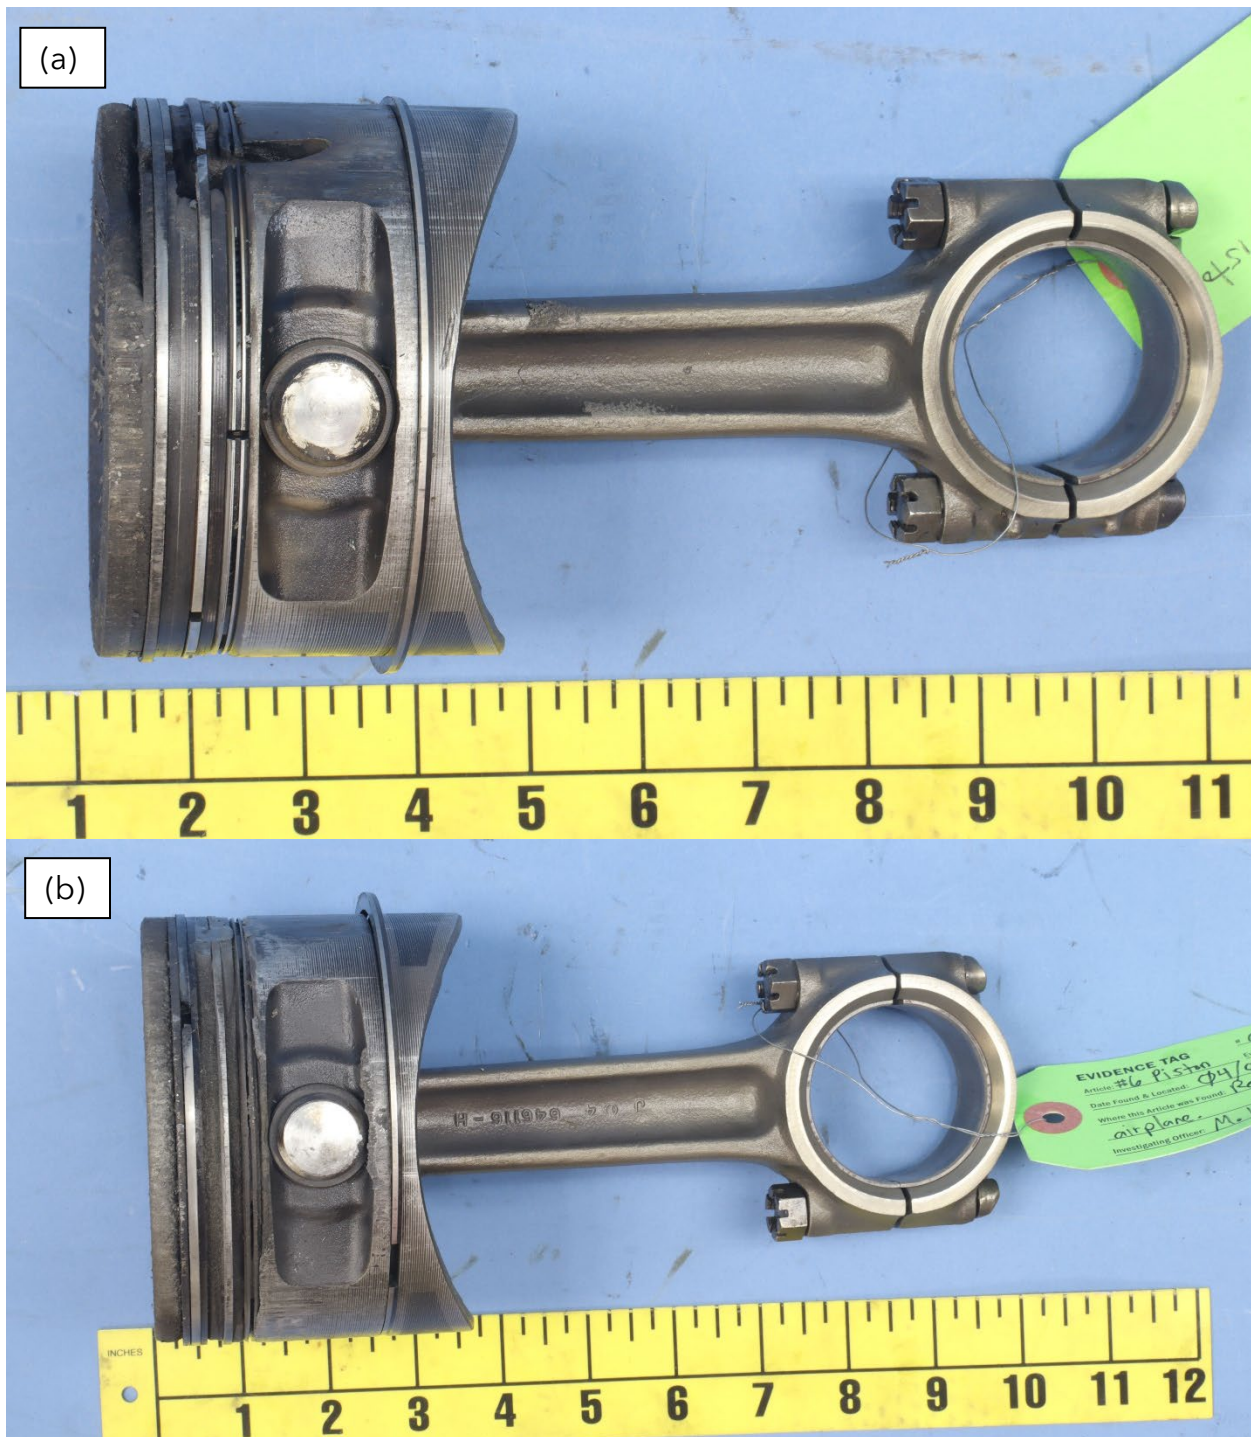
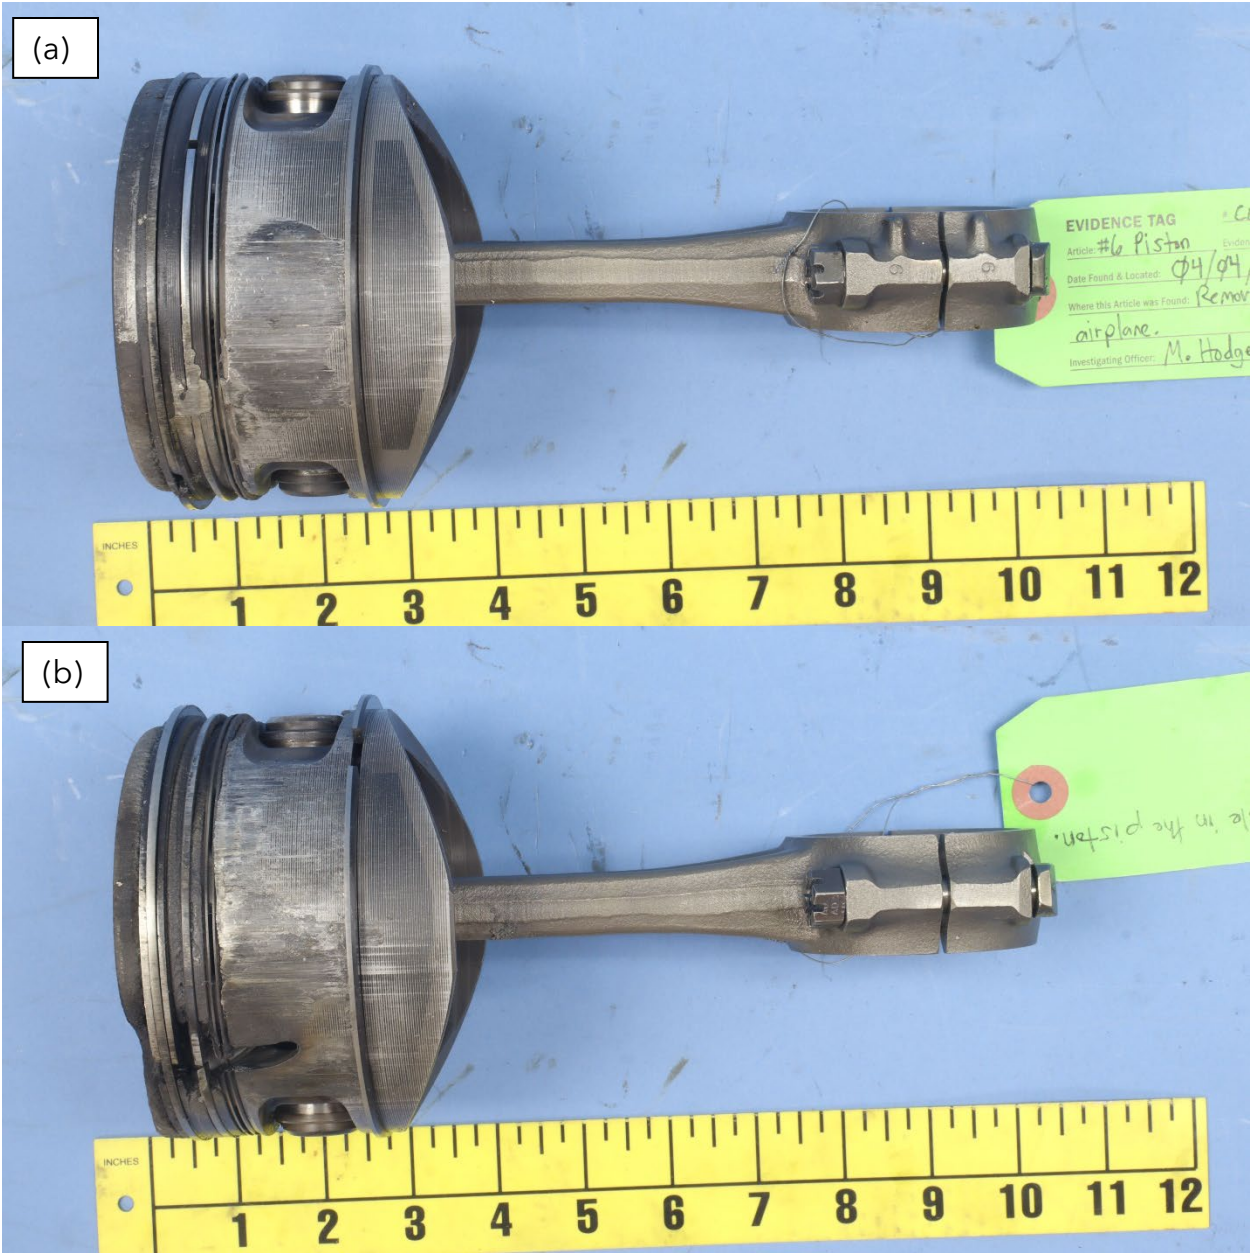
Figures and 25 show the different views of the piston assembly from the #6 cylinder position as received. Of note on the piston skirt were the minor batter marks near the piston pin face on the side in Figure 24b. In addition, the long sides of the piston skirt exhibited longitudinal streaks and gouges, consistent with comparable wear patterns along the barrel of the cylinder. The wear was severe enough to deform and smear

several piston oil rings (lower left in Figure 25a). The flanges of the connecting rod also exhibited minor impact marks (shown in Figure 24a), consistent with contact against adjacent metallic objects.

Figure 24. Opposite sides of the piston assembly from the #6 cylinder, on the piston pin faces.

Figure 25. View of the piston and connecting rod, from 90° of the views in **Figure 23**, showing sliding wear along the piston skirt surfaces.

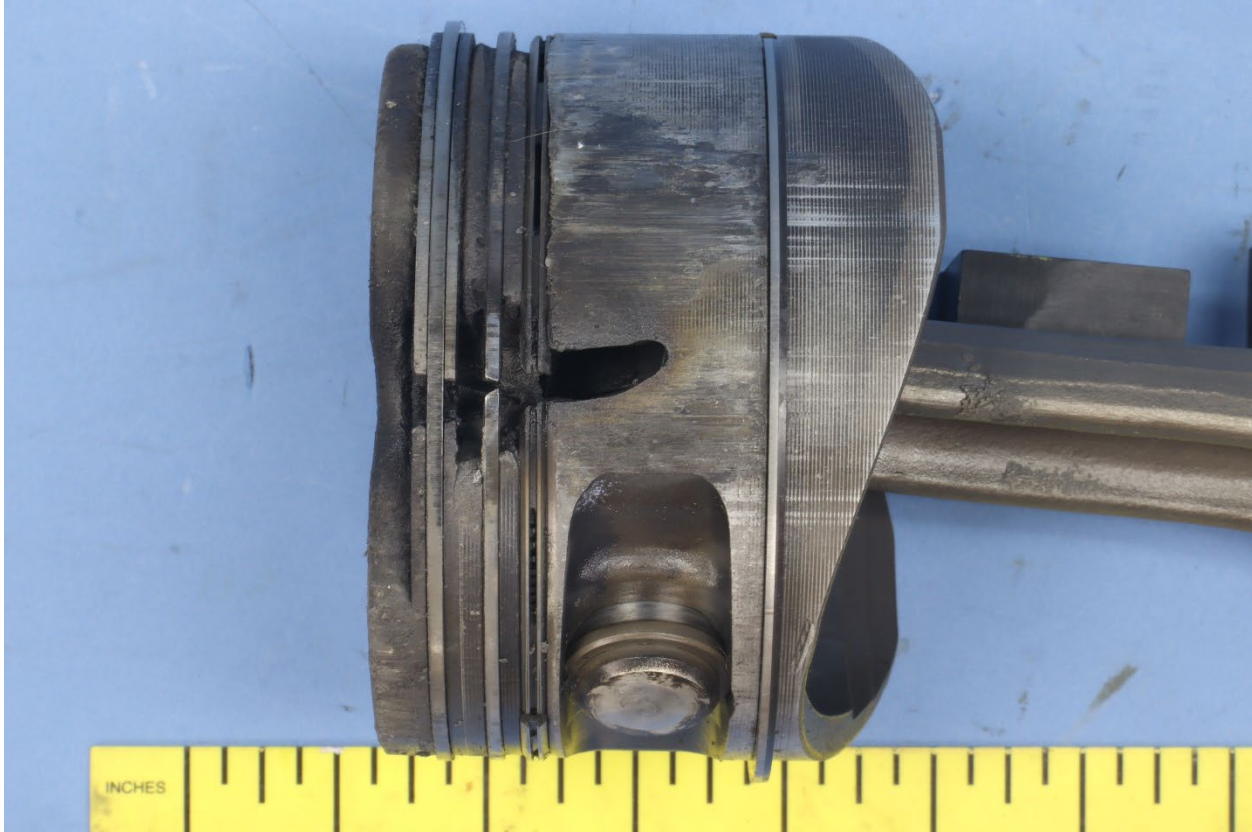
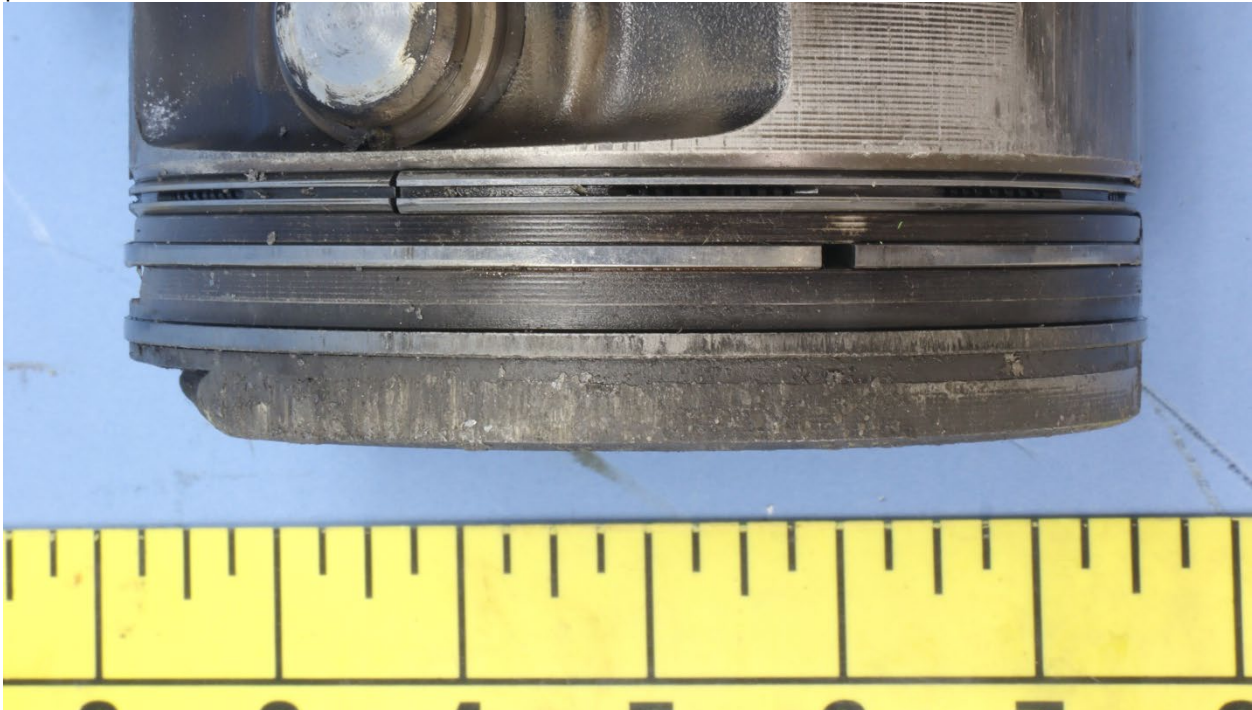
The most pronounced damage was the hole and missing material on the corner of the piston crown, exemplified in Figure 26. This hole penetrated through the piston cross-section and was consistent with missing material and local fracturing of one of the oil rings. Figure 27 shows a perpendicular view of the corner damage, demonstrating the degree of material loss of the crown in that location.

The corner of the damage and hole exhibited discoloration, darkening, and heat tinting. The periphery of the hole exhibited material thinned to an edge. These features were consistent with a high-temperature burn-through of the part. There were also longitudinal wear marks and streaks near the hole, consistent with material rubbing between the piston and the adjacent cylinder barrel. This rubbing and deformation extended to the ring material near the piston hole.

Figure 26. View of the corner of the piston skirt, showing an elongated hole in the piston.

Figure 27. Perpendicular view of the #6 piston hole (on the left), demonstrating the degree of material loss in the piston crown corner.

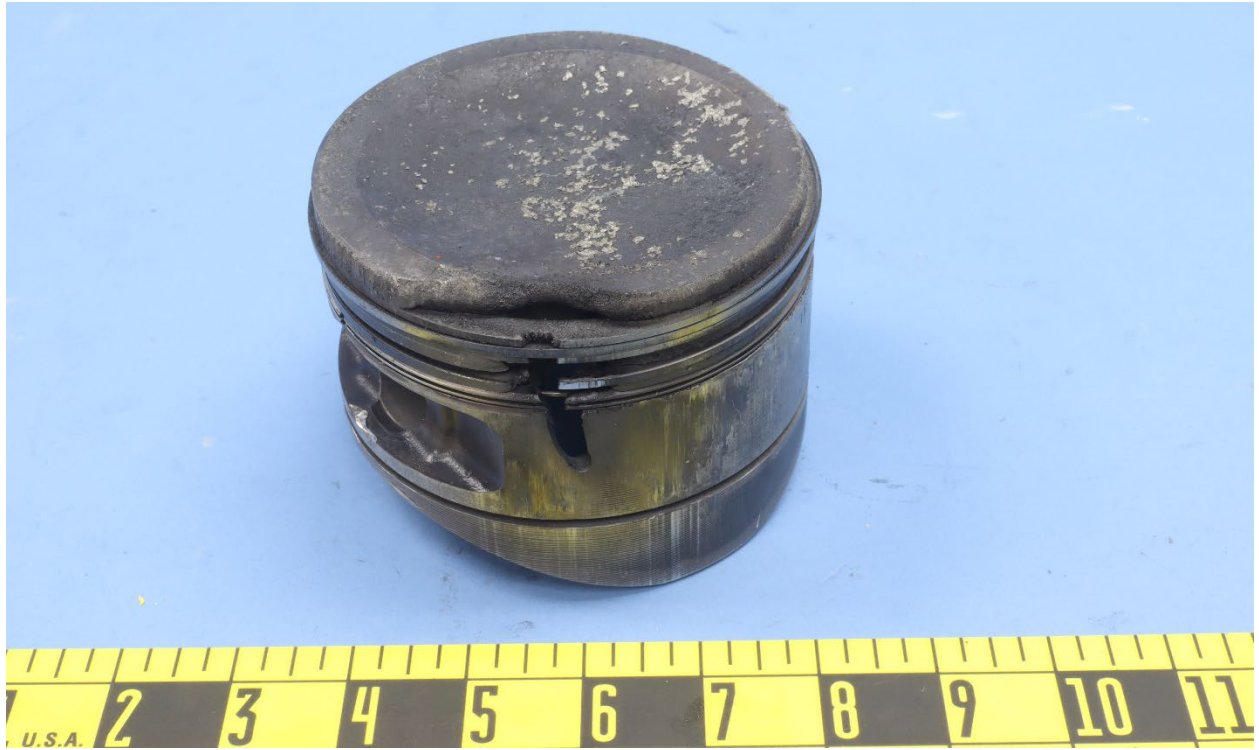
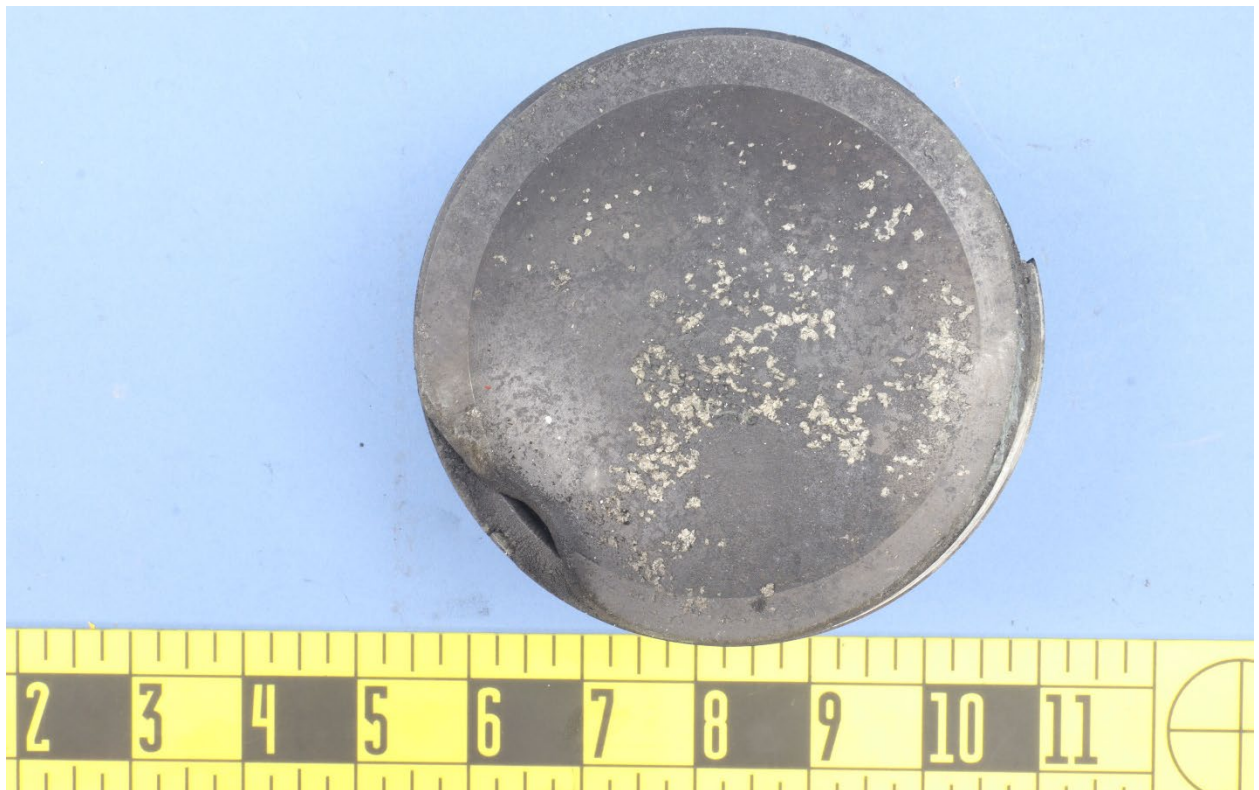
Figure 28 shows an angled view of the damage to the piston corner after disassembly and removal of the pin and connecting rod. The dimensions of the hole were measured using digital calipers, with the length being upwards of 1.28 inches long and the width up to 0.28 inches. When measured from the interior, the hole width was 0.34 inches wide (the length could not be measured with this technique from inside). The chord length of the crown damage in Figures 28 and 29 was 2.52 inches long, with 0.26 inches of crown height absent above the ring.

The rest of the piston crown exhibited white deposits, consistent with combustion deposits. The degree of deposition was less than on the top of the #4 piston.

Figure 28. Angled view of the #6 piston hole, after removal disassembly and removal of the connecting rod.

Figure 29. Oblique view of the piston crown surface, after disassembly.

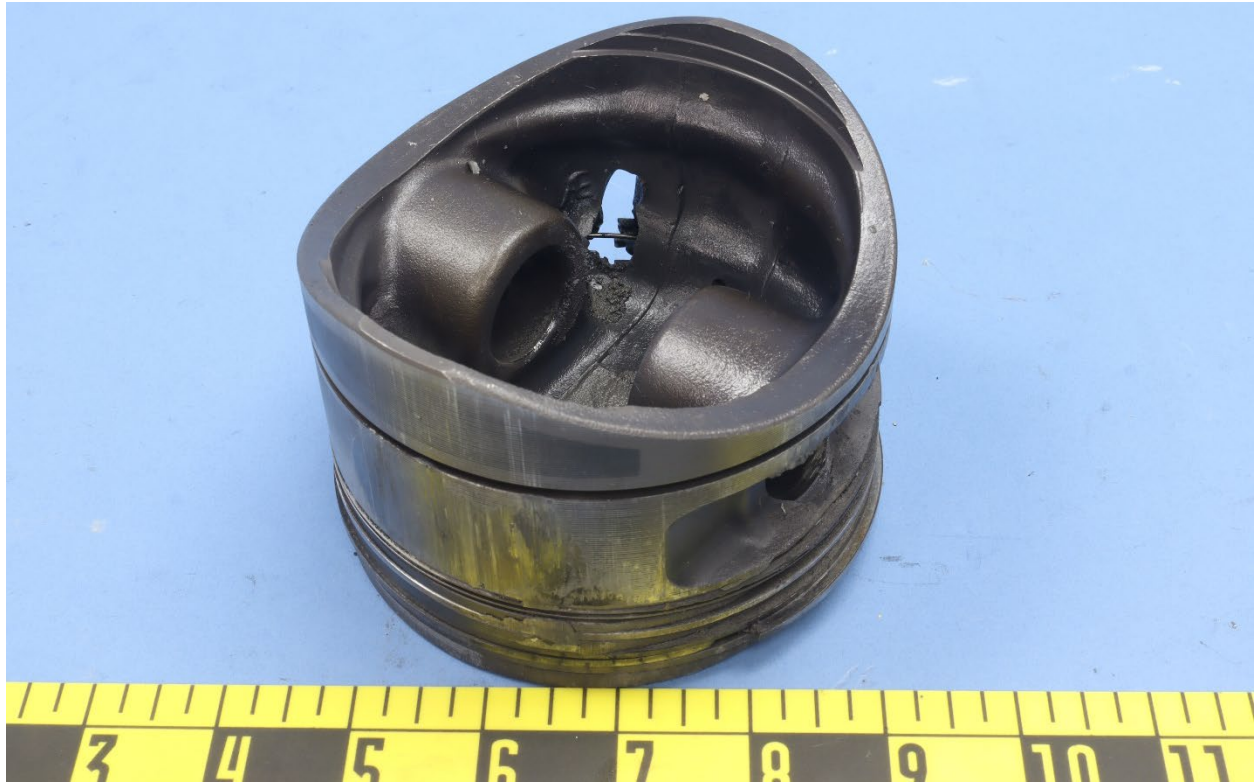
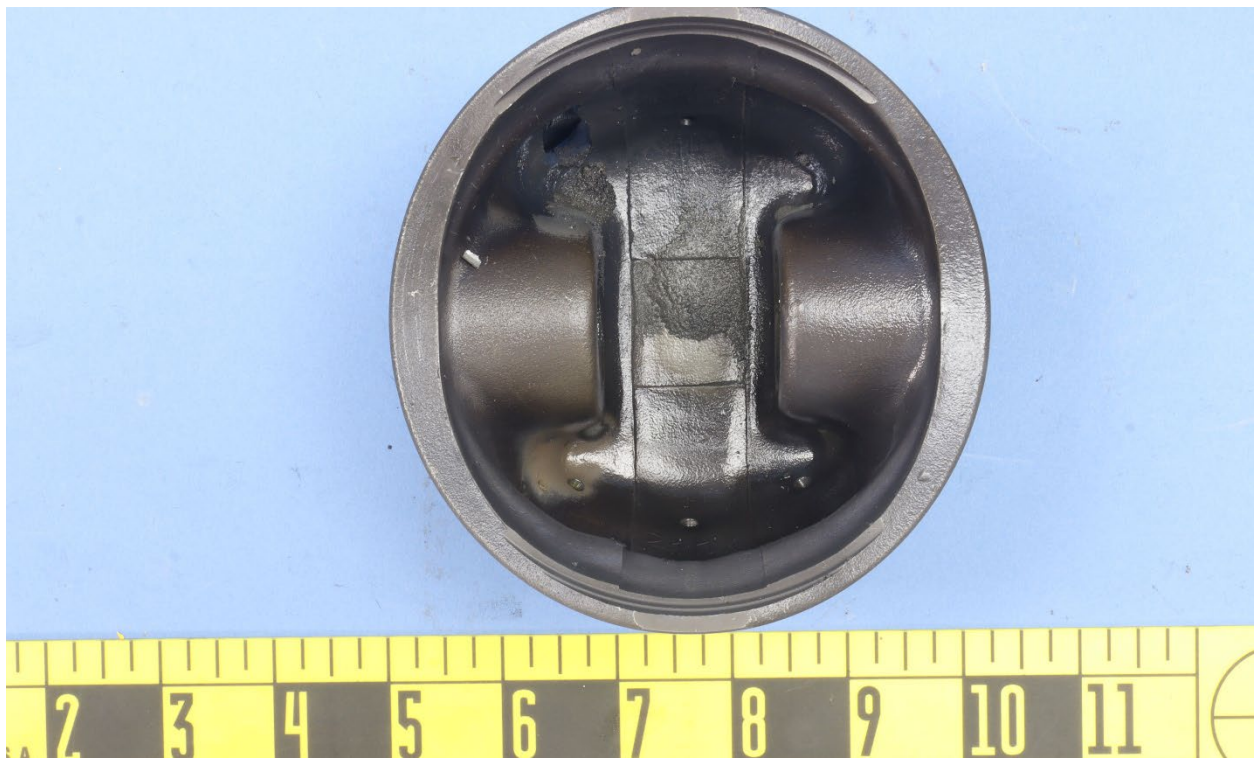
Figures 30 and 31 show the interior of the #6 piston. Figure 30 shows the hole in the corner, which exhibited a greater width than the exterior measurements. Figure 31 demonstrates the deposits in the surfaces of the piston, along with the varnishing of the surfaces.

Figure 30. The hole on the #6 piston, viewed from the interior of the piston.

Figure 31. Oblique view of the #6 piston interior, showing deposits and varnishing of the interior surfaces.

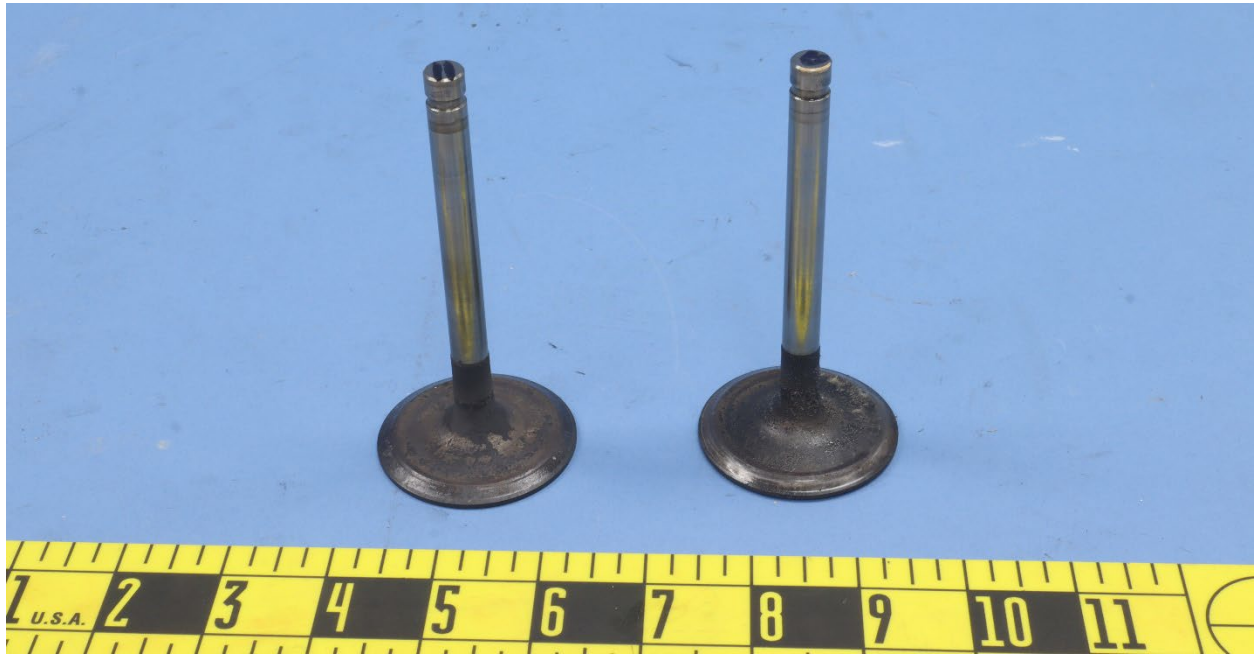
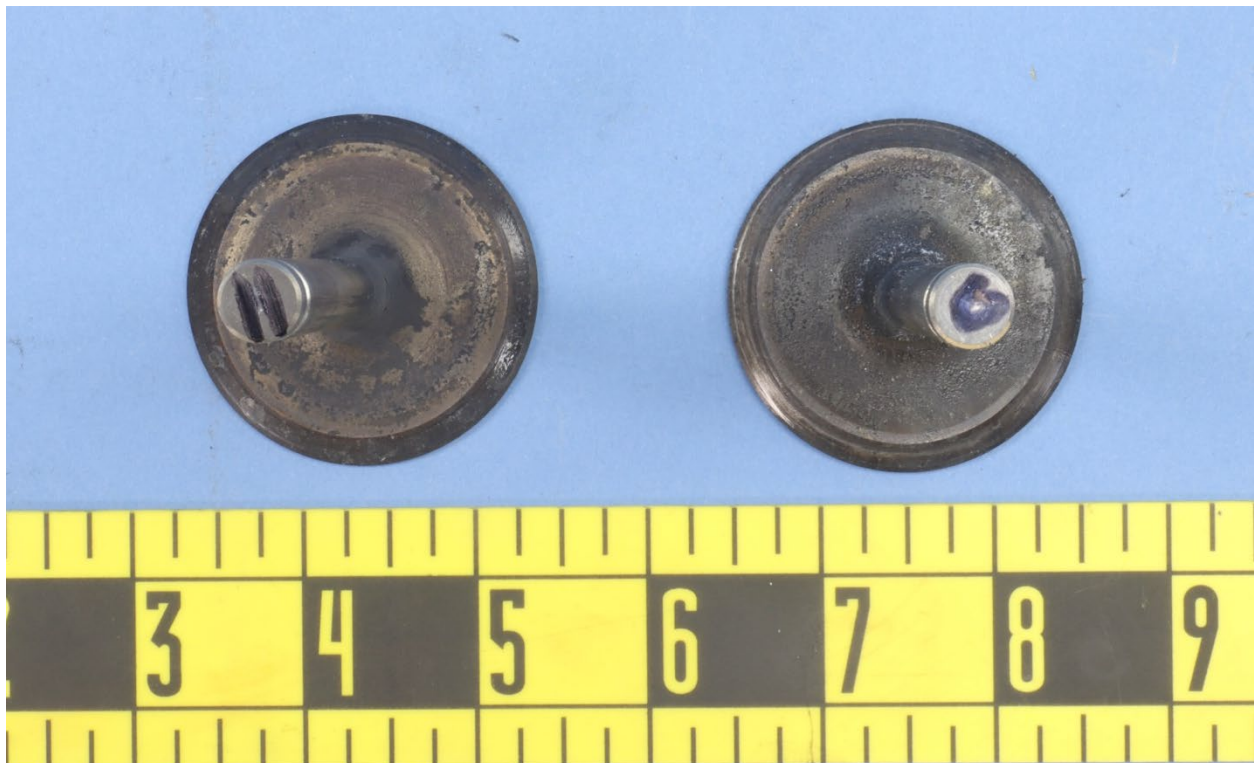
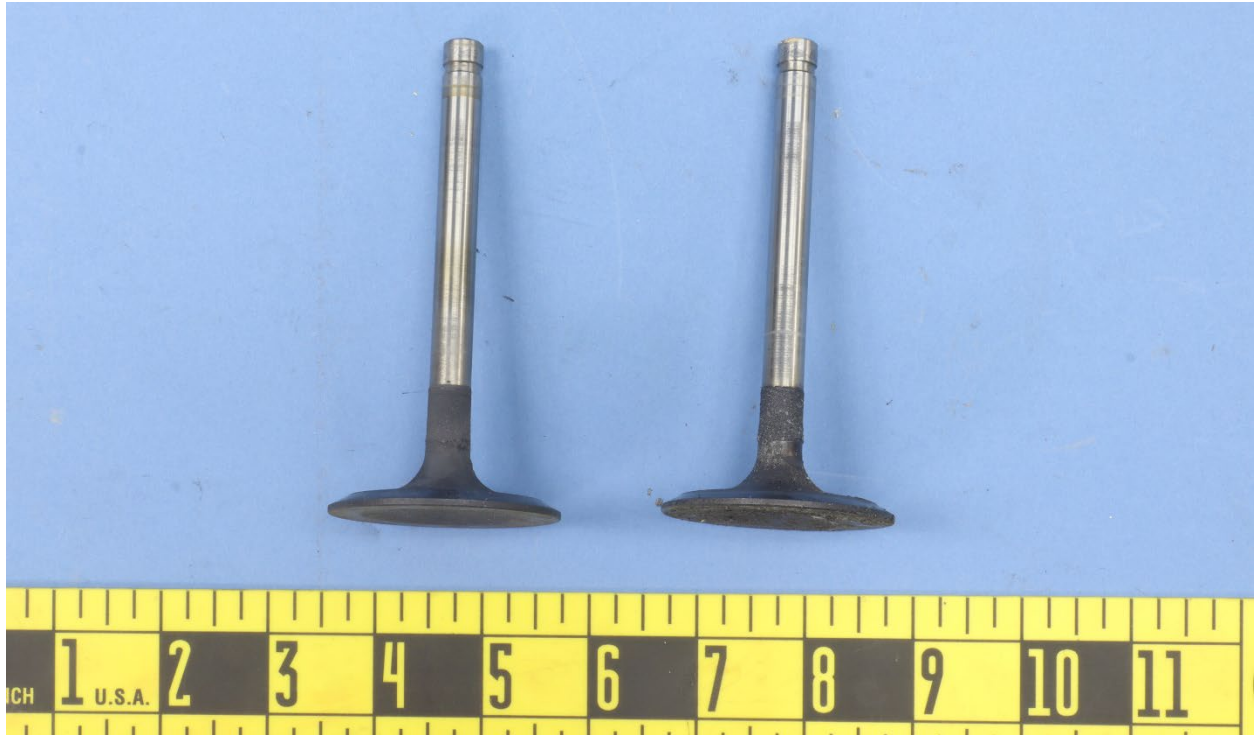
The #2 and #6 cylinders were completely disassembled, and the intake valves from each, shown in Figure 32, were measured to determine any differences in dimensions. The dimensions are listed in Table I. While the length of the #6 intake valve was longer by over 0.01 inches, this valve also exhibited more combustion deposits.

Figures 33 and 34 show different views of each valve, demonstrating the difference in surface deposits. Those on the #2 valve were browner in color and flatter over the exposed surfaces on the face, seat, and stem. In contrast, the combustion deposits on the #6 intake valve were darker and more globular and tortuous, with a reflective sheen consistent with engine oil and metal fine deposits.

Figure 32. View of the intake valves from the #2 and # cylinder positions.

Figure 33. Top-down view of the #2 and #6 intake valves.

Figure 34. Side views of the #2 and #6 intake valves.

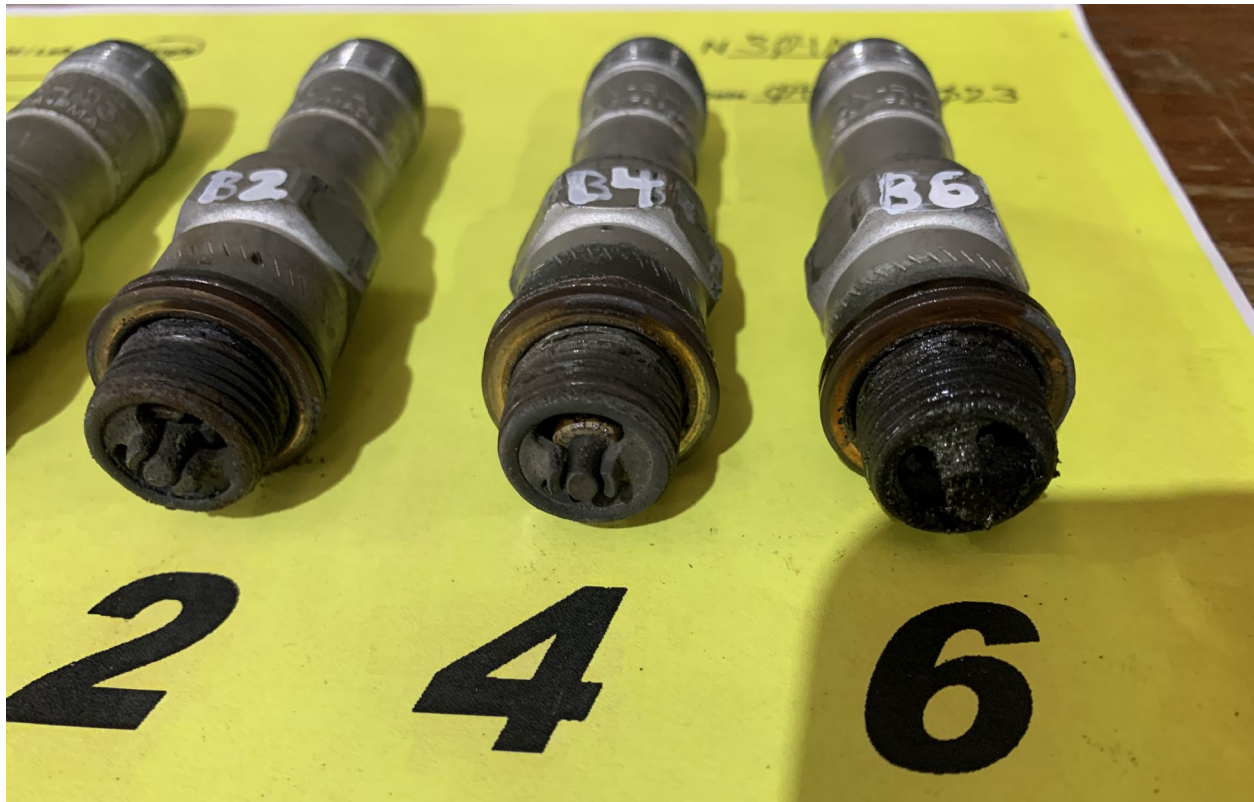
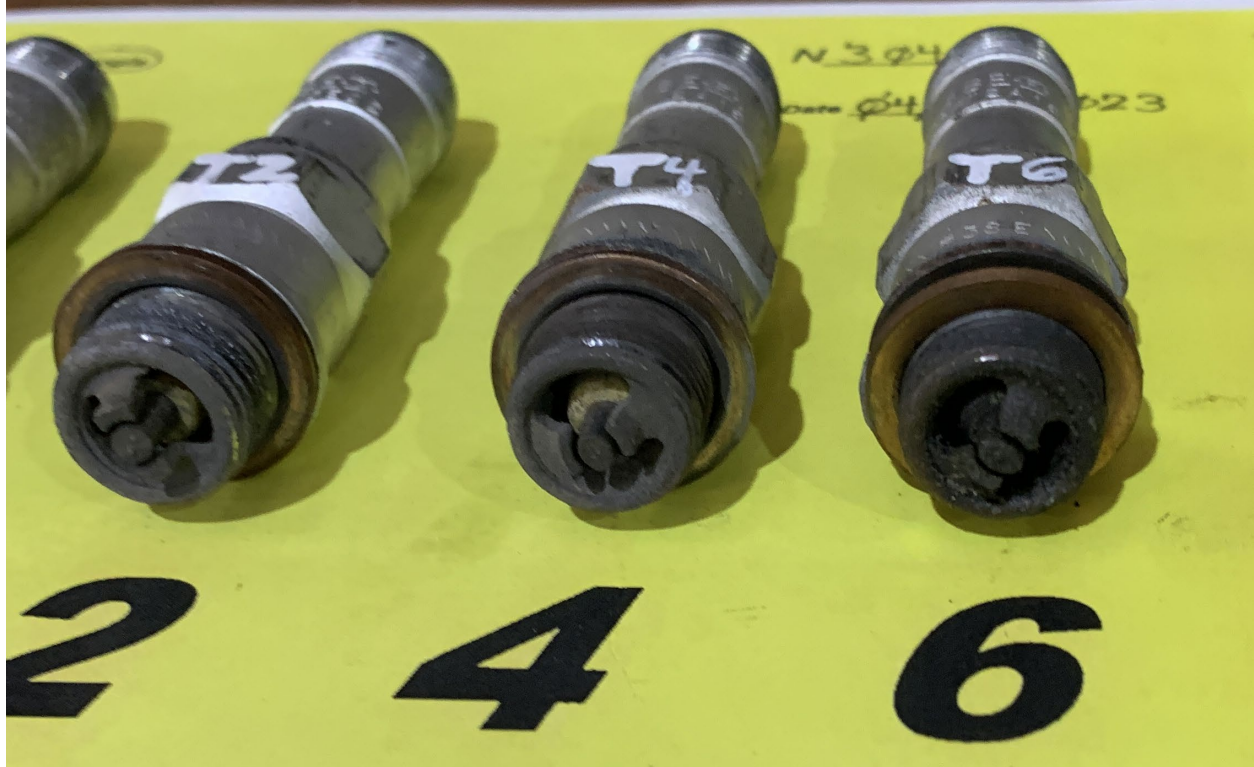
Examination of the spark plugs performed outside of the Materials Lab showed that the #6 spark plugs exhibited more surface deposits than those of the number 2 and 4 cylinders (see Figures 35 and 36). While all the spark plugs exhibited combustion deposits to some degree, the #6 plug in Figure 36 exhibited dark deposits enough to obscure the electrode surfaces. Further, the #6 spark plug in Figure 35 revealed more deposits, showing engine oil and protruding debris on all the exposed surfaces.

Figure 35. Views of the bottom spark plugs from the #2, 4, and 6 cylinders (courtesy Michael Hodges, AS-CEN).

Figure 36. Views of the opposite top spark plugs from the #2, 4, and 6 cylinders (courtesy Michael Hodges, AS-CEN).
