National Transportation Safety Board

RRD24FR001

MATERIALS LABORATORY

Factual Report 23-100

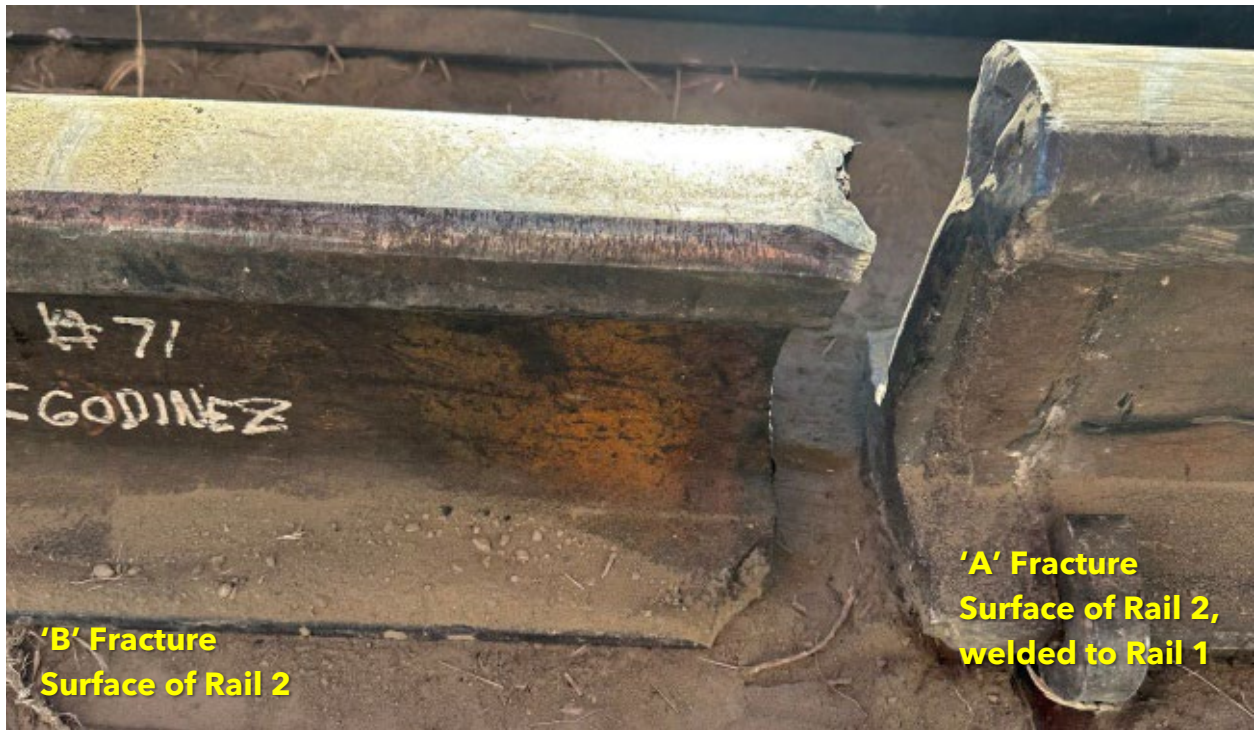
Figure 1. Photograph of the initial broken rail at M.P. 109.656 located on the left stock rail, viewed from the gage side. Weld #71 was completed on May 29, 2023 (Courtesy NTSB-RPH).

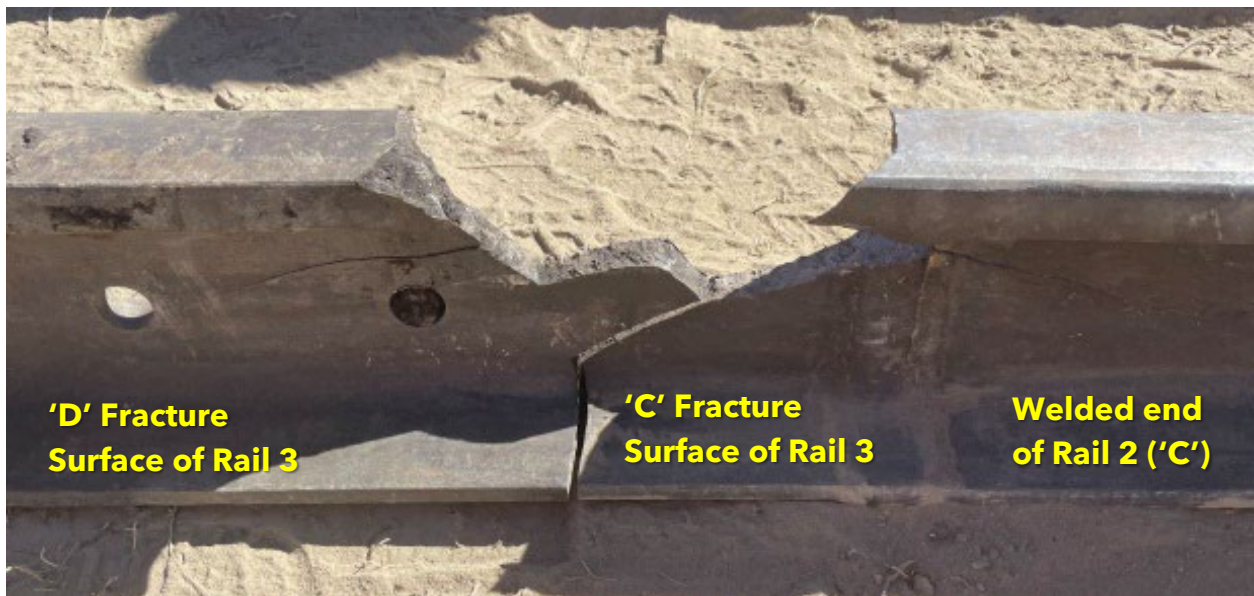
The fracture pattern at the on-scene portion of the examination for 'C' and 'D' showed crack branching as the fracture proceeded upward from the base (see Figure 2). This fracture pattern was consistent with the primary fracture along the base and web, with the secondary fracture front proceeding upward through the head.

Figure 2. Photograph of breakout in the rail located 71" north of the initial broken rail (weld #71), viewed from the field side (Courtesy NTSB-RPH).

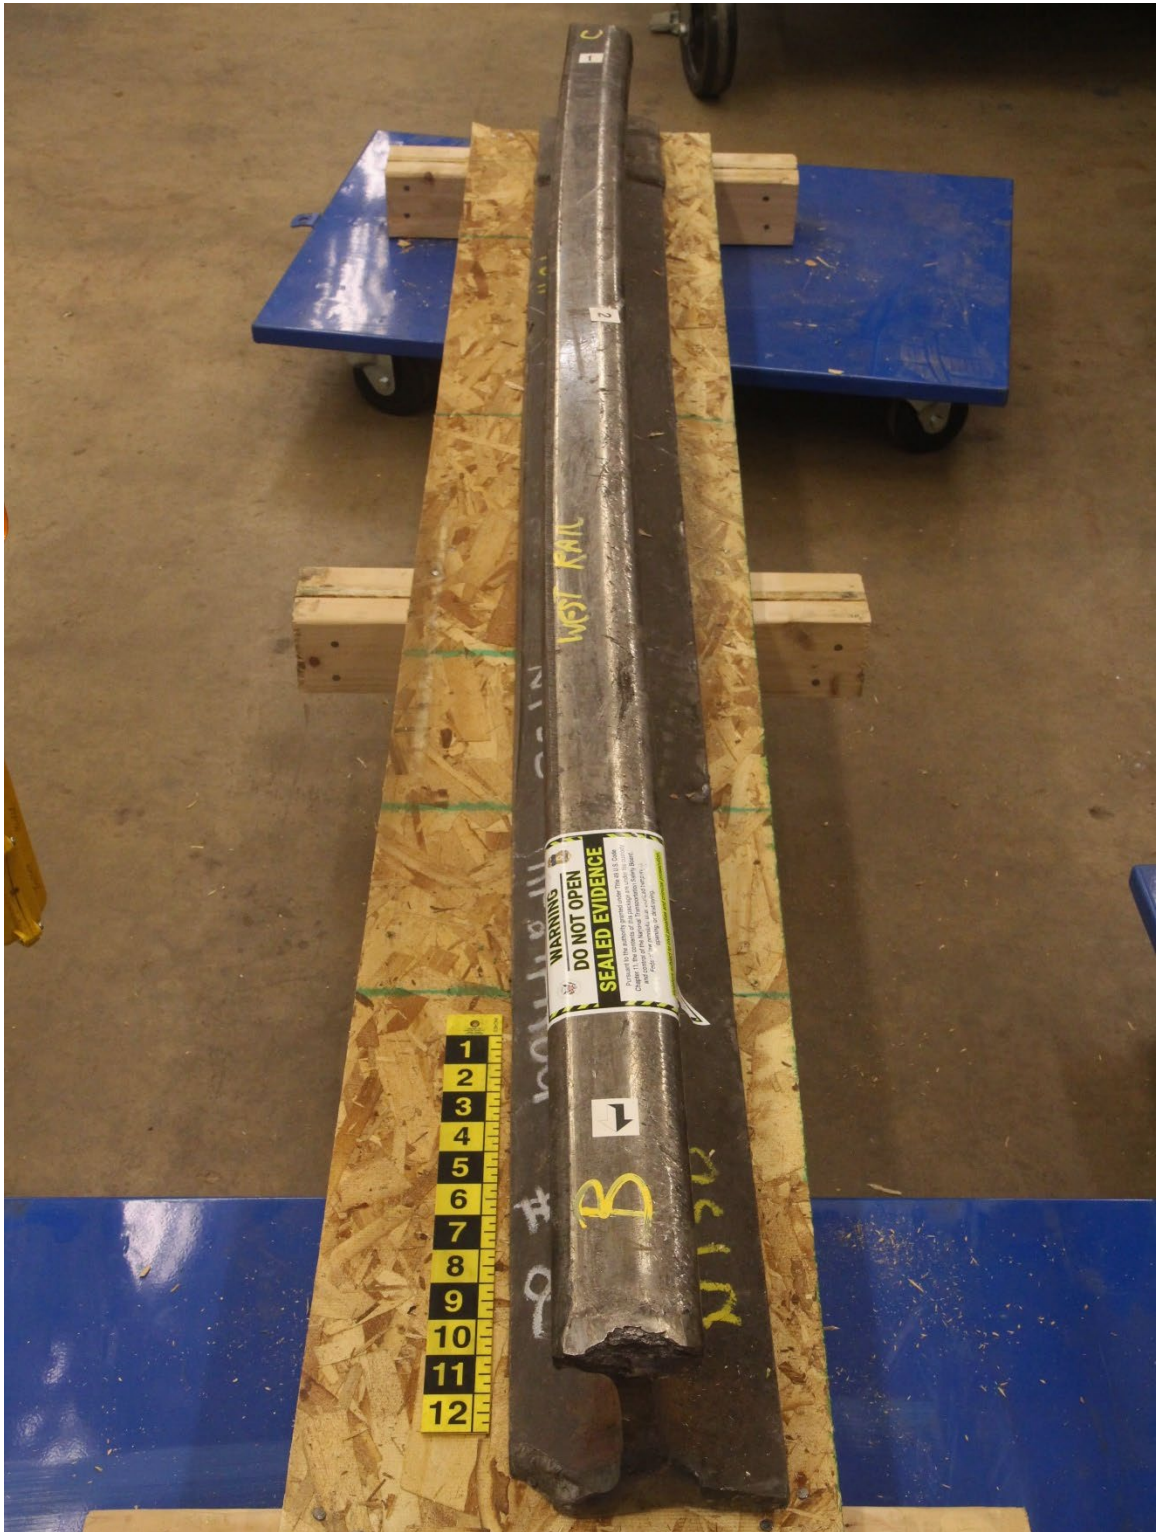
Of most concern was the fracture surface near the weld at location MP 109.656, which were labeled as fracture surfaces 'A' and 'B'. The fracture was located 0.75 to 0.95 inches from the weld edge, with the weld being approximately 1.50 inches long in the longitudinal direction. This weld, shown in Figure 1 on scene, was labeled Weld #71, and it had been completed on May 29, 2023, or 4 months and 16 days prior to the accident. Figure 4 shows this fracture surface from the side opposite the weld, or 'B'. This fragment of rail (rail 2) had deformed away from its tangent (straight) direction, shown angled to the right in Figure 4.

Figure 4. View of Rail fragment #2, showing the 'B' side of the fracture surface that mated with surface 'A', and the right ward bend in the rail, with the 'C' at the opposite end.

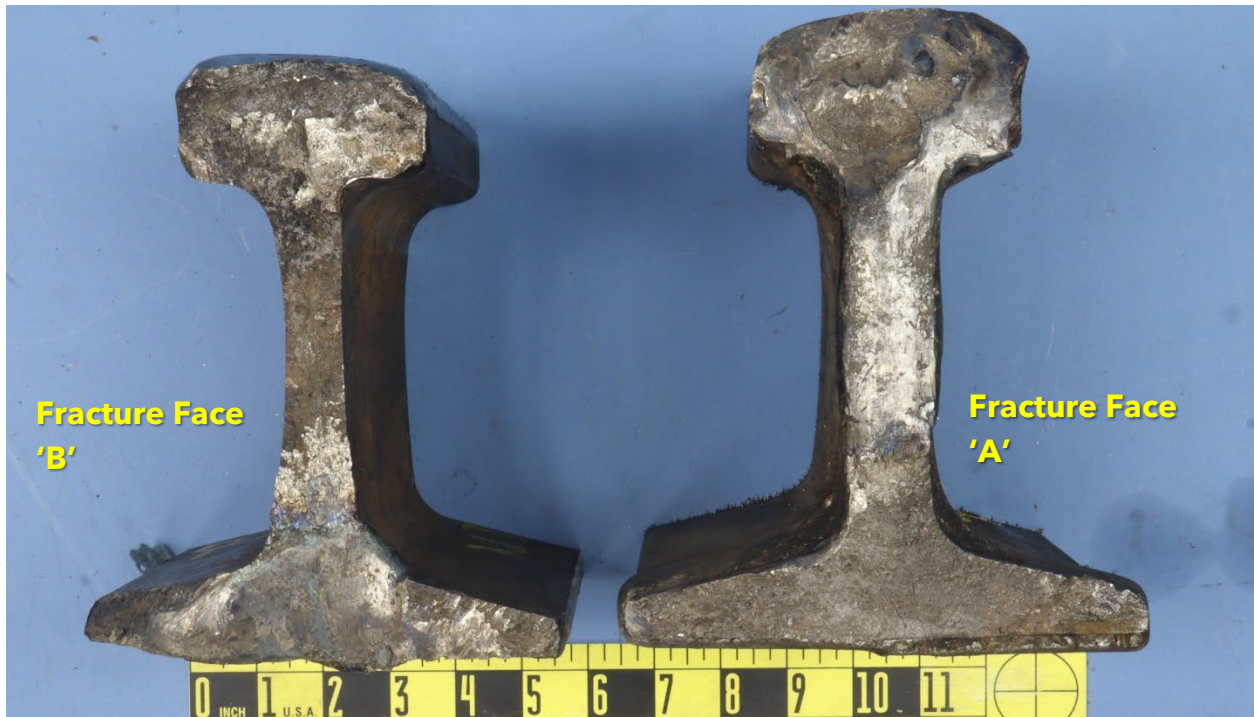
Figure 5 shows the mating 'A' and 'B' fracture surfaces facing the reader. The B side exhibited 'friction batter' or abrasion marks from contact with the mating fracture surface. These features were observed on the lower portion of the fracture, concentrated on the base and lower web. The streaks in the worn area were oriented vertically, consistent with up and down rubbing and movement. In contrast, the abrasion on the A side was concentrated along the upper web and head surfaces.

Figure 5. The mating fracture surfaces near the weld of rail at MP 109.656, showing the upstream (left) and downstream (right) sides.

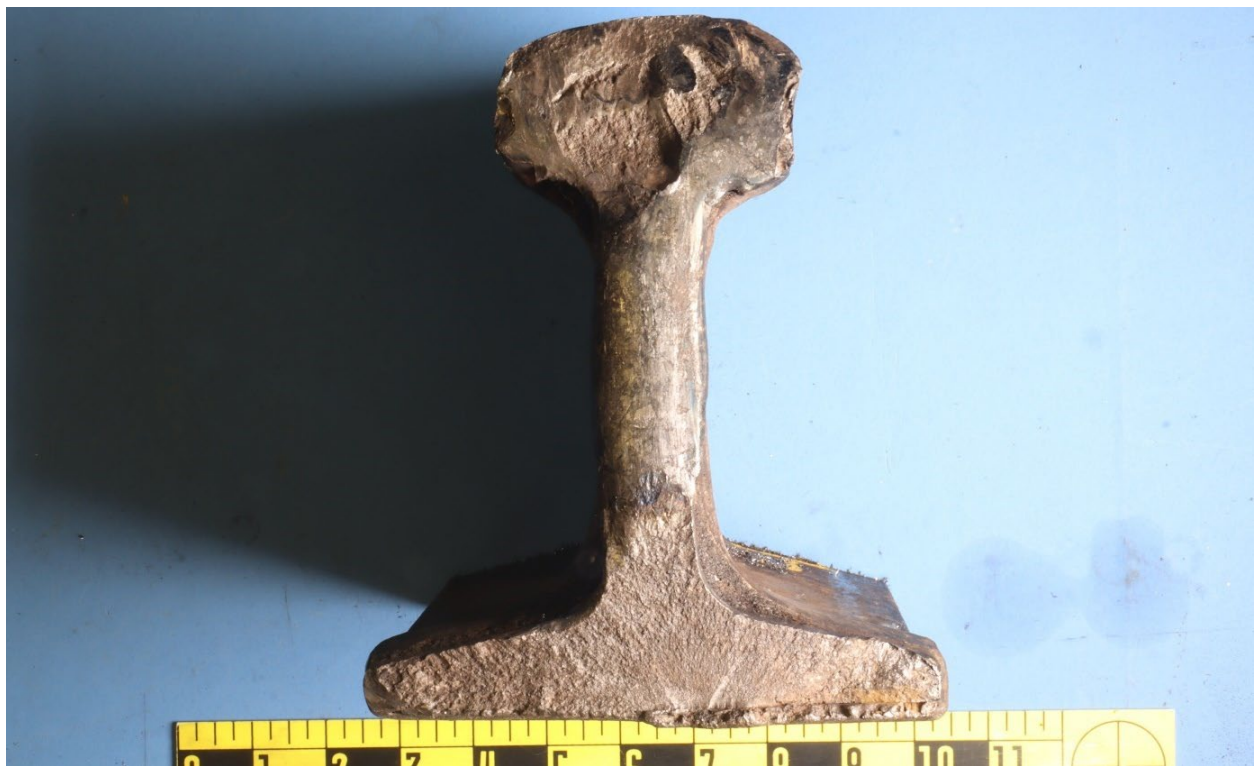
Figure 6 shows the A side fracture surface under oblique lighting to visually highlight fracture features. The surface was generally rough in texture with a dull, fibrous luster. The surface exhibited upward-spreading river patterns and downward pointing chevron patterns. These features were consistent with fracture originating from the base and progressing upward.

Figure 6. Oblique lighting view of the downstream fracture surface 'A', showing ratchet marks and chevron features emanating from the bottom of the base.

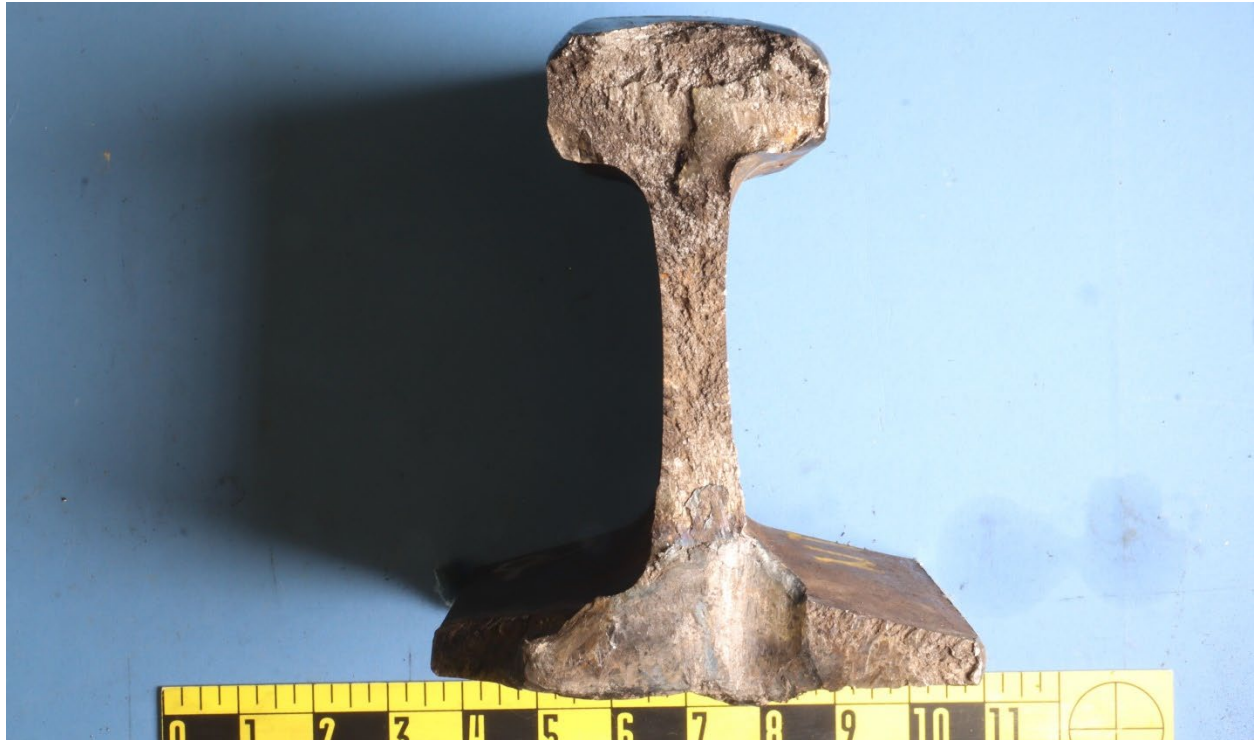
Comparing the undamaged portions of the head and web on the mating rail fracture in Figure 7 shows comparable features in the same orientation, consistent with fracture progressing upward from the web through the head. These features were consistent with fracture progressing from the base of the rail, which exhibited post-fracture damage.

Figure 7. The mating upstream side of the rail fracture surface 'B', showing abrasion and vertical rubbing in the base, with downward oriented chevron marks on the web and head.

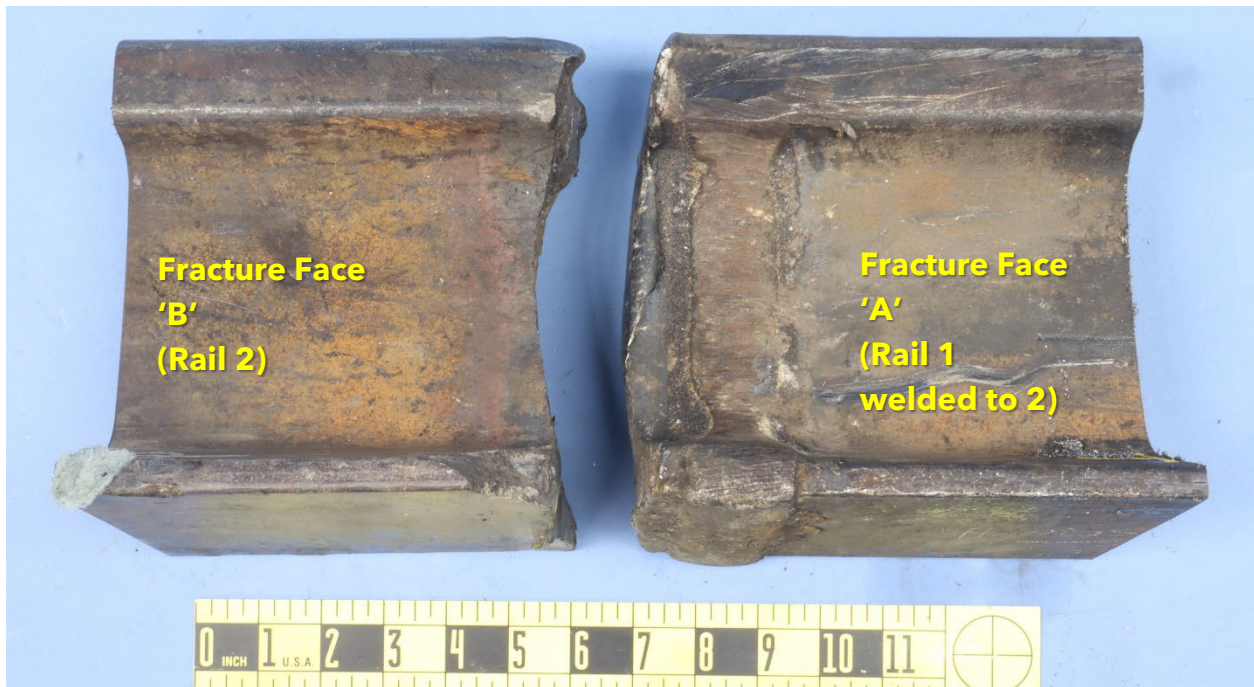
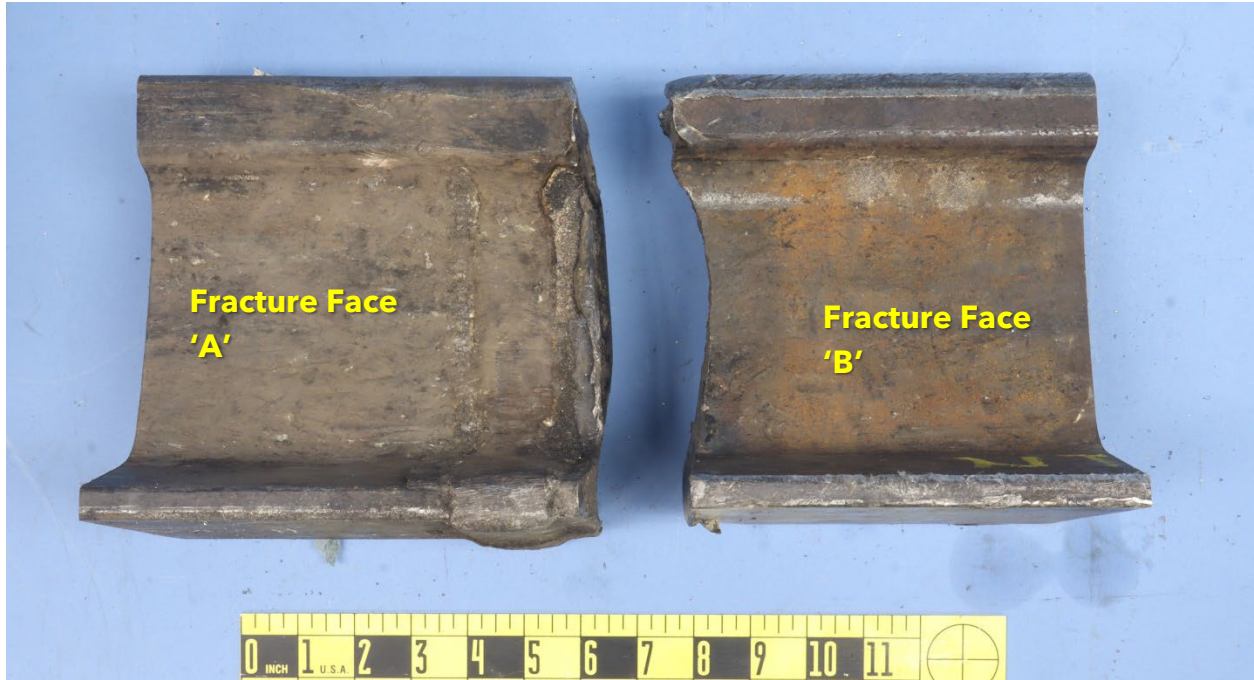
Figure 8 and Figure 9 show the mating A and B fracture surfaces from the field and gage sides, respectively. These fractures were oriented vertically, with a convex shape toward the middle of the web. The fracture was not located along the weld, but rather

0.75 inches outside the weld filler boundary within rail 2. On the field side of the web, there was a wavy longitudinal witness mark approximately 2 inches about the base. The gage side of the rail 2 portion also exhibited wear along the web angled toward the gage side, located on the fracture section of the rail with the weld.

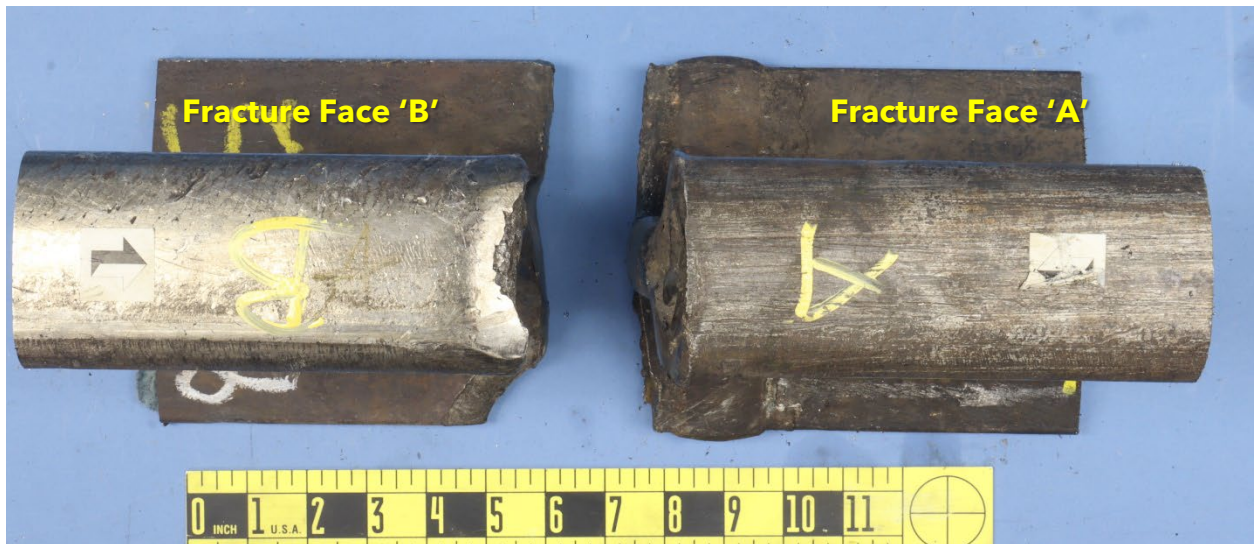
Figure 10 shows the running surface of the head about the fracture. The side of the fractured rail opposite the weld (labeled 'B' in the figure) exhibited downward oriented deformation, which can also be seen in the left in Figure 5. According to the labeling on the rail, the running direction of the derailed train was left to right in Figure 10. There were indications of shelling on the gage side of rail 2 on the left in the figure—these features were absent on the opposite side of the weld (the right rail 1 in Figure 10).

Figure 10. View of the fractured rail sections from the head running surface, with the train running direction labeled.

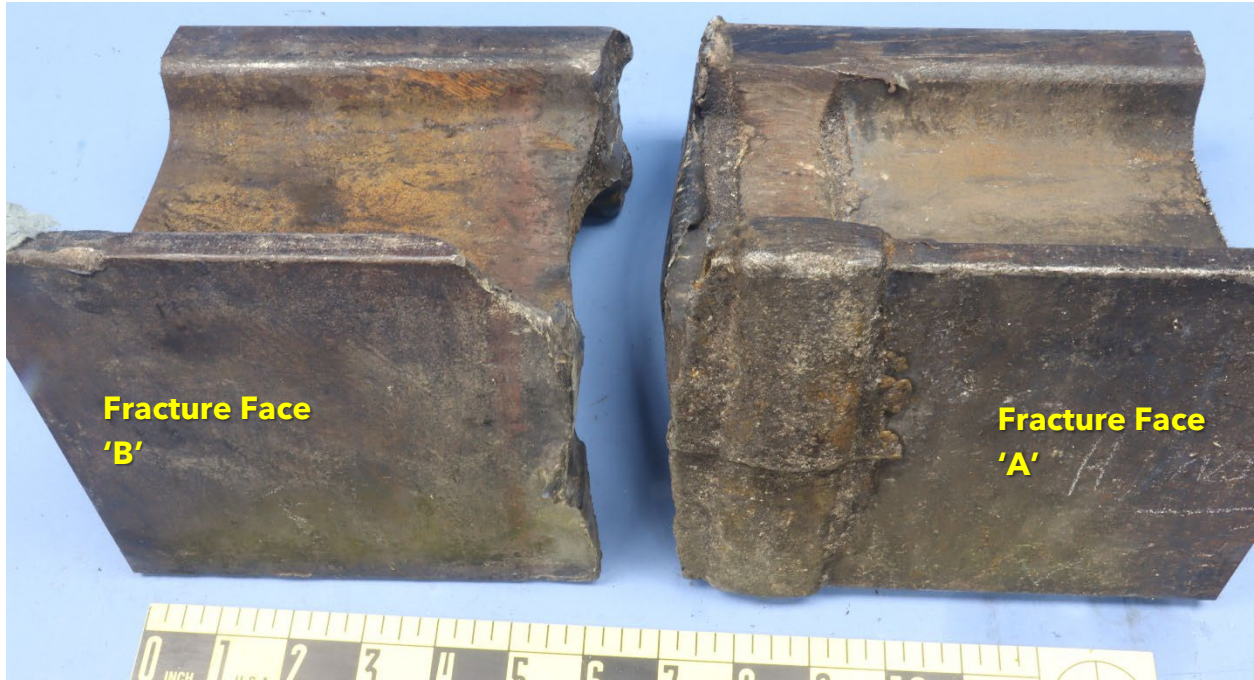
Figure 11 shows an angled view of the underside of the base from field side. This demonstrates the degree of weld filler and flash present below the base.¹ The flash thickness was approximately 0.30 inches at maximum. There was also a small piece of the base that had fractured and was missing from the 'B' side of the fracture.

Figure 11. Angled view of the base underside from the field side of the fractured rail.

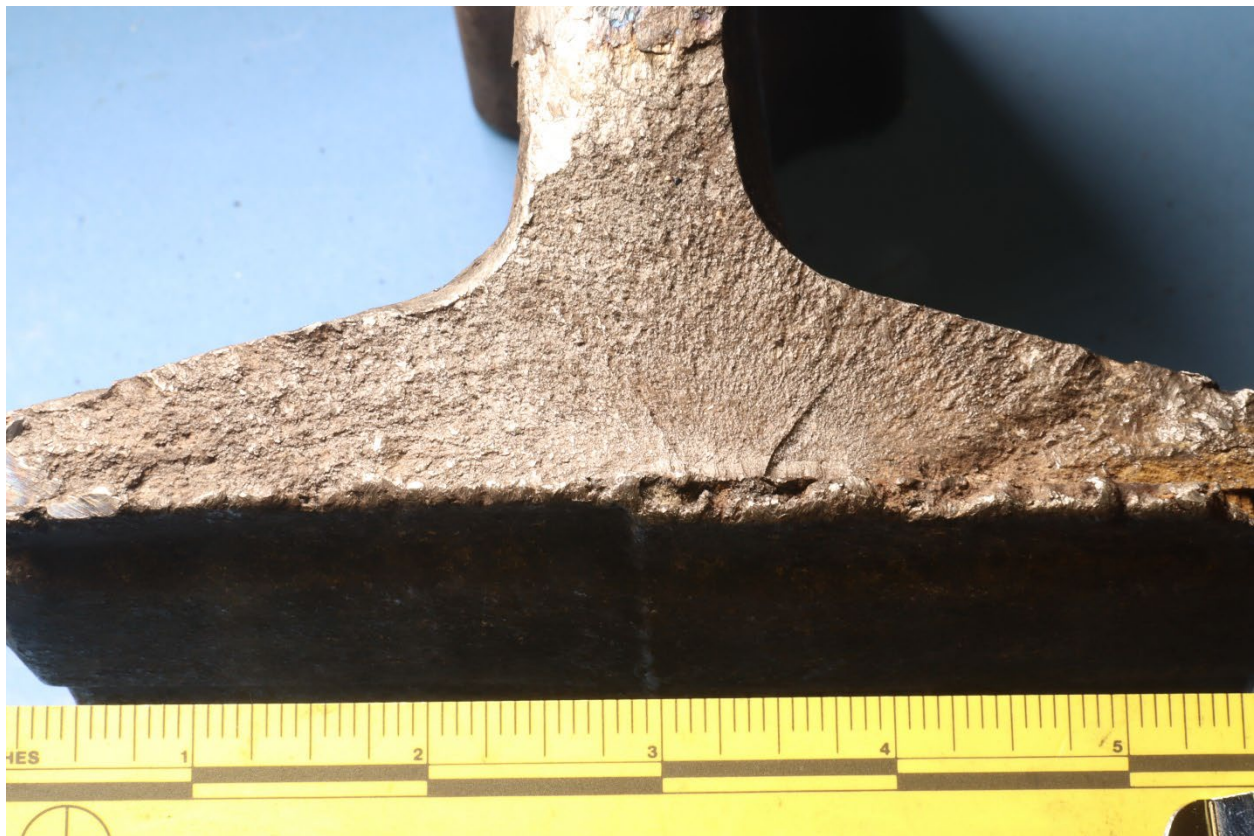
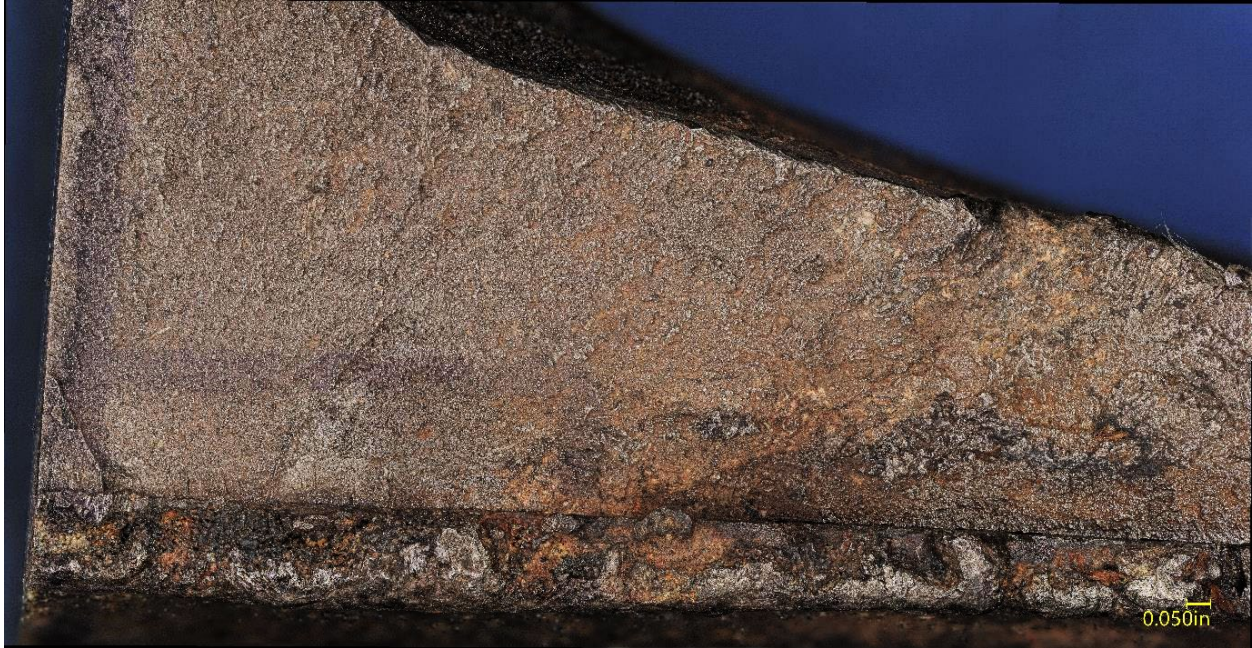
Figure 12 shows an angled view of the 'A' side fracture surface at the base, illustrating the initiation region of the fracture surface. This area was sectioned and excised for additional examination. Figure 13 shows a montage of the fracture surface section near the base after cleaning in an ultrasonic bath with acetone. The fracture surface exhibited two larger, angled river marks emanating from the underlying layer of flash.

While most of the fracture surface exhibited dull, fibrous qualities, a thumbnail shaped area was present along the initiation region with flatter features and a more reflective luster (Figure 13). The boundaries of this region are annotated in Figure 14, and they exhibited crack arrest marks, consistent with an initial progressive crack. This crack also exhibited ratchet marks, consistent with multiple crack initiation sites, as annotated in Figure 15. These initiation sites were located along the boundary between the rail base and the underlying flash.

Figure 12. Angled view of the fracture initiation area of the downstream rail fracture 'A'.

Figure 13. View of the fracture initiation area after sectioning from the downstream rail face 'A'.

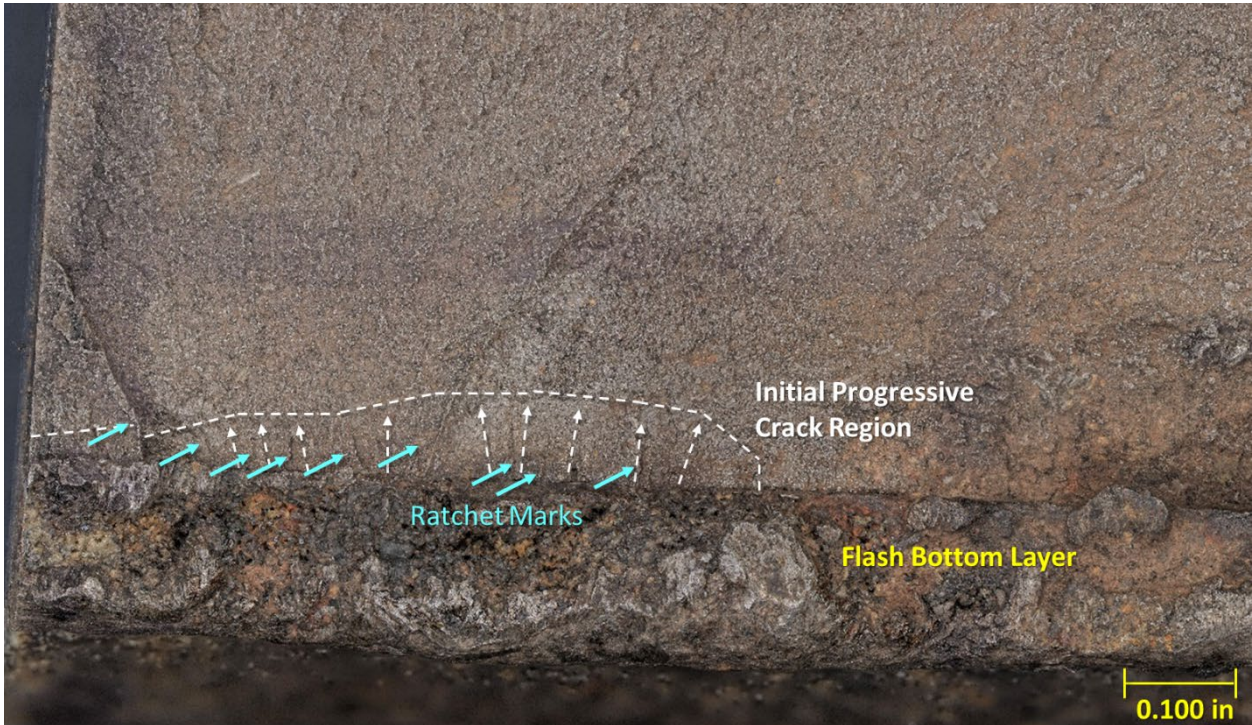
Figure 14. Annotated view of the boundary of cracking with arrest marks and ratchet marks.

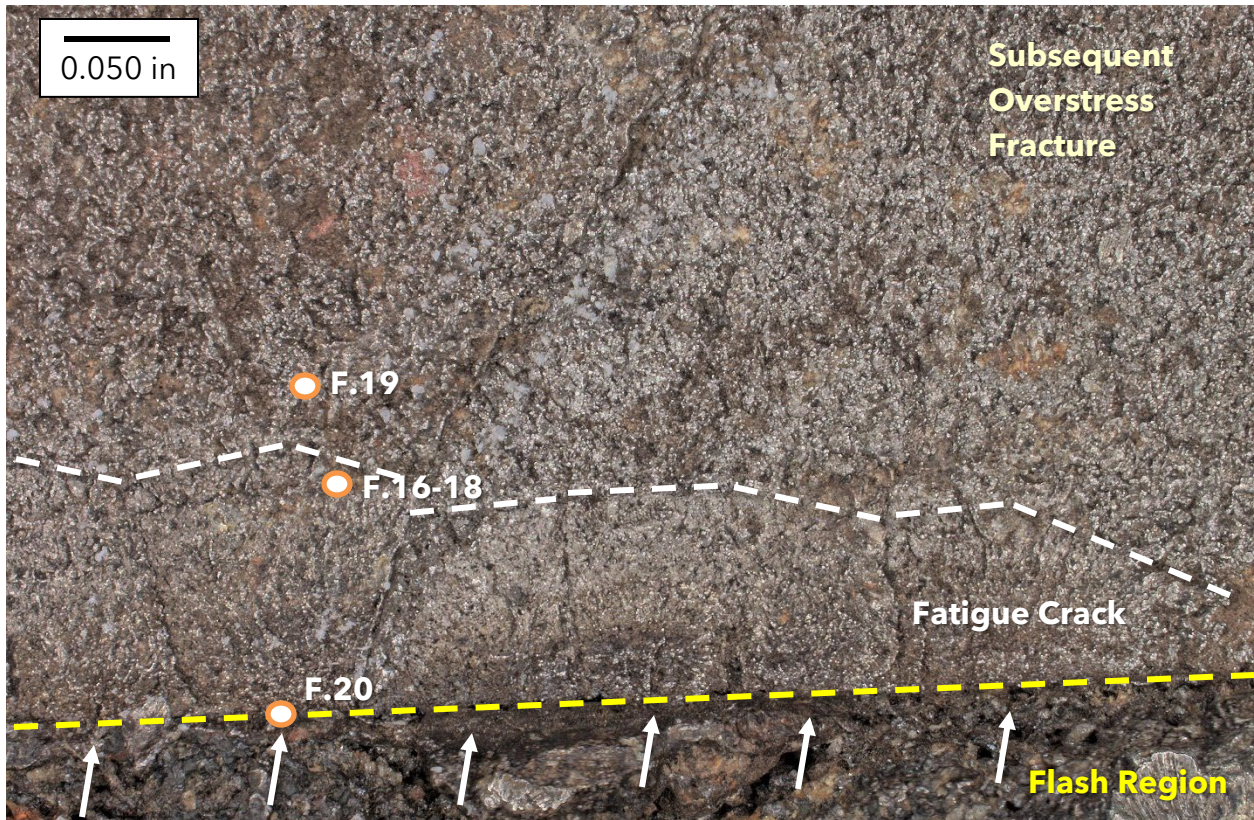
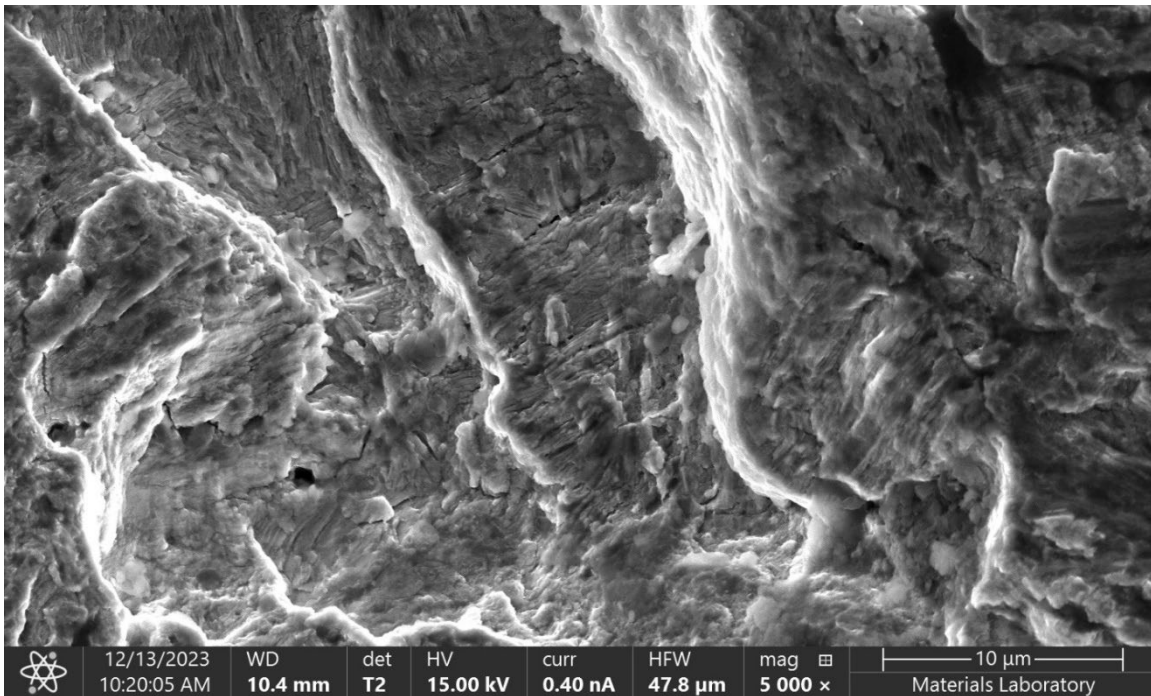
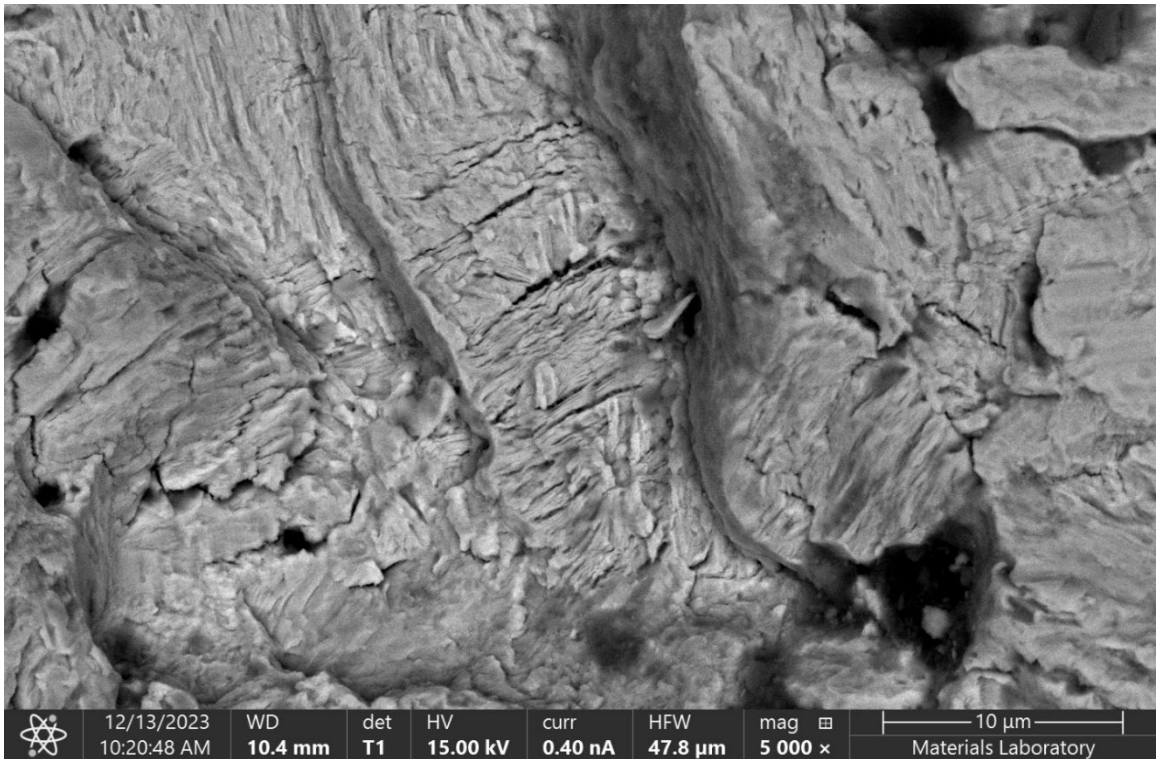
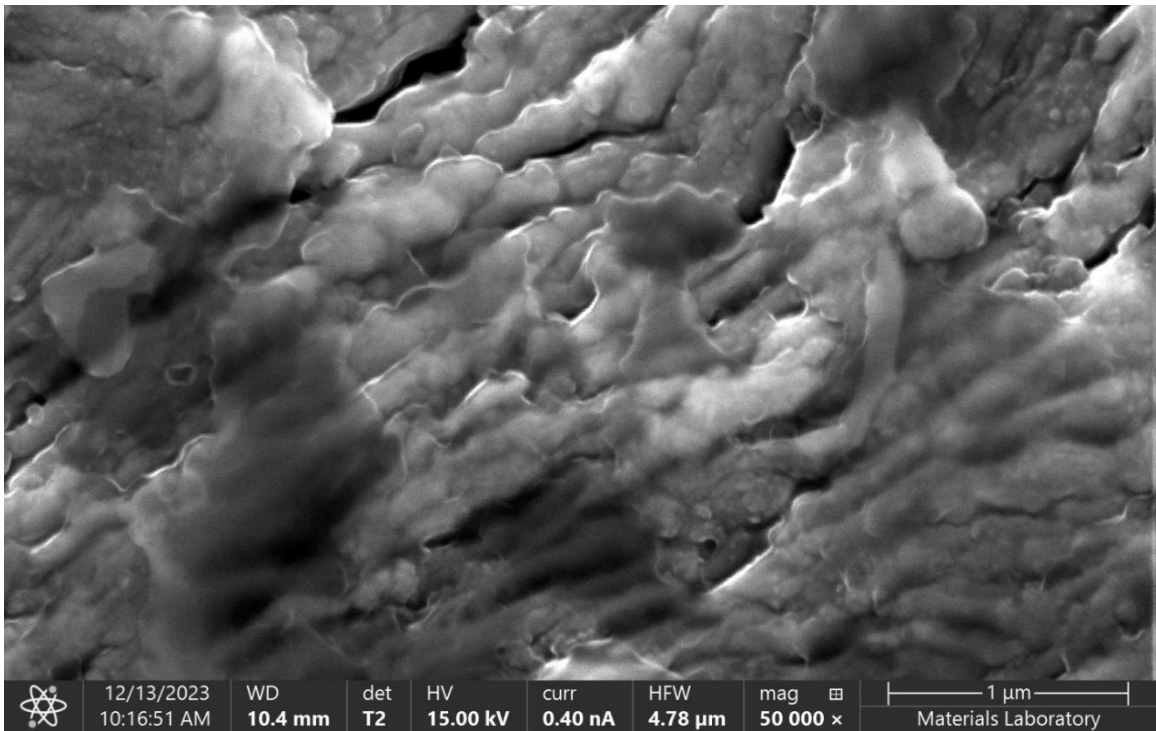
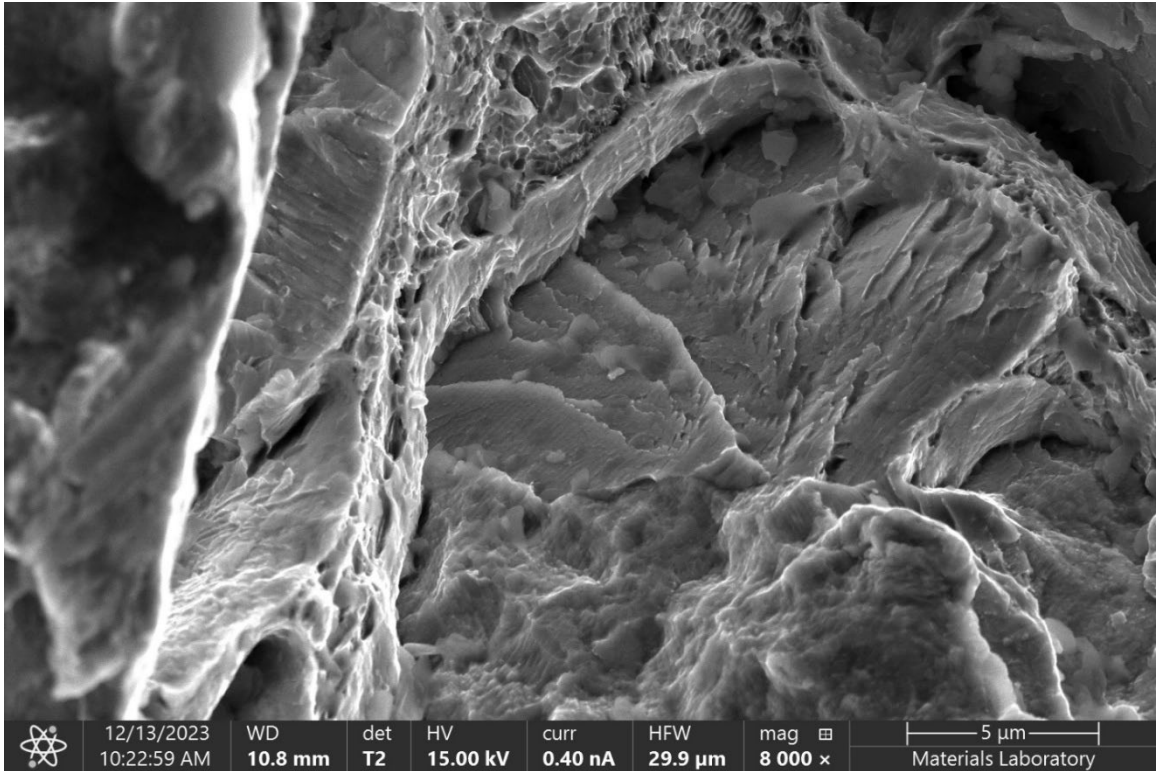
This section of the fracture surface was examined using a field emission scanning electron microscope (SEM). The locations of the figures from SEM examination are shown on Figure 15. Figure 16, Figure 17, and Figure 18 show a typical area towards the end of the initial crack. As illustrated in these figures, the crack area exhibited fatigue striations, consistent with fatigue crack propagation. Outside of the fatigue thumbnail crack, the fracture surface exhibited cleavage facets and dimpled rupture, consistent with subsequent overstress fracture. These features are demonstrated in Figure 19.

Figure 15. Closer view of some of the crack initiation sites along the boundary with the flash layer below the base, annotated to show locations of later **Figure 16** to **Figure 20**. The white arrows represent individual crack initiation sites.

Figure 16. Secondary electron (SE) micrograph of a typical area near the end of the crack in **Figure 15**.

Figure 17. Backscattered electron (BE) micrograph of the area in **Figure 16** showing distinct fatigue striations.

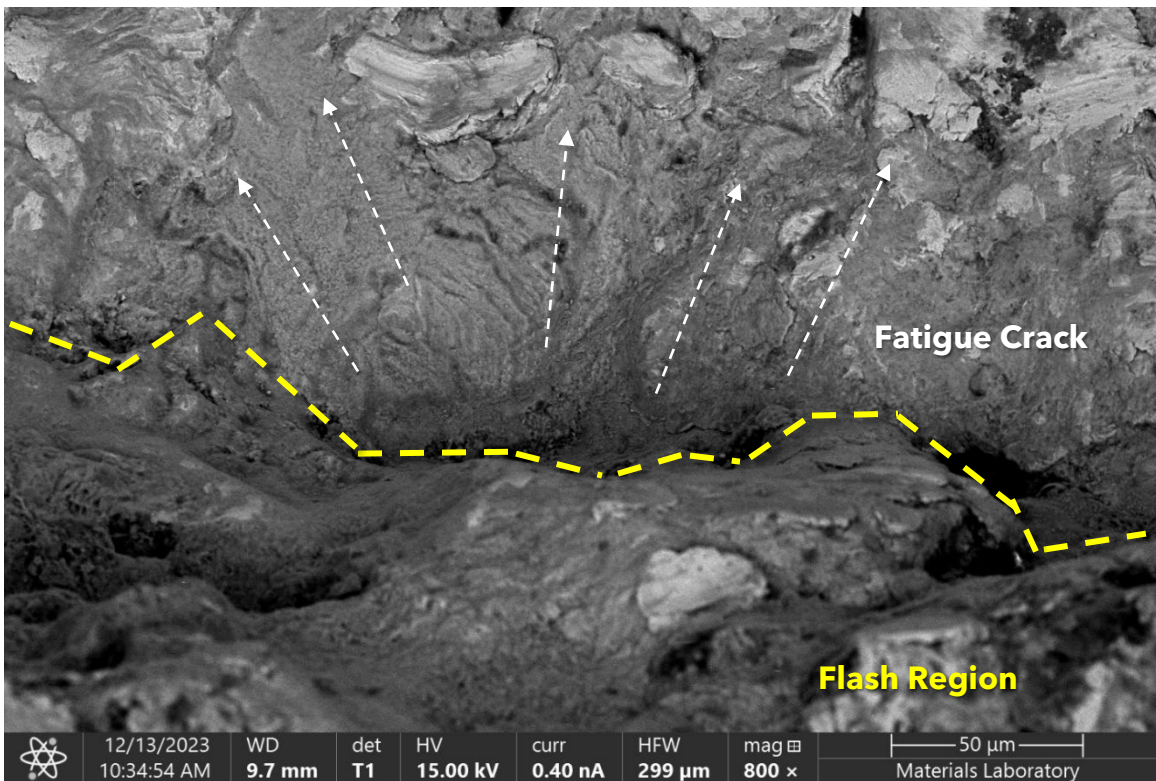
Examination of the crack initiation sites found areas with gaps, voids, and nonmetallic material. Figure 20 shows one initiation site, which exhibited an inward-oriented gap. Above this initiation site, fine striations were present, oriented consistent with crack propagation upward and outward in the figure.

Figure 20. BE micrograph of a fatigue crack initiation site along the flash/base boundary with arrows representing initial crack growth directions from initiation.

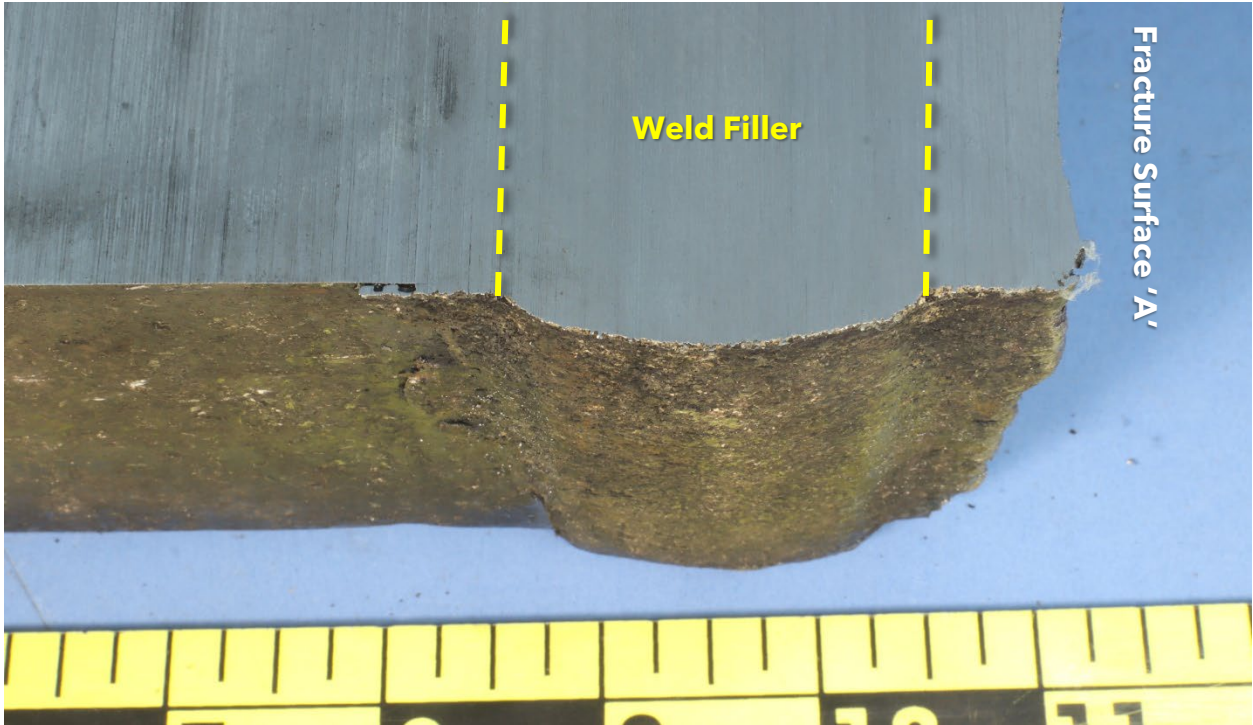
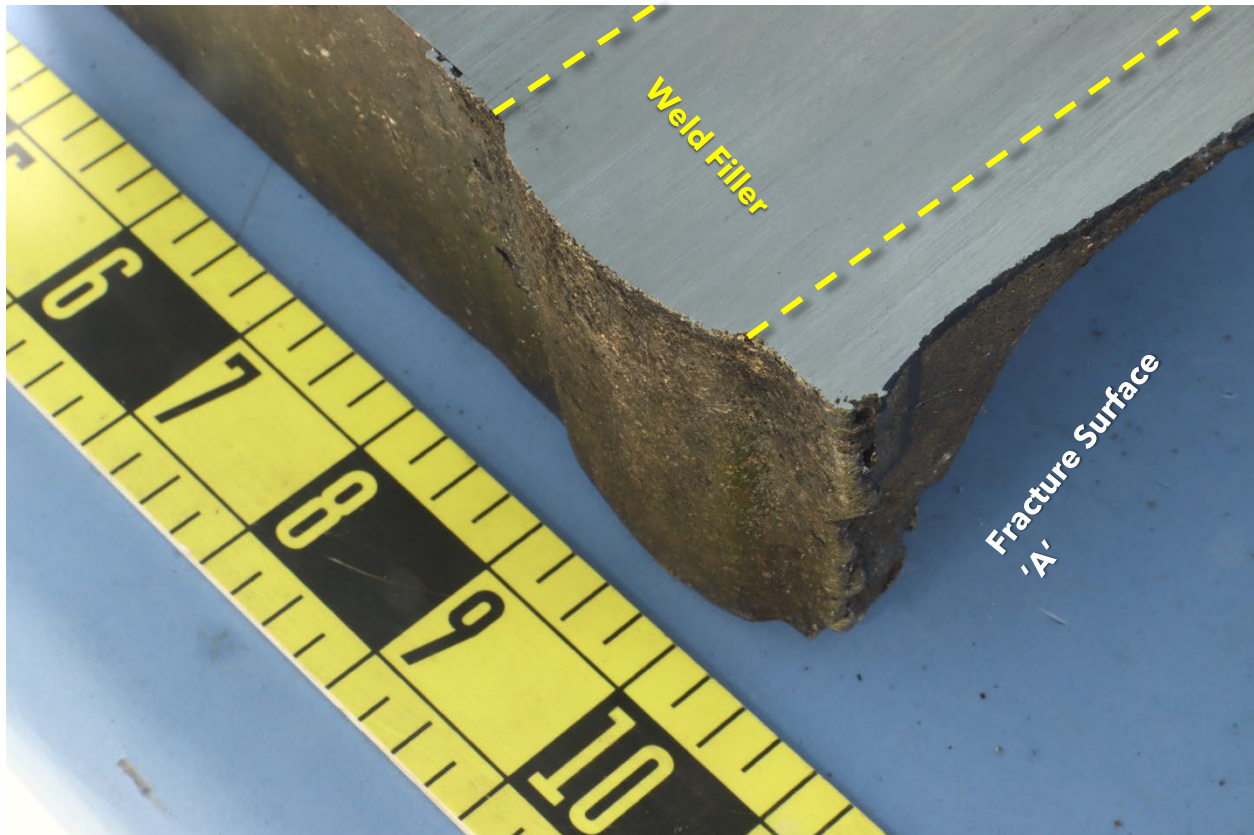
However, on the fringes of the weld boundary along the base were areas of smaller longitudinally-oriented gaps, shown in Figure 22. Figure 23 shows an angled view of the edge with the crack initiation site. A microscopic gap was present along the edge with the fracture.
