National Transportation Safety Board

RRD24FR001

MATERIALS LABORATORY

Factual Report 23-100

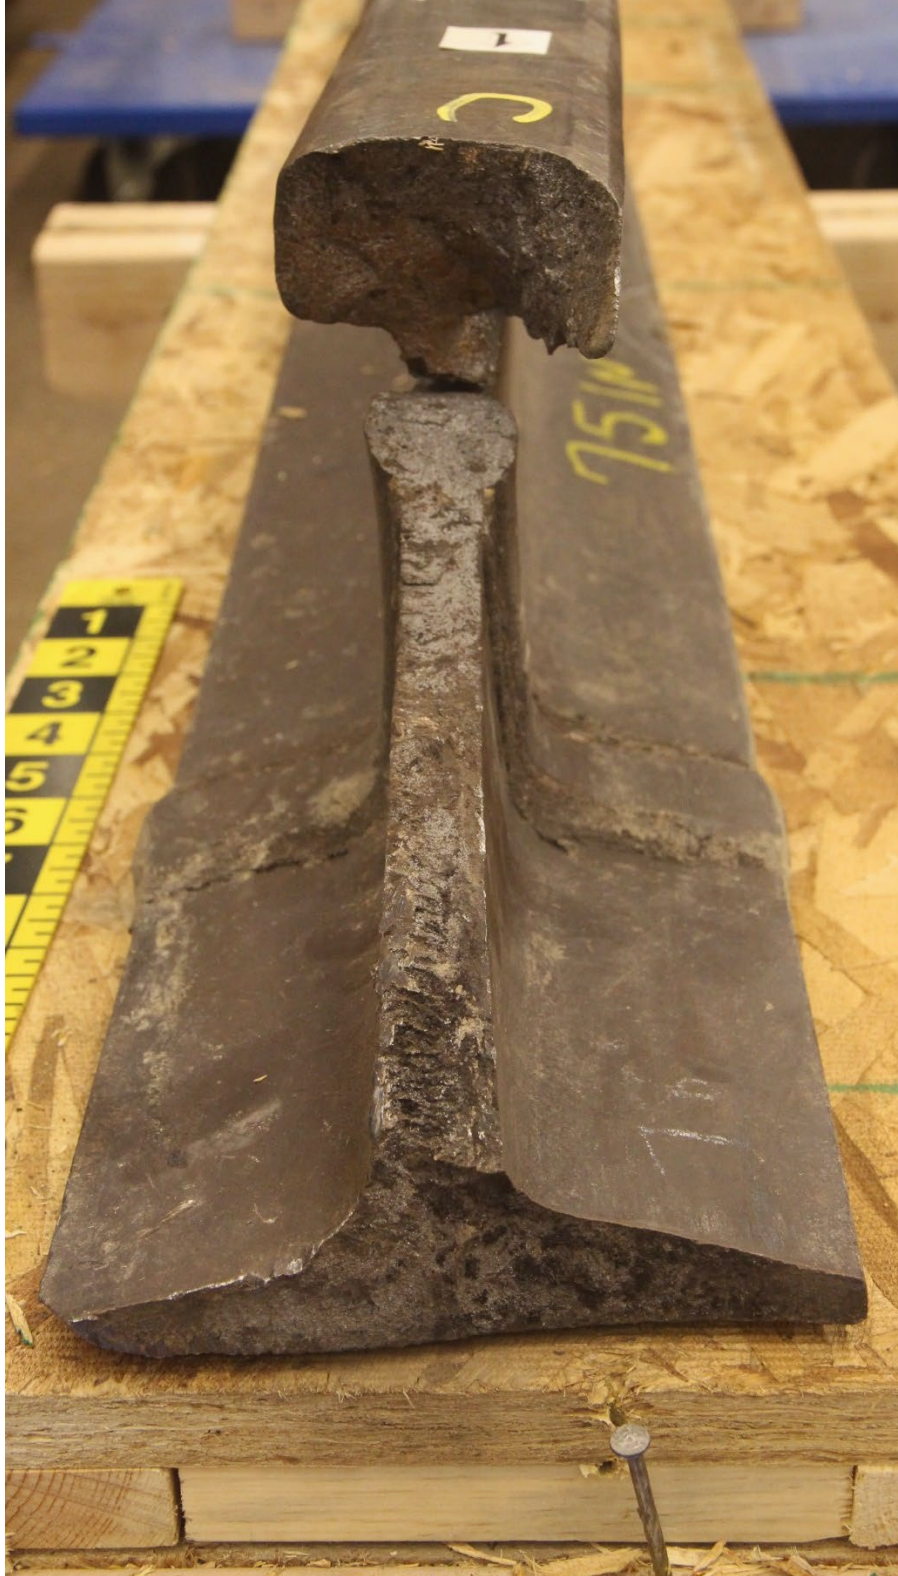
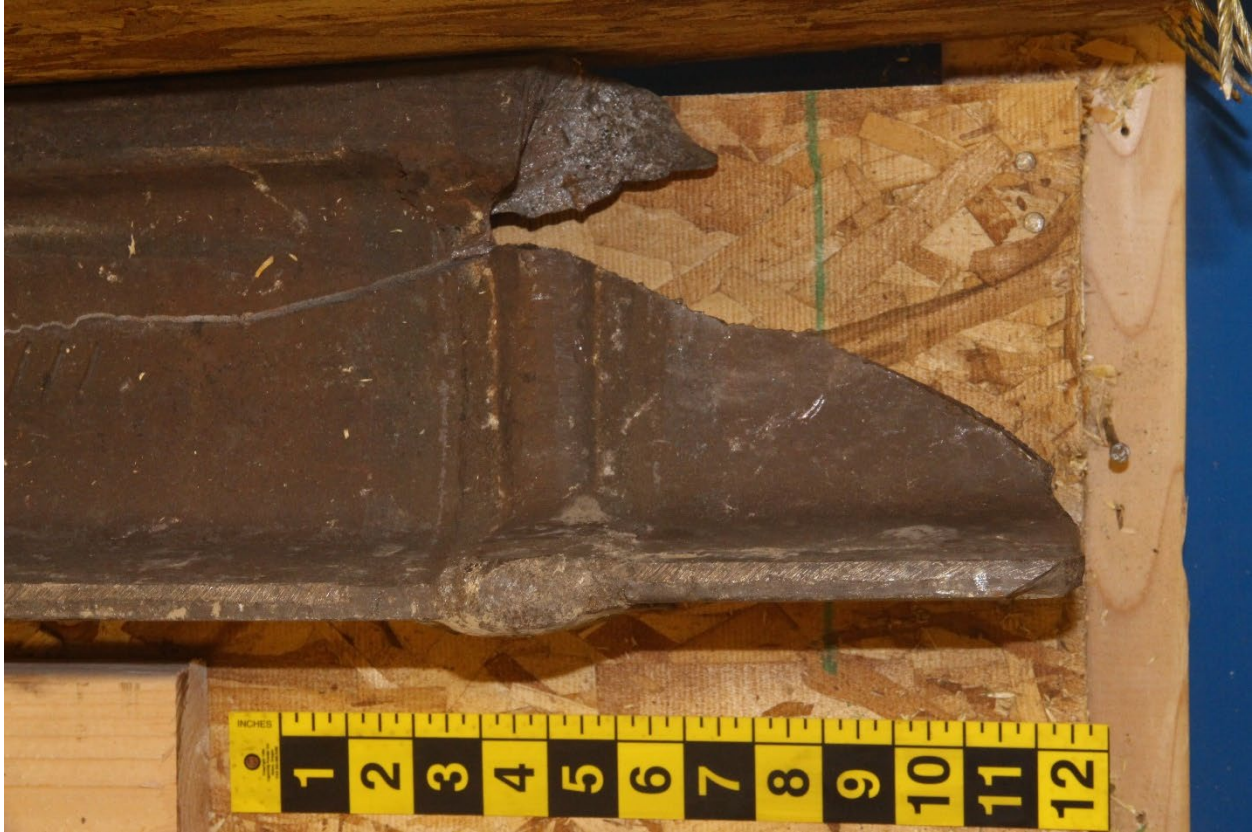
Figure 24 and Figure 25 show the 'C' side of the second fracture surface. This surface and the mating 'D' surface exhibited a zigzag shaped jagged morphology. Part of the head portion of the fracture surface was angled toward the field side, with some of the web angled towards the gage side. As shown in Figure 25 and Figure 26, the web and base portion of the fracture extended longitudinally along the web, with the fracture upwards along the head appearing as intersecting.

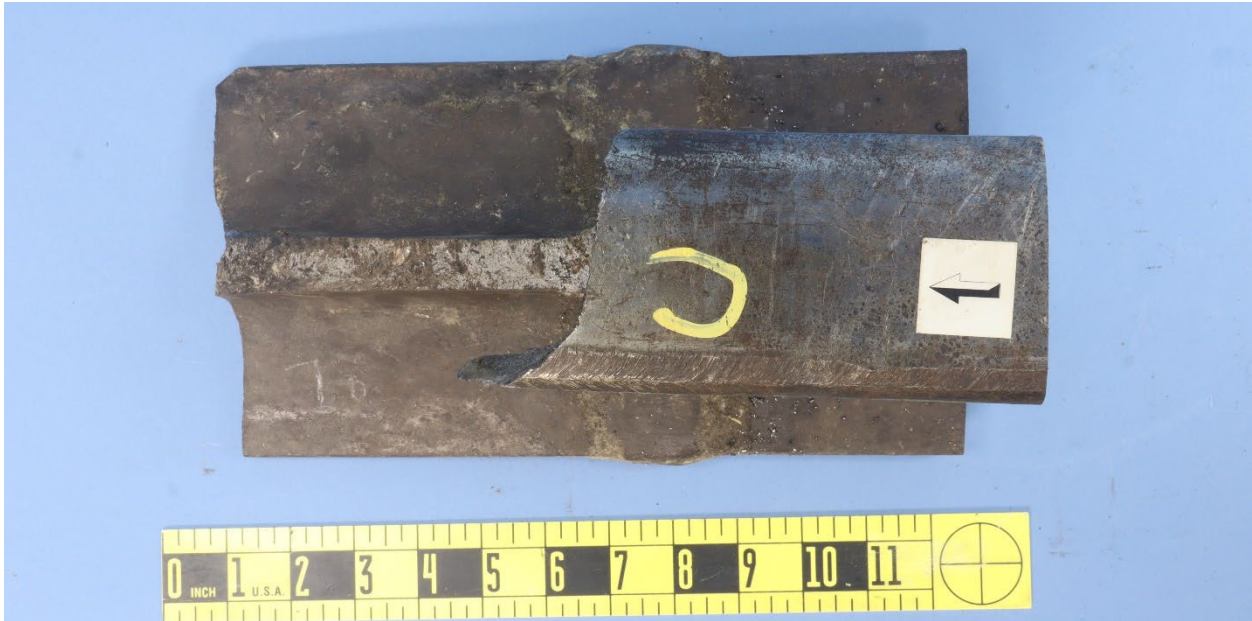
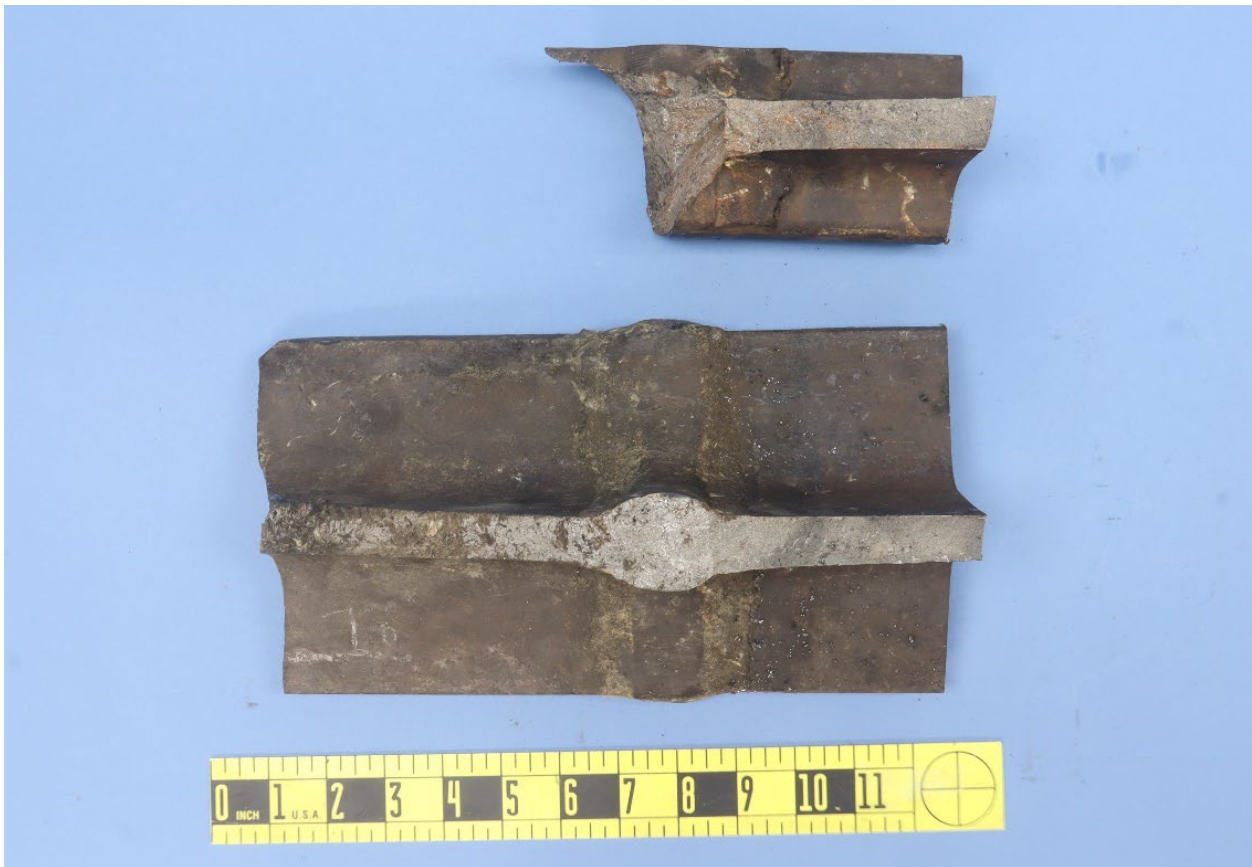
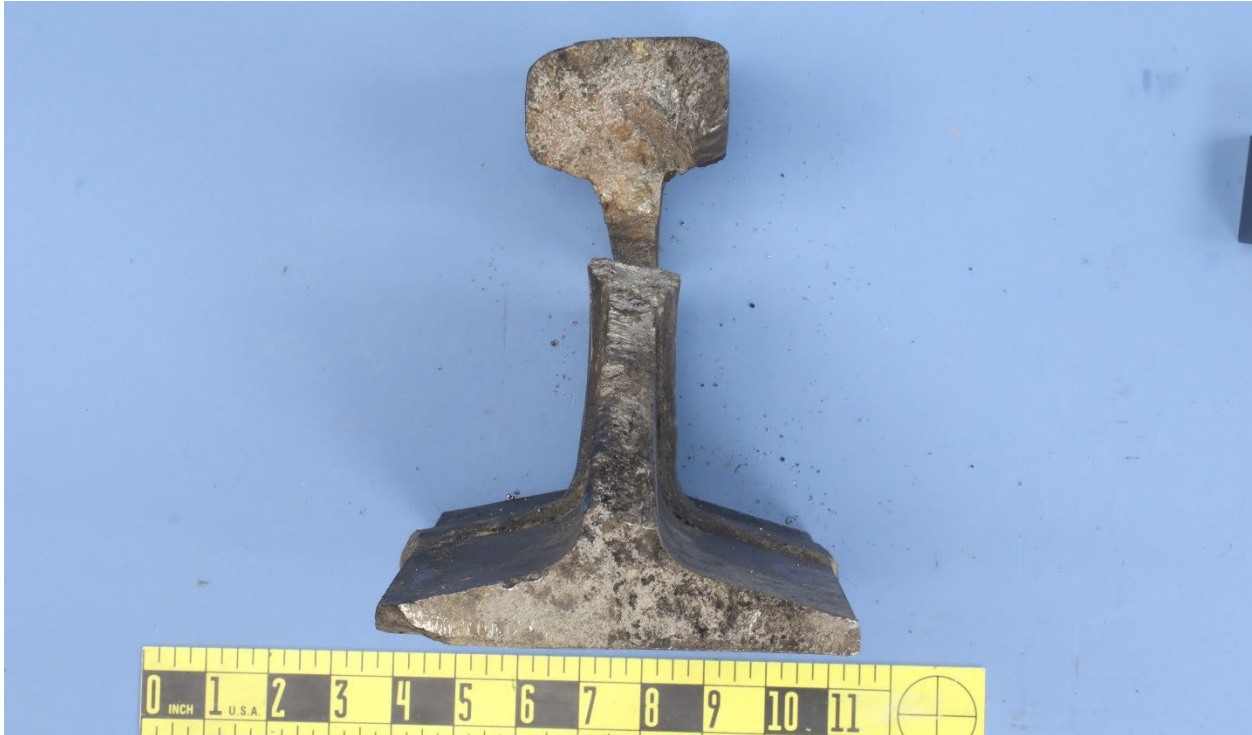
Figure 27 shows a top-down view of this fractured side of rail with the head fragment positioned as found on-scene, and Figure 28 shows the fractured head section placed to the side. Figure 29 shows the 'C' side with the sections in place at the time of fracture. All these fracture surfaces exhibited a dull luster with a rough texture, consistent with overstress fracture through rail steel. There were no indications of thumbnail cracks or features consistent with other fracture modes on these surfaces.

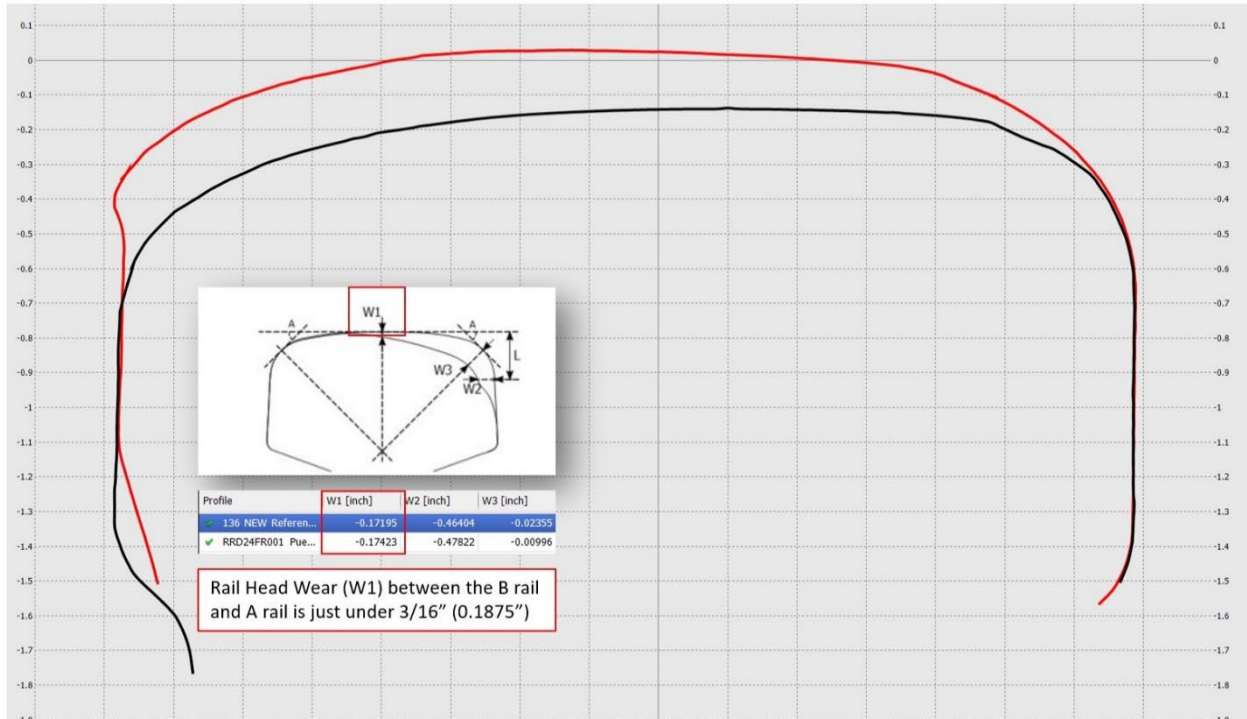
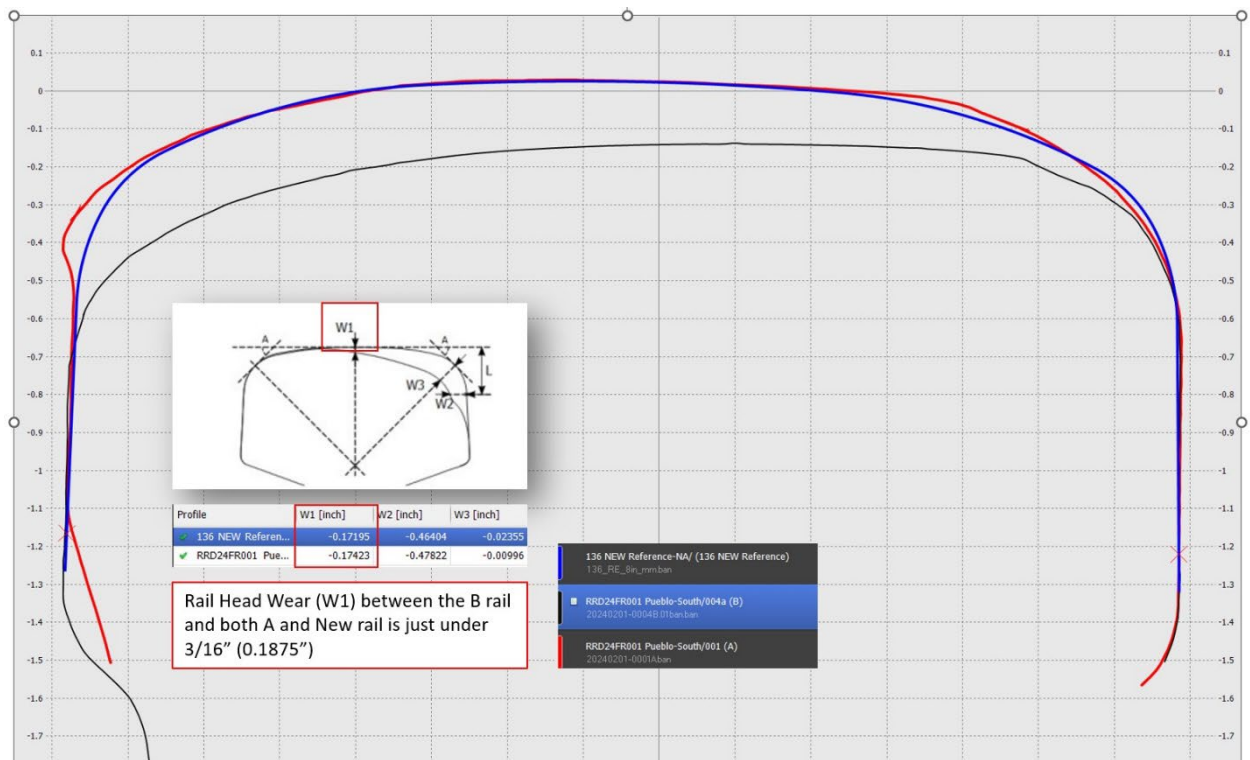
Figure 31 shows the rail profiles of both the rail 1 (from the 'A' side) and rail 2 (from the 'B' side) superimposed on each other. Figure 32 shows these same profiles compared with an ideal new 136 lbs. rail profile. These demonstrate that rail 1 profile was closer to that of a new rail, whereas the older rail 2 had worn enough to create a difference in head height. This difference was 0.1742 inches between each rail, and a difference of 0.1720 inches from the ideal new profile for rail 1.

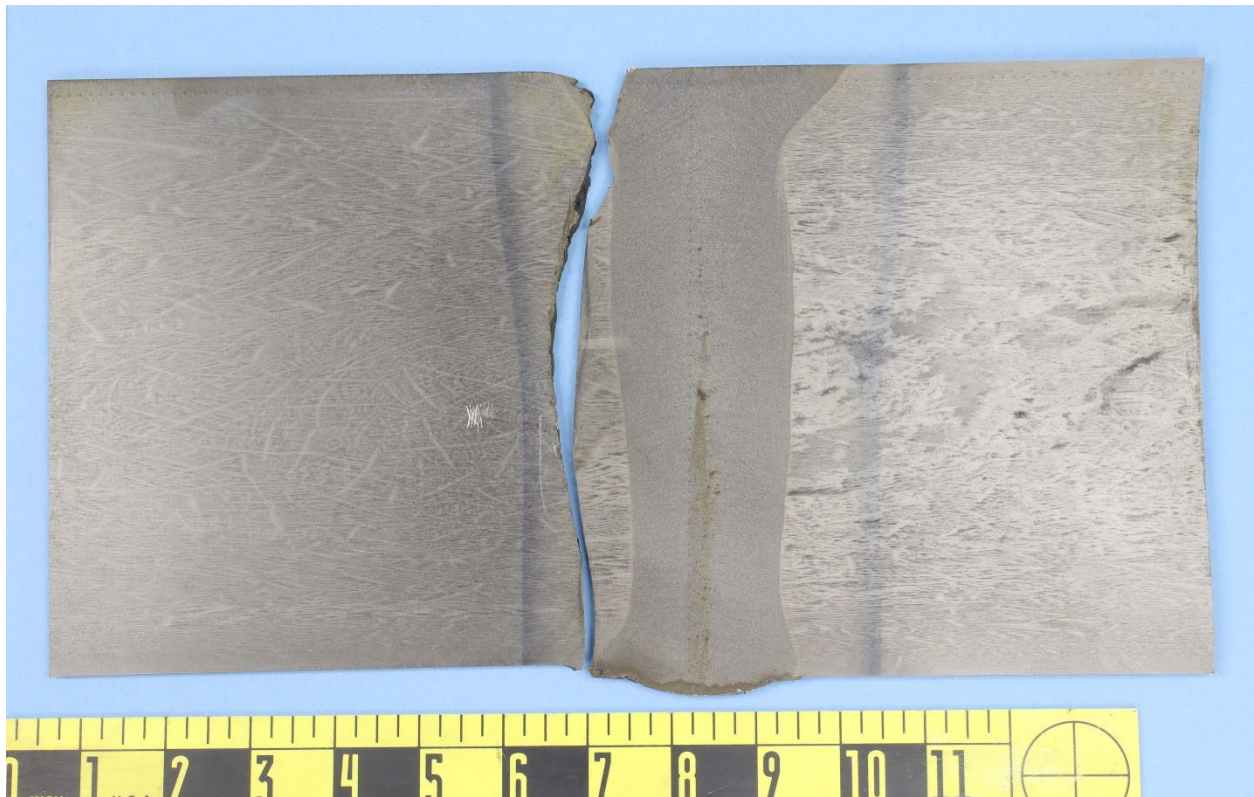
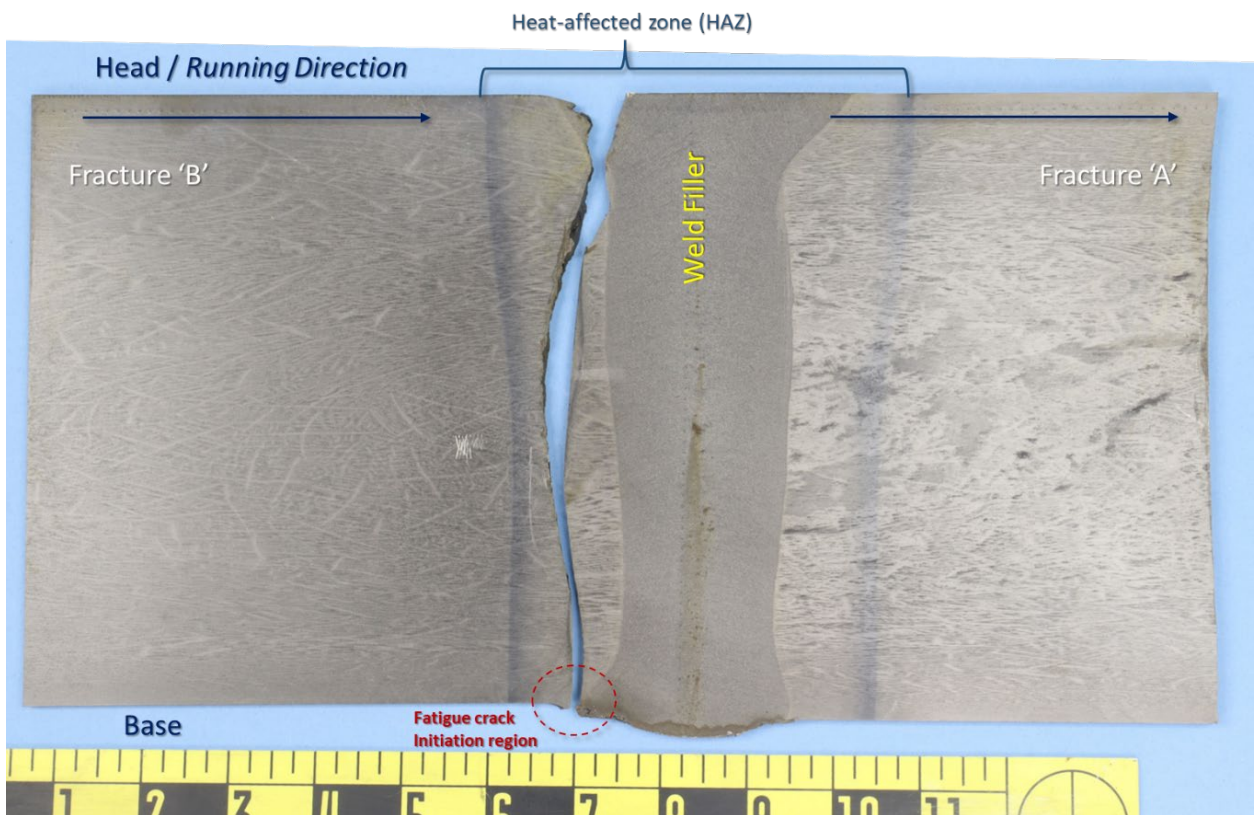
Figure 36 shows the longitudinal sections across the fracture surface and adjacent weld, after etching. Figure 37 shows the same image but annotated to show the different regions revealed from the etching process. The figures clearly show the weld filler region, which exhibited a finer grain structure than the surrounding rail microstructures. The rail exhibited coarser grains, articulated by the mottled appearance.

The surrounding heat affected zone (HAZ) was bounded by a bluish halo, as denoted in Figure 37. The fracture and the crack initiation site were outside, though adjacent to, the weld filler. The fracture was within the HAZ on the rail 2 side, except for the small region on the top near the head, denoted by the white arrows on the top of Figure 39 in that location. The white arrows on the bottom denote the space between the weld filler and initiation site to the right of the fracture.

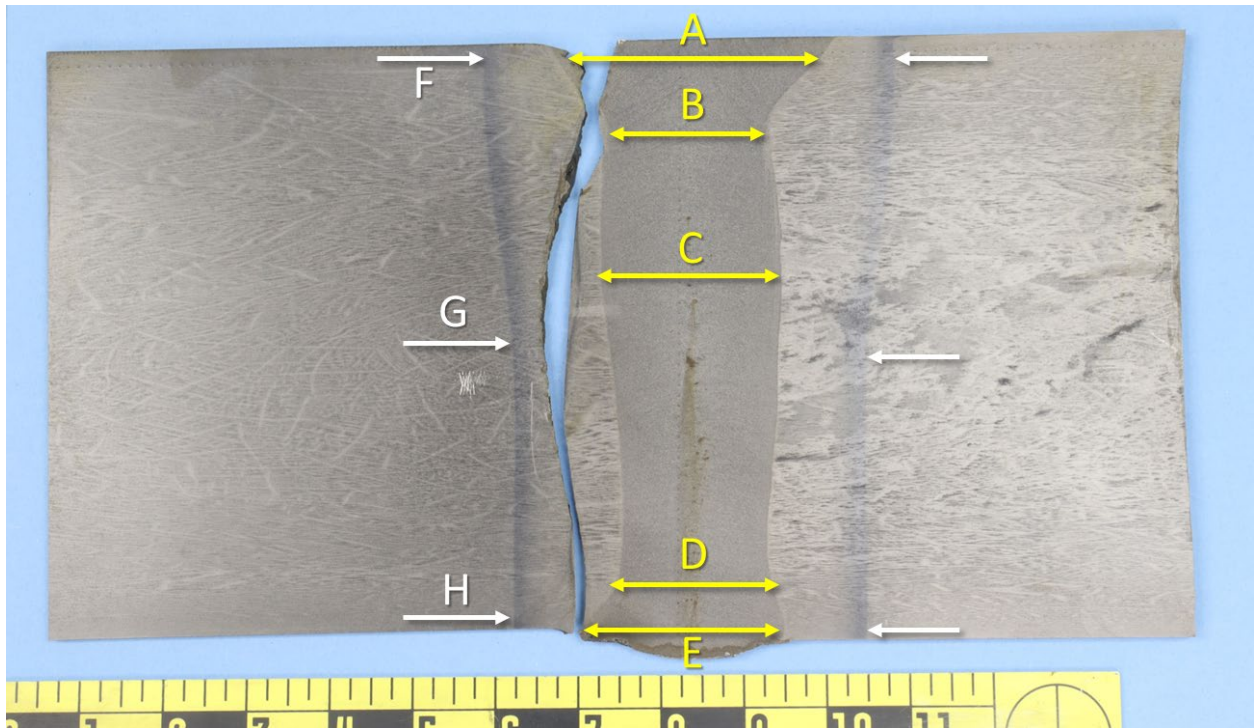
The thermite weld manufacturer, Orgo-Thermit, Inc., lists several dimensions corresponding to various required thicknesses of the weld filler and heat affected zones at various heights.² These are illustrated in Figure 38 as measurements A through H. These measurements are detailed in Table I. Additional measurements are shown in Figure 39, including head to base measurements and distances of the fracture to the filler and HAZ boundaries. None of the measurements of the weld or the surrounding HAZ were outside the requirements prescribed welding procedure.

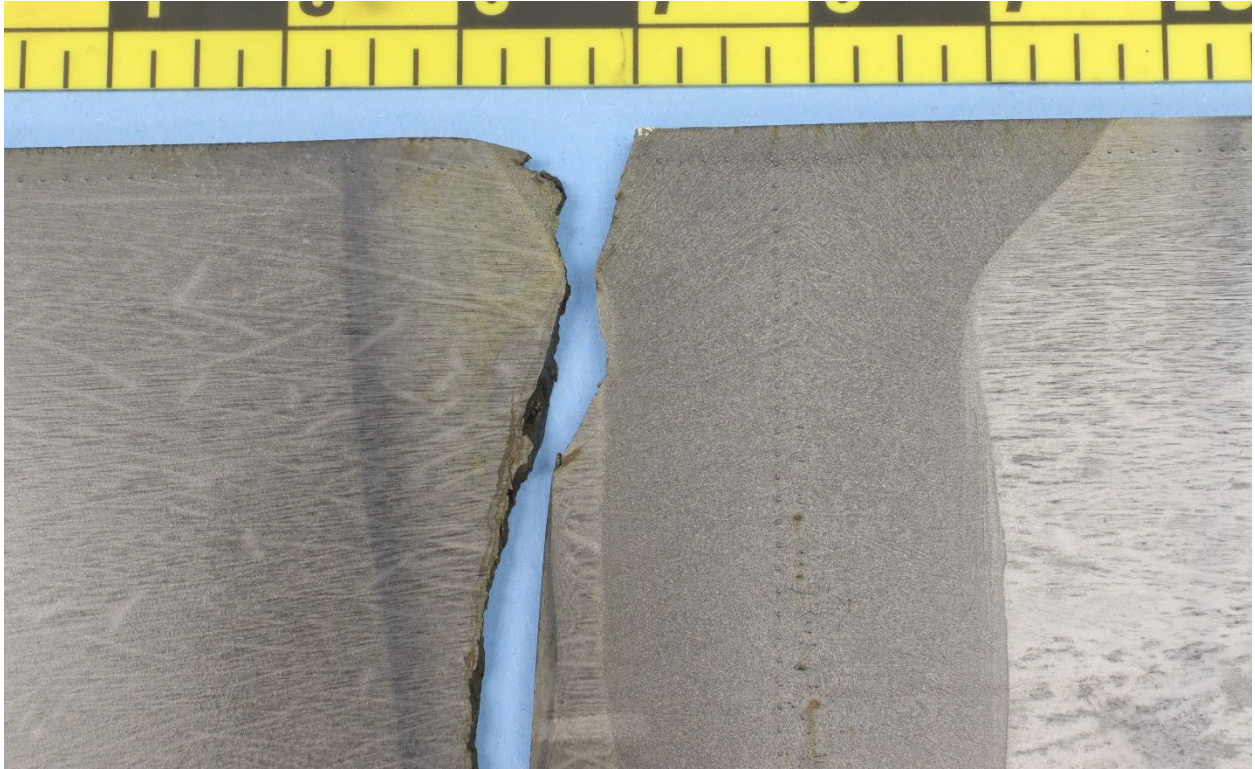
Figure 42 shows a closer view of the etched specimen where the fracture intersected the head. This was the only portion of the fracture that extended into the weld filler. This area also demonstrated the post-fracture head deformation of Rail B on the left, which exhibited downward deformation and grain flow.

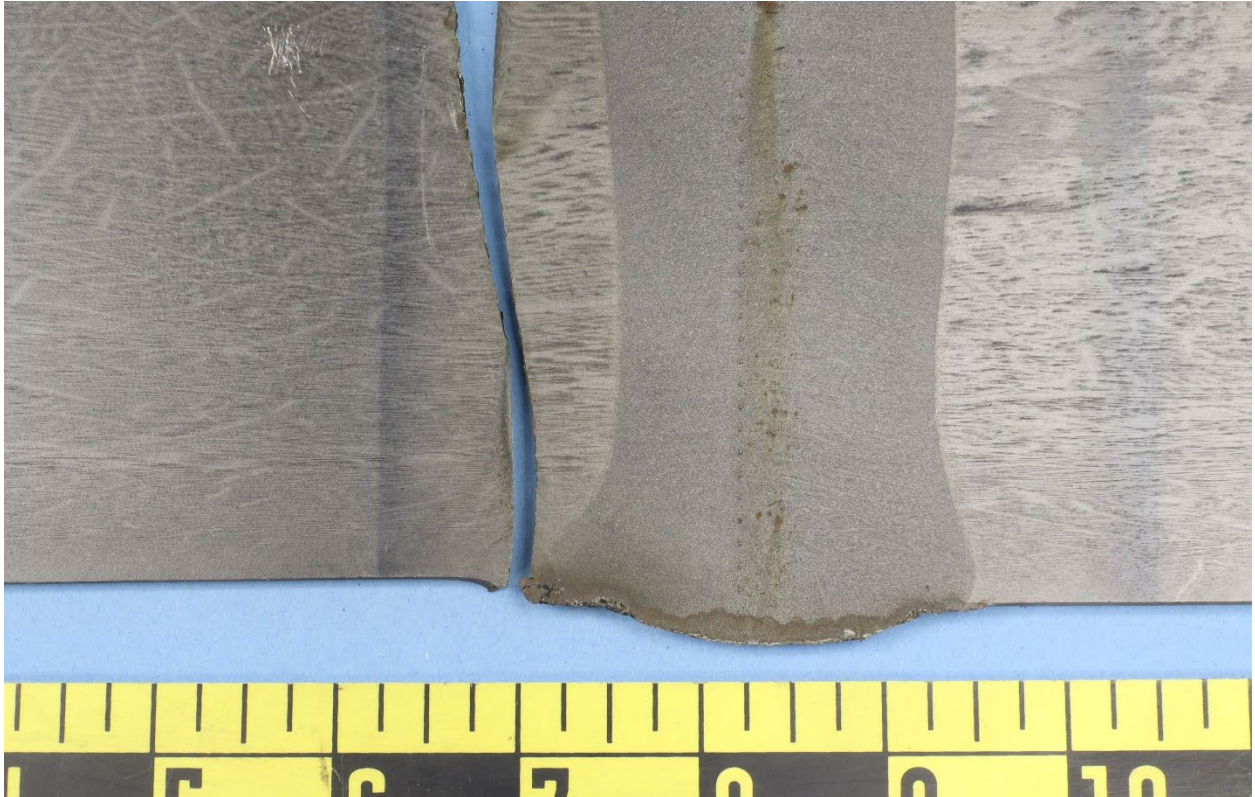
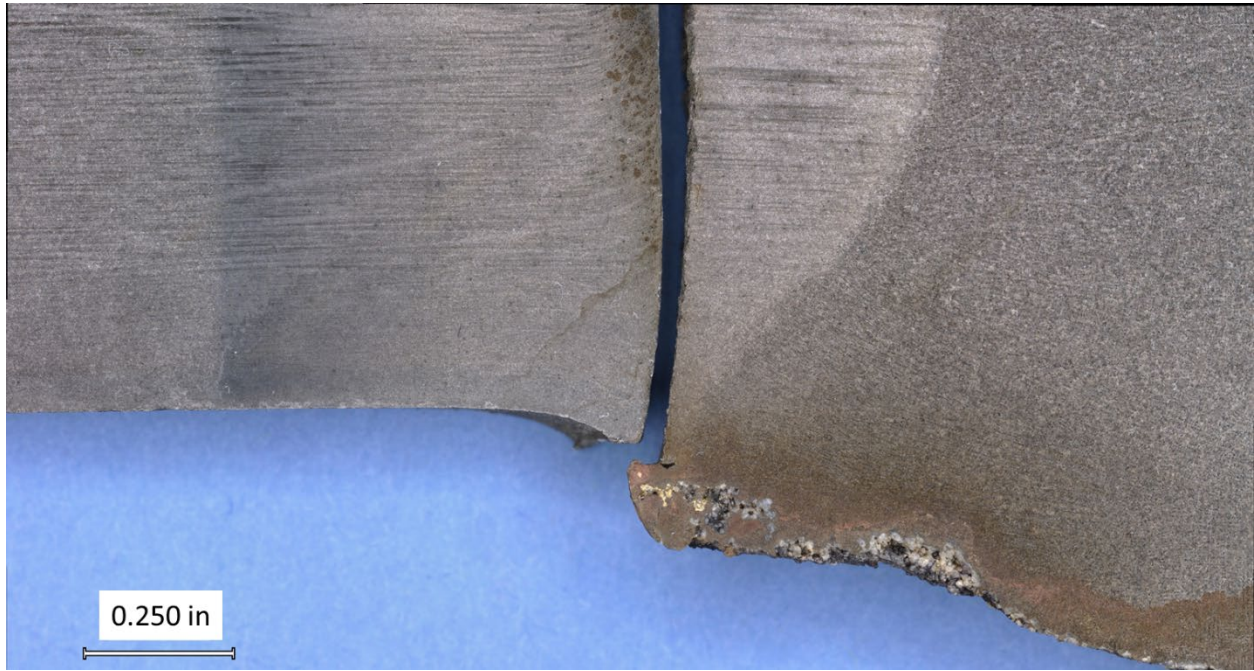
Figure 43 shows a closer view of the fracture surface near the base and the edge of the weld filler. Figure 44 shows a closer view of the area, with a porous region located below the initiation site, consistent with weld flash. This flash was located below a small crack facing the weld filler, illustrated in Figure 45. The flash contained several discolored, nonmetallic inclusions, consistent with remnants of the mold. Figure 46 shows an annotated view of several of these measurements, with the aforementioned crack between the flash and base being 0.025 inches long in this location.

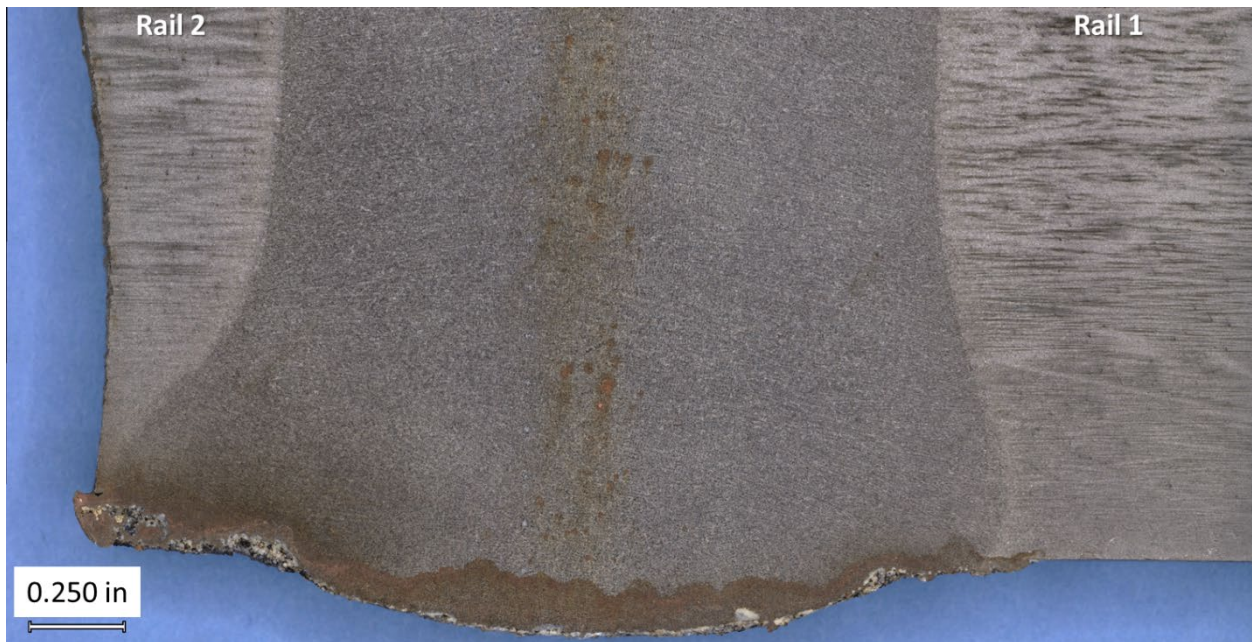
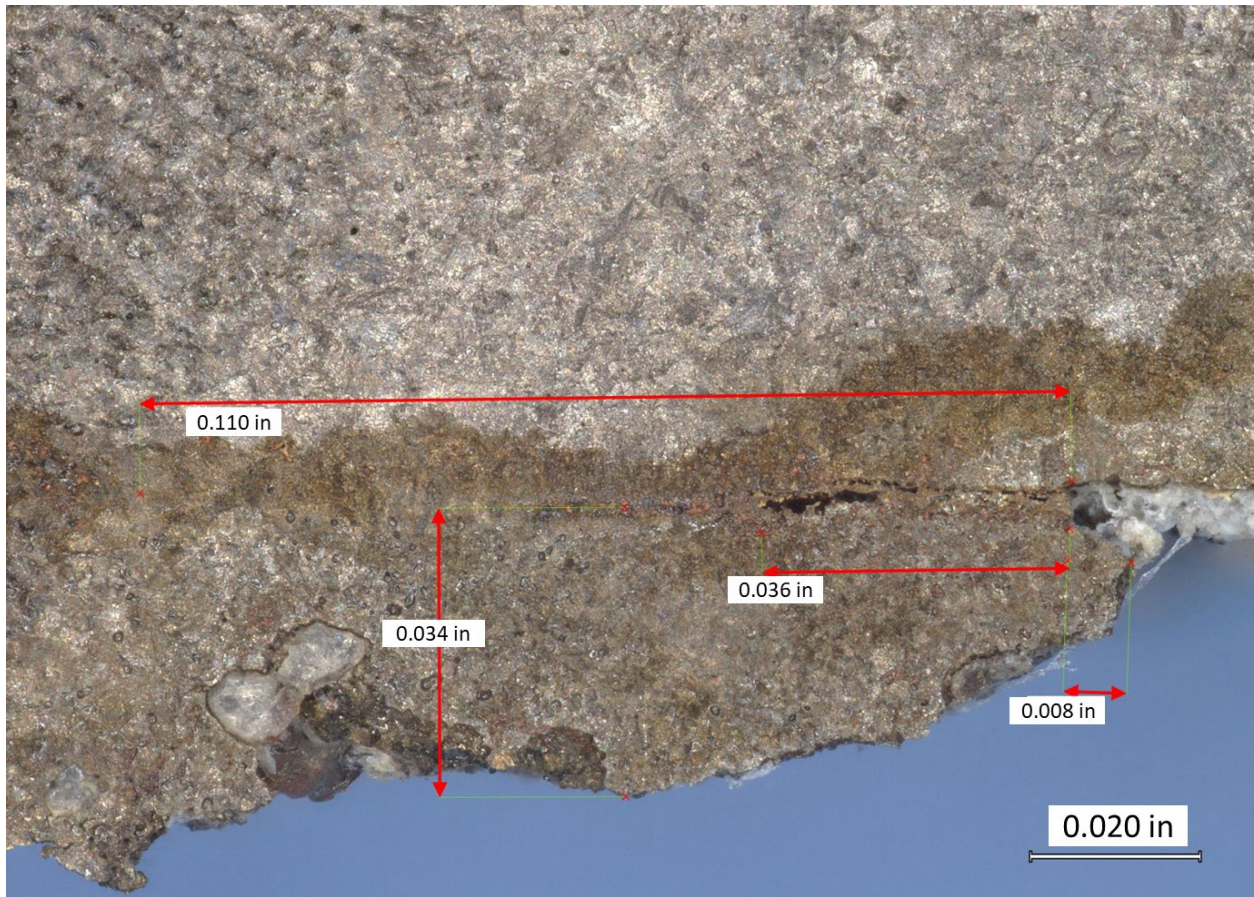
Figure 47 shows a holistic view of the base and flash at the weld filler on the opposite ('A') side of the fracture. The interface between the weld filler and the HAZ on the intact side also exhibited cracking near the base, as shown in Figure 48. This crack extended 0.036 inches between the flash and the base from an initial area of entrained material 0.008 inches at the corner. This crack was 0.034 inches from the bottom of the flash surface.

Figure 48. The opposite side of the base and flash on rail 1, showing a horizontal crack between the flash and the rail underside. Various measurements are annotated.

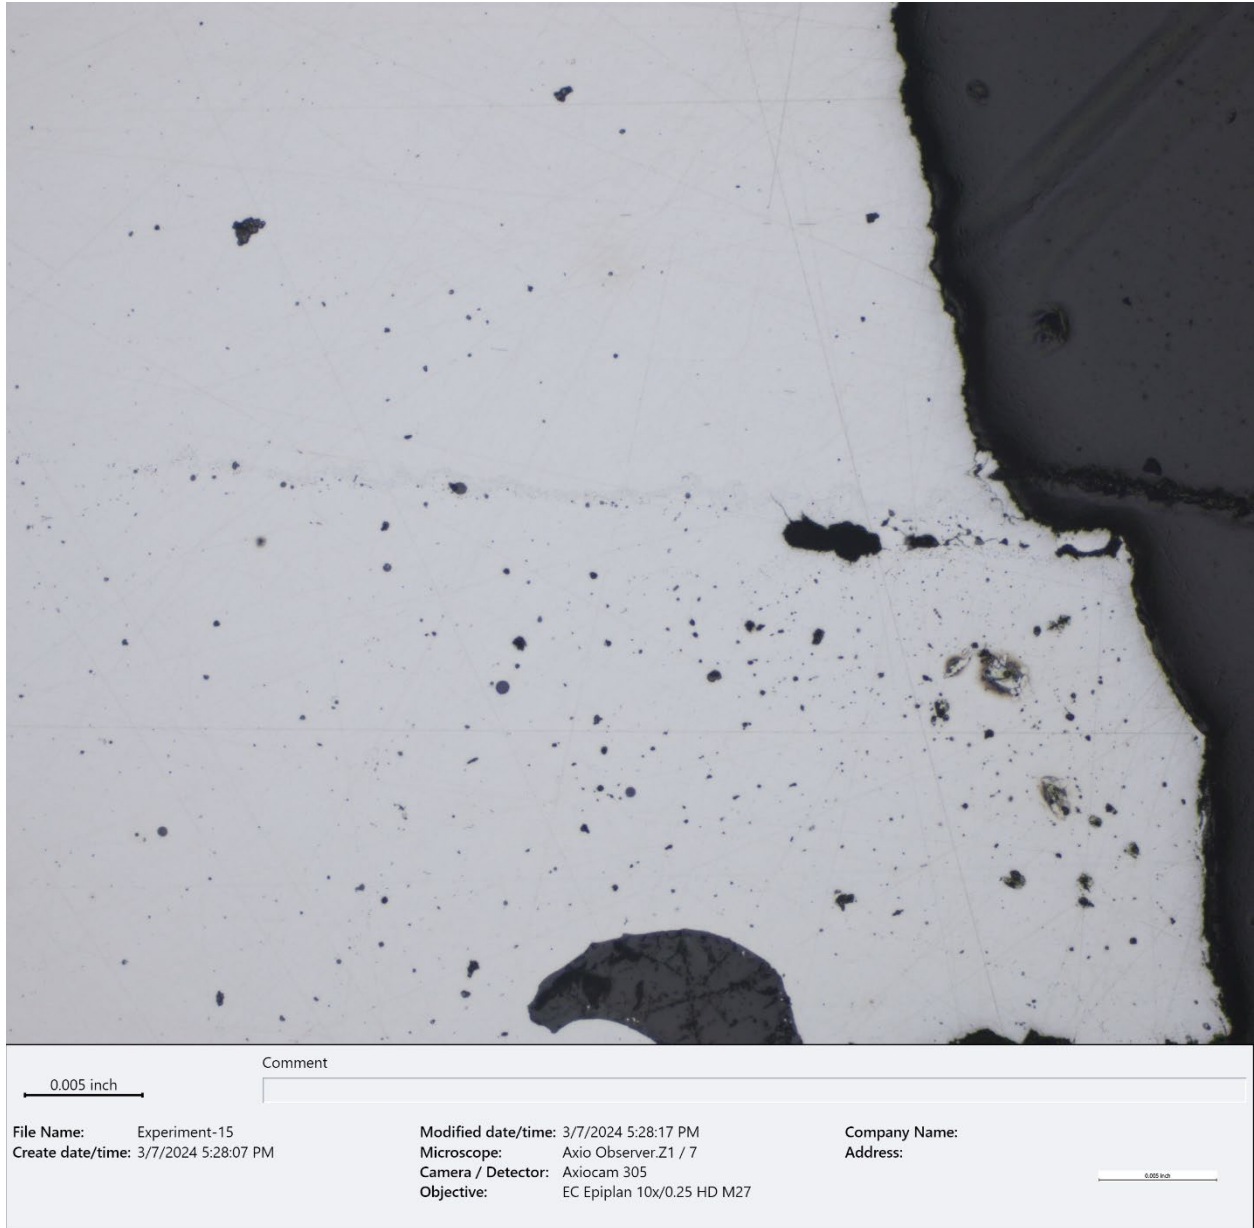
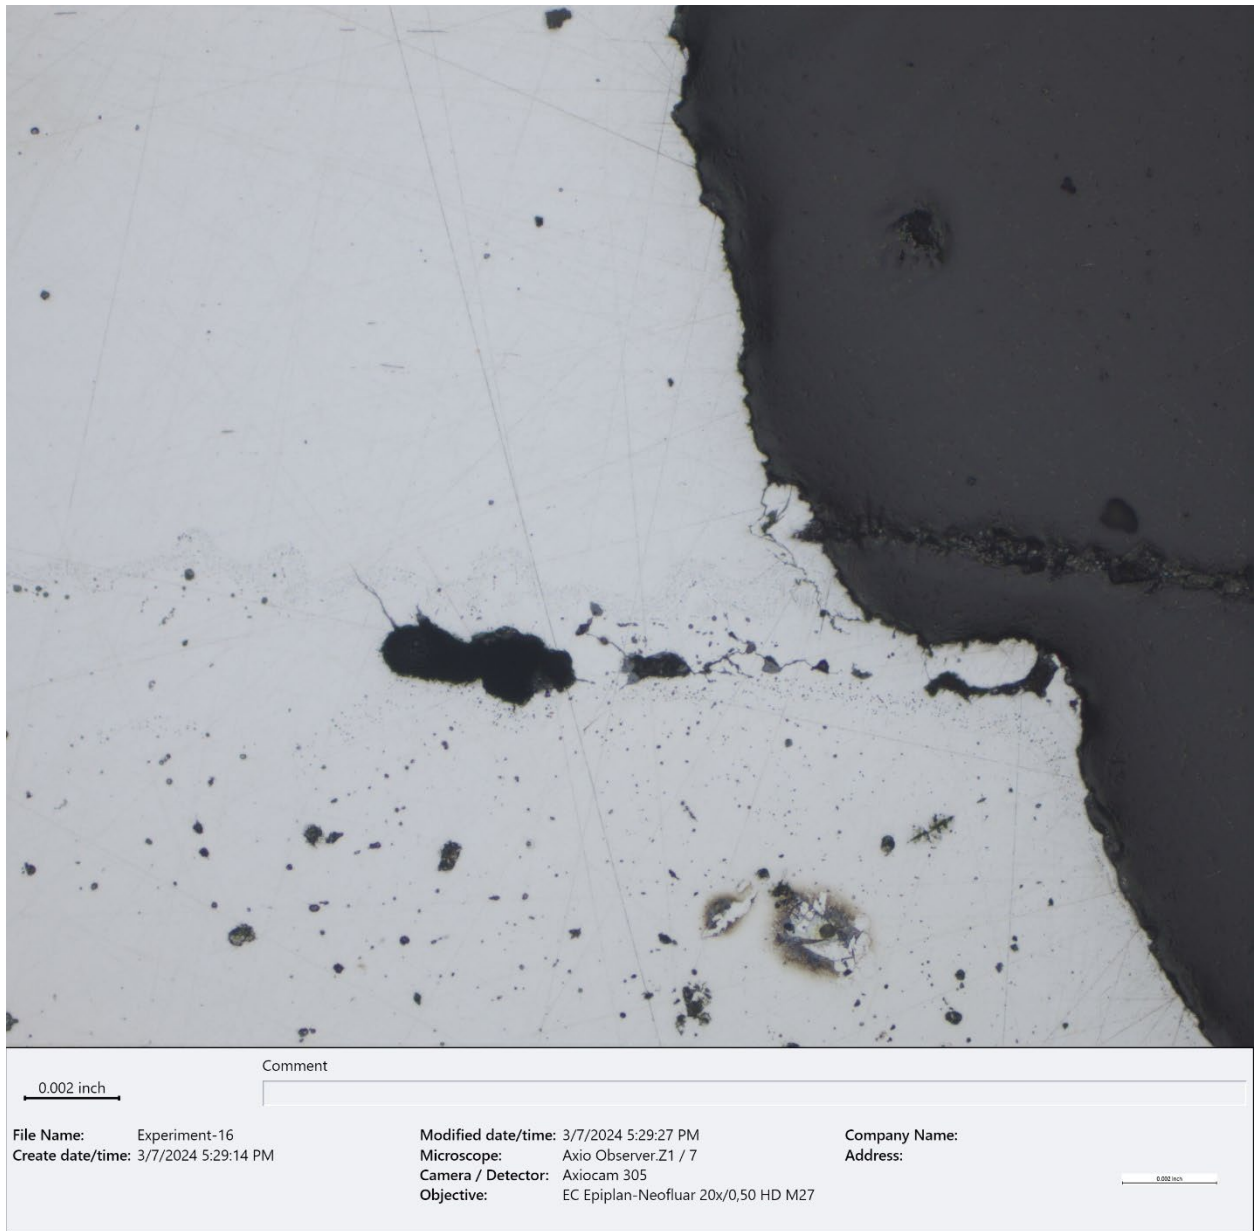
Figure 52 shows a cross section through the fracture surface 'A' between the rail 1 HAZ and the weld flash underneath the base. As shown in Figure 53, there was some contrast between the flash and the rail, in addition to several pores along the

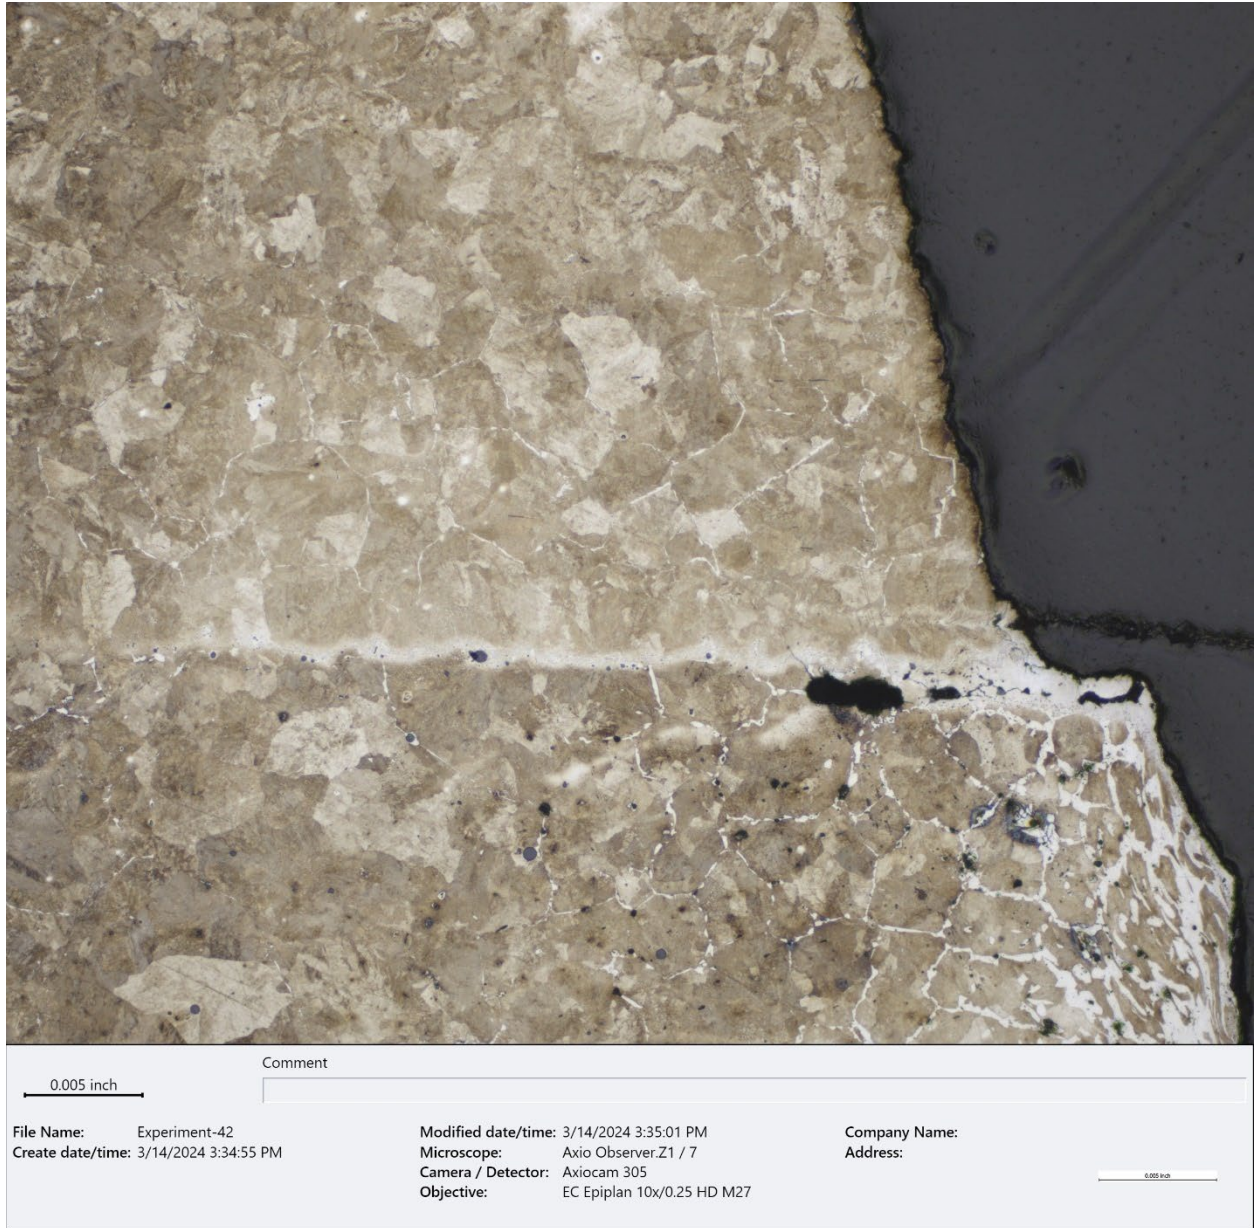
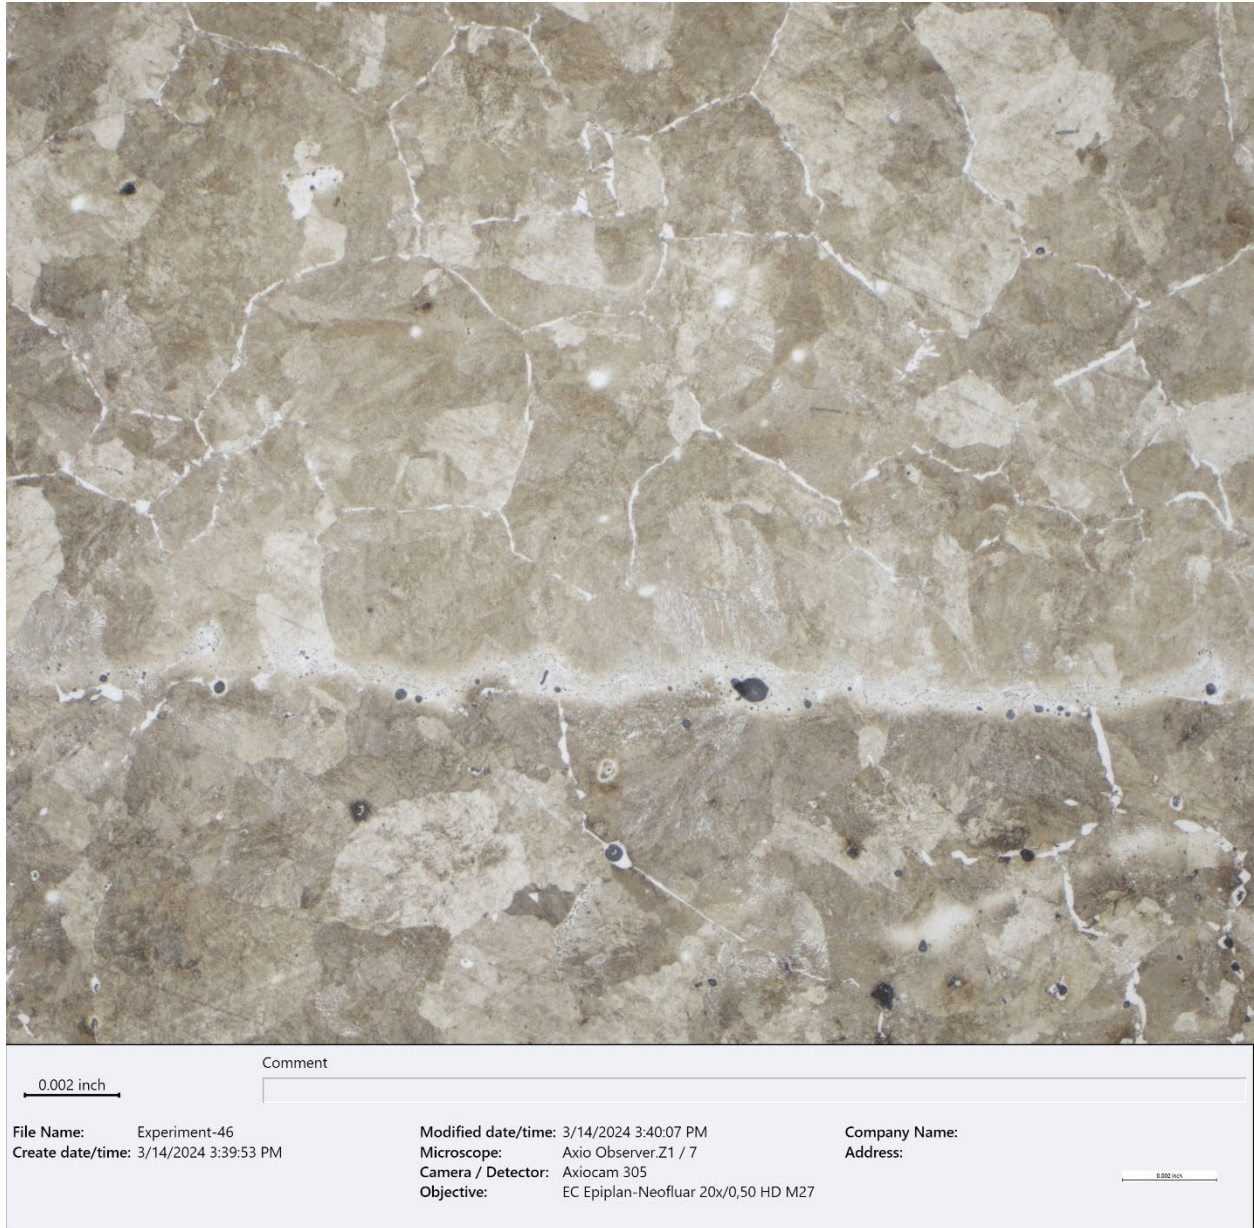
Figure 54 shows the same area in the etched condition, illustrating the differences in microstructure between the rail HAZ, flash below the base, and the weld filler on the leftmost part of the figure. The boundary manifest as a whiter-etched line, where the pores and cracks were located. While smaller, these pores continued to be present further along the boundary, as shown in Figure 55.
