National Transportation Safety Board

RRD24FR001

MATERIALS LABORATORY

Factual Report 23-100

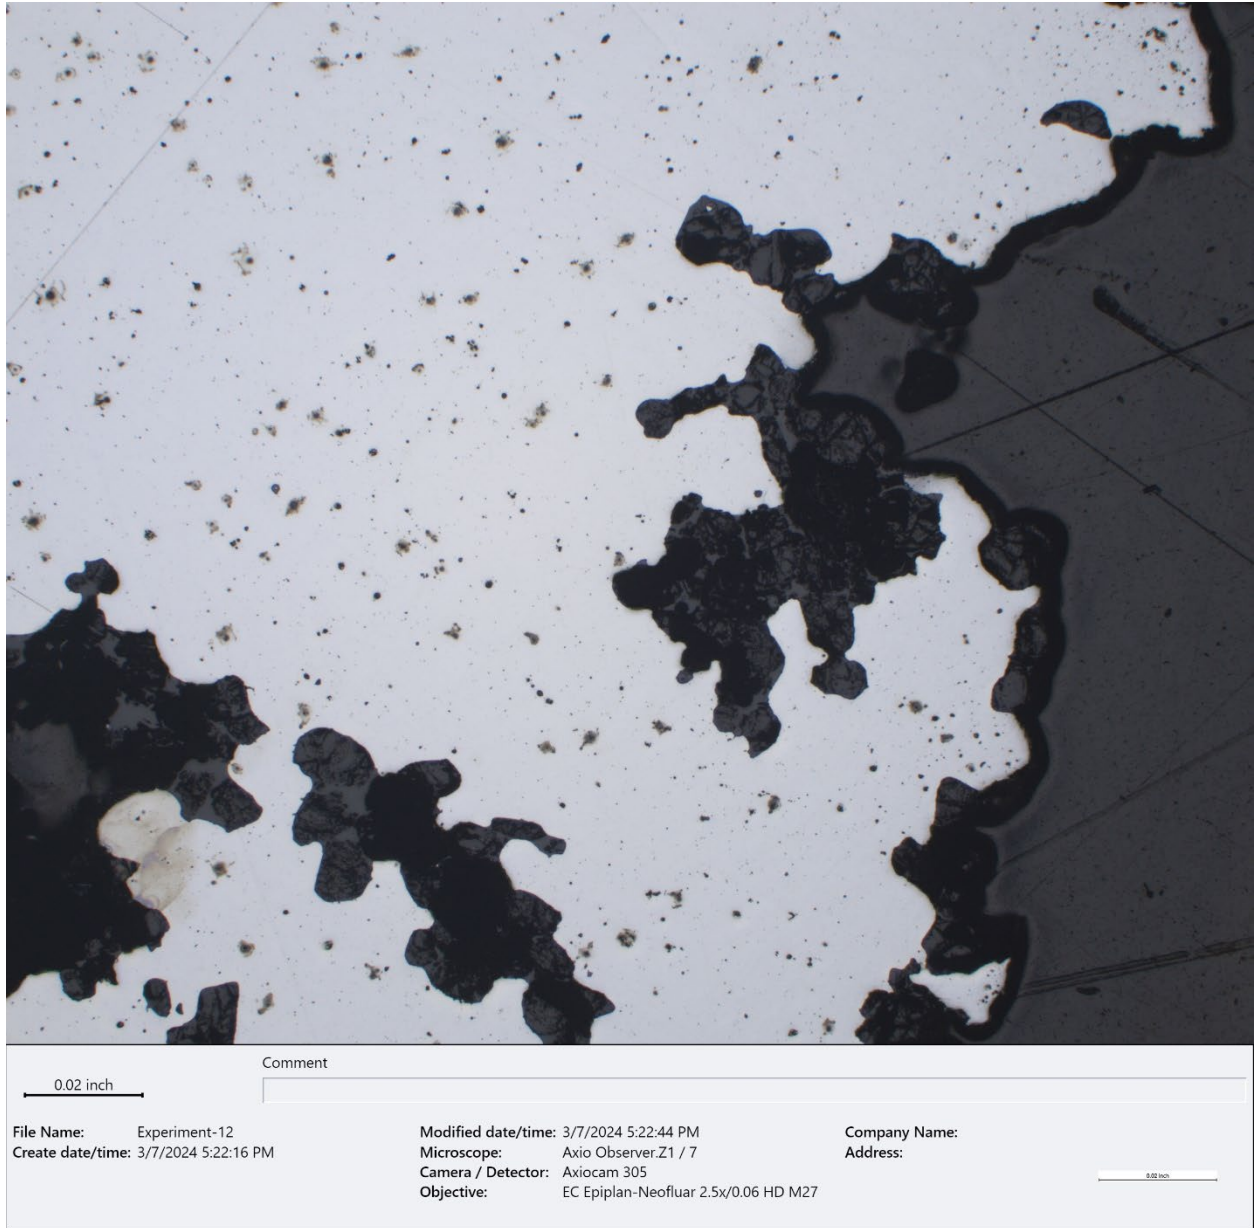
Figure 56. BF optical micrograph of a cross section through the flash at the A fracture surface, showing the porosity and entrained nonmetallic material (~200X, as polished).

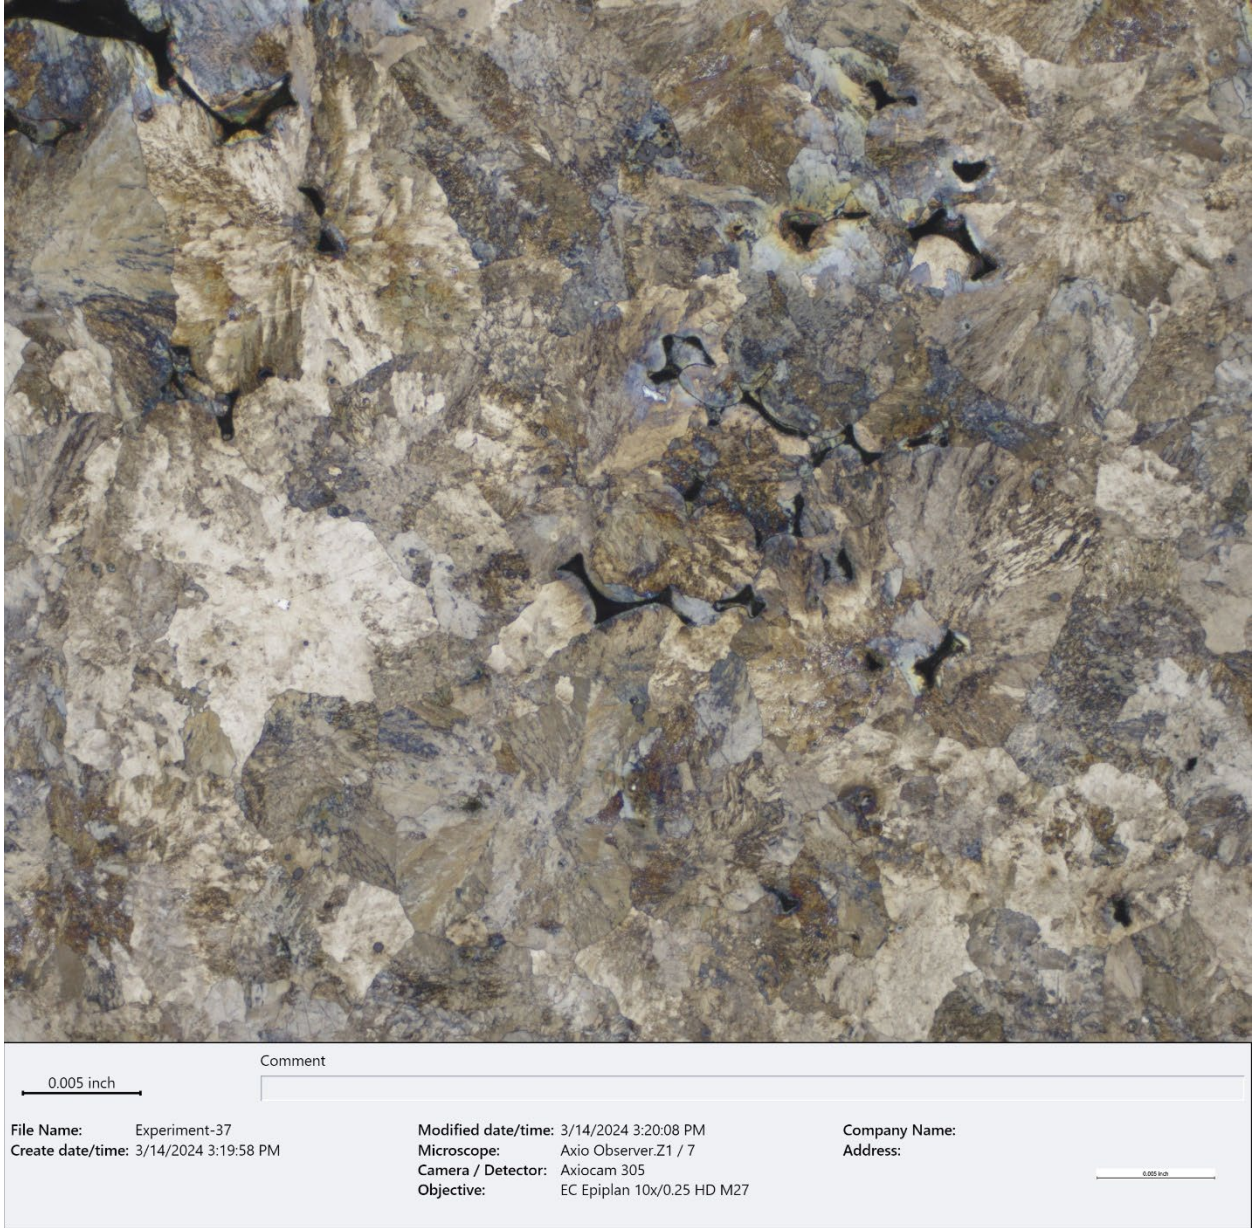
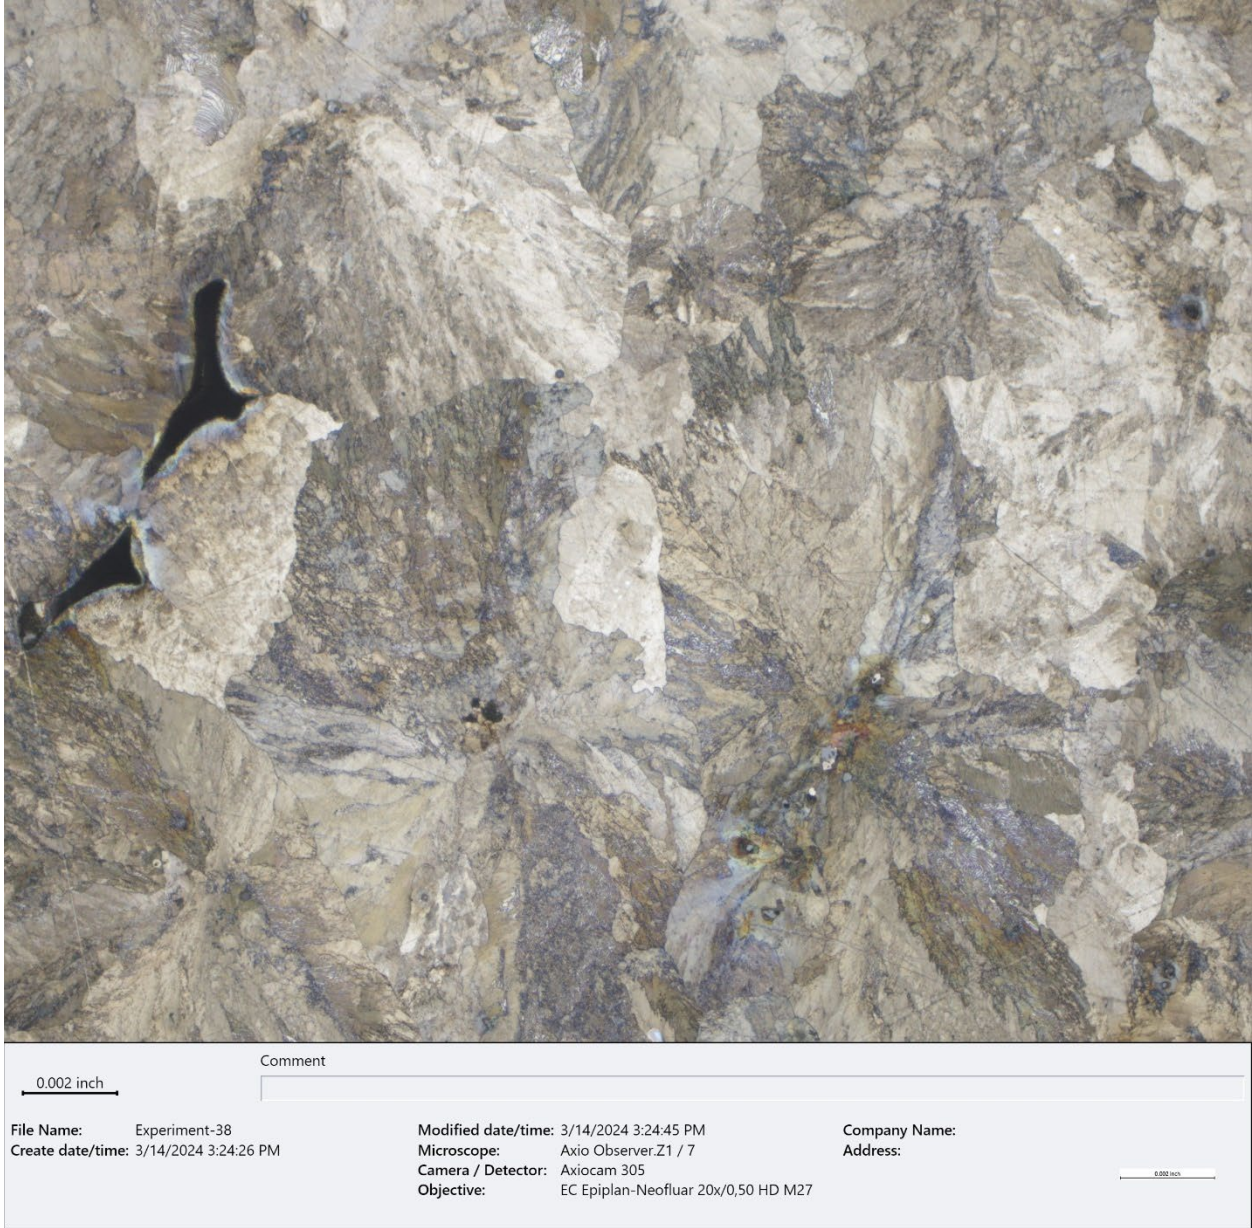
Figure 61. BF optical micrograph of a typical area of the weld filler near the base showing interdendritic porosity (~100X, etched 2% Nital).

Figure 62. BF optical micrograph of a closer view of an area in Figure 61, showing porosity and pearlitic grains (~200X, etched 2% Nital).
