Aircraft Accident/Incident Report No.: 191003

NTSB File No.: CEN20FA001

Aircraft: TBM700C2

Written by: Les Doud
Air Safety Investigator

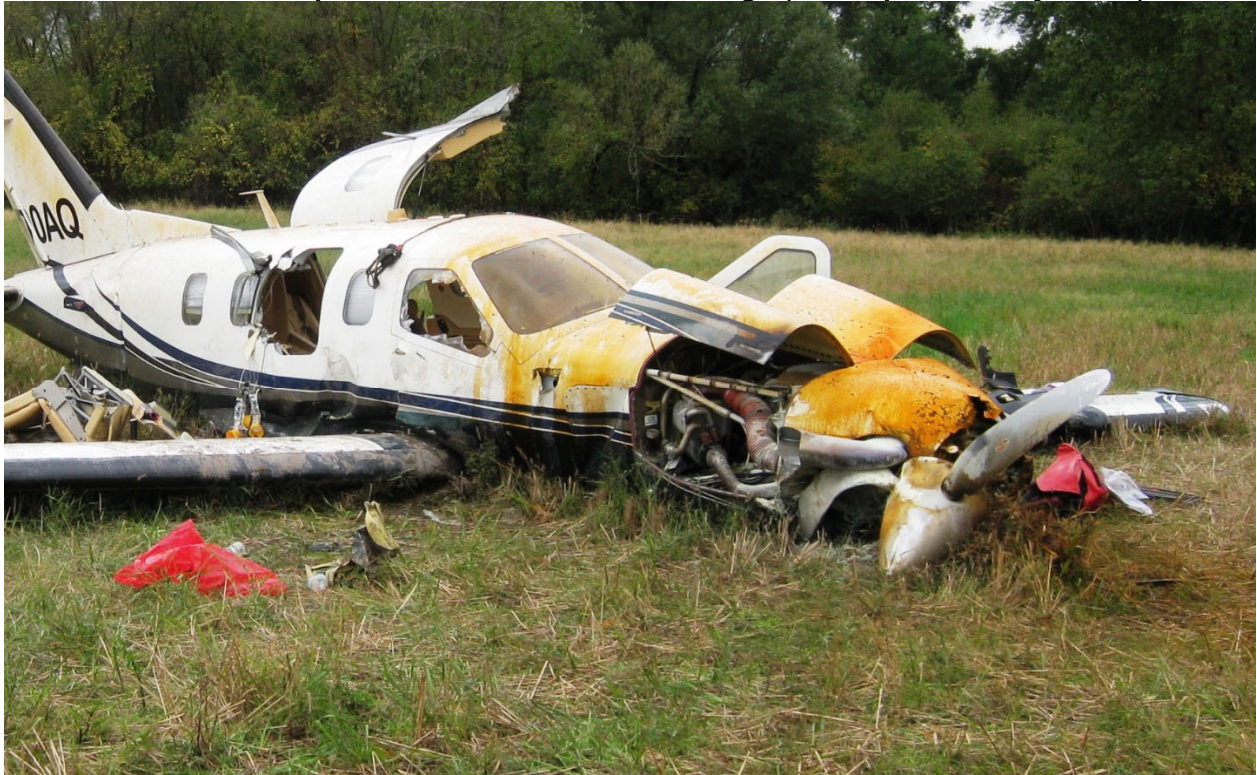
The propeller in-situ at the crash scene is shown in Photo #1.

Photo #1 – Propeller in-situ with main wreckage (Photo provided by NTSB)

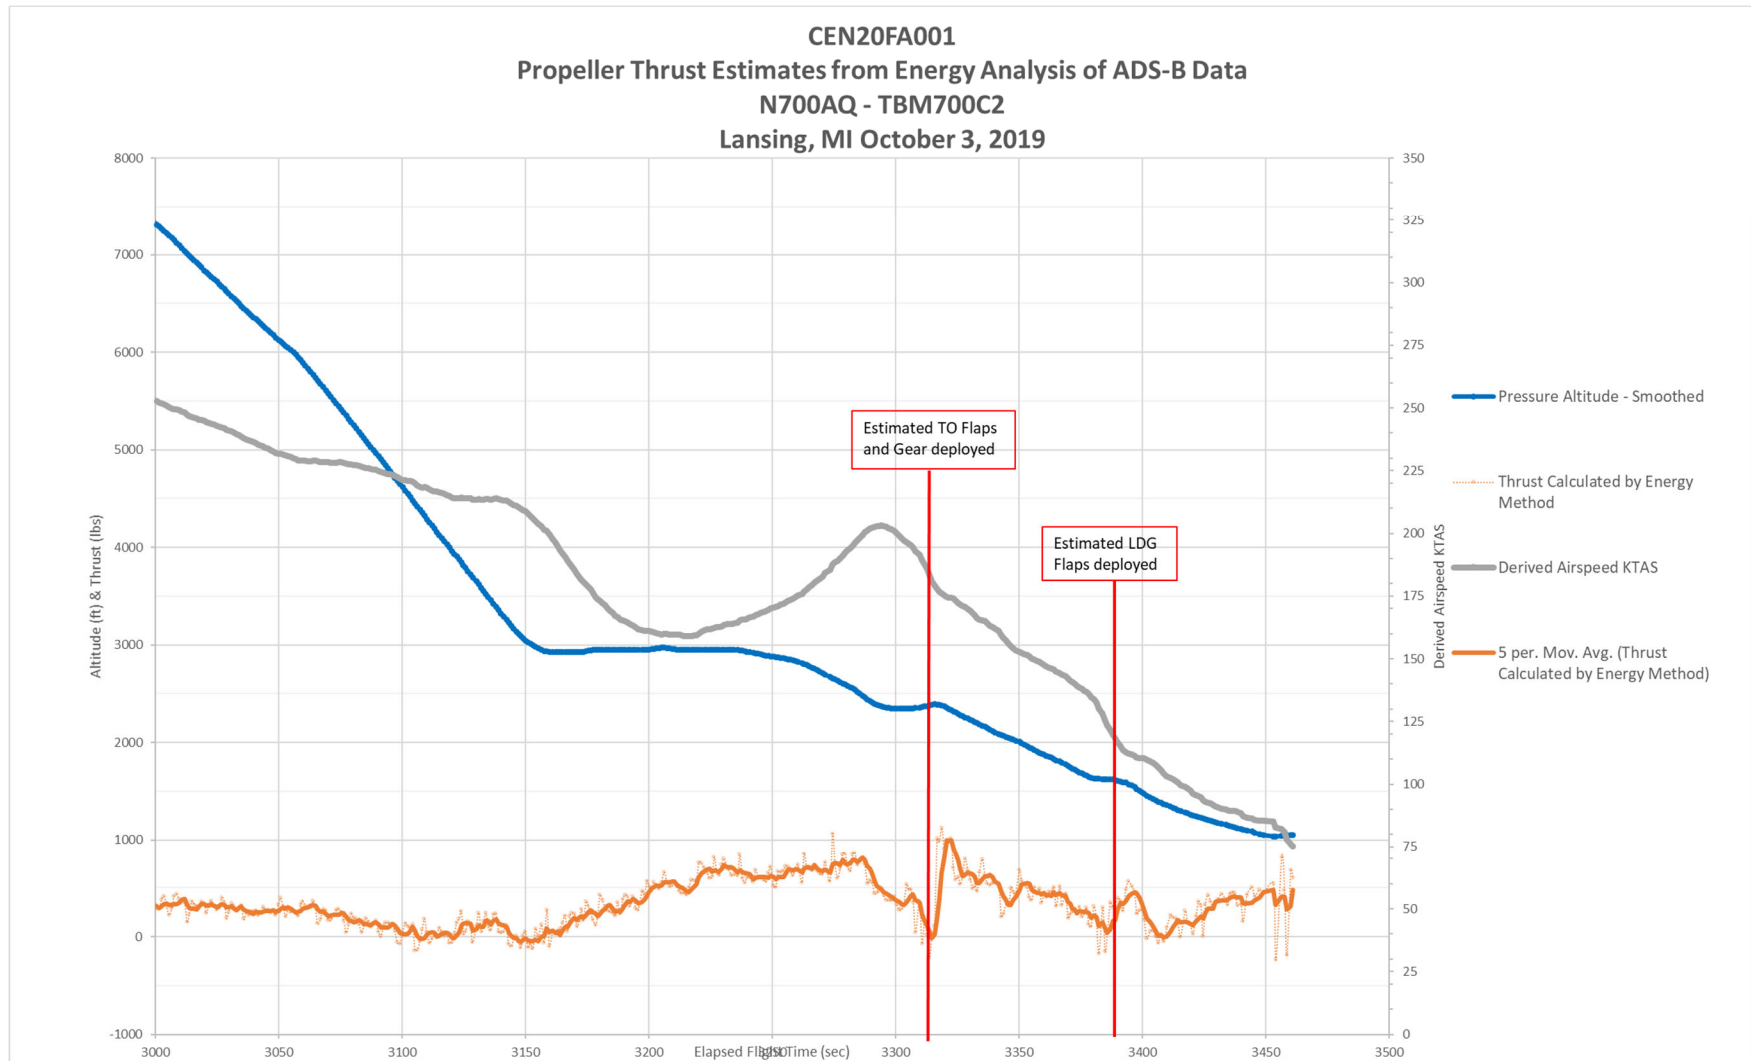
The estimated propeller thrust required during the final approach is shown in Figure 1. The estimates suggest the powerplant was running, capable of generating thrust, responding to airframe configuration changes/power lever inputs necessary to maintain the approach path until the accident sequence began. The average estimated propeller thrust over the final 11 recorded ADS-B data points was 412 lbs. The average flight condition during those final recorded data points was approximately 1050 ft. Pressure Altitude and 82 KTAS. Assuming a propeller RPM of 2000, the power required to generate 412 lbs. of thrust at that flight condition is approximately 170 Hp (24% torque) at approximately a 15.6° blade angle.

Figure 1 – Estimate of Propeller Thrust Required

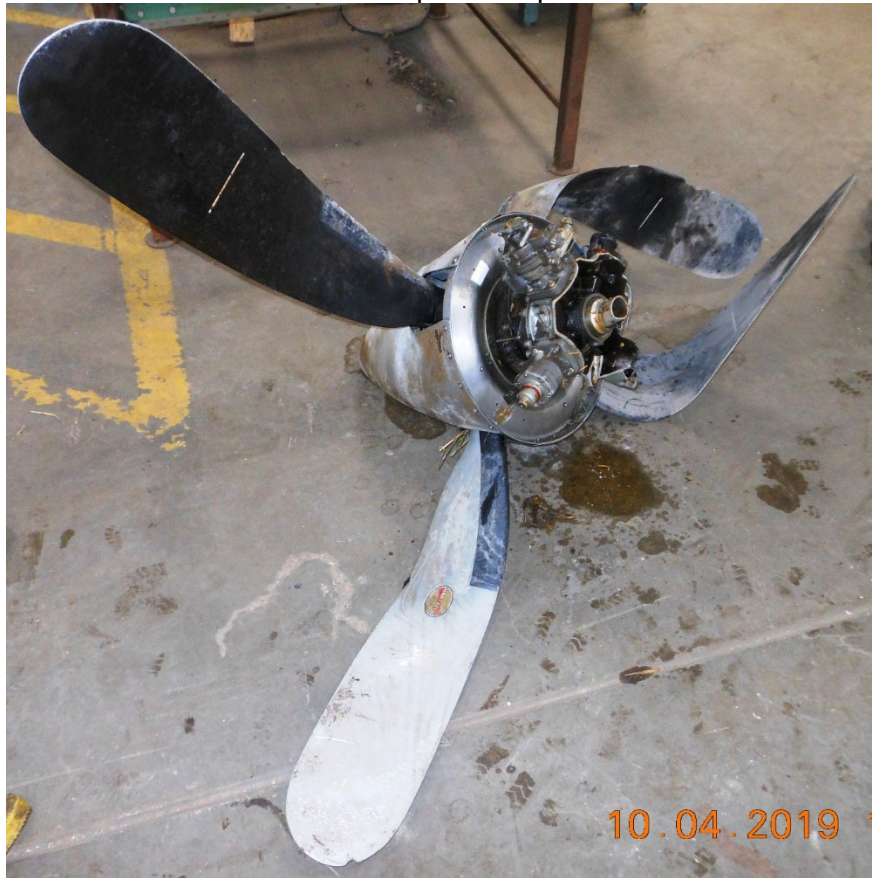
As Received: The propeller was presented for examination as shown in Photo #2. The propeller assembly remained attached to the engine propeller shaft that fractured from the engine RGB during the impact sequence. One blade was bent in the forward/thrust direction. Three blades were bent in the aft direction. All four blades exhibited chordwise/rotational scoring on the camber side with paint discoloration from the tip to the outboard end of the de-ice boot. Three blades exhibited chordwise/rotational scoring on the face side. The spinner dome was dented adjacent to one blade with a counterweight impression area with the center/average angle of approximately 44°. The pitch change rod was in the feathered position. Three blades could be partially rotated by hand force indicating fractured pitch change mechanisms. One blade had been forcefully rotated beyond the reverse stop position, two blades were in an approximate low pitch position and one blade was in an approximate feathered position. The beta ring appeared intact and undamaged with the carbon block and beta arm in position. The beta arm and valve moved freely.

Photo #2 – Propeller as-presented

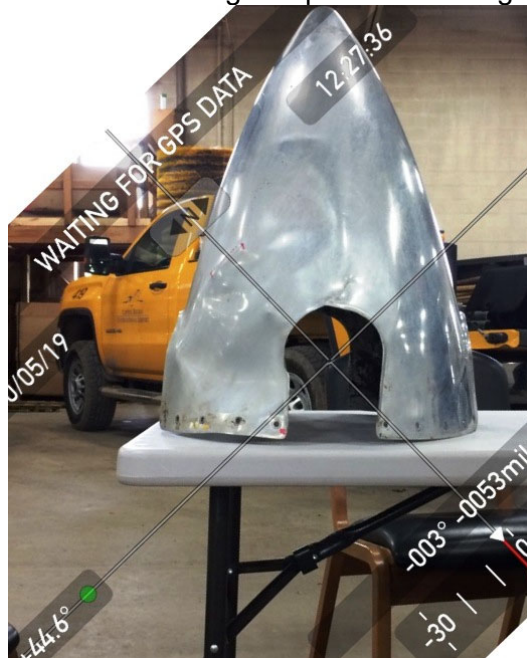
A counterweight impression in the spinner dome adjacent to the #3 blade at 44° is equivalent to a blade angle of approximately 31°. A pitch change knob mark on preload plate #3 at 8° is also equivalent to a blade angle of approximately 31.5°. A fork bumper impact mark on preload plate #1 at 27° is equivalent to a blade angle of approximately 16-17.5° which is approximately near the running flight idle blade angle hydraulic stop.

Spinner Dome: The spinner dome remained attached to the propeller assembly by all spinner mounting screws. The dome was dented adjacent to blade #3 with a counterweight impression area at approximately 44° (Photo #3). The dome had rotational scoring near the apex and longitudinal scoring in the dented area.

Photo #3 - Counterweight impression average angle

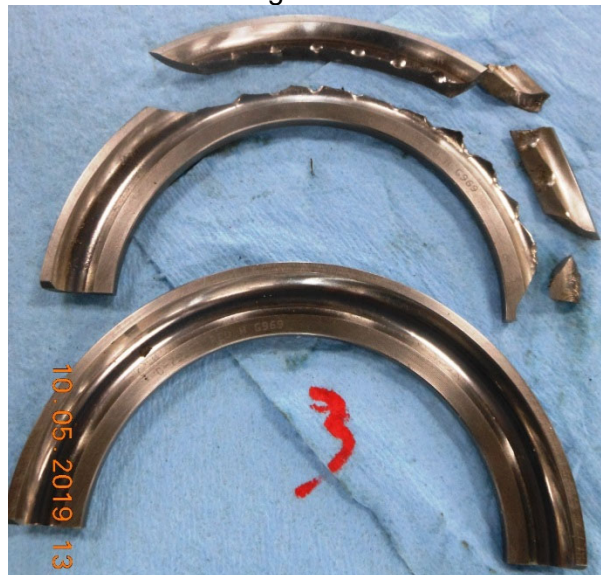
Hub Assembly: The hub unit had no visually detectable fractures or cracks. There was preload plate shelf damage in all four blade retention pockets. There were knob and/or fork impact marks on the forward hub half internal surface in all four blade retention pockets and the pitch change rod bushing was fractured. The preload plate web in the aft hub half for #2 and #3 blades was fractured inward. There was damage in the bearing race area of the #3 blade retention pocket due to a bearing race fracture. There were blade impact marks in the #2 and #3 blade apertures in the aft/trailing edge quadrant. All except #4 hub-side blade bearing race assemblies had ball impact marks to varying degrees. The #3 blade race was fractured and fragmented (Photo #4)

Photo #4 - Blade #3 bearing race fractured with ball imprints

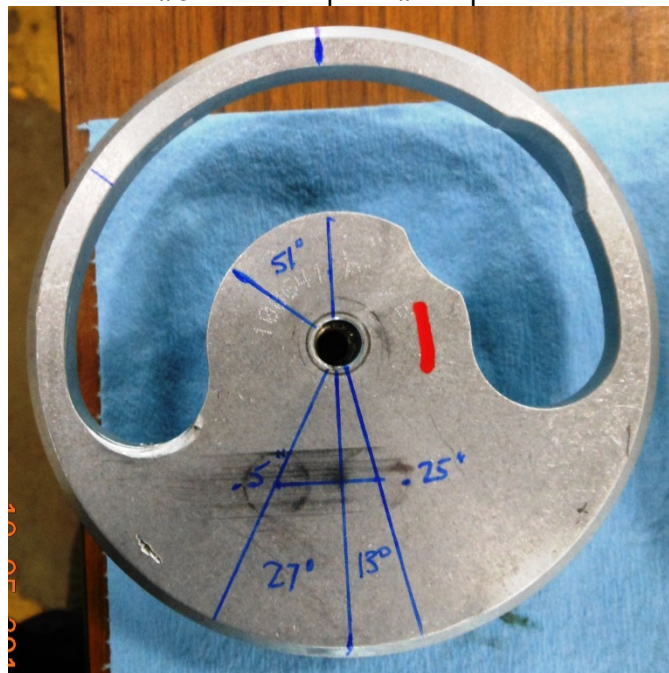
There were pitch change knob impact marks on preload plates #1, #3 and #4 at 50-51° which are equivalent to a blade angle of approximately -8°, or approximately near the mechanical reverse stop. Blade damage suggested these marks were post-impact/impact sequence marks after forceful rotation/twisting towards low pitch.

Preload Plate	Condition
1	There was a knob impact mark at 51° forward of split line in the knob slot. There were fork bumper marks at 27° forward and 13° aft of the split line. (see Photo #5)
2	There was a knob impact mark at 40° forward of split line in the knob slot.
3	There was a knob impact marks at 50° and 8° forward of split line in the knob slot.
4	There was a knob impact mark at 51° forward of split line in the knob slot.

Photo #5 - Preload plate #1 impact marks

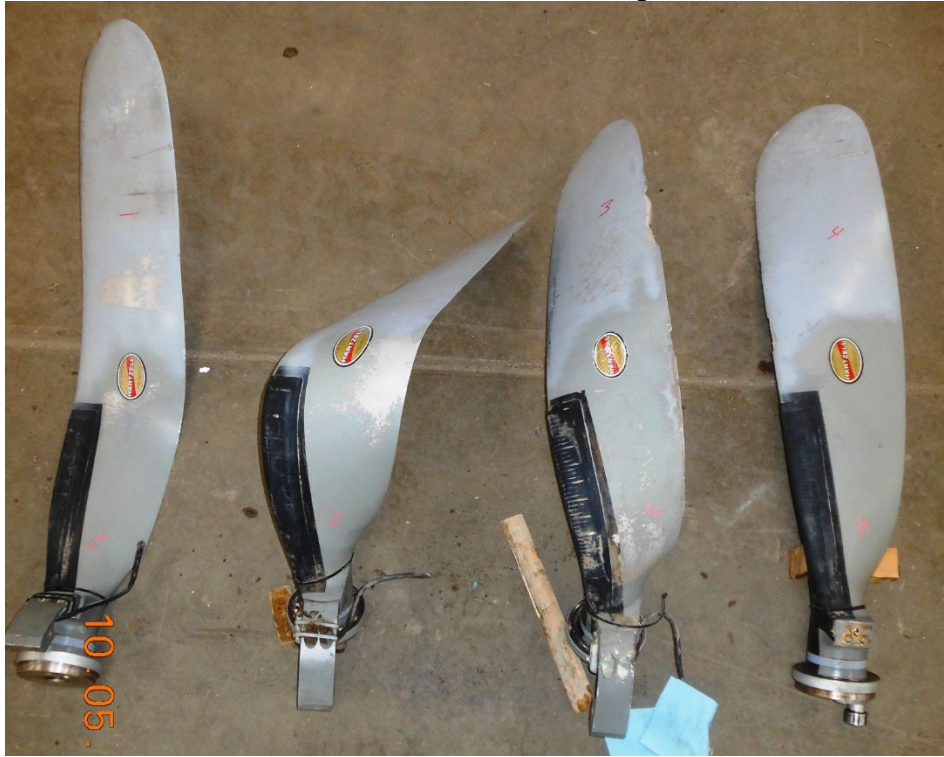
All blade damage indicated propeller impact forces with terrain were in the lead-to-trail direction with blade angle in the normal range of operation. Chordwise/rotational scoring and abrasion on the camber and face side, leading edge gouges, blade-to-hub impact marks in the lead-to-trail direction and compound bending and twisting all indicated rotation under power. Rotational scoring on the spinner dome also suggested rotation at impact. Blade bending in the forward direction, leading edge gouge deformation toward high pitch, and face side scoring all suggest zero-to-positive blade section impact angles and therefore rotation under power and generating some amount of thrust.

Propeller Blade Properties: There was visible paint discoloration on all four blades camber side from the tip down to the outboard end of the de-ice boot. See Photos #6 through #8 for blade damage.

Photo #6 - Blades camber side showing discoloration

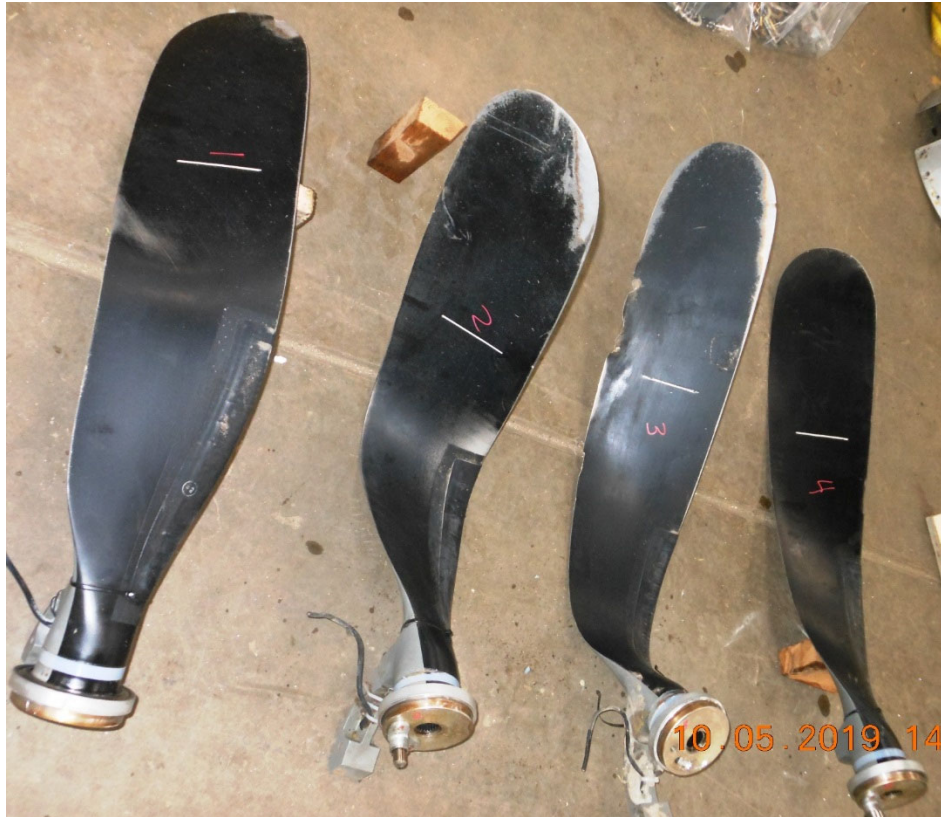
Photo #7 - Blades face side

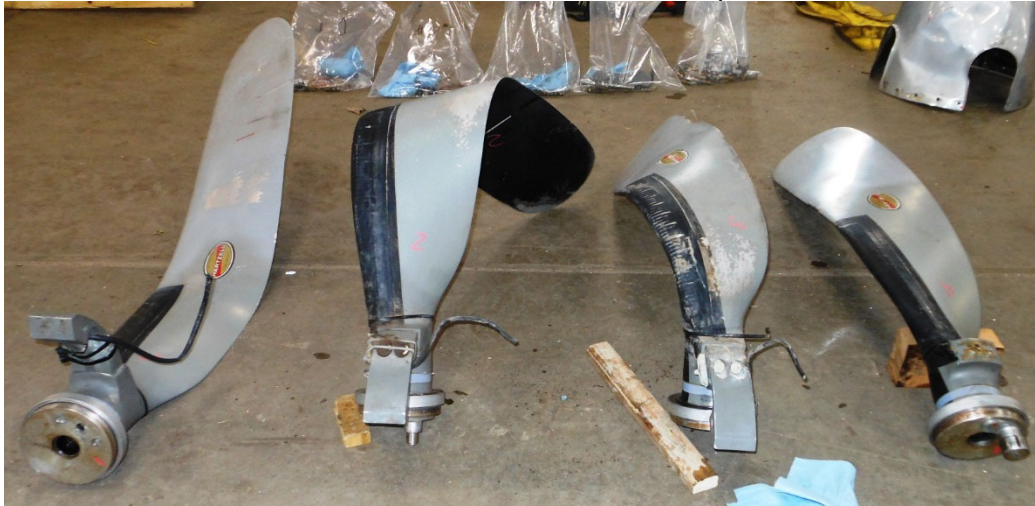
Photo #8 - Blade bend and twist comparison
