National Transportation Safety Board

CEN23LA062

MATERIALS LABORATORY

Factual Report 24-003

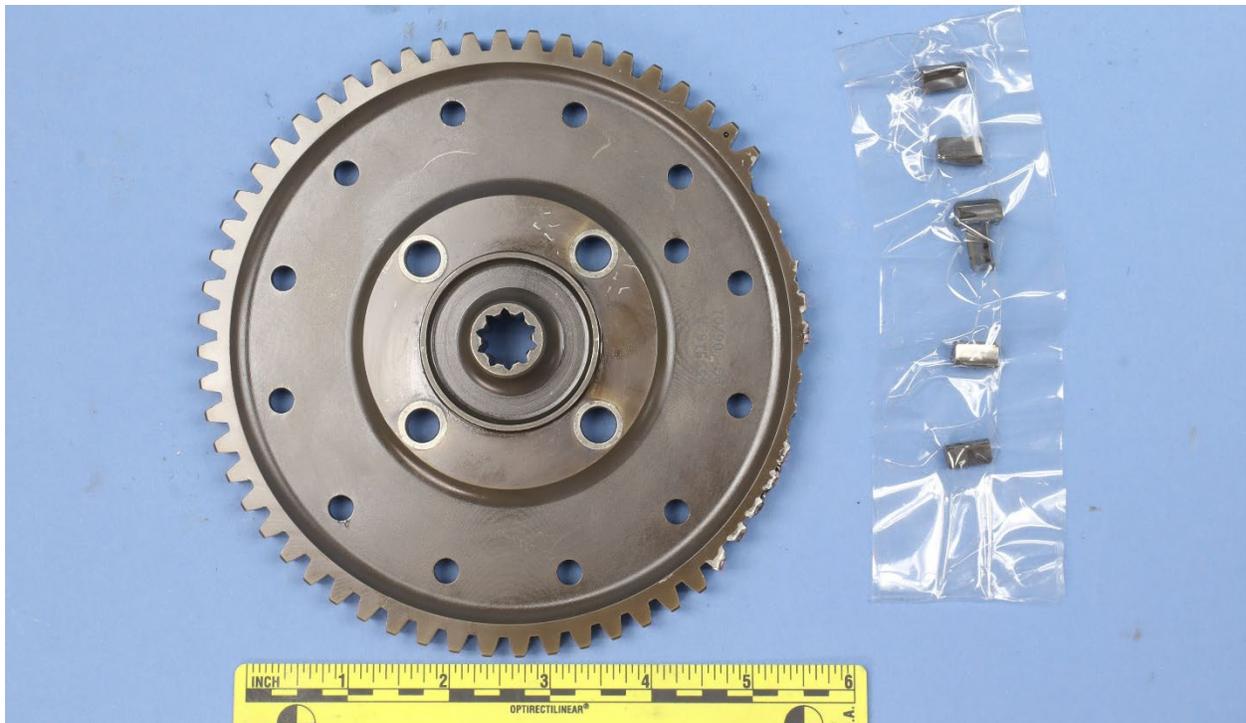
Figure 1 shows the gear from the aft face, as received with six liberated teeth packaged in clear tape. As illustrated in Figure 2, many of the gear teeth were intact, but 11 were either damaged or separated from the gear (Figure 2b). Figure 3 shows the area of the fractured and damaged gear teeth from the side. These were labeled 1 through 9 for the purposes of this report, increasing clockwise as shown in the figure (10 and 11 were not assigned as those teeth were plastically deformed rather than fractured). As shown on the face in Figure 3, the markings on the gear stated "655516 A" and "PG 06/01".

Figure 1. View of the camshaft gear from the aft side, and six of the recovered fractured teeth (received in tape on right).

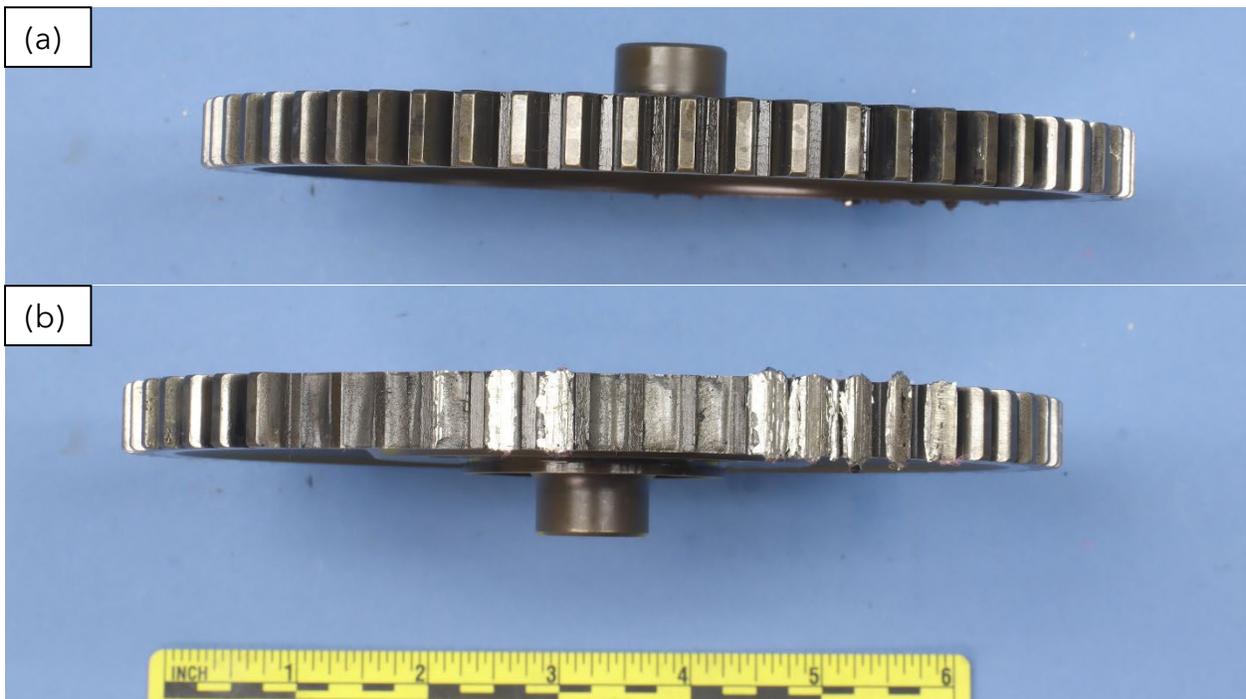
Figure 2. Opposing views of the teeth from the camshaft gear, showing (a) an intact side and (b) the side with multiple missing, deformed, and flattened teeth.

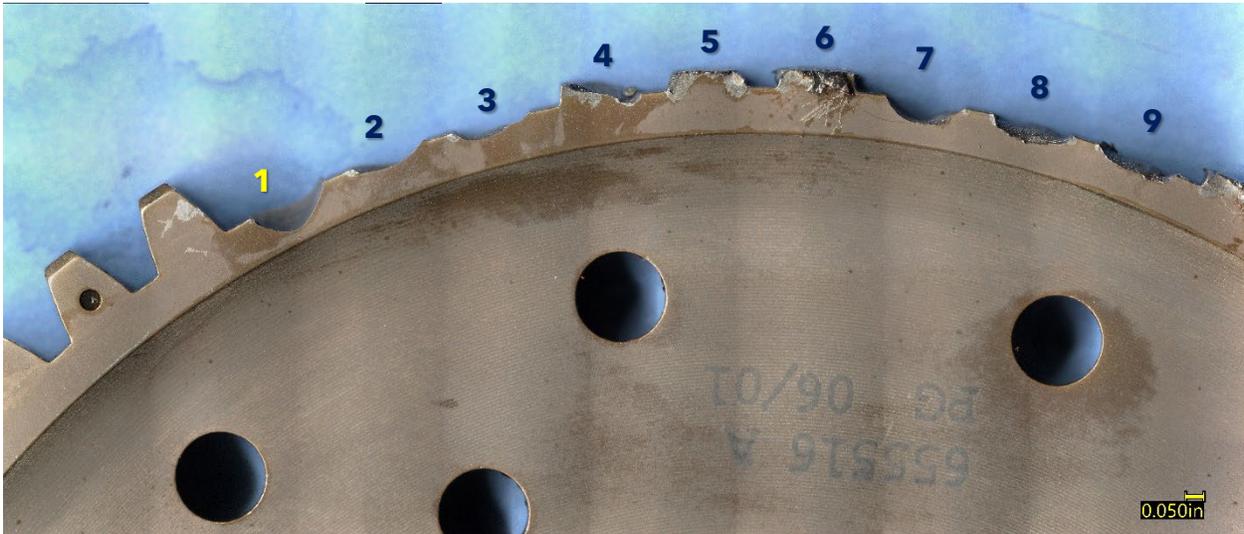
Figure 3. Side view montage of the fractured gear teeth, labeled 1 through 9 as annotated in the figure from left to right.

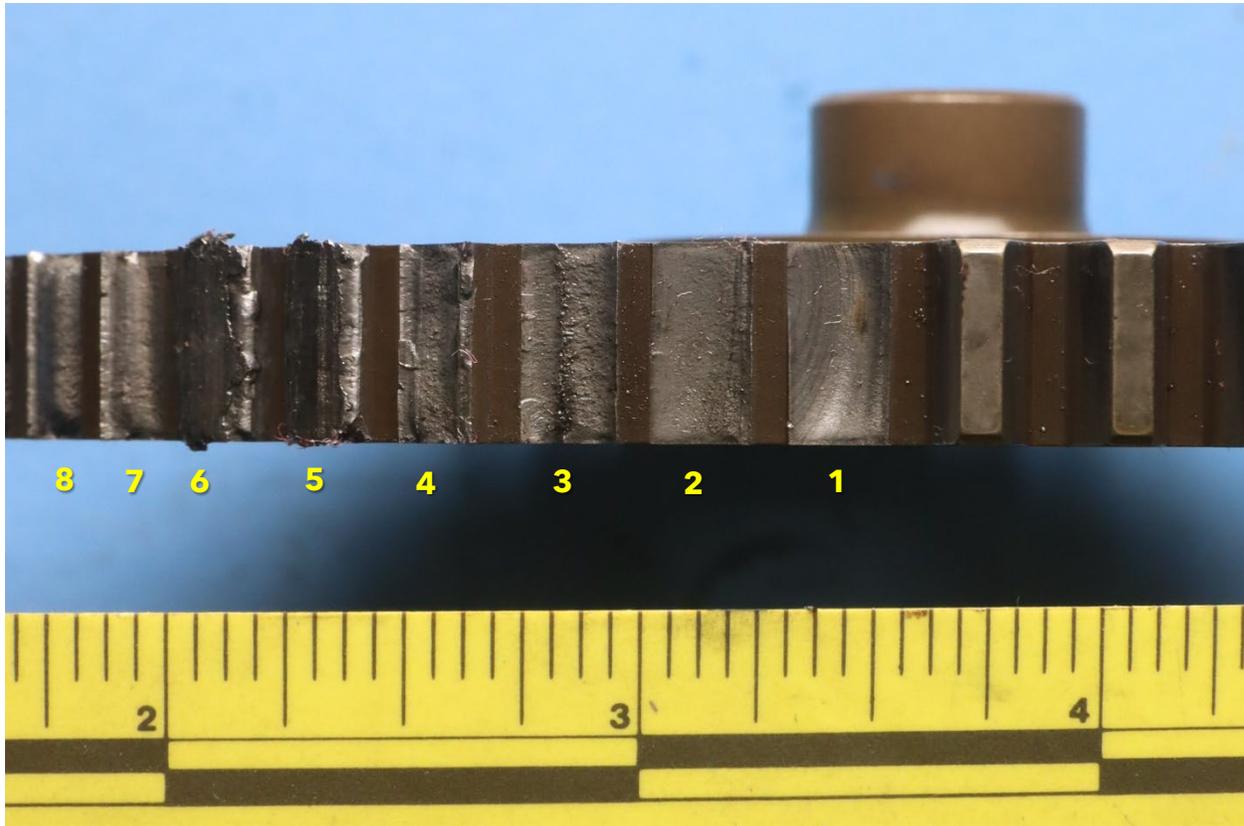
Figure 4 shows several fracture surfaces and areas of plastic deformation on teeth positions 1 through 8. Several fracture surfaces exhibited crack arrest marks, indicating crack propagation under cyclic loading. In addition, an examination of the land and flank facing the fracture surface of tooth 1 did not exhibit an indication of excessive wear or gouging.

Figure 4. Closer view of the fractured teeth on the gear, labeled from right to left in the figure.

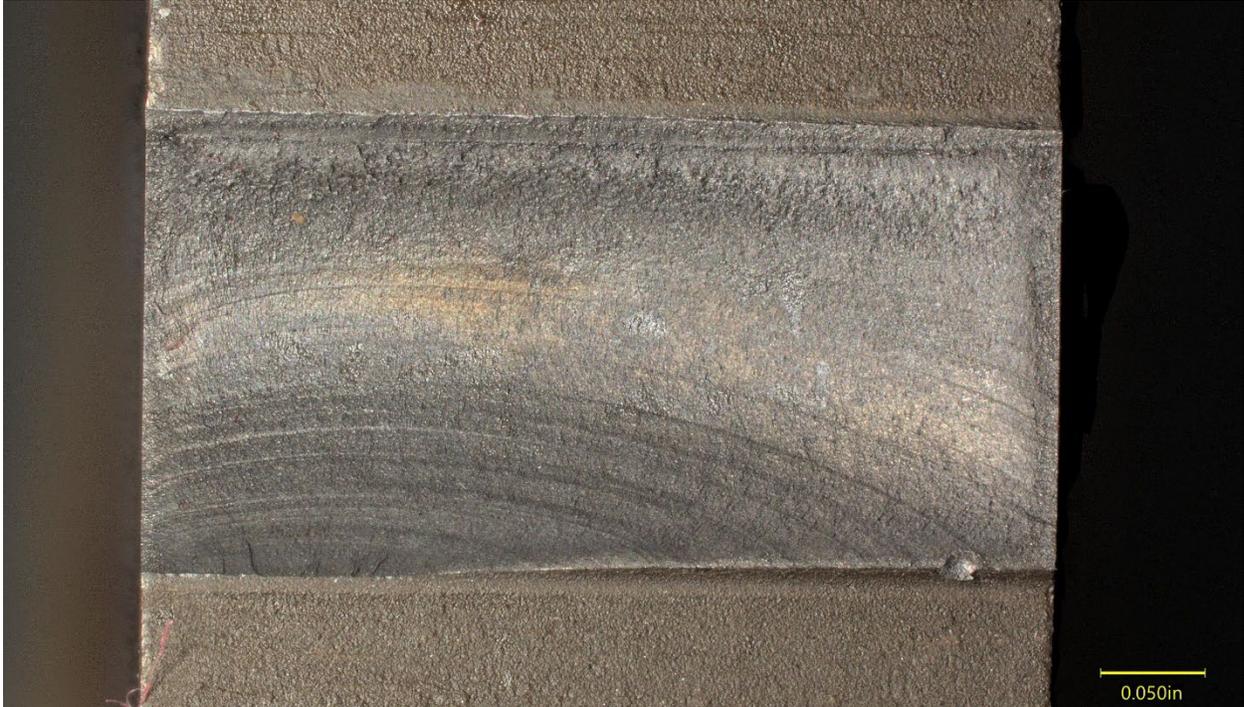
The fracture surface of the missing teeth 1 through 9 on the camshaft gear are shown in Figures 5 through 13, respectively. Teeth 5 and 6 exhibited indications of smeared material and missing face material above the pitch circle of the threads. There were also features consistent with batter, sliding, and gouging, consistent with the plastic deformation of these threads. The direction of plastic deformation was upward in Figures 9 and 10. These threads were consistent with being present and then damaged after the adjacent threads fractured.

All of the other fractured threads exhibited some degree of crack arrest marks, consistent with progressive cracking. However, threads 1 and 2 revealed the most significant degree of surface demonstrating said features and were the focus of the examination. Figures 5 and 6 show the fracture surfaces of tooth positions 1 and 2, respectively. Both exhibited concentric crack arrest marks, consistent with initiating along the lower fracture edges in both figures, consistent with the locations of the fillet radii from each tooth. The initiation areas exhibited upward-facing ratchet marks.

Figure 5. View of the fracture surface of tooth 1, showing crack arrest marks from the bottom left.

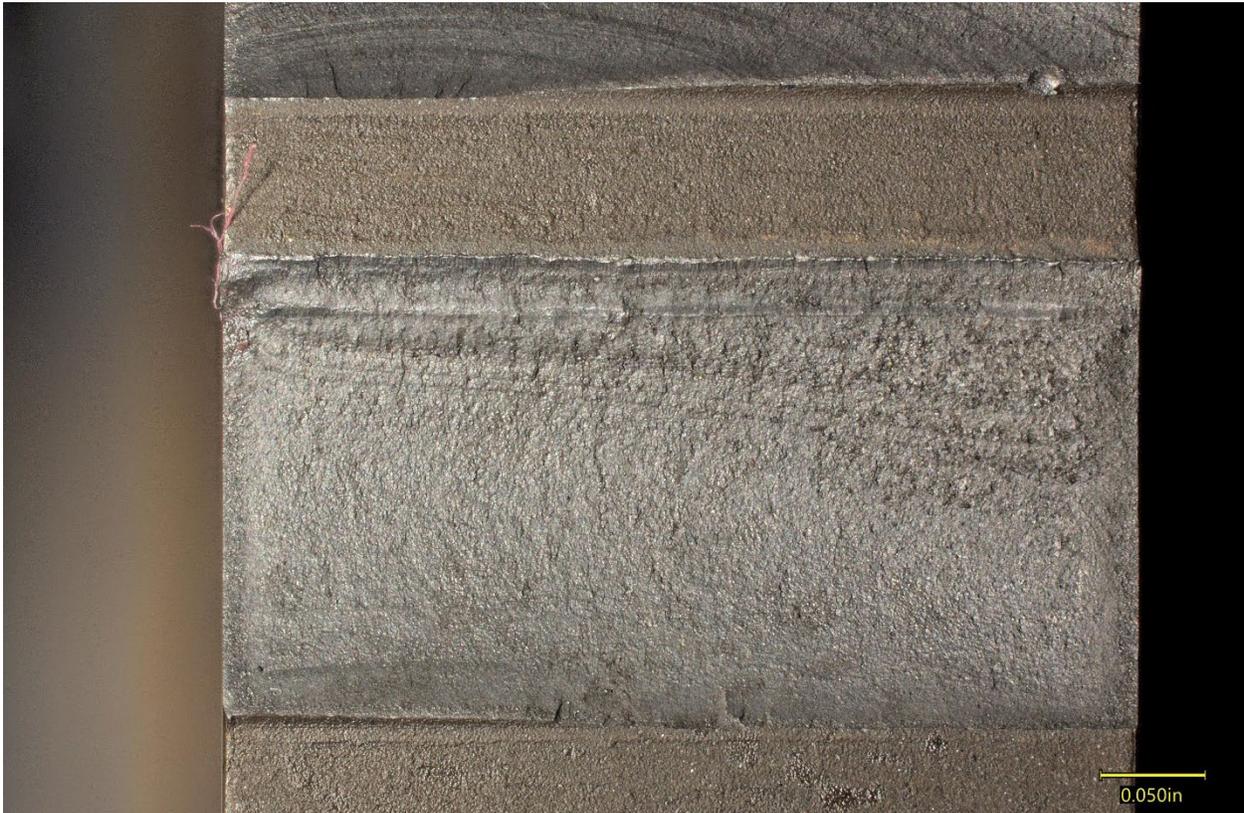
Figure 6. View of the fracture surface of tooth 2, showing crack arrest marks from the bottom and top.

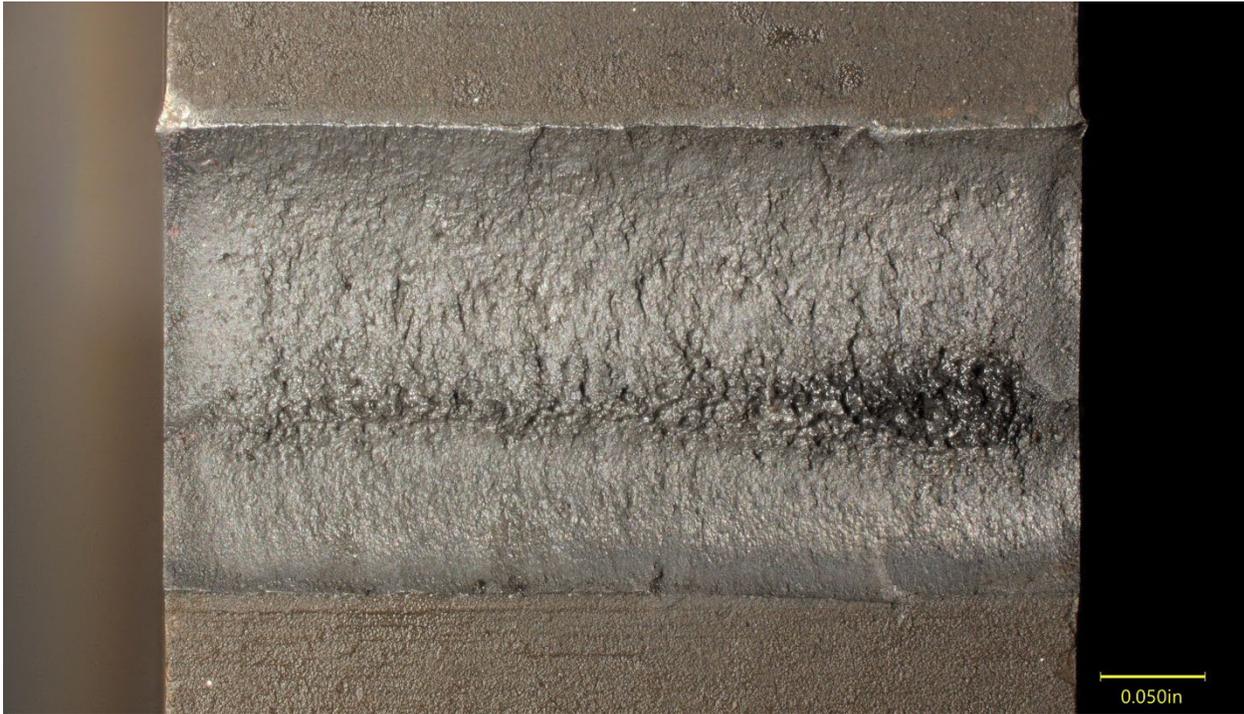
Figure 7. View of the fracture surface of tooth 3.

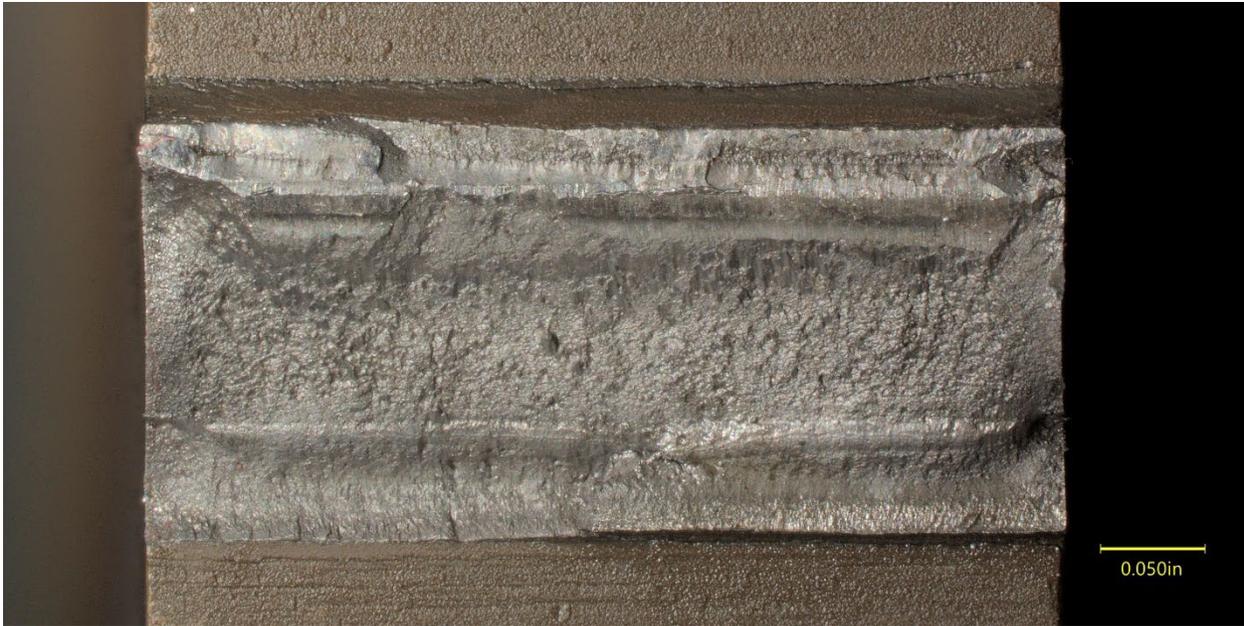
Figure 8. View of the fracture surface of tooth 4.

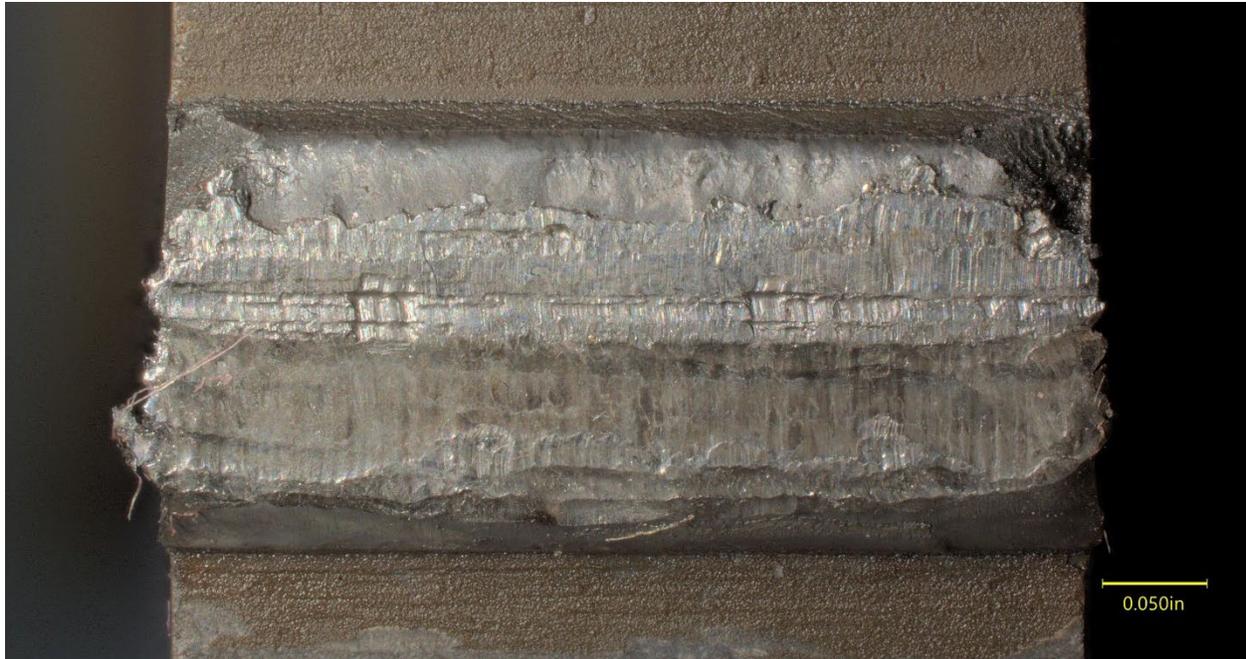
Figure 9. View of the fracture surface of tooth 5.

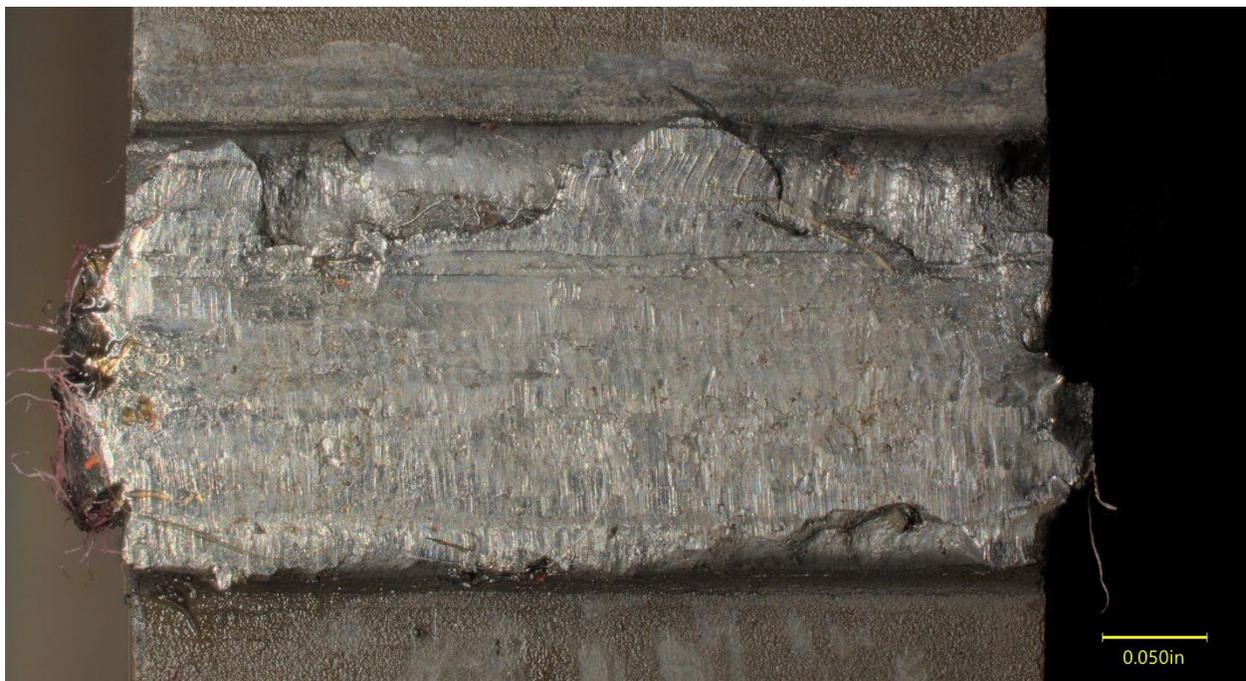
Figure 10. View of the fracture surface of tooth 6.

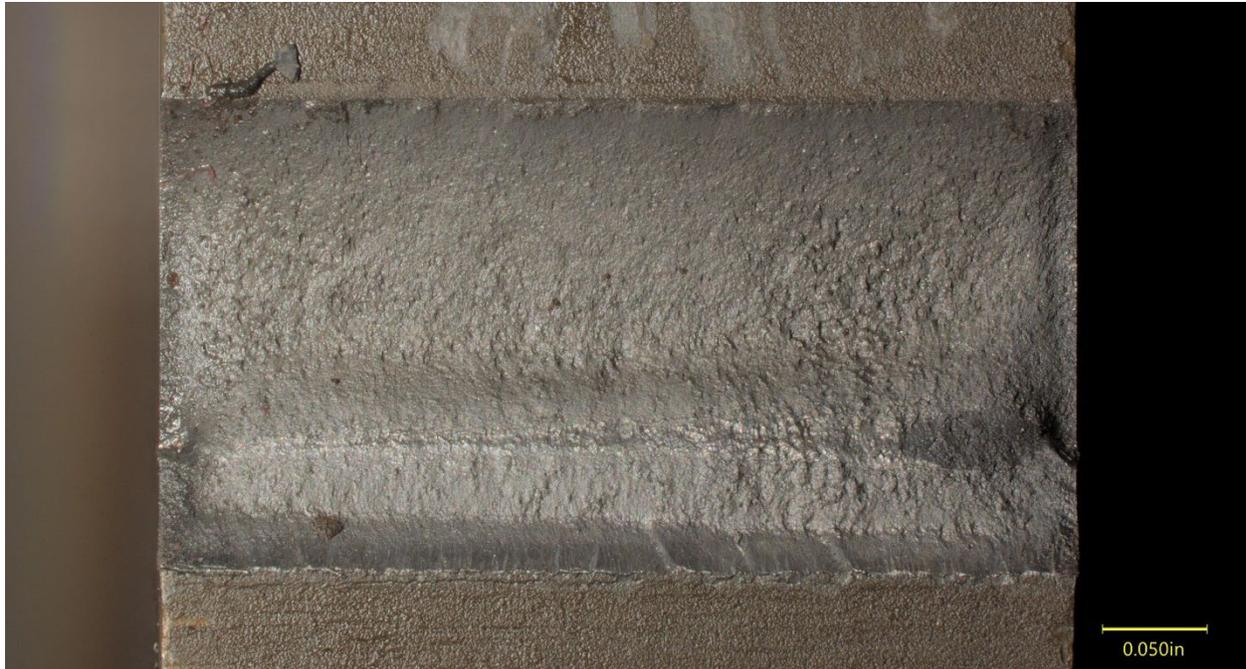
Figure 11. View of the fracture surface of tooth 7.

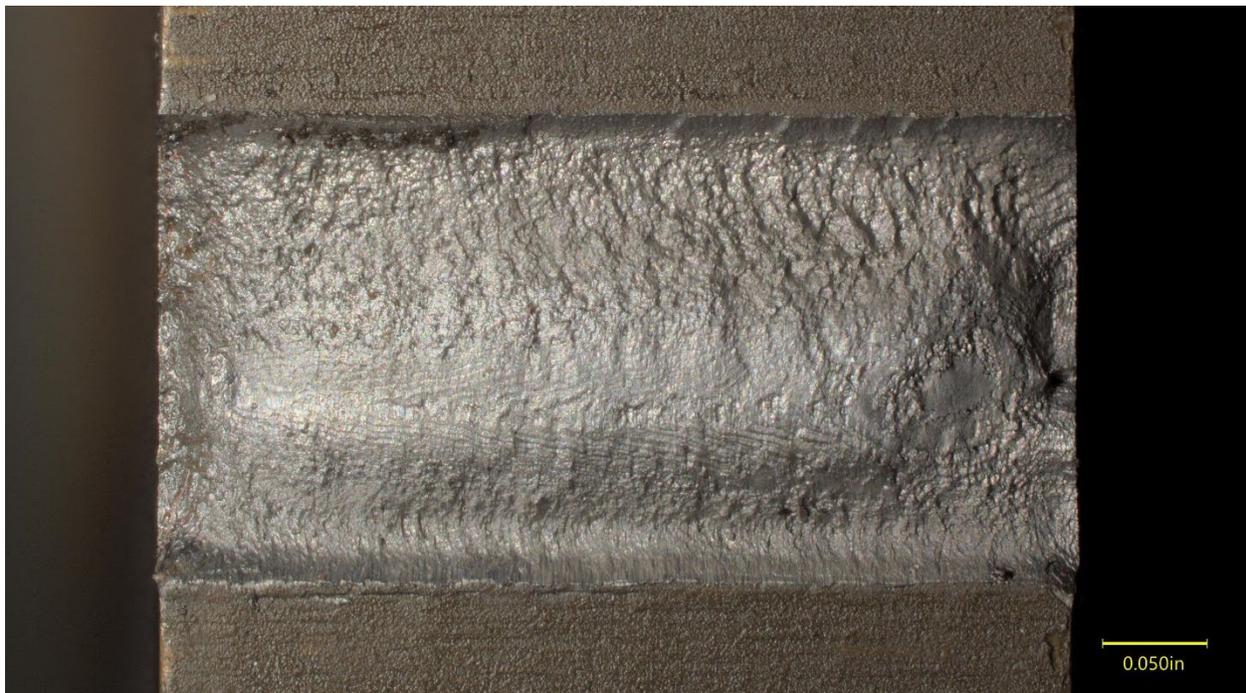
Figure 12. View of the fracture surface of tooth 8.

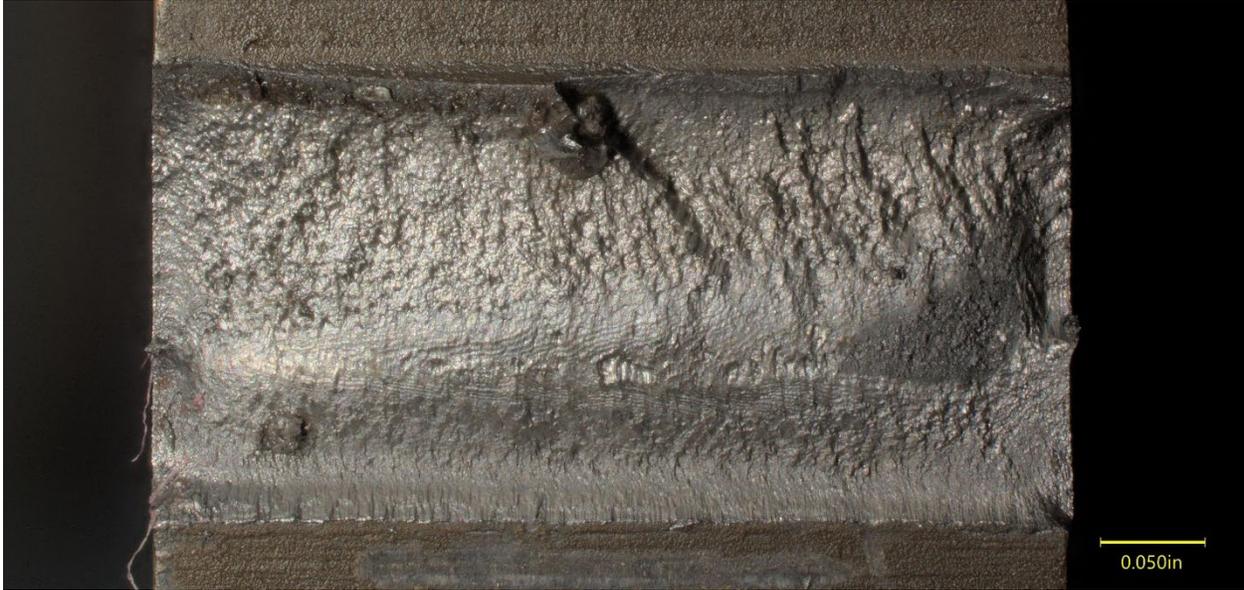
Figure 13. View of the fracture surface of tooth 9.

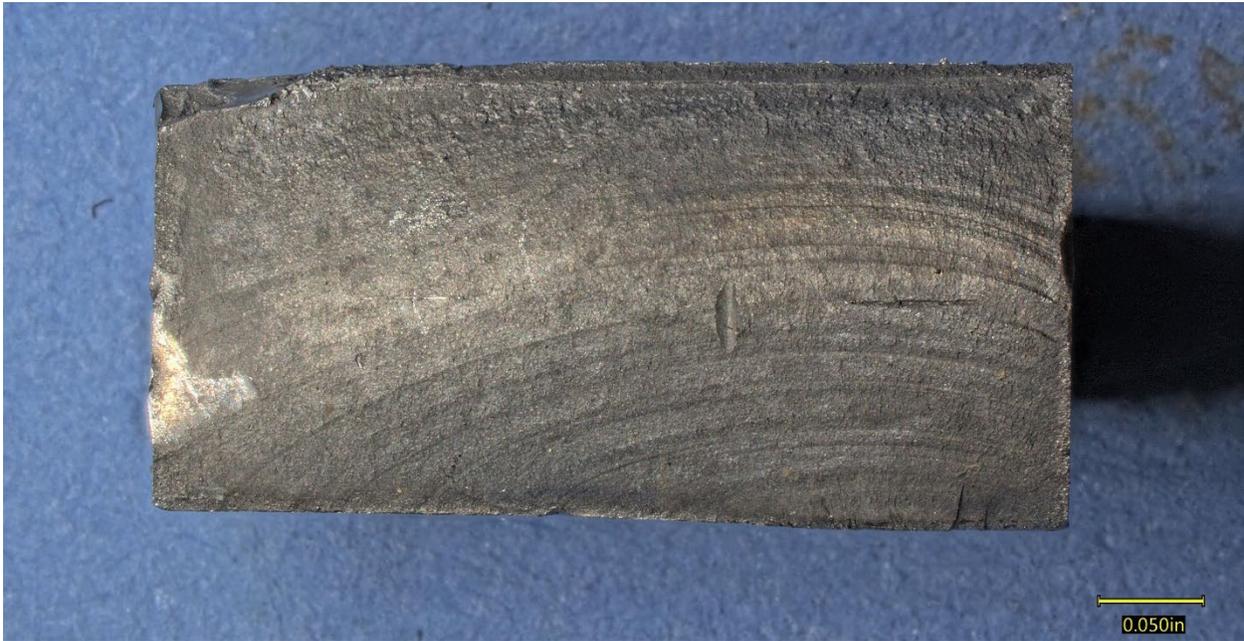
Figure 14 shows the mating fracture surface of the liberated tooth 1. The features, such as the crack arrest and ratchet marks, mirror that of the gear fracture shown in Figure 5. The crack exhibited ratchet marks near the edge, indicating multiple crack initiation sites. This area was coincident with the area from which the crack arrest marks emanated, illustrated in Figure 15. Figure 16 shows a closer view of the initiation area, demonstrating the ratchet marks. The area along the flank and fillet radius did not exhibit any plastic deformation or wear significant enough to show gouge marks. There were also no indications of corrosion at that location.

Figure 14. View of the fracture surface of tooth 1, which mated to the surface in **Figure 5**.

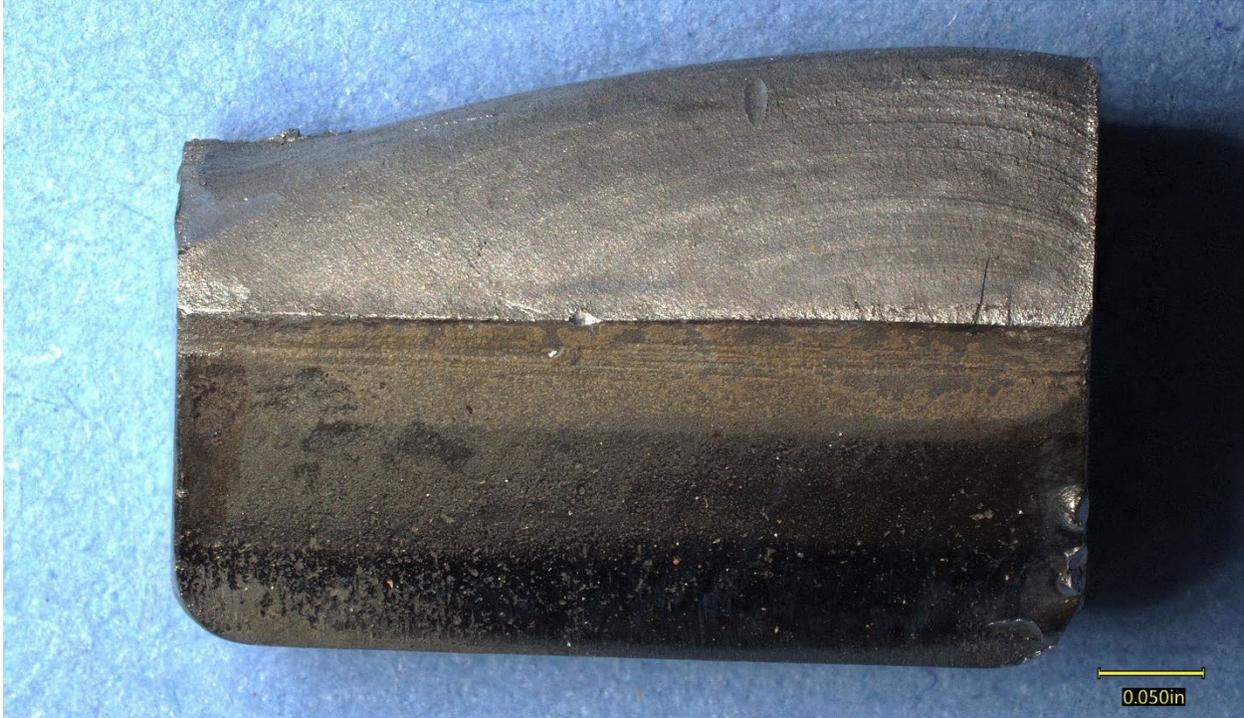
Figure 15. Angled view of tooth 1 in **Figure 14**, showing the edge of the fracture.

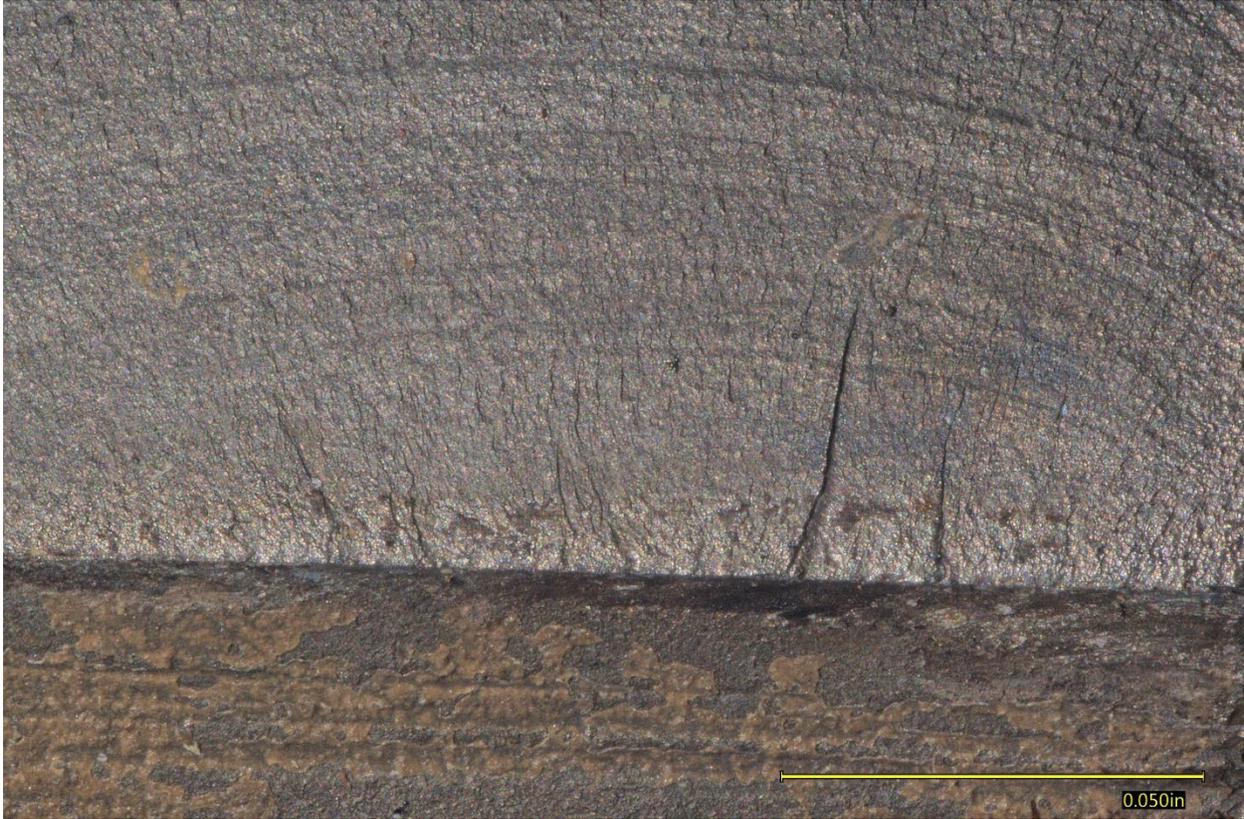
The initiation region in Figure 16 is shown in Figure 20 as seen using a SEM. The ratchet marks demarcate the separate crack initiation sites where the cracks coalesced during propagation. Figure 21 shows a backscattered micrograph illustrating areas of

Figure 16. Closer view of the edge of the tooth fracture, showing ratchet marks and crack arrest marks emanating from the crack initiation location.

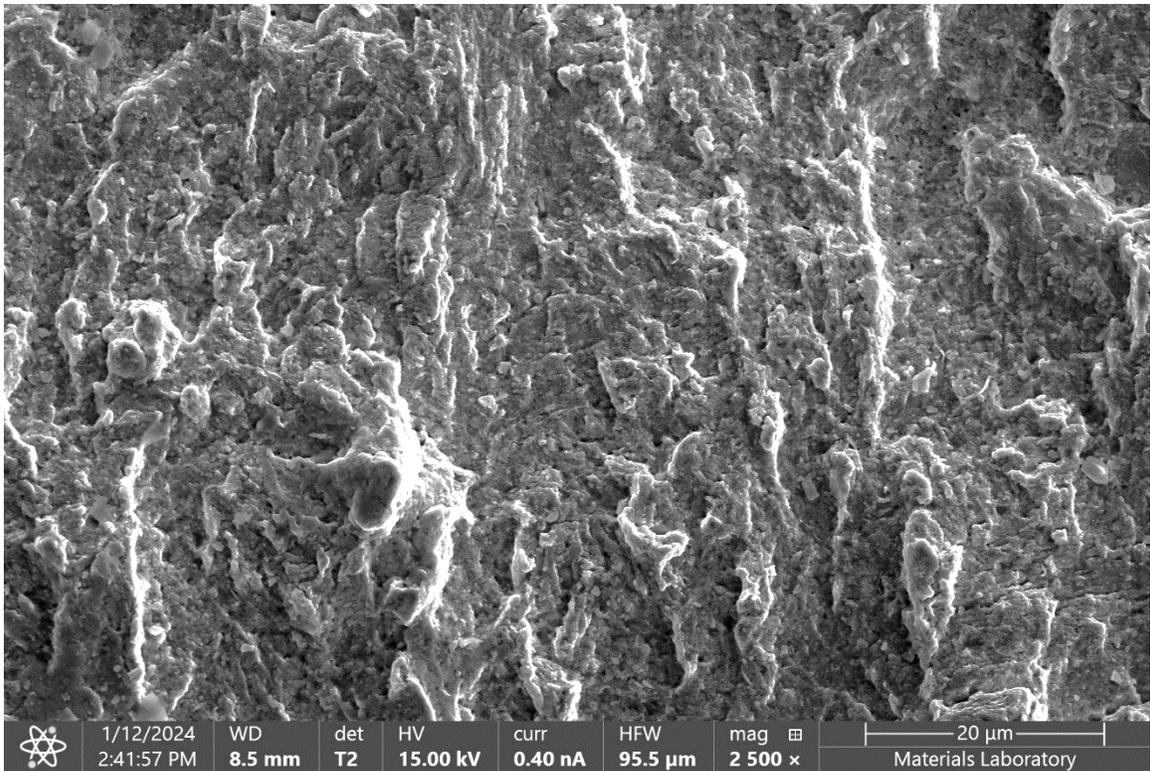
The fractured tooth 1 was examined using a field emission scanning electron microscope (SEM). Figures 17 and 18 show a typical area in the center of the fracture surface. As shown in a closer view in Figure 19, the fracture surface exhibited fatigue striations, consistent with fatigue crack propagation. These features were found throughout the tooth fracture surface, except for a thin region near the top of the area shown in Figure 14. Also at the top of the tooth fracture surface in Figure 14, there were fatigue striations, consistent with propagating inward from the opposite fillet radius.

Figure 17. Secondary electron (SE) micrograph of a typical area of the fracture surface of tooth 1, showing fatigue striations.

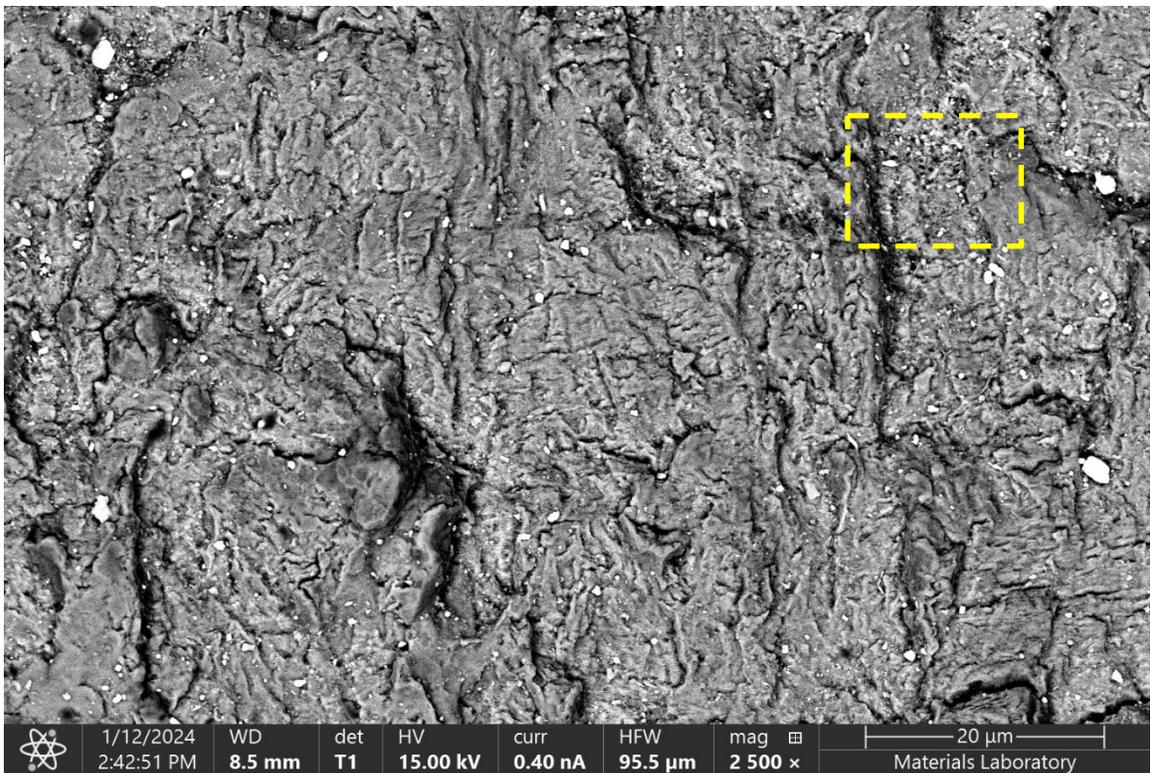
Figure 18. Backscattered electron (BE) micrograph of the area shown in **Figure 17**.

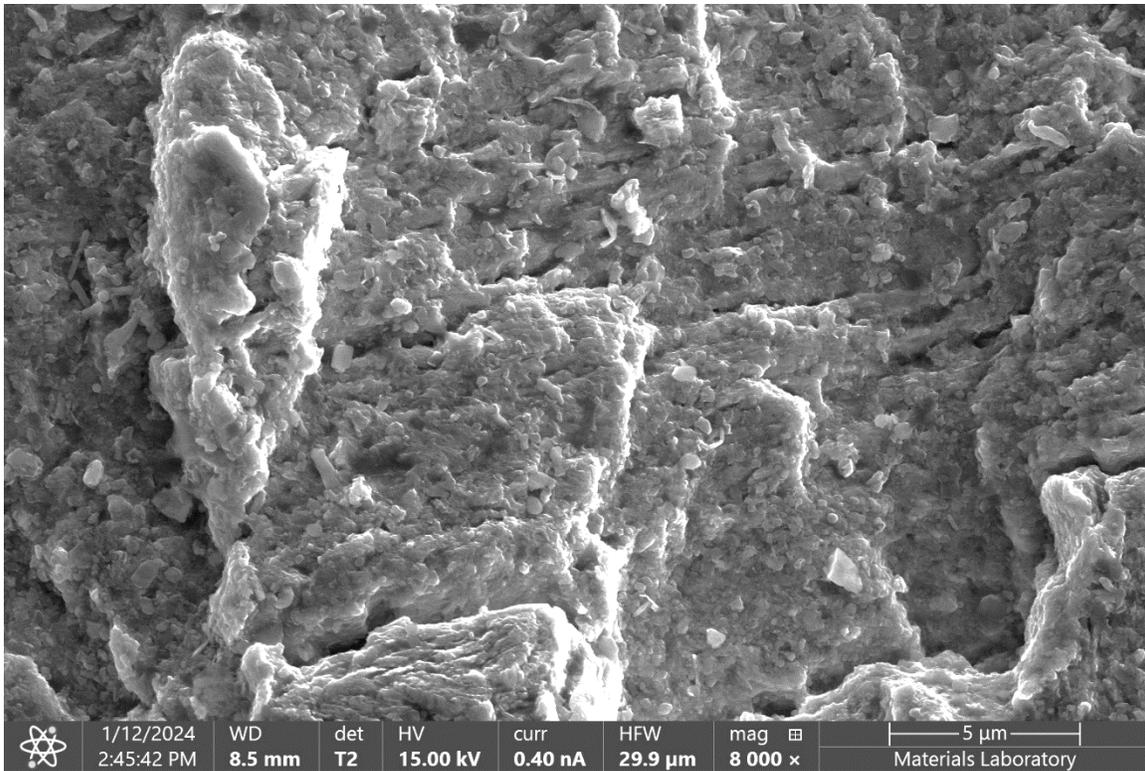
Figure 19. SE micrograph of the boxed area in **Figure 18**, showing fatigue striations.

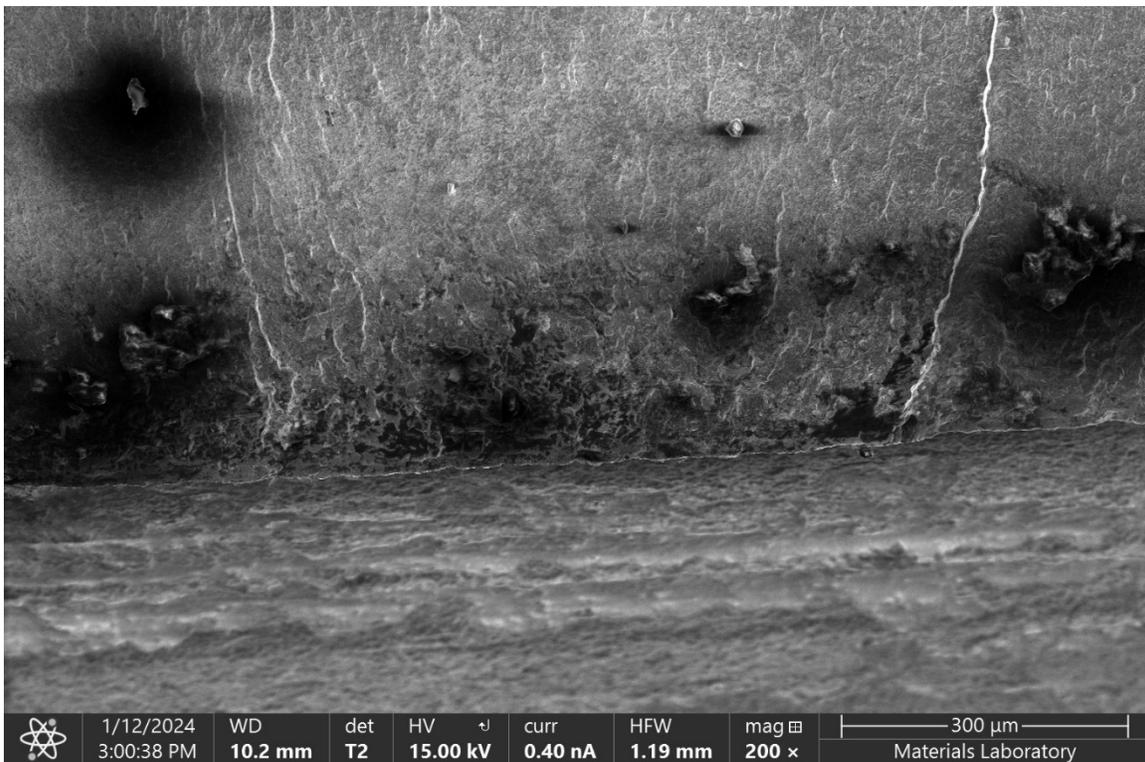
Figure 20. SE micrograph of a the crack initiation area of tooth one, along the edge shown in **Figure 16**.

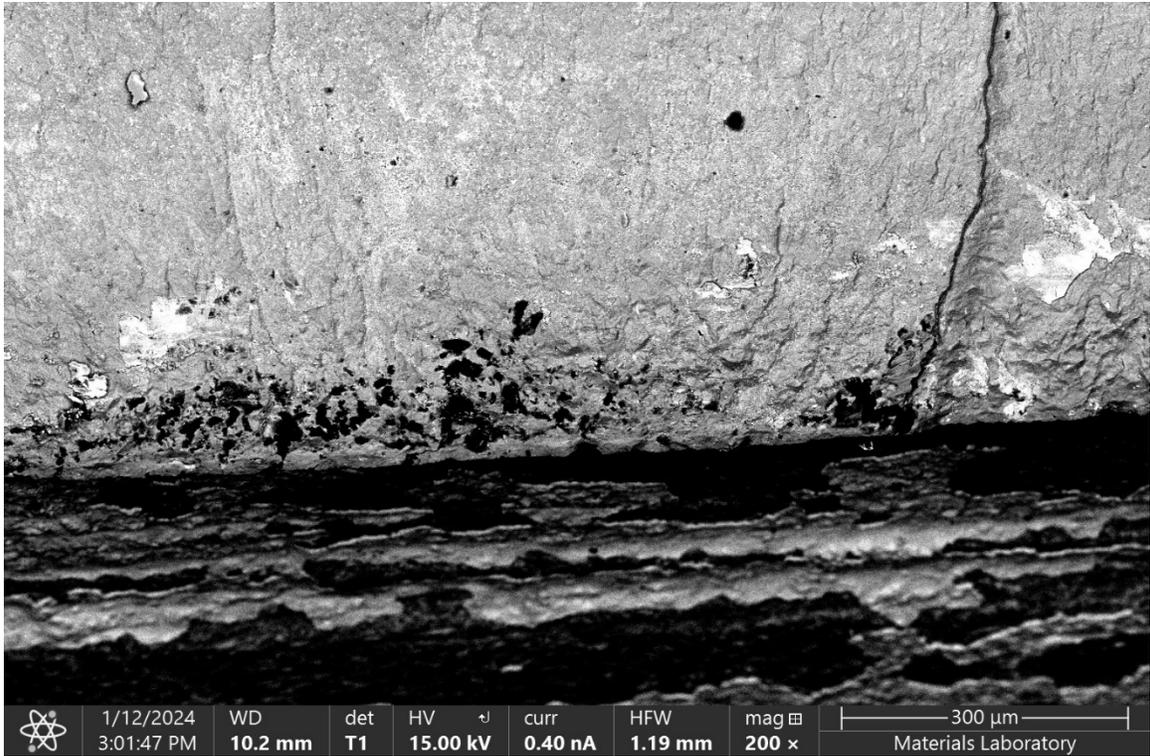
surface contamination (dark colored) near the initiation region edge.² A closer view of the leading crack initiation site is shown in Figure 22. This area was absent of material or mechanical defects but exhibited faint striations emanating from the edge. Another initiation site shown in Figure 23 revealed similar features.

Figure 21. BE micrograph of the initiation region in **Figure 20**.

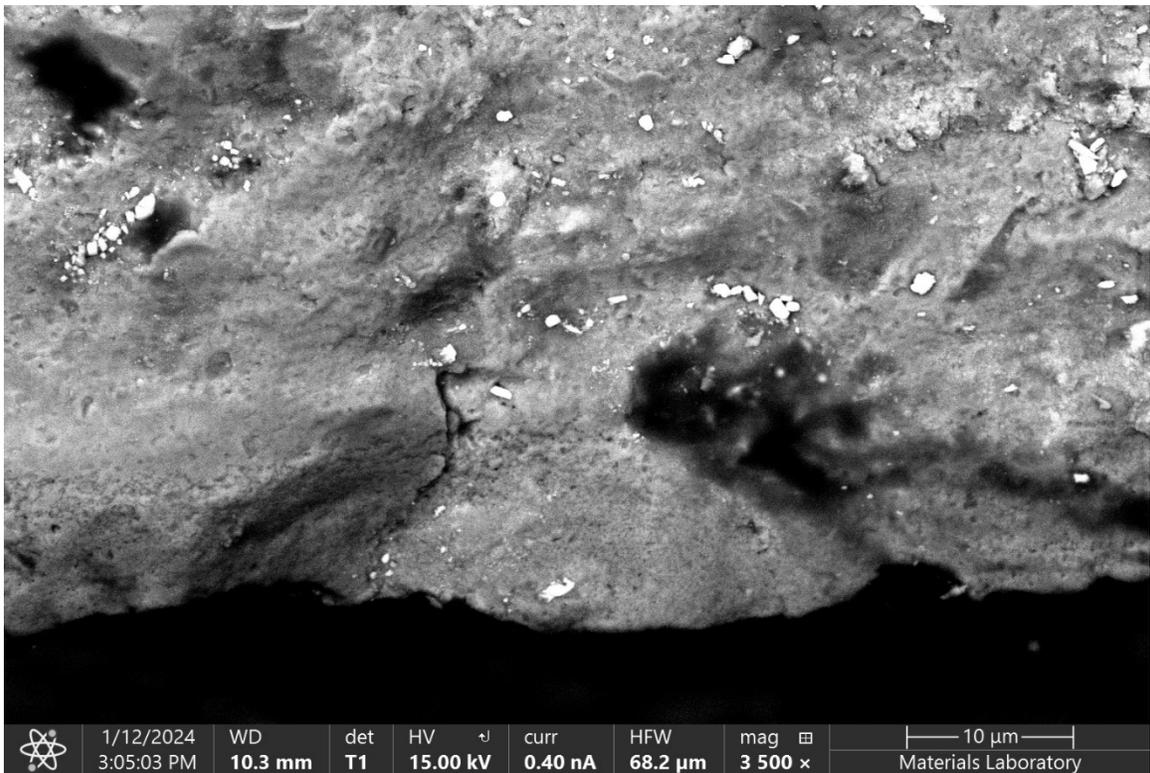
Figure 22. BE micrograph of one of the crack initiation sites in **Figure 21**.

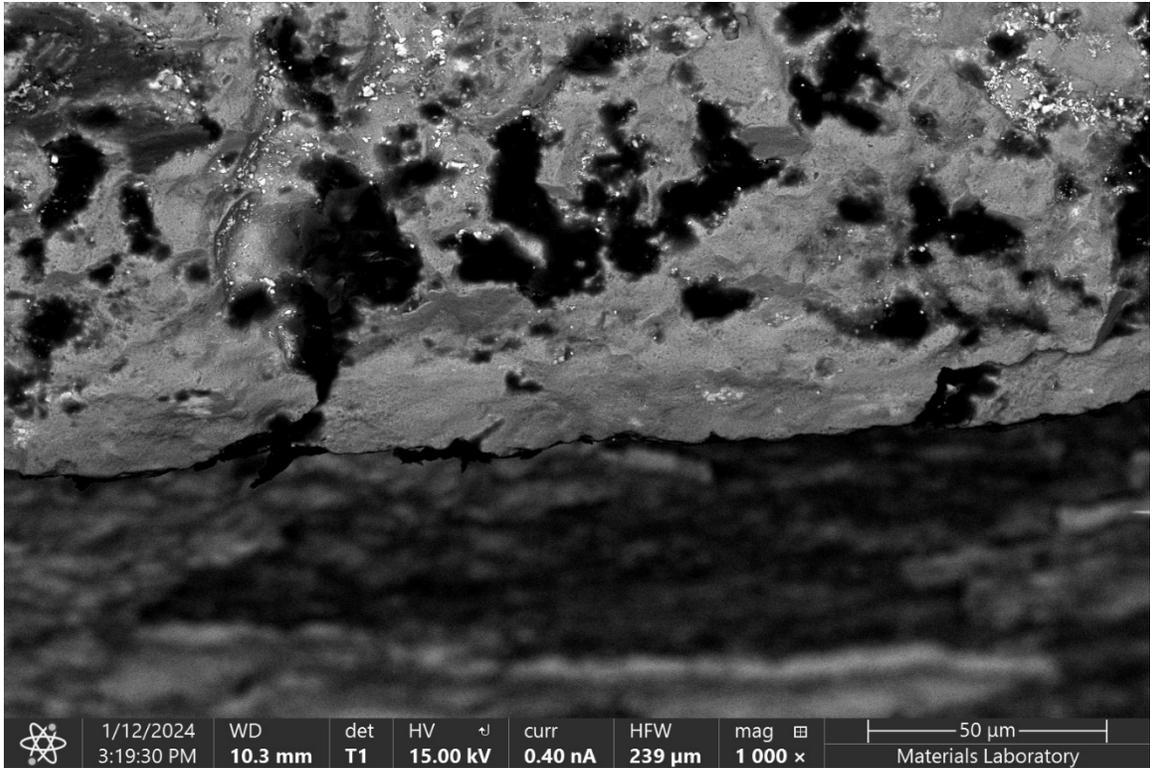
Figure 23. BE micrograph of another crack initiation site in **Figure 21**.
