National Transportation Safety Board

CEN23LA062

MATERIALS LABORATORY

Factual Report 24-003

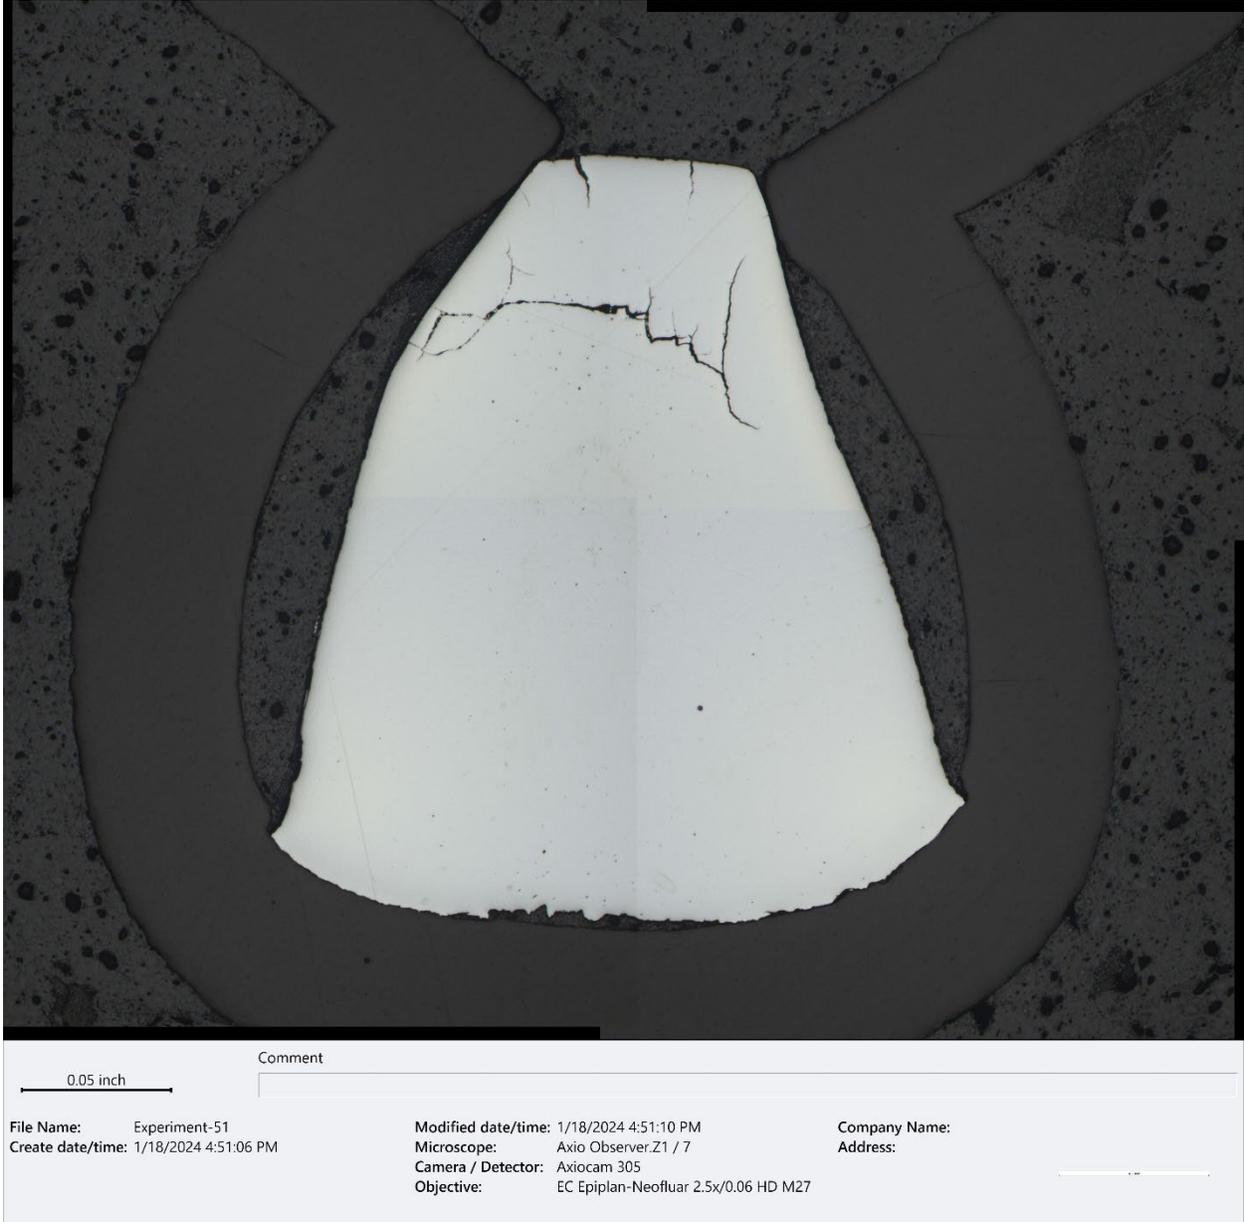
The fractured #2 tooth was mounted and polished in cross-section for metallographic examination. Figure 24 shows a montage of the tooth in its polished condition. The fatigue fracture surface comprises the bottom surface facing downward in the image. The tooth's interior exhibited branched cracking, as shown closer to the top land. The geometry of the tooth along the fracture surface shows an upward curve consistent with the fillet radii of the gear. A closer examination of the corners near the fillet radius did not exhibit corrosion pits, nonmetallic inclusions, or mechanical defects.

Figure 24. Optical bright field (BF) micrograph of a cross-section of the second fractured tooth, with the fracture surface on the bottom (~25X, as-polished, montage).

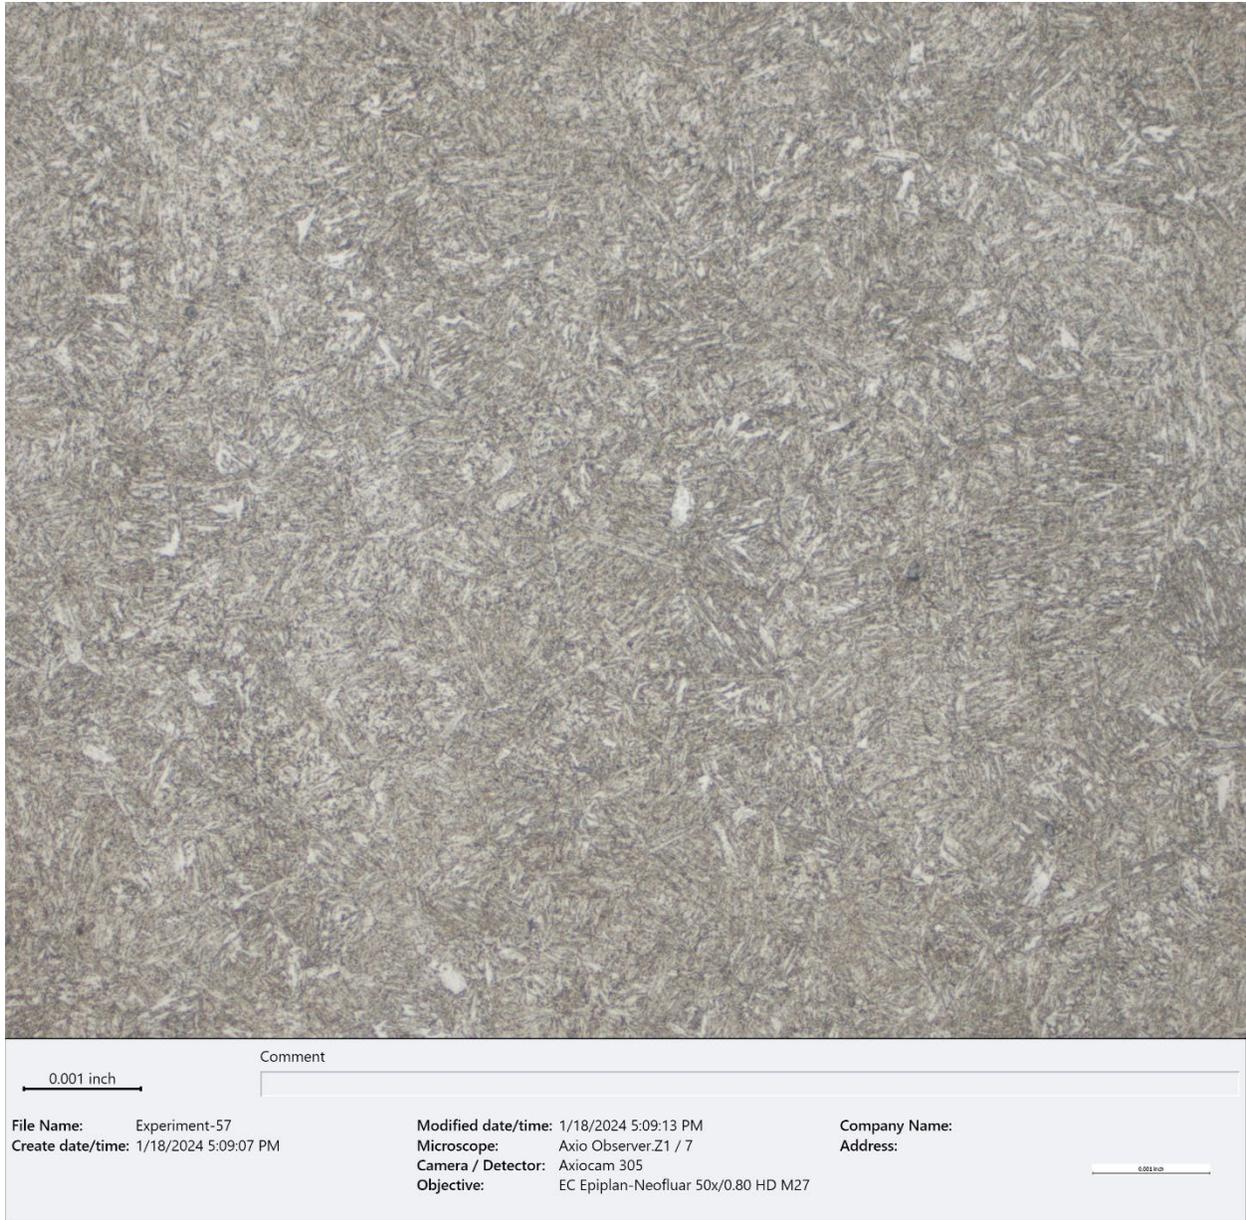
The etched view of the tooth revealed the microstructure of the tooth, which exhibited a differing structure along the surface, consistent with a case hardening. Figure 25 shows a typical area of the microstructure in the core, which was consistent with tempered martensite. Figure 26 shows the surface, which exhibited a white surface layer and a darker subsurface.

Figure 25. BF optical micrograph of a typical area of the core of the fractured tooth in Figure 24 (~500X, etched 2% Nital).

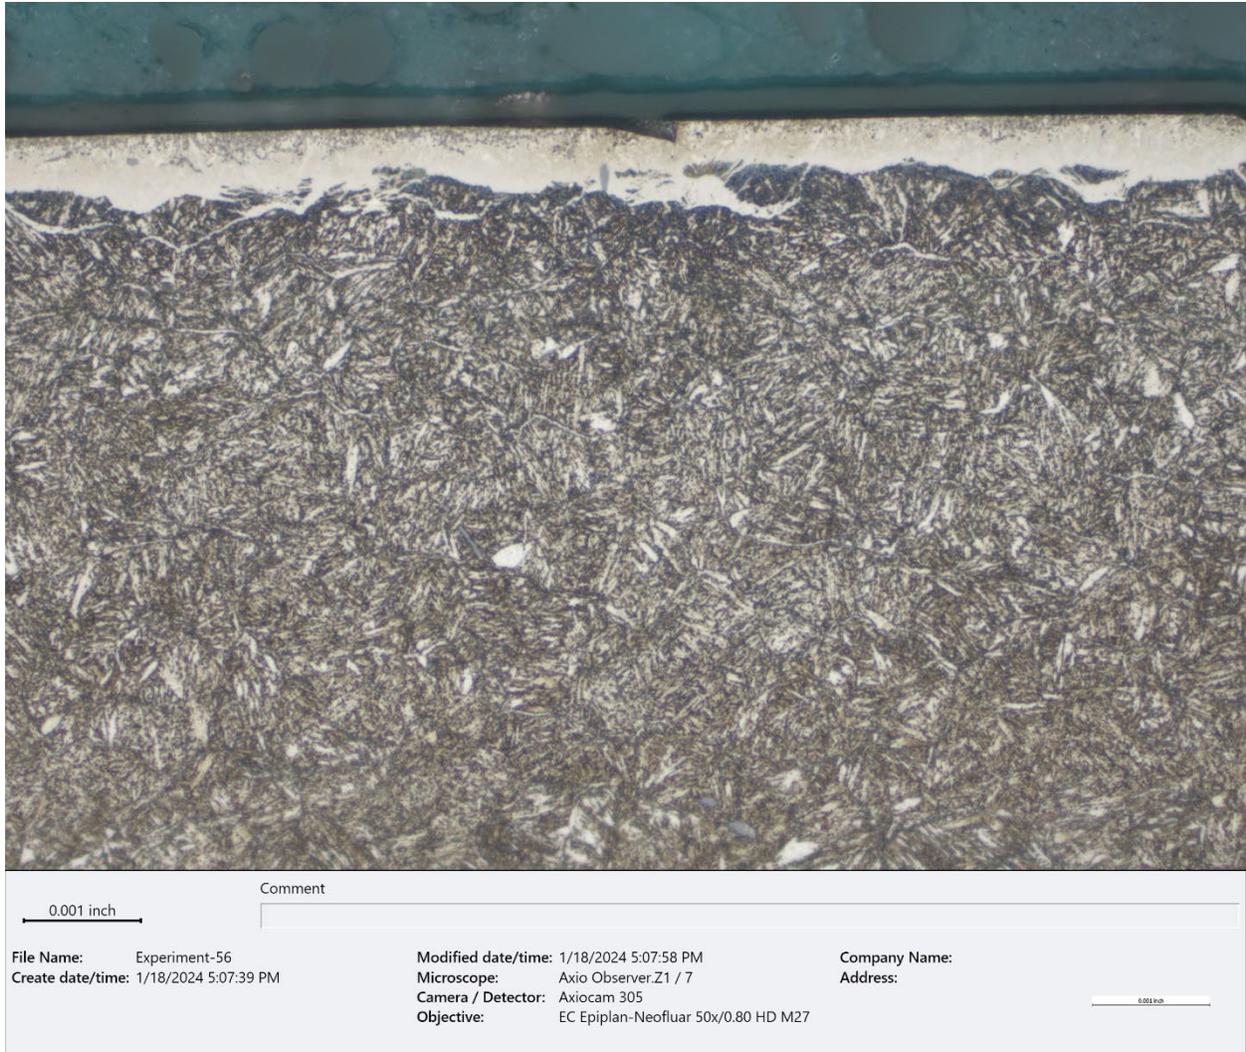
Figure 26. BF optical micrograph of a typical area of the tooth surface (flank), showing a contrasting surface layer (~500X, etched 2% Nital).

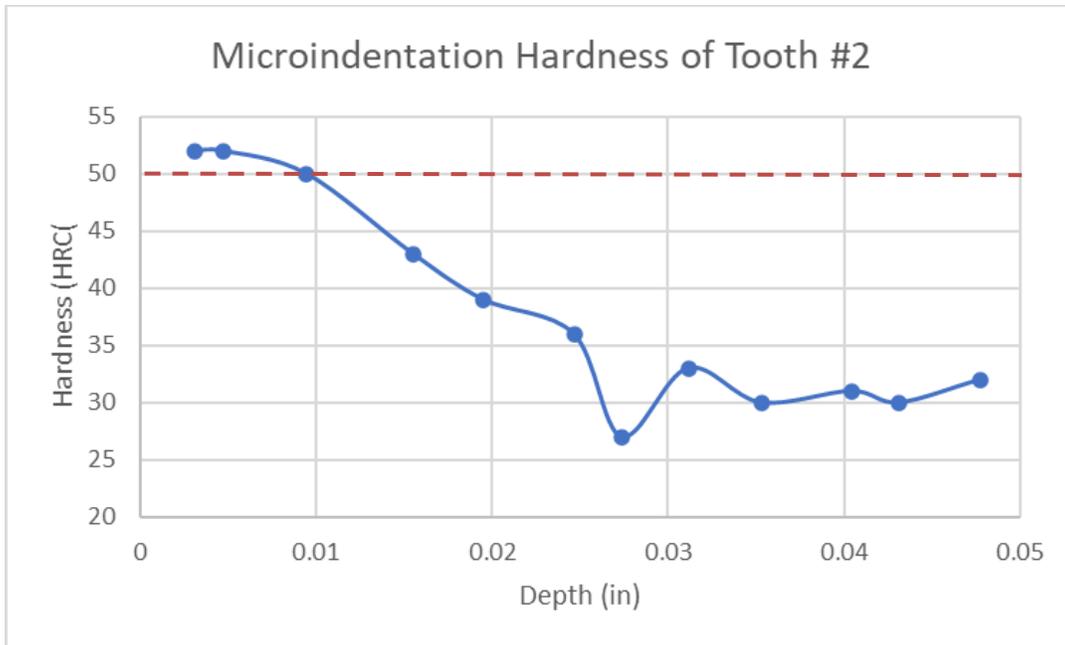
The tooth cross-section was examined using energy-dispersive X-ray spectroscopy (EDS). The composition of the gear was consistent with alloy steel. The hardness was examined using a microindentation hardness technique per ASTM E384.³ Sampled from the surface to the core interior, the hardness decreased as the depth of hardness sampling increased. Figure 27 shows a chart of the hardness data in HRC converted from HV₅₀₀.⁴ The surface hardness exceeded 50 HRC to a depth of about 0.01 inches. The core hardness averaged 31 HRC. These data were typical of a quench and tempered alloy steel with a surface hardening treatment.

Figure 27. Chart of the microindentation hardness of tooth #2 from a flank surface inward, plotted against depth (in inches). The orange dashed line represents the minimum case depth hardness of 50 HRC.
