Alaska Airlines Flight 1282

Left Mid Exit Door Plug Separation in Portland, OR

Docket No.	SA-543
EXHIBIT	
15B

Factual Report 24-007 Appendix A

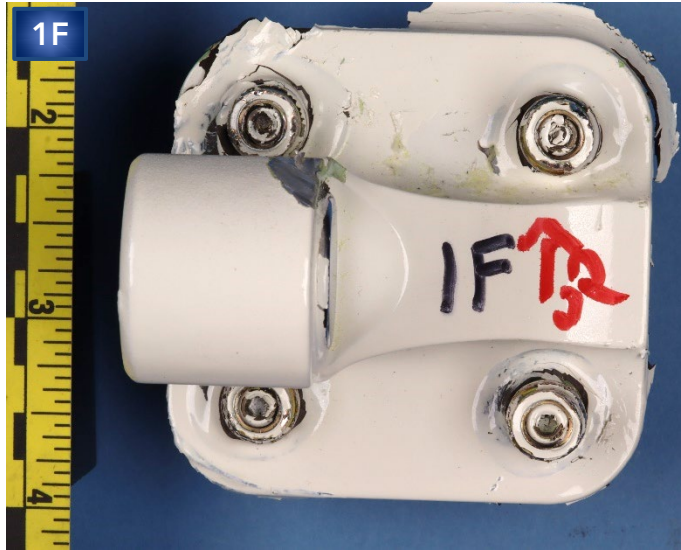
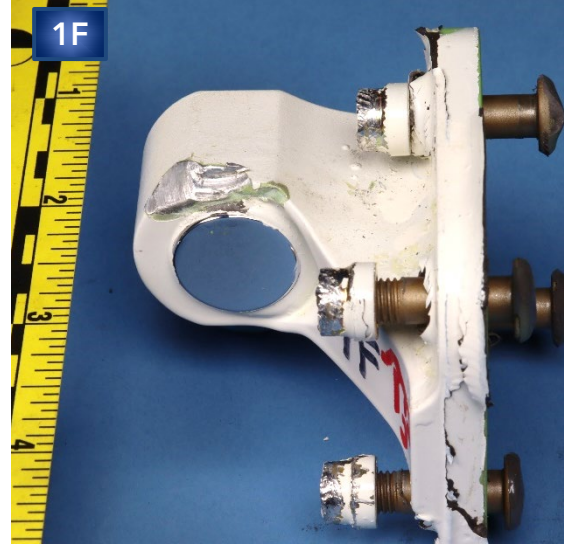
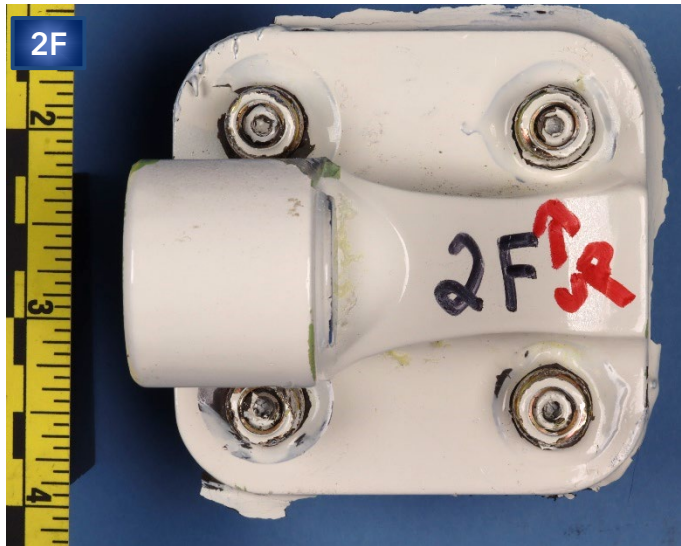
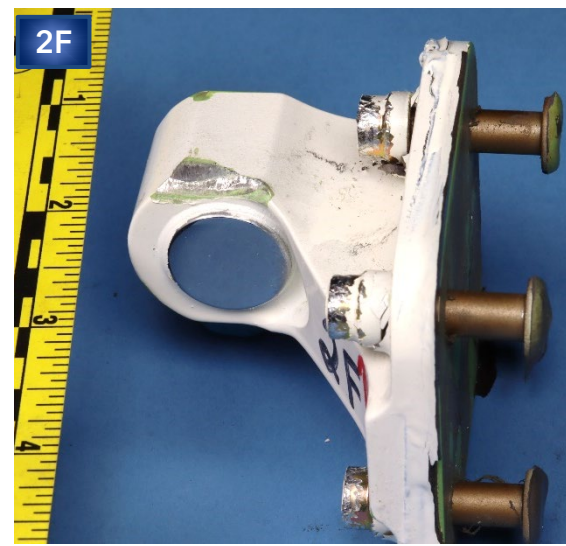
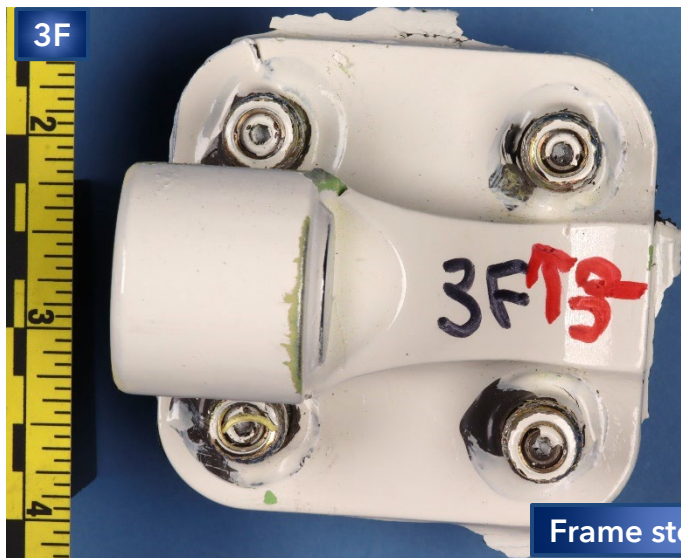
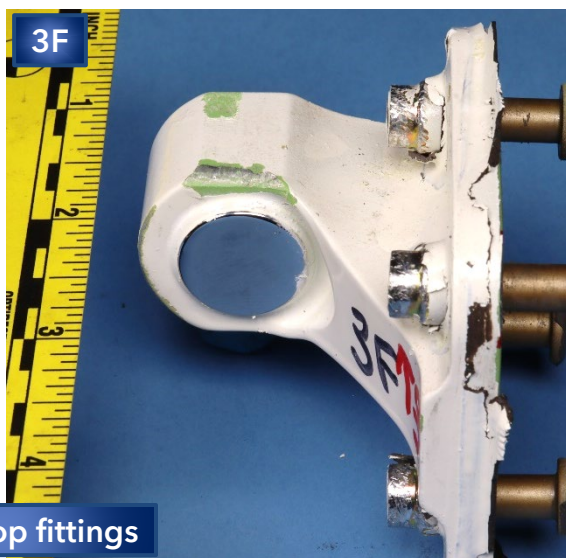
Frame stop fittings

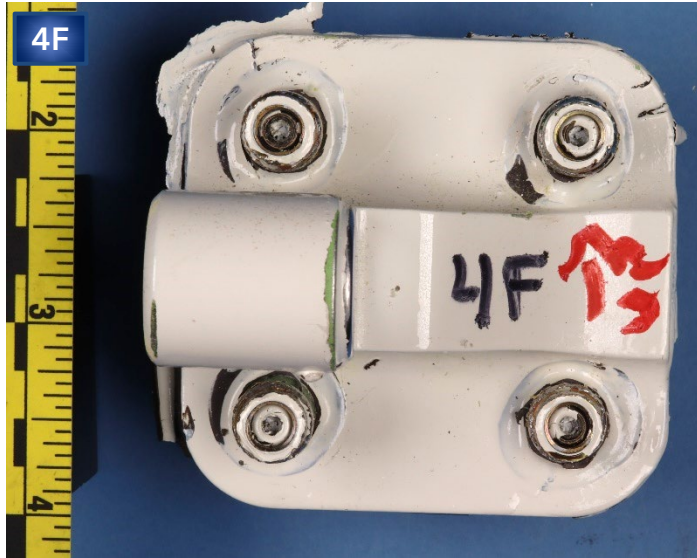
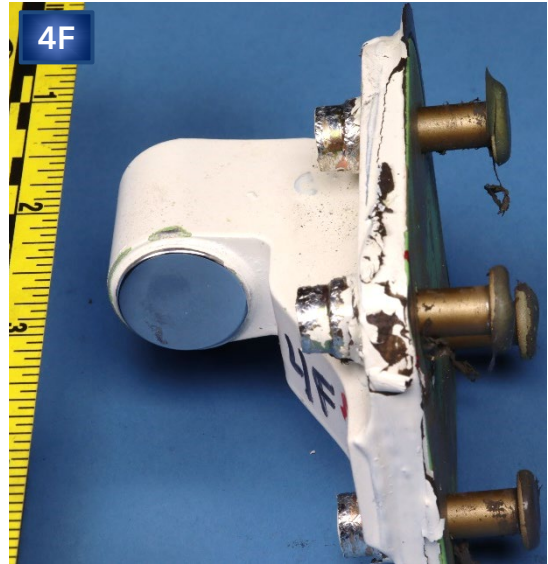
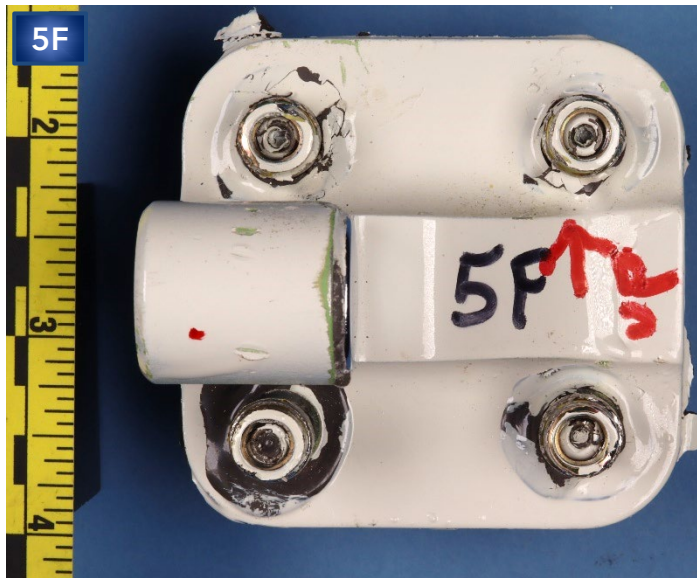
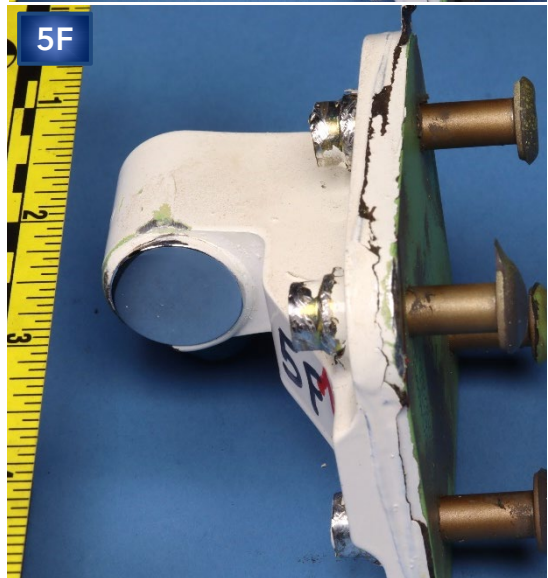
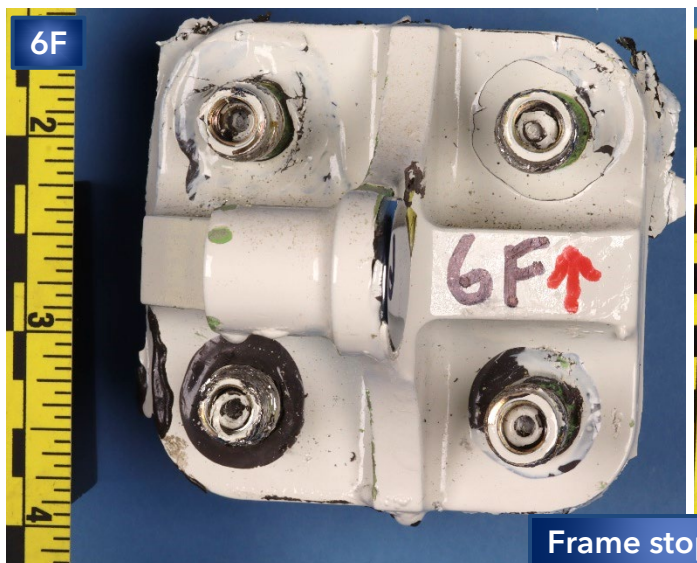
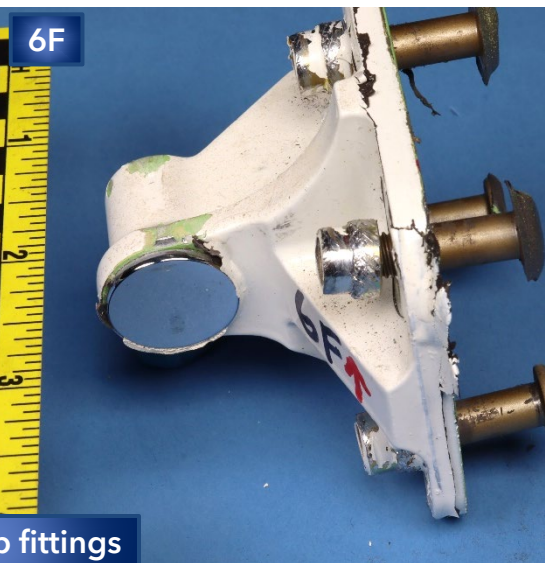
Frame stop fittings

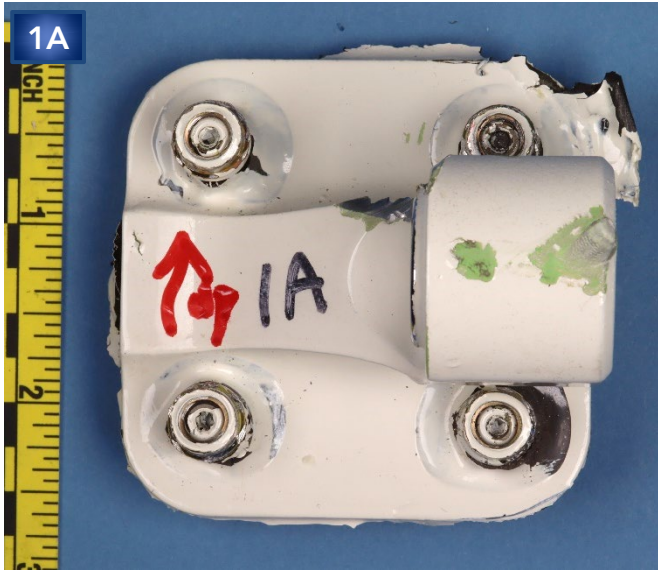
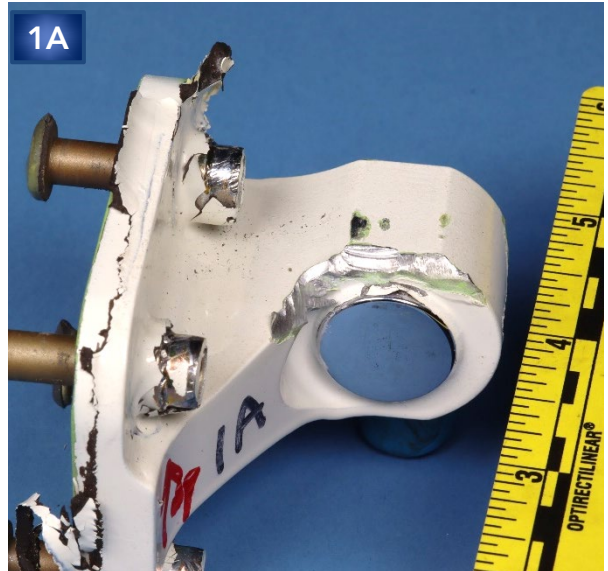
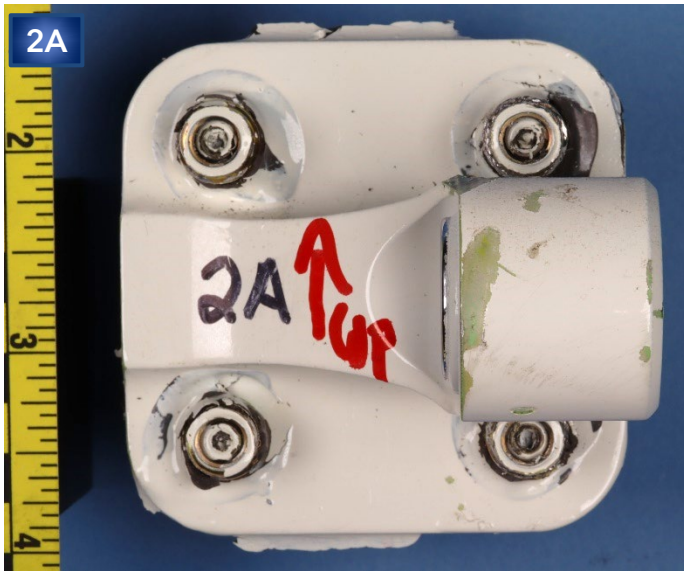
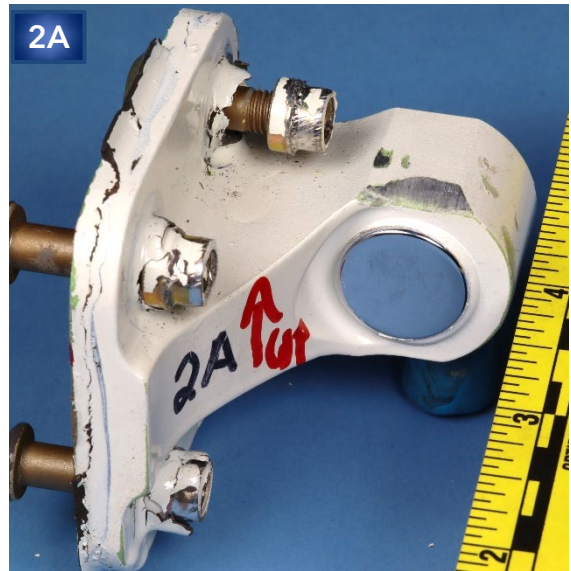
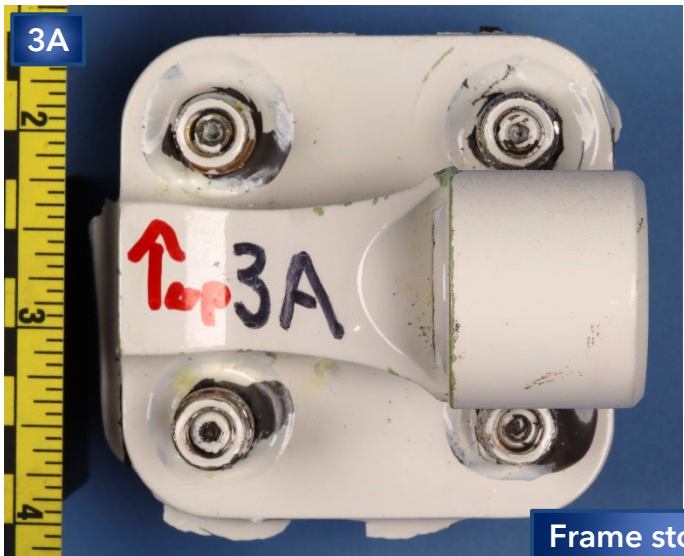
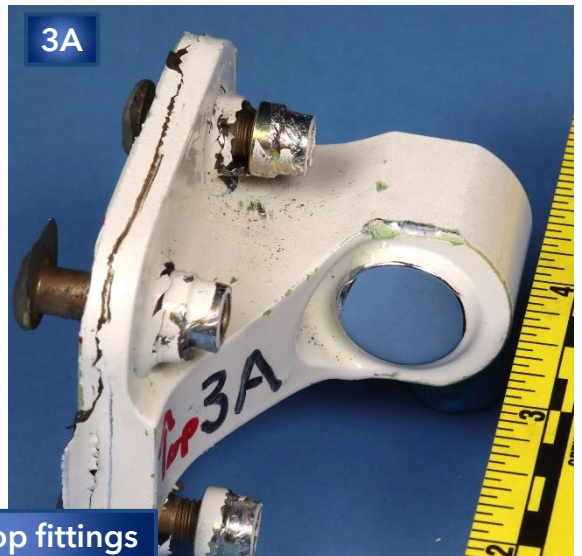
Frame stop fittings

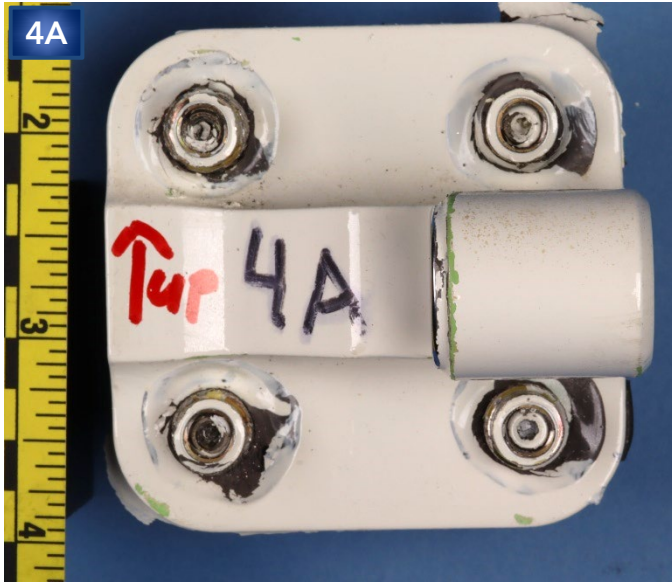
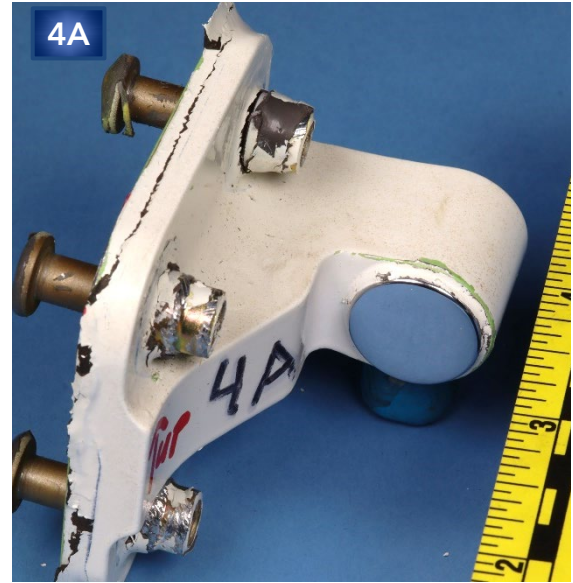
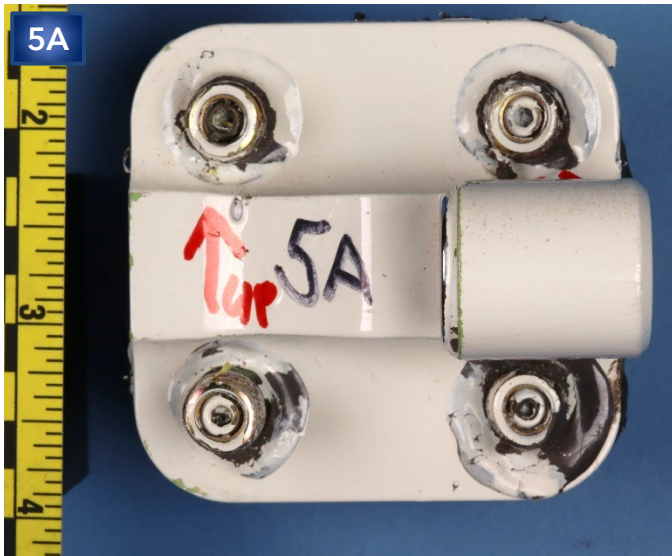
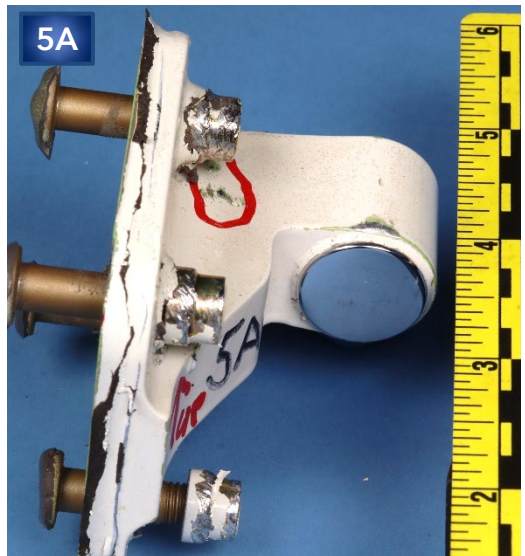
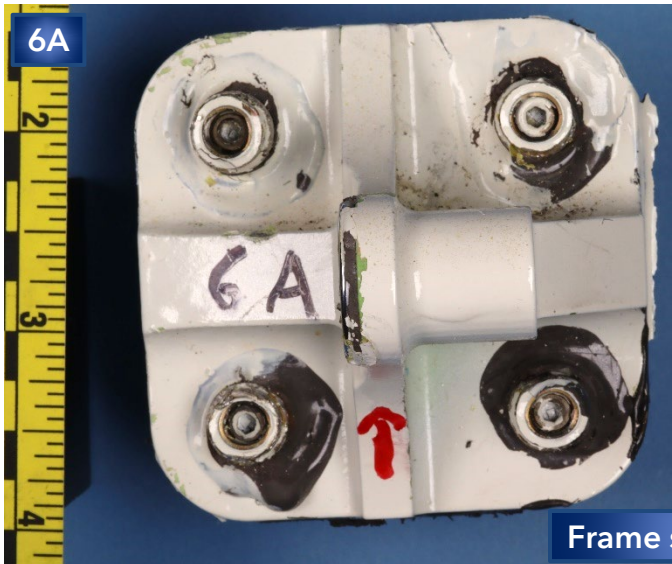
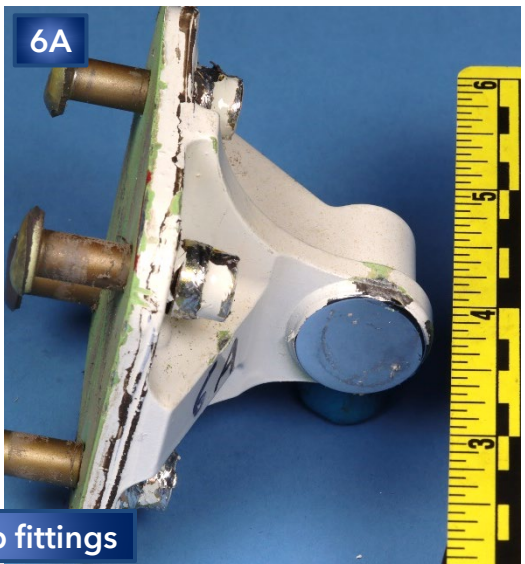
Frame stop fittings

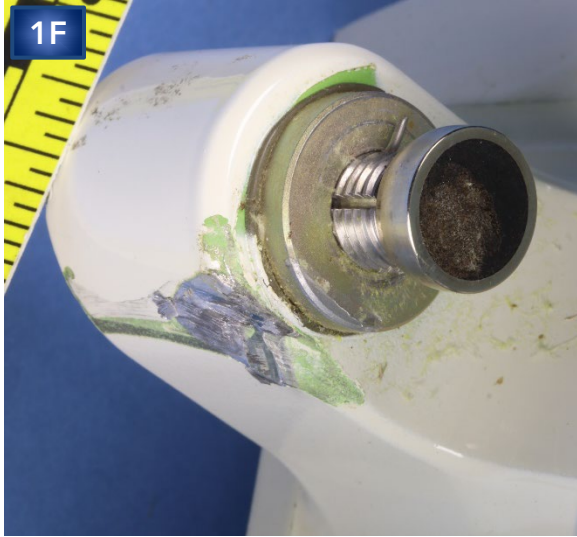
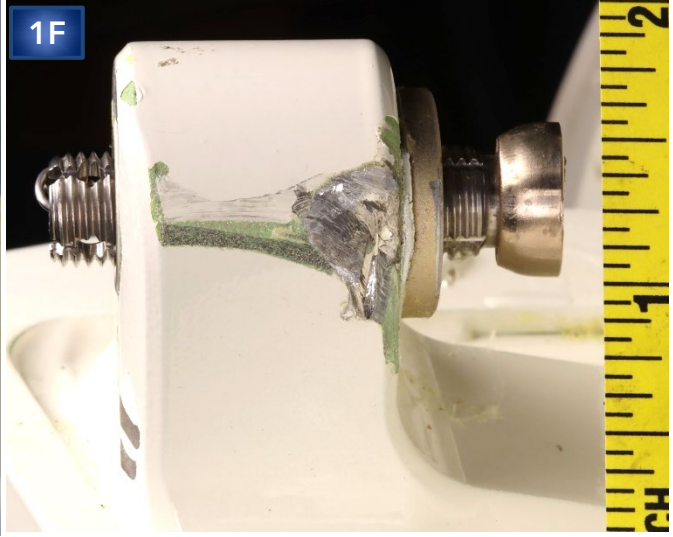
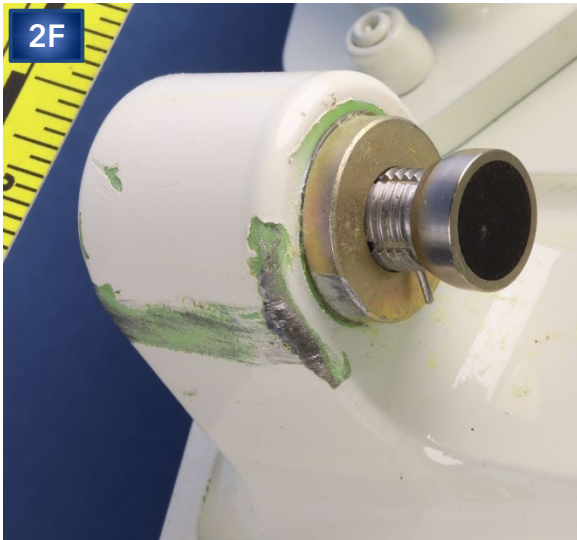
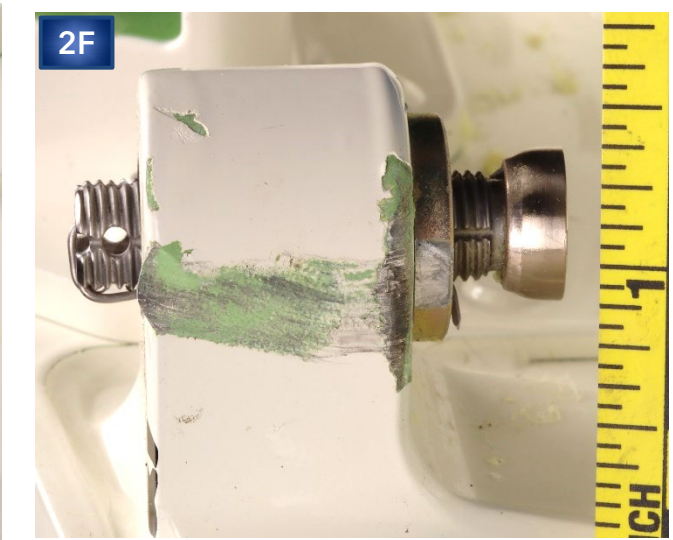
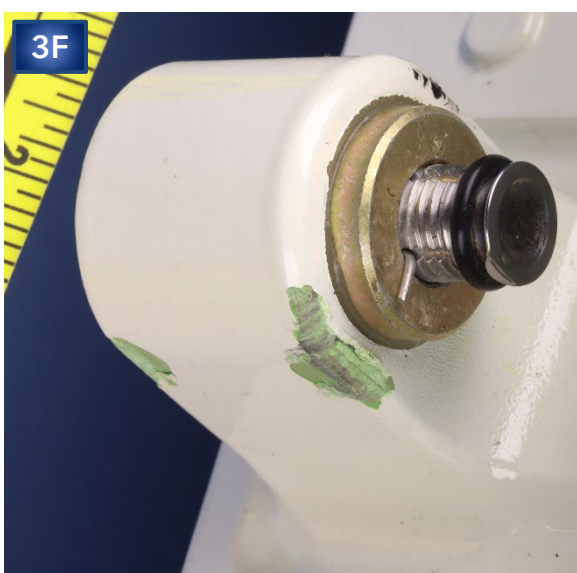
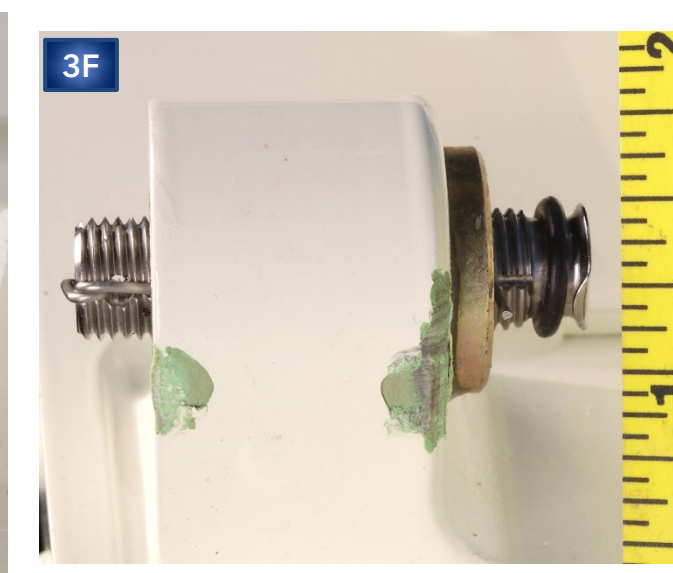
Plug stop fittings

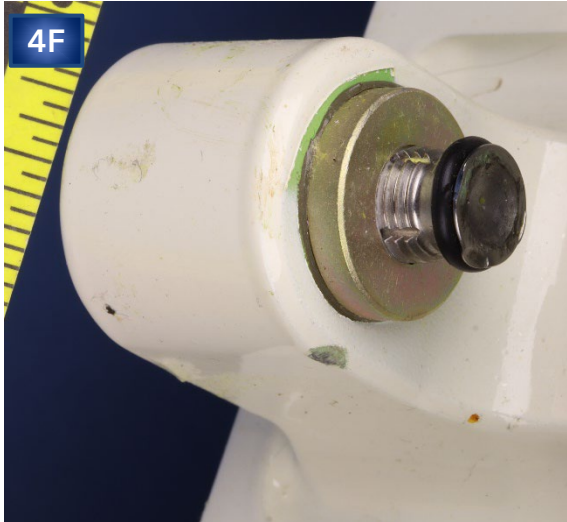
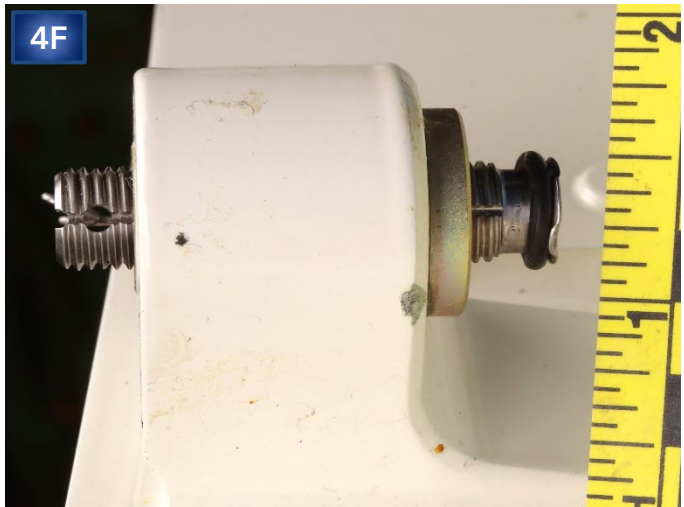
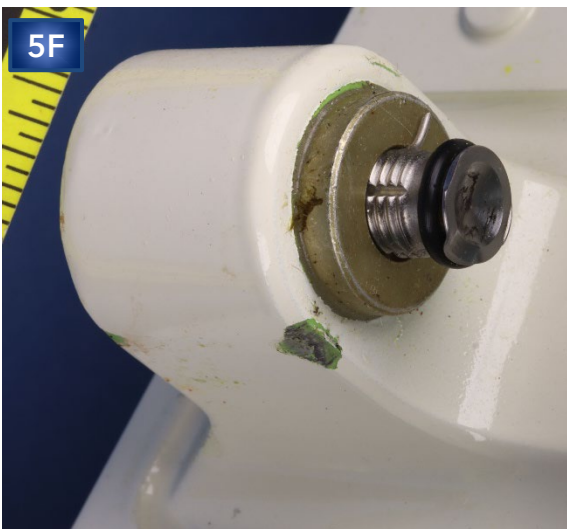
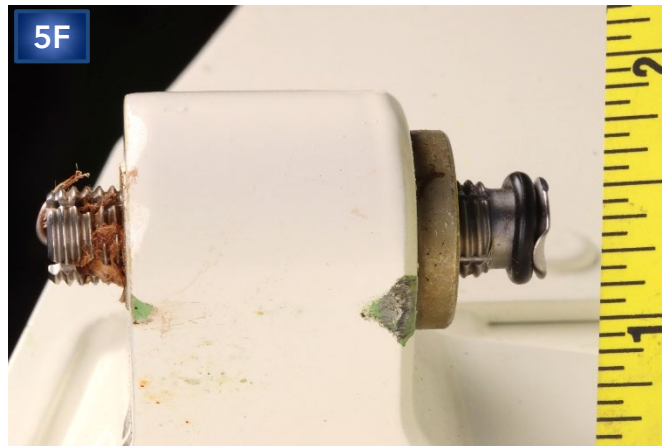
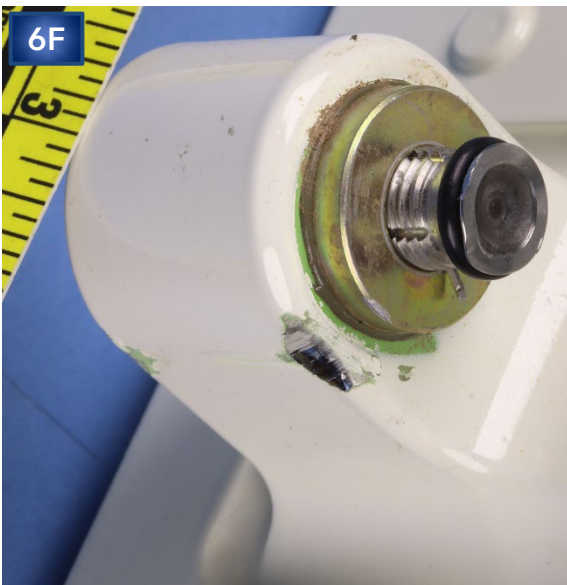
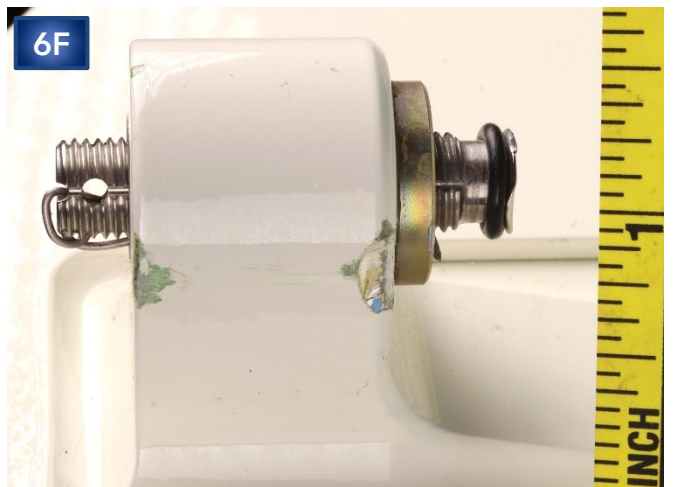
Plug stop fittings

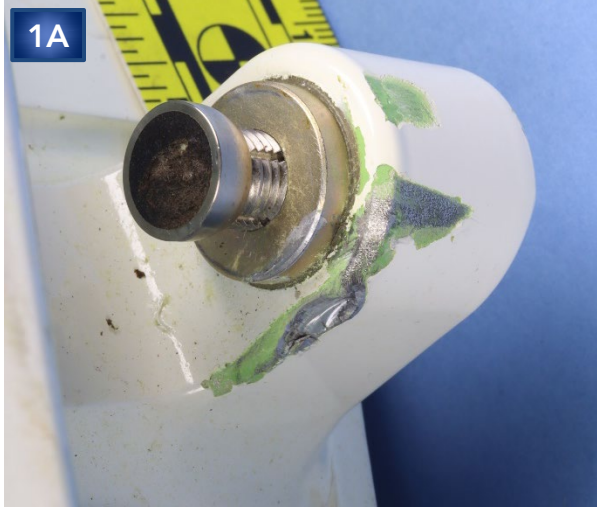
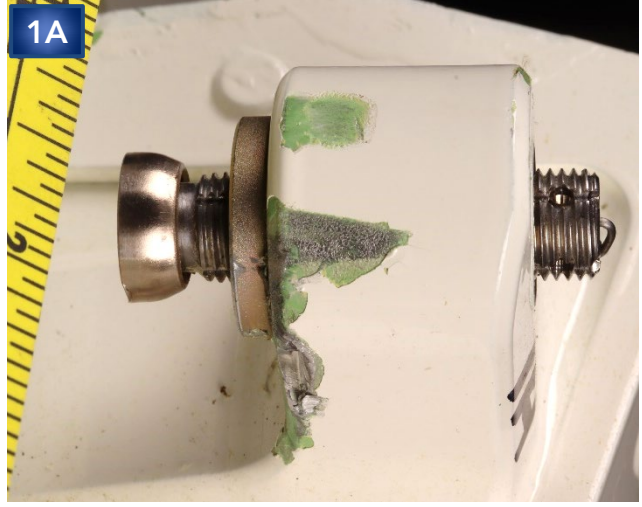
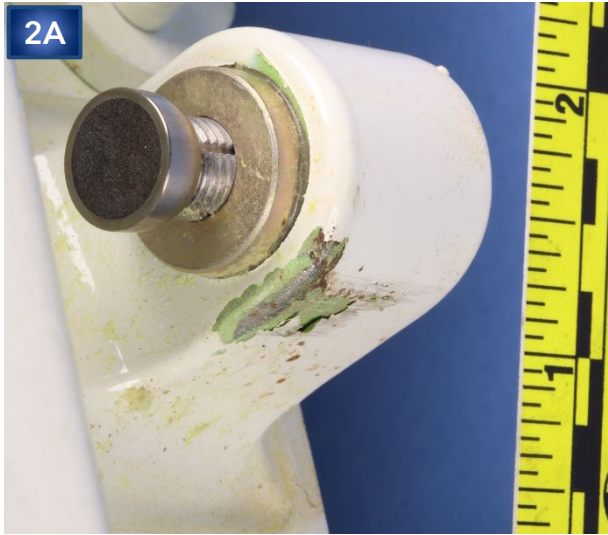
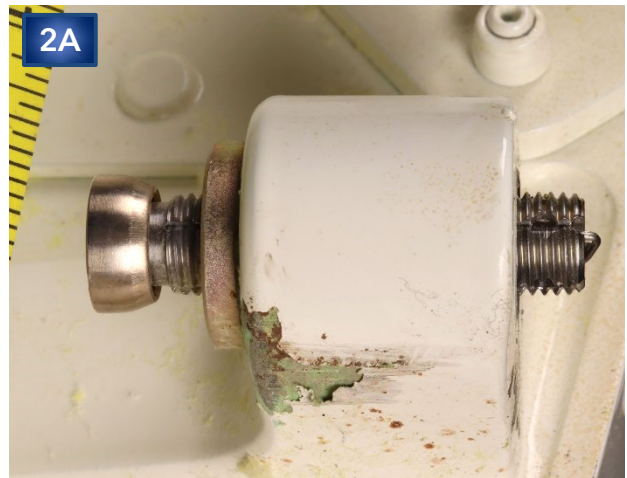
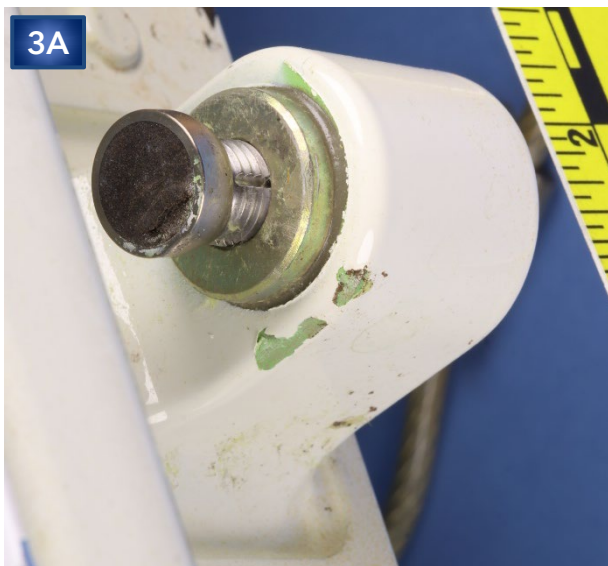
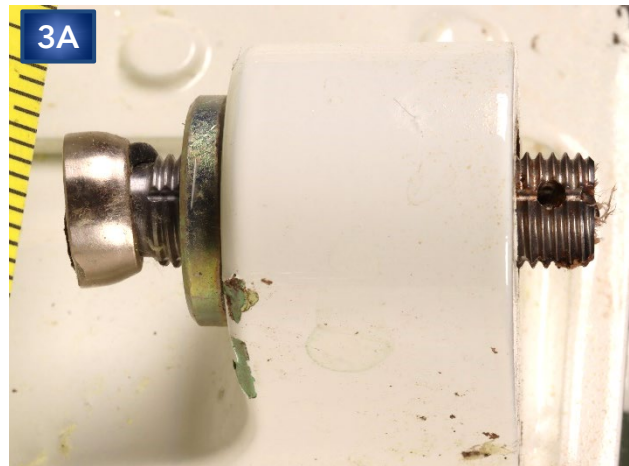
Plug stop fittings

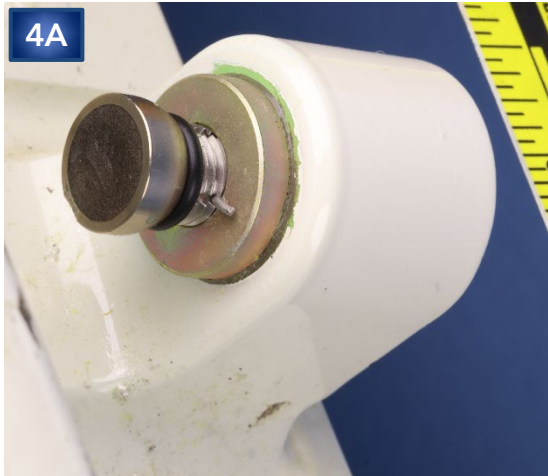
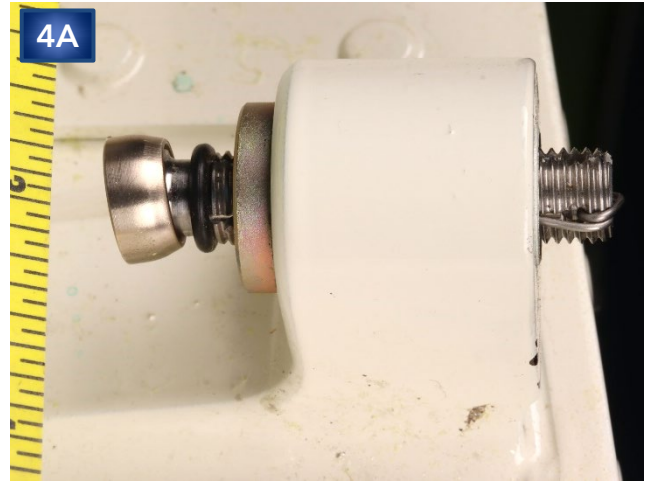
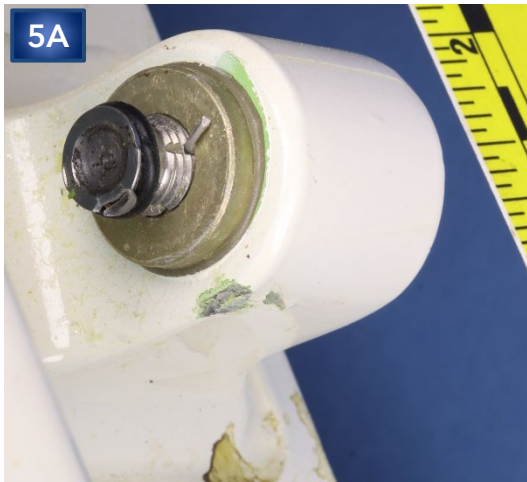
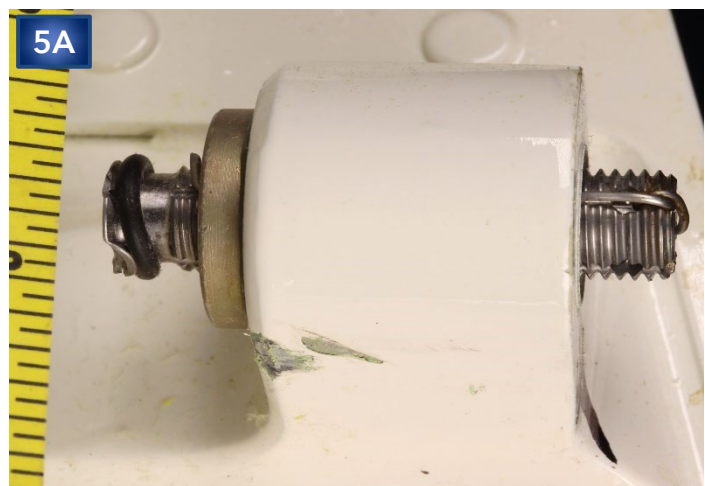
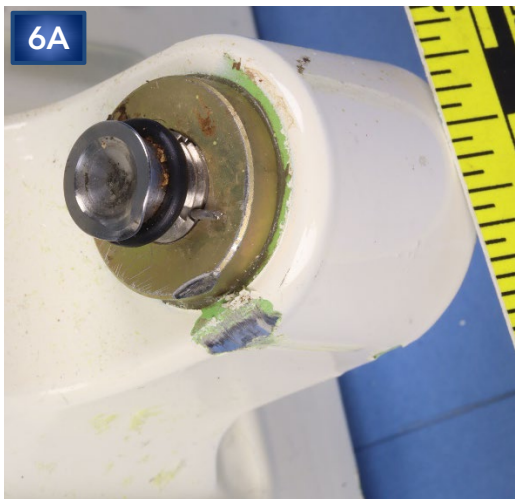
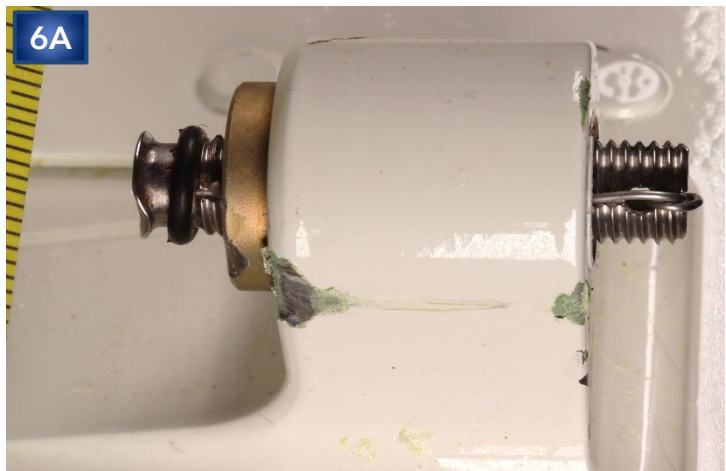
Plug stop fittings

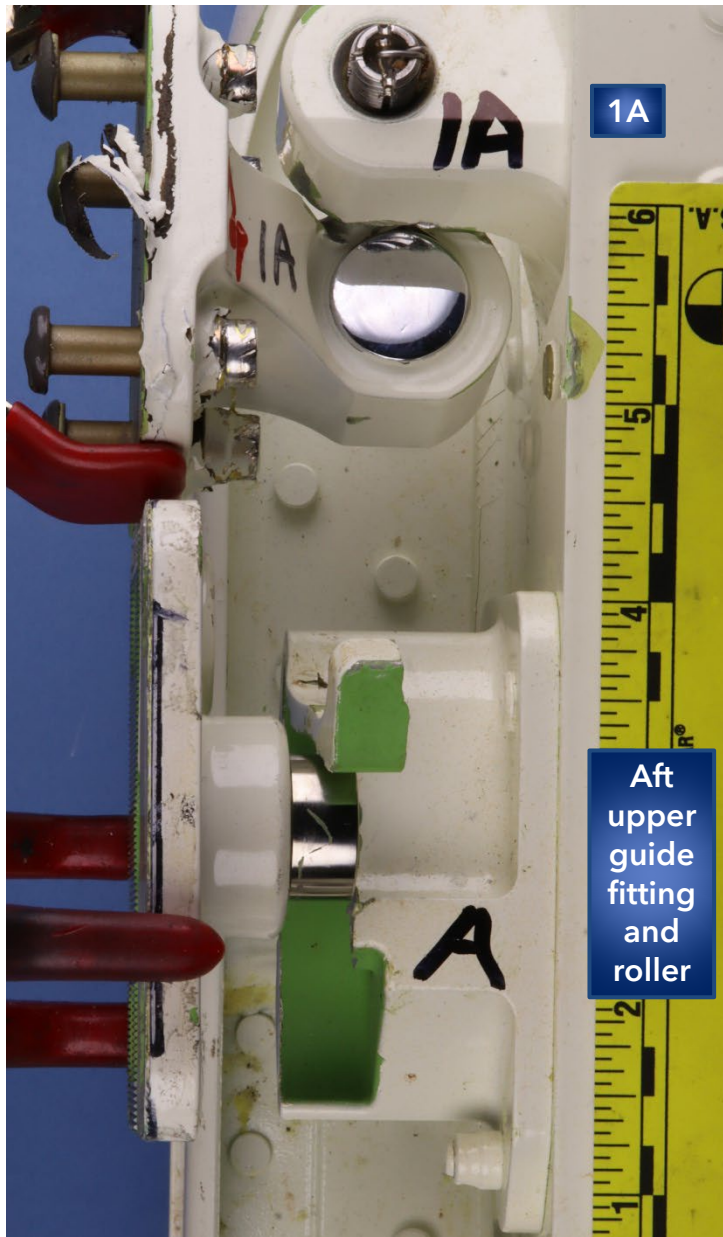
1A

Aft
upper
guide
fitting
and
roller
