Alaska Airlines Flight 1282

Left Mid Exit Door Plug Separation in Portland, OR

**Materials Group Chair's
Factual Report**
(55 Pages)

Factual Report 24-007

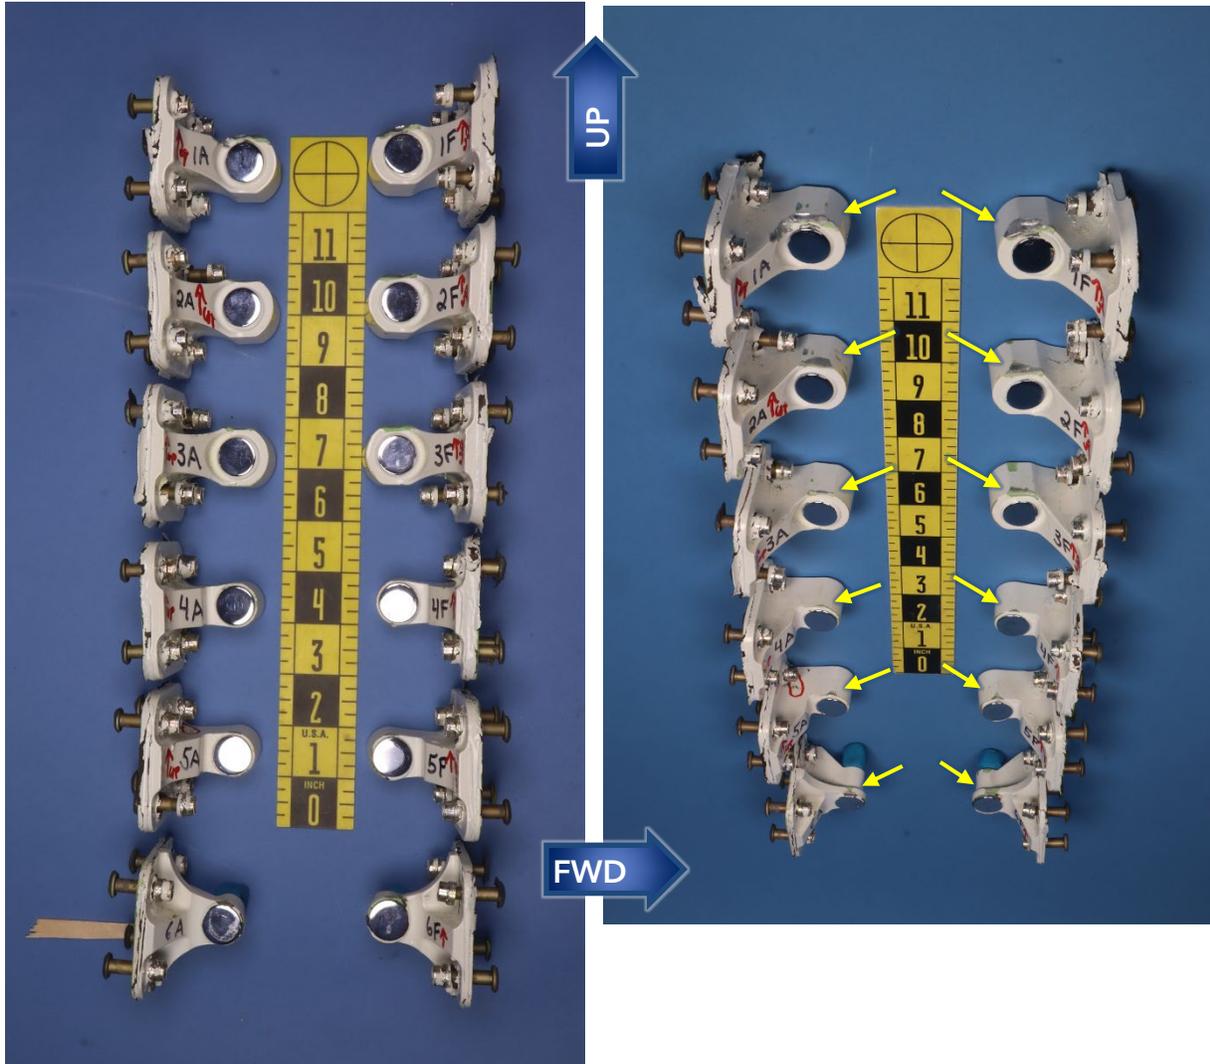
The frame stop fittings generally showed sliding contact damage at the upper sides of the fittings as indicated with unlabeled arrows in the right image in figure 9. Closer views of the damage on frame stop fittings 1A, 1F, 6A, and 6F are shown in figure 10. The damage included missing enamel and primer with deformed metal from sliding contact mostly at the upper inboard corners of the fittings. Additional images of each of the frame stop fittings are presented in Appendix A to this report. The damage was generally more extensive on the upper 6 stops (1A to 3A and 1F to 3F) and was more limited on the remaining stops from the lower portion of the MED opening with stops 4A and 4F showing the least extent of damage. As shown in the left image in figure 9, the size of the fitting around the stop pad was larger on the upper 6 fittings compared to the lower 6 fittings.

Figure 9. Overall views of the frame stop fittings that had been disassembled from the left MED frame on the fuselage. Unlabeled arrows in the right image point to sliding contact damage on the upper sides of the fittings.

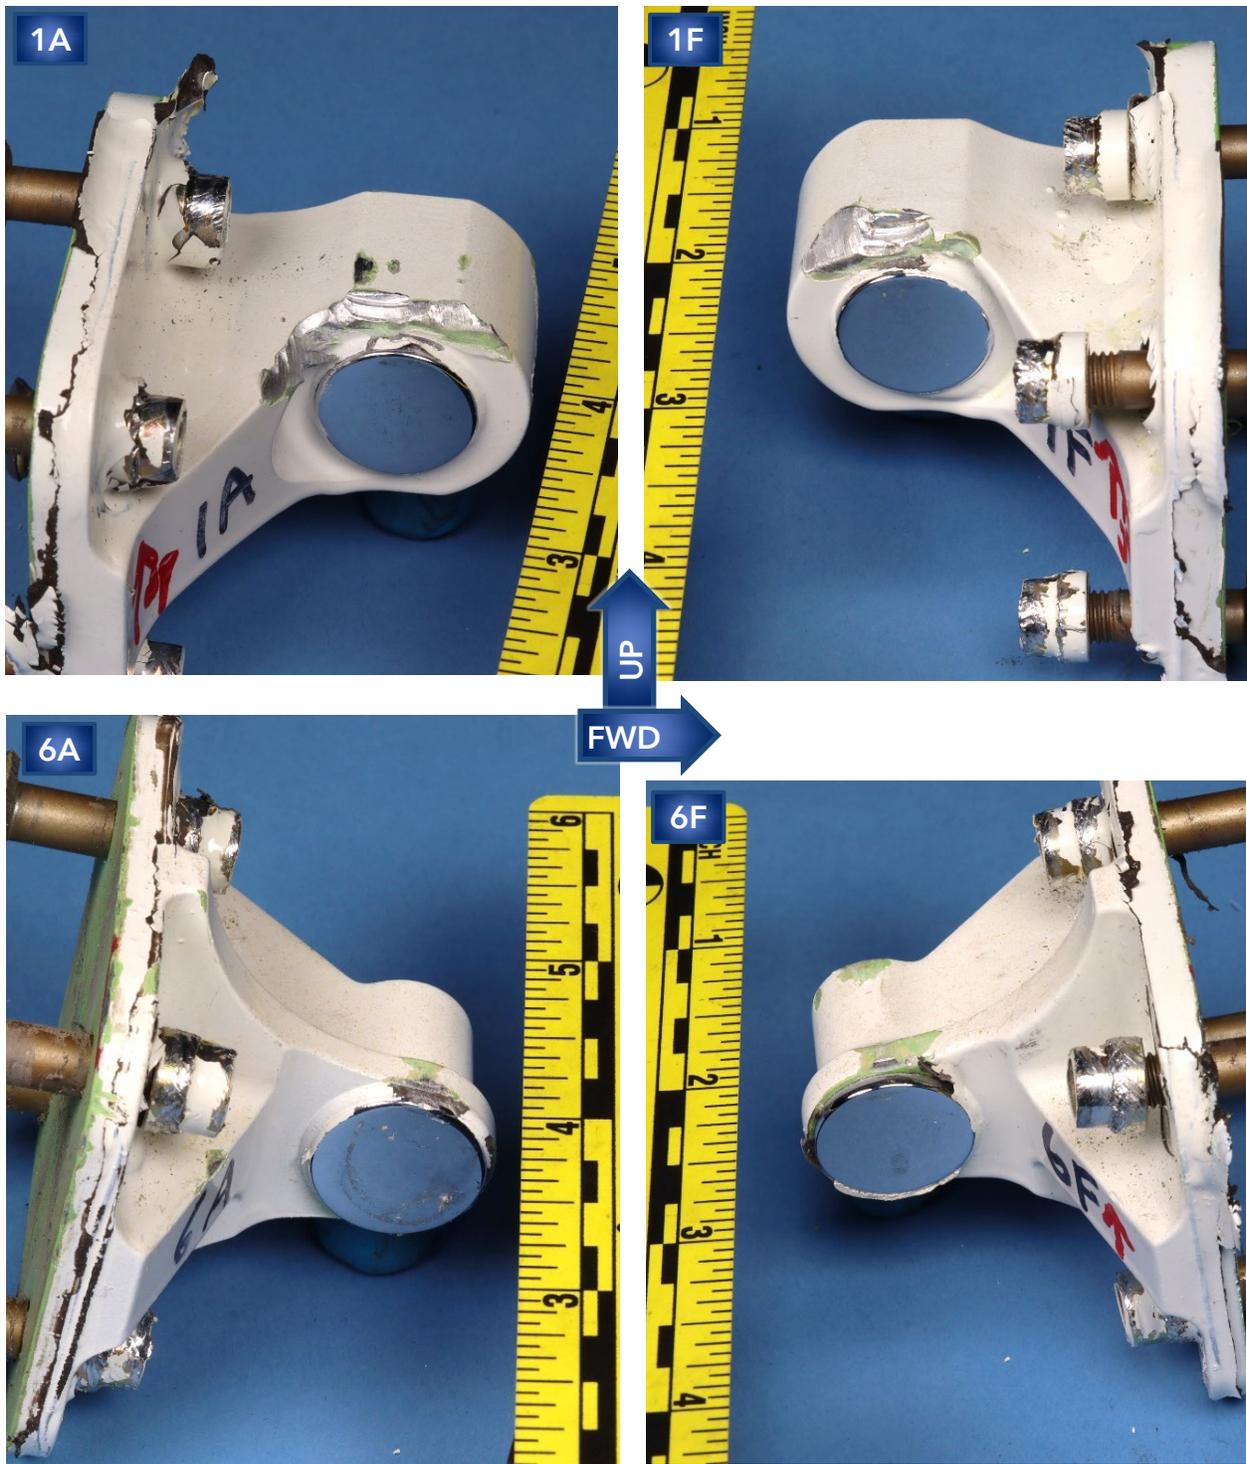
Figure 10. Closer views of damage at the upper sides of frame stop fittings 1F, 1A, 6F, and 6A (as received after disassembly from the left MED frame on the fuselage).

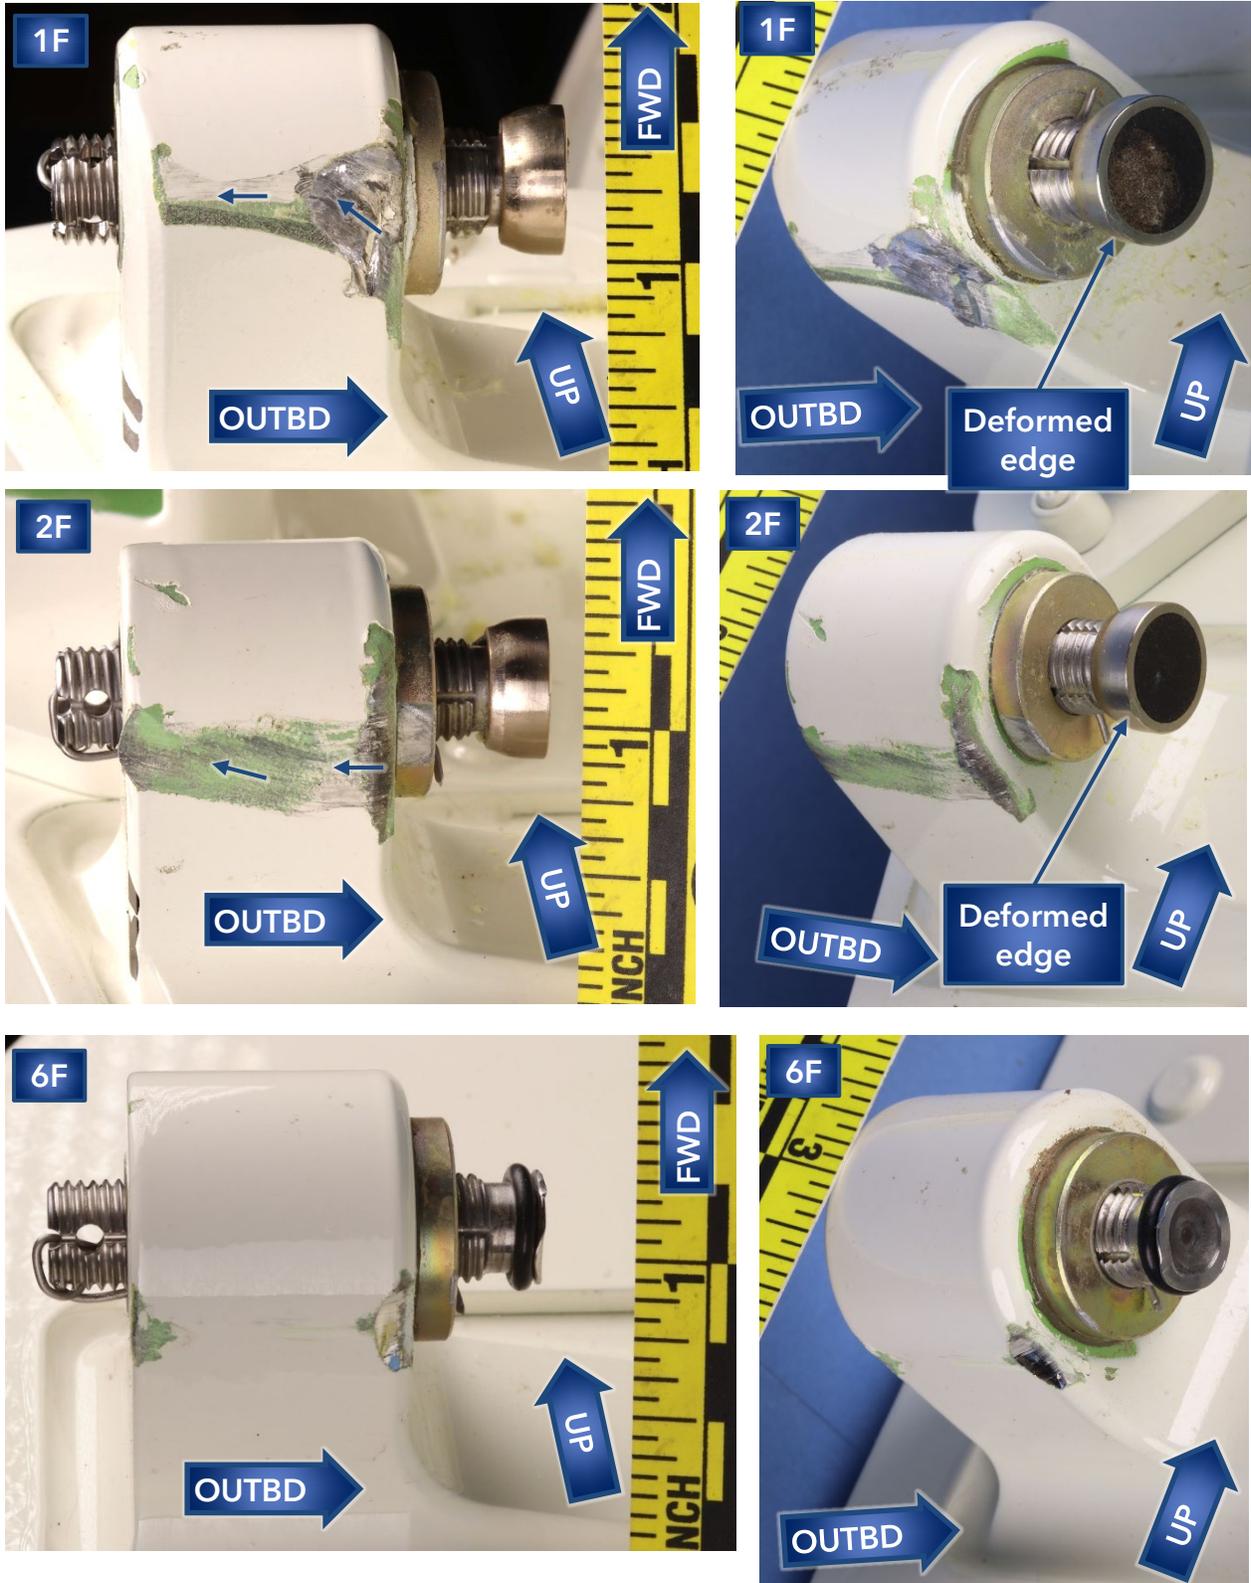
The plug stop fittings were mostly damaged from sliding contact at the lower sides of the fittings as shown in figures 11 and 12. Additional views showing the damage on all 12 plug fittings are presented in Appendix A. The damage included missing enamel and primer with deformed metal from sliding contact that was heaviest at the lower outboard corners of the fittings. The extent of damage was greatest on plug stop fittings 1F, 2F, and 1A. The damage was least on plug stop fitting 4F, where only a small area of metal on the lower inboard corner was exposed on the fitting, and plug stop fitting 4A, which had intact enamel on the entire lower side and outboard corner of the fitting.

Most of the sliding contact marks had linear features that were oriented parallel to the stop pin axis, consistent with the plug moving outboard relative to the contacted feature. However, angled sliding contact marks were observed overlaying the marks parallel to the pin axis on plug stop fittings 1F and 2F. Unlabeled arrows in the upper left and middle left images in figure 11 indicate sliding contact marks that were oriented parallel to the stop pin axis and those oriented at an angle. The angled marks were consistent with the plug displacing outboard and aft relative to the contacted feature.

The angled sliding contact marks that overlaid the marks parallel to the stop pin axis at plug stop fittings 1F and 2F (see figure 11) were consistent with the plug displacing aft after it had displaced outboard while contacting the frame stop fittings. As shown in the upper left image in figure 13, plug stop fitting 1A had marks on the aft side of the fitting that corresponded to contact with parts of the frame fitting aft of the stop pad. At location 1F, the damage to frame stop fitting from contact with the plug stop fitting was also skewed aft of the stop pad as shown in the upper right image in figure 13.

Figure 11. Views of sliding contact and pin head damage on plug stop fittings 1F, 2F, and 6F on the forward side of the left MED plug. Unlabeled arrows in the upper left and middle left images indicate directions of sliding contact.

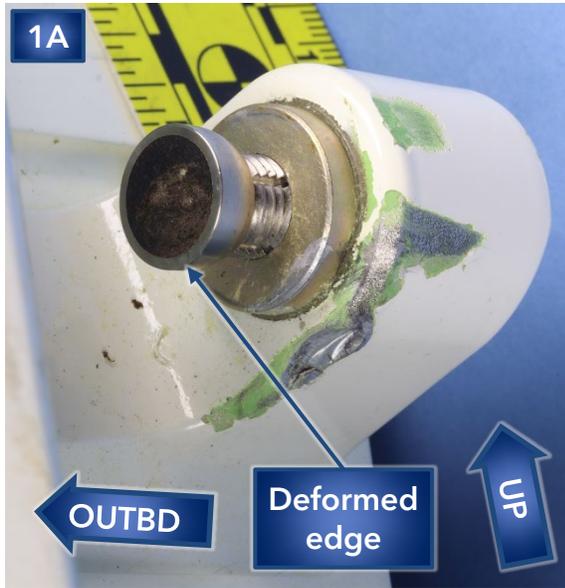
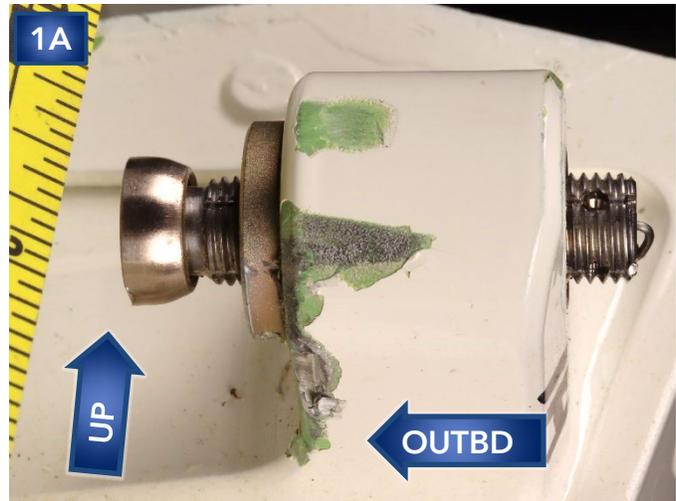
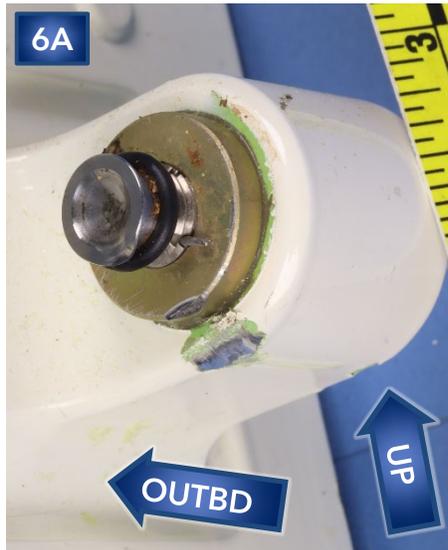
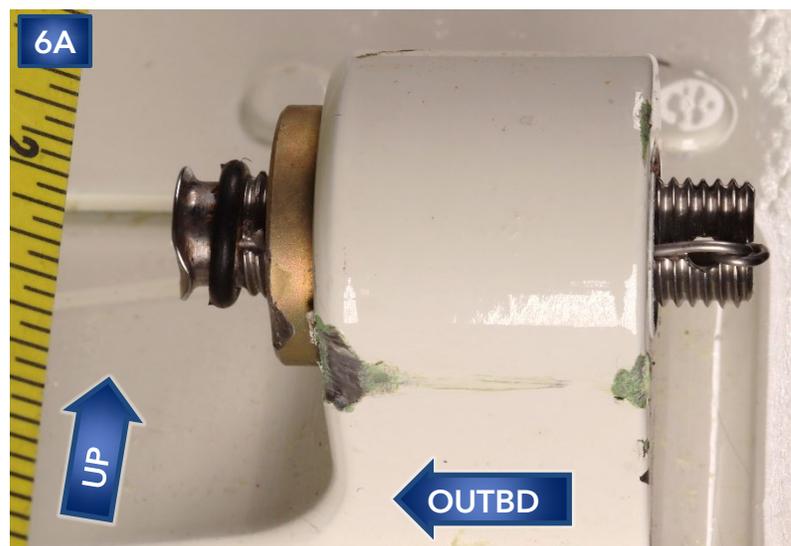
Figure 12. Views of sliding contact and pin head damage on plug stop fittings 1A and 6A on the aft side of the left MED plug.

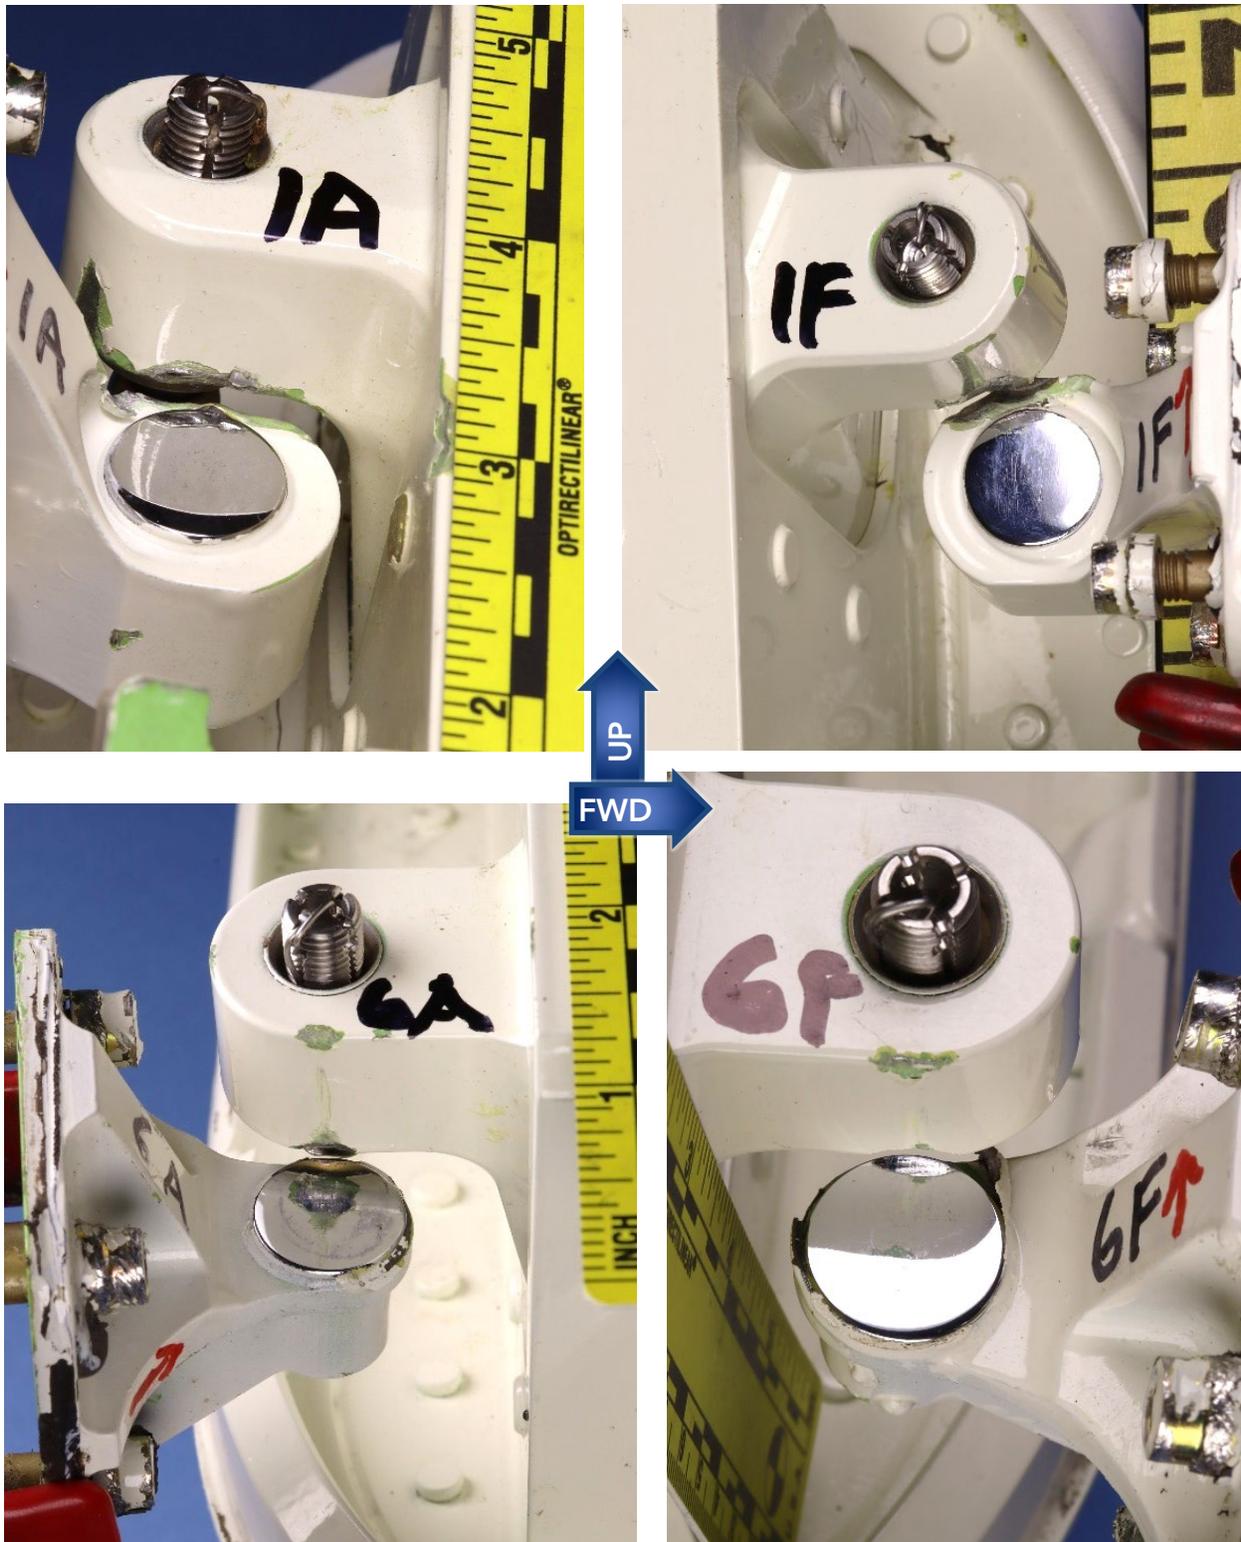
The orientation and geometry of the sliding contact marks and damage on the frame stop fittings and plug stop fittings mostly had features consistent with the plug being displaced upward and then outboard. The images in figure 13 show the frame stop fittings positioned next to the mating plug stop fittings at stop positions 1A, 1F, 6A, and 6F. The fittings were positioned so that corresponding areas of sliding contact damage were next to each other with the plug fittings positioned at the upper inboard side of the corresponding frame fitting. Additional images with similar relative positioning at each of the stop positions are included in Appendix A.

Figure 13. Close views of stop locations 1F, 1A, 6F, and 6A with sliding contact damage on the frame stop fittings placed next to the corresponding sliding contact damage on the plug stop fittings.

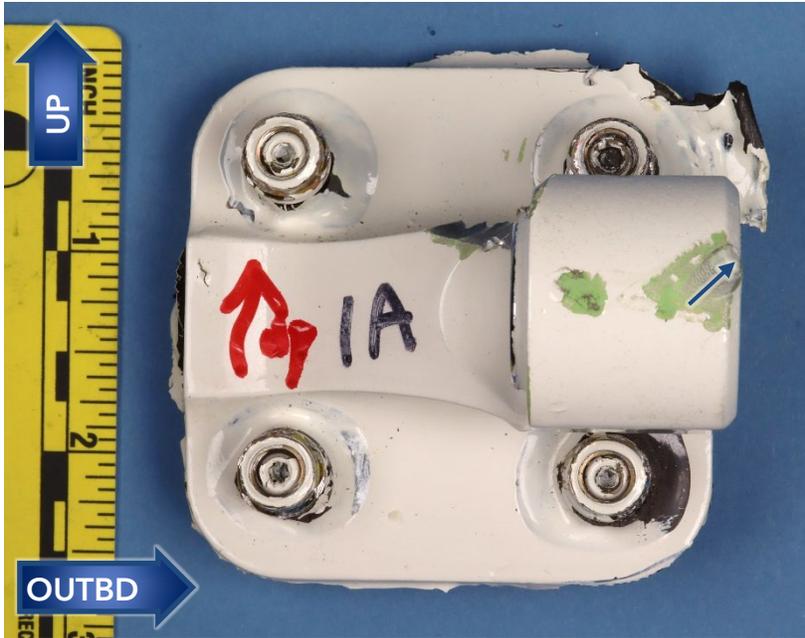
Angled sliding contact marks were also observed on the forward side of the frame stop fitting next to the outboard edge of the fitting as shown in figure 14. Corresponding contact marks were observed on a damaged area on the plug below plug stop fitting 1A. The frame stop fitting is shown next to the plug with the corresponding contact marks placed next to each other in figure 15 where the plug is displaced upward, outboard, and aft relative to the frame at the point of contact. The direction of the sliding contact and the change in depth associated with the marks are also consistent with the plug moving upward, outboard, and aft relative to the frame at the point of contact when the marks were made.

Figure 14. Forward side of frame stop fitting 1A. An arrow indicates the direction of relative motion associated with the sliding contact damage on the forward side of the fitting next to the outboard edge.

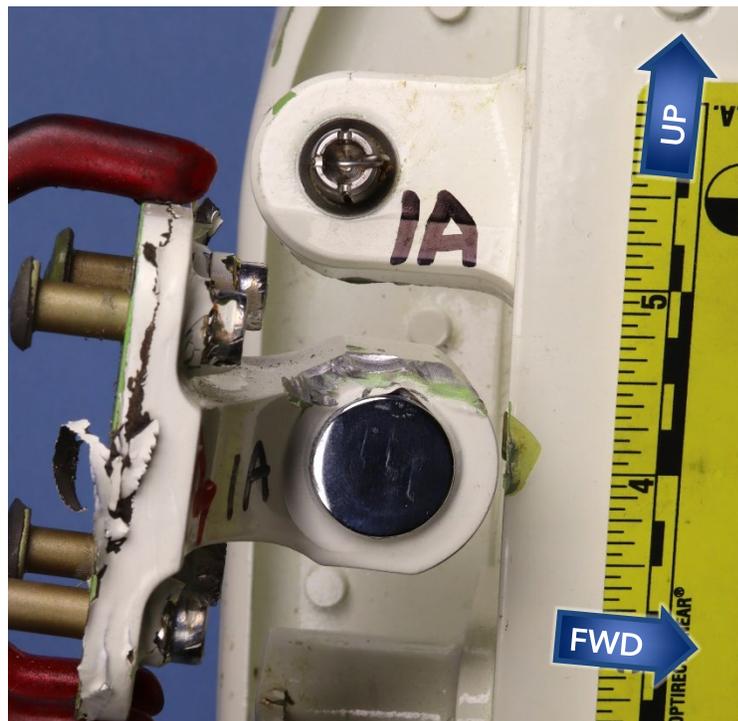
Figure 15. Frame stop fitting 1A with sliding contact damage noted in the previous figure placed next to corresponding damage on the aft side of the plug below plug stop fitting 1A.

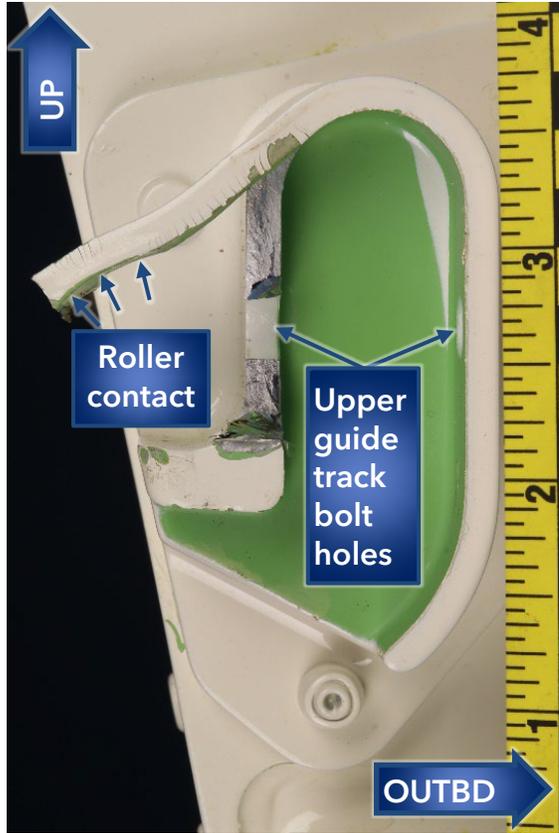
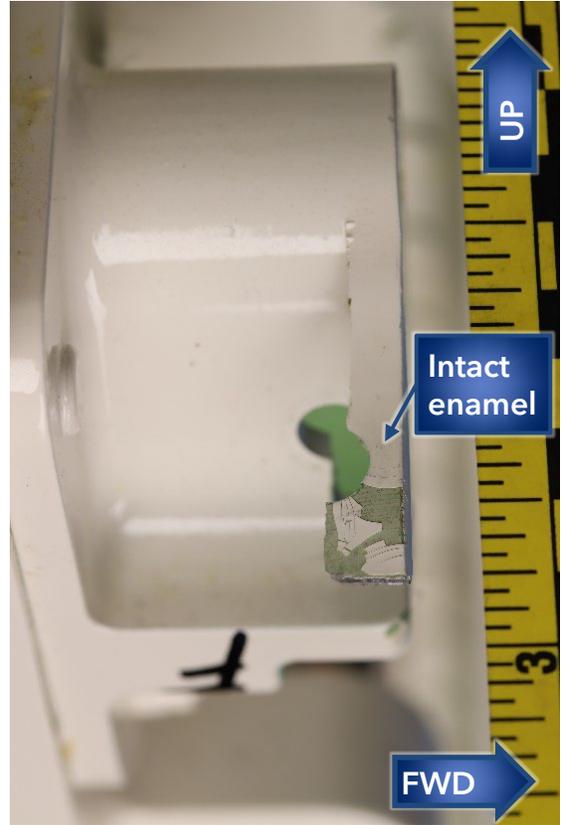
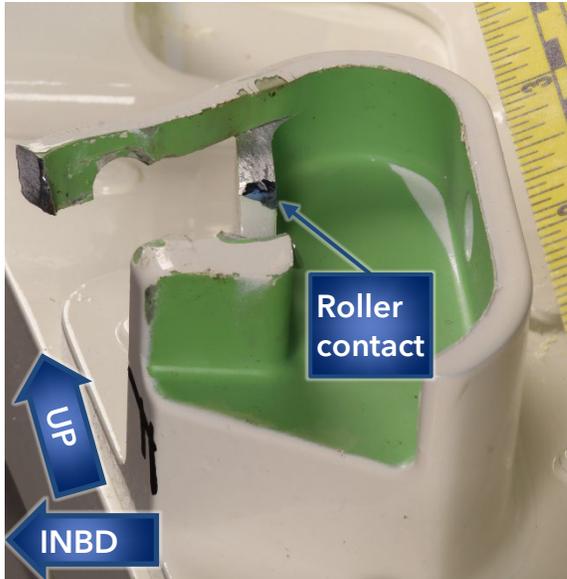
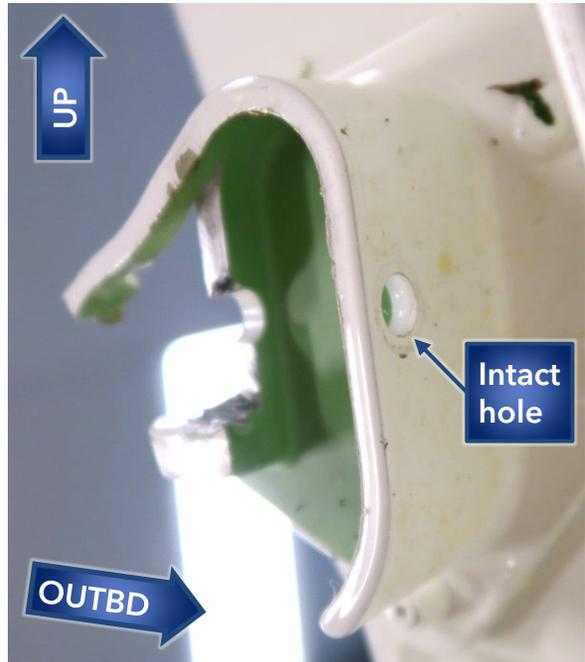
The forward and aft upper guide fittings on the left MED plug are shown viewed from various angles in figures 16 and 17. Each fitting had a vertical fracture through the inboard wall of the guide track that intersected the inboard upper guide track bolt hole. In each fitting, the fractured wall piece on the side closer to the frame opening (forward side in the forward fitting and aft side in the aft fitting) remained attached to the rest of the fitting at the upper end of the piece where it was bent

On the forward upper guide fitting, the fractured and bent piece had a curved deformation near the lower end of the piece. Deformation with a similar geometry was located at a similar location on the aft upper guide fitting. Arrows in the upper left images in figures 16 and 17 indicate this area of curved deformation in each fitting with a radius of curvature that was consistent with the geometry of the bearing outer races on the upper guide rollers attached to the MED opening frame. The apex of the curved deformation relative to the original inboard wall plane was located below the centerlines of the upper guide track bolt holes in each fitting.

As shown in figures 16 and 17, the upper guide fittings had intact enamel with no evidence of contact damage around the inboard sides of the inboard upper guide track bolt holes and the outboard sides of the outboard upper guide track bolt holes, including much of the surface around the holes on the fractured and bent pieces as indicated in the upper right images in figures 16 and 17. Areas with missing enamel had tension cracks corresponding to the outside of the bend from the curved roller contact deformation. Faint circular marks consistent with prior contact with washers associated with the upper guide track bolt were visible on the forward upper guide fitting during preliminary examinations. However, both upper guide track bolts were missing from the intact and undeformed outboard holes of the upper guide fittings, and all damage and deformation to the inboard holes appeared to be associated with contact with the upper guide rollers.

Figure 16. Views of the forward upper guide fitting on the left MED plug. Deformed areas consistent with roller contact are indicated.

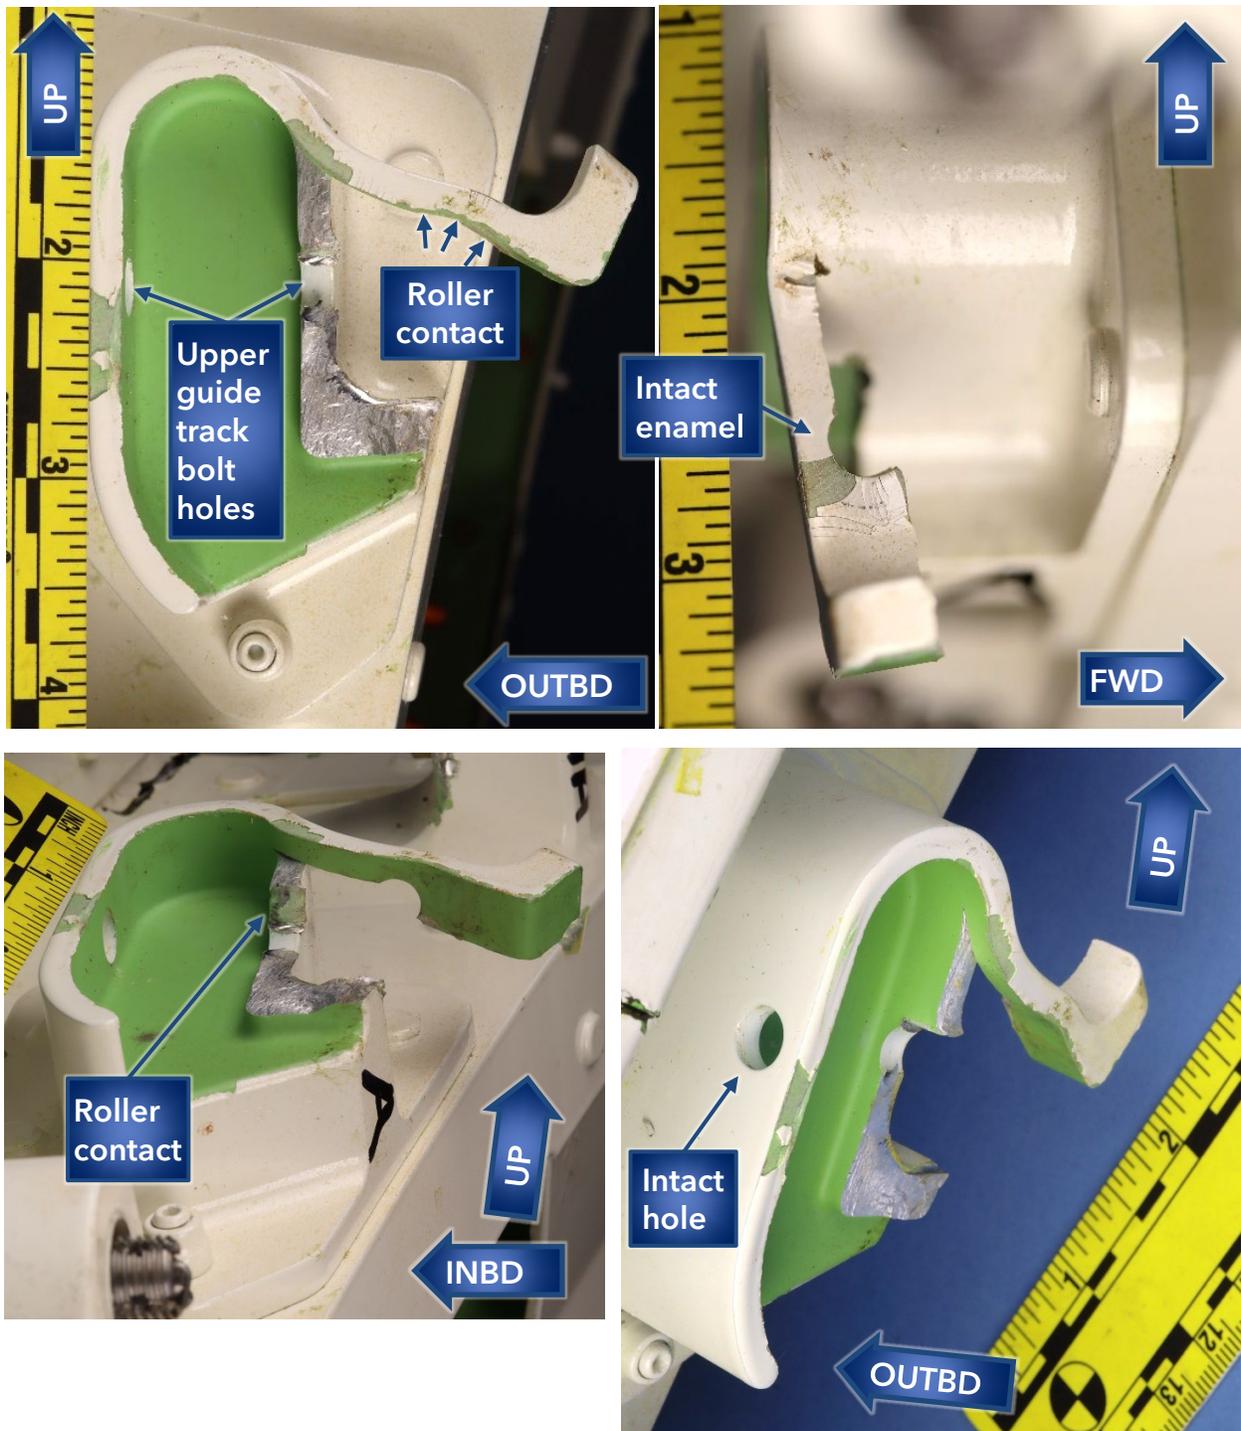
Figure 17. Views of the aft upper guide fitting on the left MED plug. Deformed areas consistent with roller contact are indicated.

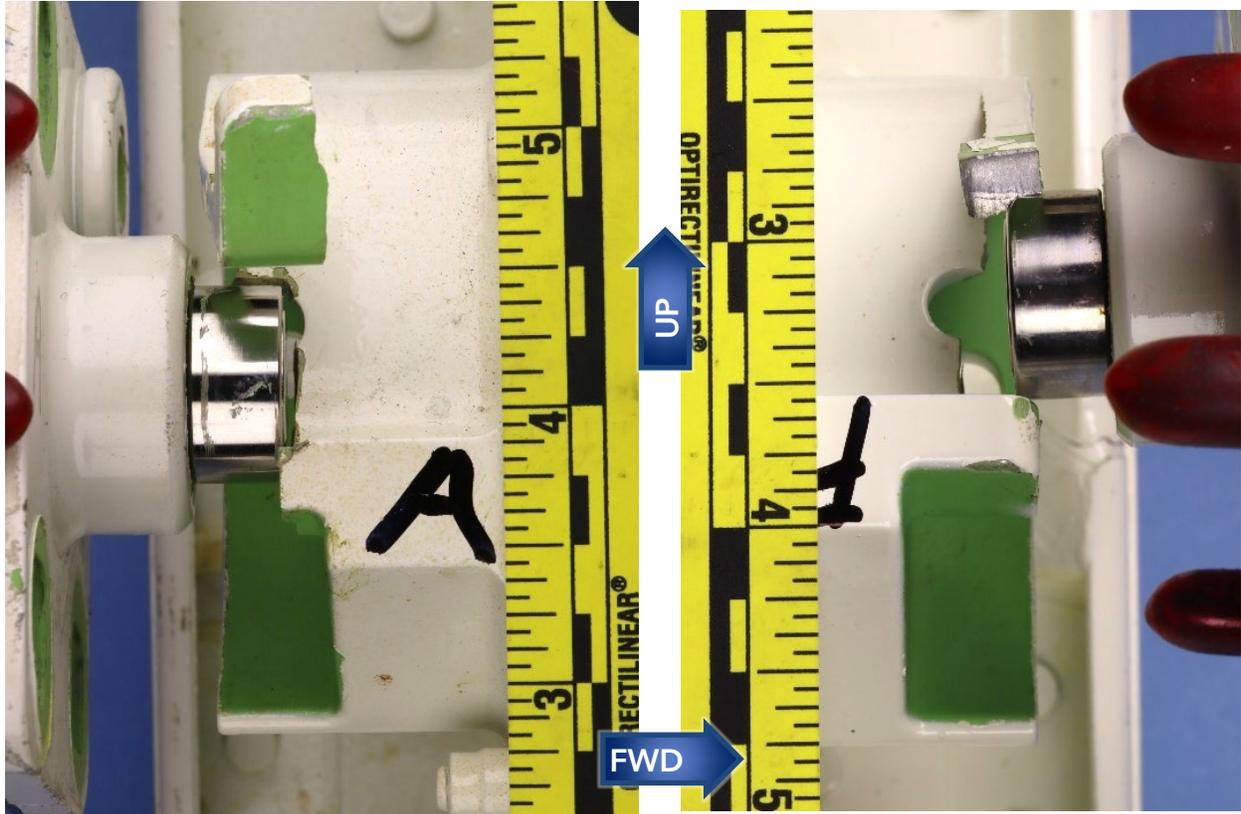
The upper guide fittings had deformed areas at the upper sides of the inboard upper guide track bolt holes with smooth reflective surfaces. The deformation extended onto the fracture surface and was not continuous to the mating side of the fracture, indicating that it occurred after the fracture. The smooth deformed areas had features consistent with roller contact on the upper side of the bearing outer race. These areas of roller contact at the upper side of the upper guide track bolt hole are indicated in the lower left images in figures 16 and 17. In the left image in figure 18, the roller is shown positioned against the contact damage at the upper side of the upper guide track bolt hole on the aft upper guide fitting. Similar roller contact marks were also observed at the lower end of the fracture on the forward upper guide fitting corresponding to contact with the lower side of the roller, and the roller is shown positioned near the lower contact area on the forward upper guide fitting in the right image in figure 18.

Figure 18. Views of the forward (right image) and aft (left image) left MED plug upper guide fittings with the upper guide rollers positioned close to corresponding contact marks and deformed features on the fittings.

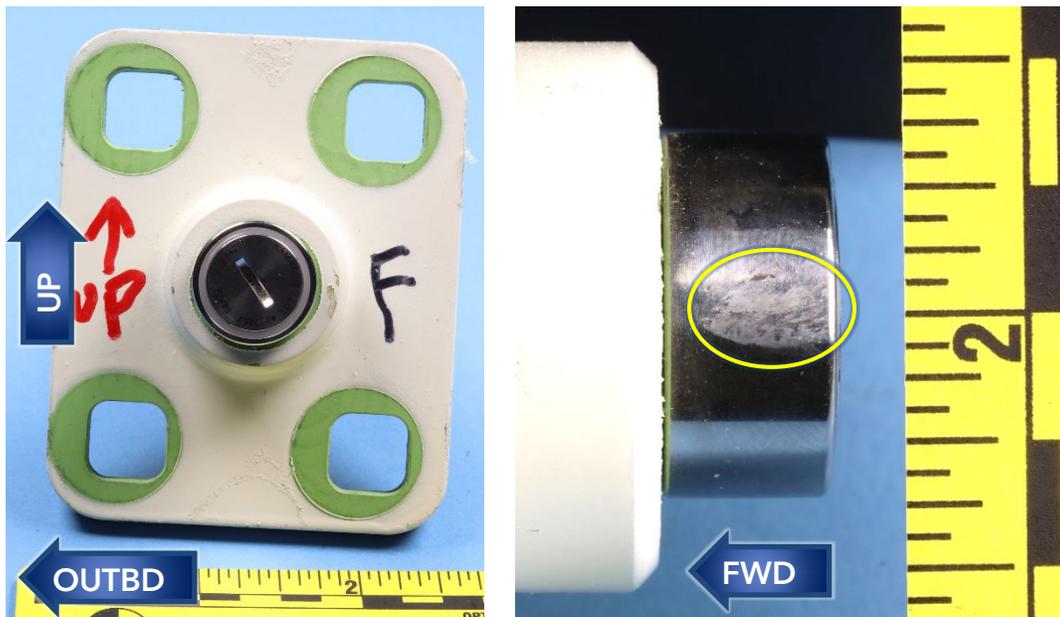
Figure 19. Upper guide roller removed from the forward side of the left MED frame (left image). The right image shows an area of metal transfer on the outer race (circled area).

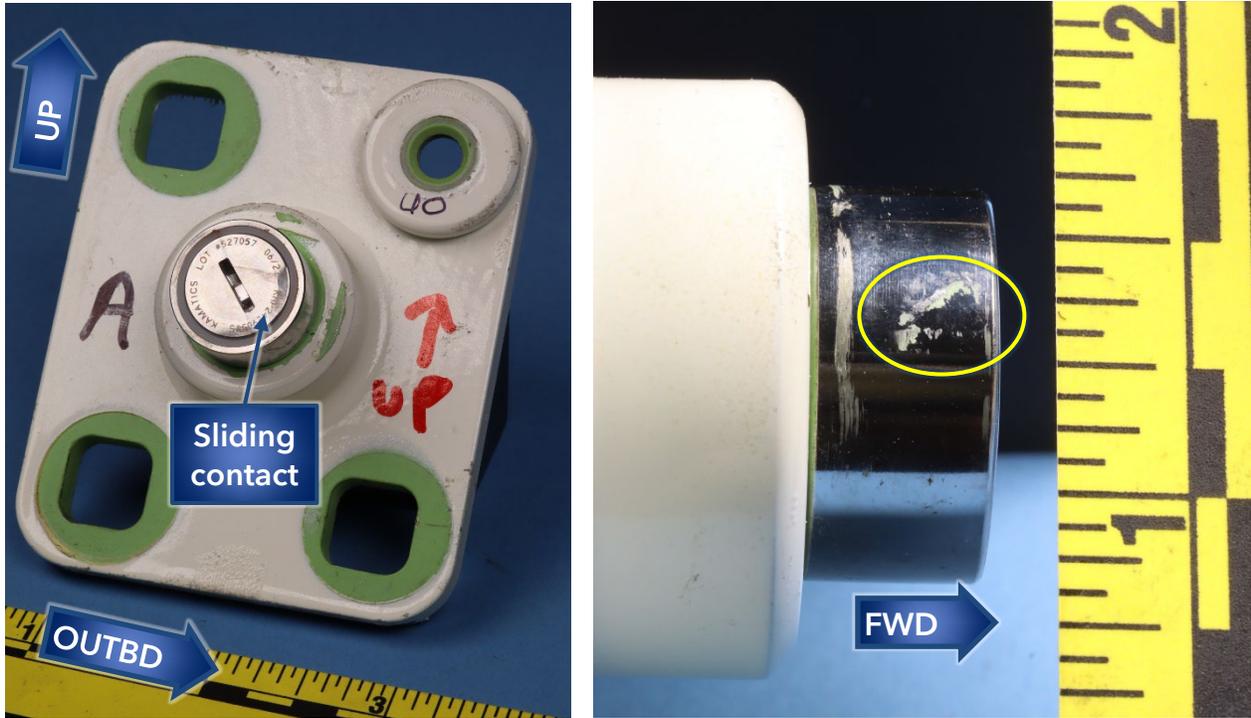
Sliding contact marks were observed on the forward face of the aft upper guide roller bearing as shown in the left image in figure 20. Enamel on the fitting face next to the bearing was also disturbed at the upper and outboard sides. The bearing outer race had green deposits on multiple areas around the circumference appearing consistent with deposits of primer. Most of the primer was located in a thin line near the aft side of the outer race next to the fitting. However, one area of green deposits appeared to have a mashed appearance across the outer race extending toward the forward face of the bearing as shown circled at the right in figure 20.

Figure 20. Upper guide roller removed from the aft side of the left MED frame (left image), where sliding contact marks were observed on the forward face. The right image shows an area of enamel and primer transfer on the outer race (circled area).

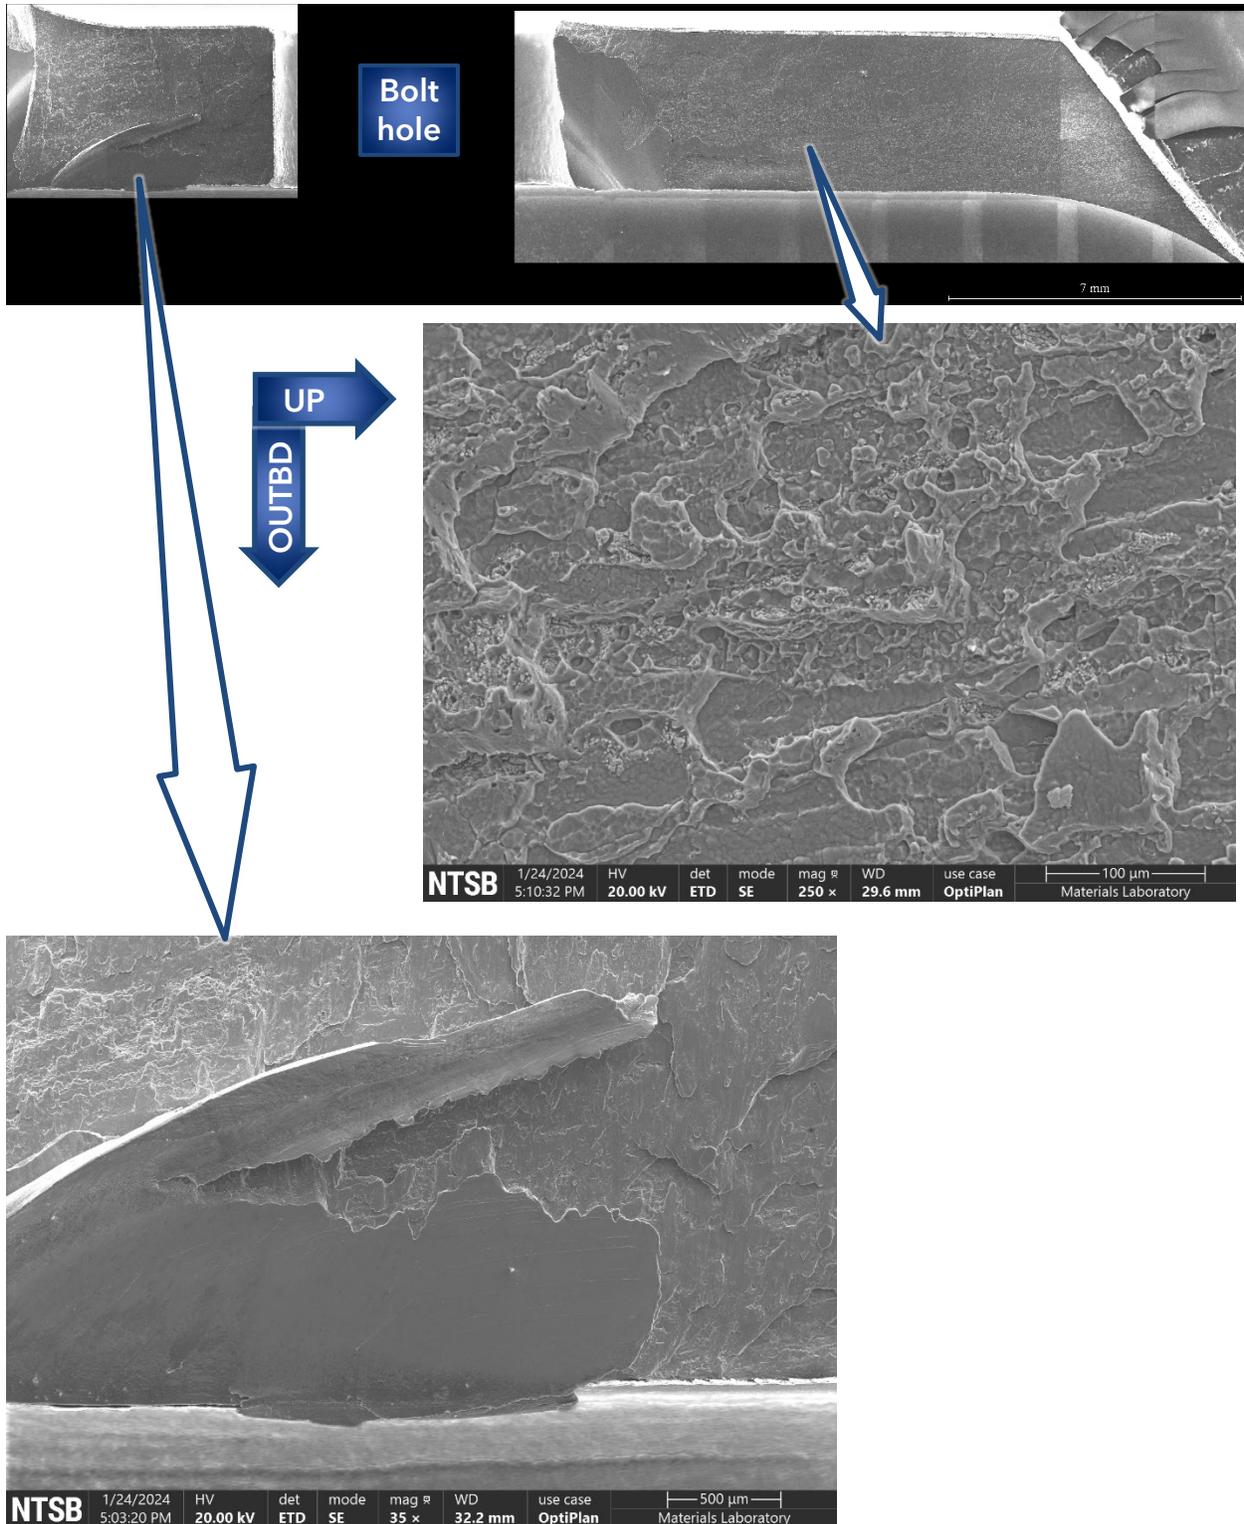
The fracture surfaces on the forward and aft upper guide fittings were examined using a scanning electron microscope (SEM), and representative images are shown in figures 24 and 25. The fracture surfaces showed dimple features consistent with ductile overstress fracture as shown in the middle images in figures 24 and 25. Smooth areas with curving features were observed in areas below the upper guide track bolt holes on each surface as shown in the lower images in figures 24 and 25. The curving features were deformation marks associated with sliding contact damage consistent with post-fracture contact with the upper guide roller outer race.

No indication of any preexisting crack or progressive fracture mechanism was observed on the examined fracture surfaces.

Figure 24. Montage of stitched SEM images of the fracture surface on the forward upper guide fitting from the left MED plug (upper image) with magnified views of typical fracture features (middle image) and an area of smearing damage on the lower outboard side of the fracture (lower image).

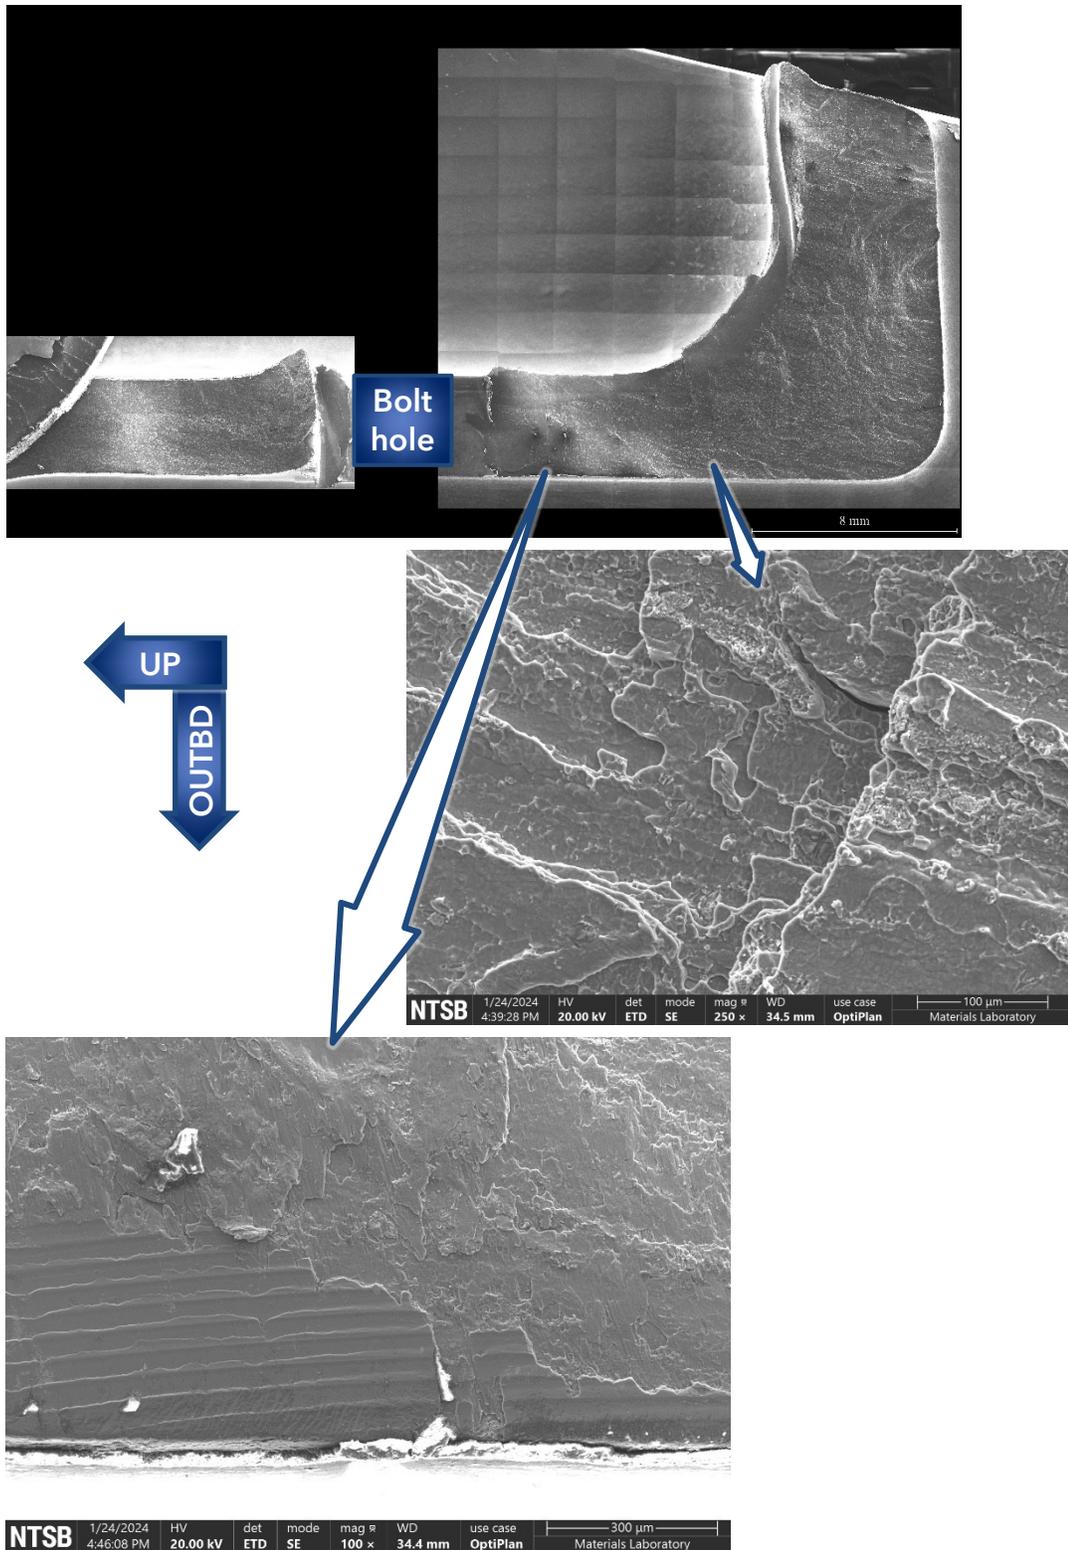
Figure 25. Montage of stitched SEM images of the fracture surface on the forward upper guide fitting from the left MED plug (upper image) with magnified views of typical fracture features (middle image) and an area of smearing damage on the outboard side of the fracture near the bolt hole (lower image).
