Alaska Airlines Flight 1282

Left Mid Exit Door Plug Separation in Portland, OR

**Materials Group Chair's
Factual Report**
(55 Pages)

Factual Report 24-007

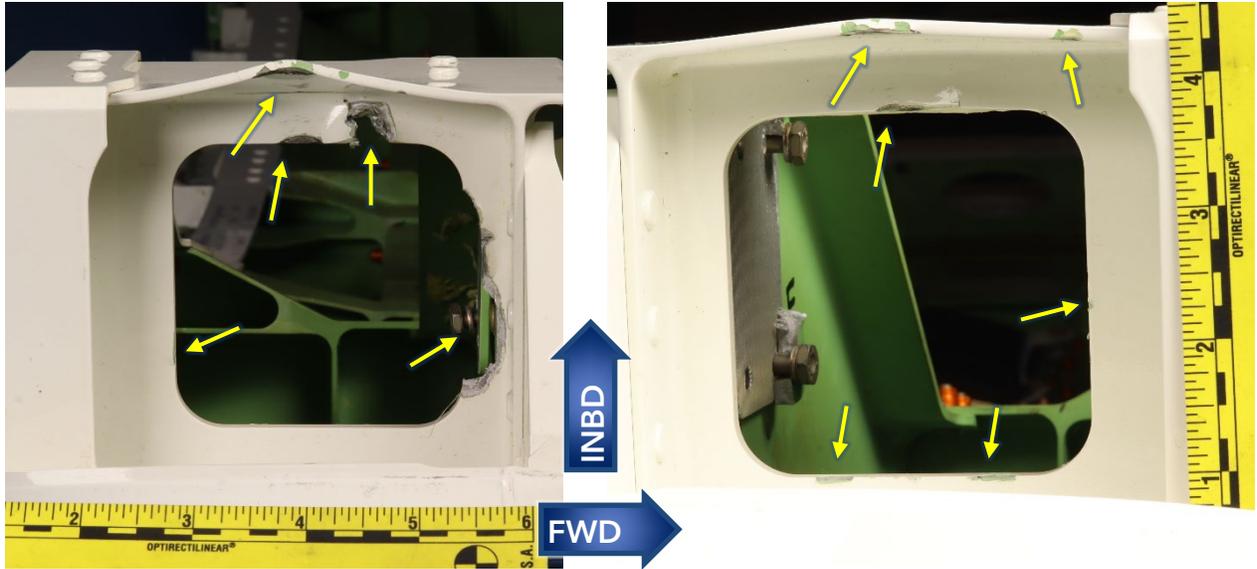
Openings for the lower hinge assemblies in the left MED plug lower beam structure are shown in figure 26. At the forward hinge opening, contact marks were observed at the lower side of the opening on the inboard, forward, and outboard sides as indicated with unlabeled arrows in the right image in figure 26. The lower end of the inboard flange on the lower beam was also deformed inboard. At the aft hinge opening, contact marks, deformation, and missing material were observed at the lower side of the opening on the inboard, forward, and aft sides as indicated with unlabeled arrows in the left image in figure 26. The lower end of the inboard flange of the lower beam was deformed inboard similar to deformation at the forward hinge location, but the extent of deformation was greater.

Figure 26. Lower end of the left MED plug showing openings in the lower beam structure for the forward (right image) and aft (left image) lower hinge assemblies. Arrows point to areas of contact damage.

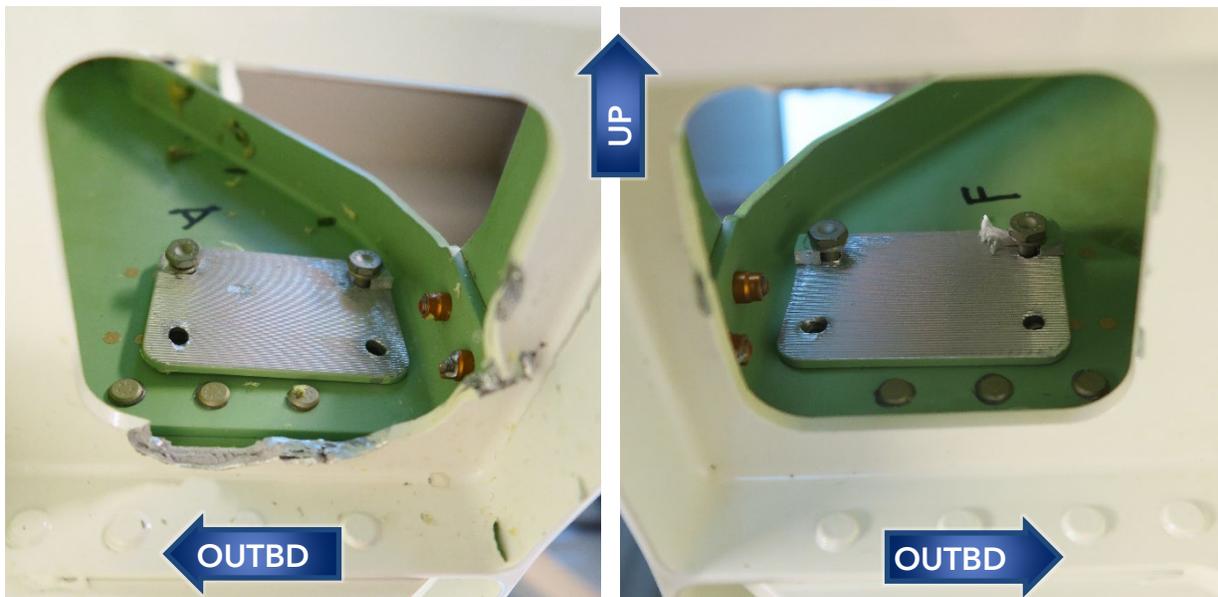
The forward and aft hinge guide fittings were fractured from the plug as shown in figure 27. Where each fitting had been attached, the two lower attachment bolts were fractured, and the two upper attachment bolts remained intact. The threaded ends of the fractured attachment bolts were retained in the nut plates that were attached to the MED plug. As shown in figure 28, all attachment bolts at both the forward and aft hinge guide fitting attachments had similar extents of the threaded end extending beyond the nut plate with approximately 2 to 3 threads exposed. The head end of the fractured bolt at the lower inboard location for the aft hinge guide fitting remained within its hole in the fitting's flange, and head ends of the other three fractured bolts were missing. The heads on each of the intact bolts and the bolt head piece that remained in the aft hinge guide fitting all were marked "B30NM3" around a central dimple, consistent with the specified bolts.

Figure 27. Views of serrated plates at the forward (right image) and aft (left image) hinge guide fitting attachment locations on the left MED plug as viewed through the hinge assembly openings in the lower beam structure.

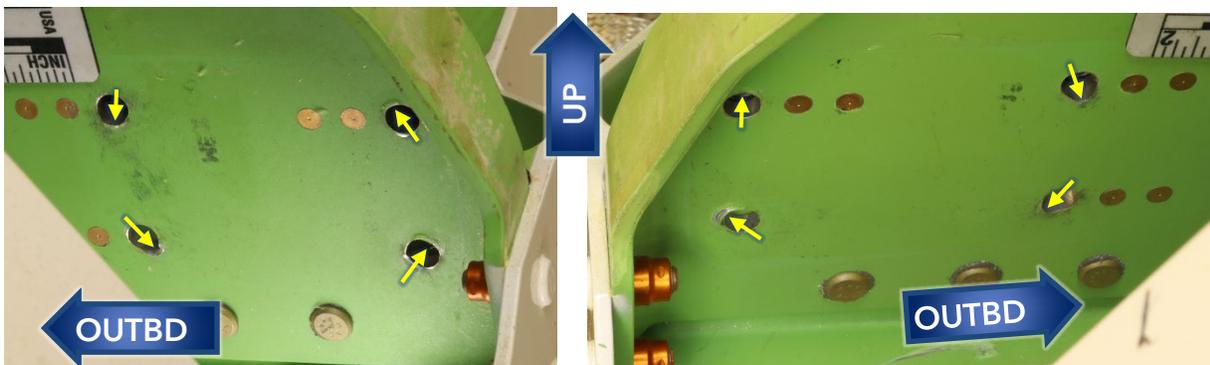
The hinge guide fitting attachment holes in the left MED plug are shown in figure 30 after removing the serrated plates. The edges of the holes showed deformation consistent with bearing contact damage from the attachment bolts, and unlabeled arrows in figure 30 point to the location of the bearing contact damage. The bearing damage had a circular contact pattern consistent with both hinge guide

Figure 30. Left MED plug vertical rib surfaces at the hinge guide attachment locations after the serrated plates were removed. Unlabeled arrows point to areas of bearing damage at the edges of the attachment holes.

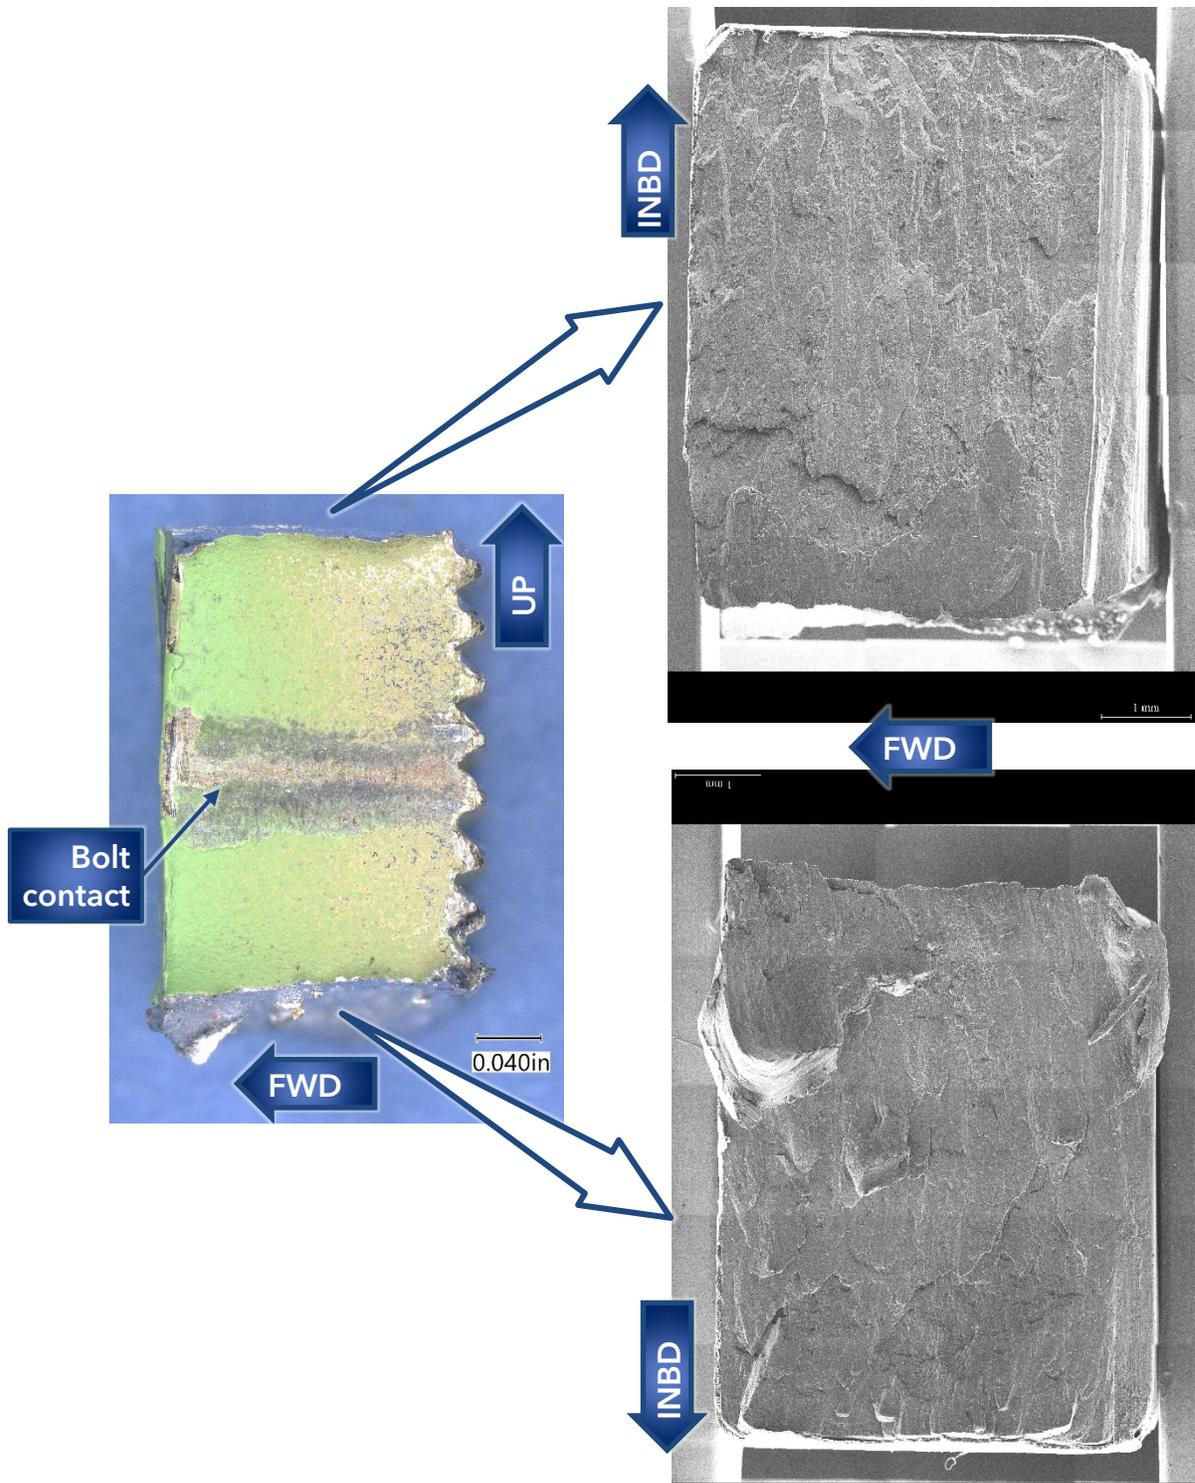
The hinge guide fitting flange pieces shown in figure 29 were further examined using an optical stereo microscope and an SEM. The pieces at the upper inboard locations on the forward and aft hinge guide fittings had similar features, and the piece from the forward hinge guide fitting is shown in figure 31 as representative of both pieces. The pieces were fractured from the inboard side of the hinge guide fitting flanges at the upper inboard holes. Evidence of heavy contact with the attachment bolt was observed with missing primer and slight deformation in the contact area. The fracture surfaces had a smeared appearance with elongated dimple features consistent with ductile overstress fracture. Overall SEM images of the fracture surfaces on the piece from the forward hinge guide fitting flange are shown at the right in figure 31. Similar features were observed on the flange piece from the aft hinge guide fitting shown in figure 29.

Figure 31. Fractured flange piece at the upper inboard attachment location of the forward hinge guide fitting showing an optical image of the hole bore (left image) and SEM images of the upper (upper right image) and lower (lower right image) fracture surfaces.

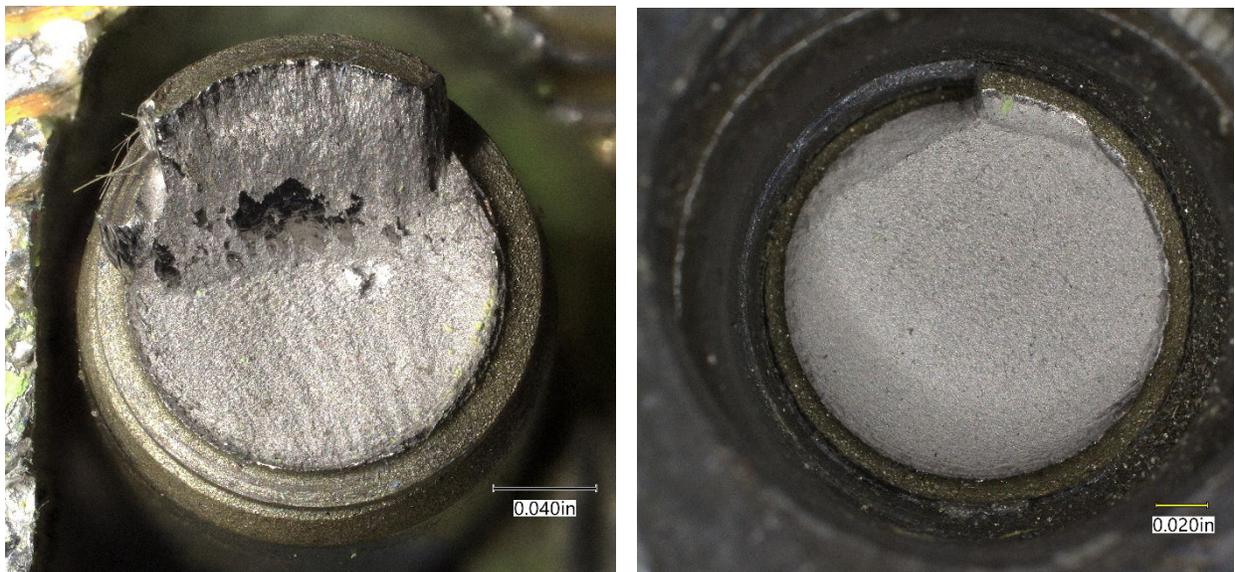
Fracture surfaces on the lower attachment bolts for the forward and aft hinge guide fittings are shown in figures 32 and 33, respectively. On the fractured lower attachment bolts for the forward hinge guide fitting, the fracture surfaces on the lower inboard bolt shown at the left in figure 32 had uniform rough matte gray features consistent with ductile overstress fracture. The lower outboard attachment bolt shown at the right in figure 32 had smeared features with rough features near the middle, features consistent with ductile overstress fracture under direct shear loads. On the fractured lower attachment bolts for the aft hinge guide fitting, the lower inboard bolt shown at the left in figure 33 had a large shear lip on one side of the fracture consistent with a bending load associated with the fracture. The overall fracture pattern on both lower attachment bolts for the aft fitting shown in figure 33 had uniform rough matte gray features consistent with ductile overstress fracture. No evidence of preexisting cracks or damage was observed on any of the hinge guide fitting attachment bolts.

Figure 33. Fracture surfaces of the lower inboard (left image) and lower outboard (right image) attachment bolts for the aft hinge guide fitting from the left MED plug.

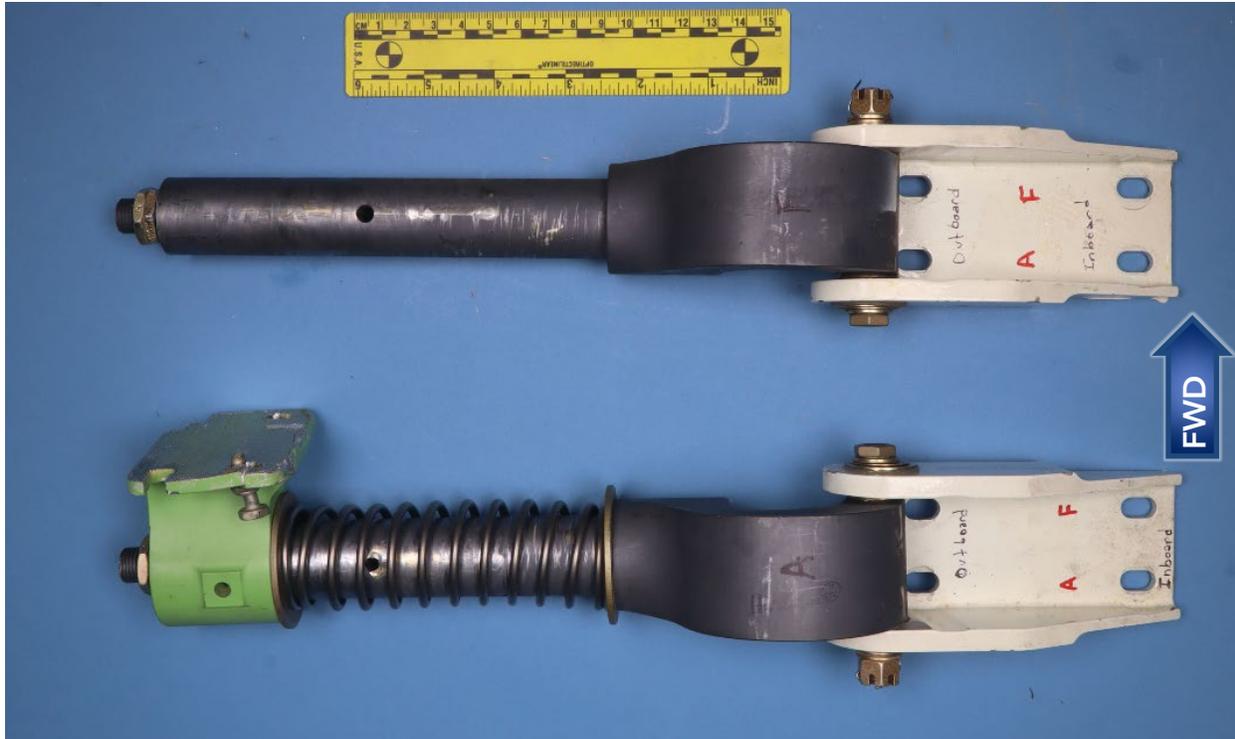
A close view of the recovered lower hinge assemblies with attached lower brackets disassembled from the left MED frame are shown as received in figure 34. The hinge guide fitting, lift assist spring, lift assist spring washers, stop washer, and vertical movement arrestor bolt hardware were missing from the forward lower hinge assembly as shown in figure 34. On the aft lower hinge assembly, the vertical

movement arrestor bolt hardware was missing, and the hinge guide fitting was positioned against the stop washer at the upper end of the hinge fitting. A phenolic washer was also missing from the upper side of the aft hinge guide fitting leaving remnants of adhesive in the area associated with the missing washer.

Figure 34. Overall view of the inboard side of the hinge assemblies with attached lower hinge brackets from the left MED plug as received.

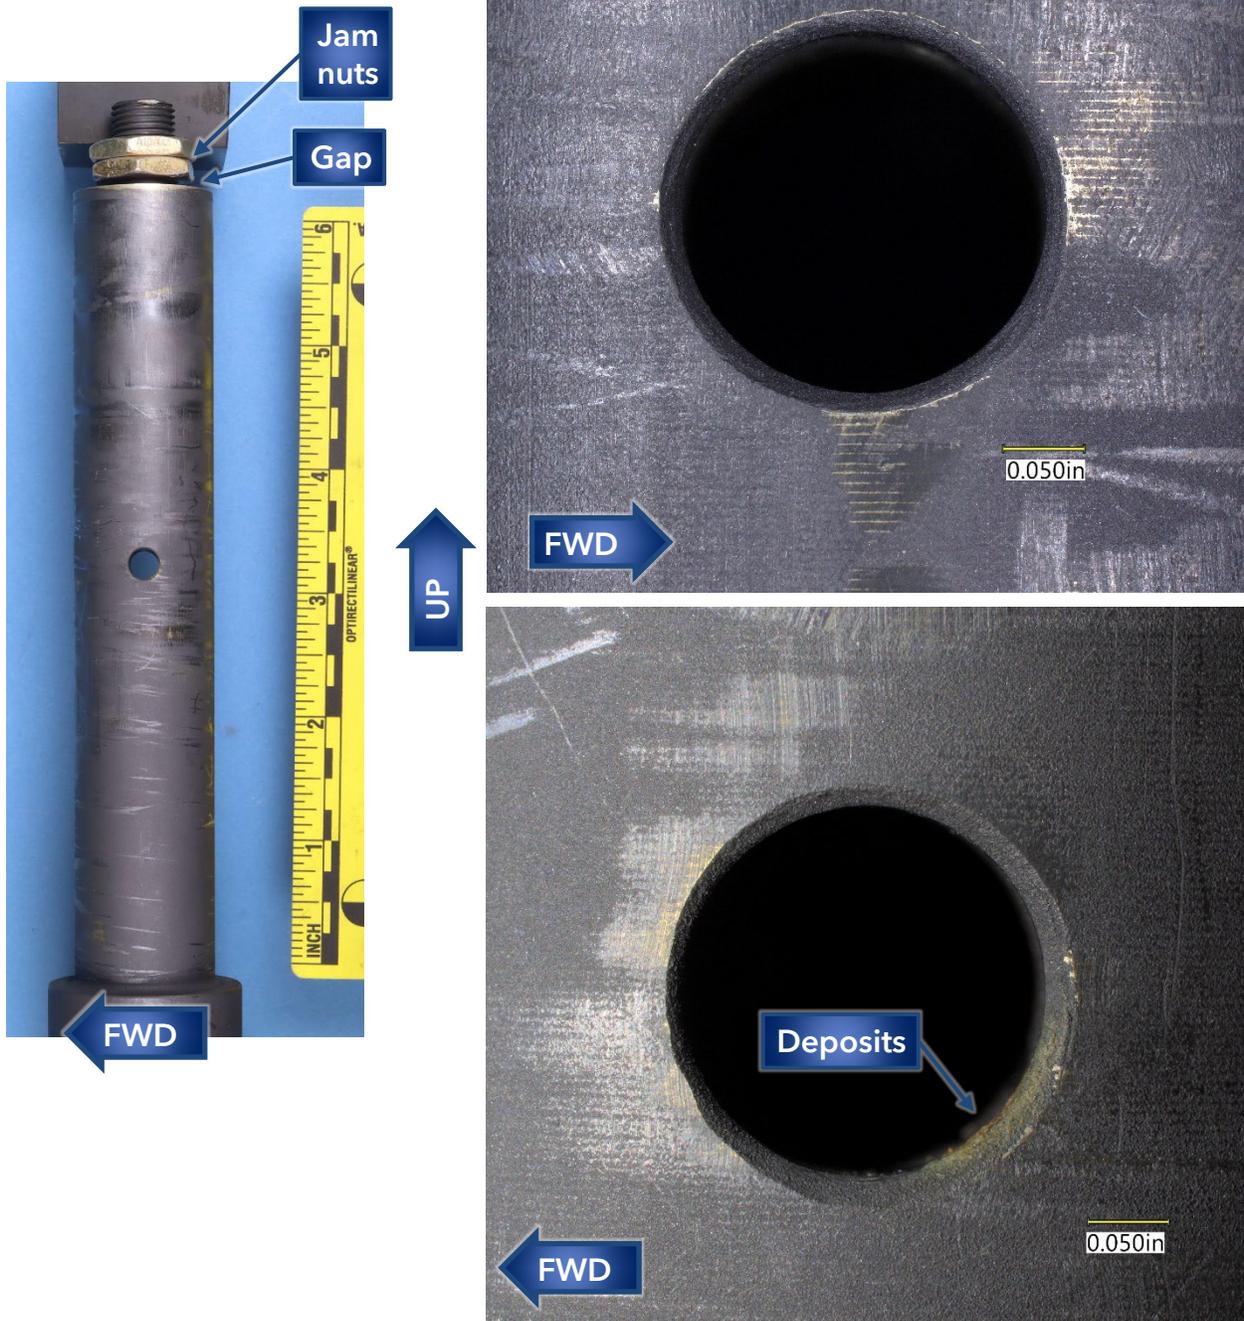
Closer views of the forward hinge fitting shaft including areas around the vertical movement arrestor bolt hole through the shaft are shown in figure 37. The dry film lubricant was rubbed and disturbed on the shaft consistent with contact with the lift assist spring and washers and the hinge guide fitting. Around the vertical movement arrestor bolt holes, the dry film lubricant was disturbed, exposing the underlying conversion coating. Orange-colored deposits were observed on the surface in the lower aft quadrant of the hole at the outboard side of the hinge fitting as indicated in the lower right image in figure 37. When analyzed using energy dispersive x-ray spectroscopy (EDS), the deposits generally had spectra with higher peaks of aluminum, oxygen, and chromium when compared to spectra obtained from

adjacent areas of the hinge fitting, which showed a high peak associated with molybdenum and sulfur, consistent with the dry film lubricant. The vertical movement arrestor bolt holes were circular and showed no evidence of damage or deformation from bearing contact with a vertical movement arrestor bolt.

The jam nuts were present and installed on the threaded upper end of the forward hinge fitting as indicated in figure 37. The jam nuts were tight against each other with hand forces applied to the nuts. A gap was observed between the lower jam nut and the upper face of the fitting shaft as noted in figure 37. The size of the gap was consistent with the thickness of the missing stop washer, and damage consistent with contact with the washer was observed on the lower edges of the lower jam nut including extending up the rounded edges at corners between adjacent wrench flats.

Figure 37. Forward hinge fitting shaft (left image) with closer views of the vertical movement arrester bolt hole at the inboard (upper right image) and outboard (lower right image) surfaces.

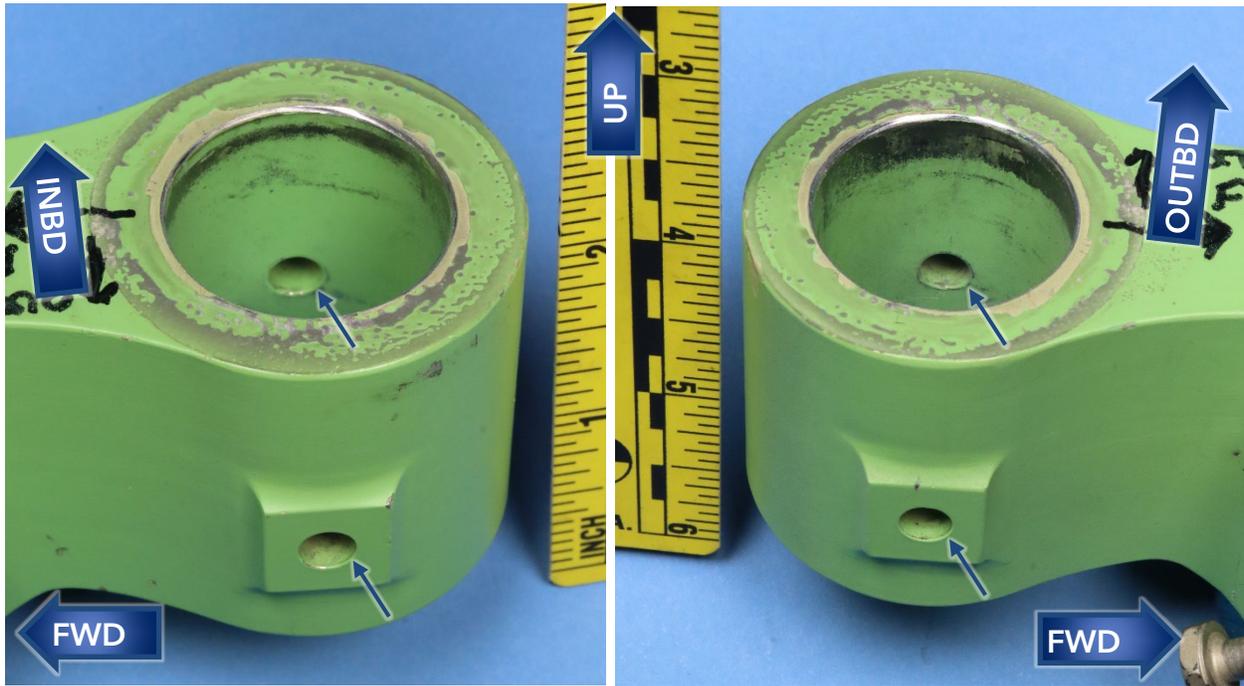
Close views of the vertical movement arrestor bolt holes through the inboard and outboard walls of the aft hinge guide fitting are shown in figure 38. The vertical movement arrestor bolt holes were circular with mostly intact primer and showed no evidence of damage or deformation from bearing contact with a vertical movement arrestor bolt.

Figure 38. Vertical movement arrestor bolt holes (see unlabeled arrows) at the inboard and outboard sides of the aft hinge guide fitting viewed at angles to show the lower surfaces of the hole bores at the outboard ends (left image) and inboard ends (right image) of the holes.

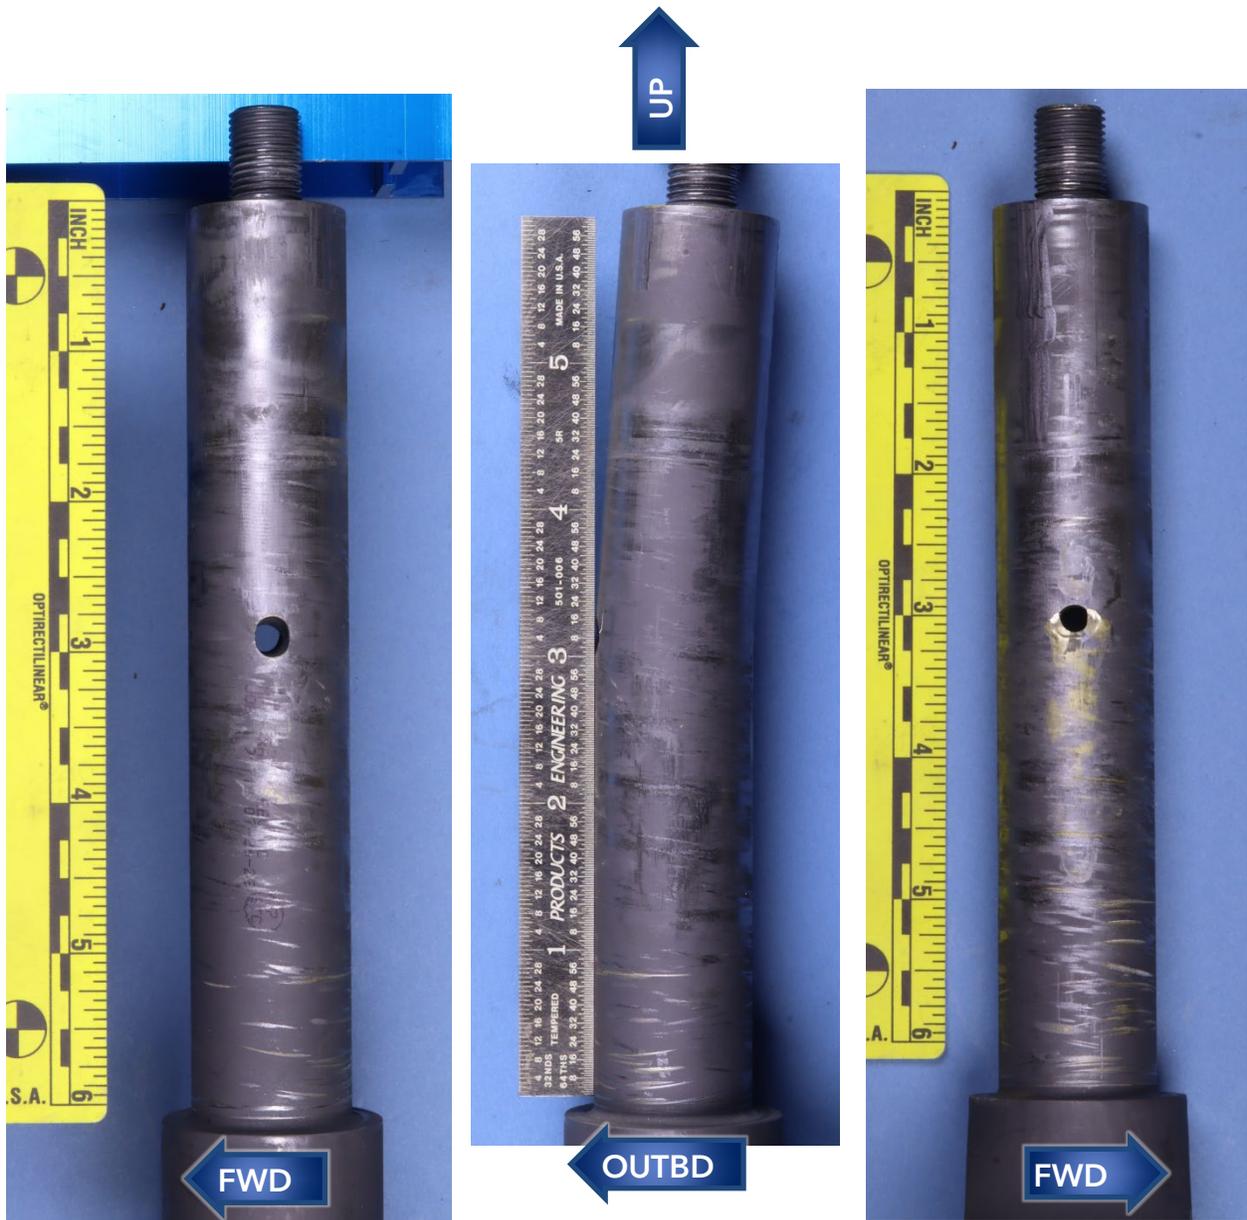
Figure 39. Aft hinge assembly shaft after disassembly showing the inboard (right image) and outboard (left image) sides of the shaft. The middle image shows the bend in the shaft as viewed looking forward.

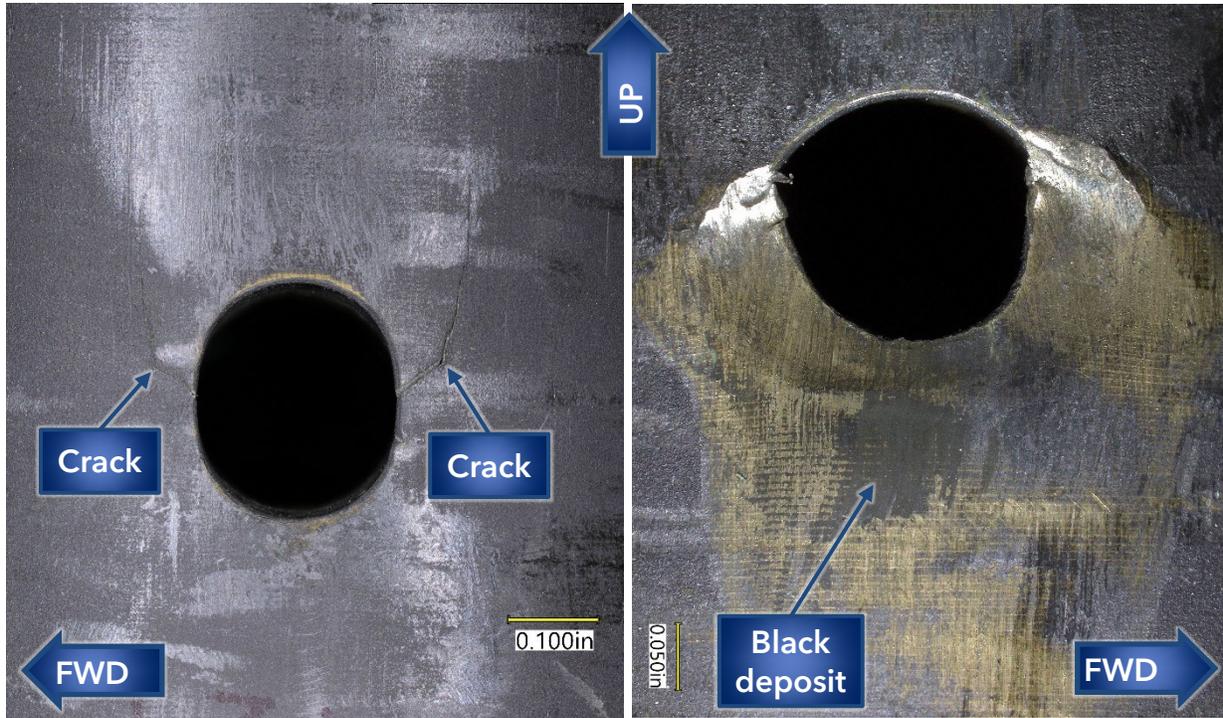
Closer views of the vertical movement arrestor bolt hole through the aft hinge fitting are shown in figure 40. On the outboard side of the hinge fitting, the vertical movement arrestor bolt hole was elongated, and small cracks were observed at the forward and aft sides of the hole as noted in the left image in figure 40. The upper and lower sides of the elongated hole each had a radius corresponding closely to the specified hole diameter but with centers offset by 0.039 inch. The cracks intersected the hole at the forward and aft sides, and the area around the cracks was slightly concave consistent with plastic deformation (necking). Upon closer examination of the unopened cracks in the SEM, the fracture plane appeared to intersect the surface at a slant angle consistent with ductile overstress fracture. Although hole elongation was observed, the vertical movement arrestor bolt hole showed no evidence of damage or deformation from bearing contact with a vertical movement arrestor bolt.

Figure 40. Closer views of the vertical movement arrestor bolt hole through the aft hinge fitting at the inboard (right image) and outboard (left image) surfaces.

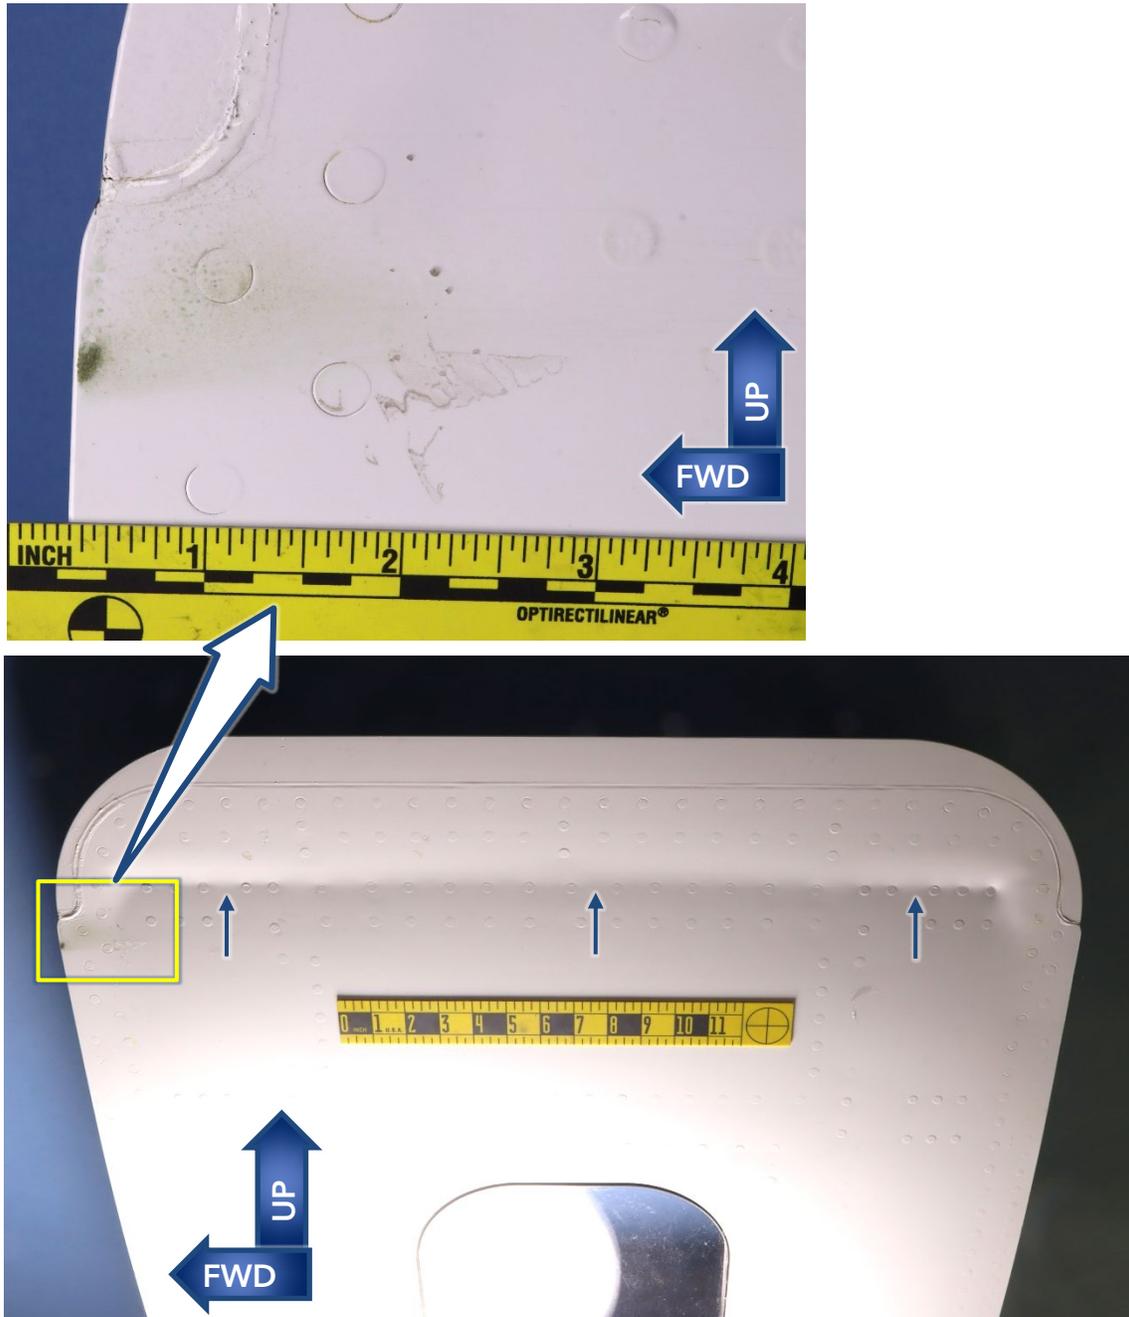
Figure 46. Exterior surface of the left MED plug. Unlabeled arrows point to a crease associated with outward bending at the upper end of the plug. A dark green deposit observed at the upper forward side of the left MED plug exterior surface is shown in the upper image.

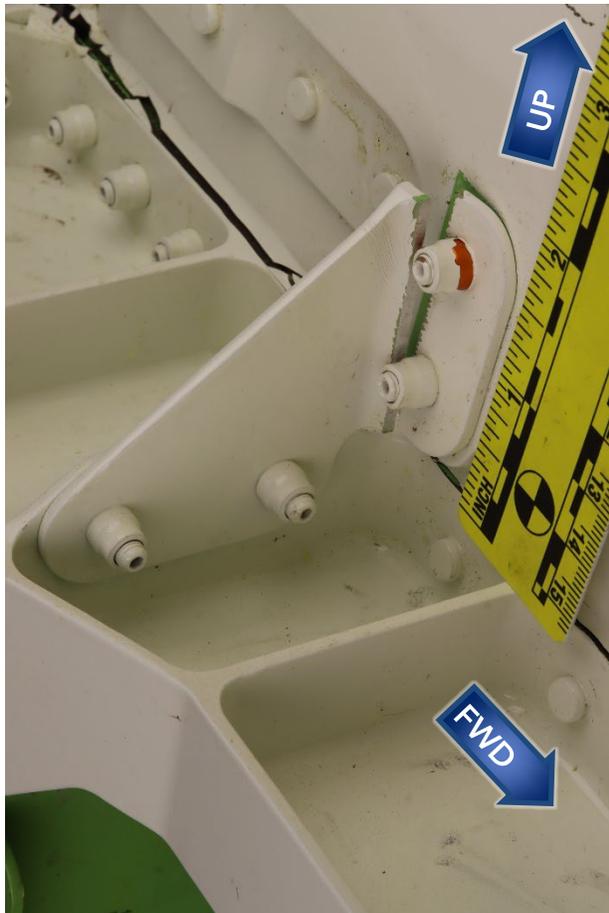
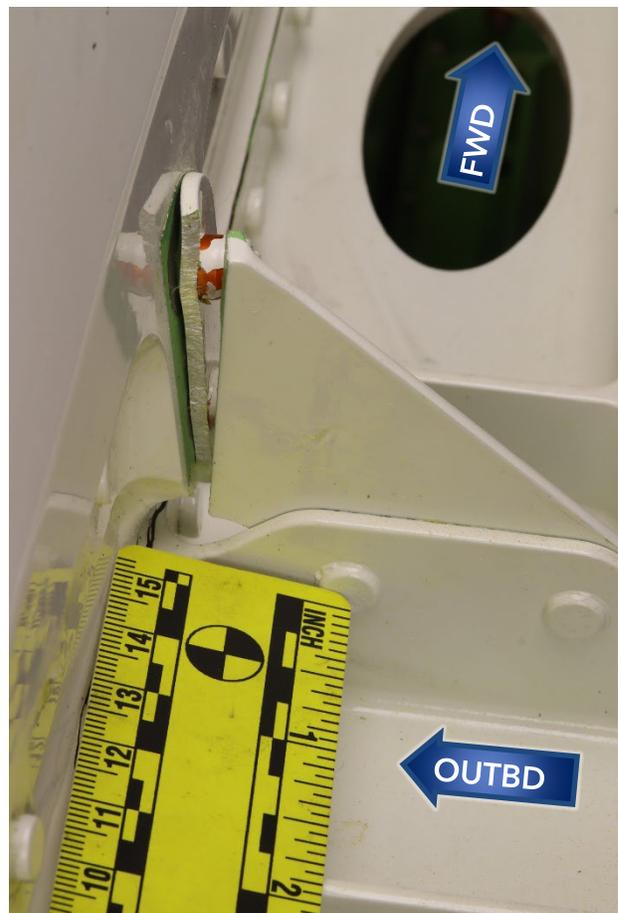
Figure 48. Close views of the aft gusset showing fracture features typical of the three gussets.

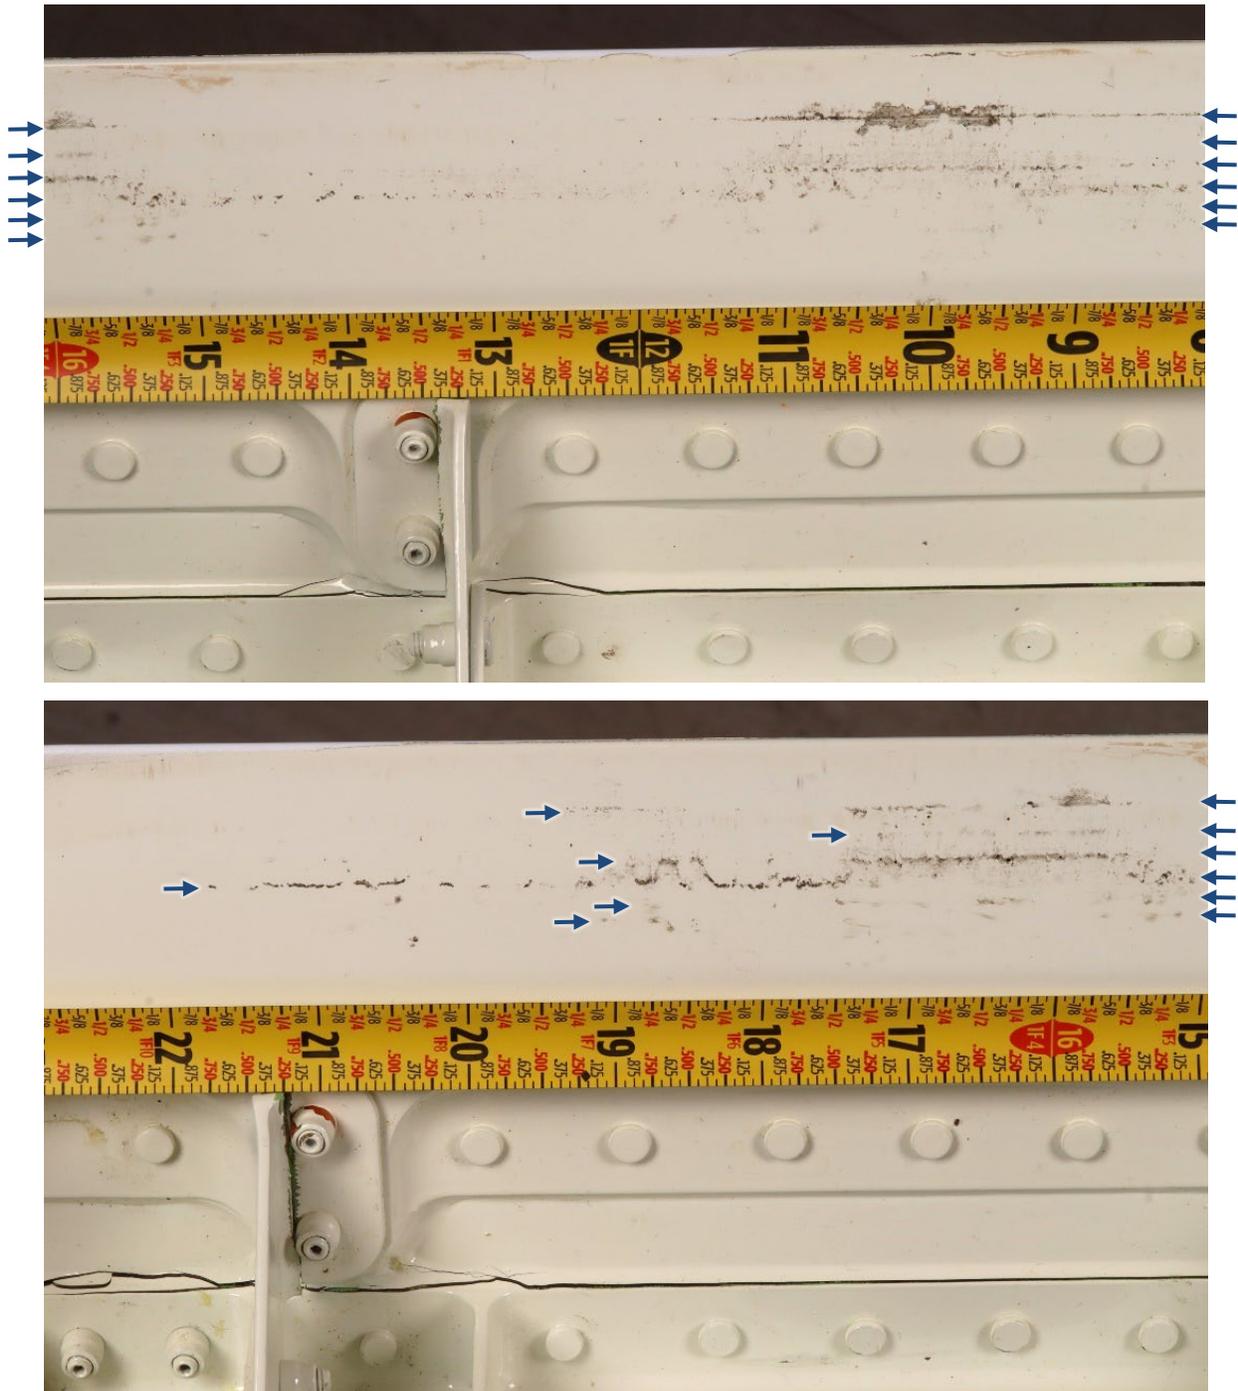
Figure 49. Dark deposits at the upper edge of the left MED plug in the seal contact area. Arrows point to deposits that appeared to be concentrated along horizontal lines between the arrows. The left side of the upper image overlaps the right side of the lower image as shown by the ruler that remained stationary when the photographs were taken.
