National Transportation Safety Board

MATERIALS LABORATORY

Factual Report 24-023

Location: Jackson, Mississippi
Date: January 24, 2024 (Location 1)
January 27, 2024 (Location 2)
Vehicle: Atmos Energy Corporation Residential Gas Distribution System
Investigator: Sara Lyons (RPH-21)¹

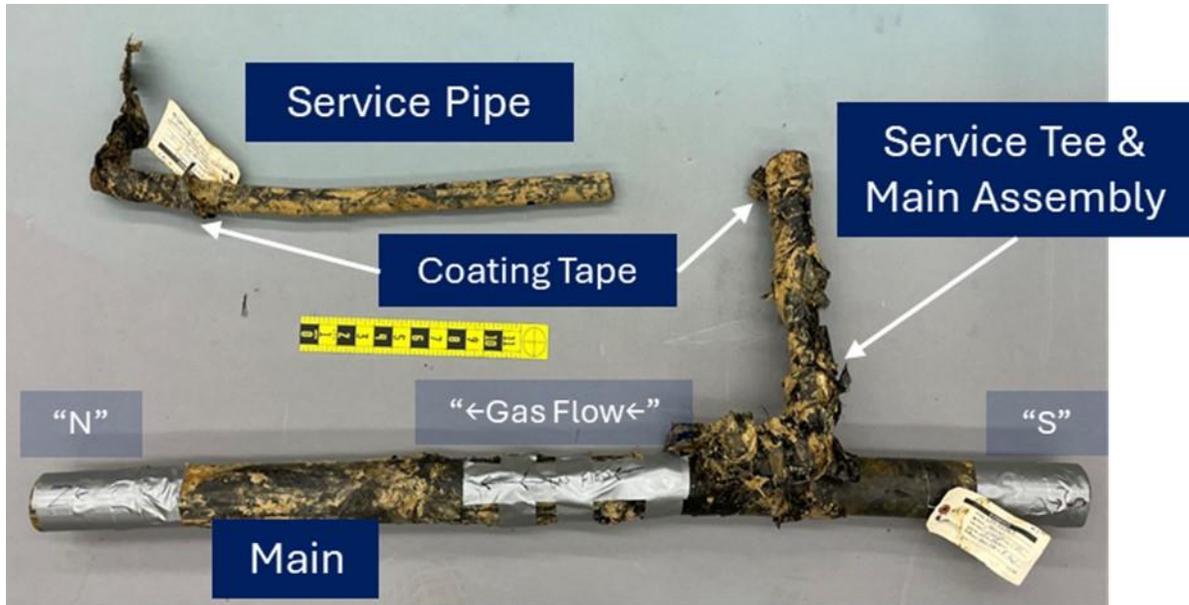
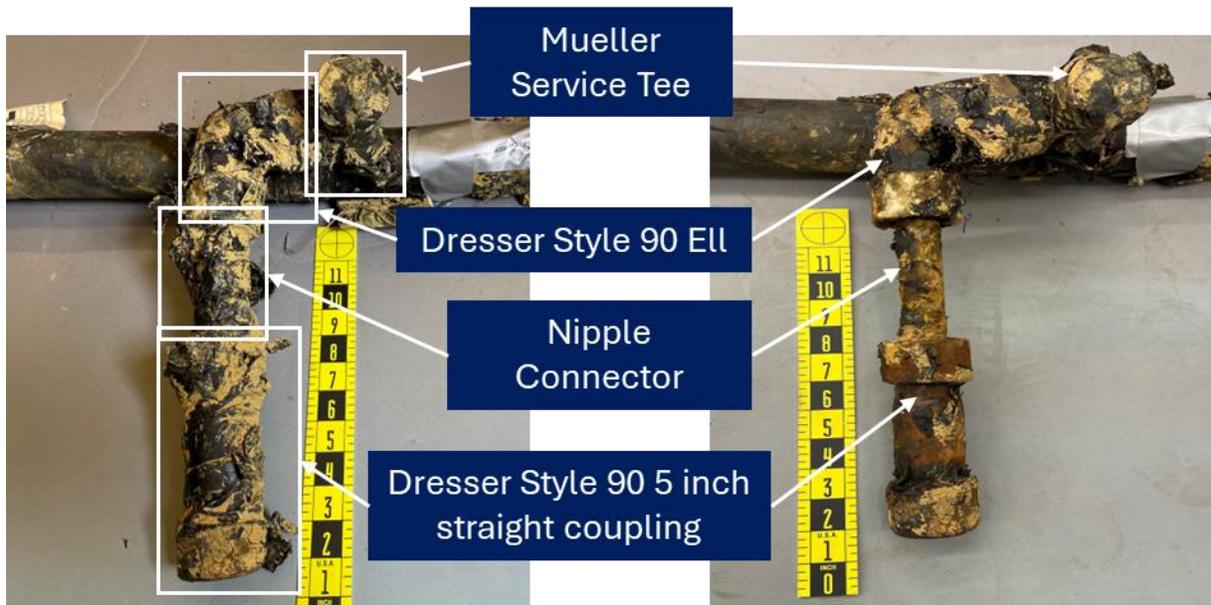
Figures 1 and 2 show photographs of the as-received main, tee, and service pipe from Location 1. The excavated gas line components from 190 Bristol Dr were submitted in two pieces. The larger piece consisted of a 2-inch iron pipe size (IPS) steel main, Mueller service tee, a Dresser ¾-inch Style 90 Ell connector, a short section (less than 6 inch visible) of ¾-inch steel nipple, and a Dresser 5-inch Style 90 straight coupling. The couplings and tee³ were identified by stamped markings on the pieces. The main was coated by a hard black material. The straight coupling, service pipe, ell, tapping tee, and the main around the tapping tee were covered in a black tape. The tape in some areas was loose and peeling away from the assembly. A black, viscous substance was visible on some areas not covered by tape. Several areas of the service pipe showed evidence of exposed metal. Black and brown corrosion products were visible on areas where the bare metal was exposed. There was no evidence that the corrosion had penetrated through the pipe walls.⁴

Figure 1. As-received main, tee assembly, service pipe and coupling from 190 Bristol Blvd (Location 1).

Figure 2. (Left) Top view of as-received main and tee assembly at Location 1 with coating tape. (Right) Similar view with coating tape removed.

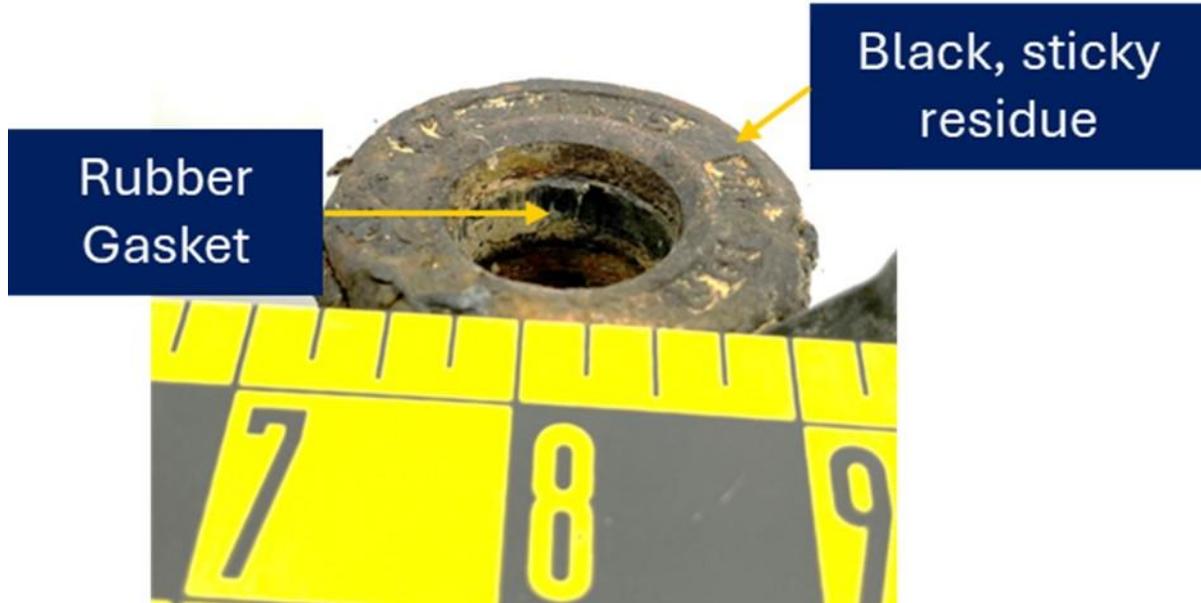
At the exposed downstream end of the straight coupling, a rubber gasket was visible inside the end nut (Figure 3), lining the opening. Per instructions from

Dresser,⁵ the service pipe is inserted into this hole during installation. The nut is then tightened down, forcing the rubber gasket to compress onto the pipe and forming a gastight seal. Dried clay and brown corrosion product were found on the gasket except for one small area that exposed the black surface of the gasket, as shown in Figure 3.

Figure 3. Open downstream end of the straight coupling on the tee and main assembly, at Location 1. A rubber gasket was visible inside the open end.

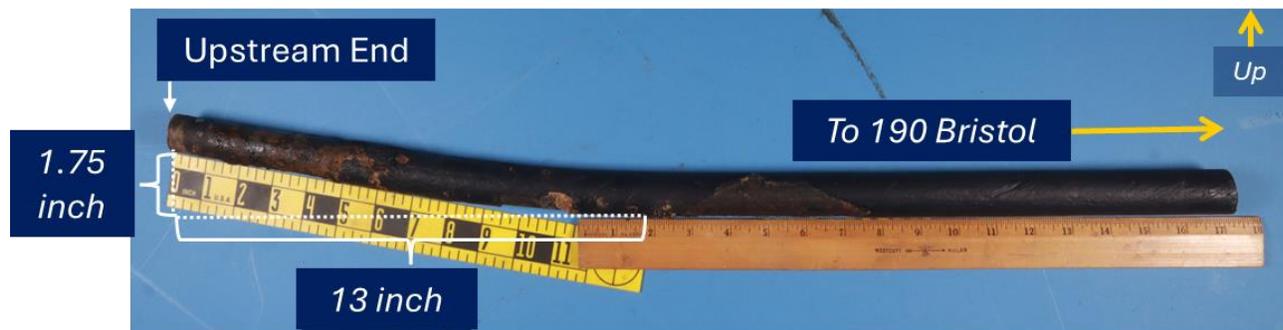
The service pipe was bent approximately 13 inches from the upstream end. The upstream end of the pipe was bent up relative to the downstream. The pipe was straight on both sides of the bend, as observed by placing rulers under the straight segments of the pipe (Figure 4). The upstream end was displaced laterally from the straight-line projection of the downstream end by 1.75 inch.

Figure 4. The service pipe at Location 1 was bent approximately 13 inch from the upstream end with straight segments on either side of the bend.

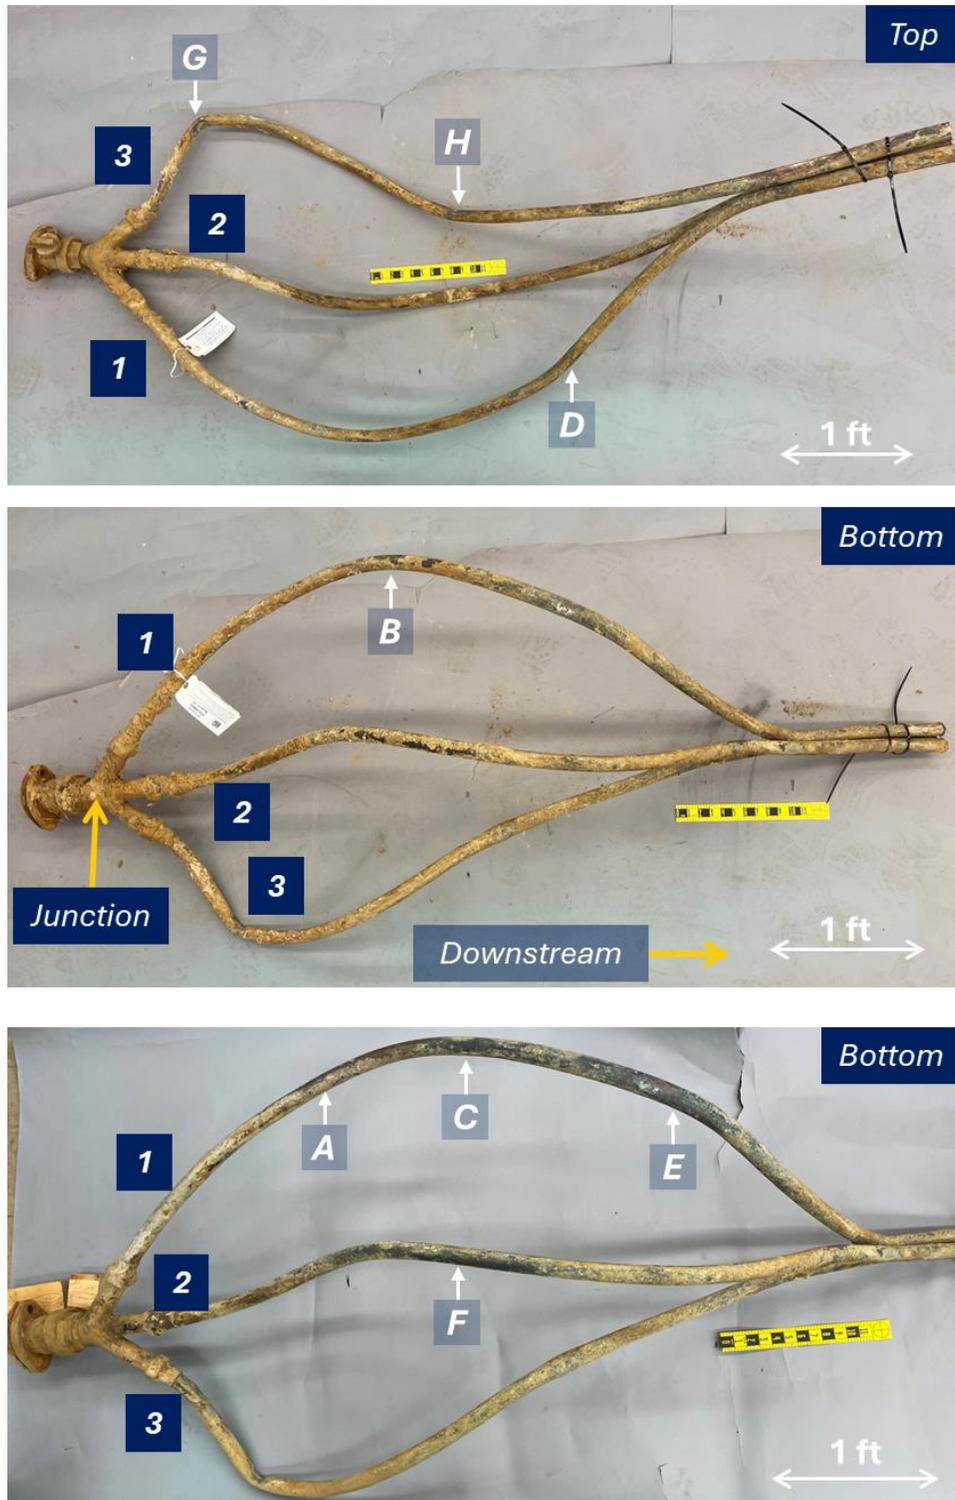
A section of copper water pipes excavated from Location 1 was also submitted (Figure 5). This piece was installed above the gas service pipe. The assembly consisted of three flexible copper pipes (approximately 1 inch outer diameter) connected to a double wye fitting that would have connected to the water main. Generally, these pipes spread outward from the double wye, curved downwards (deeper into the ground, as excavated) to approximately the halfway point, and then curved back upwards and towards a central point approximately in line with the orientation of the double wye. The pipes were arbitrarily labeled "1" through "3" by the NTSB Materials Lab for purpose of orientation. Per the NTSB Pipeline Operations Group report, pipe 1 traversed over the gas service pipe in the vicinity of Area "E" (labeled in Figure 5).¹⁰ The pipes were cleaned with a soft plastic bristle brush and water and surface damages were recorded (Table 2). Several notable areas of damage on pipe 1 are described in the following text, some of which are accompanied by close-up photographs.

Pipe segment	Area of Interest	Associated close-up image	Approx. start and end distance ¹² (inch)	Calculated Length (inch)	Approx. clock position when looking downstream	General observation
1	A	--	23 - 27	4	2:00 - 4:00	Mixed black and green corrosion product
1	B	Fig. 6	27 - 36	9	5:30 - 6:30	Shiny parallel scrapes diagonal to axis of pipe.
1	C	--	35 - 40	5	4:00 - 8:00	Mixed black and green corrosion product
1	D	Fig. 7	48	1	12:00	Shallow dent, linear, 1 inch long
1	D	Fig. 7	54.5	1	12:00	Shallow dent, linear, 1 inch long
1	E	Fig. 8	44 - 54	10	3:00 - 9:00	Mixed black and green corrosion product
2	F	--	21 - 34	13	4:00 - 8:00	Mixed black and green corrosion product
3	G	--	14	1	Whole pipe	Pipe kinked to form ~120° upward angle. Appears pinched, almost reducing the inner diameter to closure. Edges of the deformed areas are shiny.
3	H	--	35 - 37	2	11:00 - 3:00	Dent partially closes off the pipe.

Figure 5. (Top) Top surface of the copper water pipes as received. (Middle) Bottom surface of the pipes as received. (Bottom) Bottom surface of the pipes after cleaning with water, revealing areas of black and green corrosion product. The right side of the pipes were held together by tie straps to facilitate shipping and transportation. Areas marked with letters are associated with damage noted in Table 2.

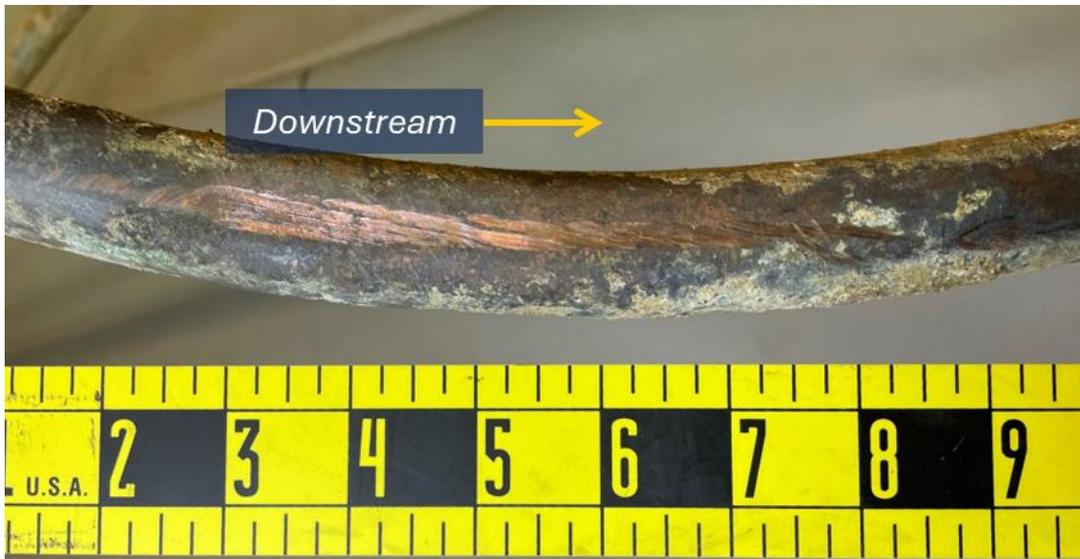
A series of diagonal (relative to the cylindrical axis of the pipe) scrapes was noted starting approximately 27 inch from the double wye fitting (Area "B", close-up in Figure 6). The scrapes were copper-colored and shiny in appearance. This area extended 9 inch along the length of the pipe. Viewed from the fitting towards the cut

end, the widest point of the scrapes extended from the 5:30 position to the 6:30 position (approximately 0.5 inch wide).

Figure 6. Series of surface scratches located on the bottom of pipe 1 (Area "B" in Figure 5).

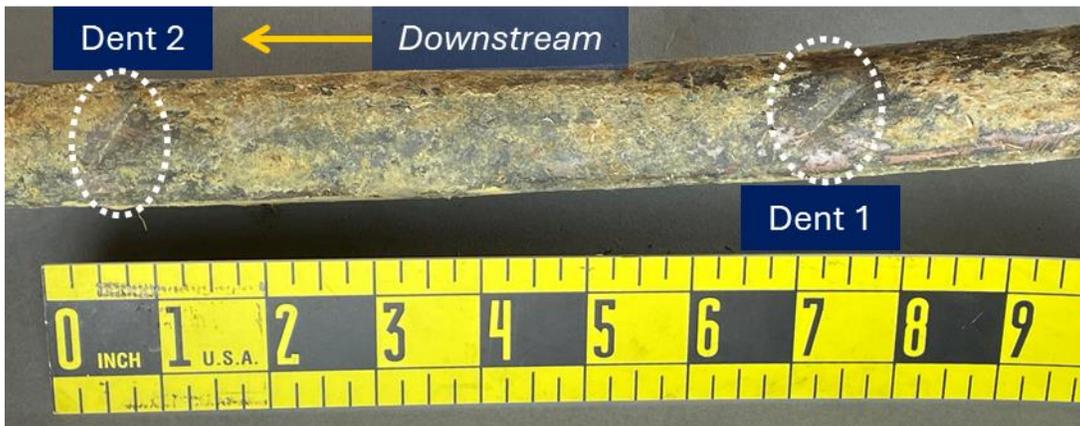
Further downstream, two dents were noted on the top of pipe 1 (Area "D", close-up in Figure 7). The first was located 48 inch from the fitting, and the second was 54.5 inch from the fitting. They were approximately 1 inch long and parallel to each other, angled approximately 45° compared to the axis of the pipe.

Figure 7. Two dents located on the top of pipe 1 (Area "D" in Figure 5).

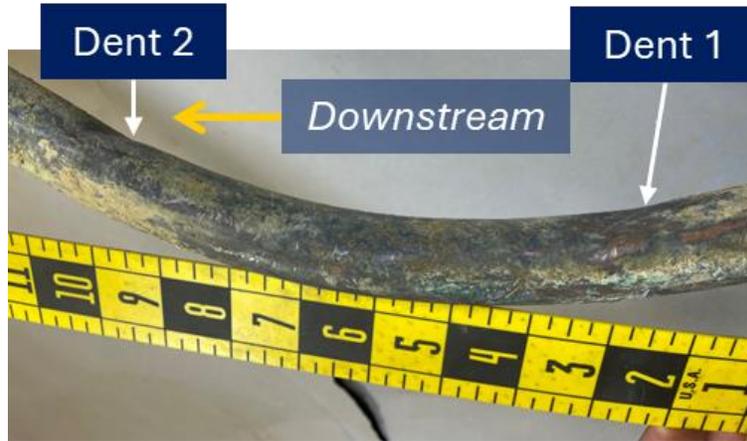
The bottom of pipe 1 in the area below the two dents showed a mix of black and green corrosion product (Area "E", close-up in Figure 8).¹¹ Similar areas of corrosion product were noted at other locations on pipe 1 and on pipe 2.

Figure 8. Area "E" in Figure 5 showing pipe 1 from the side. Black and green corrosion product was visible on the bottom of the pipe near where the two topside dents were located. The two dents from Area D (Figure 7) are visible in this image

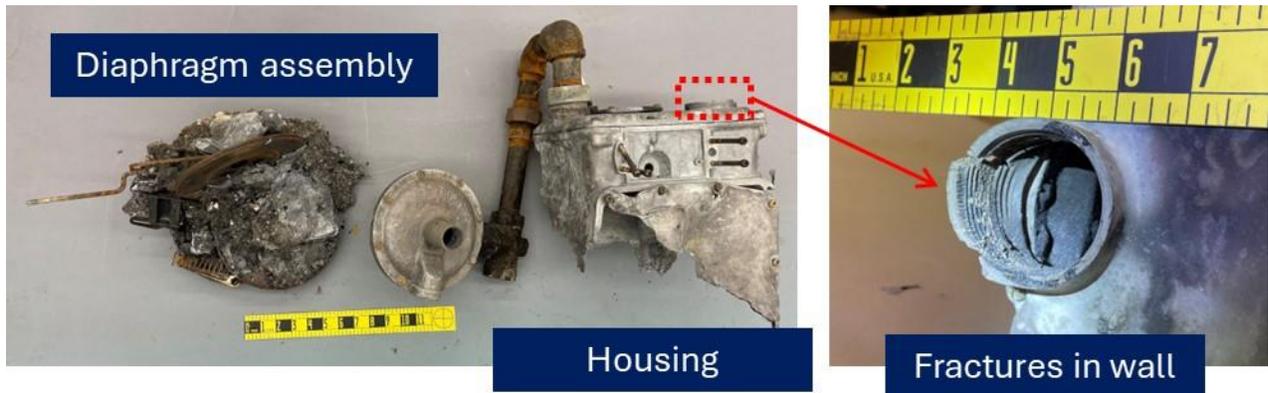
Pieces of the diaphragm and housing for the gas meter from Location 1 are pictured in Figure 9. The bottom half of the housing was missing. The remaining housing showed extensive signs of melting and re-solidification. The remains of the diaphragm mechanism were fused together with a mixture of metallic material and ash. A female-threaded connection on the top of the housing was deformed and

fractured. Damage to the diaphragm and housing was consistent with exposure to heat for an extended period.

Figure 9. (Left) Remains of gas meter housing and diaphragm assembly. (Right) Fractures seen in wall of the outlet connection threading.

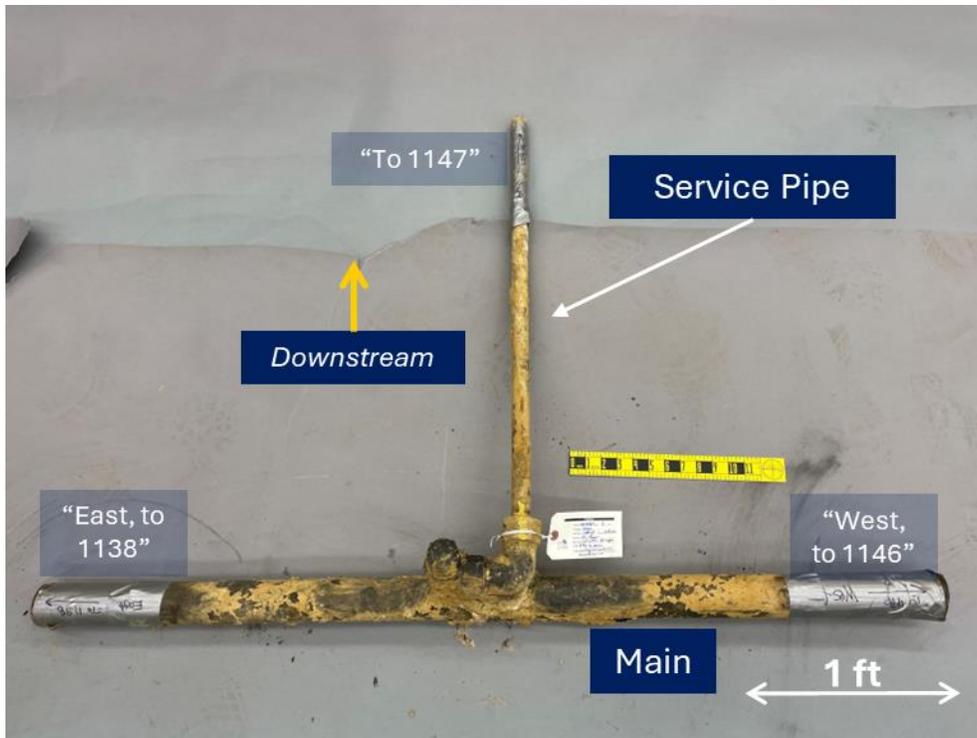
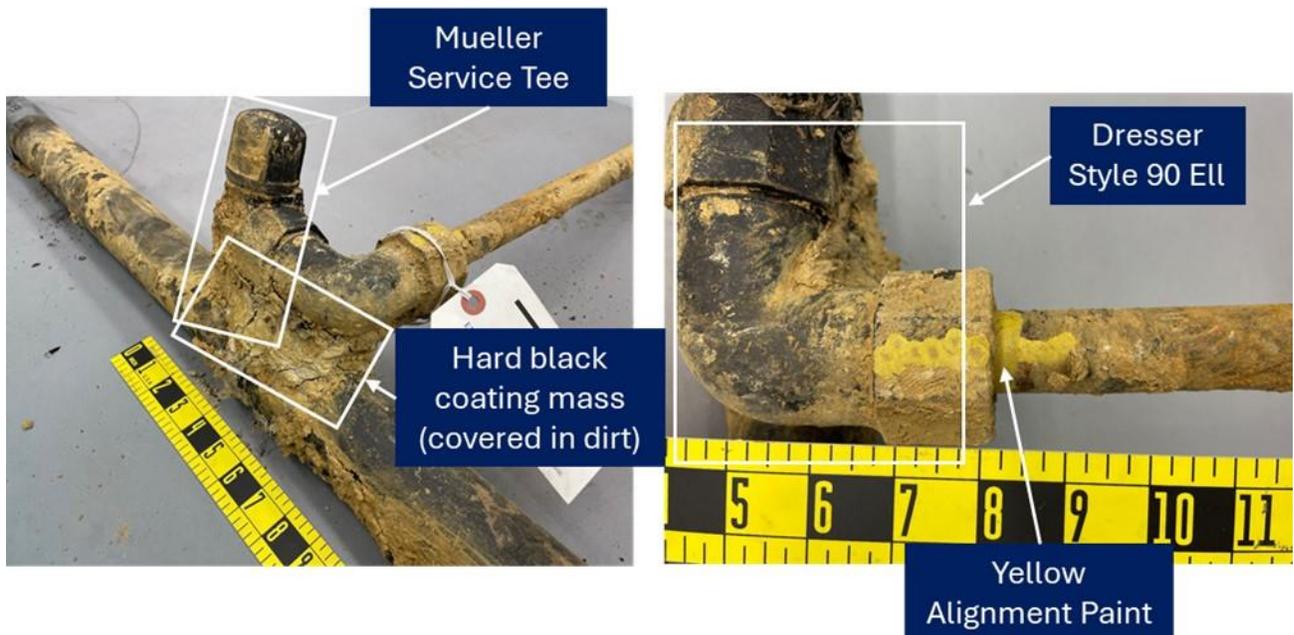
Figures 10 and 11 show the parts as received from Location 2. The gas main, tee¹³ and service pipe assembly from 1147 Shalimar Dr. was submitted as a single piece. The assembly consisted of a 2-inch main, Mueller H-17510 service tee, a Dresser ¾-inch Style 90 Ell connector, and a section of ¾-inch service pipe (measured approximately 2.5 feet in length, 1.045 inch outer diameter, 0.790 inch inner diameter). A section of the pipe was cleaned with soapy water and a soft plastic bristle brush to expose bare metal, and that section was subjected to a portable XRF alloy analyzer for analysis. The chemical composition showed in general a high amount of iron (91 wt %) and some silicon (6.9 wt %), with other elements showing less than 1 wt%.¹⁴ The outer surface of the main was covered with a black coating (resembling a hard tar-like material). A greater amount of black coating was present at the tee and the surrounding area, and a mass of coating extended between the main and the ell connector. Sections without the black coating showed brown and black corrosion product with no appreciable wall loss. There was no evidence that the corrosion had penetrated through the pipe walls.

A patch of yellow paint in the rough shape of a cross was visible on the outer surface of the service pipe and the ell connector where the pipe was inserted (visible in Figure 11). Per the Atmos party representatives¹⁵, the yellow paint was added during excavation to mark the relative position and alignment between the service pipe and the ell connector, as the connection was loose. Upon receiving the pipe at the NTSB Materials Laboratory and removal from the shipping crate, the service pipe was able to be moved around in its connection. The assembly was handled carefully to avoid further loosening the joint. All other joints in the assembly were rigid (did not move relative to each other).

Figure 10. Main, tee, and service pipe as-received from 1147 Shalimar Dr (Location 2). Text in quotes are the notes written on the pipes as-received.

Figure 11. (Left) Oblique and (right) top views of the tee, ell, and service pipe joint from Location 2. Yellow paint marks the alignment of the service pipe as-received.

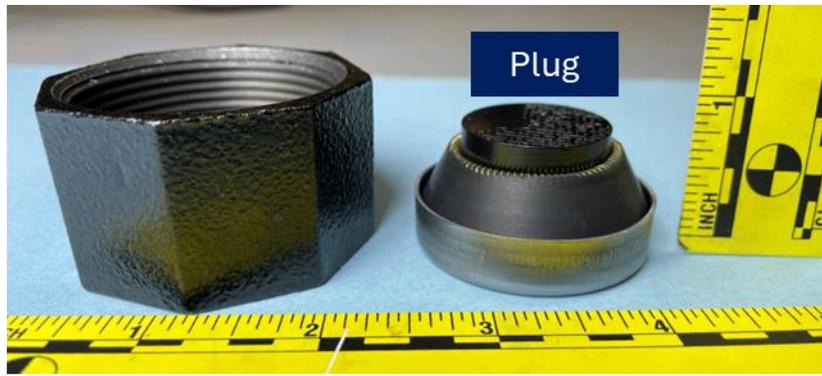
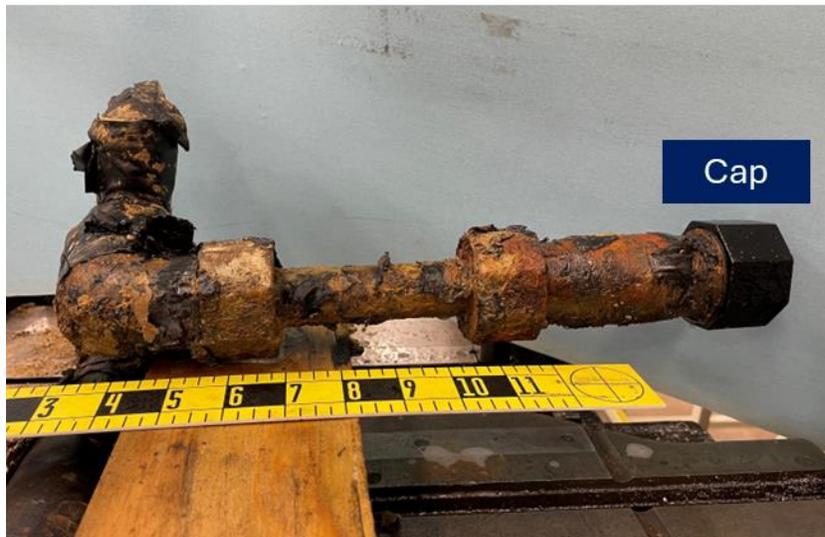
Pressure tests were performed on the tee assembly and service pipe separately. The nut and gasket at the open end of the straight coupling on the tee assembly were replaced with a Dresser ¾-inch cap adapter (Figure 12).¹⁸ Soapy water was applied to the test articles to aid with leak detection. The pressure test results are summarized in Table 3. No leak flow was measured, and no bubble formation was observed in either the assembly or the service pipe.

Figure 12. (Top) Cap used to seal the open end of the assembly from Location 1. (Bottom) assembly and tee during pressure test. No bubble formation was observed on any surface during the test.

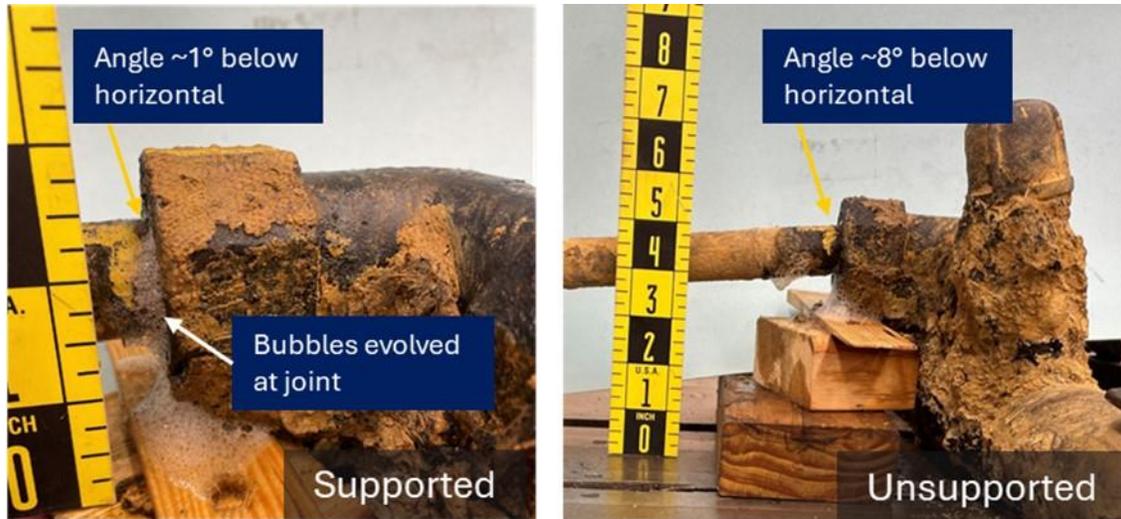
During setup of the pressure test, it was noted that the service pipe could be moved and turned in its connection to the pipe assembly at the ell joint. Prior to the start of testing, it was noted that the pipe had slipped out of the joint by approximately 1/16 inch during handling of the assembly, based on a gap between the yellow marking paint and the nut. When the main was secured such that the ell was parallel to the ground, the service pipe would droop downwards under its own weight unless it was supported. Thus, two pressure tests were conducted (Figure 13).

For the first pressure test, the service pipe was supported on blocks to minimize the angle between the ell and the service pipe. The measured angle between the axis of the pipe and the axis of the ell was approximately 1°. When tested in this configuration, soap bubble formation was observed at the joint between the service pipe and the ell starting at 5 psig of applied pressure. However, the flow rate was too low to be measured by the flowmeter (<0.13 SCFM, air) at all pressures.

For the second pressure test, the support blocks were removed and the pipe was allowed to droop downwards under its own weight. In this configuration, the measured angle was approximately 8°. Bubbles formed at the service pipe/ell joint starting at 5 psig. Starting at 20.8 psig, the joint made an audible hiss and soap water applied to the joint was expelled before bubbles could form. Starting at 30.2 psig, the flowmeter measured a positive flow rate. Table 4 contains a summary of pressure test results.

Figure 13. (Left) Bubbles formed at the joint between the ell and the service pipe at Location 2 when the service pipe was supported. (Right) Air escaping at higher pressures forced the soapy water out of the joint before significant bubbling could occur.

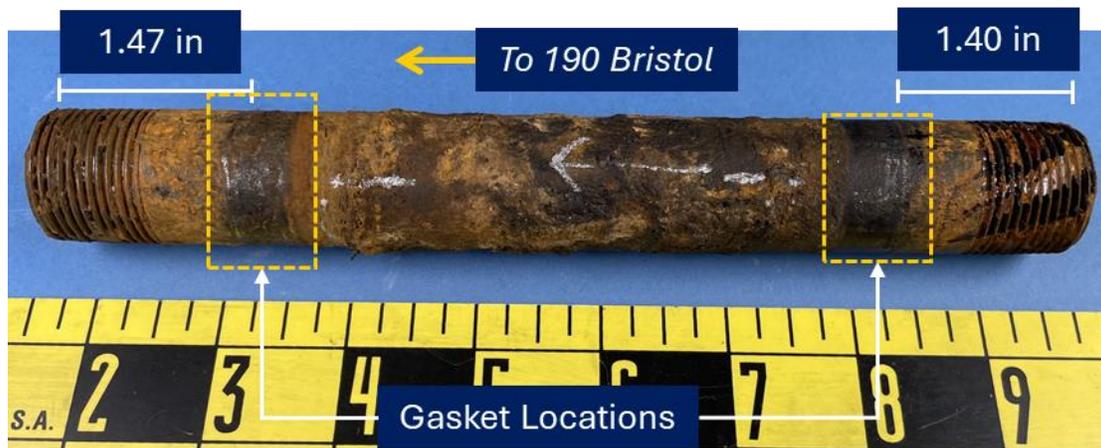
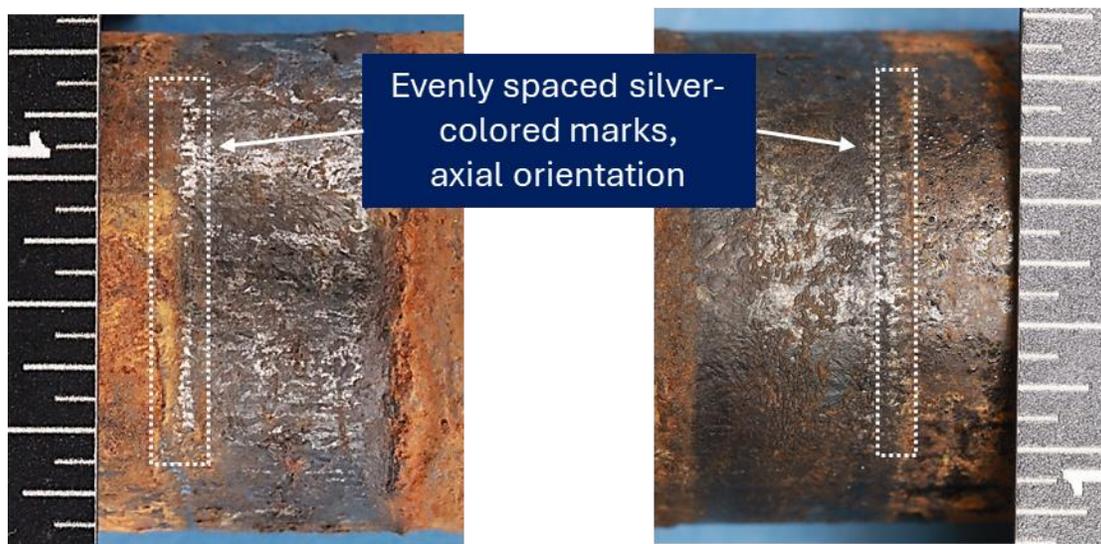
The connecting nipple was removed from the ell and straight coupling. The toes of the gaskets were located approximately 1.4 inch away from the ends of the nipple (Figure 16), consistent with a stab depth of 2 inch. Brown rust was present across much of the surface of the pipe, except where the gaskets had been. These regions had developed significantly less rust. In the locations under the toes of each gasket, a series of silver-like, highly reflective marks were visible. These marks were linear, parallel to the axis of the nipple, and evenly-spaced around the circumference of the nipple.

Figure 16. (Top) Nipple between the straight coupling and the ell from Location 1. Yellow boxes mark the location of gaskets prior to removal. (Bottom Left) Gasket location on the downstream end of the nipple. (Bottom Right) Gasket location from the upstream end of the nipple. Silver-like reflective marks were seen around the circumference of the nipple under where the toes of the gaskets had been located.

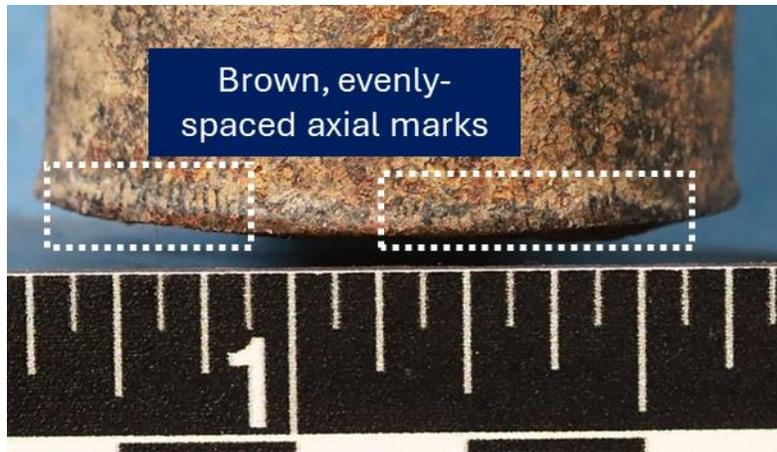
A bench stereoscope was used to examine the upstream end of the service pipe. The end of the service pipe flared outward slightly, creating a lip along the outside edge of the pipe. Evenly-spaced linear marks, similar in size to the marks seen on the nipple pipe, were visible at the edge of the lip, running around the circumference of the pipe (Figure 17). Spacing between the marks was measured to be approximately 0.02 inch. A layer of corrosion product was present on the marks, having a brown or black appearance.

Figure 17. Evenly spaced axial marks seen at the flared upstream end of the service pipe from Location 1.

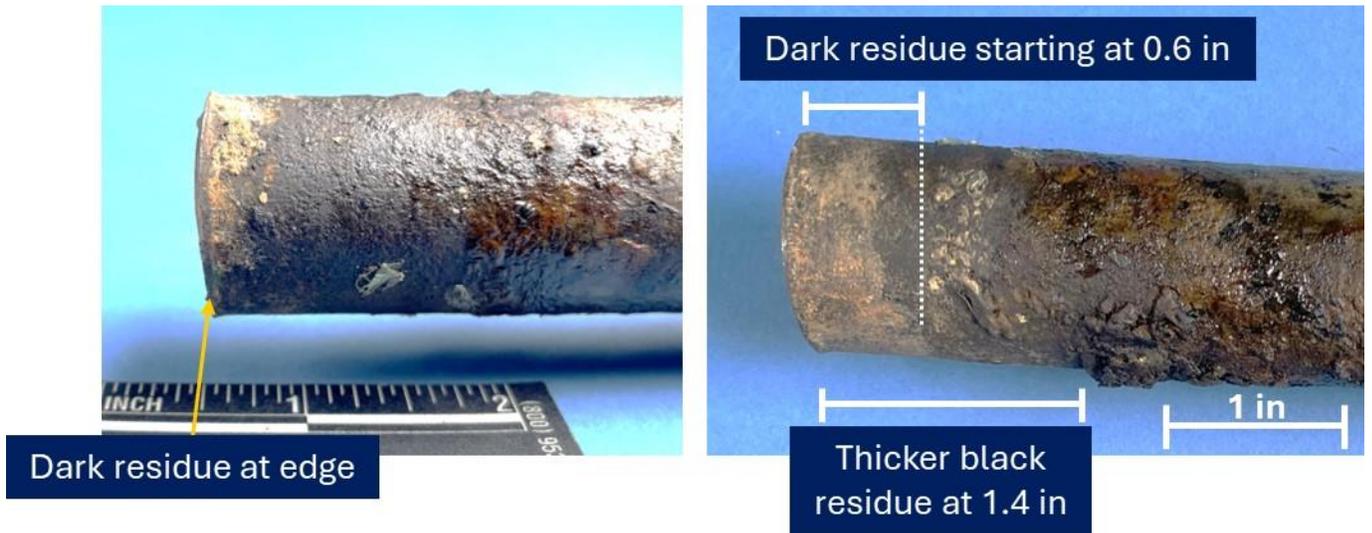
The amount of dark residue on the outside of the pipe at the upstream end increased moving towards downstream (Figure 18). A thin layer of dark residue extended all the way to the upstream end on one side of the pipe. Elsewhere, the thin layer of residue did not start until 0.6 inch from the end. The tape was adhered to the pipe starting approximately 1.2 inch from the upstream end. Thick pieces of sticky residue were visible beginning approximately 1.4 inch from the end. The residue was

resistant to removal using dish soap, ethanol, and an Alconox²² solution when scrubbed with a soft plastic bristle brush.

Figure 18. Dark residue progression from the upstream end of service pipe from Location 1 (left) viewed at the top of the pipe (right) viewed from the side of the pipe.

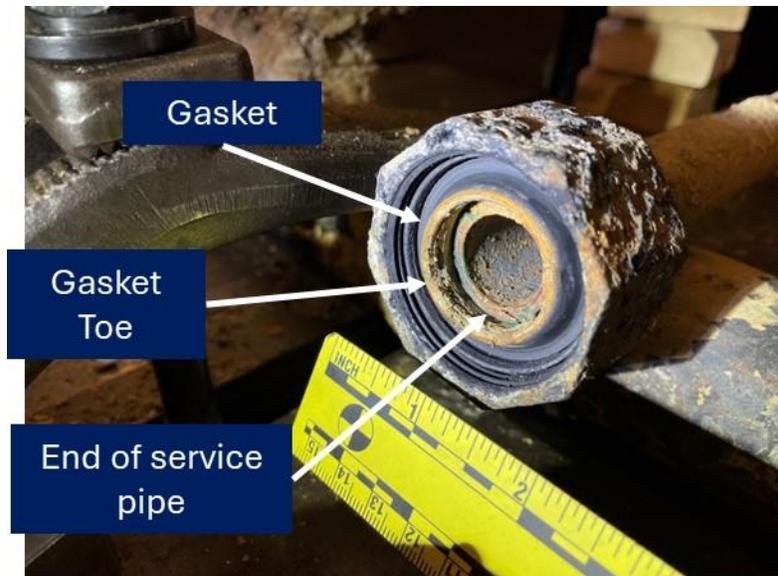
The connection between the ell and the service pipe was disassembled with the service pipe in place. Upon removal, it was discovered that the service pipe did not fully extend through the rubber gasket (Figure 19). A layer of brown dirt was visible on the inner wall of the gasket. This layer of dirt extended from the toe to approximately 0.25 inches along the inside wall of the gasket. Patches of green corrosion product were visible on the dirt and on the end of the service pipe. The service pipe was removed from the gasket and the gasket was collected for further examination.

Figure 19. Service pipe, gasket, and end nut from Location 2 after disconnection from the assembly. The service pipe did not feed fully through the gasket, with an approximately 0.25 inch space between the toe of the gasket and the end of the pipe.

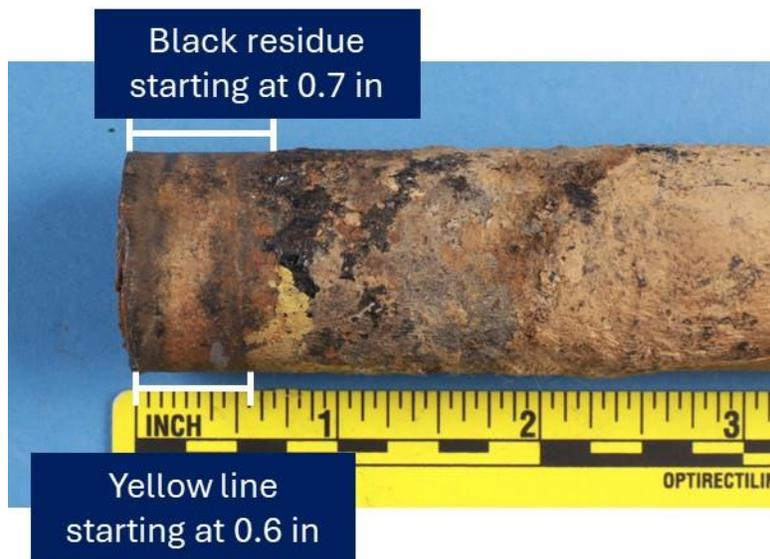
The yellow paint mark was measured to be 0.6 inch from the upstream end of the pipe. At 0.7 inch, a circumferential line of hard black tar-like material adhered to the service pipe (Figure 20). This residue stretched approximately one-third of the way around the circumference of the pipe. A sample of this residue was compared against the hard black residue material found on the end nut using Fourier Transform Infrared Spectroscopy (FTIR). FTIR showed a match between the two specimens, which were consistent with a coal tar epoxy coating material. The residue on the nut extended to the inner rim of the nut where the pipe was inserted (Figure 21). The location of the residue roughly lined up with the location of the residue on the pipe when it was inserted into the nut and aligned with the yellow paint marks, with overlap between the residue on the pipe and the residue on the inner rim of the nut. The end nut, retainer cup, and an exemplar gasket were assembled per the Dresser schematic. The distance from the toe of the gasket to the outer edge of the end nut was measured using calipers and found to be approximately 0.8 inch.

Figure 20. Black residue visible on the upstream end of the service pipe from Location 2 close to the yellow paint marking.

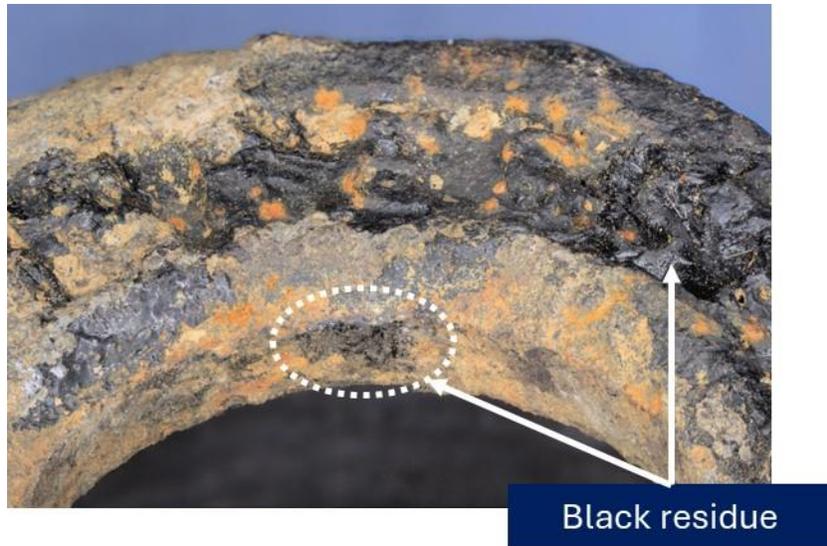
Figure 21. The end nut from the ell at Location 2. Hard black residue was seen on the stamped surface of the nut and on the wall where the nut would have been in contact/near contact with the service pipe when it was inserted (white circle).

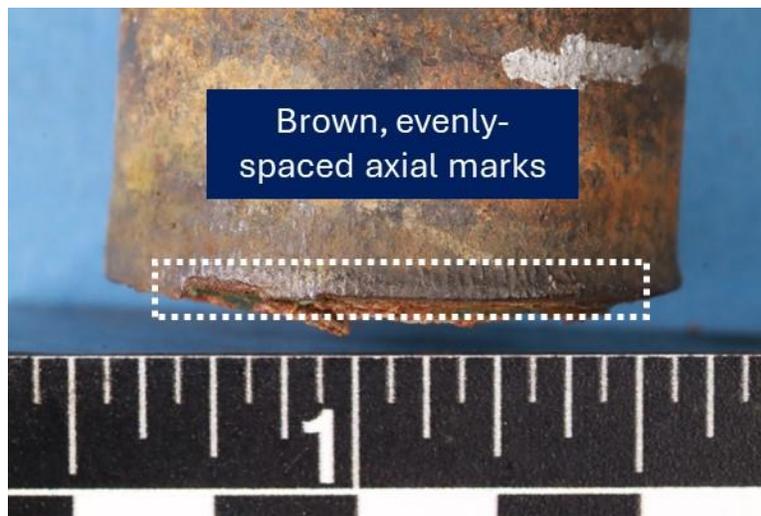
The end of the service pipe was flared, similar to the pipe from Location 1. Further, examination of the service pipe under the bench stereoscope revealed evenly spaced axial marks around the lip of the edge (Figure 22). The spacing of these marks measured approximately 0.02 inch. The marks were covered with a layer of corrosion product with a brown-black appearance, similar to the marks on the pipe from Location 1.

Figure 22. Evenly-spaced axial marks seen at the flared upstream end of the service pipe from Location 2.

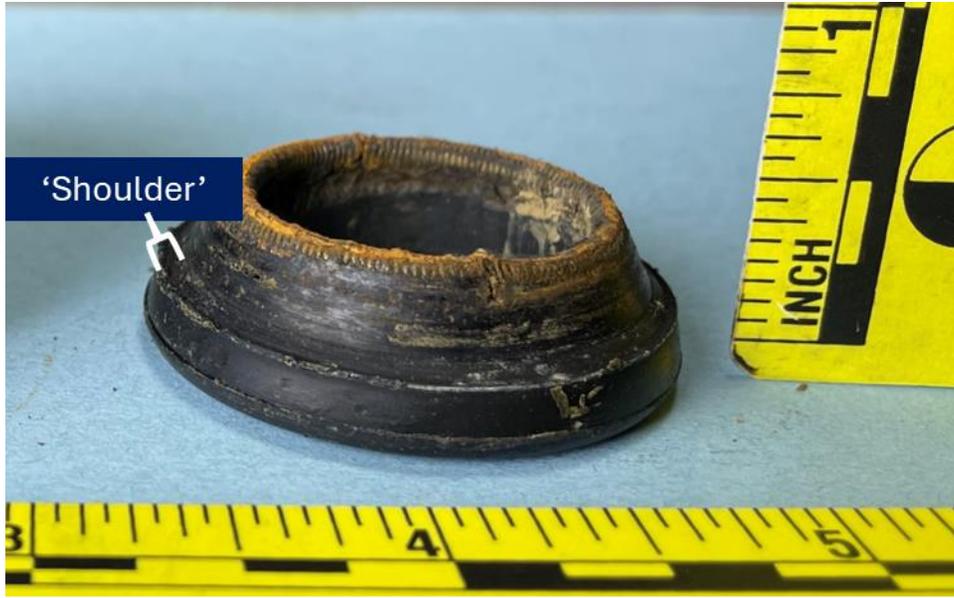
through “5” as detailed in Table 5. None of the gaskets removed from the assemblies had straight outer walls. Rather, the gaskets had a ‘shoulder’ that ran around the circumference of the gasket (Figure 23). The cross-sectional dimensions of the gaskets were measured with calipers and are recorded in Table 6; dimensions are linked to the schematic in Figure 24. The measured dimensions of the gaskets were consistent with the exemplar gasket for joints of those dimensions. Further, all gaskets showed similar deformation at the inner diameter of the heel, where a small amount of material extruded out of the gap between the outer wall of the service pipes and the retainer cups. All gaskets were pliable under an applied pressure and showed no evidence of dryness or surface cracking when examined under a bench stereoscope. Further, the gaskets had alphanumeric characters molded into the heel. Per input from the Dresser party member, these markings denoted the gasket size, elastomer material type, and the year the gasket was manufactured²⁴, among other information.

Figure 23. Gaskets taken out of the couplings in service had an angled 'shoulder' that ran around the circumference of the outer wall of the gasket. Example: gasket from Location 1 (for comparison, see the exemplar in Figure 15).

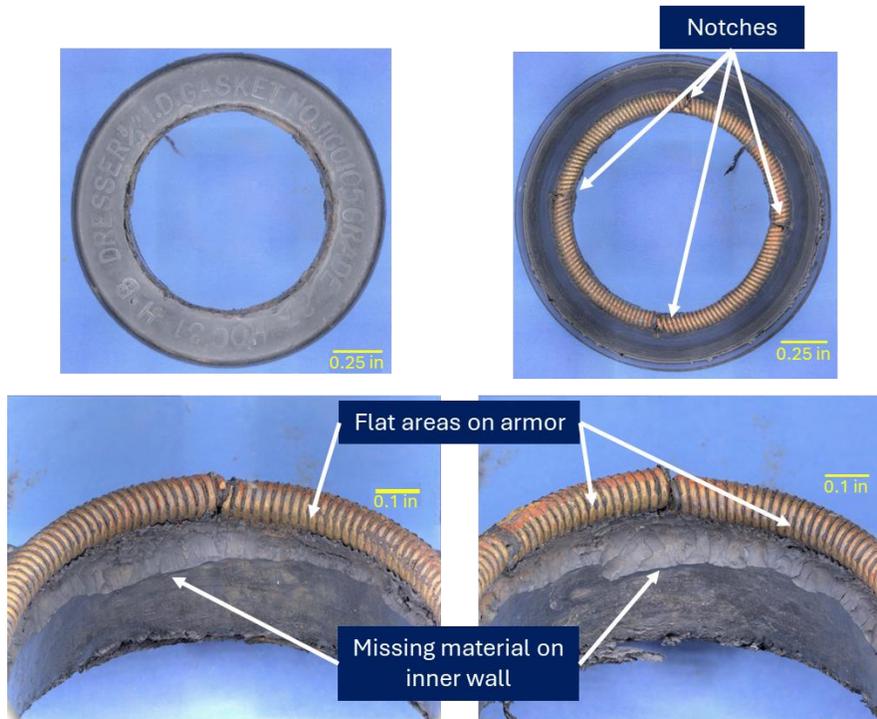
Gasket 1 showed damage resembling a fissure traveling around the circumference of the inner wall below the armor (Figure 25). At its widest, the fissure was approximately 0.15 inch wide (measured from the base of the armor towards the heel of the gasket) with a depth of approximately 0.03 inch, measured in a Keyence VHX-7000 digital microscope.²⁵ This armor was shaped in a ‘tight-wound’

configuration, per the Dresser party member. Spacing between the windings of the armor was approximately 0.02 inch. The windings on the gasket armor were not continuous around the circumference of the gasket. Four notches were placed in the armor at 90-degree intervals. Per the Dresser party member, these were added to the armor to optimize the electrical bond in the coupling when installed.²⁶ The armor by the inner wall showed a flat region; this region was visible on windings around the circumference of the gasket. Based on the identification marks found in the heel portion, this gasket was manufactured in 1971.

Figure 25. Condition of Gasket 1 (Location 1, straight coupling, downstream side) after cleaning in ultrasound bath with soapy water.

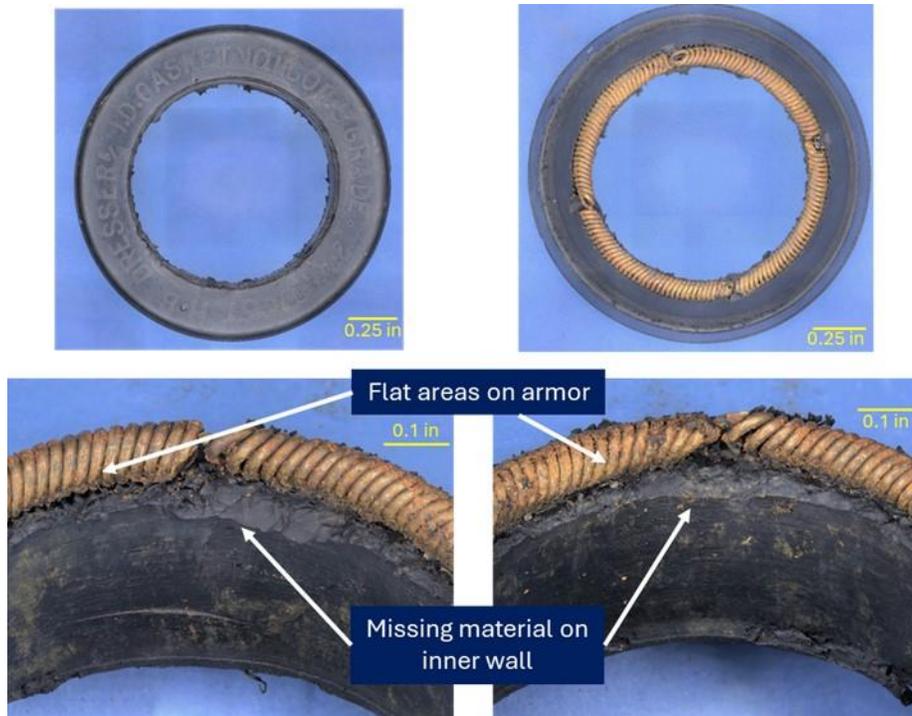
Gasket 2 showed some damage to the inner wall, especially in the area where the armor abutted the rubber. Like Gasket 1, this damage resembled a fissure traveling around the circumference of the inner wall below the armor (Figure 26). At its widest, the fissure was approximately 0.09 inch wide (measured from the base of the armor towards the heel of the gasket) with a depth of approximately 0.02 inch. This gasket also had a 4-notch type armor configuration. The armor by the inner wall showed a flat region. Based on the identification marks found in the heel portion, this gasket was manufactured in 1971.

Figure 26. Condition of Gasket 2 (Location 1, straight coupling, upstream side) after cleaning in ultrasound bath with soapy water.

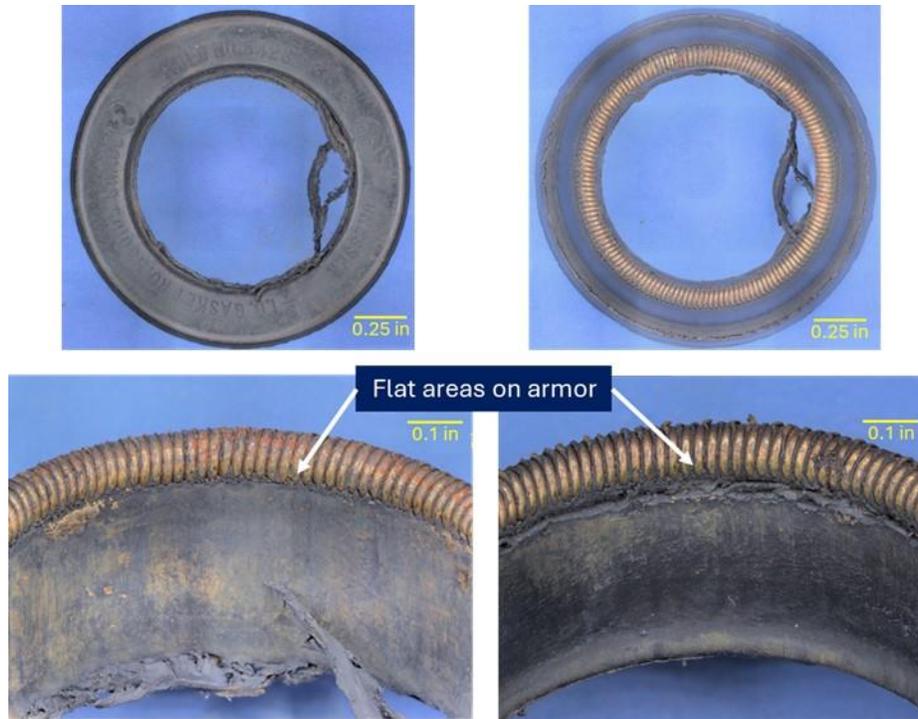
Gasket 3 had a different armor configuration from Gaskets 1 and 2 (Figure 27). The gasket used a tight-wound configuration, but it was continuous around the circumference of the gasket with no notches. The inner wall of the gasket was largely intact, with some damage to the rubber at the wall, where some separation existed between the rubber and the armor. The armor along the inner wall also showed damage consistent with contact wear. Per the markings on the heel, it was determined that the gasket was manufactured in 1963.

Figure 27. Condition of Gasket 3 (Location 1, ell) after cleaning in ultrasound bath with soapy water.

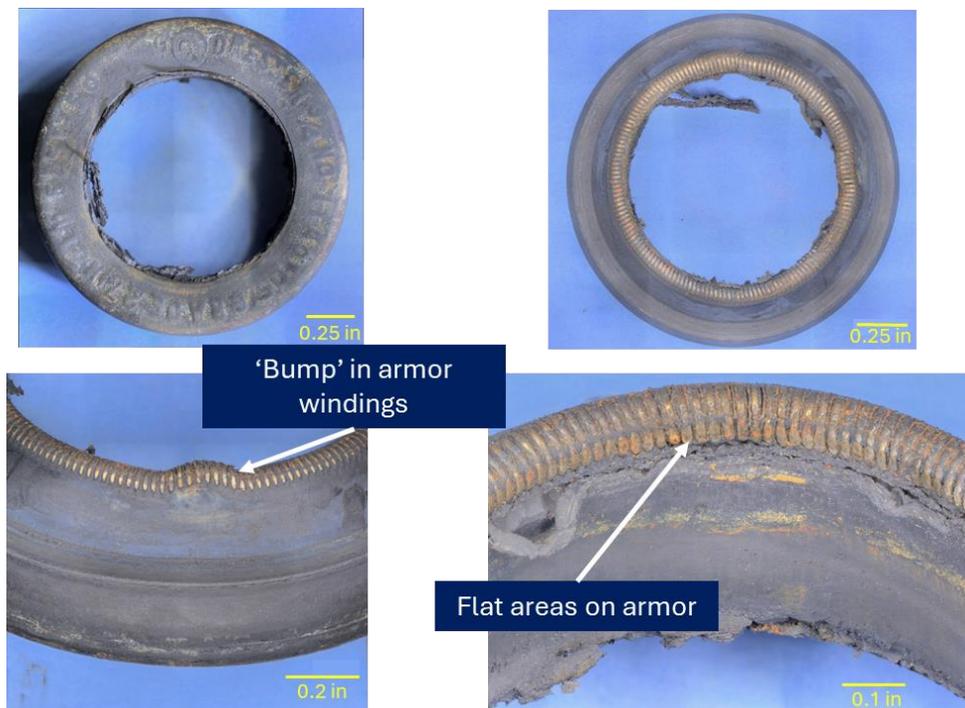
Gasket 4 was stuck in the metal retainer cup and had to be pried out. A wood wedge was inserted between the heel portion of the gasket and retainer cup at various locations of the joint. The wood wedge did not penetrate the joint. This procedure was repeated with a tool containing a steel wedge and the procedure separated the gasket from the retainer cup. Stamped labeling around the heel of the gasket was obscured in several places. However, the portions of the characters that were visible were consistent with the specified part ("11G0105").²⁷ The year indicator was partially obscured but indicated that the gasket had been manufactured between 1960 and 1969. Per the Dresser party member, the lack of notches in the armor (as seen in Gaskets 1 and 2) indicates that this gasket would likely have been produced no later than 1963. The inner wall of the gasket was largely intact, with some damage to the rubber on the inner wall where some separation existed between the rubber

and the armor (Figure 28). The armor along the inner wall also showed a flat region. The armor was continuous around the circumference of the gasket with no notches. Spacing between the windings of the armor was approximately 0.02 inch. At one point along the armor, the armor was deformed, forming a 'bump' in the circle. This bump was approximately 0.12 inch wide and 0.04 inch tall. Damage to the rubber outer wall near this bump was consistent with contact damage on the rubber.

Figure 28. Condition of Gasket 4 (Location 2, ell) after cleaning in ultrasound bath with soapy water.
