National Transportation Safety Board

ERA24FA300

MATERIALS LABORATORY

Factual Report 24-048

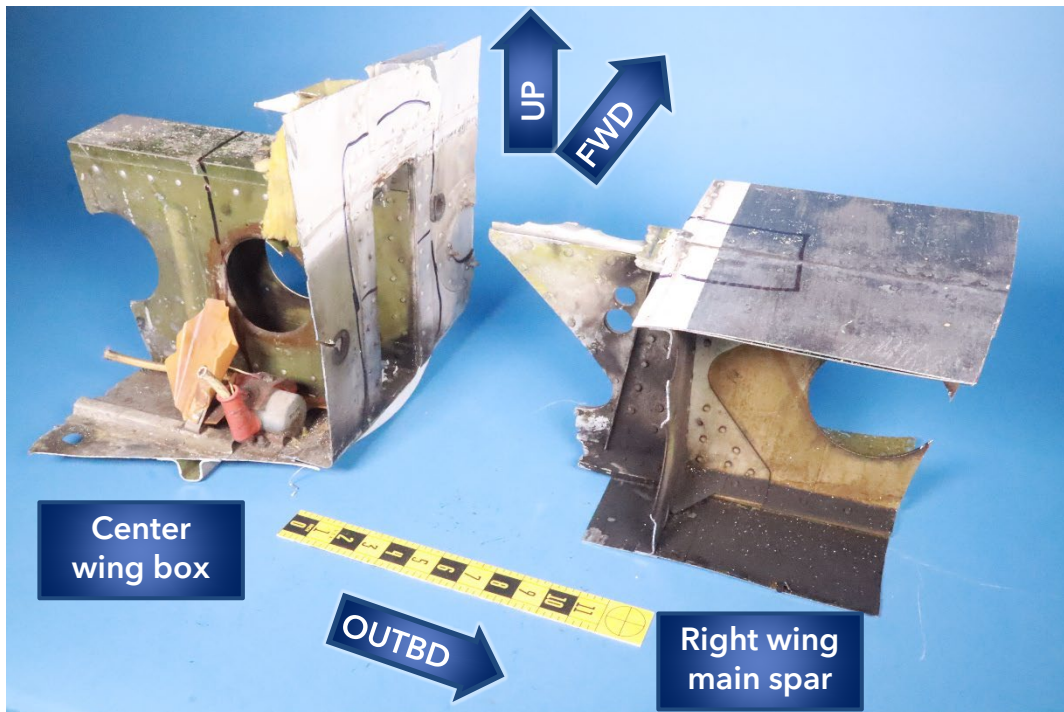
The submitted center wing box piece and right wing main spar piece are shown in figure 1 as received. The right wing main spar upper and lower caps were fractured at the outboard attachment bolt holes. The spar showed general deformation consistent with the wing bending aft relative to the fuselage as shown in figure 2. The spar upper and lower caps had rough, irregular features on slant angles consistent with ductile overstress fractures. A view of the fracture surface on the lower cap is shown in figure 3. The lower cap displayed features consistent with mostly tensile loading whereas the upper cap showed upward bending deformation, a fracture pattern consistent with upward wing bending loads associated with the fracture in addition to the aft bending loads. No evidence of any preexisting cracks or defects were observed associated with the fracture surfaces.

Figure 1. Overall view of the submitted components as received.

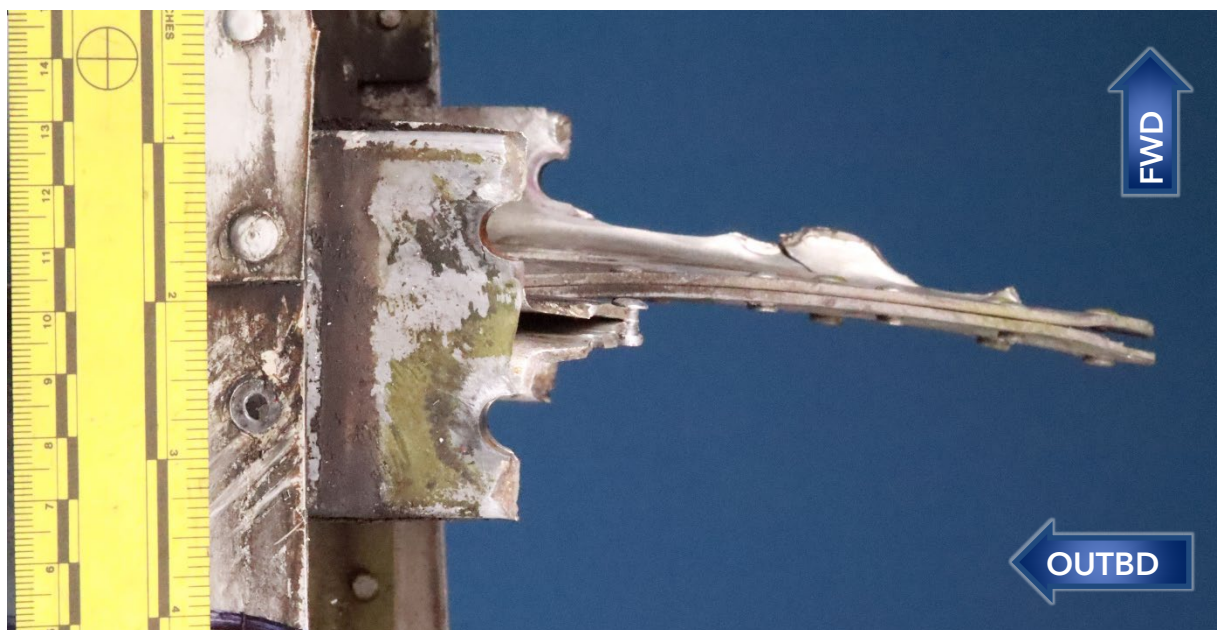
Figure 2. Right wing main spar fracture as viewed looking upward.

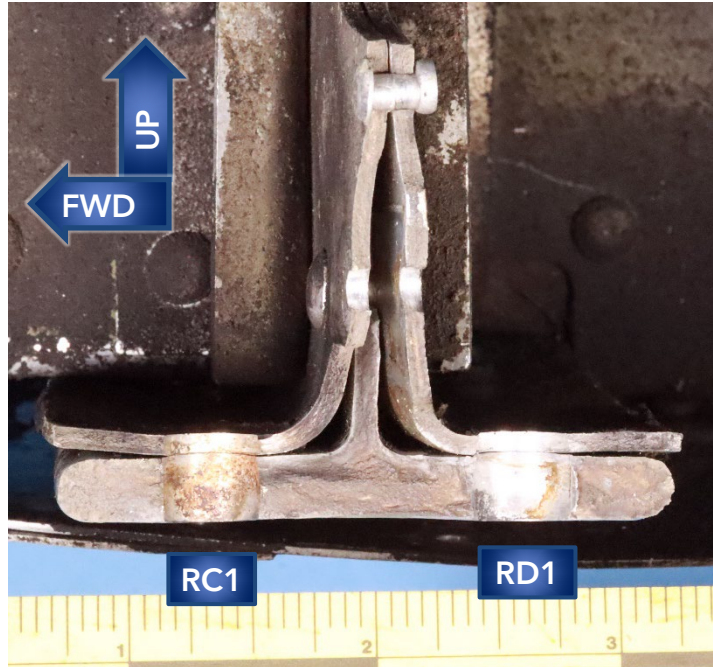
Figure 3. Right wing main spar lower cap fracture surface as viewed looking outboard.

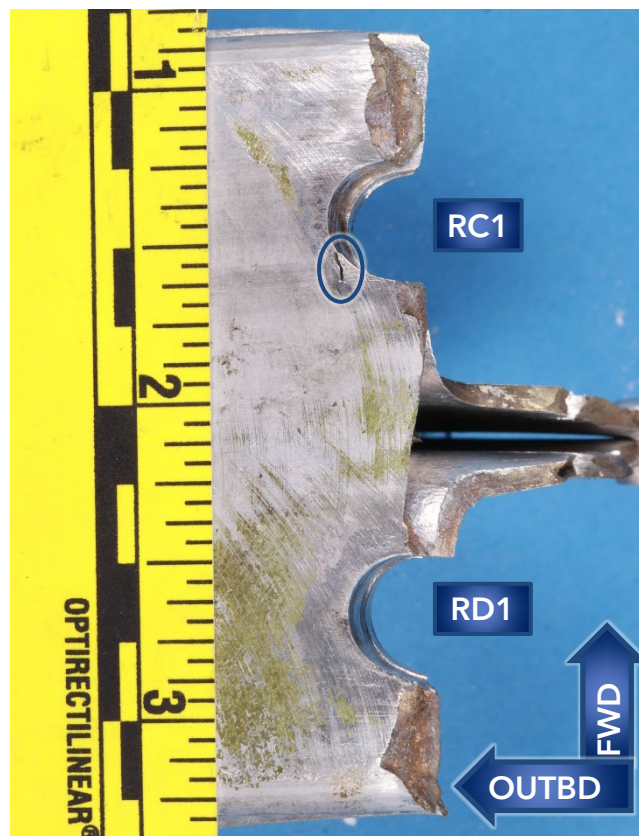
A transverse cut was made through the lower cap outboard of the attachment holes to separate the outboard side of the fracture from the remainder of the spar cap piece. The piece was then cleaned using a soft-bristle brush dipped in acetone followed by additional cleaning with an ultrasonic cleaner while submerged in a beaker of acetone. A view of the lower surface after sectioning and cleaning is shown

Figure 4. Cleaned right wing main spar lower surface adjacent to the fracture surface. A small partially opened crack intersecting hole RC1 is circled.

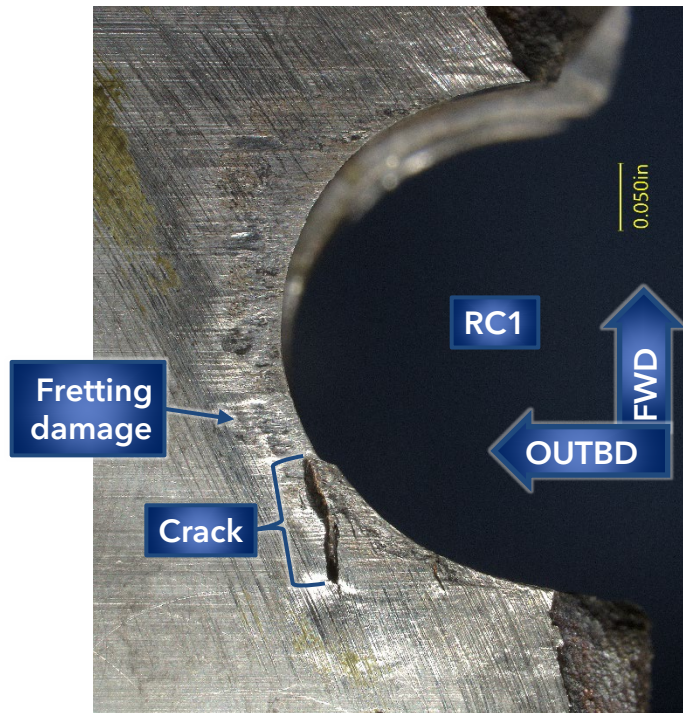
in figure 4, and a closer view of the area around hole RC1 is shown in figure 5. The surface around the outboard side of the hole was rough and pitted consistent with fretting damage. A small crack that was partially opened was also observed as indicated. As shown in figure 5, the partially opened crack was oriented in approximately the transverse plane and intersected hole RC1 on the outboard side of the hole aft of the hole centerline.

Figure 5. Closer view of the partially opened crack and fretting damage at the outboard side of hole RC1.

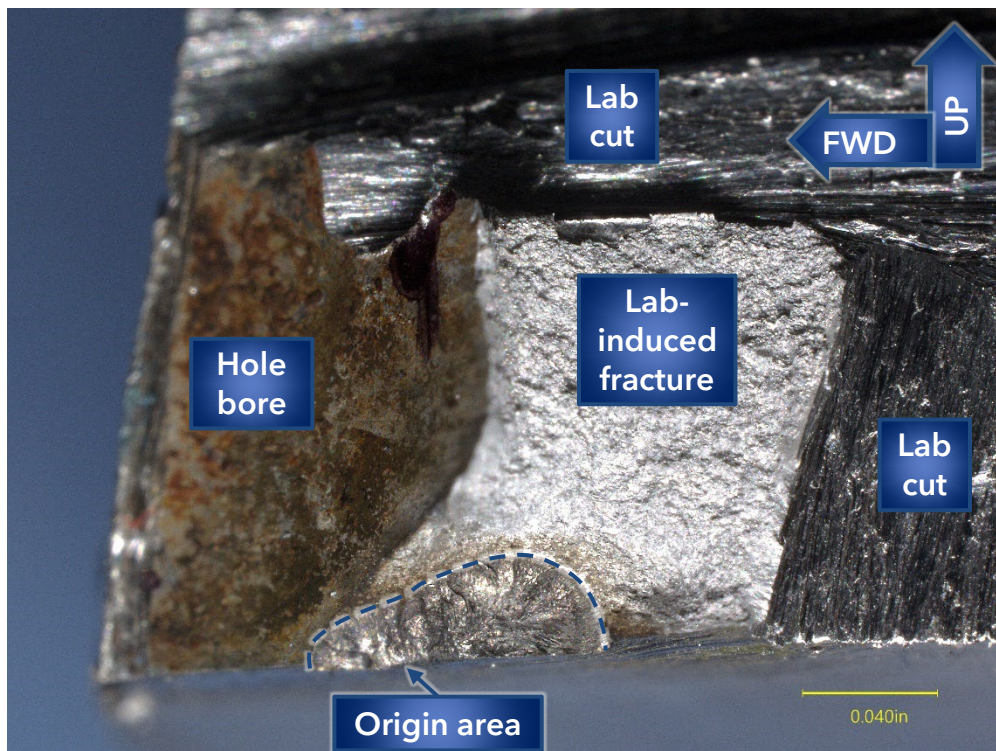
Additional cuts were made through the lower spar to completely open the crack shown in figure 5 by lab-induced fracture. A view of the lab-induced fracture surface showing the outboard side of the opened crack is shown in figure 6. The crack had a curving boundary with crack arrest features on the fracture surface consistent with fatigue. The fatigue features emanated from an origin area located on the lower surface in the area with fretting damage adjacent to hole RC1. The fatigue crack was up to 0.030 inch deep from the lower surface and was 0.088 inch long in the transverse direction where it intersected the lower surface.

Figure 6. Lab-opened fracture surface after opening the crack intersecting hole RC1 showing fatigue features associated with the crack indicated in the previous figure. A dashed line indicates the fatigue boundary.
