# National Transportation Safety Board

WPR23FA044

## **MATERIALS LABORATORY**

Specialist's Factual Report 24-077

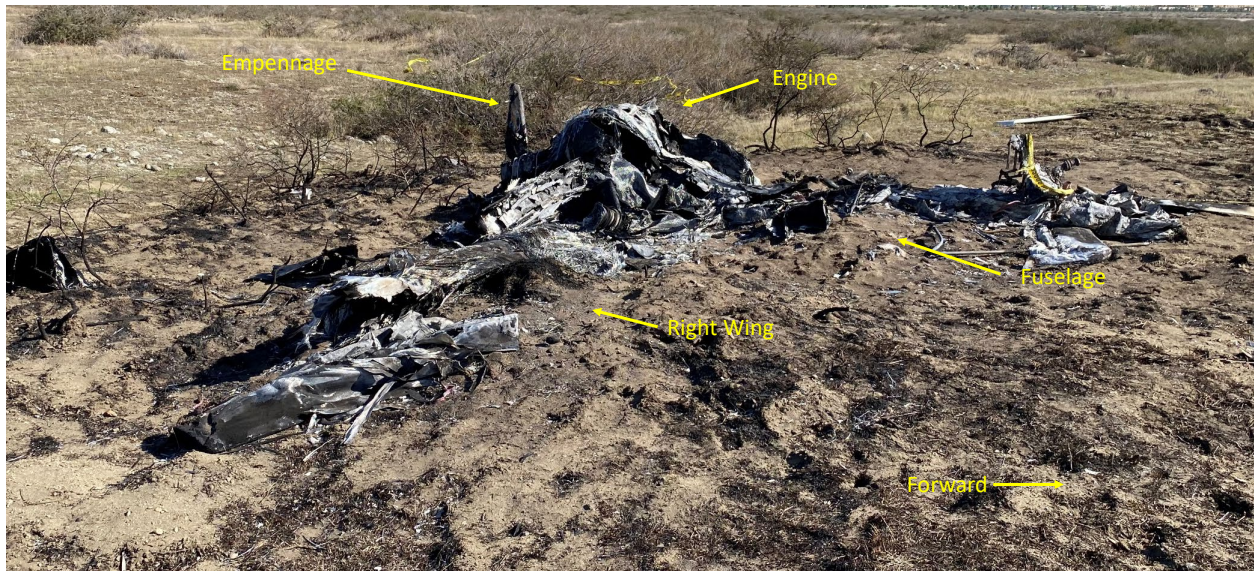
Several small pieces of fuselage and empennage were found away from the impact site and were largely intact with limited fire damage. The remaining composite portions of the aircraft were either missing or heavily fire damaged. The fire damaged composite portions consisted of the carbon fiber mat with the resin burned out as a result of fire/heat exposure as shown in Figure 1.

**Figure 1.** Overall photograph of accident aircraft on scene.

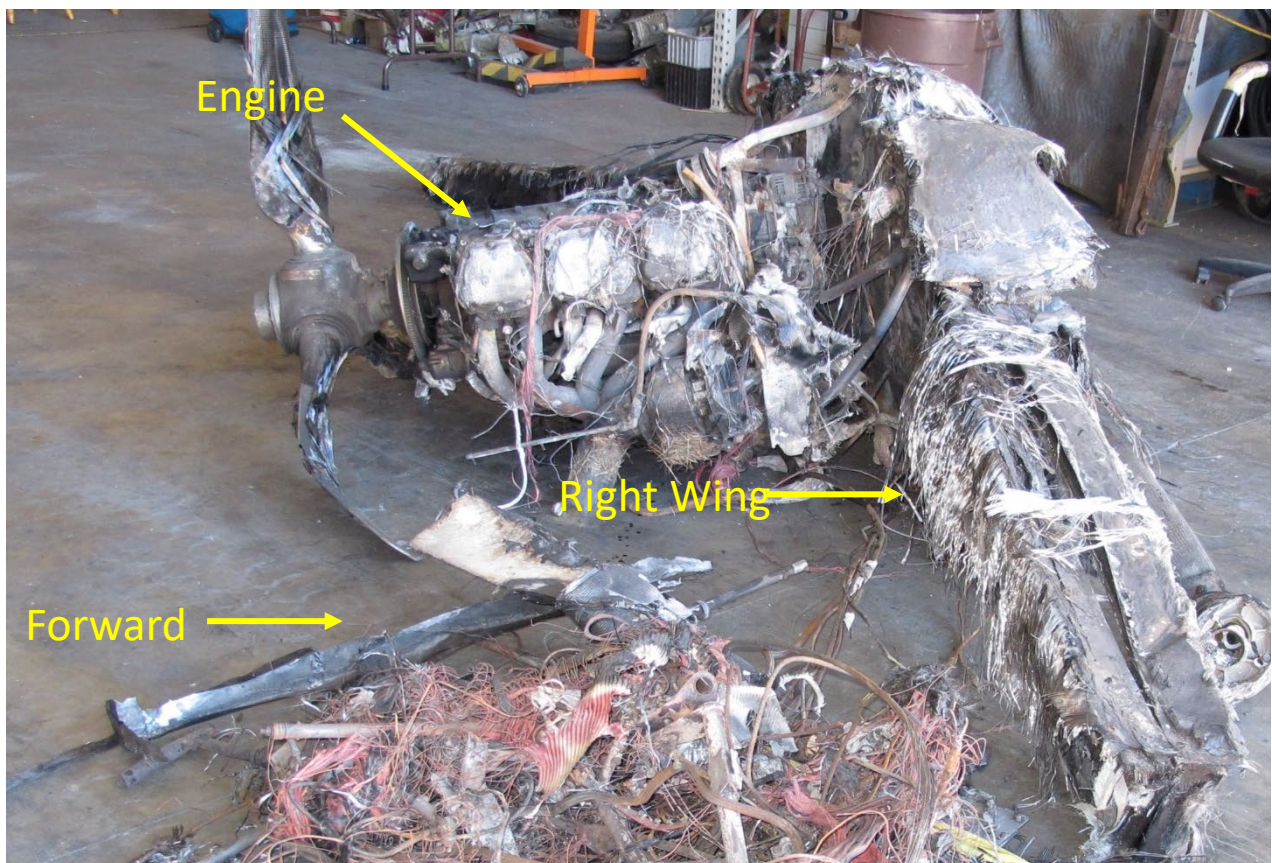
The wing remnants (spars and the remains for upper flight surfaces) were still attached to the engine and engine firewall as shown in Figure 2. During the examination, the engine mounts were cut to separate the engine from the wings/firewall section.

**Figure 2.** Propeller, engine, firewall, and right wing.

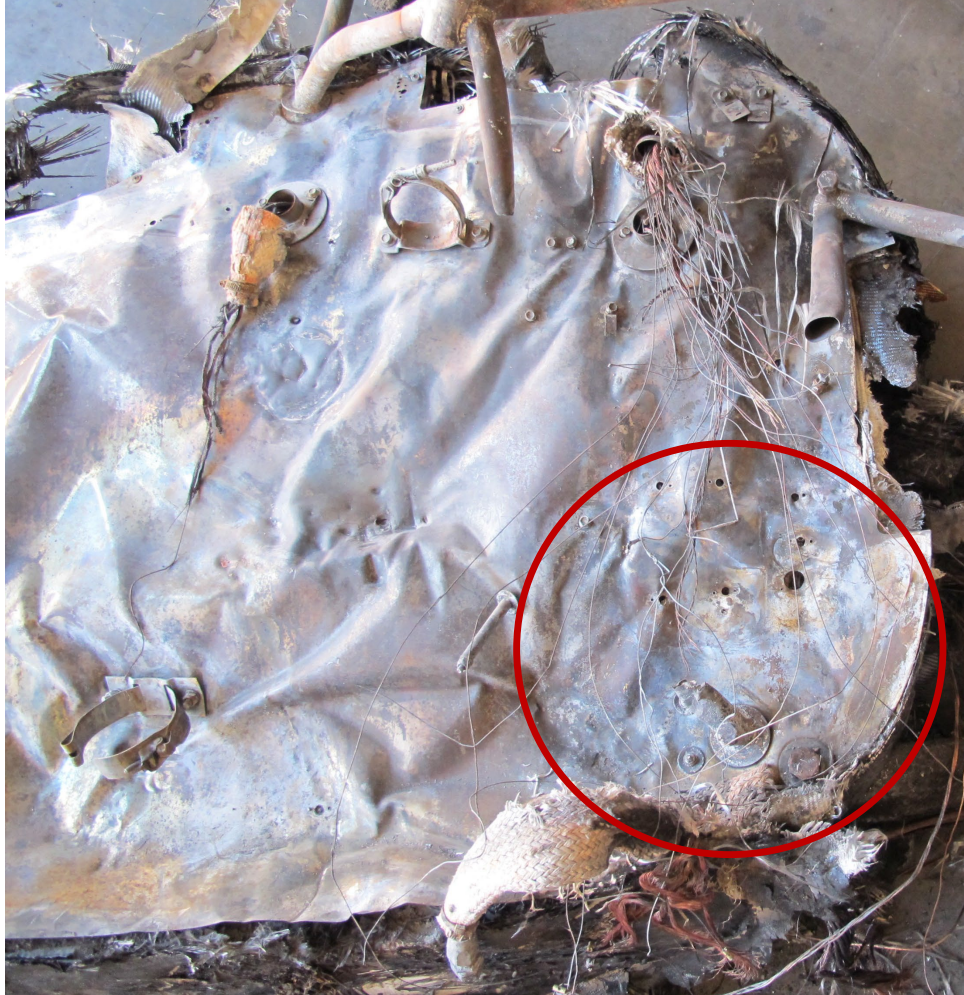
The firewall had varying levels of thermal discoloration and sooting with significant whitening and oxidation in the lower right quadrant of the firewall as shown in Figure 3. There were several indentations in the surface of the firewall that corresponded to various components (fuel pump and oil filter) on the accessory case. The left wing spar was delaminated and thermally damaged but was still completely attached to the firewall as shown in Figure 4. The right wing spar was delaminated and exhibited heavy thermal damage. It also had significantly more damage at the attachment point than the left spar, as shown in Figure 5.

**Figure 3.** The right side of the fire wall. Thermal damage highlighted by red circle.

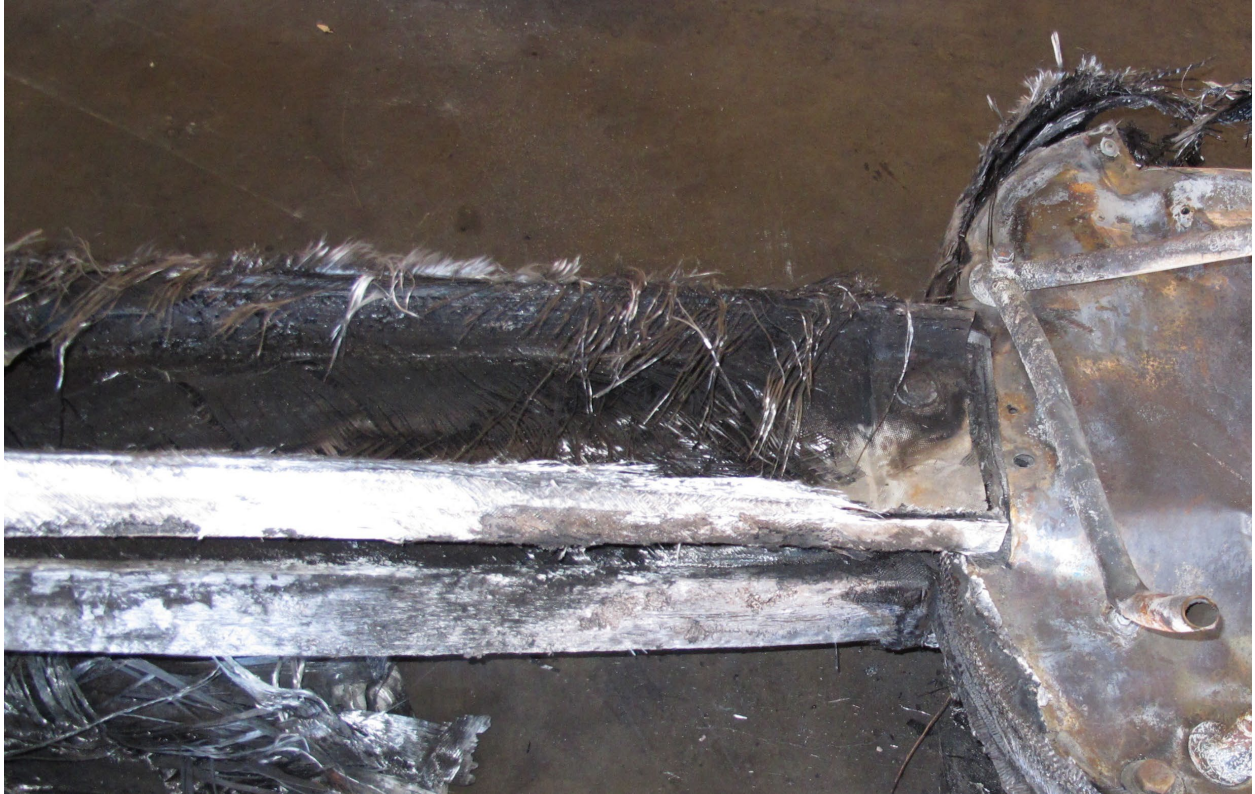
**Figure 4.** Left wing spar attachment at the firewall.

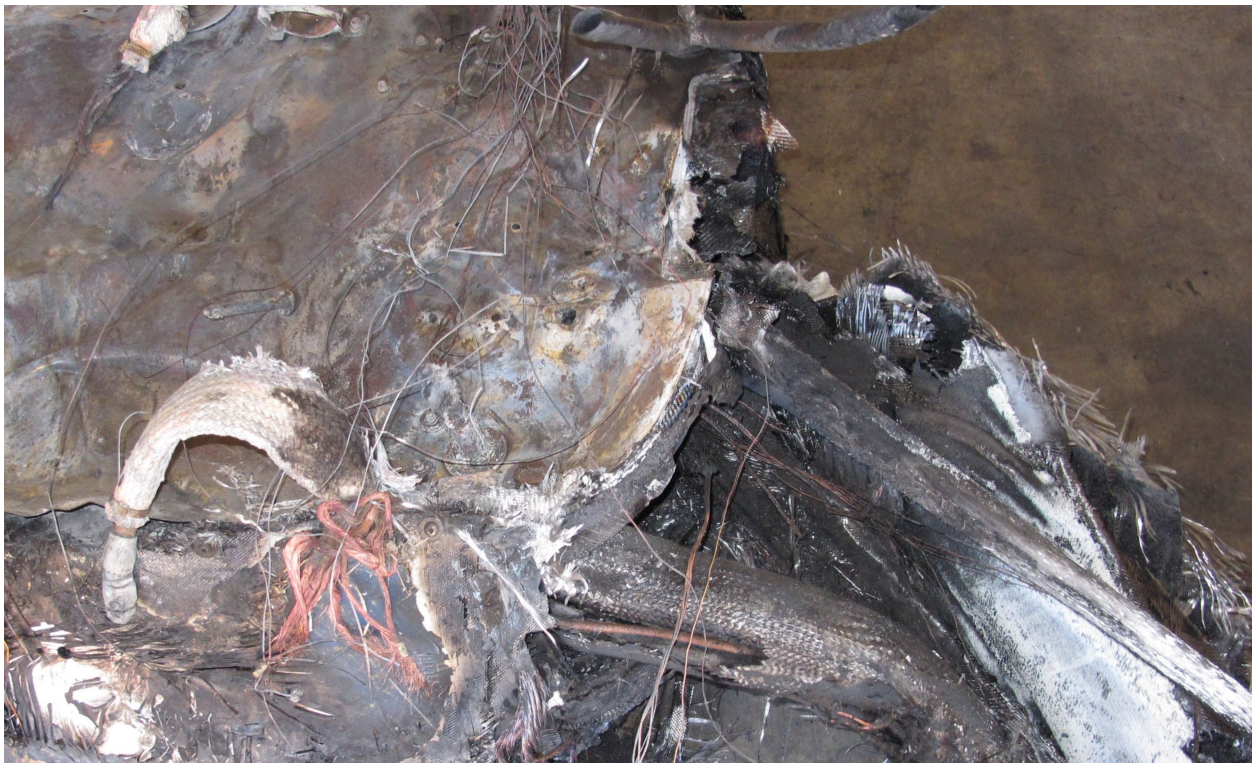
**Figure 5.** Right wing spar attachment.

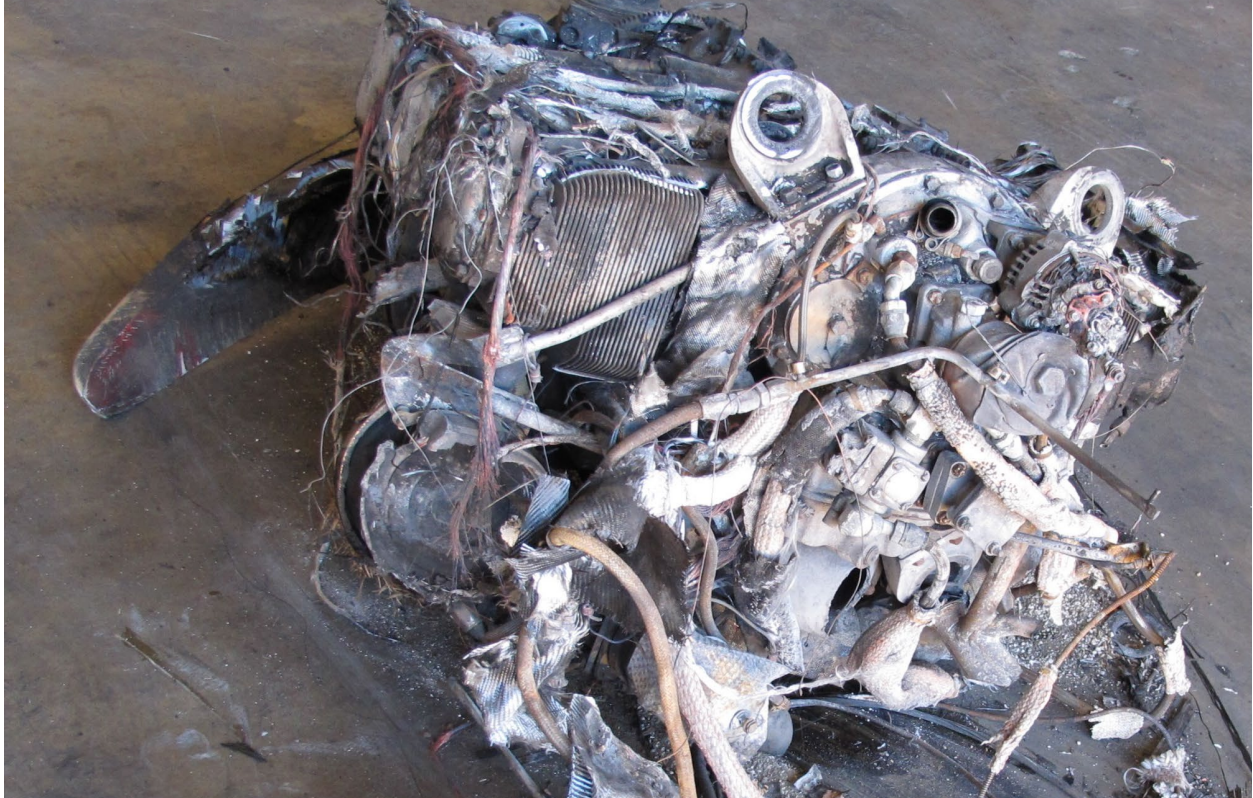
A visual examination of the engine was performed after the engine was removed from the firewall. The engine was heavily sooted with several areas of thermal damage. The most severe area of thermal damage was located on the forward end of the engine in the area of the accessory case and turbocharger as shown in Figure 6. The secondary alternator case was melted. The oil filter was thermally discolored and exhibited significant impact damage. The fuel pump cover was melted and sooted. The forward plate on the hydraulic pump exhibited some melting. All cylinder assemblies were sooted. The rocker box covers for Cylinders 2,4 and 6 were thermally discolored as shown in Figure 7. The oil filter, fuel pump, hydraulic pump and oil pump were removed to visualize the accessory case as shown in Figure 8. A distinct V-shaped burn pattern was found to the right of the oil

**Figure 6.** Front of engine.

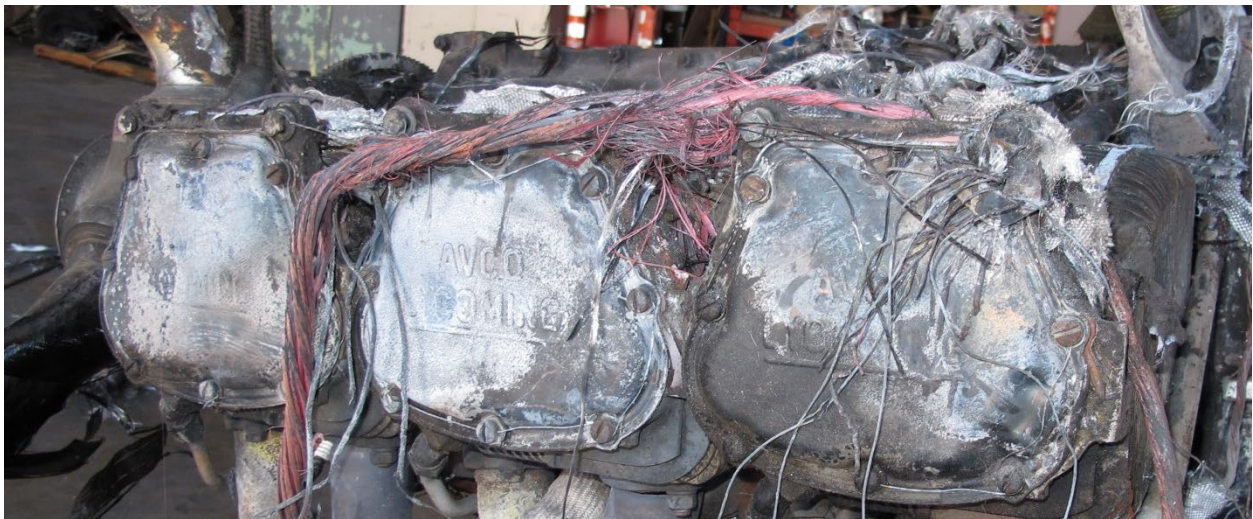
**Figure 7.** Thermal damage to cylinder covers (Cylinders 2, 4 & 6).

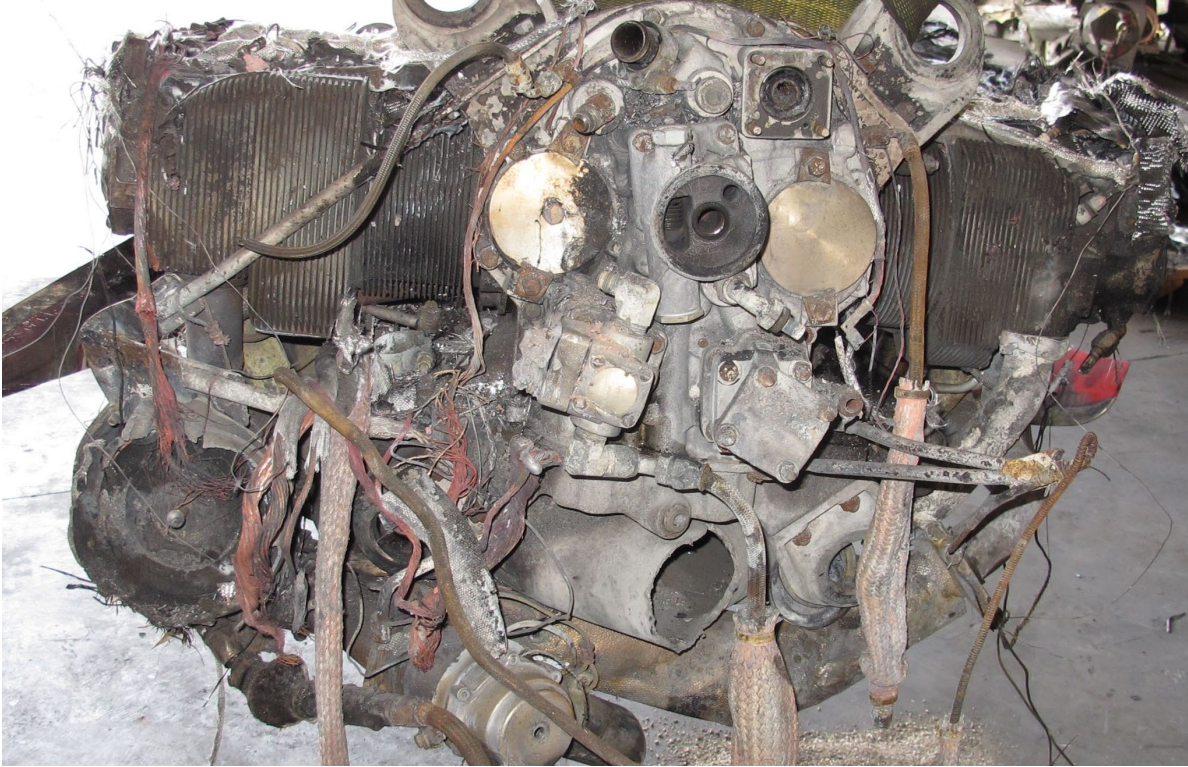
**Figure 8.** Accessory area of engine (forward section of engine).

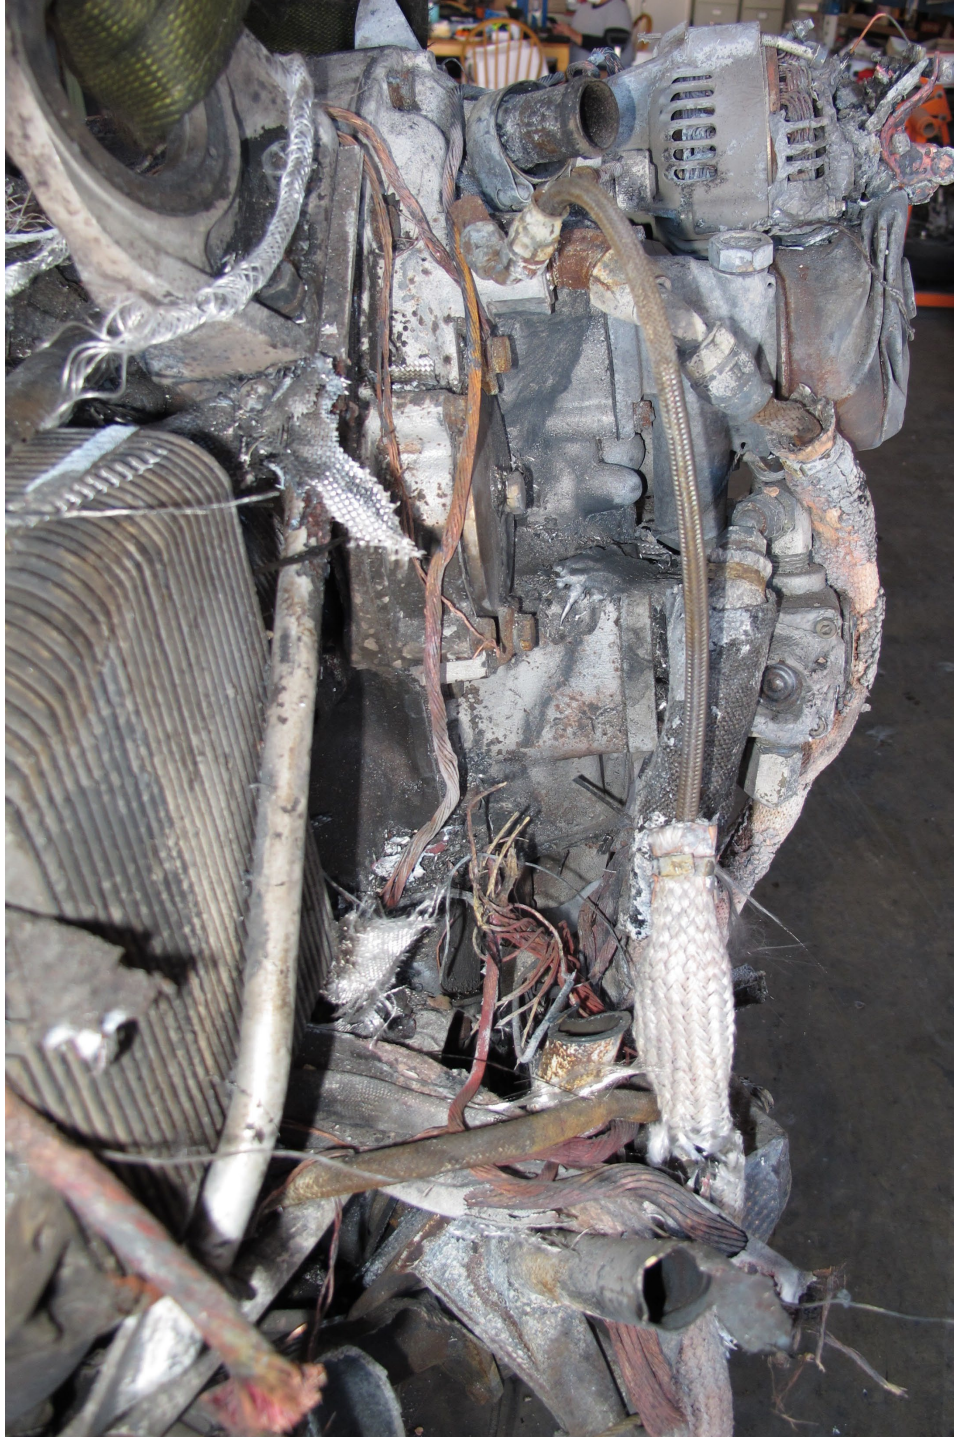
filter/pump and right mag plate. The pattern extended down and to the right towards the turbocharger. A closeup photograph is shown in Figure 9. The aluminum cover on the "cold" side of the turbocharger was melted as shown in Figures 10 and 11. All associated electrical wiring was missing insulation but the individual conductors showed no signs of electrical arcing such as beading, welding or surface erosion.

**Figure 9.** Burn pattern on accessory case.

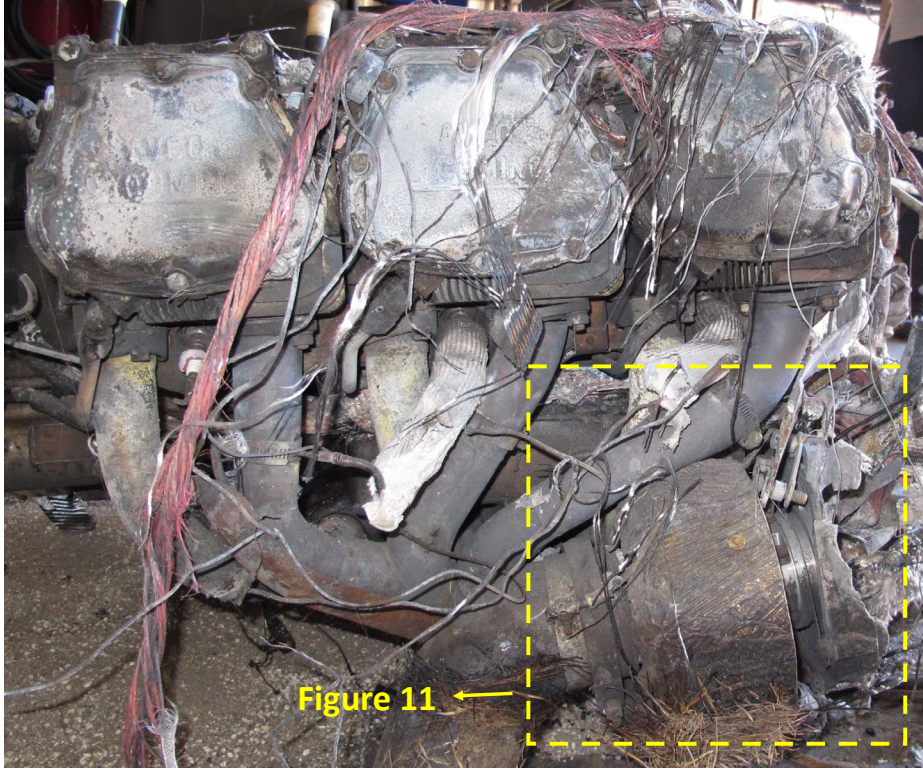
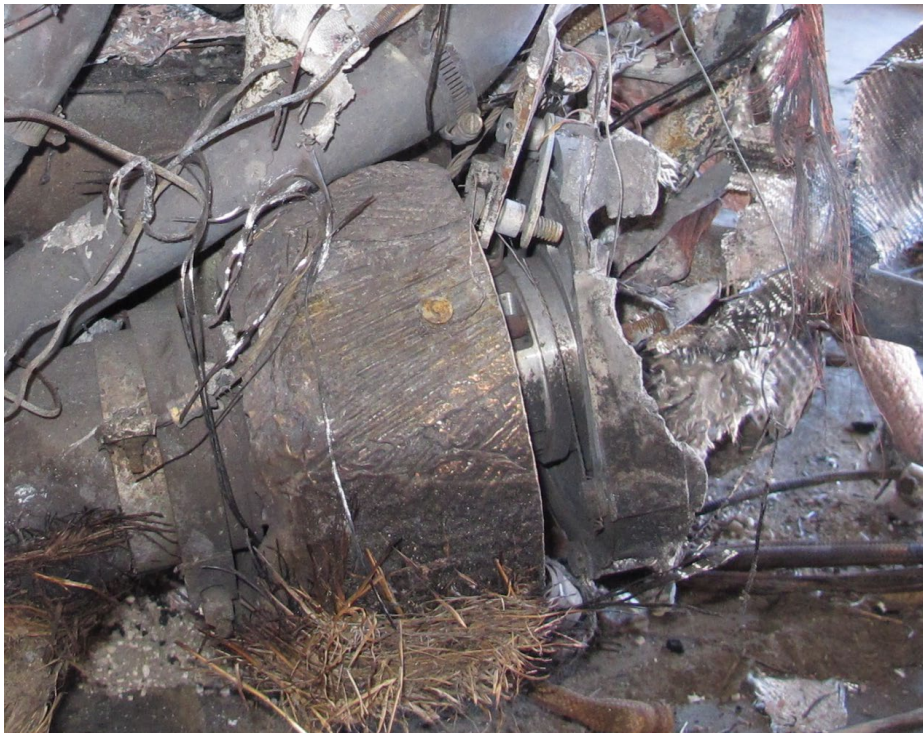
**Figure 10.** Right side of engine with turbocharger.

**Figure 11.** Closeup of turbocharger.
