National Transportation Safety Board

DCA24MM031

MATERIALS LABORATORY

Factual Report 24-080

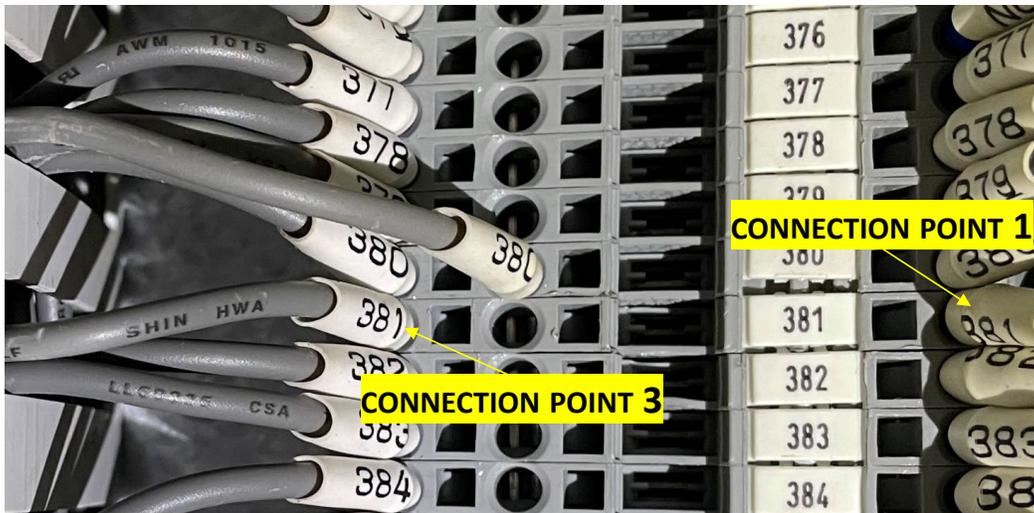
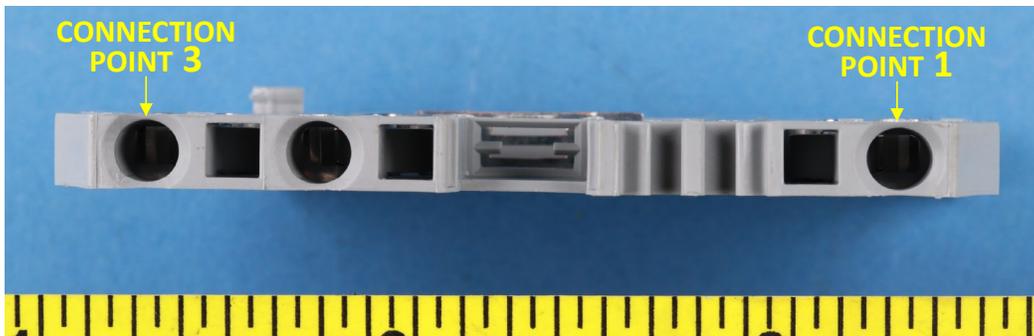
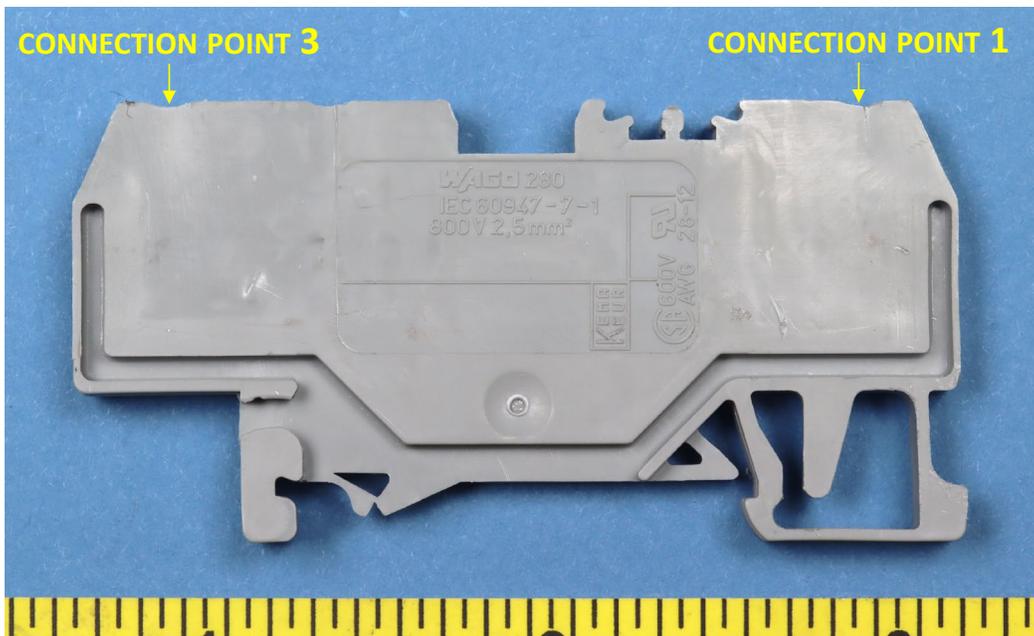
A photo of Terminal Block 381 with wires connected as installed within the electrical cabinet onboard the *Dali* is shown in the top of Figure 10. The configuration of the electrical system on the *Dali* had wires assembled to connection points 1 and 3 of Terminal Block 381, labeled in the figure. The bottom photos in Figure 10 show the appearance of the terminal block after removal from the electrical cabinet. Figure 11 shows the two sides of Terminal Block 381 as received in the NTSB Materials Laboratory. One side had markings identifying the terminal block as a model WAGO 280, IEC 60947-7-1, with a size of 2.5 millimeters-squared and 800-volt capacity.

Figure 10. (Top) Close-up photo of Terminal Block 381 with wires connected as installed within the electrical cabinet onboard the *Dali*. (Middle and Bottom) Close-up photos showing the top and side of Terminal Block 381 after removal from the electrical cabinet.

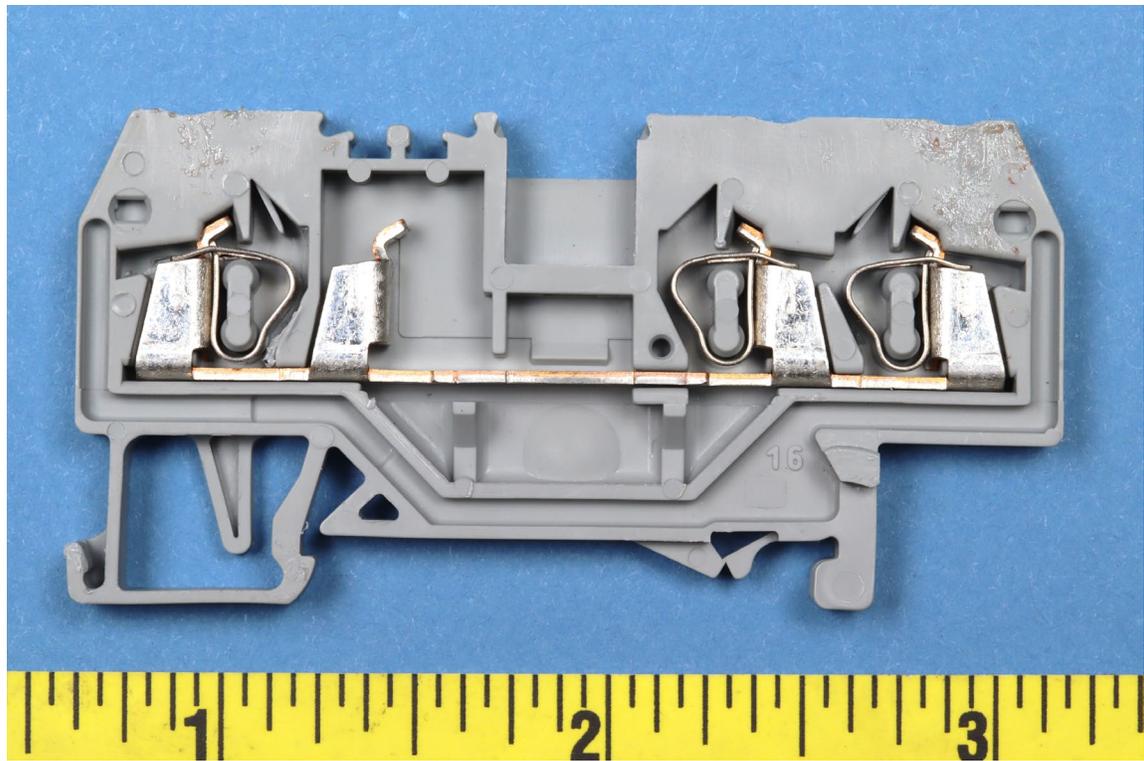
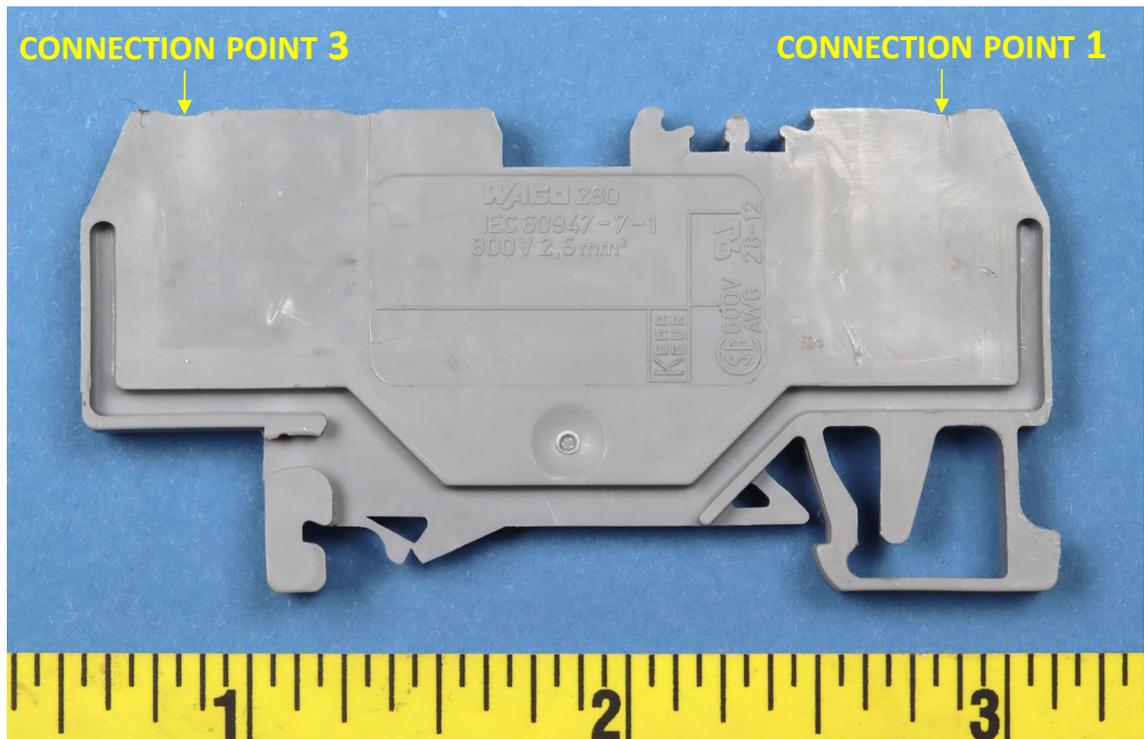
Figure 11. Close-up photos showing the two sides of Terminal Block 381 after removal from the electrical cabinet.

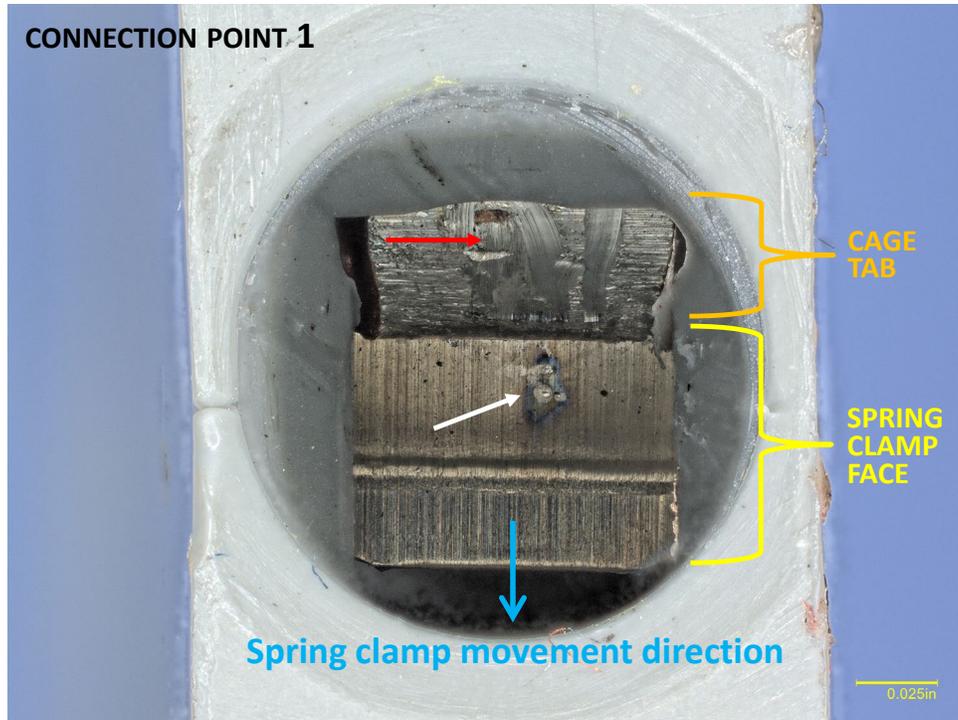
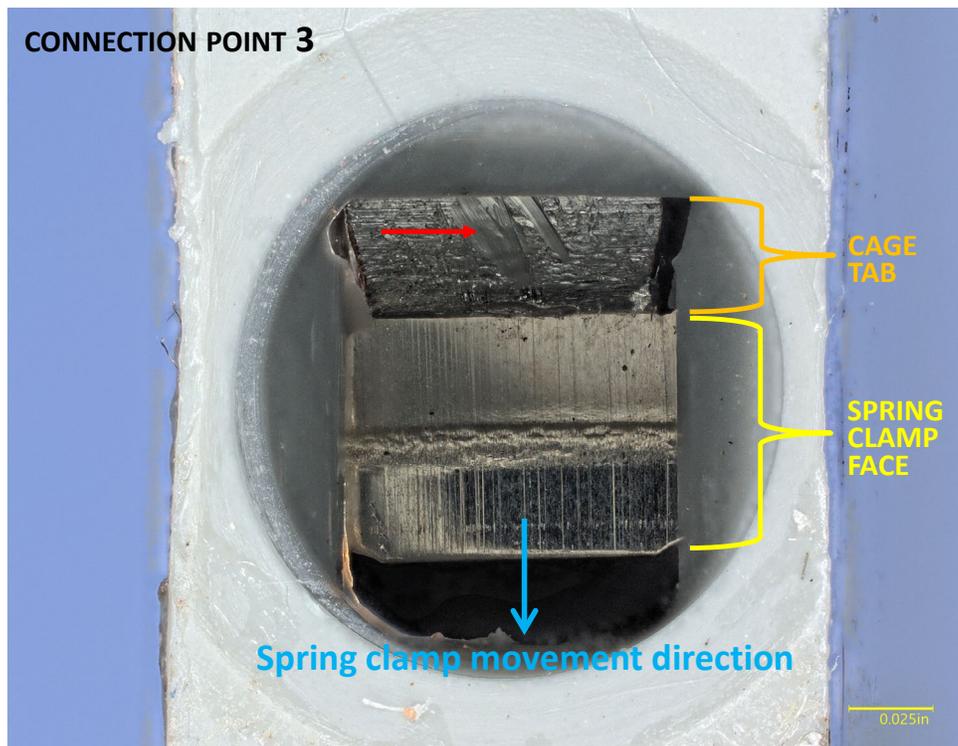
Views looking downwards into connection points 1 and 3 at the top of the cage tab and spring clamp face are shown in Figure 12. Scrape marks were visible on the cage tabs, indicated by the red arrows. More scrape marks were present on the cage tab from connection point 1 than the cage tab on connection point 3. Metal spatter consistent with arcing was observed on the spring clamp face in connection point 1, indicated by the white arrow. With the spring clamp actuated, the opening of the connection points measured approximately 0.081 inches long by 0.099 inches wide.

Figure 12. Digital microscope images looking downwards on Terminal Block 381 into connection points 1 and 3 at the top of the cage tab and spring clamp face. Red and white arrows point to scrape marks and arcing damage, respectively.

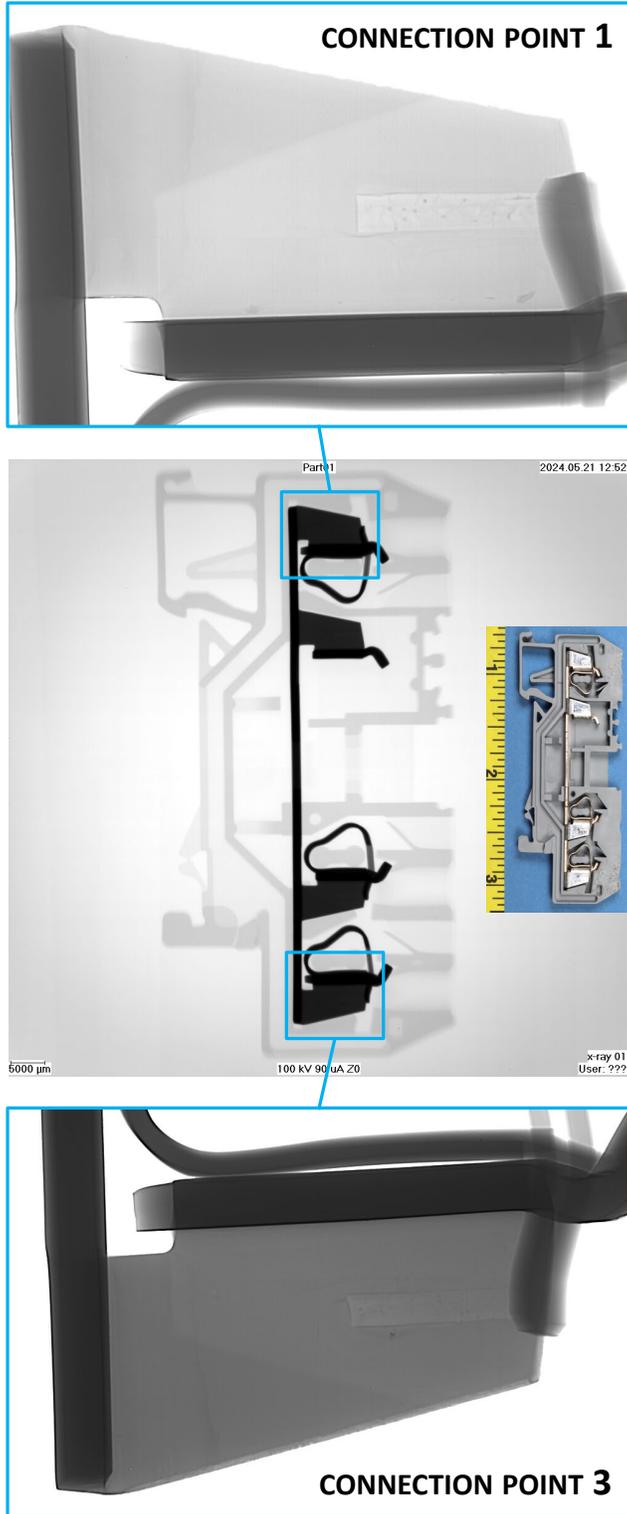
The terminal block was examined using x-ray to nondestructively view inside the cages with the conductor bar still assembled within the polymer form. Planar views inside the cages of connection points 1 and 3 are shown in Figure 13, while an angled view showing an isometric view of the cage from connection point 1 is shown in Figure 14. No wire debris or other obstructions were observed within either cage.

Figure 13. X-ray images of planar views inside the cages of connection points 1 and 3 on Terminal Block 381.

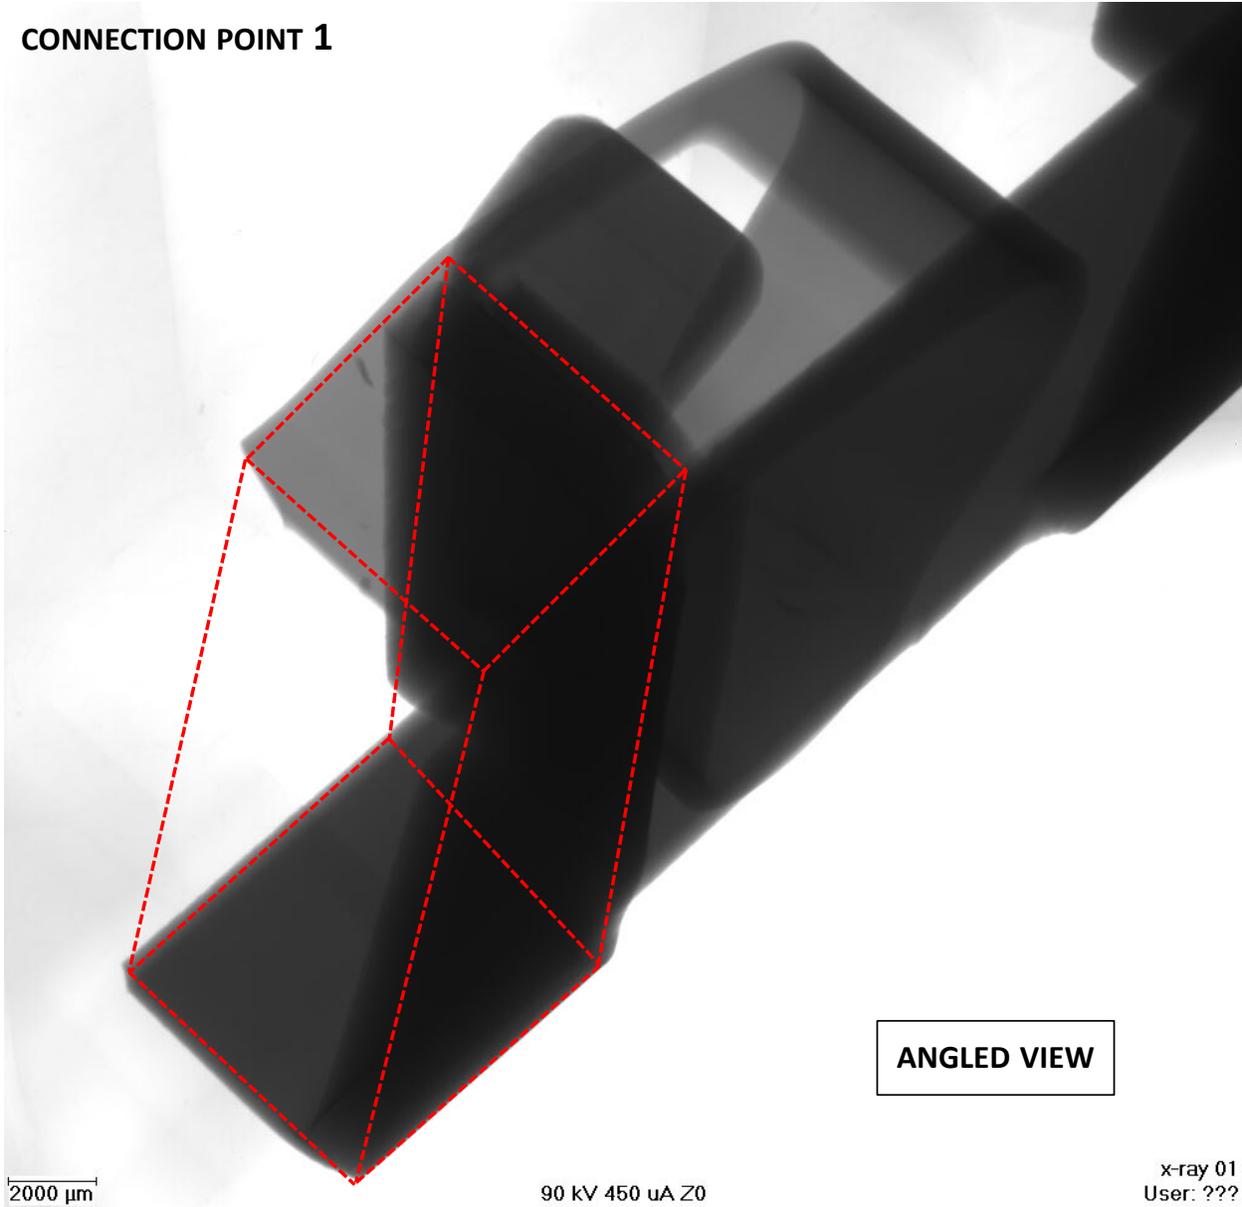
CONNECTION POINT 1

Figure 14. X-ray image of an angled view inside the connection point 1 cage on Terminal Block 381.

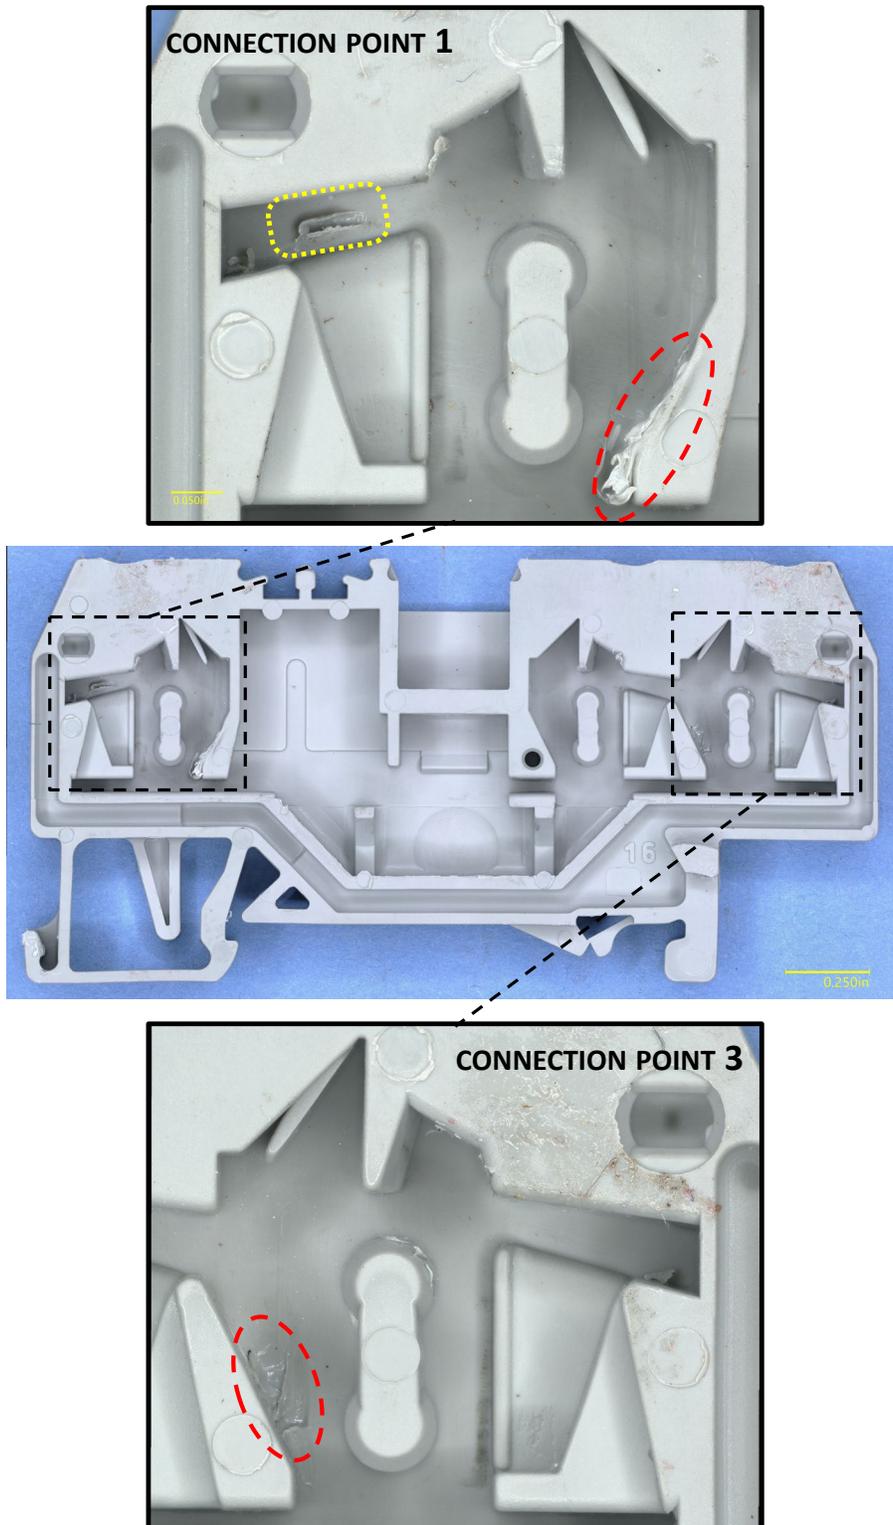
The conductor bar was disassembled from the polymer form and both pieces were examined. Views of both sides of the components after disassembly are shown in Figure 15. Figure 16 shows digital microscope images of connection points 1 and 3 on the polymer form. A distinct gouge was visible in the gate channel of connection point 1, indicated by the yellow dotted line. The gouge was consistent with contact from the spring clamp gate during actuation of the spring clamp. Scratches and ridges from scratching were observed in the operating ports of both connection points, as indicated by the red dashed lines. The scratches were consistent with tool insertion into the operating ports during spring clamp actuation.

Figure 16. Digital microscope images of connection points 1 and 3 on the polymer form of Terminal Block 381. The red dashed lines encircle scratches and ridges in the operating ports of both connection points. The yellow dotted line encircles a distinct gouge in the gate channel of connection point 1.

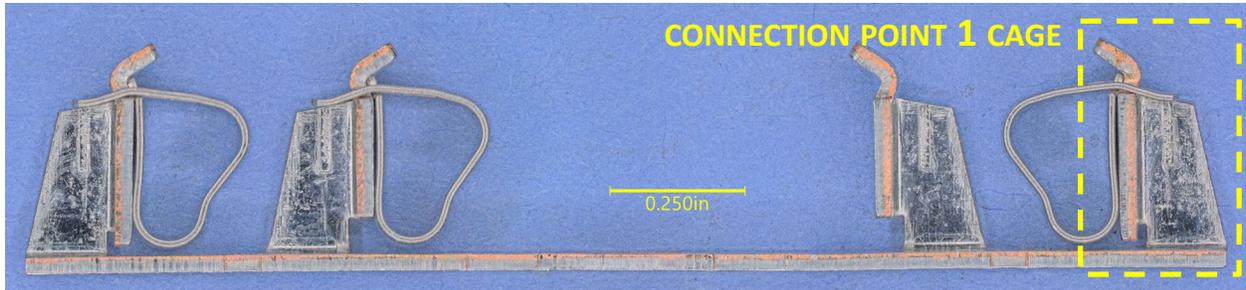
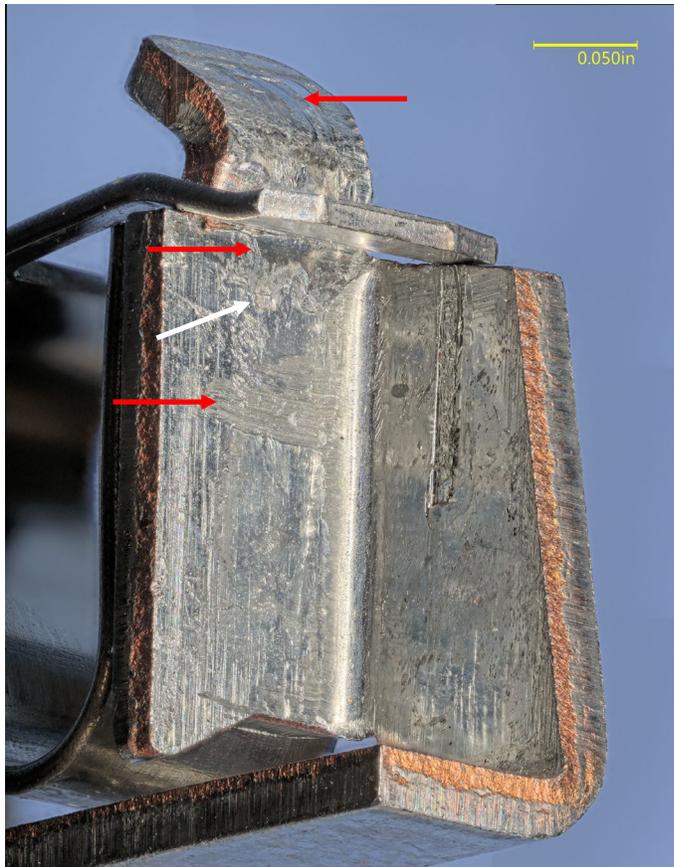
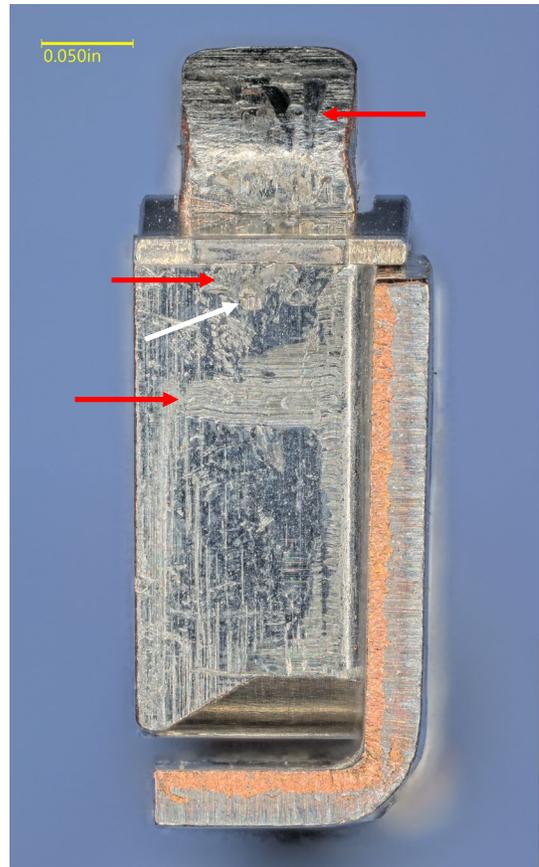
Figures 17 and 18 show digital microscope images of the cages from connection points 1 and 3, respectively, on the disassembled conductor bar. The red arrows point to scrape marks on the cage tabs and cage sides. The cage side of connection point 1 had multiple sets of scrape marks at different heights, while the cage side of connection point 3 only had scrape marks at one height. Material transfer consistent with electrical conduction (white arrows) was also observed on the cage sides. Close-up images of the arcing damage on the spring clamp face from connection point 1 are shown in Figure 19. The arcing damage consisted of distinct circular marks surrounded by light-colored halos, with adjacent blue and purple discoloration, consistent with metal spatter.

Figure 17. Digital microscope images of the cage from connection point 1 in Terminal Block 381. The red and white arrows point to scrape marks and material transfer from electrical conduction, respectively.

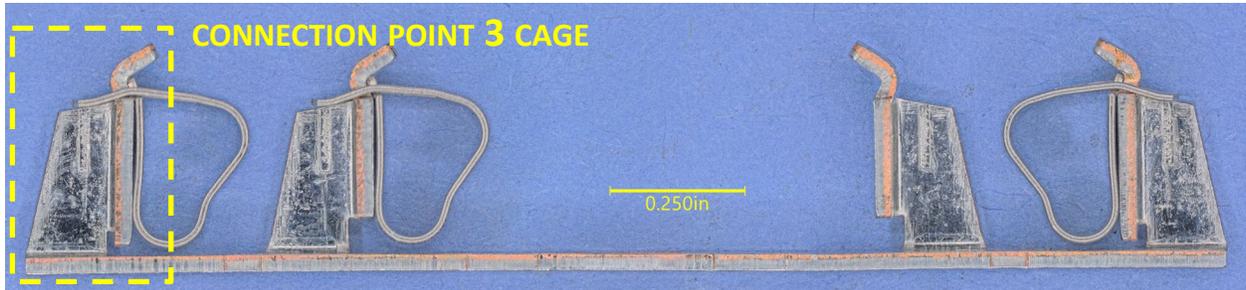
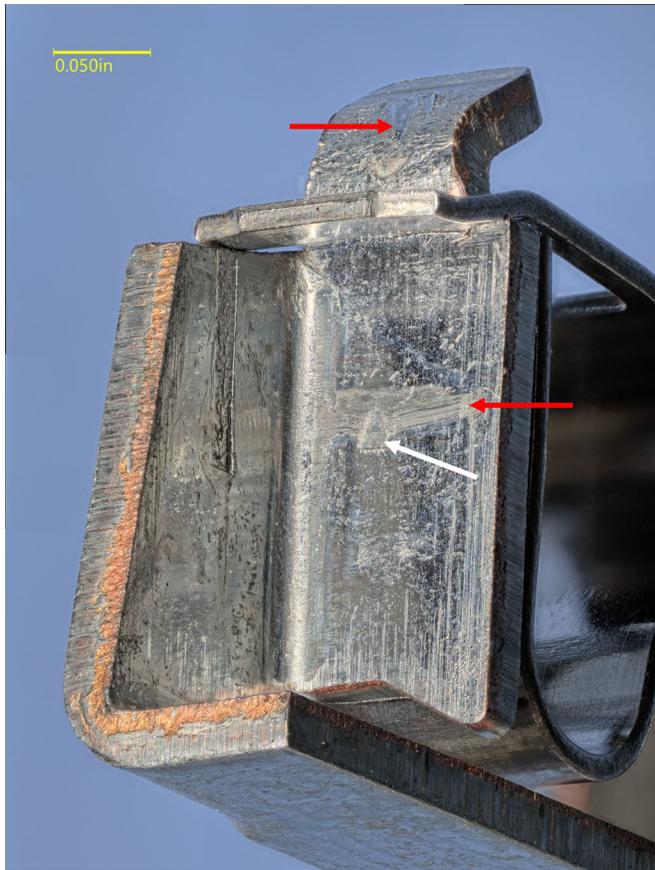
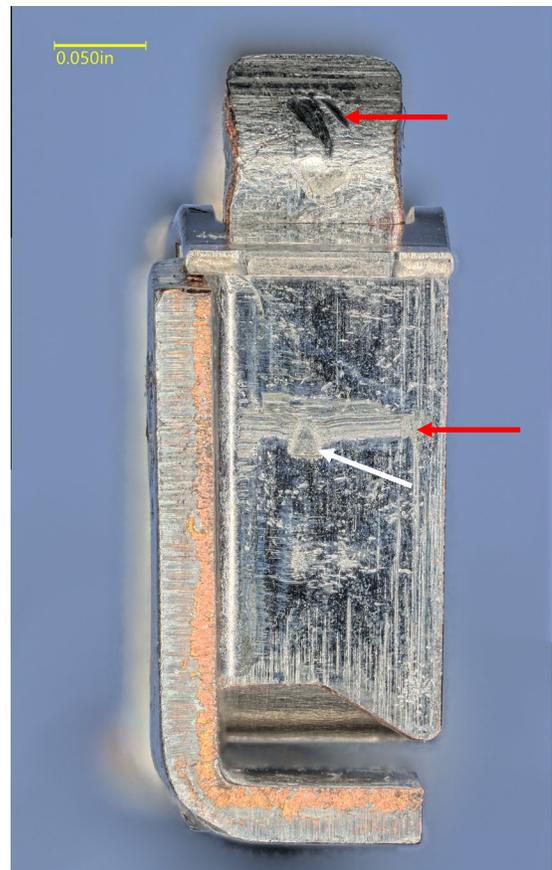
Figure 18. Digital microscope images of the cage from connection point 3 in Terminal Block 381. The red and white arrows point to scrape marks and material transfer from electrical conduction, respectively.

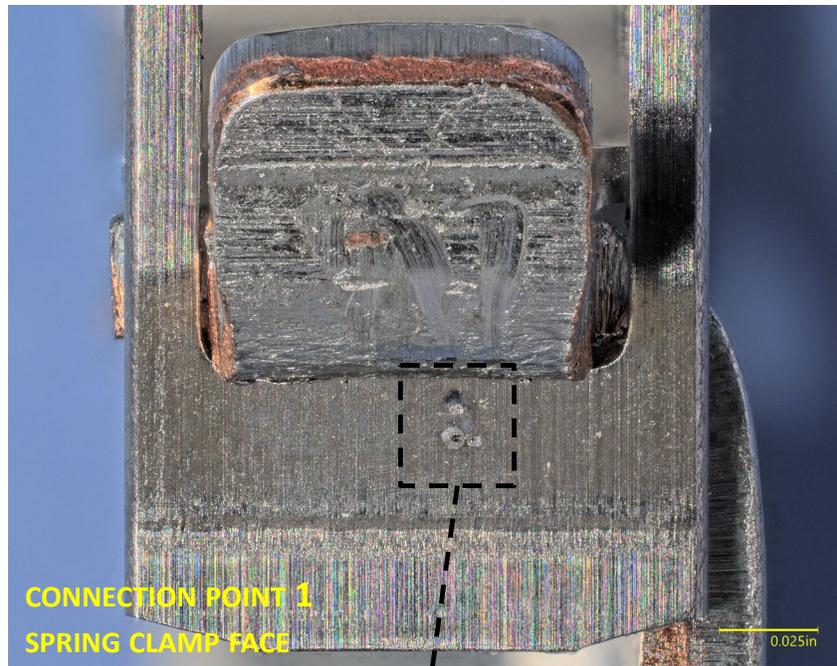
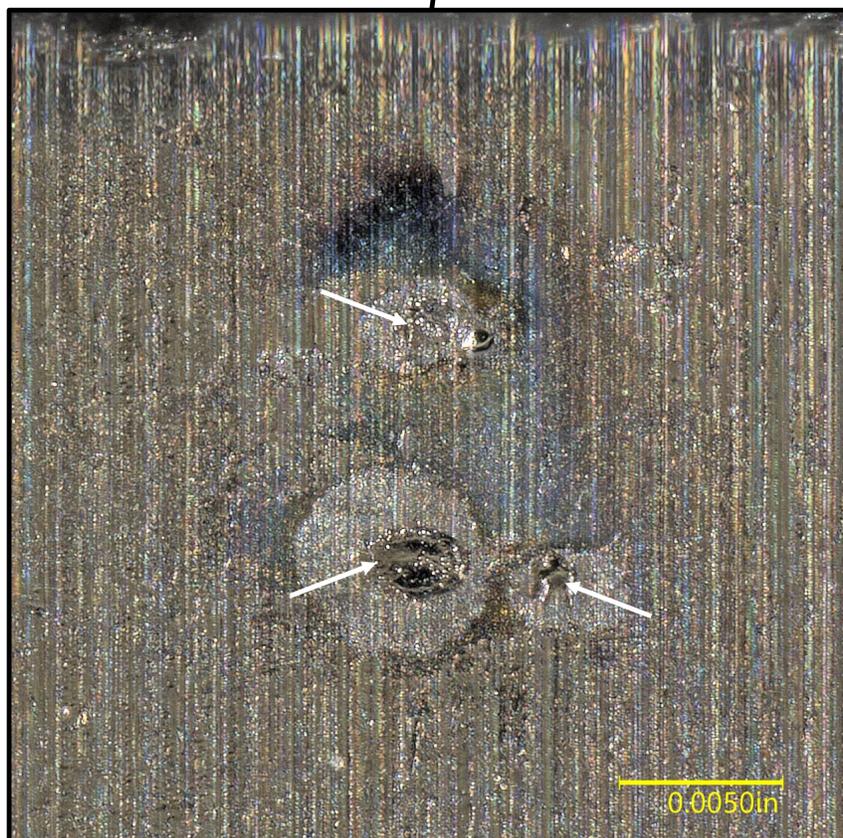
Figure 19. Digital microscope images of the spring clamp face from connection point 1 in Terminal Block 381. The white arrows point to metal spatter consistent with arcing.

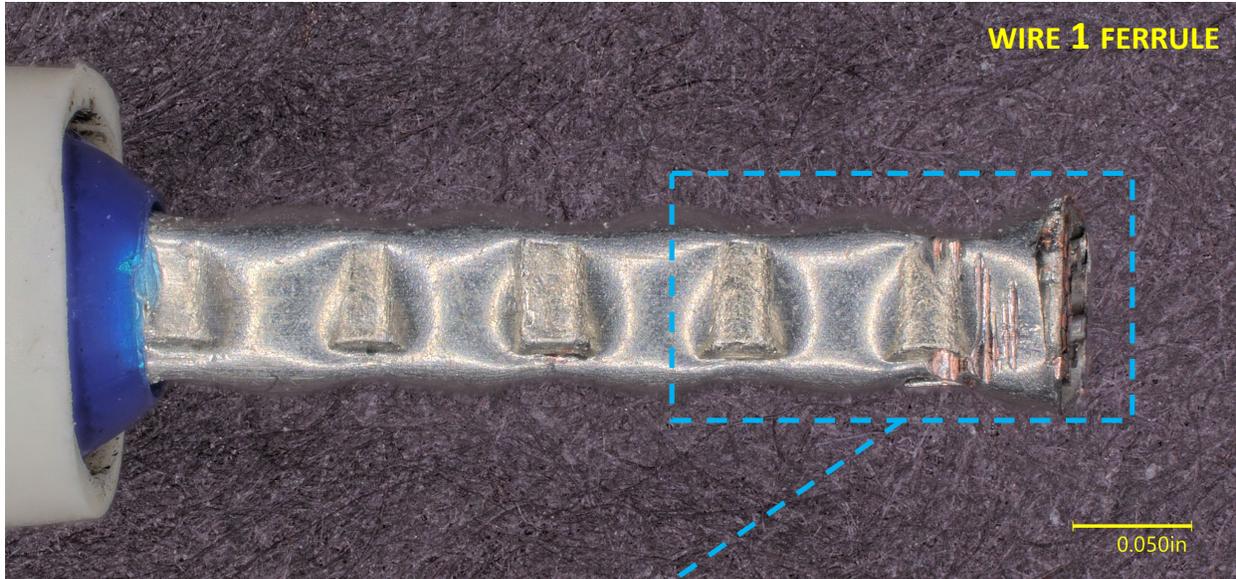
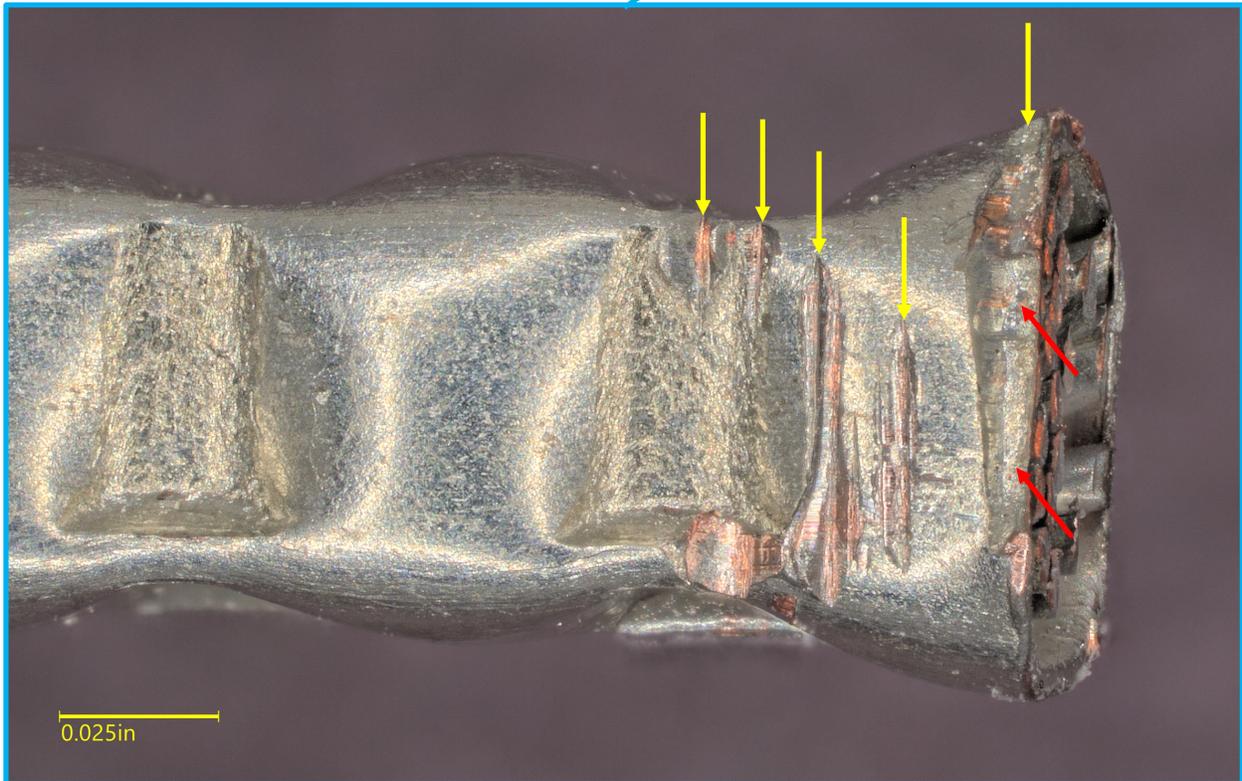
images of opposing sides of the wire 1 ferrule are shown in Figure 21. Higher magnification images of the two sides are shown in Figures 22 and 23. Figure 22 shows one side had multiple distinct linear gouges (yellow arrows), consistent with contact with the edge of the spring clamp gate. A depression with scrape marks (red arrows) was observed on the end of the ferrule in-line with one of the gouges. Material transfer consistent with electrical conduction was visible on the side of the ferrule opposite the gouges, indicated by the white arrows in Figure 23. The same side of the ferrule also had material smeared along the edge, as indicated by the orange arrows.

Figure 22. Digital microscope images of one side of the wire 1 ferrule from Terminal Block 381 with multiple distinct linear gouges (yellow arrows). A depression on the end of the ferrule in-line with one of the gouges is indicated by the red arrows.

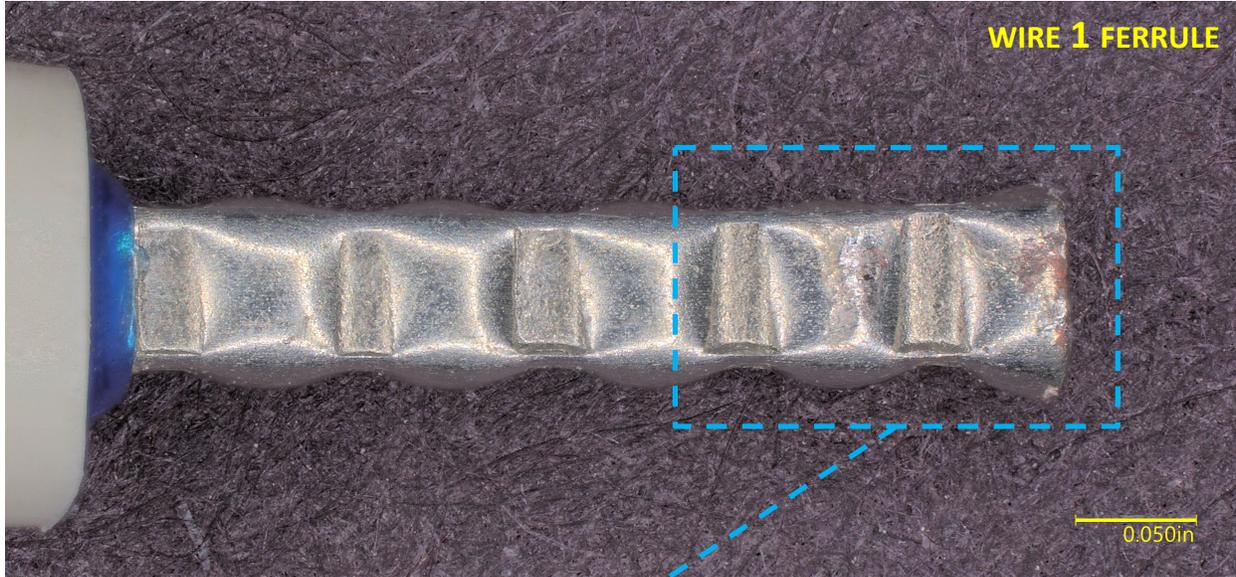
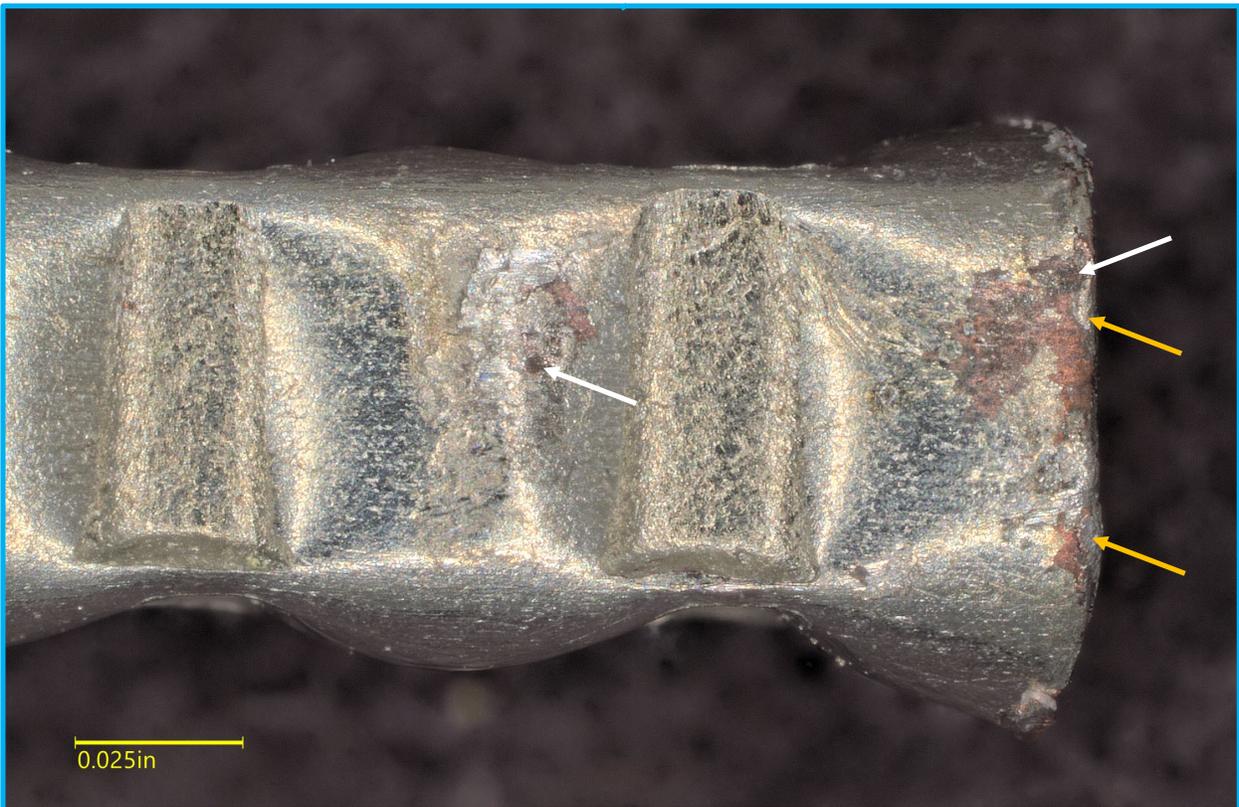
Figure 23. Digital microscope images of the side opposite the one from Figure 21 of the wire 1 ferrule from Terminal Block 381. The white and orange arrows point to material transfer from electrical conduction and smeared material, respectively.

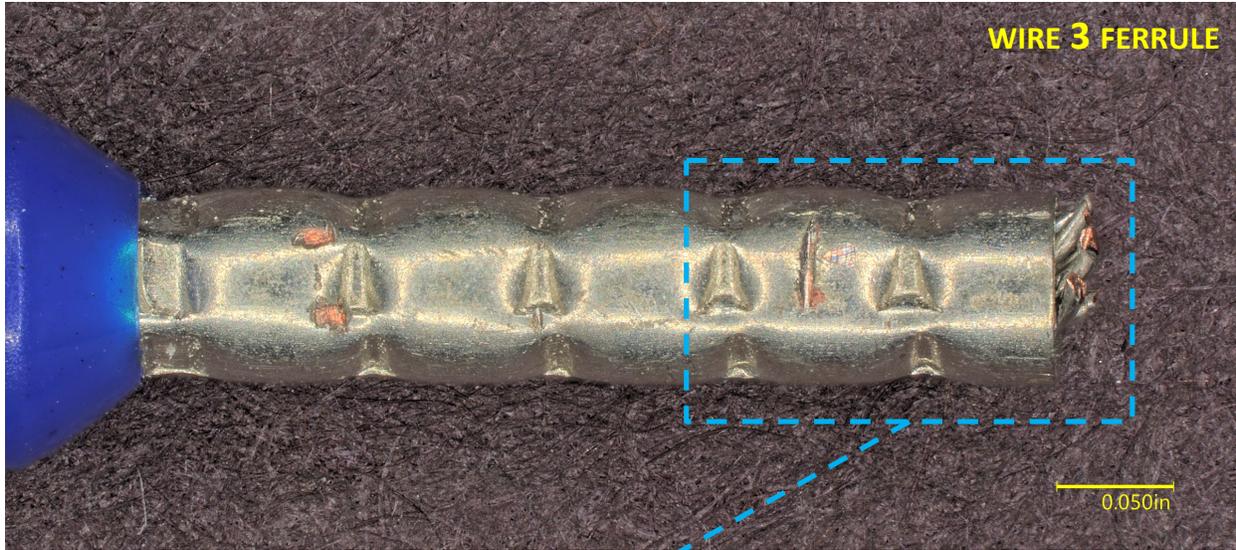
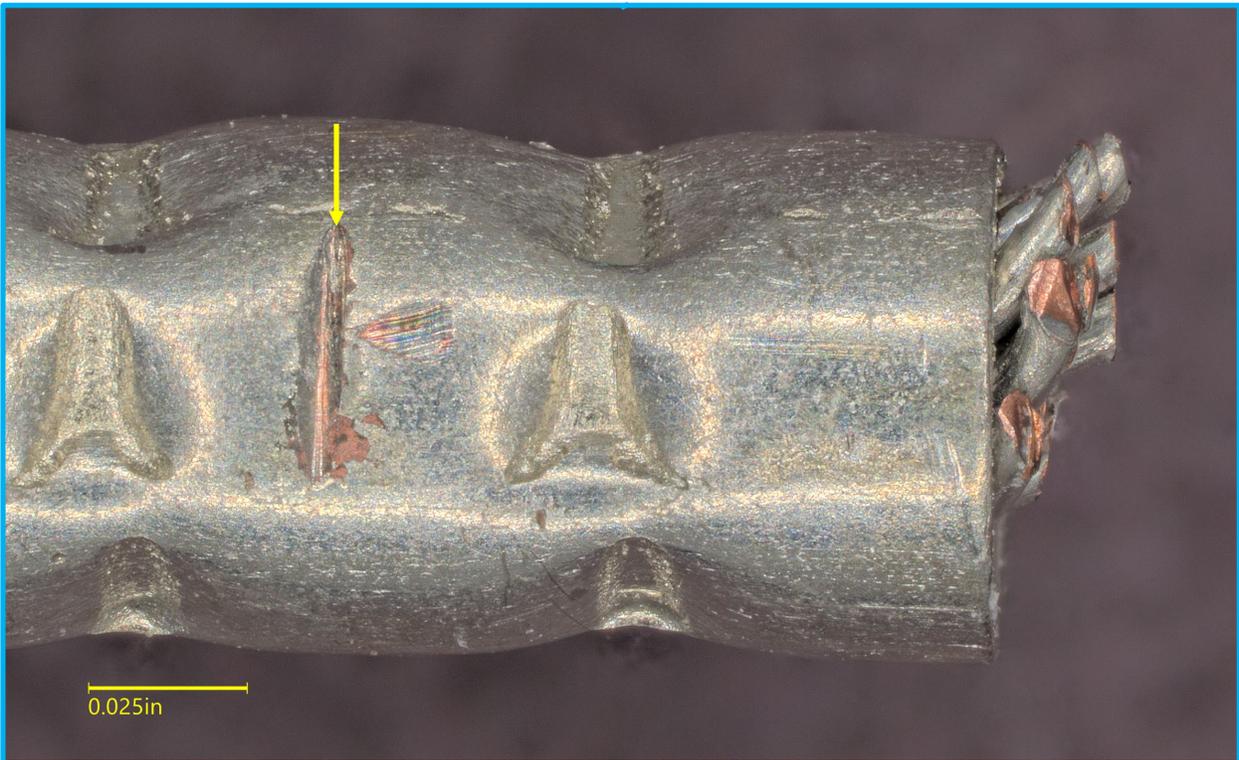
The submitted portion of the wire assembled within connection point 3 is shown in Figure 24, and hereafter is referred to as wire 3. The following part markings were observed on wire 3: LL69935 CSA TEW 105°C 600V FT1 -F- RoHS LF PoHS LF SHIN HWA. Digital microscope images of opposing sides of the wire 3 ferrule are shown in Figure 25. Higher magnification images of the two sides are shown in Figures 26-28. Figure 26 shows one distinct linear gouge (yellow arrow), consistent with contact with the edge of the spring clamp gate. Figure 27 shows two circular gouges (black arrows) observed on the same side as the linear gouge but closer to the ferrule casing. The cause of the circular gouges was unknown. Material transfer consistent with electrical conduction was visible on the side of the ferrule opposite the gouges, indicated by the white arrows in Figure 28.

Figure 26. Digital microscope images of one side of the wire 3 ferrule from Terminal Block 381 with one distinct linear gouge (yellow arrow).

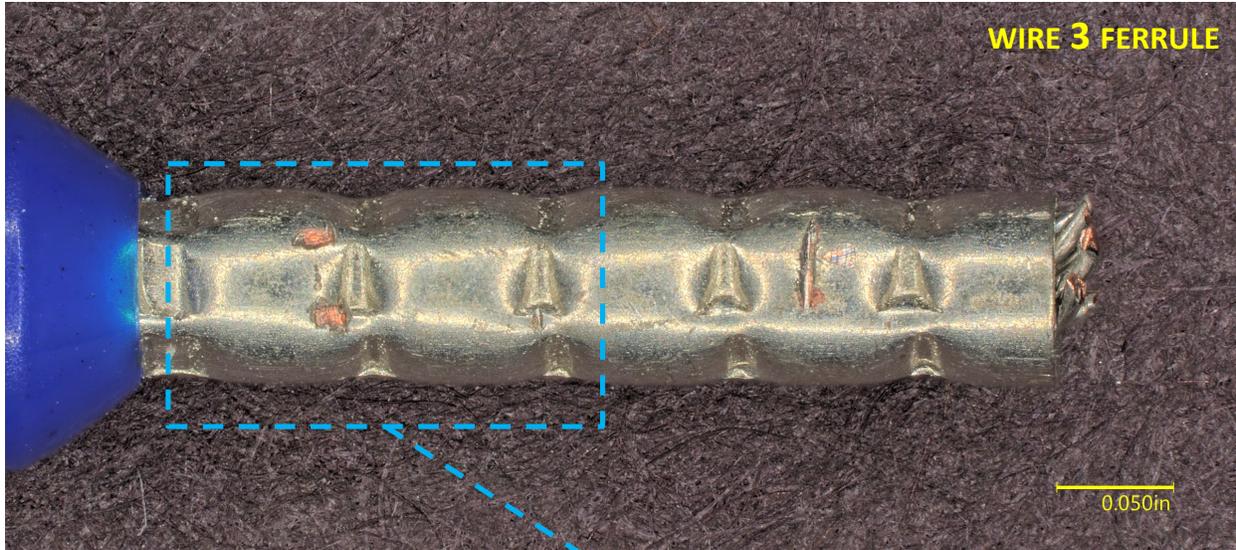
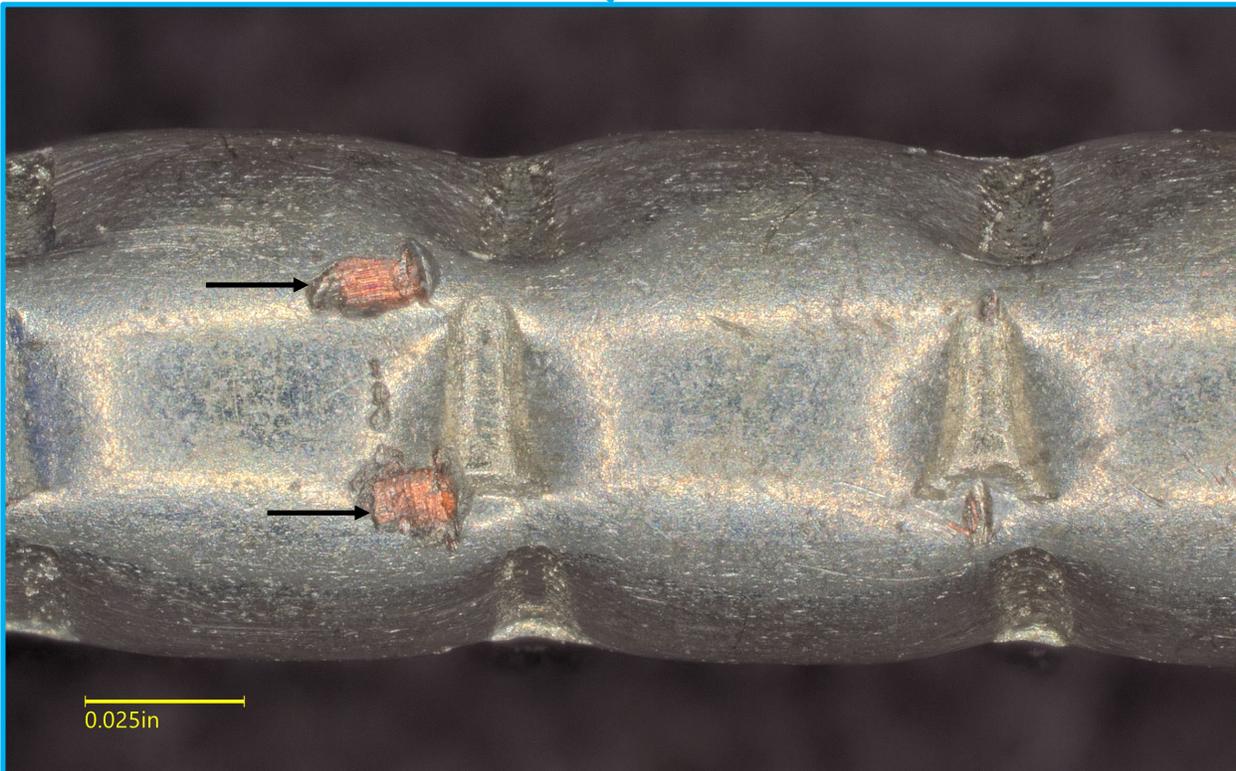
Figure 27. Digital microscope images of the same side shown in Figure 24 of the wire 3 ferrule from Terminal Block 381. The black arrows point to two circular gouges.

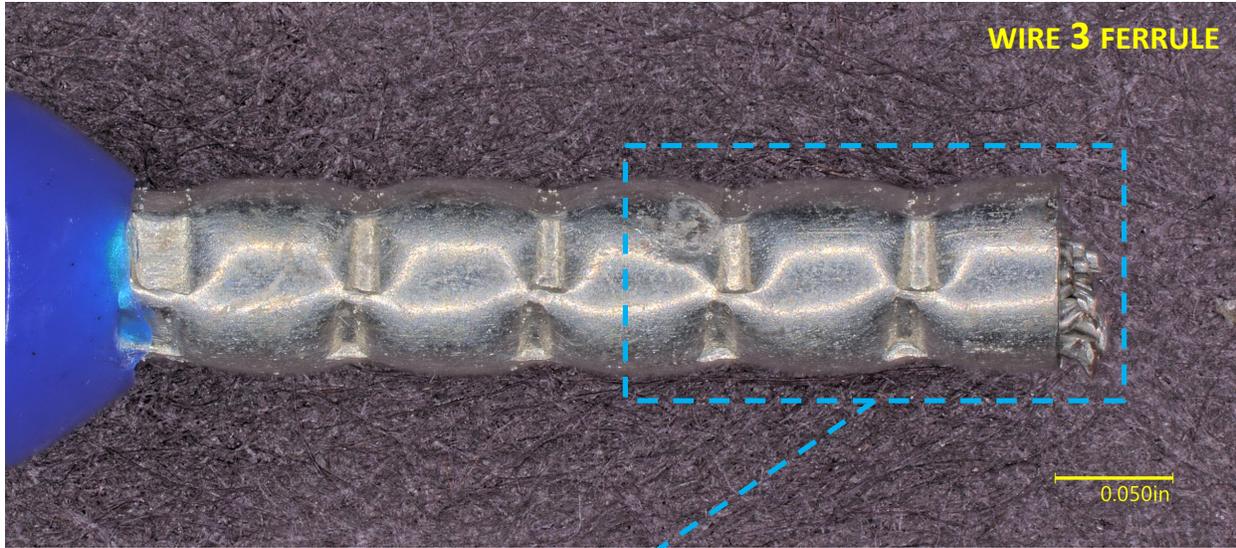
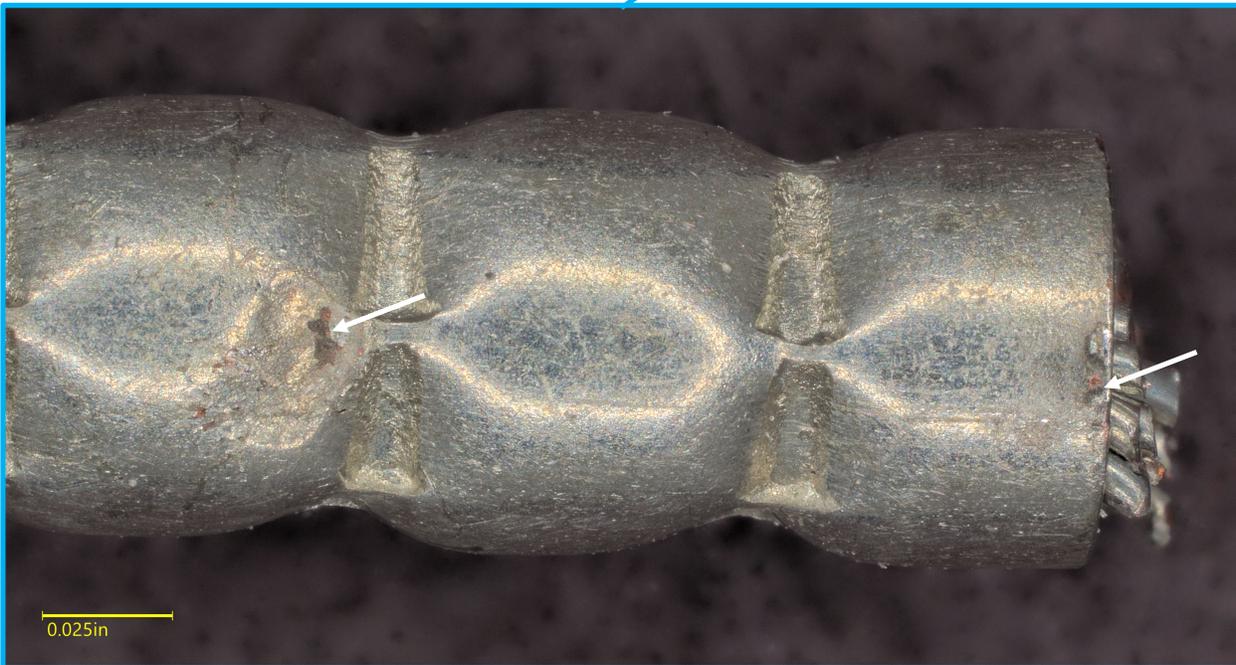
Figure 28. Digital microscope images of the side opposite the one from Figures 24 and 25 of the wire 3 ferrule from Terminal Block 381. The white arrows point to material transfer from electrical conduction.
