National Transportation Safety Board

DCA24MM031

MATERIALS LABORATORY

Factual Report 24-080

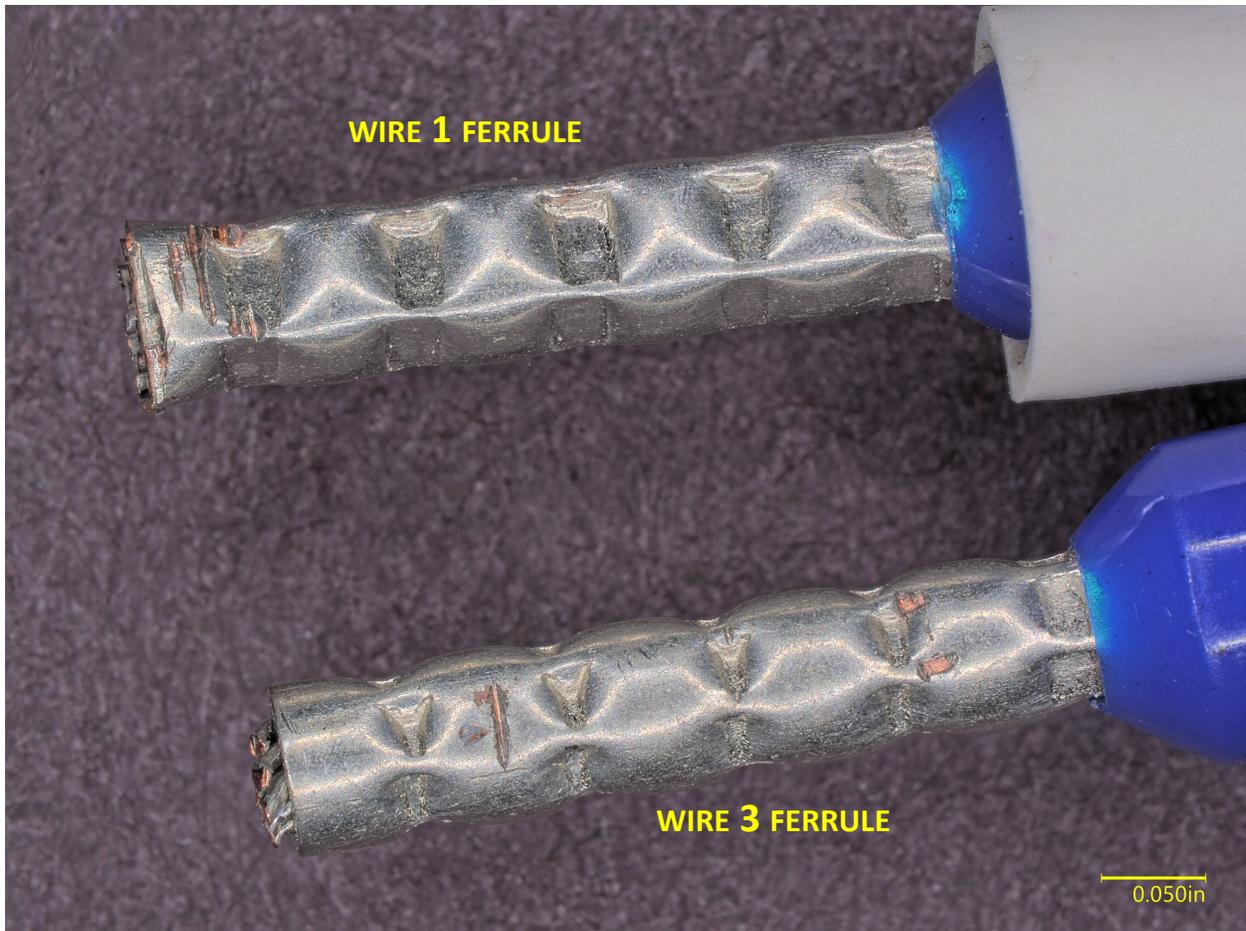
Figure 29 shows a side-by-side view of the ferrules from wires 1 and 3. The wire 1 ferrule had four crimp marks circumferentially while wire 3 had six crimp marks around the circumference. The different crimp patterns created different ferrule profiles, as seen in the comparison of the wire ends shown in Figure 30. The four-sided crimping of the wire 1 ferrule resulted in a roughly square-shaped profile that measured roughly 0.077 inches by 0.091 inches, while the six-sided crimping of wire 3 resulted in a circular profile with an approximate 0.084-inch diameter. The depression with scrape marks (red arrow) on the end of the wire 1 ferrule resulted in the flattening of one corner. The strands adjacent to the flattened ferrule corner had also been flattened. Figure 31 shows an angled view of the flattened corner of the wire 1 ferrule. The flattening resulted from the depression (red arrows) which angled inwards towards the center of the wire. The yellow arrows in Figure 31 indicate the linear gouges discussed previously, with one linear gouge directly in-line with the depression that caused the flattened ferrule corner.

Figure 29. Digital microscope image comparing side views of the ferrules from wires 1 and 3 from Terminal Block 381.

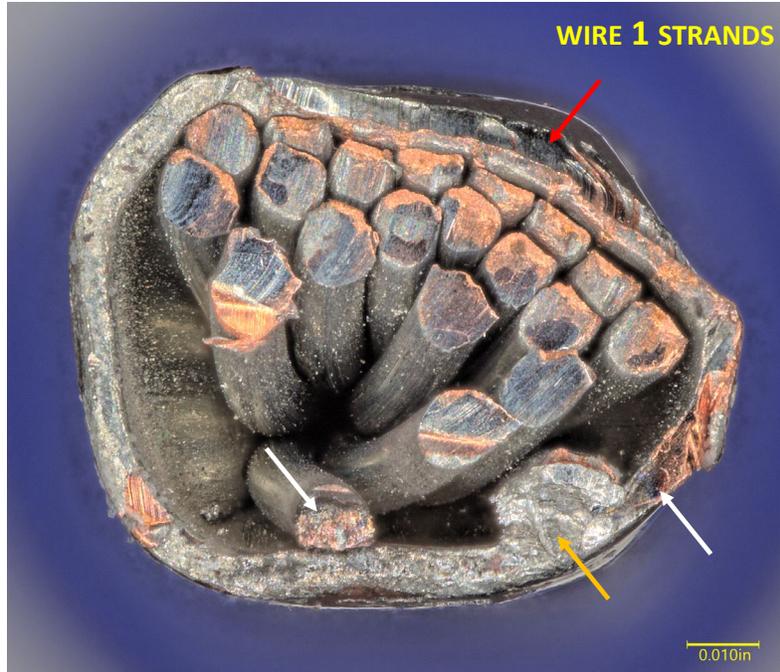
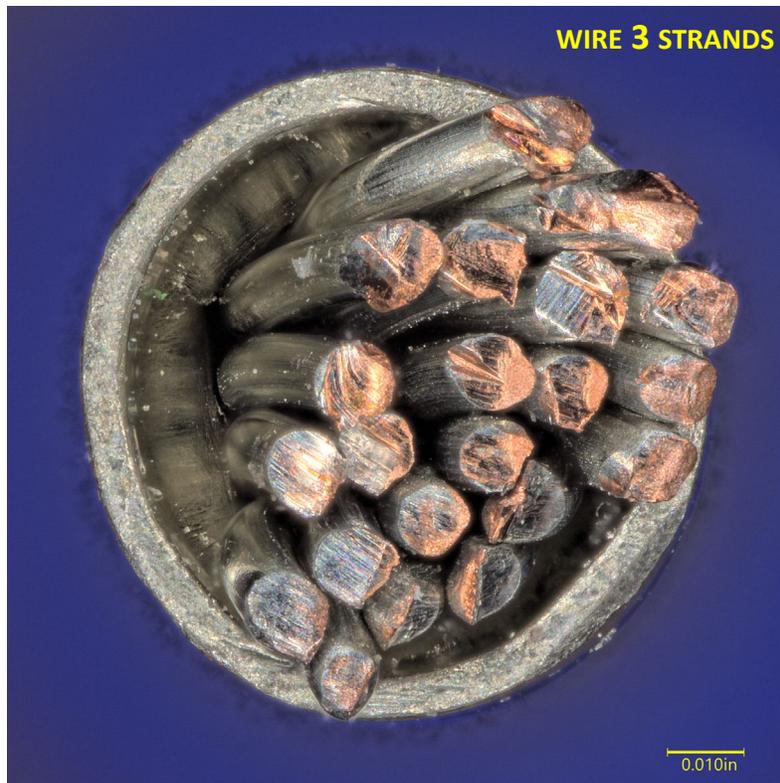
There was additional damage to the end of the wire 1 ferrule along the side opposite the flattened corner. Material appeared to have been dragged from the side of the ferrule and smeared over the edge, covering one of the strands (orange arrows, Figures 30 and 31). Erosion consistent with arcing (white arrows) was observed on one strand adjacent to the damaged ferrule edge, as well as on the ferrule edge adjacent to the strand covered by smeared material.

Figure 30. Digital microscope images of end views comparing the ferrules from wires 1 and 3 from Terminal Block 381. The red arrow points to the depression in one corner of the wire 1 ferrule. On the opposite side of the wire 1 ferrule there was erosion consistent with arcing and smeared material (white and orange arrows, respectively).

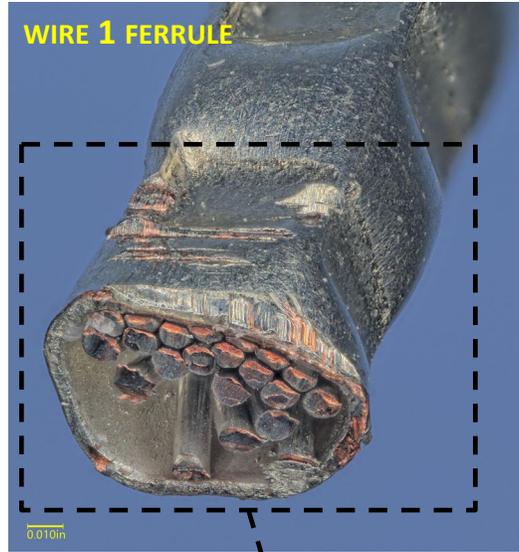
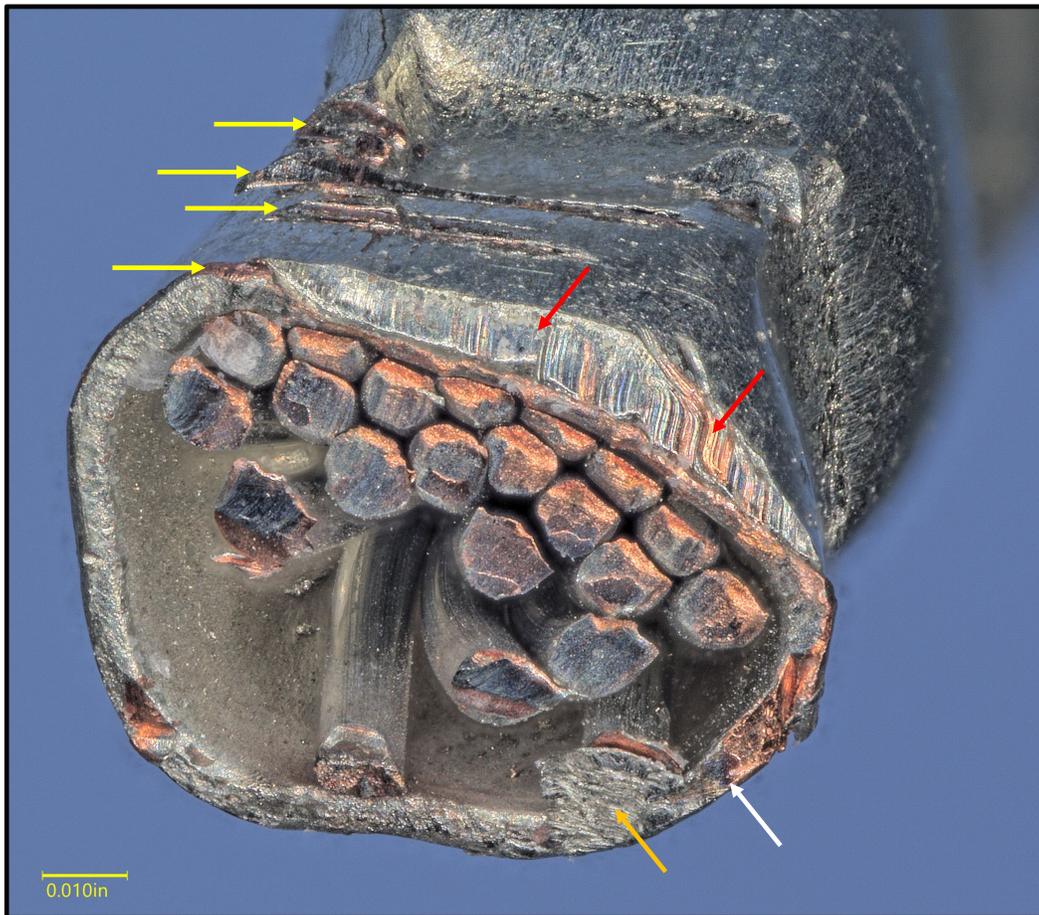
Figure 31. Digital microscope image of an angled view of the ferrule on wire 1 from Terminal Block 381. The yellow and red arrows point to linear gouges and a depression, respectively, on one side of the ferrule, while the white and orange arrows point to erosion consistent with arcing and smeared material, respectively, on the opposite side.

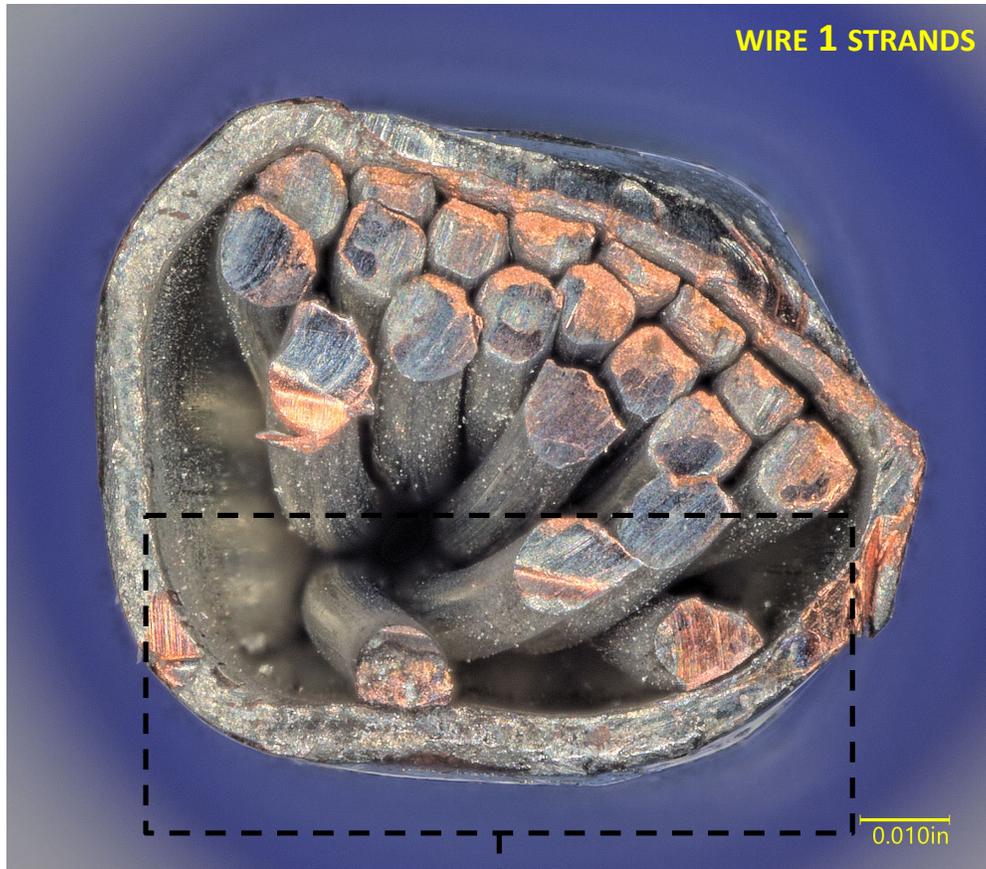
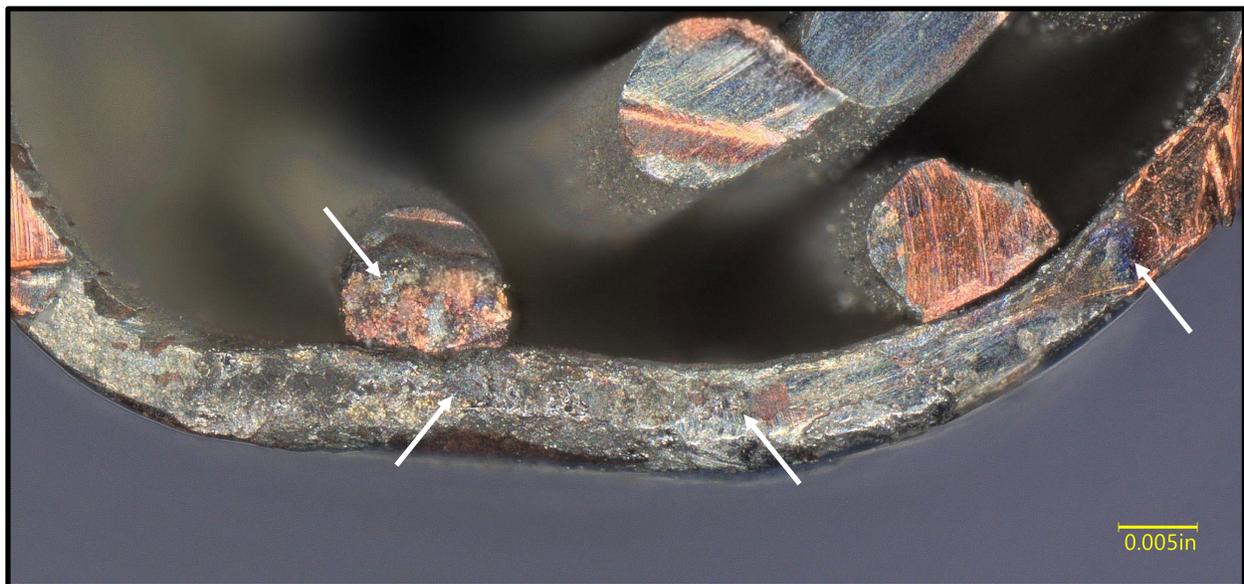
The smeared material was removed from the edge of the ferrule and the end of wire 1 was re-examined. White arrows in Figure 32 point to multiple locations with erosion consistent with arcing on the ferrule edge, as well as on one strand adjacent to that edge.

Figure 32. Digital microscope images of the end on the wire 1 ferrule from Terminal Block 381 after smeared material was removed from one side. The white arrows point to erosion consistent with arcing on the ferrule edge and one adjacent strand face.

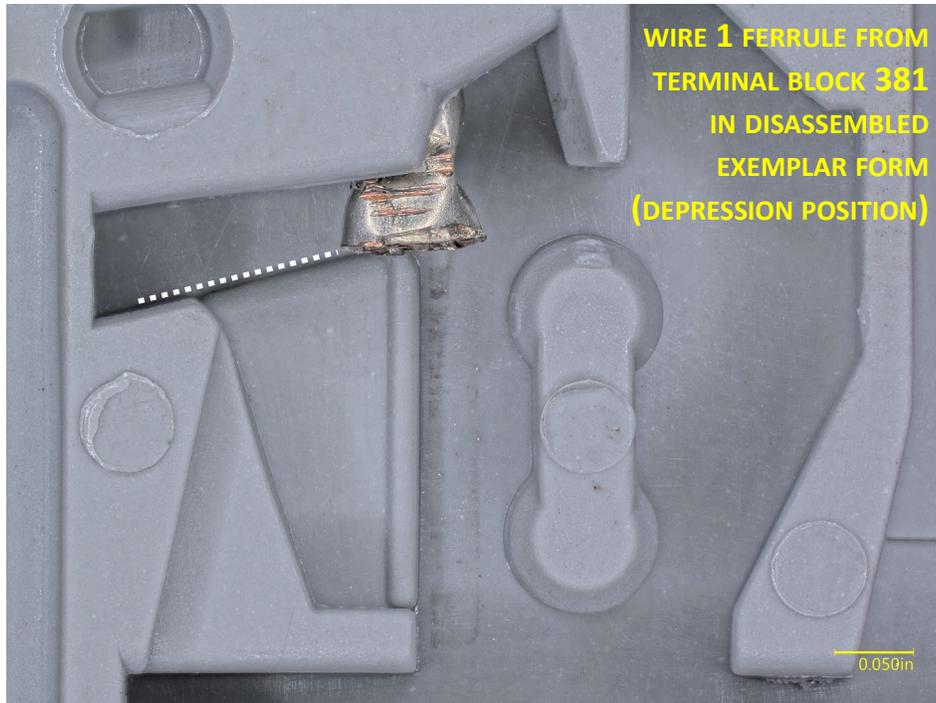
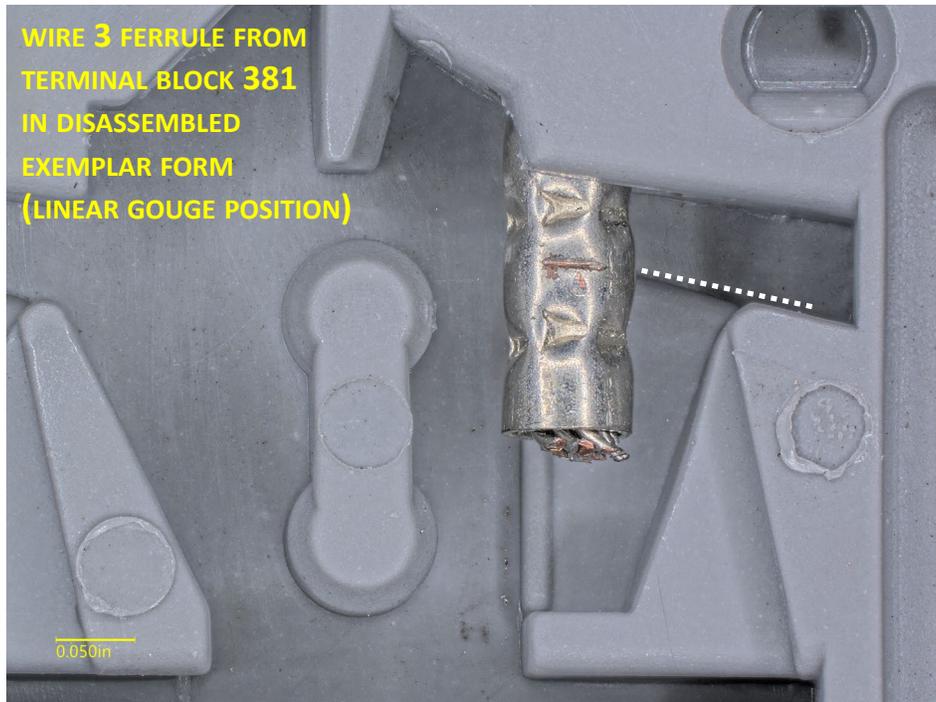
The conductor bar was disassembled from one exemplar terminal block to expose the connection points in the polymer form. The wires from Terminal Block 381 were then inserted into their respective connection points at different positions in the exemplar terminal block form. The top of Figure 33 shows wire 1 positioned with the depression on the end of the ferrule in-line with the spring clamp gate edge, with the white dotted line indicating the path along which the spring clamp gate would move. The bottom of Figure 33 shows wire 3 positioned with the sole linear gouge in the ferrule in-line with the spring clamp gate edge, with the white dotted line again indicating the path along which the spring clamp gate would move. Both wires were then inserted to the maximum depth possible in their current condition into the cage areas of the connection points, as shown in Figure 34. The ferrule on wire 3 could touch the bottom of the cage area, while the depth to which the ferrule on wire 1 could be inserted was shallower due to the still assembled labeling band restricting movement into the connection point. The depth of the wire 1 ferrule into the corresponding connection point being restricted by the labeling band as compared to the wire 3 ferrule is illustrated by the macro photo shown in Figure 35.

Figure 33. Digital microscope images of the ferrules from wires 1 and 3 from Terminal Block 381 inserted inside the corresponding connection points in a disassembled polymer form from an exemplar terminal block. The white dotted lines indicate the path along which the spring clamp gate would move. (Top) Wire 1 was positioned with the depression on the end of the ferrule in-line with the spring clamp gate edge. (Bottom) Wire 3 was positioned with the sole linear gouge in the ferrule in-line with the spring clamp gate edge.
