**NATIONAL TRANSPORTATION SAFETY BOARD  
OFFICE OF HIGHWAY SAFETY  
WASHINGTON, D.C.**

**TECHNICAL RECONSTRUCTION GROUP CHAIRMAN'S  
FACTUAL REPORT**

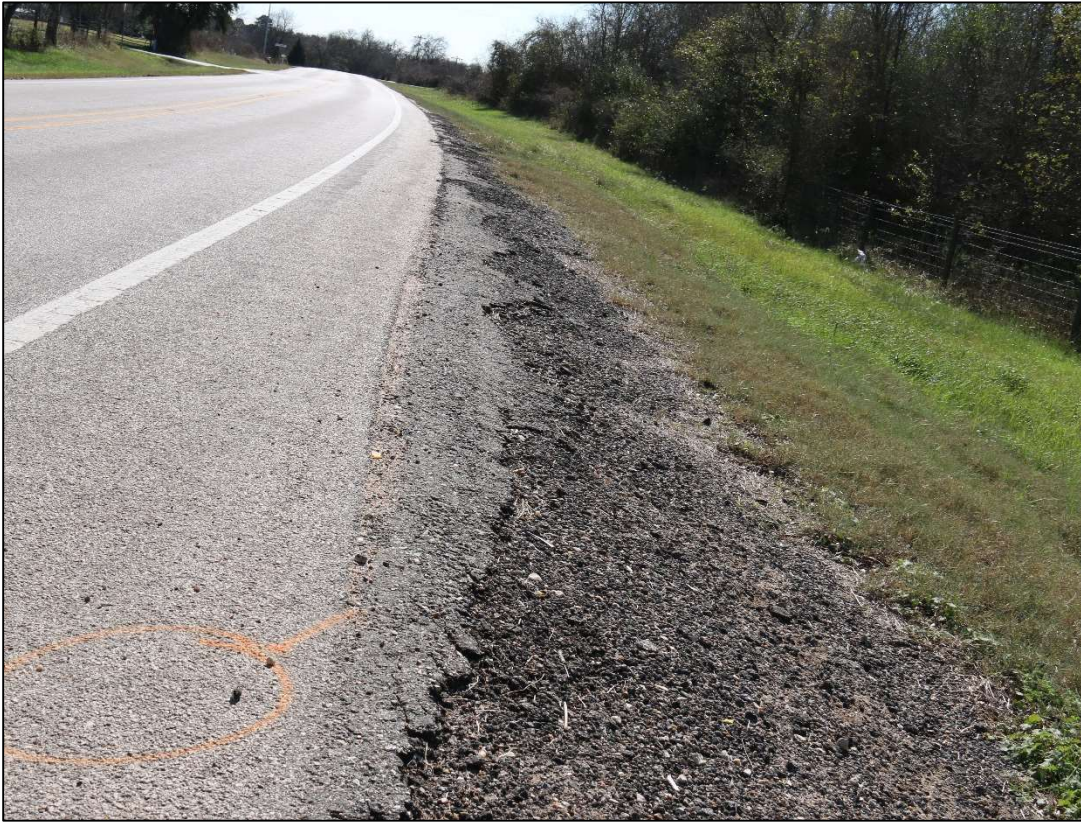
Contiguous with the southbound right shoulder (west side of highway) was a 26 to 28-inch-wide area of compacted aggregate that likely supported the pavement edge. In many places this compacted aggregate had a thin asphalt overlay. While some areas of this asphalt overlay were fractured, it exhibited a descending slope that transitioned smoothly to the grass-covered foreslope. In areas where the overlay exhibited a drop at the edge, the vertical displacement did not exceed about 1.25 inches. At the other locations where there was less roadside aggregate or no overlay atop the aggregate, a slight edge drop could be present at the shoulder edge, although the vertical difference was found not to exceed two inches.

**Figure 3:** Photograph depicting southbound right roadway edge near area of bus roadway departure.

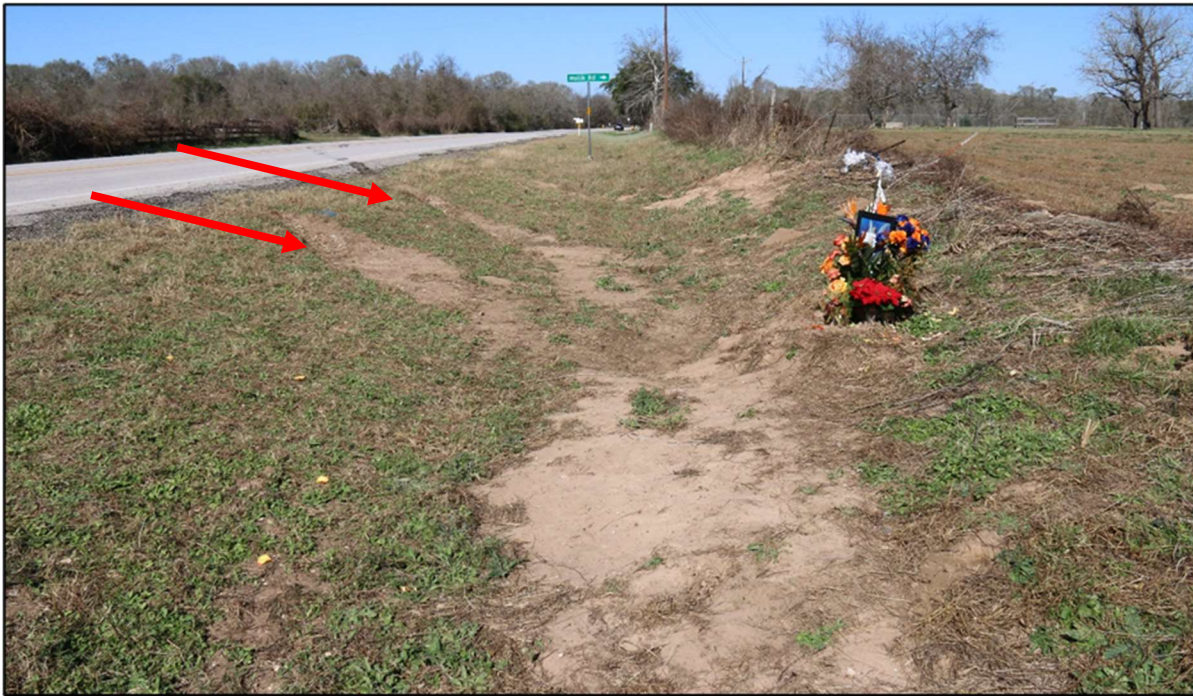
In the area of the final roadway departure before overturning, a wide ditch was present. While a (descending) foreslope was contiguous with the highway, the depth of the ditch and relative height of the backslope varied considerably throughout the area. Where the bus departed the pavement, the ditch appeared to be more prominent while at other locations there was no ditch or discernible backslope. Site measurements of the ditch revealed an overall width of 27-28 feet and approximate maximum depth of 35 inches. The fore slope exhibited a grade of about -16-17% (6:1), while the backslope was about +25-26% (4:1).

**Figure 4:** Photograph depicting northward view of east roadside adjacent the northbound travel lane where the school departed the highway and overturned. Soil furrows (indicated by red arrows) from the bus tires are visible.

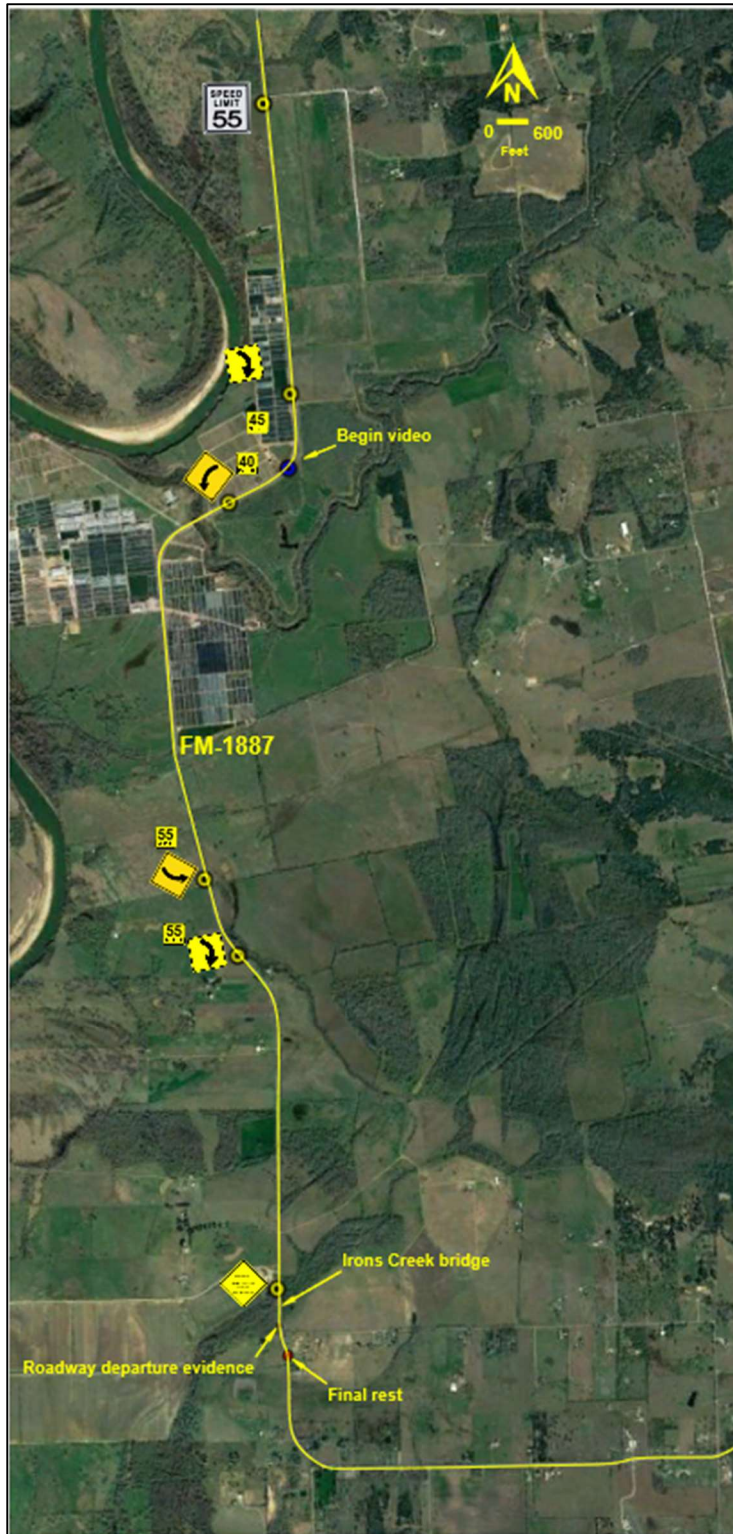
**Figure 5:** Google Earth overlay depicting southbound highway sign placement north of the crash site.

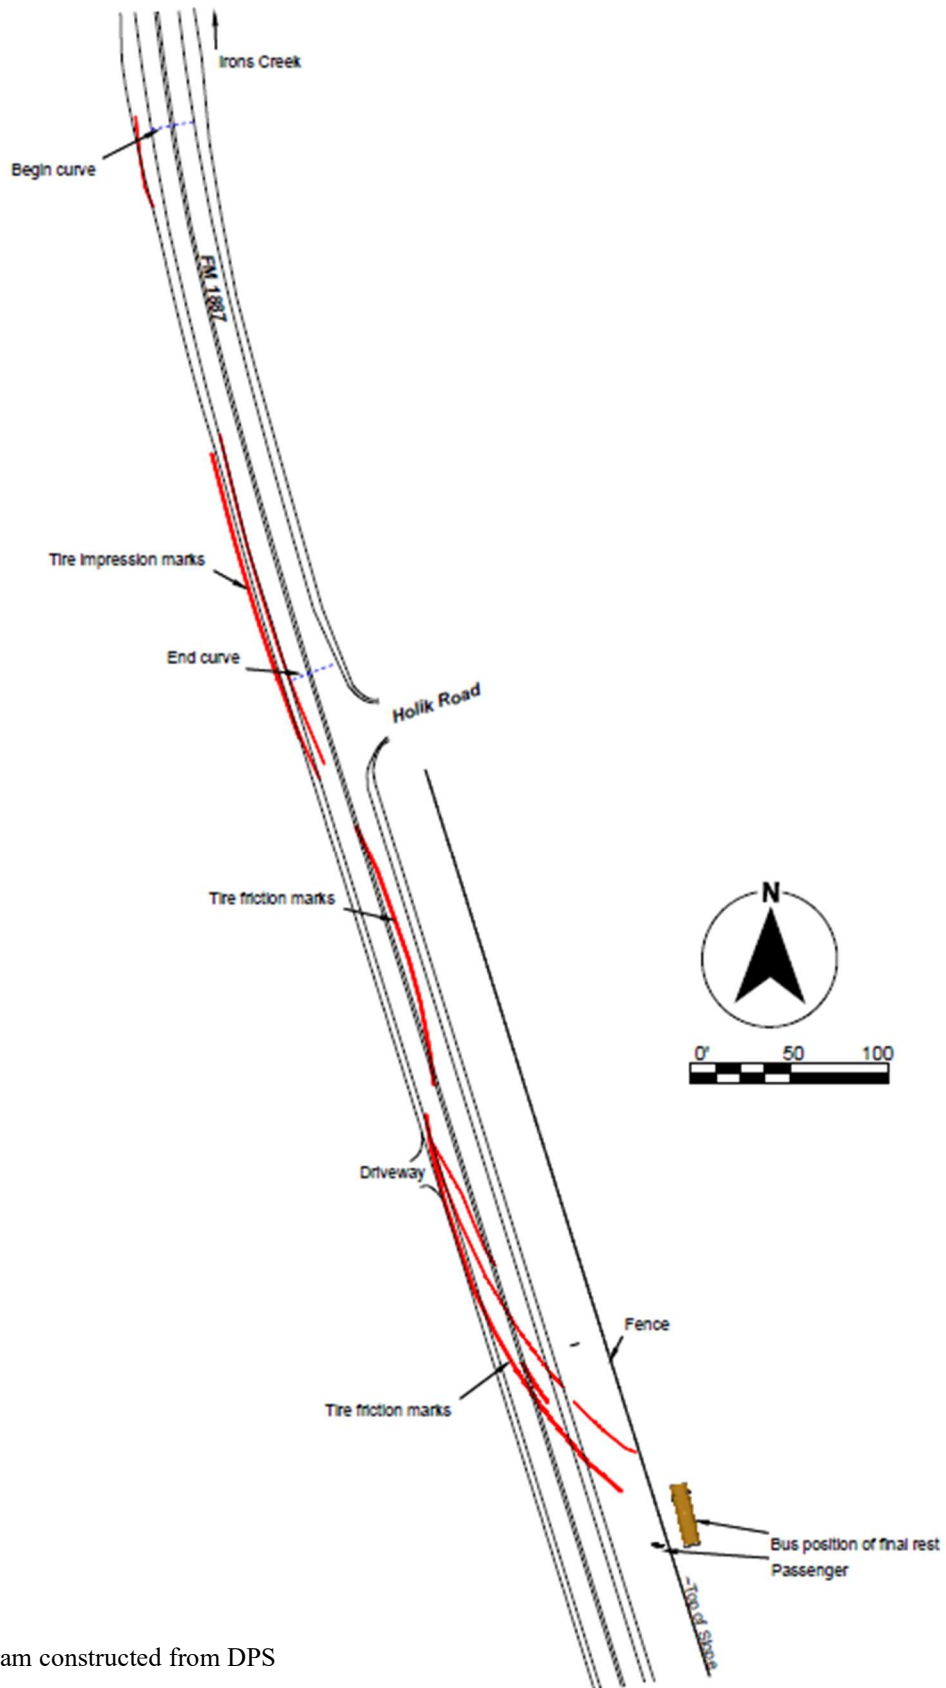
**Figure 6:** Scene diagram constructed from DPS mapping data.

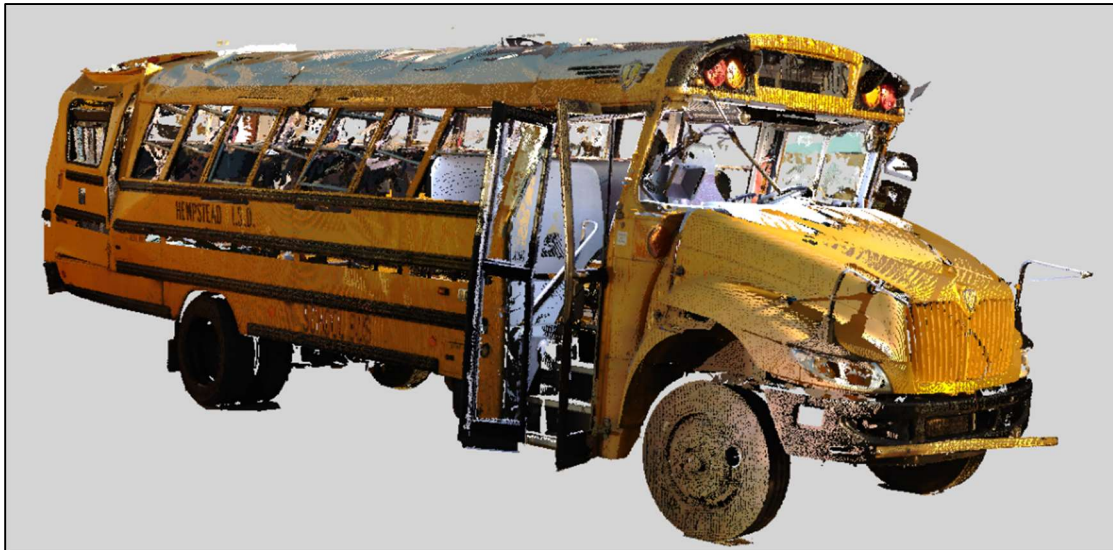
The vehicle primarily exhibited damage along the right (passenger) side roofline beginning at the rear corner and progressing forward. Damage was more significant at the rear of the vehicle. The left (driver) side roof exhibited areas of impact depression and paint scarring that was less substantial than damage on the right side. Seams along the roof exhibited entrapped dirt and some vegetation indicative of ground contact with a rear to front movement. The roof and support pillars above the lower windowsill were shifted toward the driver side about nine degrees. The upper half of the rear emergency exit door frame exhibited a similar lateral displacement. The greatest area of deformation appeared at the right rear corner roof line which in addition to the leftward displacement was vertically compressed about four inches. Soil debris embedded in areas of the body, primarily at the right rear, was indicative of vehicle motion and orientation during the roll event. There was no discernible reduction to the vehicle wheelbase or overall length.

**Figure 7:** Screen capture image of the 3D point cloud rendering of the involved bus as observed from the right front of the vehicle.

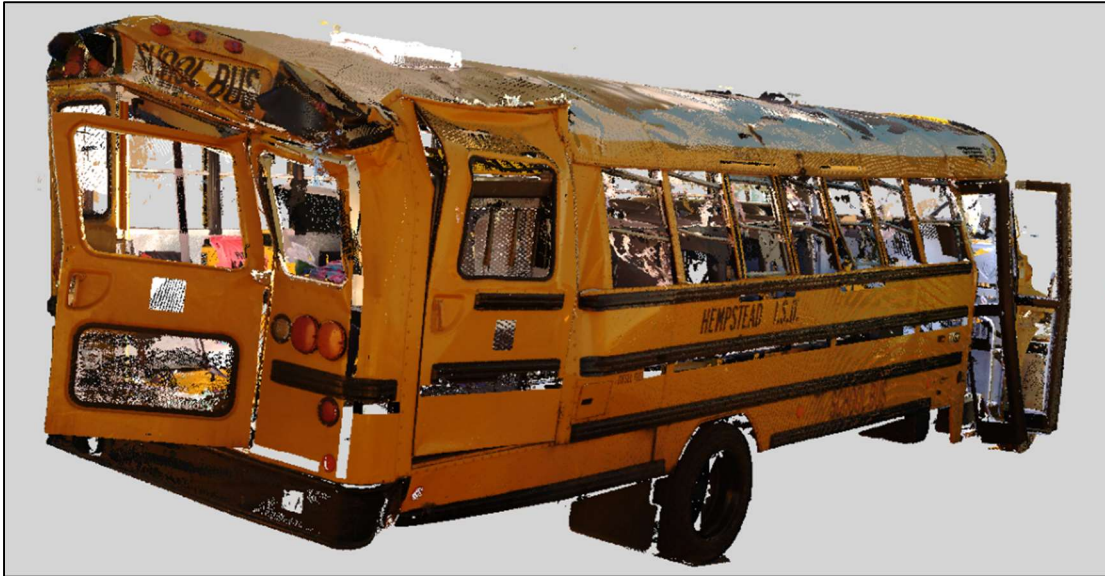
**Figure 8:** Screen capture image of the 3D point cloud rendering of the involved bus as observed from the right rear of the vehicle.
