RE: BARGE SM3 Grounding- - DOL: 8/30/2020  
Assured: Northline Seafoods, LLC  
Preliminary "Brief" Damage Report DV3148 "Hull & Machinery"

### **BARGE SM3 – DV3148**

#### **Preliminary “Brief” Damage Report Photo Log**

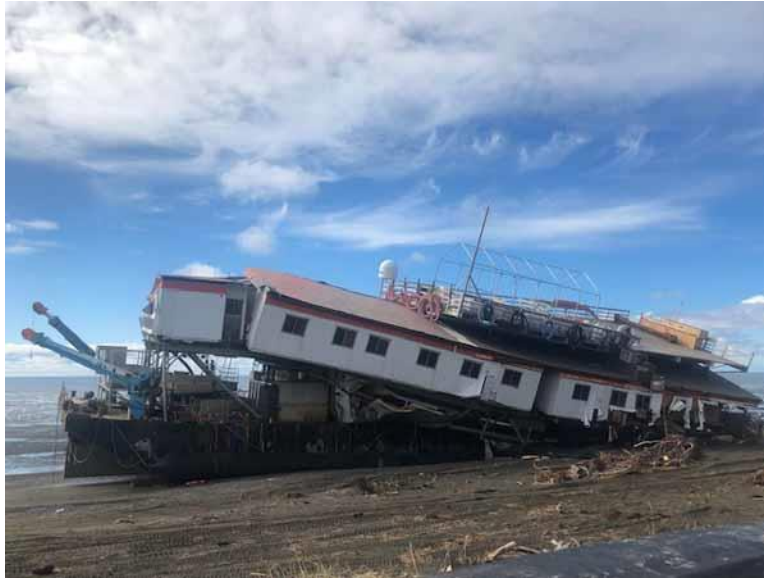
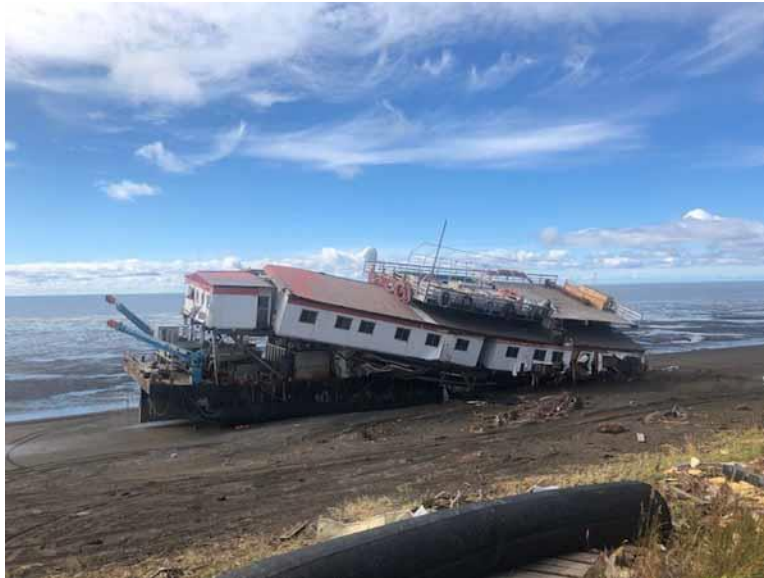
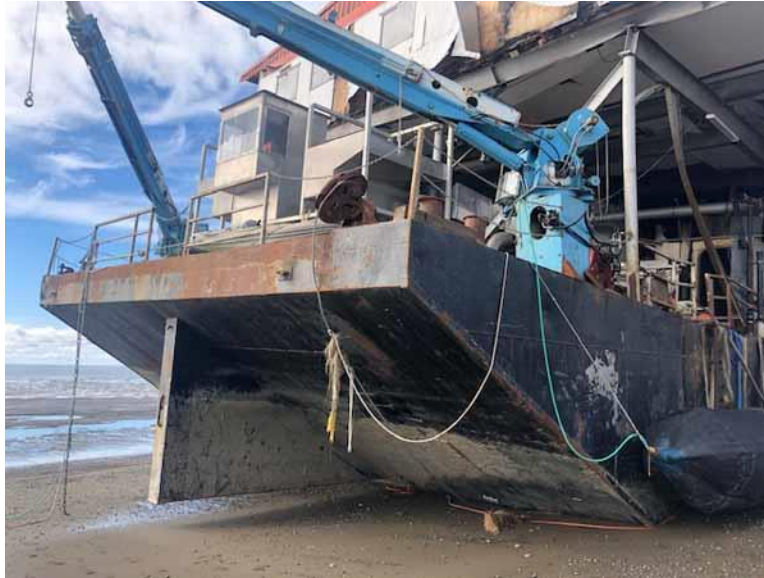
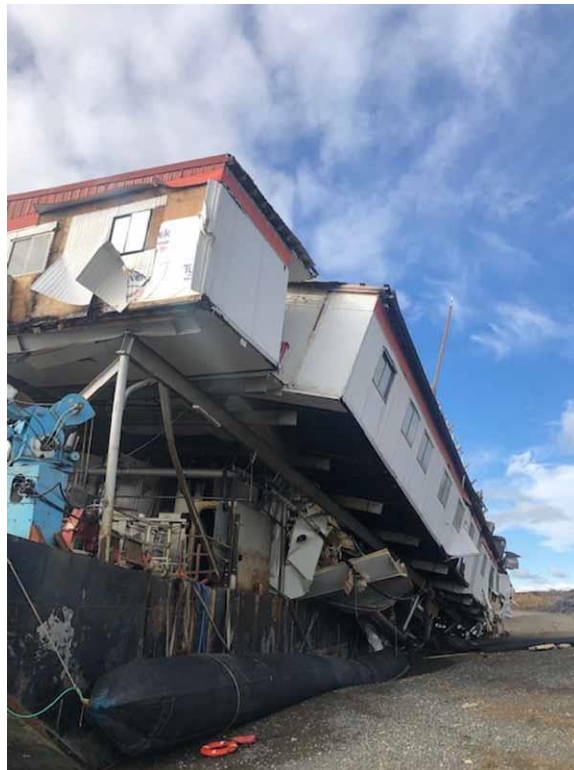
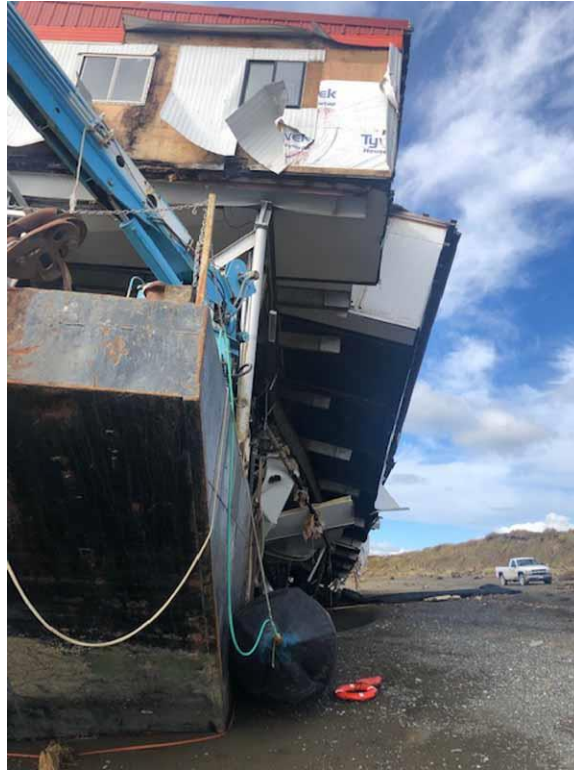
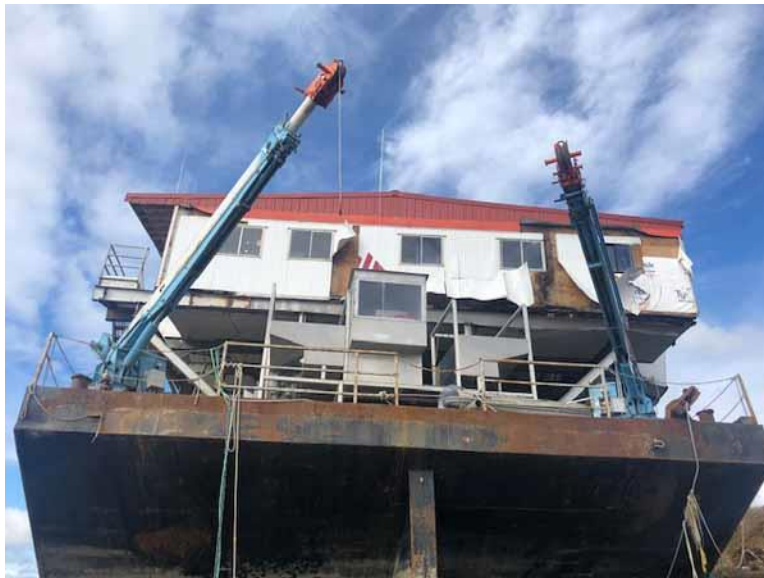
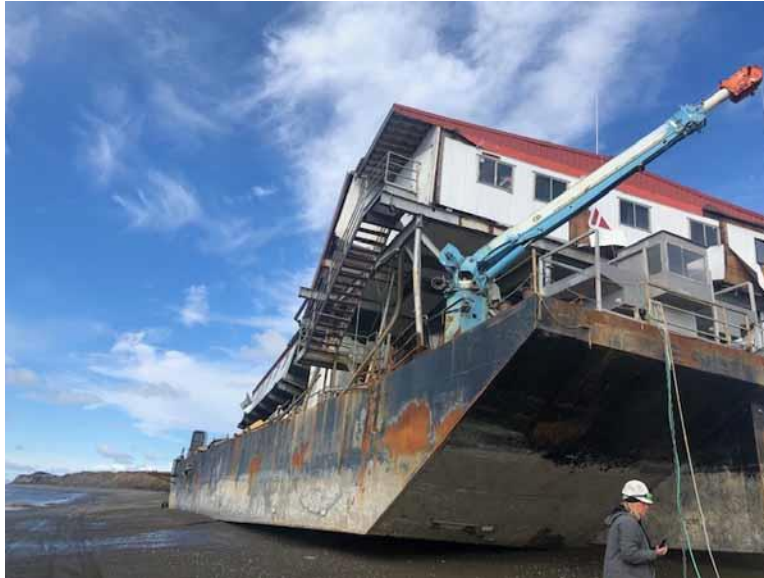
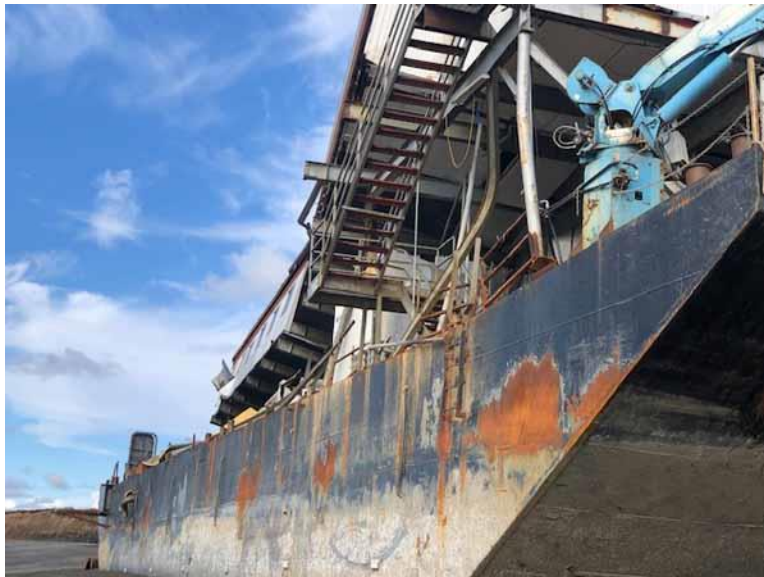
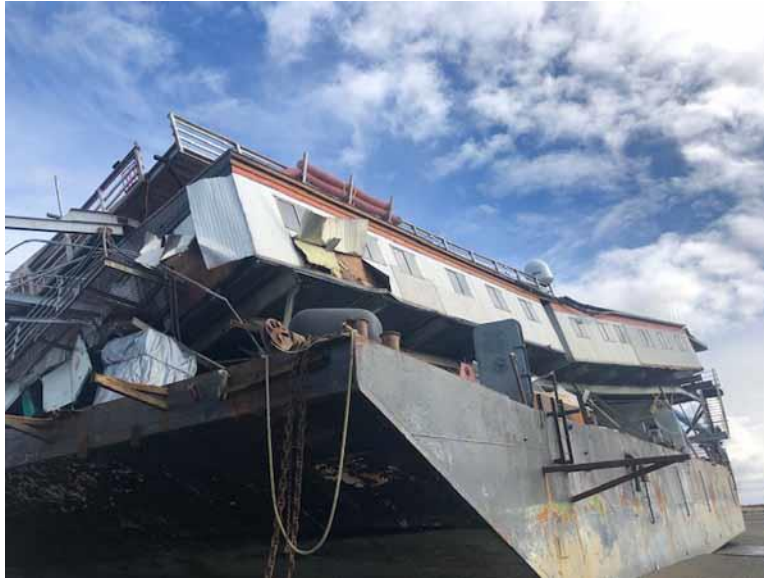
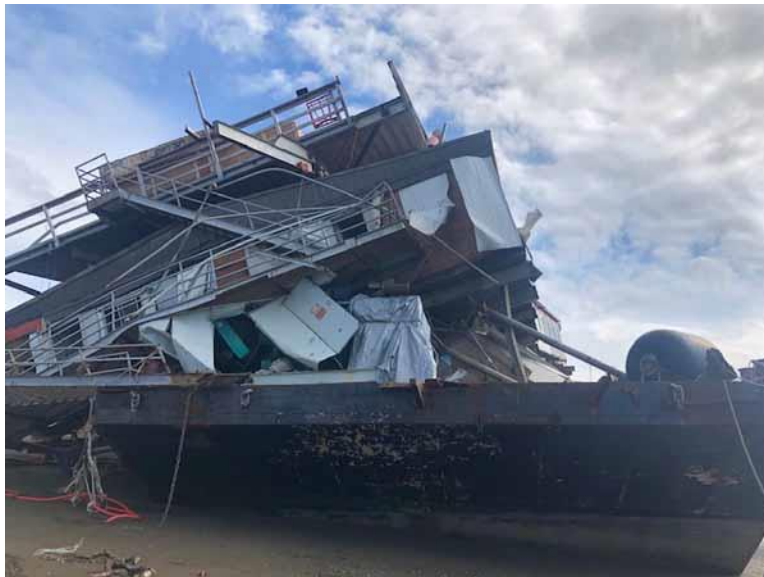
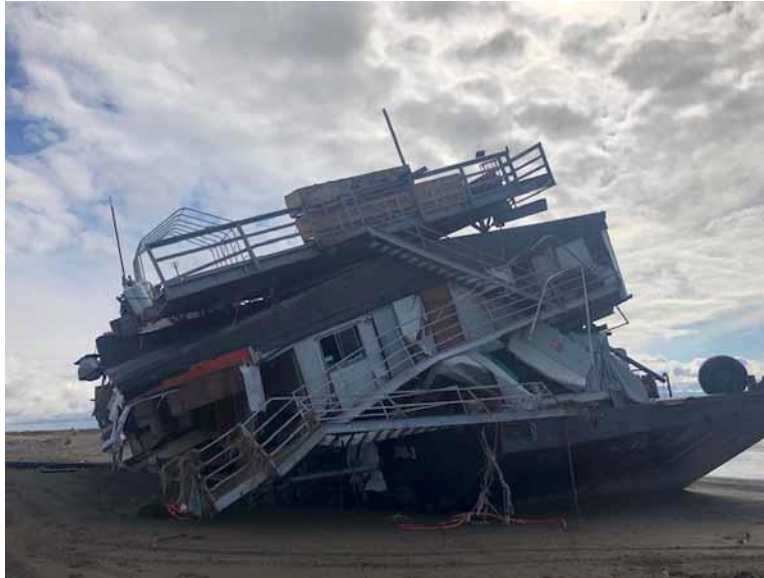
The entire vessel rests hard aground, at low tide, parallel to, and up approximately 100 yards from the shoreline, approximately 5 miles East Southeast of the Village of Ekuk, Alaska. At high tide stages the Barge is exposed to sea water storm surge. Barge structural damage is evident where the deck plate is torn away where support weld-on columns ripped loose or compressed into the deck and the machinery below deck upper watertight door enclosure house was ripped away. This exposes the barge to further down flooding in various compartments aside the critical machinery space.

- 1.-11. Views of the Barge SM3 hull and collapsed upper super structure as she lies aground low tide on the Ekuak, Alaska area beach.
- 12.-30. Various views of the Barge SM3 above deck superstructure collapsed onto the barge process house and deck.

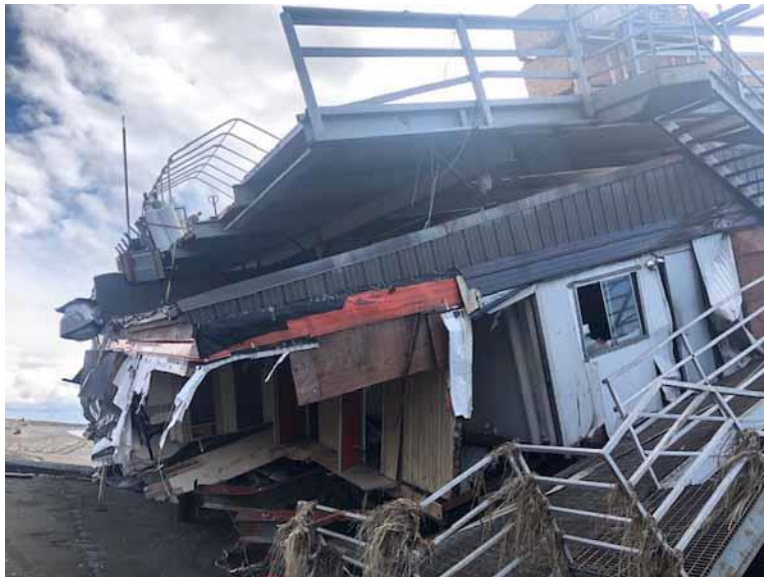
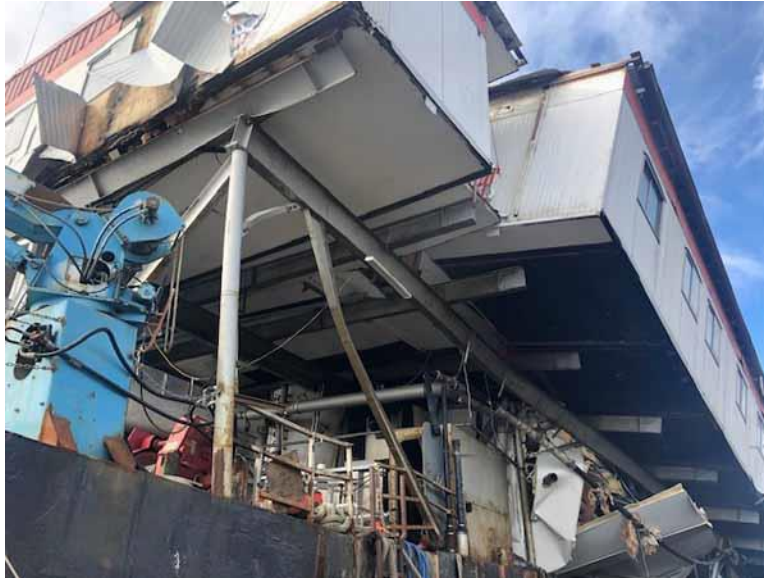
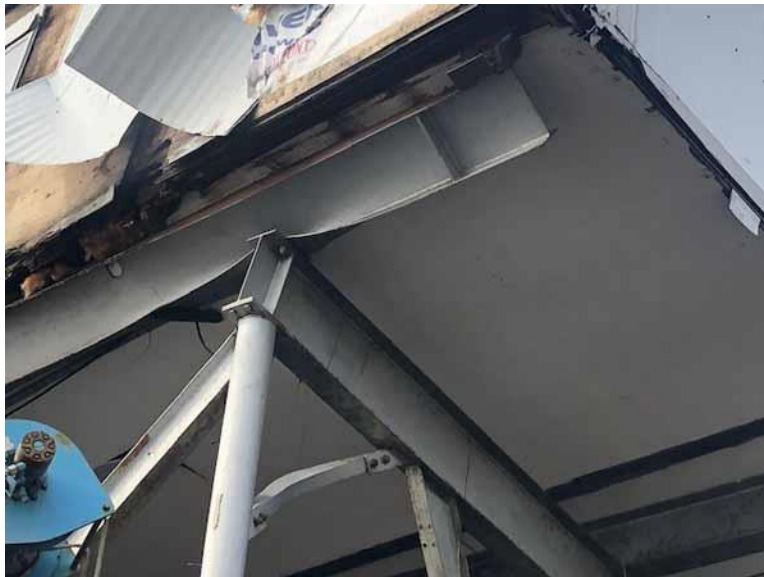
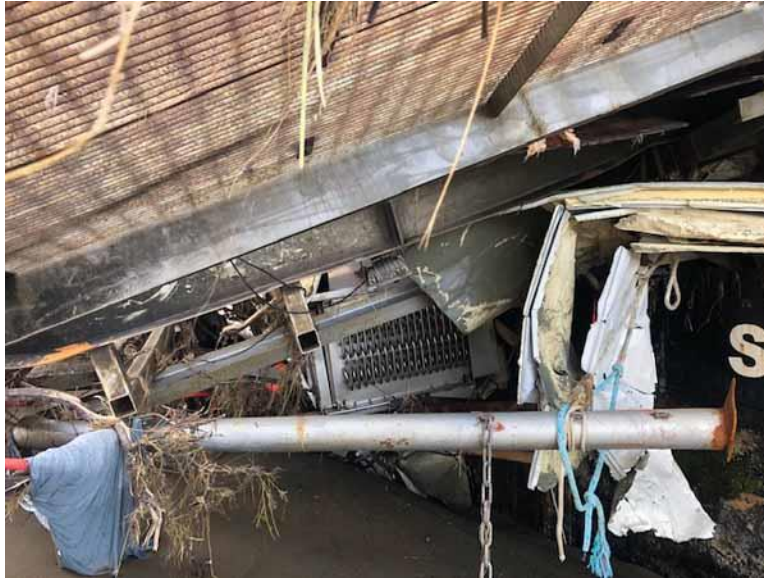
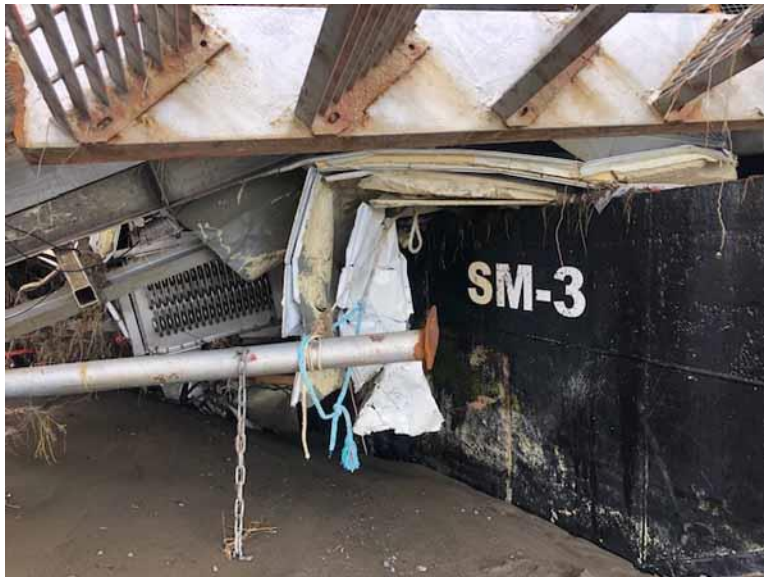
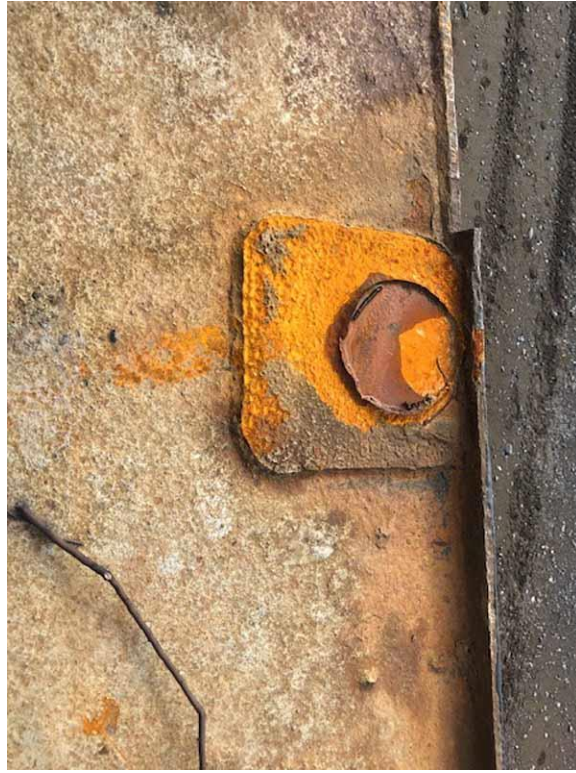
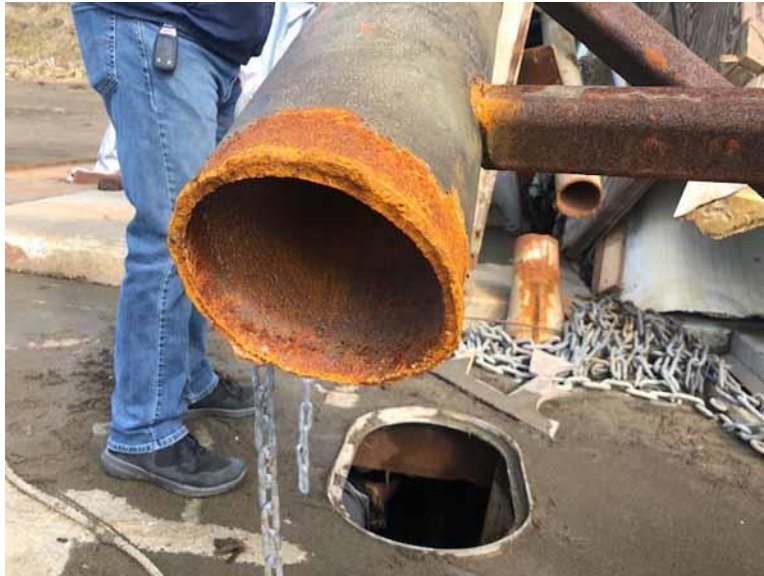
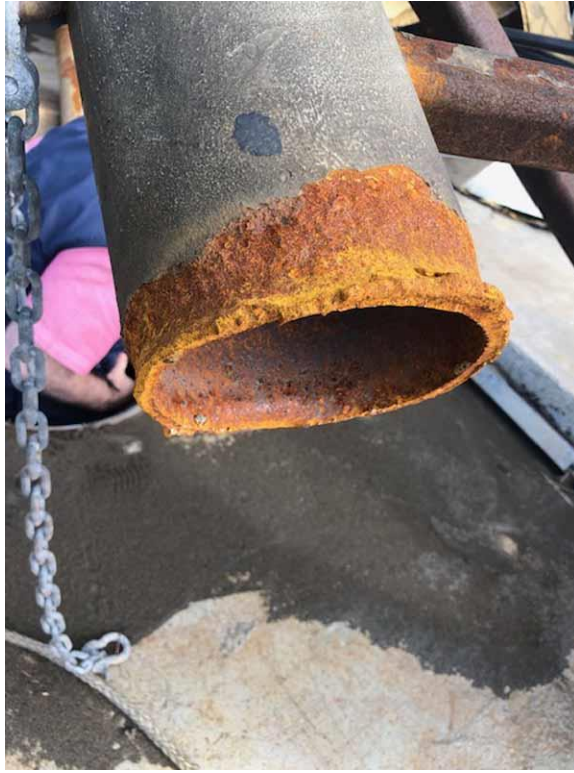
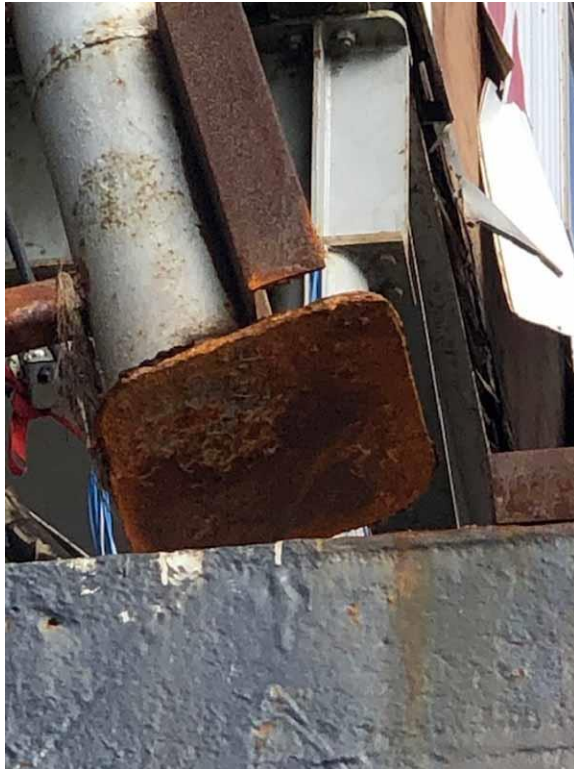
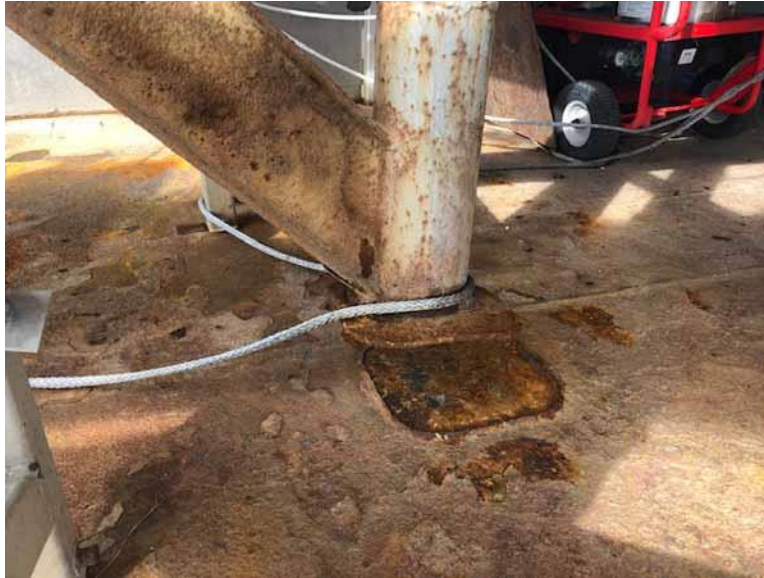
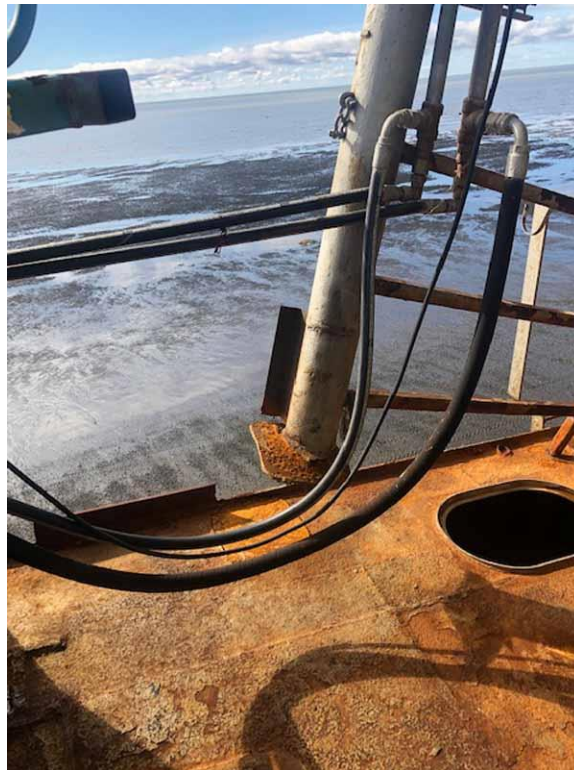
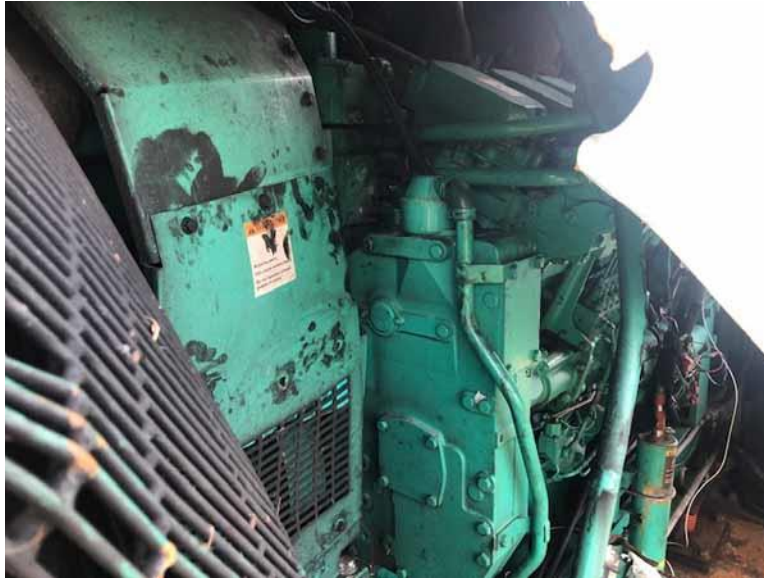
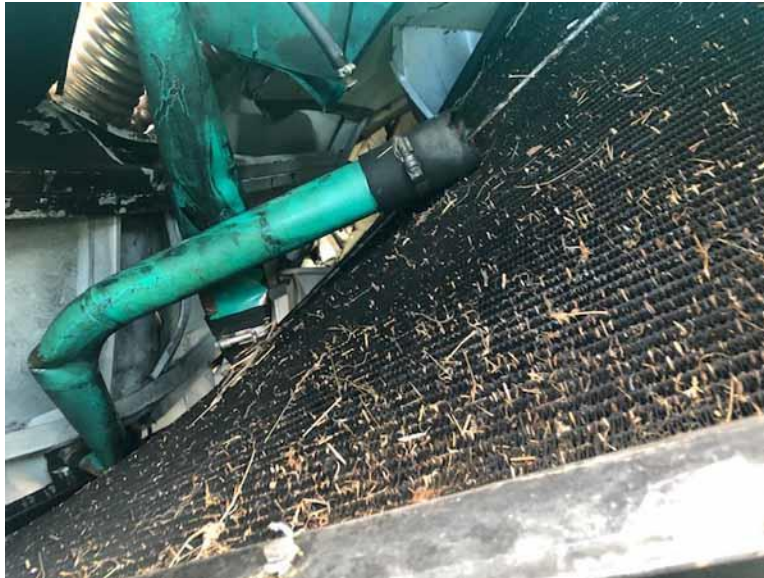
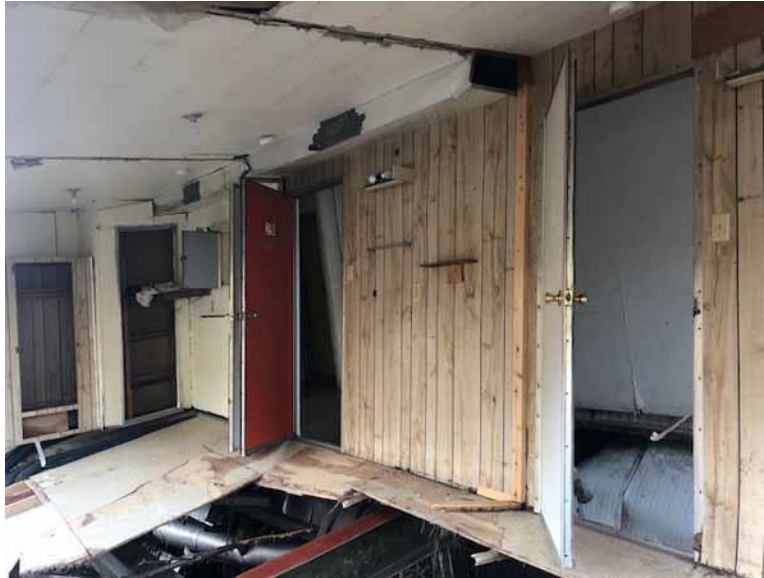
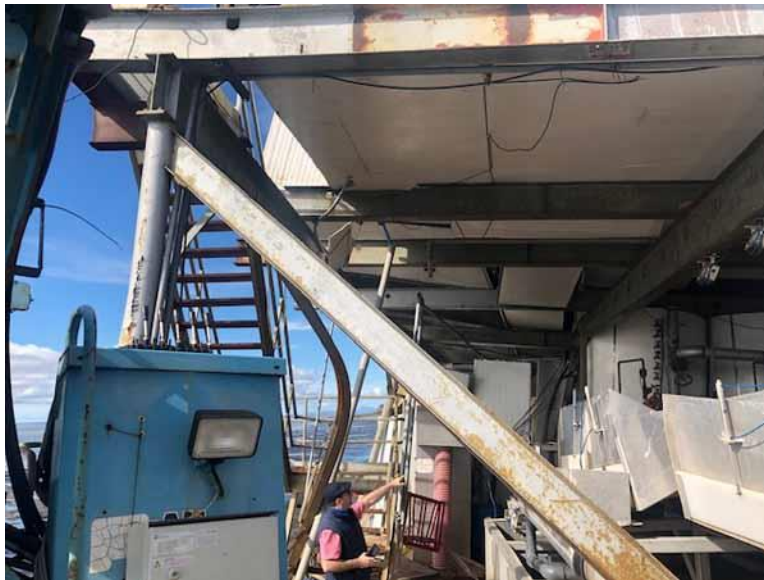
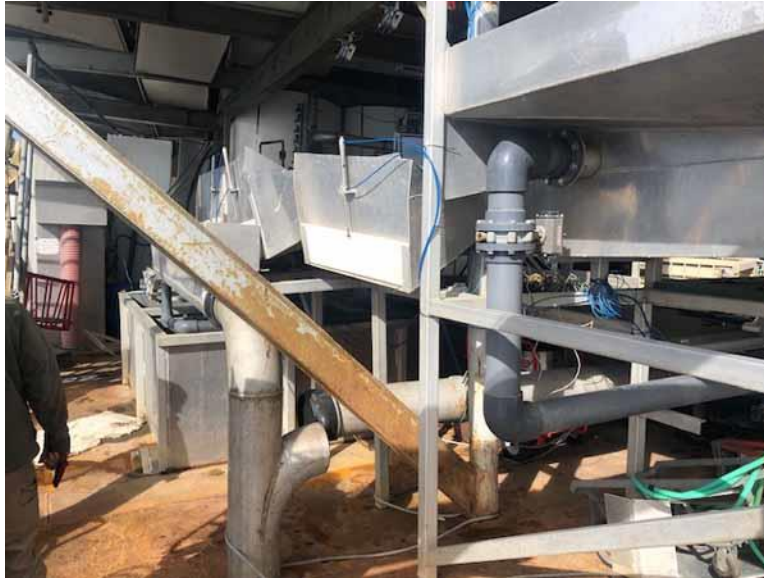
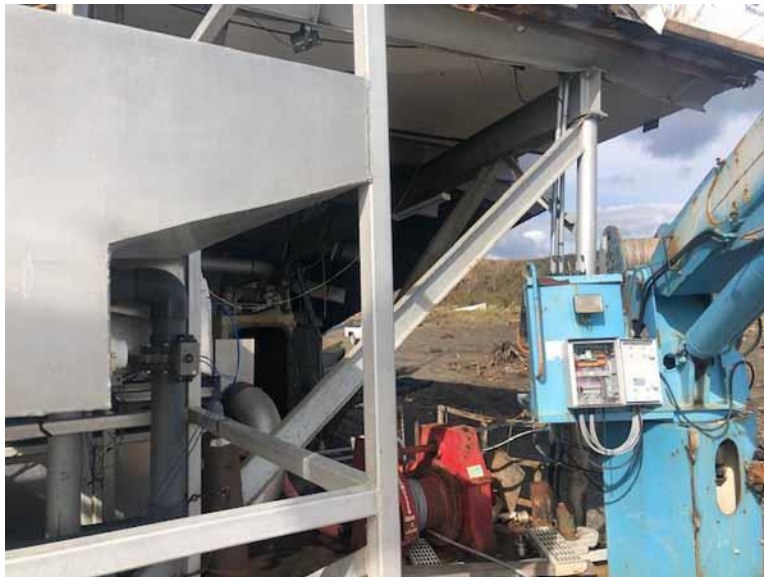
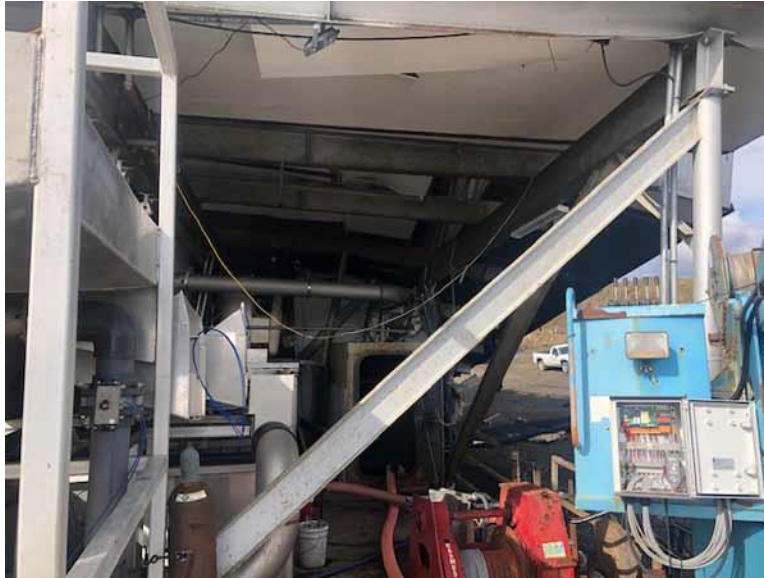
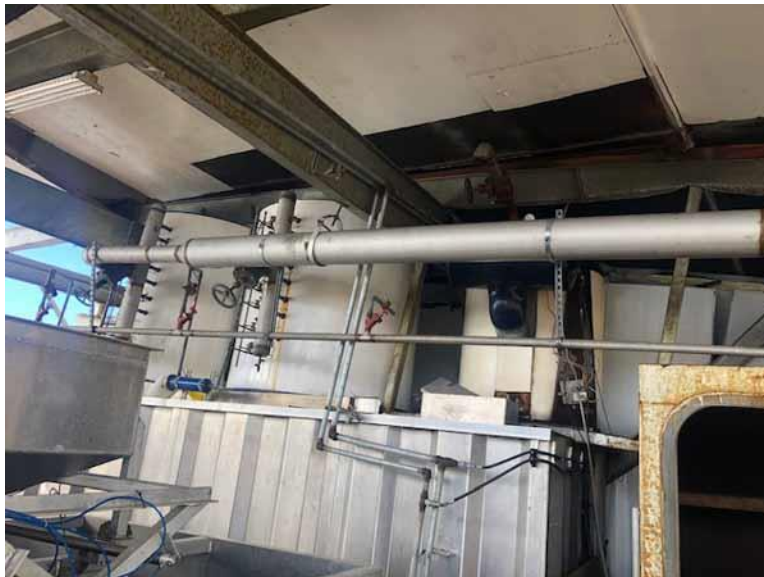
The upper superstructure with H-beam girder/vertical column support collapsed down onto the factory/freezer plant structure distorting the scantling supports, crushing that plant and shifting this entire above deck housing assemblies heavy over to the Barge starboard side and beyond to partially drag onto the beach.

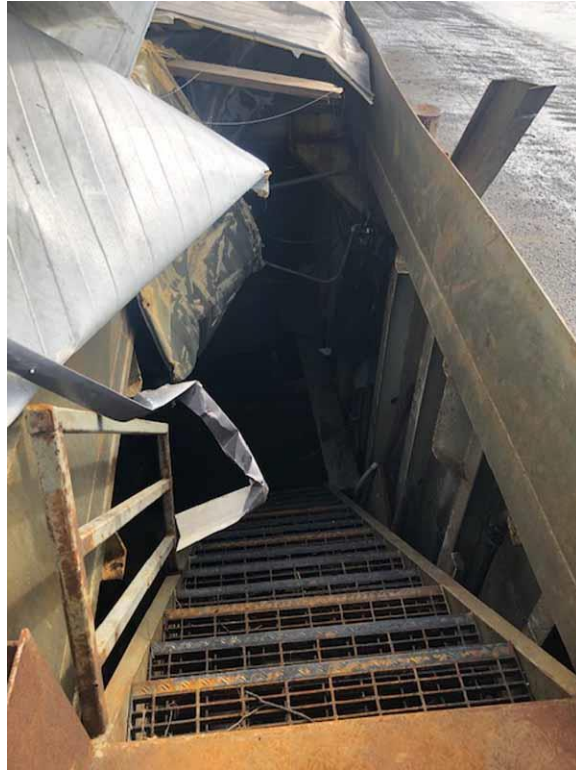
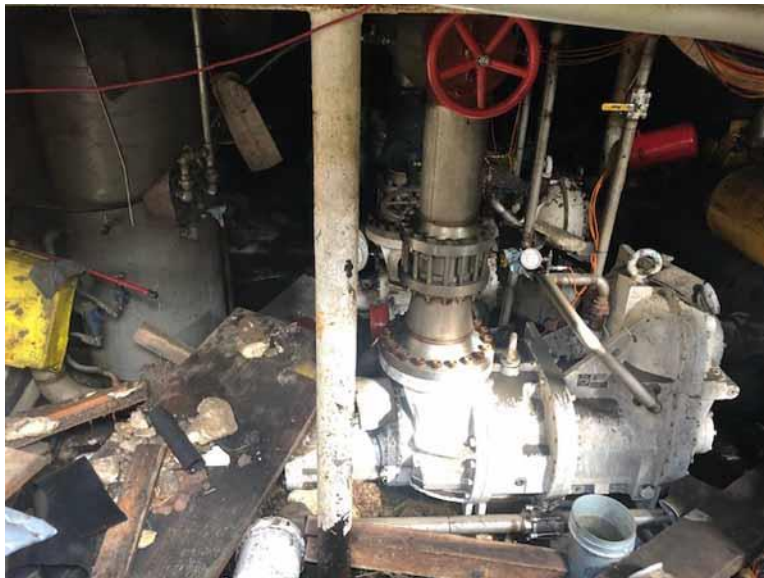
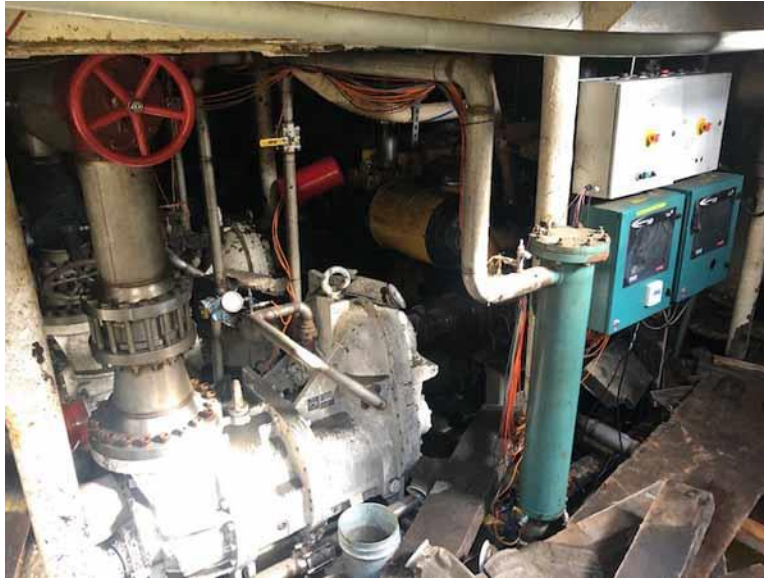
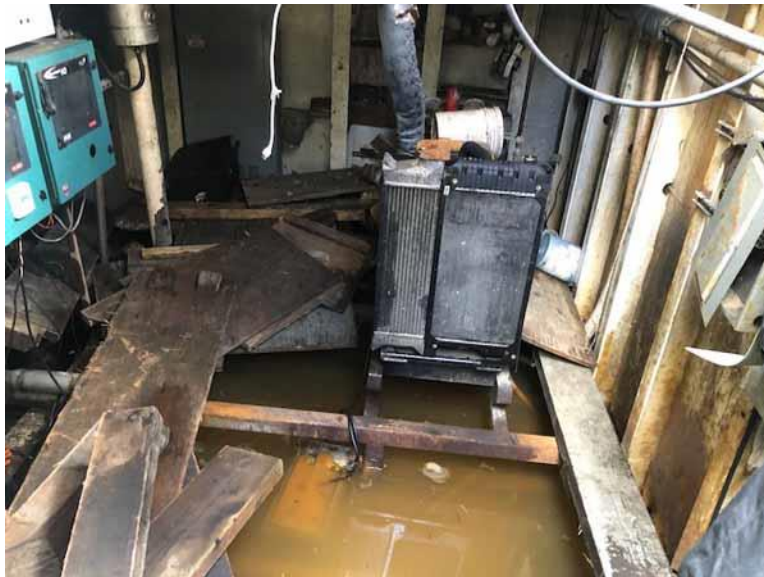
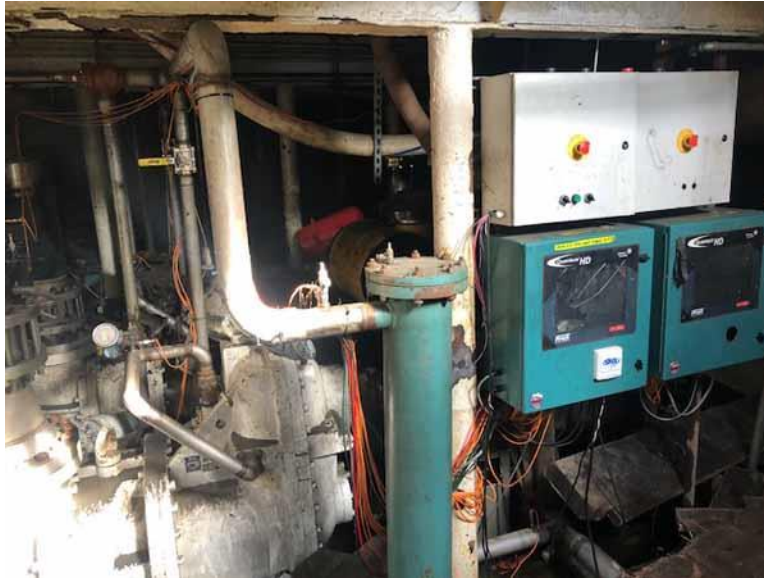
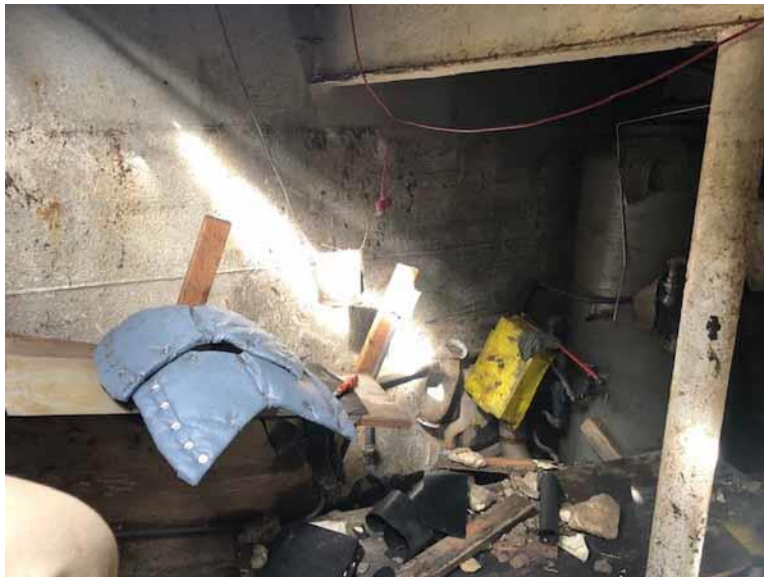
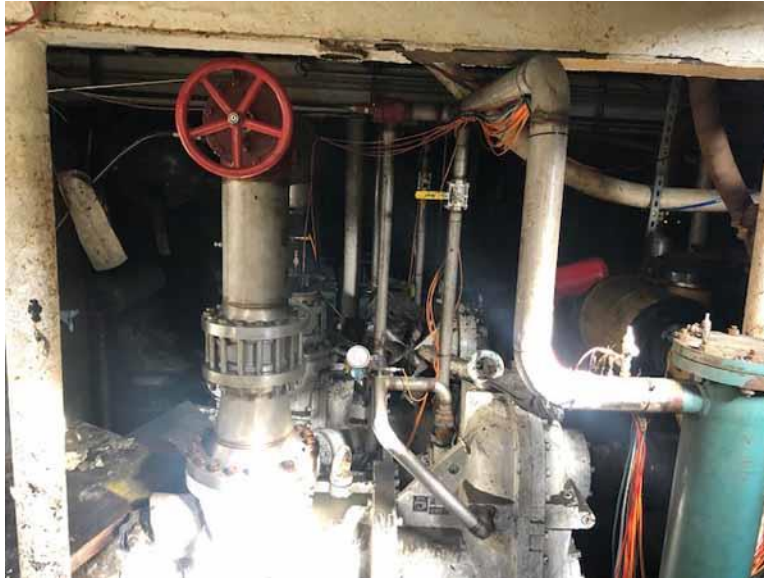
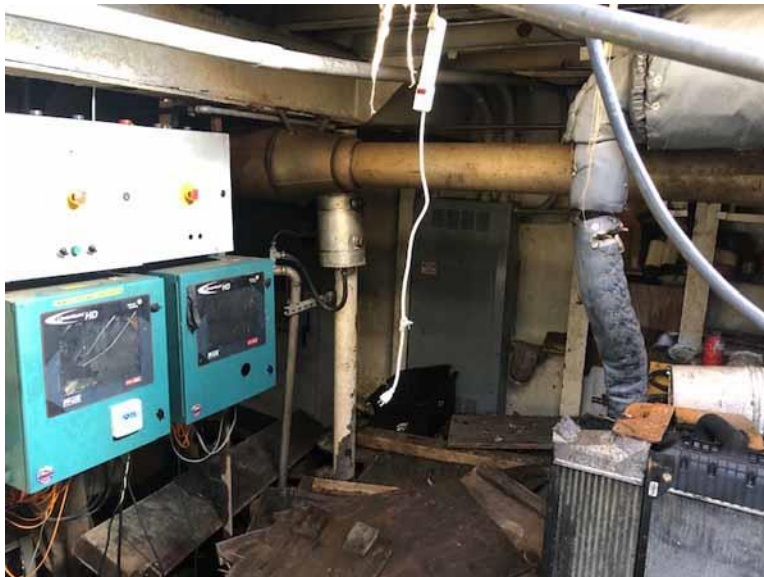
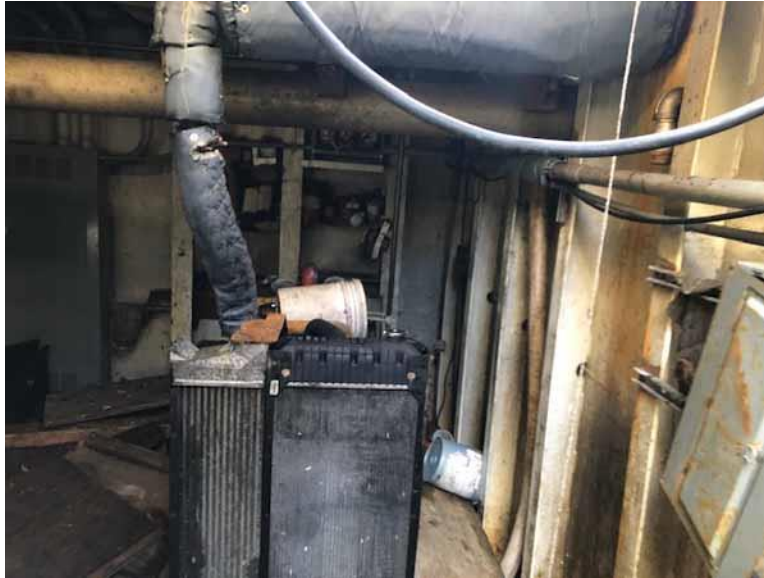
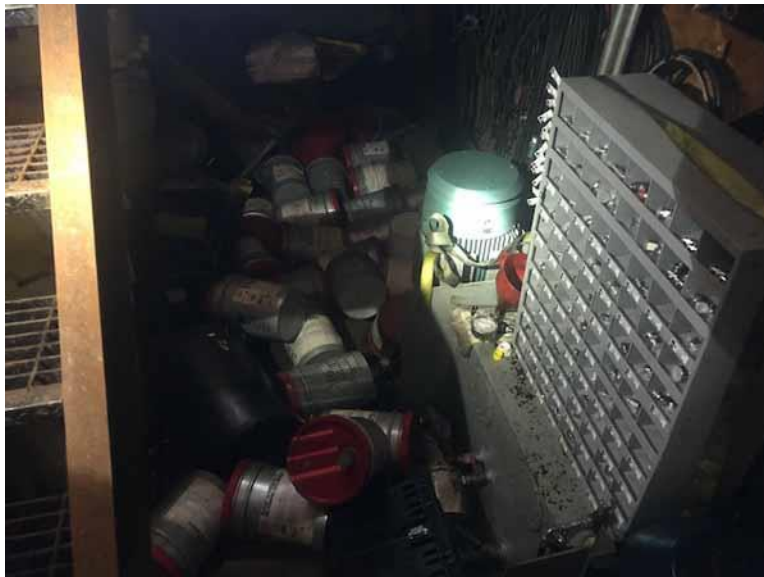
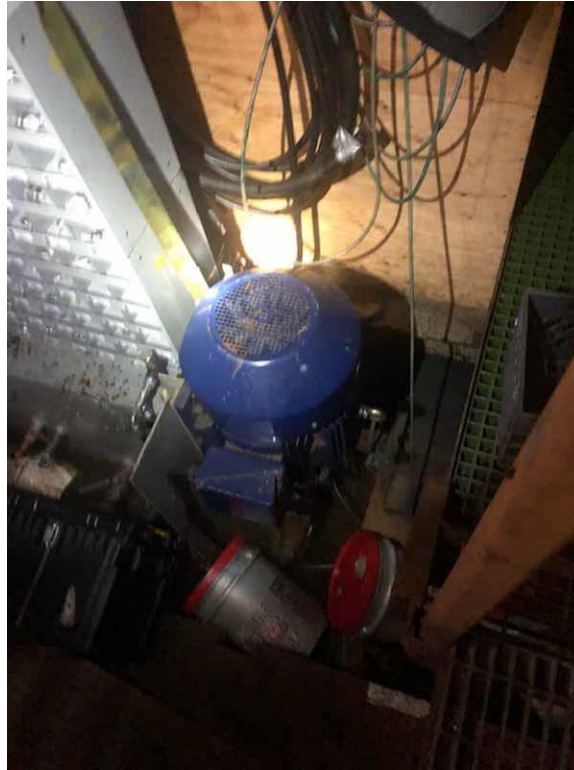
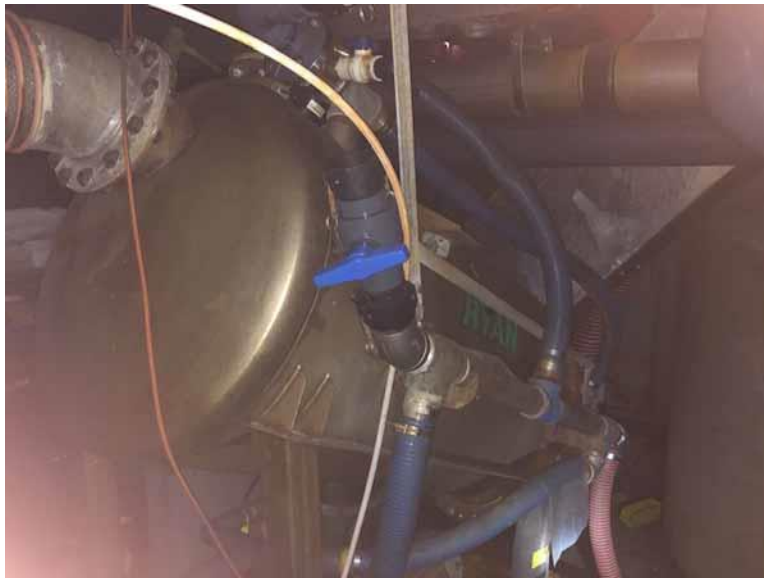
The entire below deck machinery critical space was down flooded by the storm surge sea water approximately three quarters up the floor to ceiling, covering all the critical factory/freezer support diesel plants, refrigeration components and the AC/DC electrical distribution.

- 31.-42. Views of the Barge SM3 below deck seawater down flood areas and damage, especially in the engine/packing room space.
- 43.-47. Views of the Barge SM3 beach debris field above the barge and high tide line, then disbursed approximately 1.5 miles each way off the barge amidships starboard side.

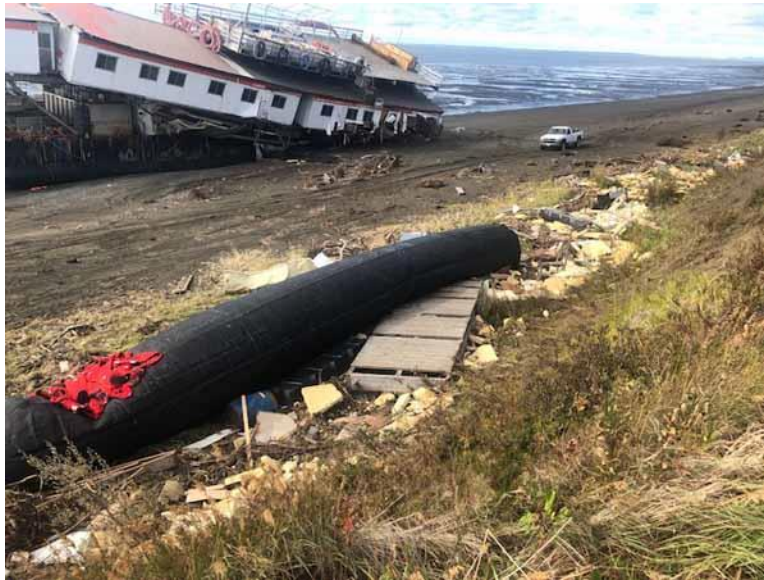
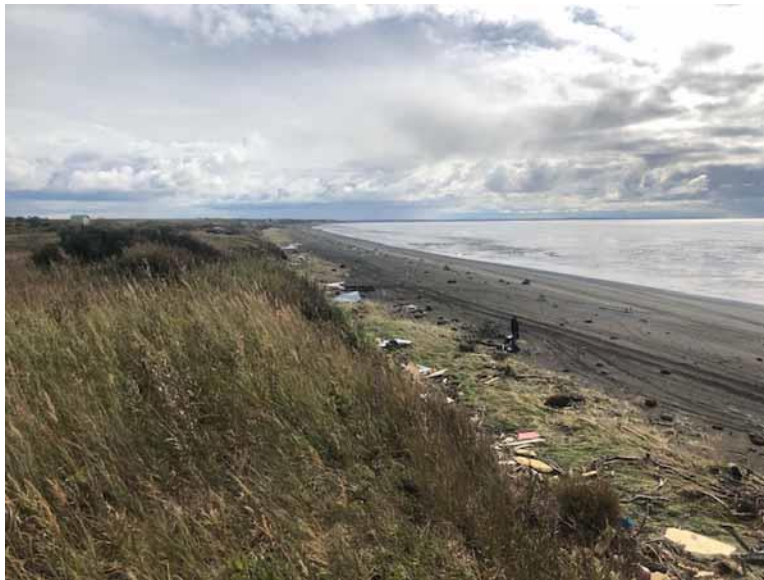
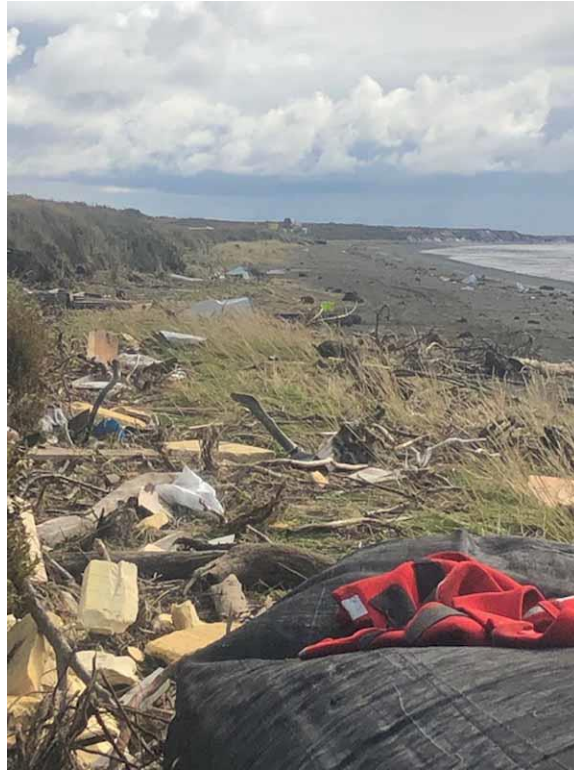
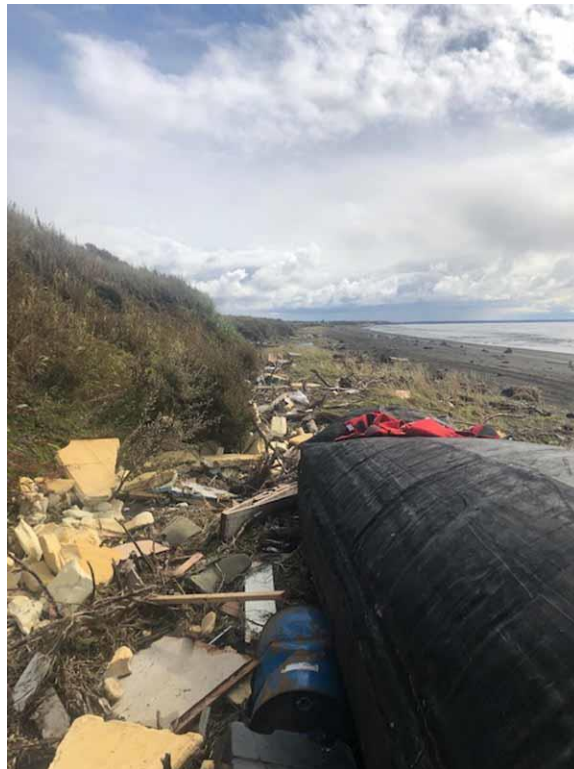
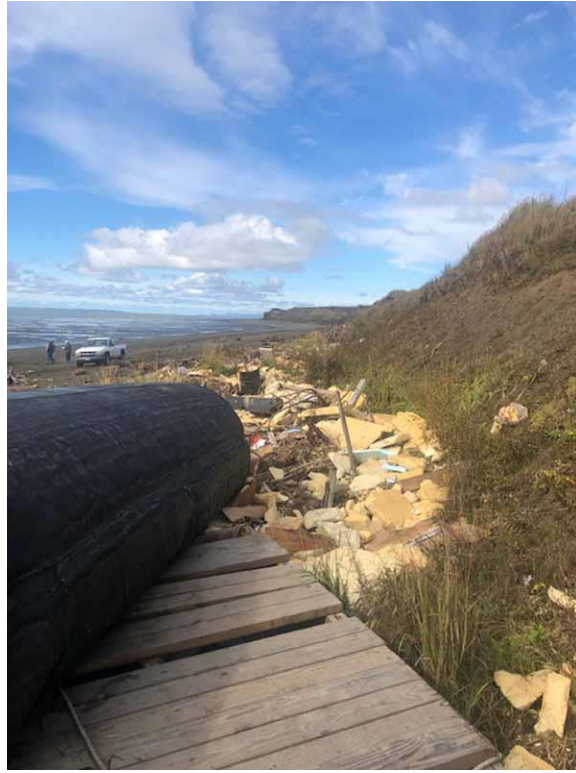
The upper highwater beach level, up against the rising bluff, off the Barge starboard side, has an extensive and heavy debris field extending approx. 1.5 miles each side of the barge amidships. Debris consist of foam insulation pieces, fenders, wood and siding sections, barrels, lines, and so on with slight diesel odor, closest to the center of the debris field and off the barge starboard side. No oiled beach gravel or materials was observed.

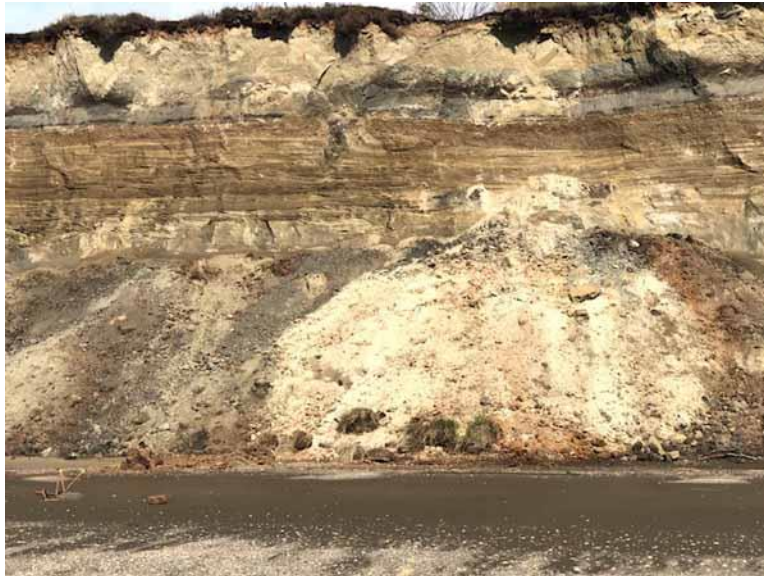
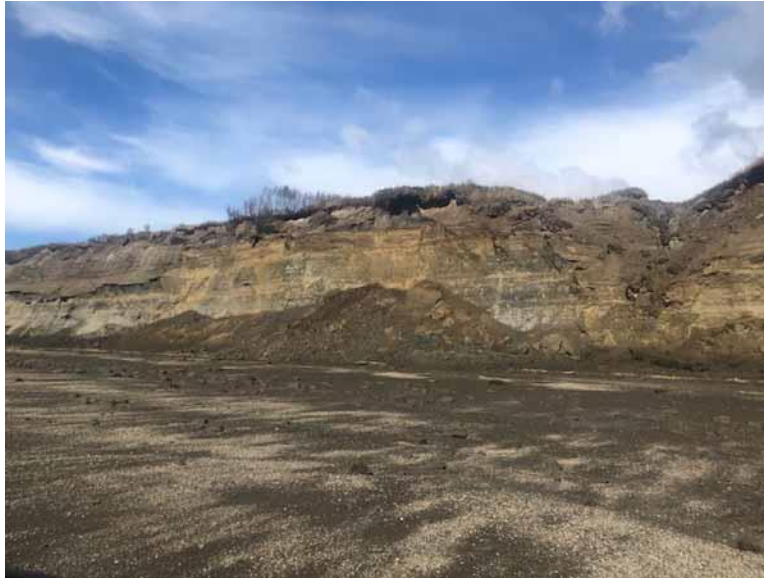
- 48.-49. Sample views of the beach upper bluff erosion collapse due to the recent storm involved in this incident.
- 50.-54. Views of the Barge SM3 moorage ball steel top plate section that ripped off the ball with the barge connect padeye yet attached to that plate section.
