RE: BARGE SM3 Grounding- - DOL: 8/30/2020  
Assured: Northline Seafoods, LLC  
Preliminary "Brief" Damage Report DV3148 "Hull & Machinery"

### **BARGE SM3 – DV3148**

#### **Preliminary “Brief” Damage Report Photo Log**

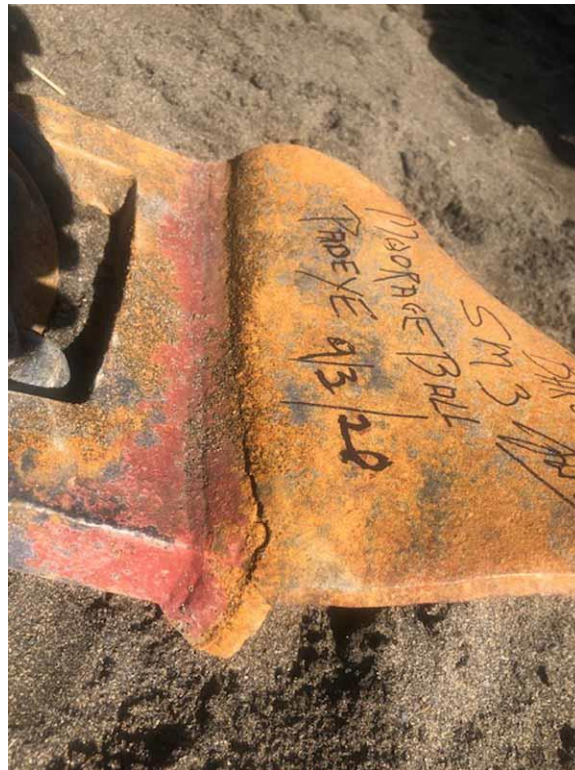
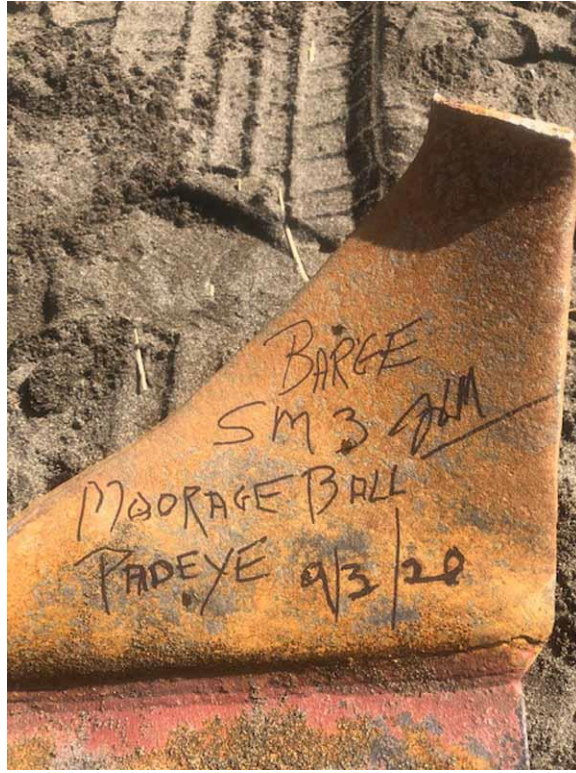
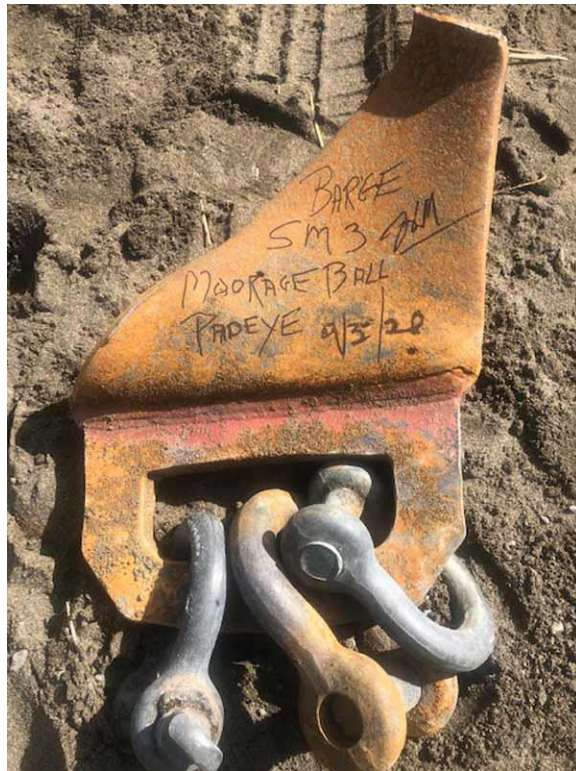
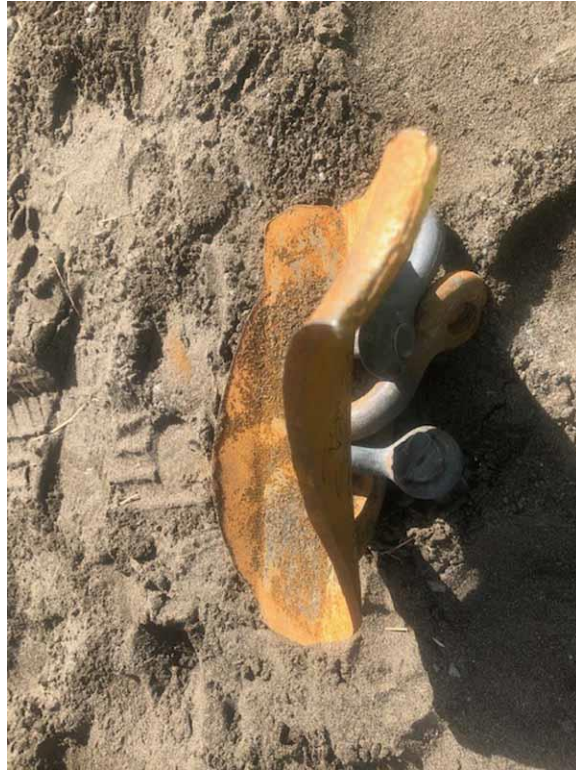
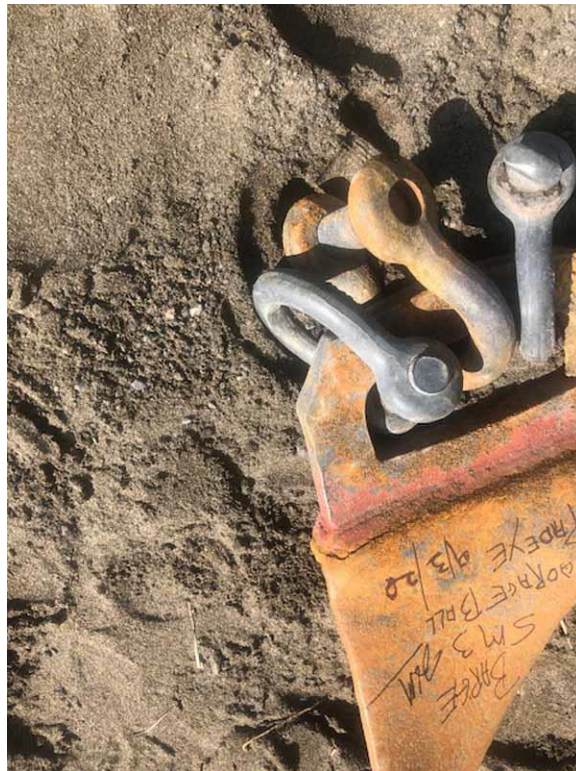
Based on the undersigned’s observations and discussions with the barge owner’s representatives, the barge was moored off on the owner’s two-anchor moorage flotation ball system, as normal, when an unpredicted, heavy and violent high wind storm, of reported 80 mph winds, developed, with heavy sea surge, where the barge broke away from the moorage ball itself, where the steel ball plate ripped away under the connect padeye, resulting in the barge drifting onto the beach and being pushed upon and toward the beach high tide line, violently and abruptly, pounding the barge starboard side hull into the beach causing the above deck super structure assembly to collapse and shift off center to starboard and over the barge side.

5. The moorage ball padeye/ripped plate section is in the possession of the owners at present, has been marked for evidence by the undersigned, and will be shipped to the undersigned in the near future. In the meantime, the remaining sections of the moorage system is offshore as is the affixed moorage ball and will either be retrieved by the owners or the salvors prior to or during the removal of the barge. Both the owner and the chosen salvor will be advised to preserve the moorage ball itself for further inspection evidence safe keeping.

- 48.-49. Sample views of the beach upper bluff erosion collapse due to the recent storm involved in this incident.
- 50.-54. Views of the Barge SM3 moorage ball steel top plate section that ripped off the ball with the barge connect padeye yet attached to that plate section.

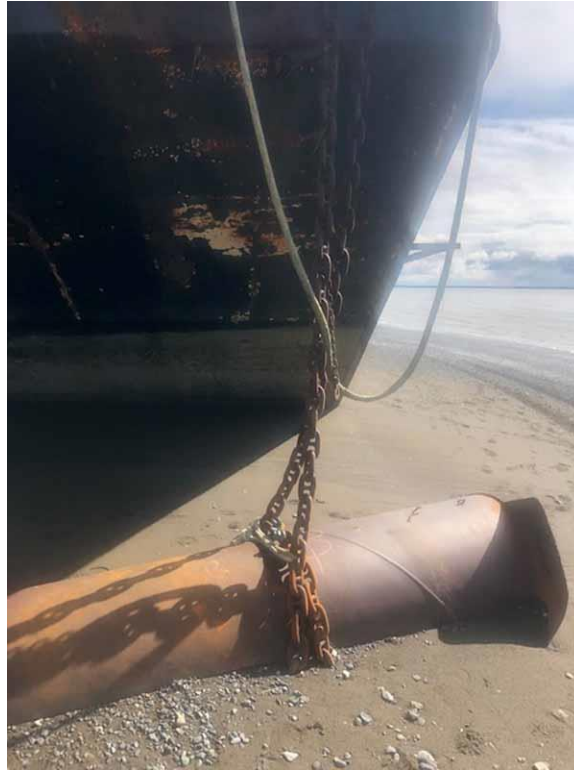
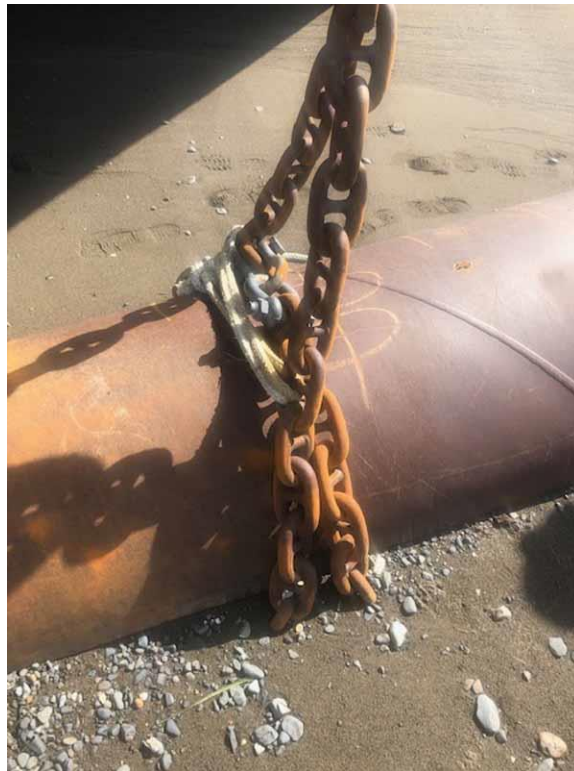
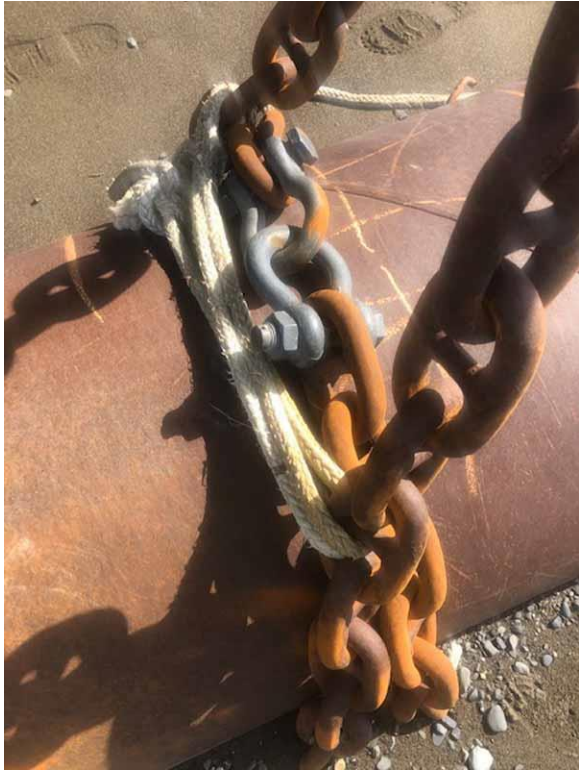
- 55.-57. Views of the Barge SM3 to moorage ball hook up chain and shackle that were connected to the moorage ball when the ball failure occurred. Those components did not fail.
