**From:** [FP Product Application Support](#)  
**To:** [Luke Wisniewski](#)  
**Subject:** RE: Gates General Inquiry - Luke  
**Date:** Wednesday, July 10, 2024 3:24:31 PM  
**Attachments:** [image002.png](#)  
[image003.png](#)  
[image004.png](#)  
[image005.png](#)  
[image006.png](#)  
[image007.png](#)

The 1/2" hose in question, was on a hydraulic steering pump assembly onboard a towing vessel. Specs on the hose was: Gates 8G1 spiraled reinforcement hydraulic hose with four layers (plies) with the following markings/specifications: 1/2" (12.5 mm) Gates (manufacture) 8G1 (model /name) wire braid hose with a minimum work pressure of 16.0 MPa ( 2325 PSI), minimum burst pressure 9,300 PSI, ISO 1436, 1SN R1ATS / EN853 1SN / SAE 100R1AT, Flame Resistant MSHA 2G-11C, AM100718, 1577, -40F to 212F, meets ISO 15540 / ISO 15541, Engineering in USA Made in Mexico, 01:23:59. AM – Mexico 10 – October, 07 – Day, 2018 - Year

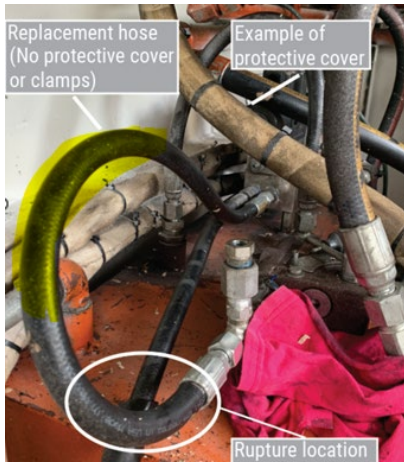
Thank you for that information. Since this hose was in service for 3 ½ years, we believe that the hose assembly ruptured because of movement causing the hose assembly to fatigue over time. The highlighted portion below is unsupported allowing for the hose to move. Below are some suggestions we came up with.

1. Clamp (P-clip) the current hose to provide support so it helps movement fatigue (not sure if this is possible?)
2. Shorten the length of the hose and add in 90 degree fittings and adapters to try to reroute the hose assembly (pages 55 and 56 of Safe Hydraulics brochure cover hose assembly routing tips)
3. Use a different hose that has a two braid reinforcement instead of one braid reinforcement that G1 hose has (options screenshotted below, G2XH, M4K)

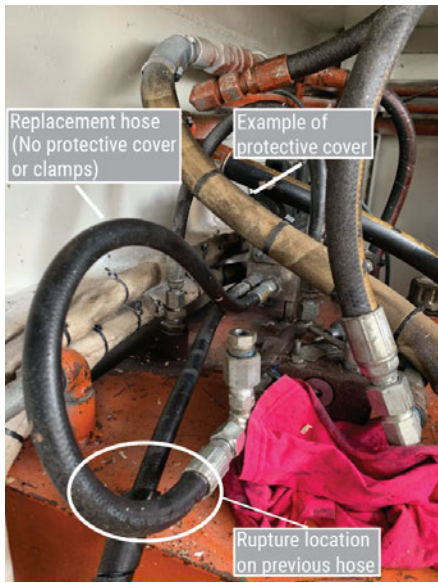
1. What is the application pressure? Working pressure was approximately 1,000 psi Are there any pressure spikes? None reported. Max pressure of the steering gear pump was 2,000 psi.
2. Does the hose have any movement when in operation? Unknown
3. How long has this hose been in service/how long did it last before rupturing? Approximately 3.5 years.
4. Based on the photo of similar configuration, was this ruptured hose also bent right after the fitting/coupling? Yes, the photograph below shows the replaced hydraulic hose (same length and configuration) with the ruptured location from the previous hose circled. The ruptured hose was removed by the operator. No photographs were taken of the ruptured hoses in place after the incident.

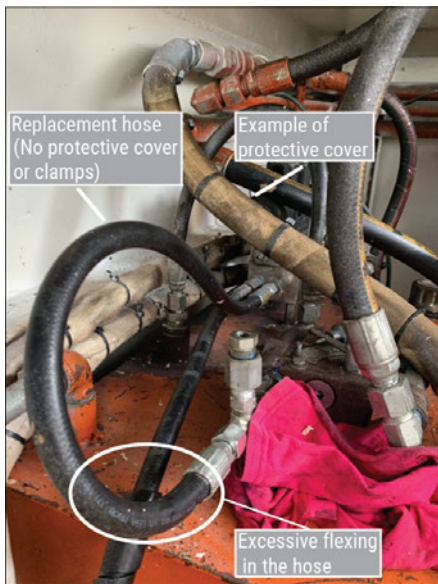
The ruptured hose was configured similar to the below photograph of the replacement hose. The hose burst was near the coupling, approximately facing the 1 o'clock position.
