Evaluation of Controllable Pitch Propeller (CPP) Blade – Maunalei

SOCOTEC Project LF221713

LF221713-P-01

November 8, 2022

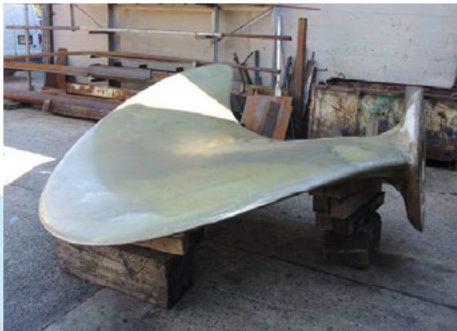
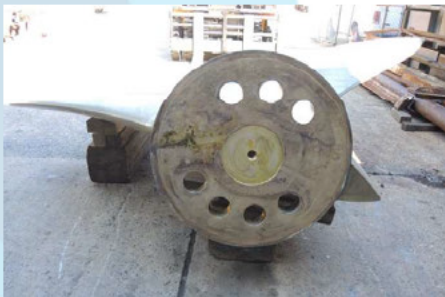
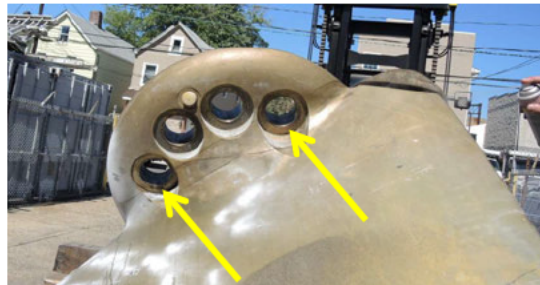
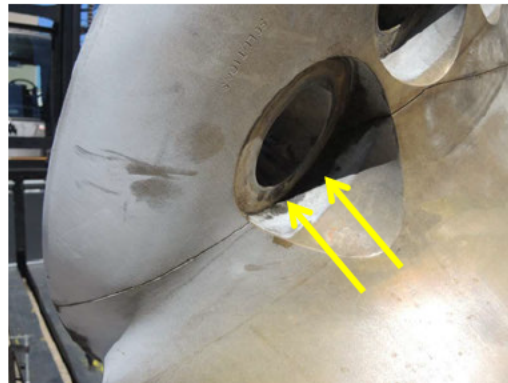
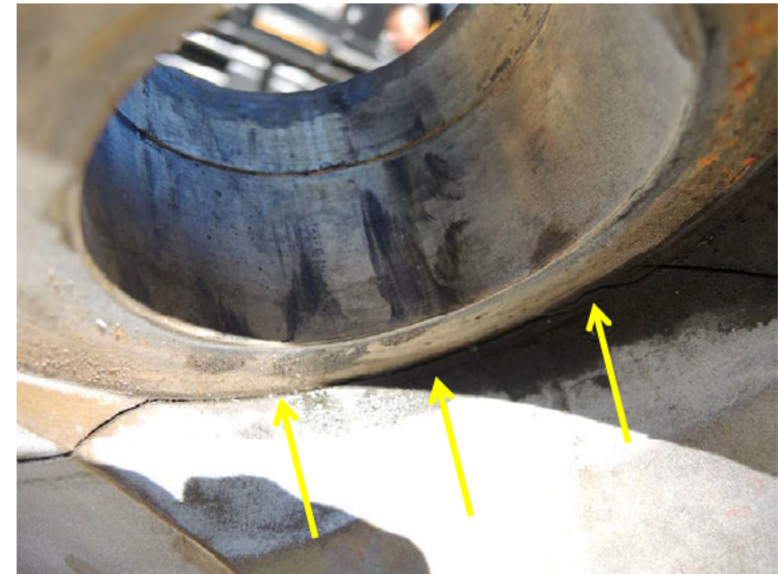
- Visual examination in the as-received condition at Brady Marine Repair confirmed the presence of two cracks at hub bolt hole counterbore edges.
- No evidence of significant corrosion attack, wear, or impact damage to the blade was observed.
- **Manufacturer stamped markings:**
 - F_120320_01 DNV_GL N141ZA4D 29-05-20 BLD N-2433 APH1241 P4 G_4768 KG
8934.7 KG/M SKEW=40 RH MAN ENERGY SOLUTIONS
- **Hub region was subsequently sectioned by Brady Marine for transfer to SOCOTEC.**

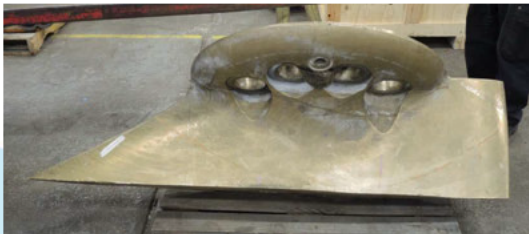
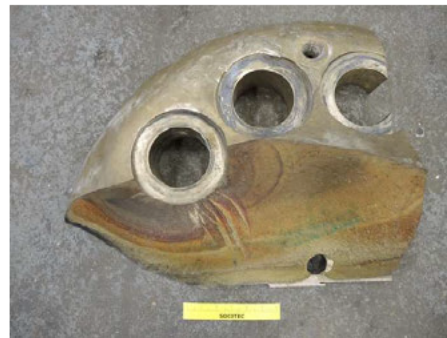
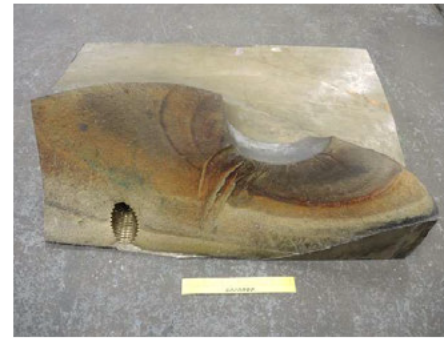
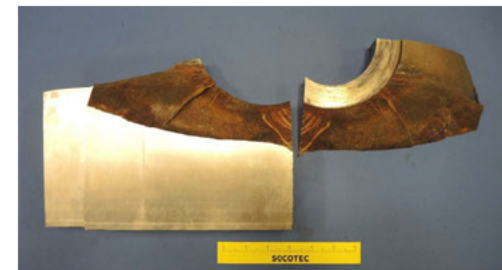
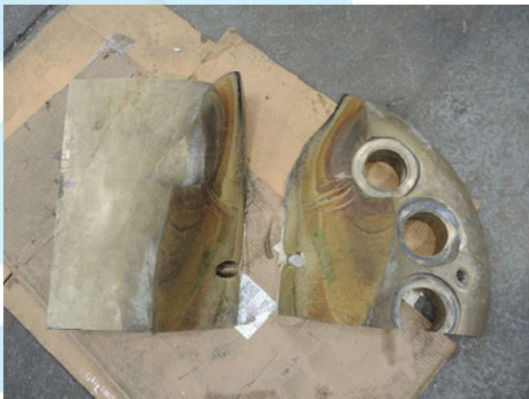
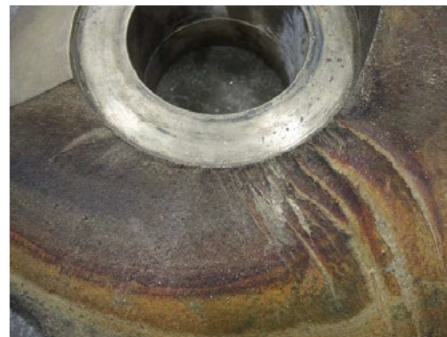
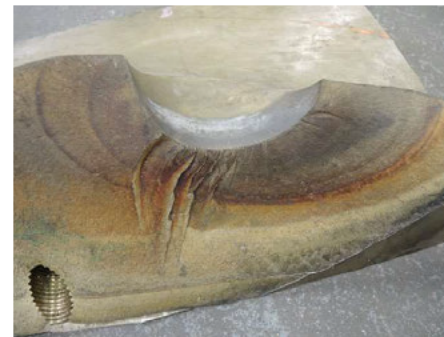
- All blade sections cut by Brady Marine were transferred to SOCOTEC, including the hub region containing the two cracks.
- Bandsaw sectioning was conducted to extract the areas of the hub that contained the cracks.
- The conchoidal (i.e., thumbnail-shaped) appearance of the crack fracture surfaces and the ratchet marks observed at the bolt hole counterbore edges were visually consistent with progressive cracking in the nature of high-cycle fatigue that initiated at the bolt hole counterbore edges.

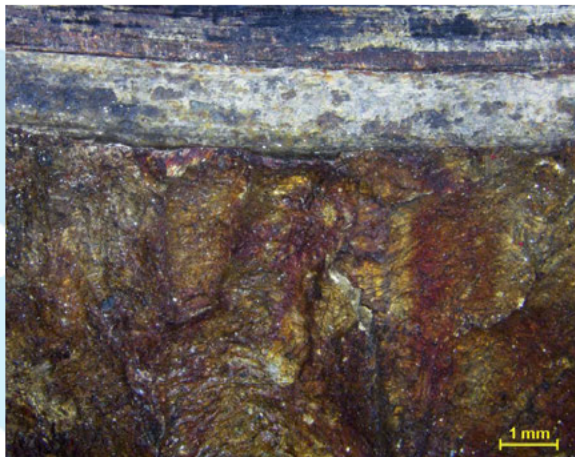
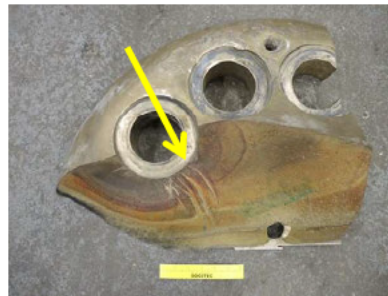
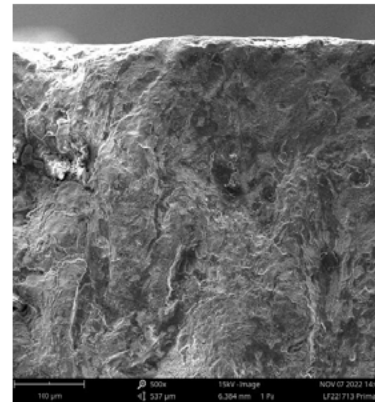
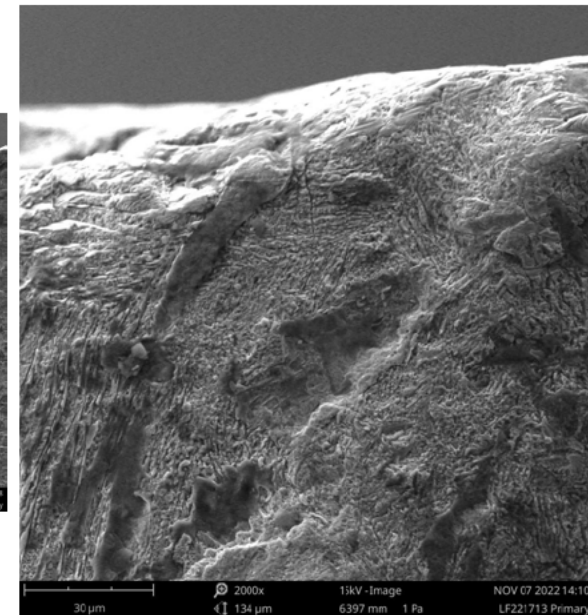
- **Optical stereomicroscopic examination of crack initiation locations at the bolt hole counterbore edges confirmed the presence of ratchet marks. No evidence of casting discontinuities that, if present, could have contributed to the fractures was observed.**
- **Isolated areas of shrinkage porosity were observed away from the fracture initiation regions.**
- **Scanning electron microscopic (SEM) examination of representative fracture surface areas confirmed a furrowed morphology with striations, features consistent with progressive cracking in the nature of high-cycle fatigue.**

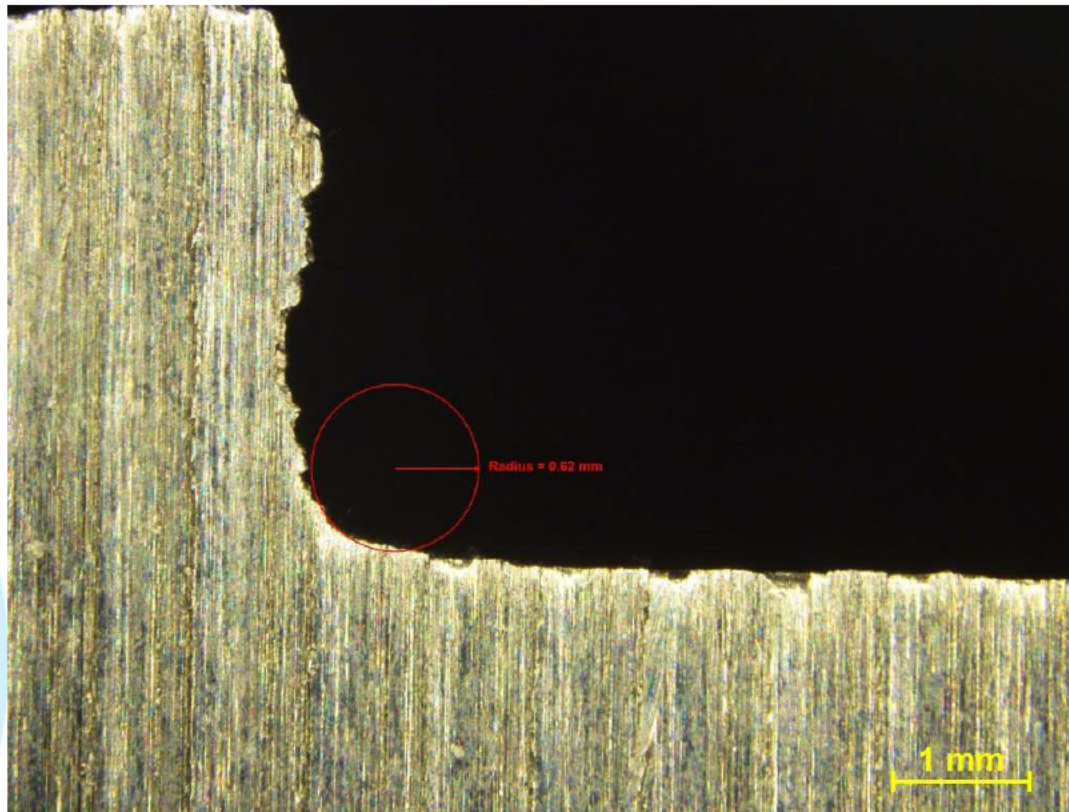
- Optical stereomicroscopic examination of the bolt hole counterbore cross-section measured a radius of less than 1 mm.

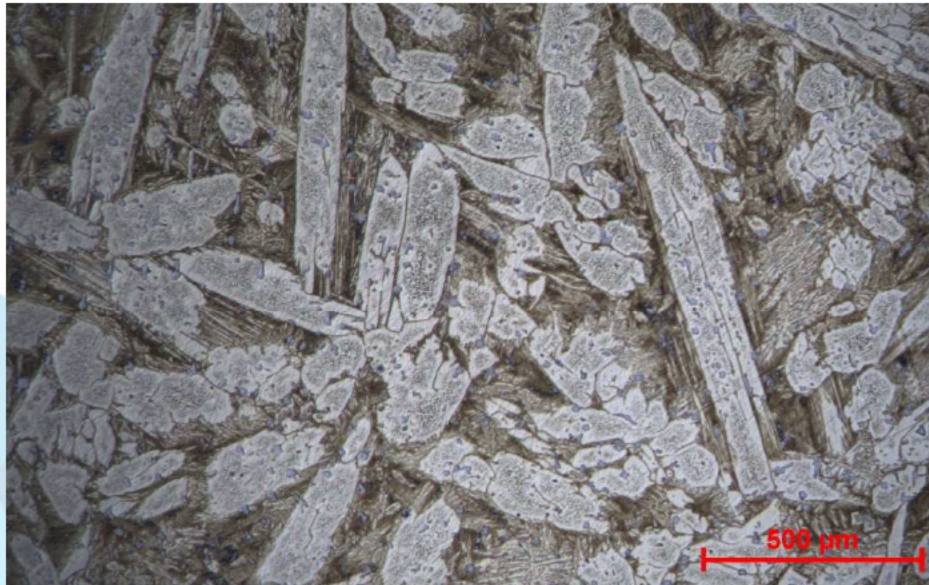
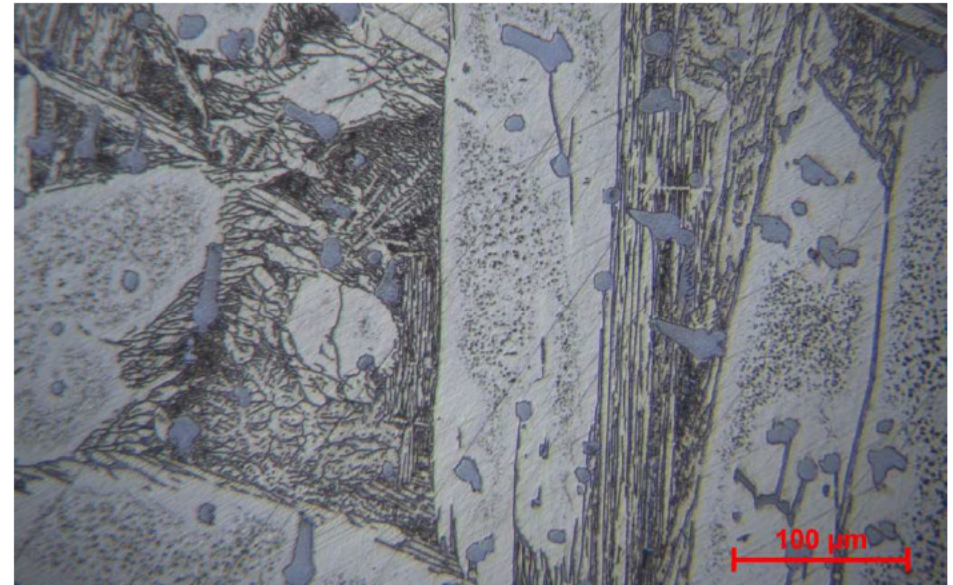
- Metallographic evaluation of a specimen sectioned and prepared from the hub region exhibited a microstructure of α -phase particles in a β -phase matrix, consistent with a cast copper alloy.
