# SURVEY STATEMENT

Name of vessel:	<b>MAUNALEI</b>
Owner:	<b>Matson Navigation Company, Inc.</b>
IMO Number:	<b>9273686</b>

Survey station:	<b>Seattle</b>
Place of survey:	<b>Portland, Oregon(USA)-Vigor Shipyard</b>
Survey started:	<b>2022-08-13</b>
Survey completed:	<b>2022-08-29</b>
Lead surveyor:	<b>Nair, Dinesh</b>
Surveyor:	<b>Read, Philip M; Dasgupta, Sanglap</b>

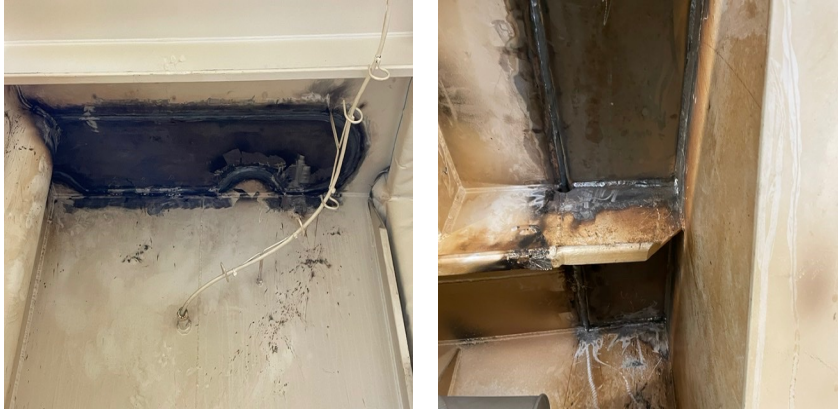
Corroded and holed deck plating, overhead Emergency generator room, is to be rectified and dealt with. Prior to repair, repairs procedure is subject to review by DNV.

Prove that the wasted deck above the E-gen room under the drain pipe meets the fire integrity requirement of table 9.6.

Damaged deck plating repaired and found satisfactory.

*Damaged plate on deck renewed and found in order.*

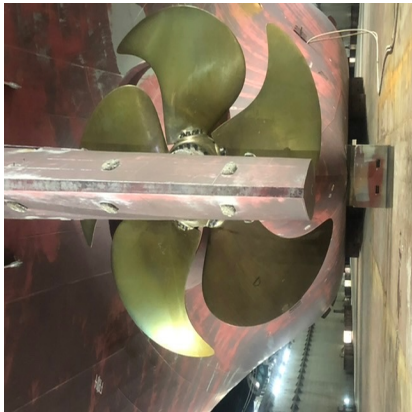
Renewed #4 blade

Crack noted on CPP blade #4 and the blade was replaced by new certified blade ( DNV cert. #N141ZA4D)supplied by MAN. Crack noted in way of pressure side bolt holes for # 2 blade. Same was weld repaired by approved welder in line with approved weld procedure. After completion of the temporary repair, blade was mounted on hub, tested and found no oil leak and in order. All the repair work as well installation was done in presence of MAN Engineer. MAN suggested restrictions on engine speed and power. As informed, onboard testing will be done by MAN Engineer during sea passage. Report issued by MAN to be forwarded to DNV for our review. During voyage, crew should closely monitor CPP parameters such as pressure,oil quality, temperature or other parameters which are suitable as per MAN advice. DNV recommend first diver inspection within one month and should be be witnessed by DNV surveyor and thereafter within three months in operation.Further diver inspections may be needed depending on the time until final repair. Customer informed they have plans for diving inspections frequently for close monitoring the repaired area.

Vessel dry docked at Vigor Marine Shipyard, Portland. Damaged CPP blade # 4 renewed and #2 blade temporary repaired. A new condition issued for the temporary repair.
