Service Report

MAN PrimeServ

P-21400 VBS1810-5

Matson

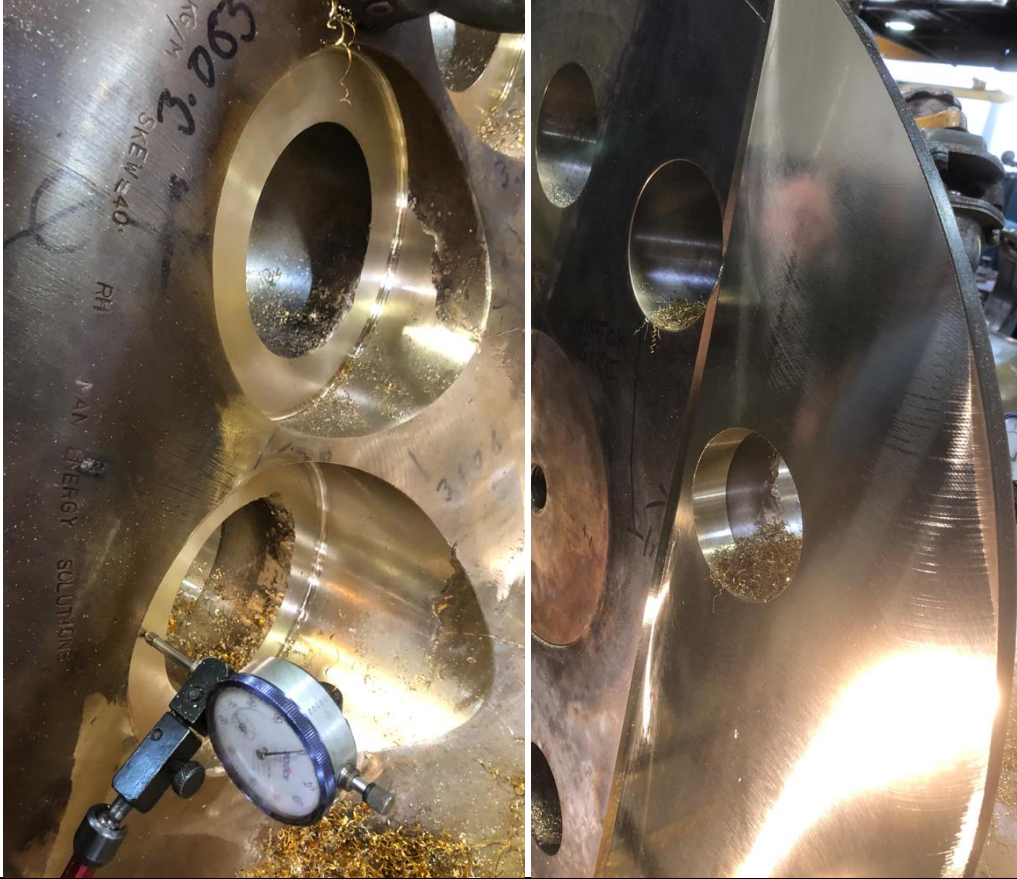
Blade 2# screws holes 6 - 7 after machining and with radius 3mm.

Blade 2# was welded according to WPS MAN.001.CU3.

After welding and cooling the blade was brought to Wester Machine Work to be machined according to drawing 2212061-2 with **Ø6 rounding on the 4 aft blade screws holes.**

The four blade screw hole on the aft side were machined with **radius 6 for stress relieve.**
