Service Report

M/S MAUNALEI

Destination: COSCO Nantong Shipyard, China
 Participants: Liu Xiaobo, Yu Zheng
 Reason for visit: Supervised for CPP installation and commissioning

As requested our MAN-Engineers Mr. Liu Xiaobo and Mr. Yu Zheng attended above mentioned vessel in COSCO Nantong Shipyard from 27 September to 07 November 2020. The reason for attendance was supervise for CPP installation and commissioning.

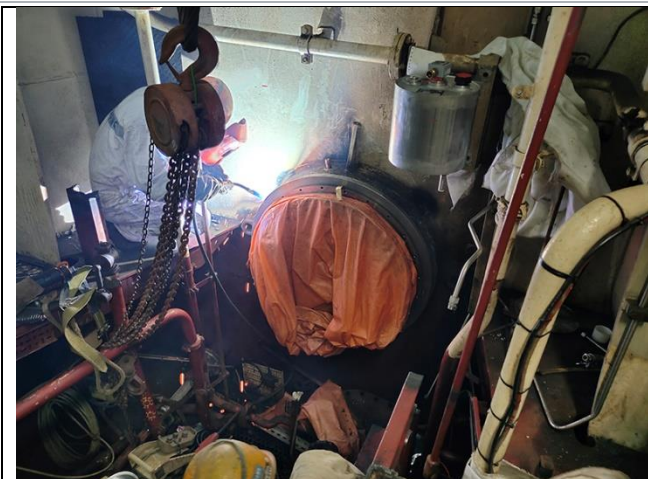
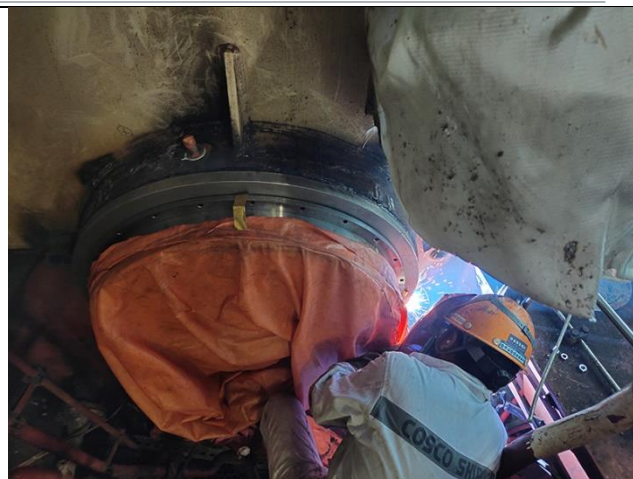
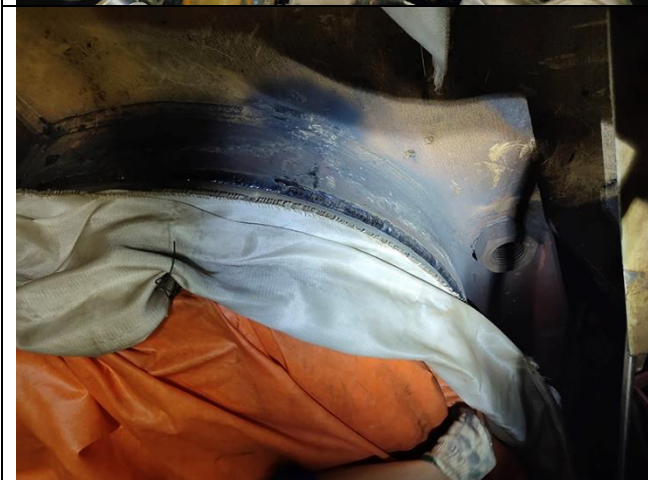
Cross welded the welding flange onto hull boss.

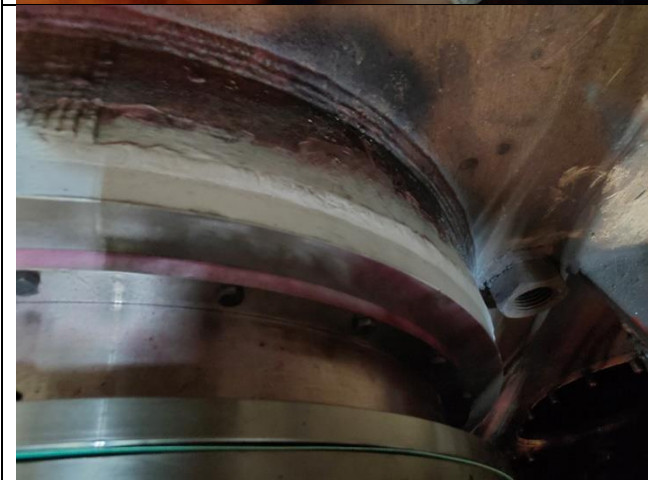
Got dye-check for welding.

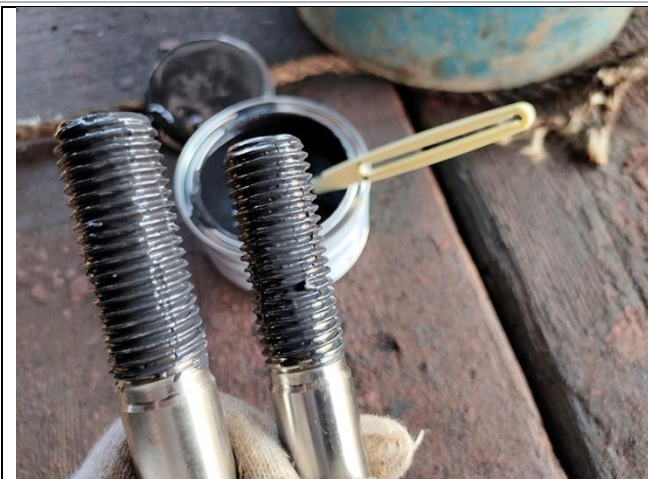
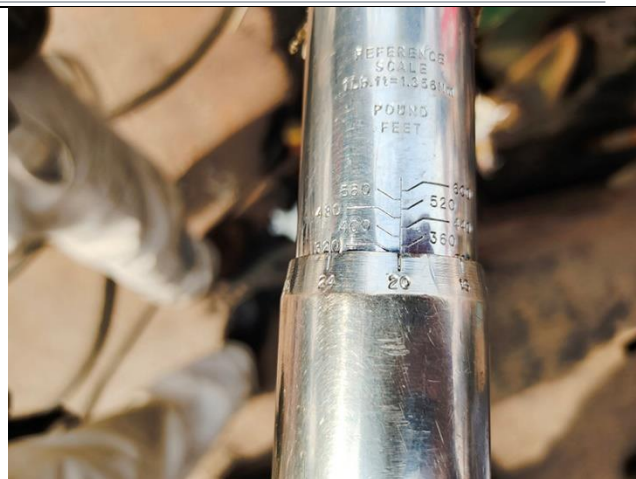
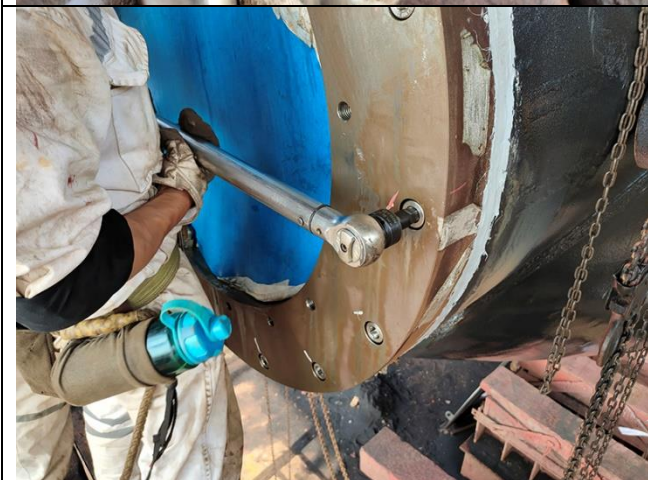
Cross tightened screws (Pos. 104) up to 340 Nm and lubrication with MOLYCOTE GN+.

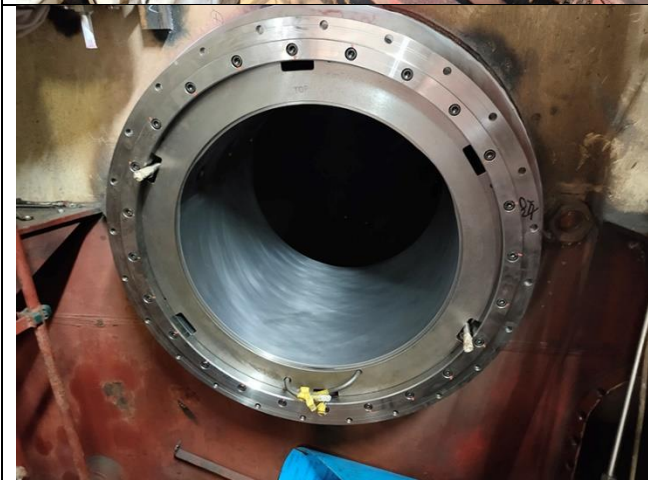
Installed adaptor flange.

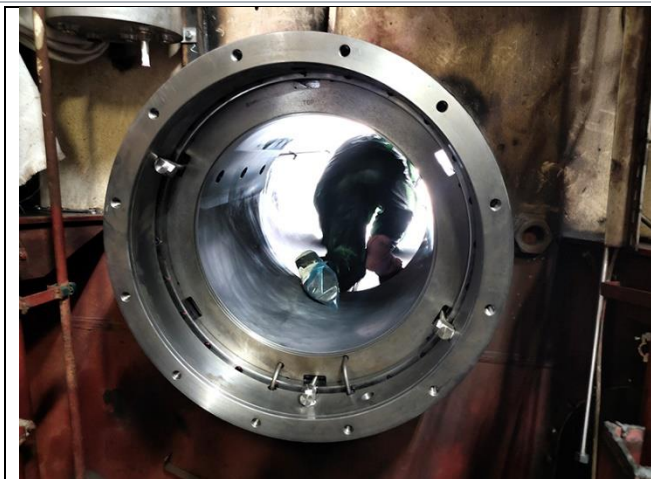
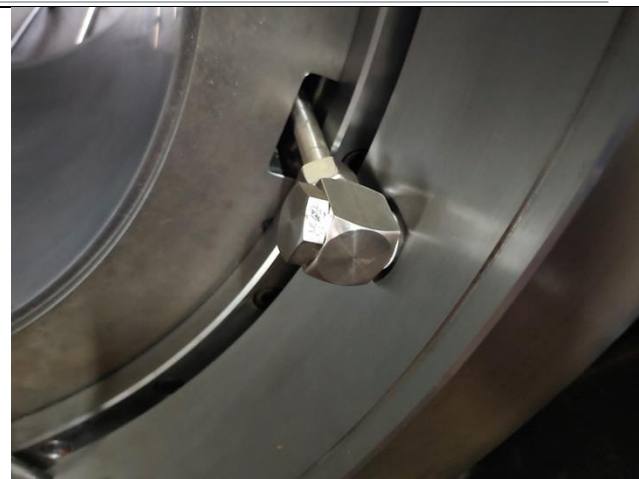
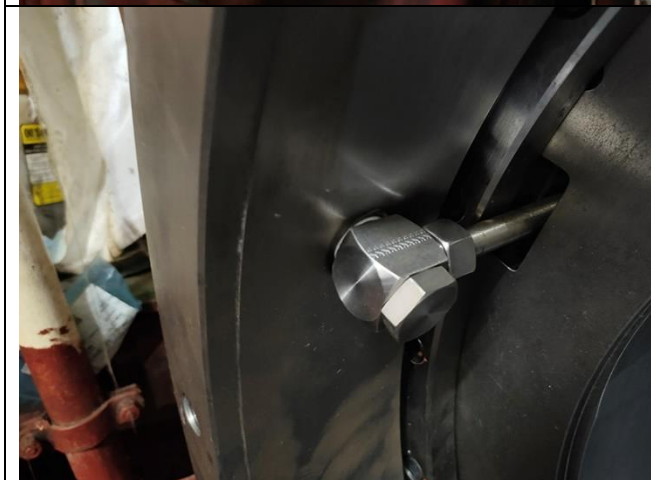
Assembled oil box and connected banjo couplings of after seal pipes with LOCTITE 572.

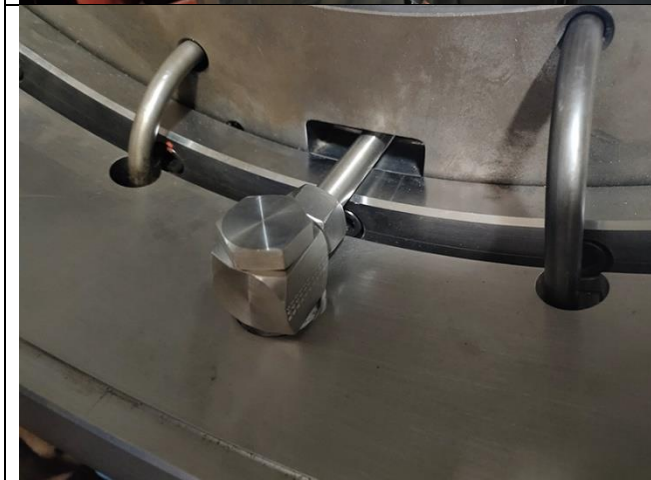
Connected banjo coupling of sampling pipe with LOCKTITE 572.

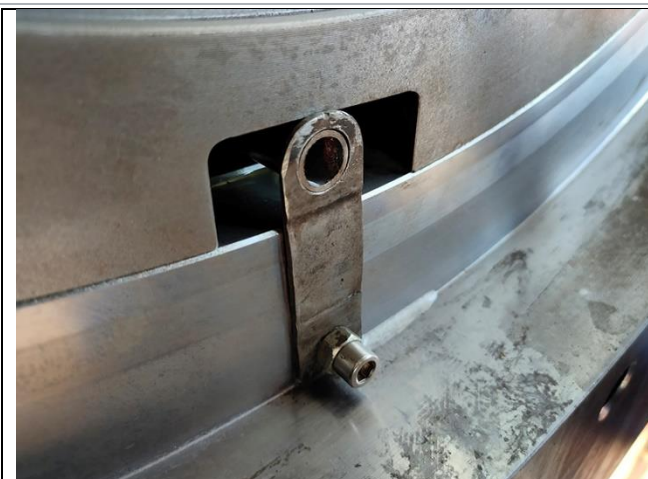
Fixed sampling pipe after side.

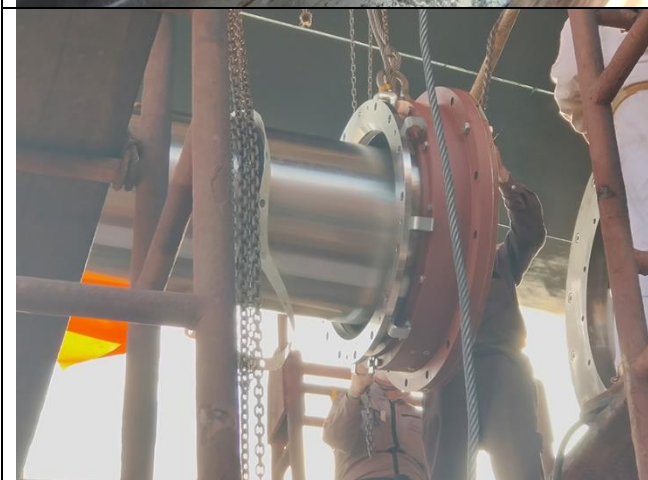
Mounted after stern tub seal onto propeller shaft supervised by SKF's engineer.

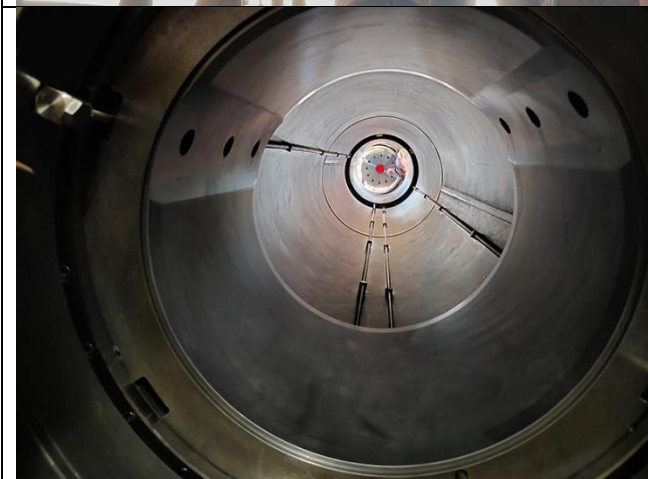
Well cleaned stern tub.

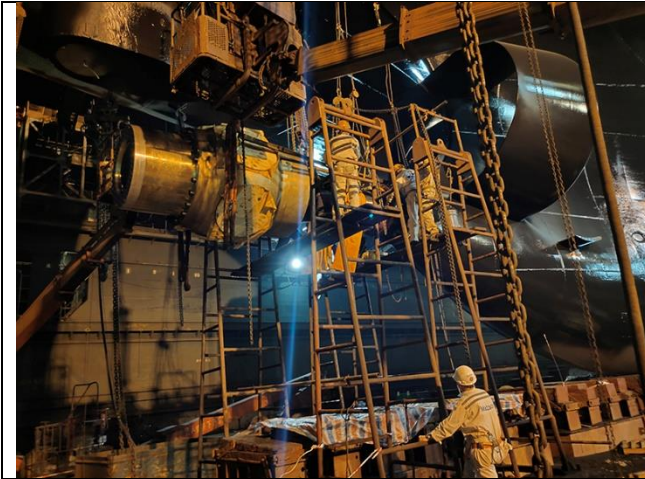
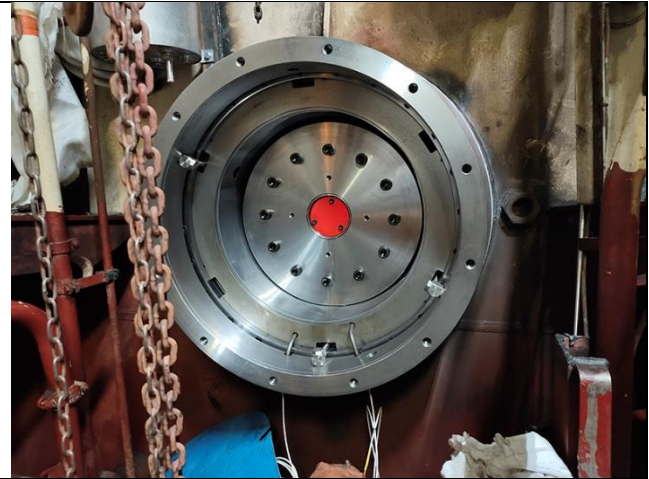
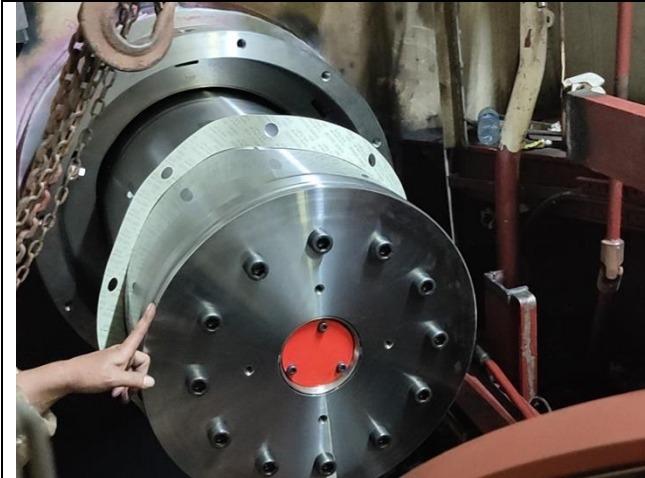
Mounted propeller shaft into stern tub until distance final position around 500 mm.

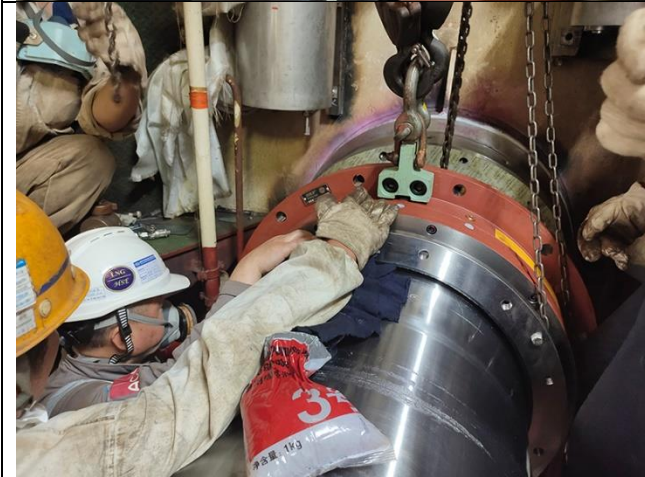
Mounted stern tub forward seal onto propeller shaft supervised by SKF's engineer.

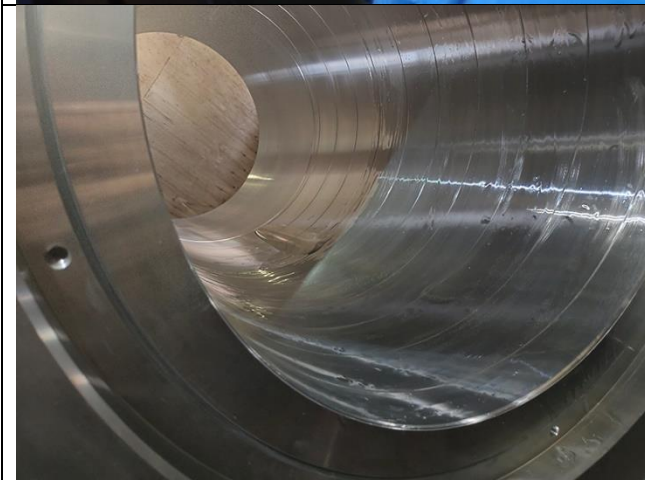
Lubricated coupling flange with lubrication oil.

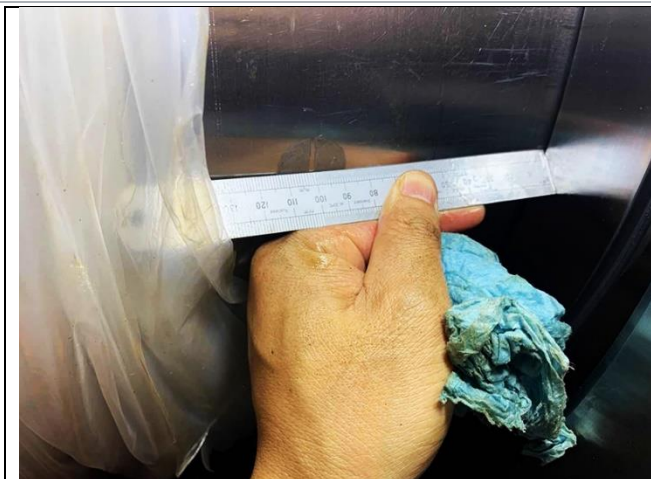
Carefully moved coupling flange to position where is distance stamp on propeller shaft 100 mm.

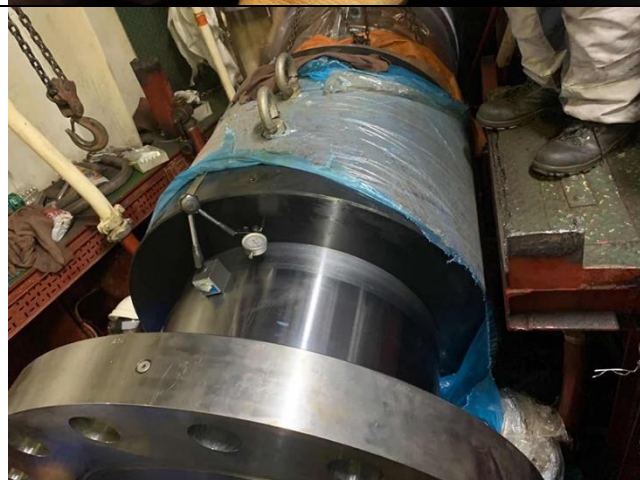
Connected high pressure and low pressure pumps, then pulled up muff coupling according MAN instruction.

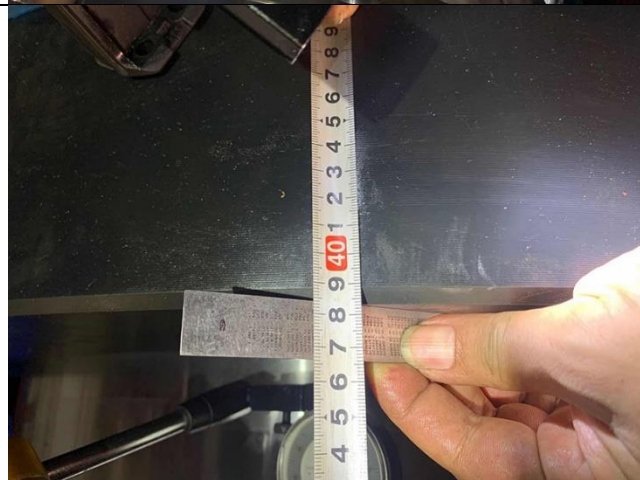
- cleaned shaft mounting area very well and then installed coupling according to MAN's instruction manual
- Coupling flange distance to mark on propeller shaft is 100 mm
- Pulled up to "A" distance is 384.5 mm, muff was moving 42.5 mm
- P Jack pressure was 190 bar, P1 Muff pressure was 200 bar, P2 Muff pressure was 1650 bar.

Pulled up muff coupling to "A" distance 384.5 mm

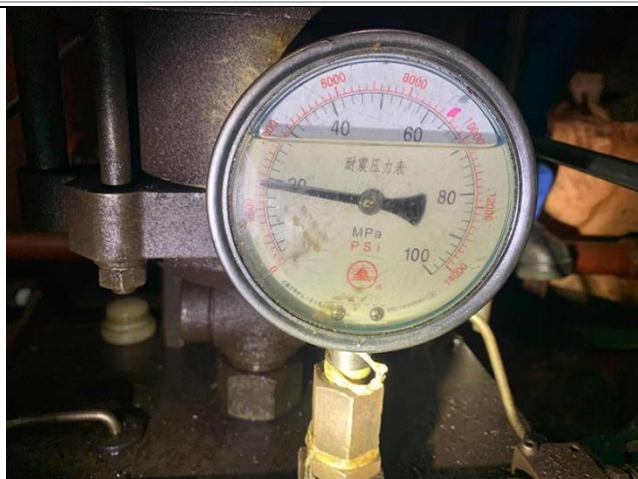
P Jack final pressure was 190 bar.

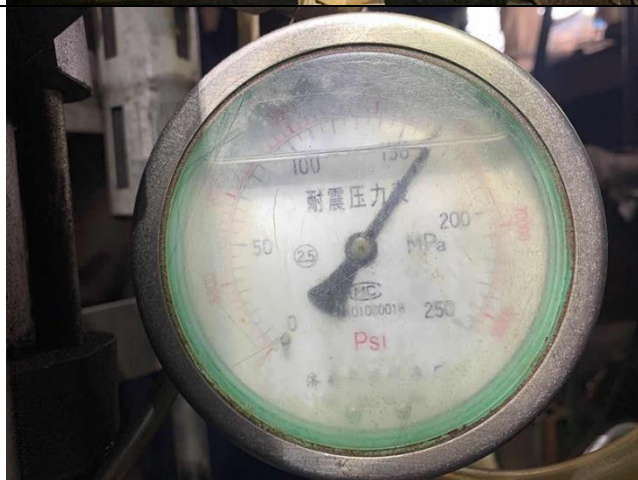
P Muff pressure was from 200 bar raise up to 1650 bar.

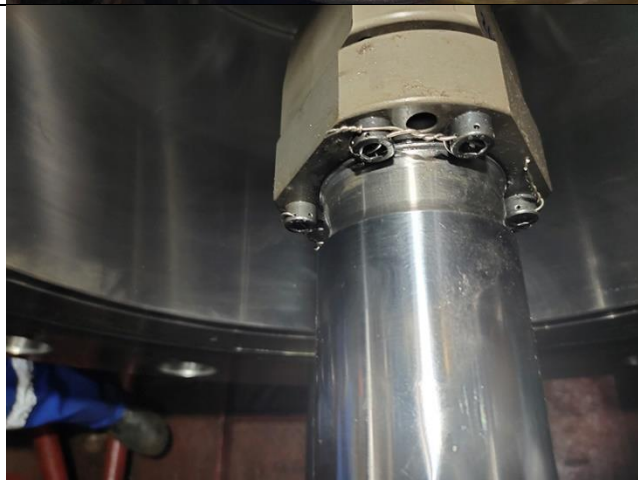
Connected servo oil pipes of propeller shaft and OD shaft.
 Measured the GAP between flanges, the deviation of 3 point clearances were within 0.05mm.
 Security screws with locking wire.

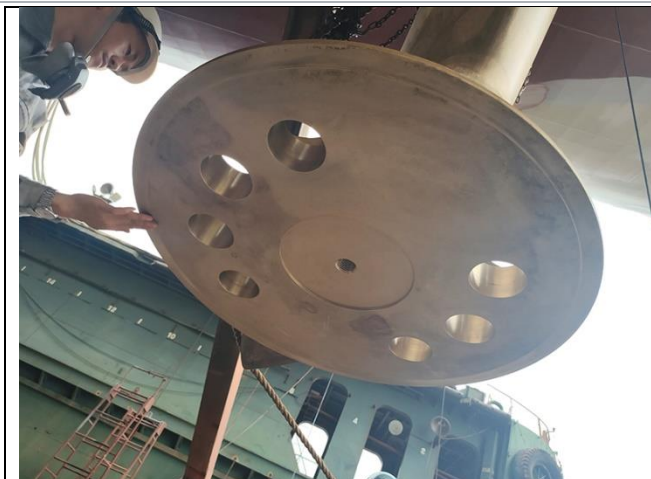
Well cleaned blade foot.

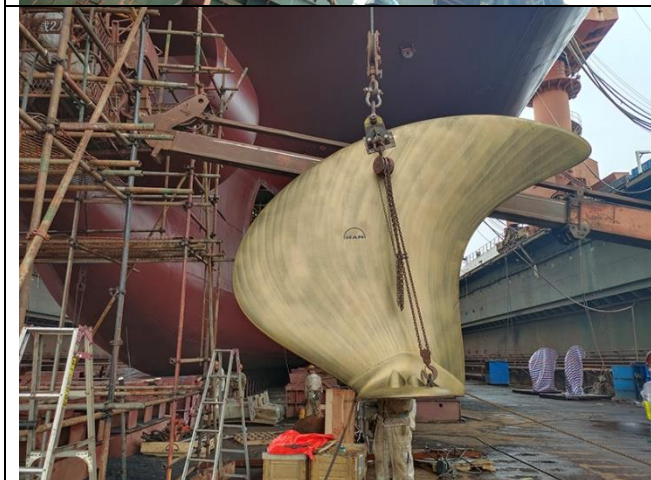
Lifted up propeller blade above to propeller hub.

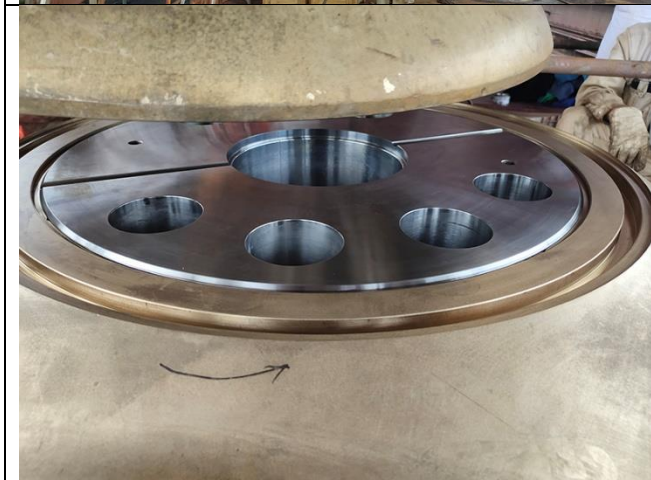
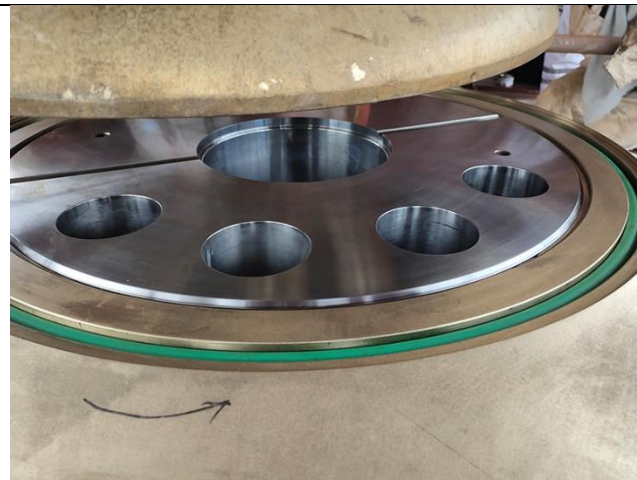
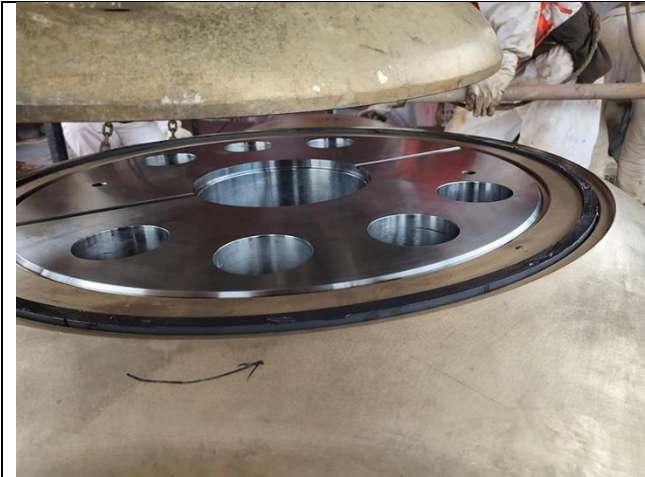
Well cleaned hub and blade flange.
Mounted seal ring and slide ring.
Add MOLYCOTE GN+ on slide ring contact surface.

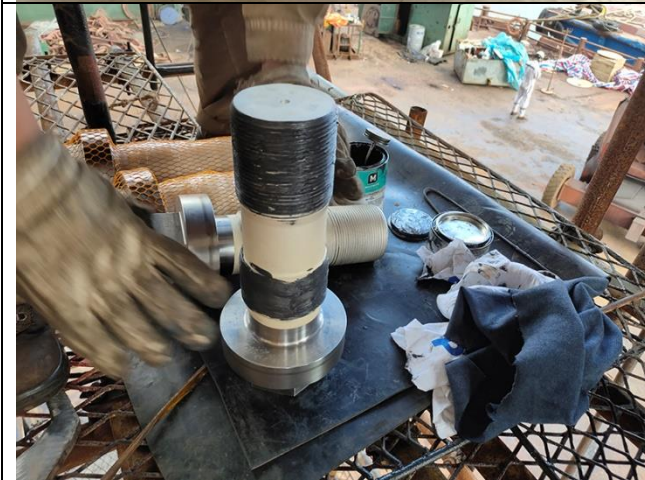
Lubricated all thread and contact surface of blade screw with MOLYCOTE GN+

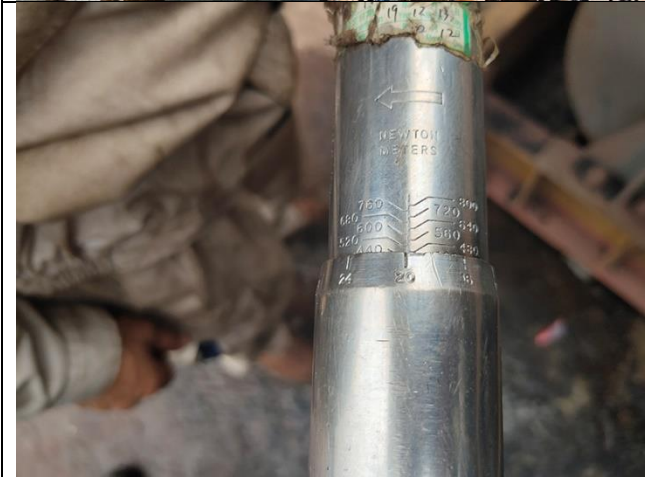
Cross pre-tightened blade screws up to 500 Nm.

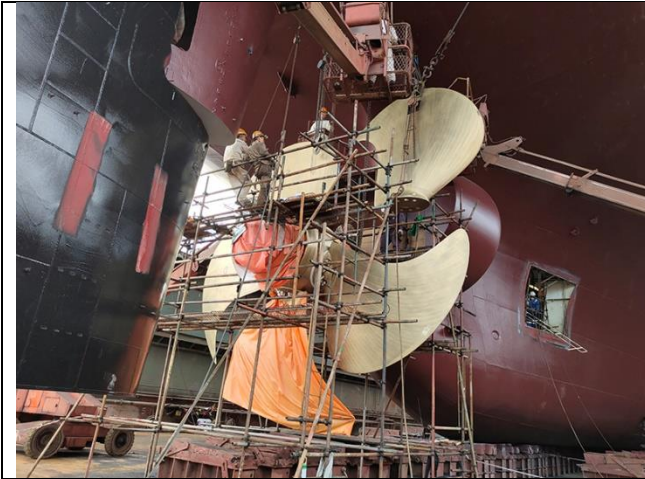
Lifted last propeller blade up to propeller hub.

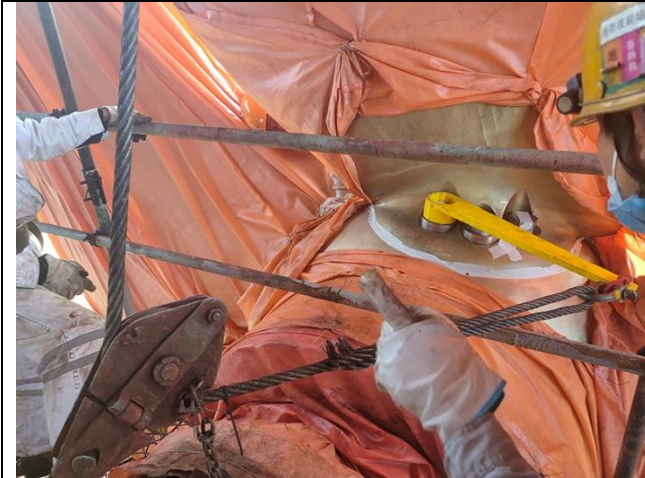
Cross tightened blade screws up to 500 Nm + 105 mm arc length 1st time.

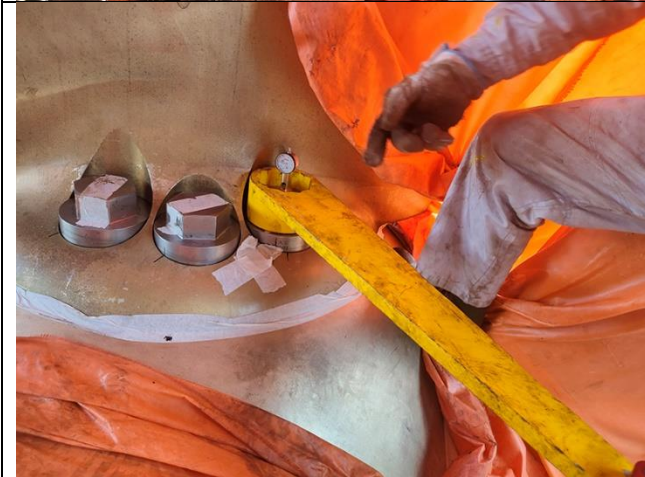
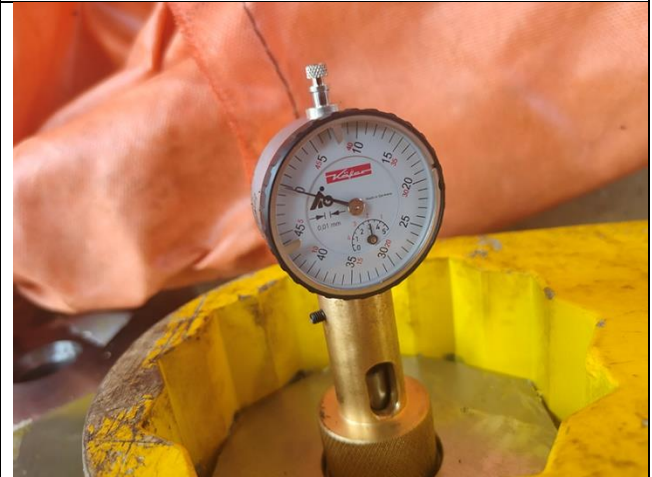
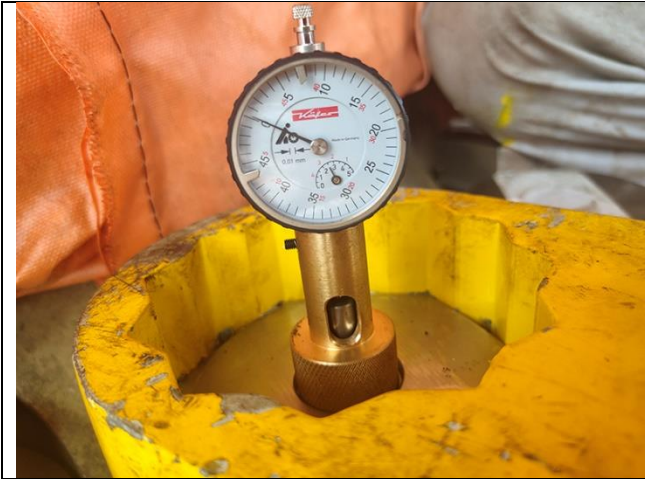
Completely loosened one screw, mounted dial gauge and adjusted to 0, retightened this screw up to elongation is 0.5 mm. This second tightening was repeated until all screws in the connection are tightened twice.

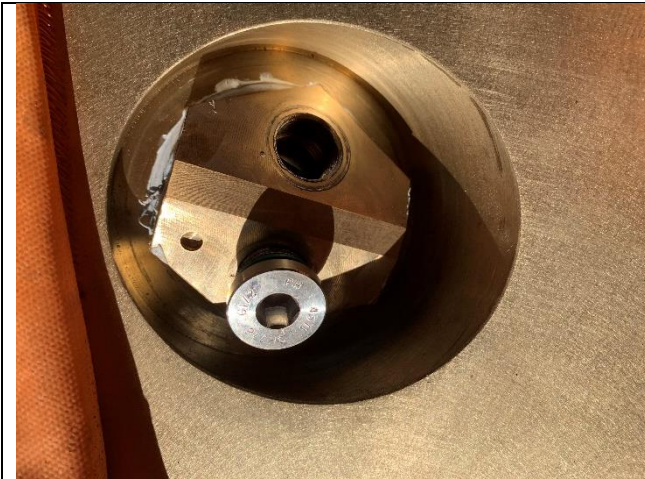
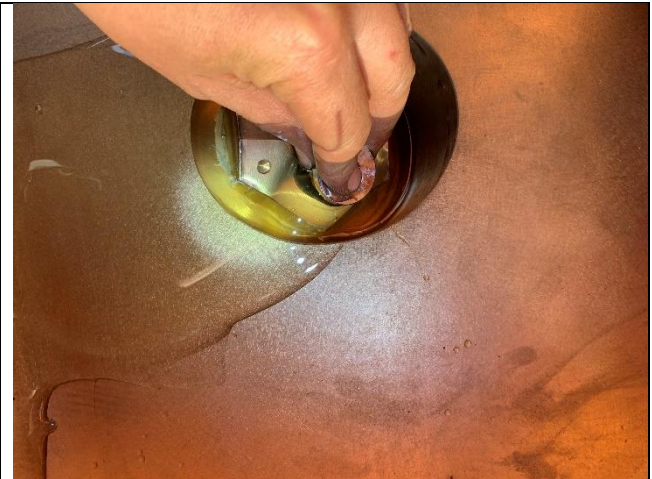
Filled hub oil and pressure tested

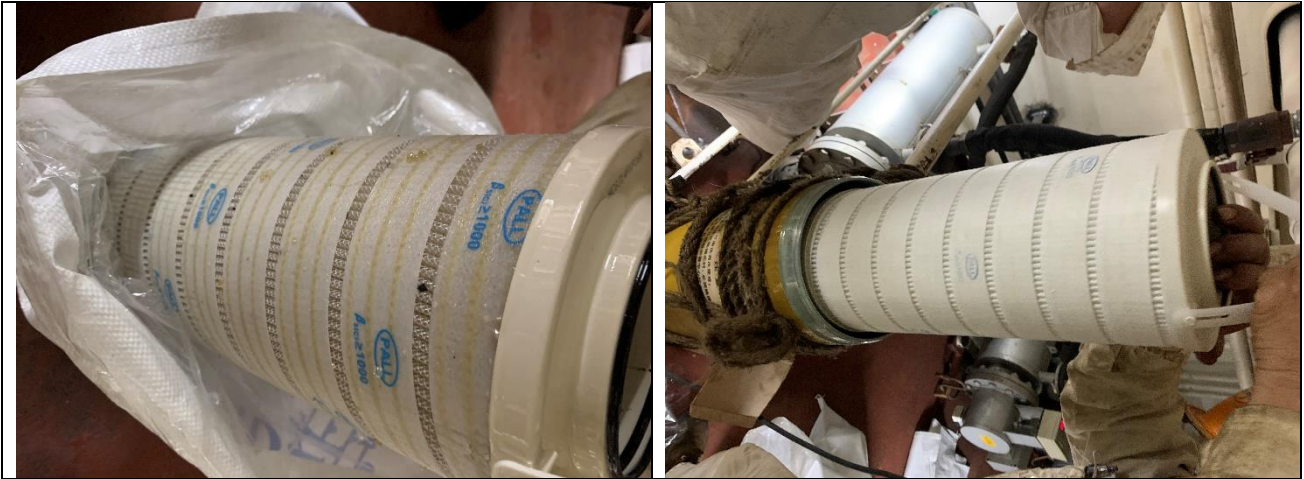
Flushing filters checked and replaced

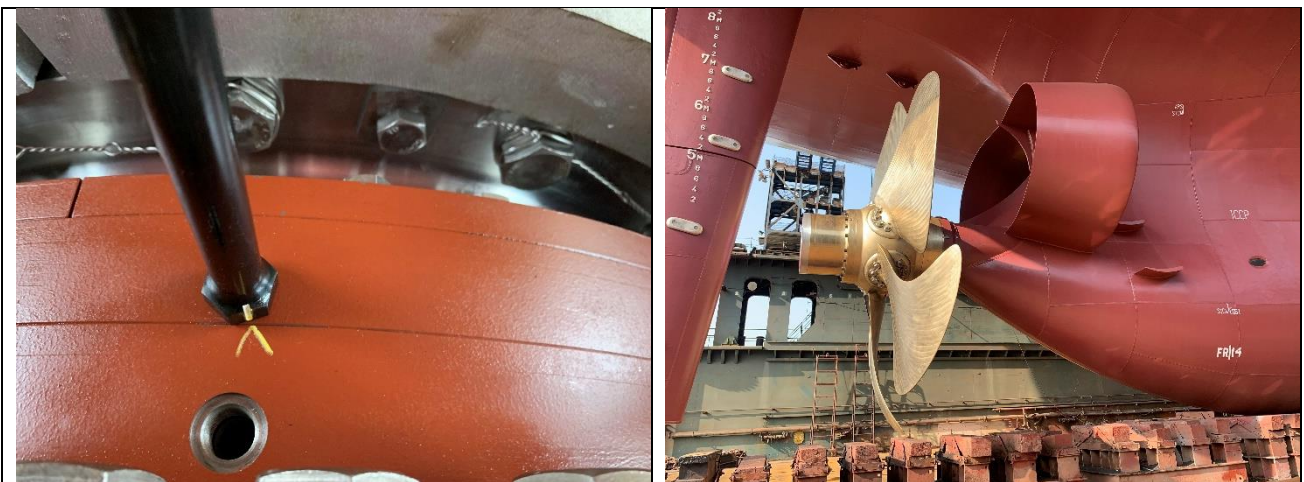
Wear down measured and final installation of shaft outside

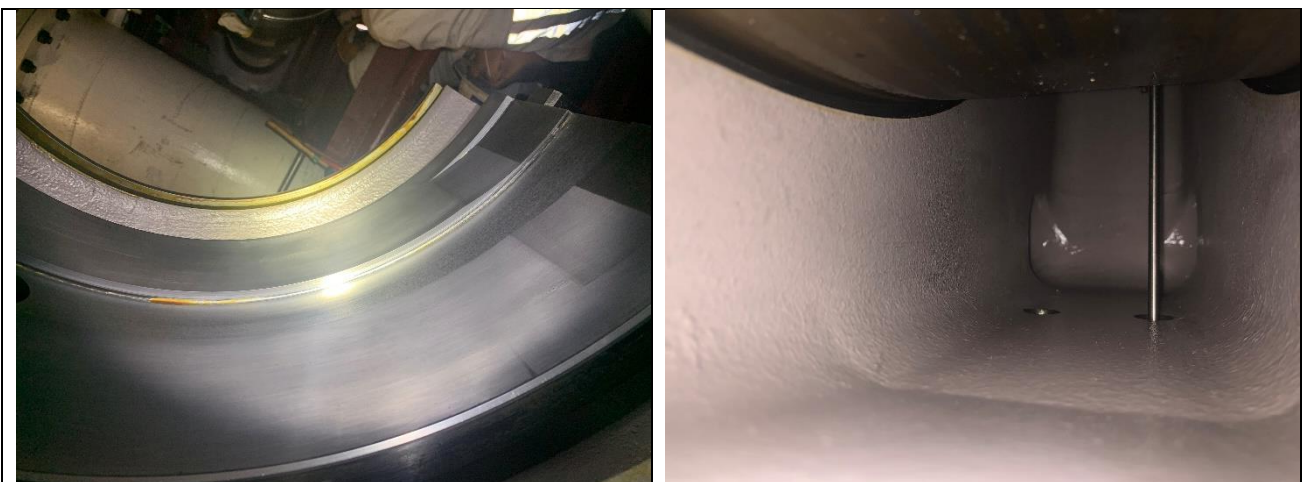
Intermediate shaft bearing cleaning condition checked

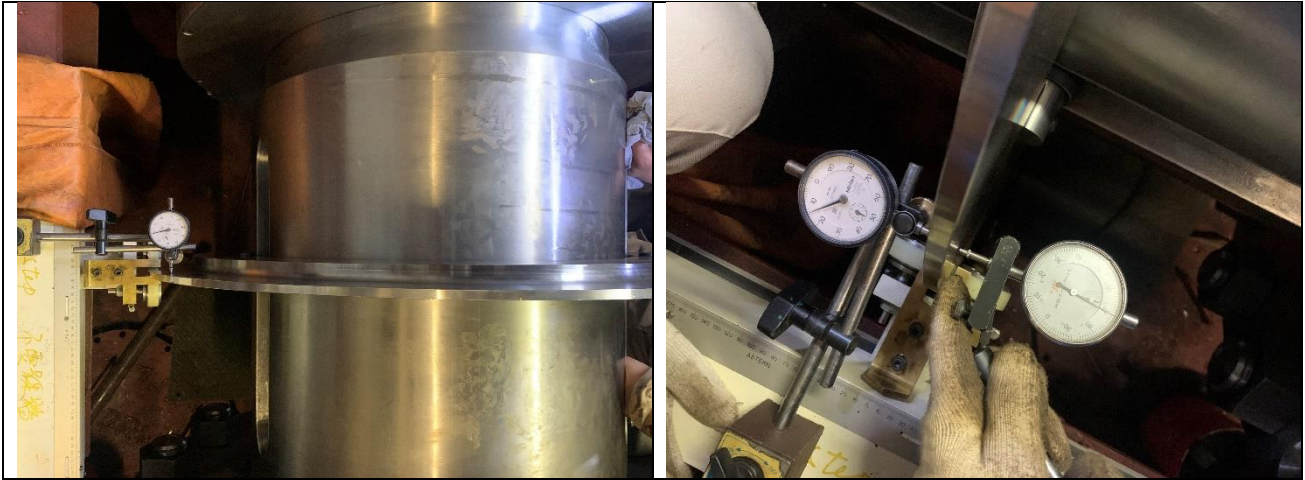
Feedback ring alignment checked and adjusted

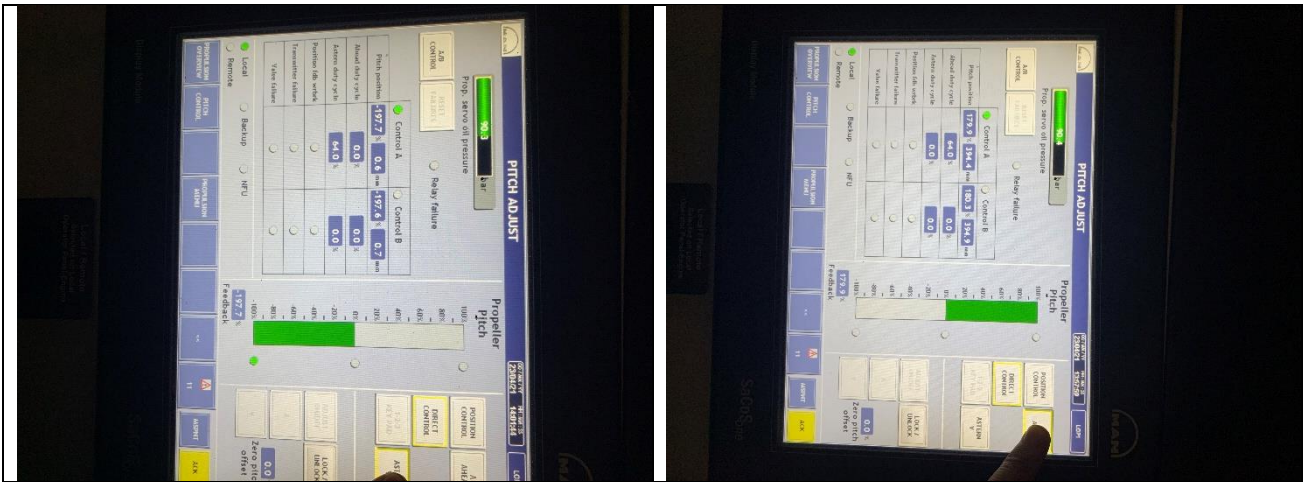
Pitched to mechanical ahead and astern position

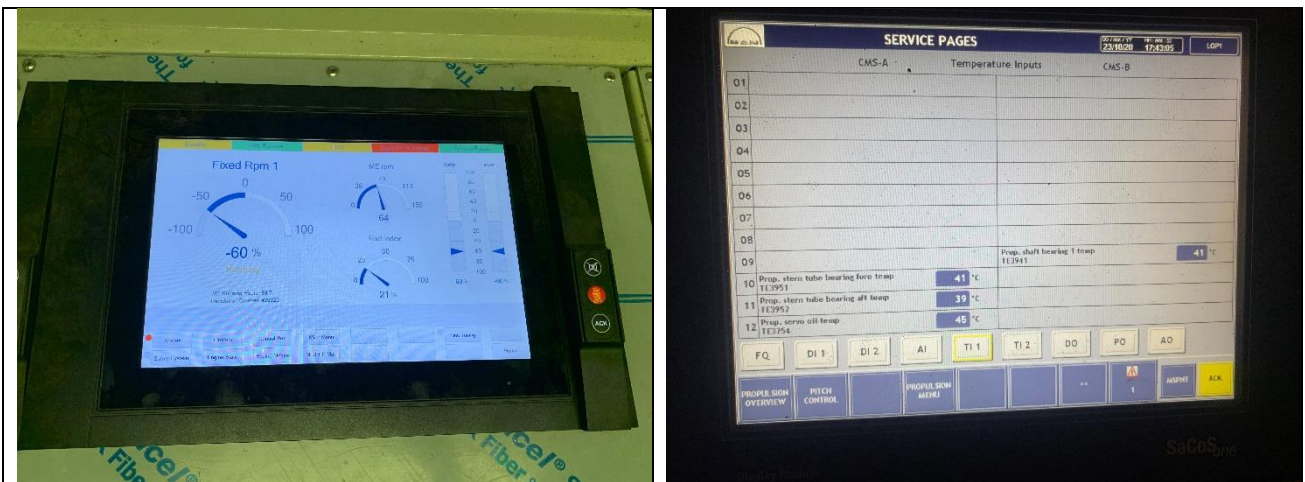
Pitch tested with ME running at different rpm

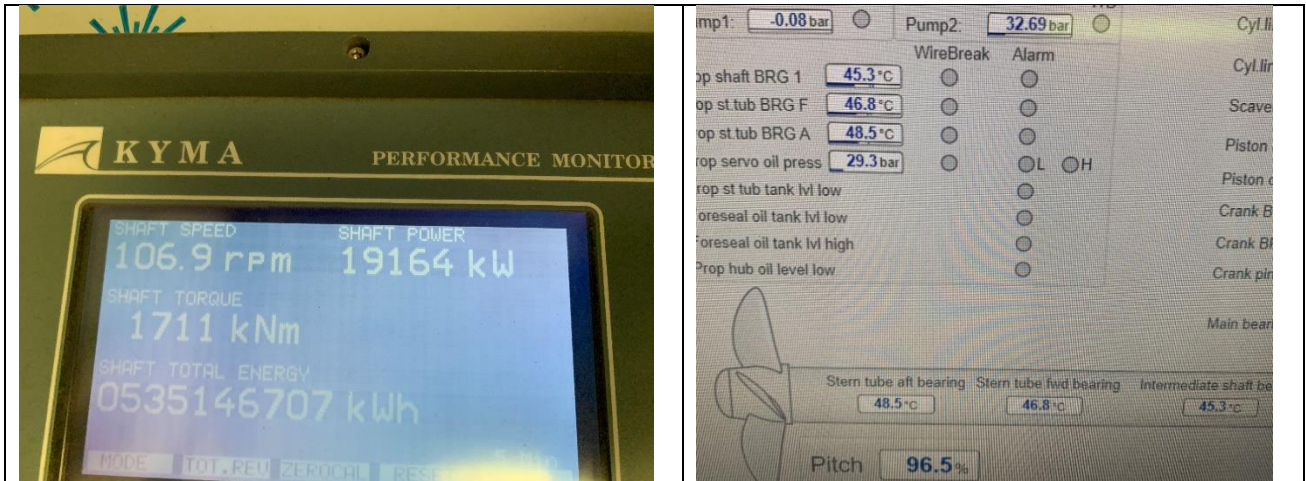
Engine running with 100% pitch ahead and shaft bearing

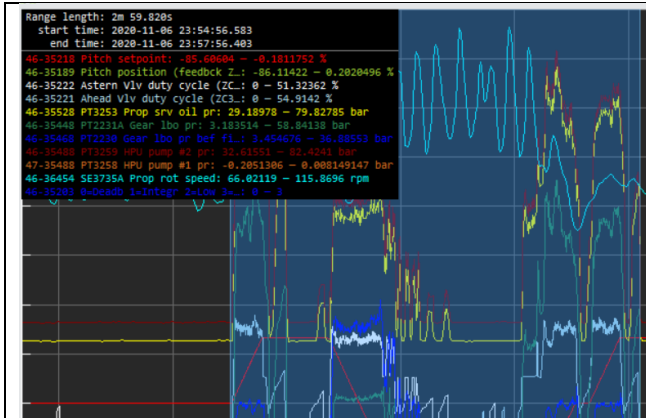
-ME running with -100% pitch astern, since ME rpm was very unsteady, so ME load can't be recorded, and according to chief engineer, they are satisfied with this engine full astern maneuvering ability since already tested in river

During -100% astern pitch testing, handle was moved from zero to emergency astern, ME rpm was hunting too much, Kongsberg engineer will test it with crew when he get feedback from HO since they are sailing together this voyage

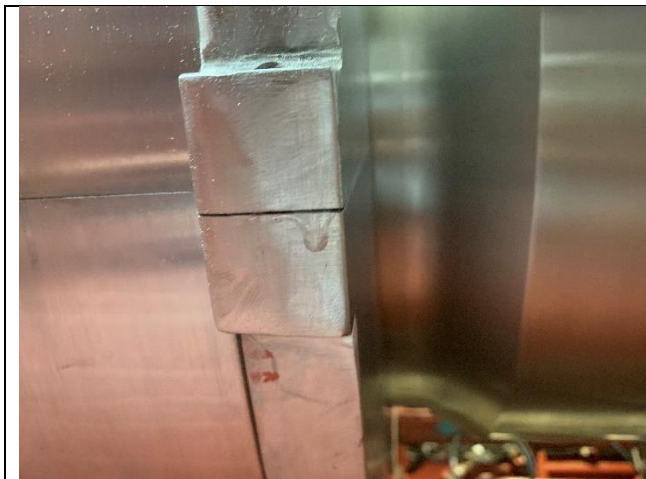
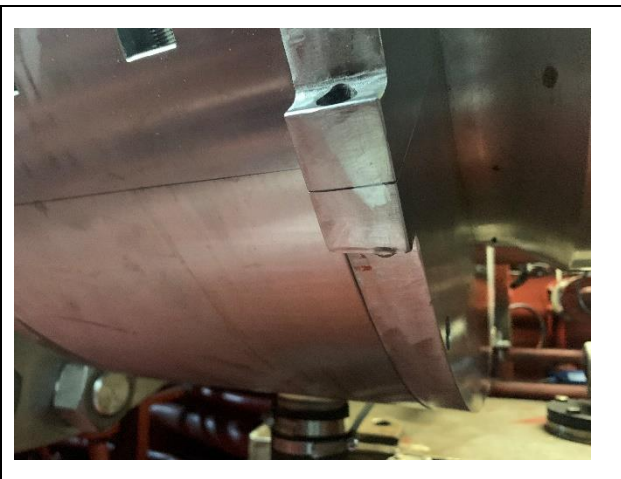
-During sea trial , found forward end cover has oil leakage, it was leaking from two half cover contacting surface, there has more 0.35mm gap between two part, loosened lower half cover round bolt, tried to tightened the alignment bolt to make gap small and to stop leakage, but unfortunately broken the bolt, so leakage still happens, and this leakage has to be fixed afterwards

Oil leaking from end cover contacting area

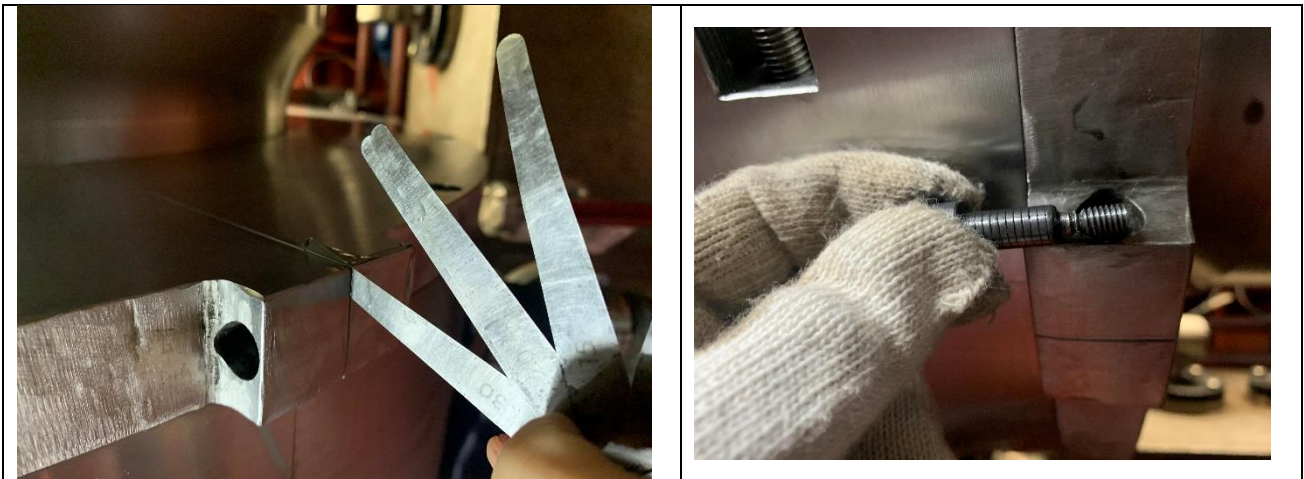
Gap between two parts was more than 0.35mm, and broken alignment bolt

Tried to fix the oil leakage on OD ring cover but failed, and broken the alignment bolt
 Sea trial documents for vessel signed with master/CE and DNV surveyor
