National Transportation Safety Board

Office of Highway Safety

HWY23FH010

FACTUAL REPORT OF INVESTIGATION

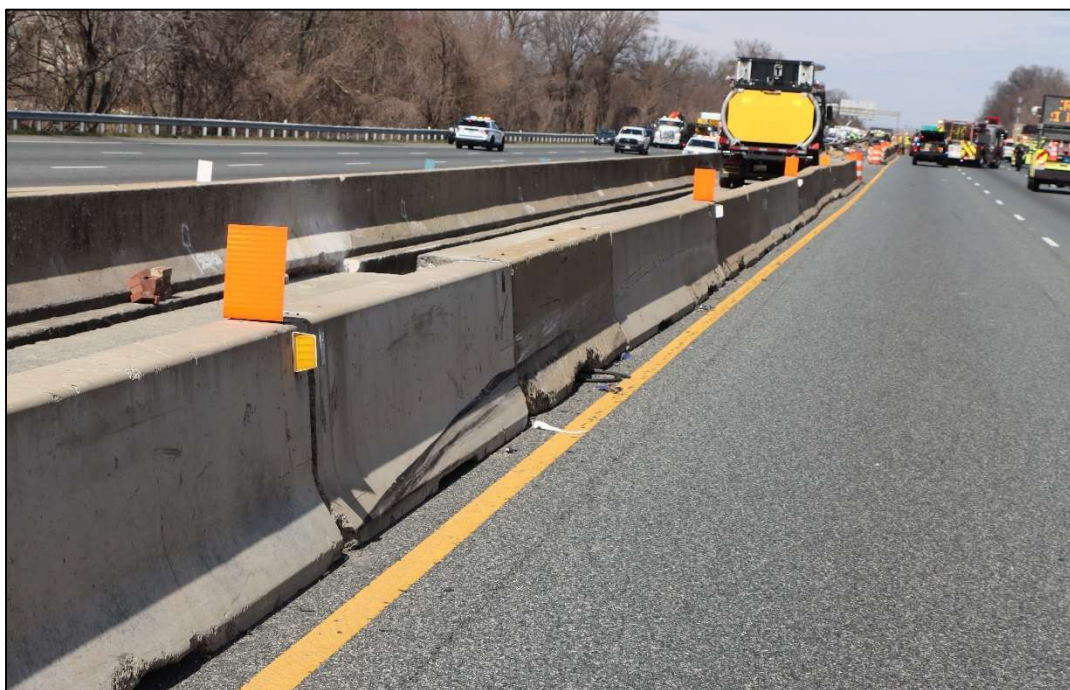
As depicted in the **Figure 3** photograph, the Volkswagen was forced into contact with the flexible concrete barrier during the initial contact between the two vehicles. No substantial movement of the barrier was observed.

Figure 3: Photograph depicting evidence of Volkswagen contact with flexible concrete barrier (Maryland State Police - cropped).

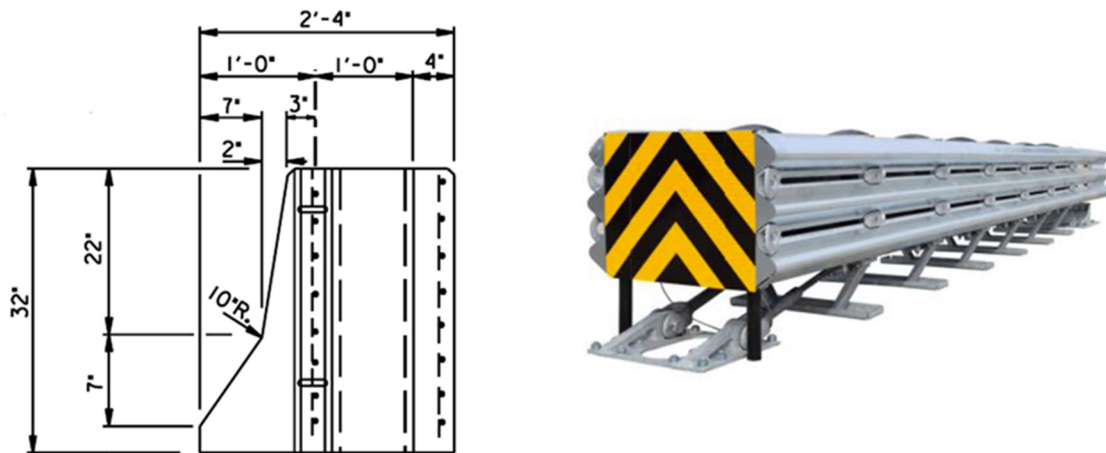
Figure 4 depict images of the F-shape barrier and end-treatment system.

Figure 4: Images depicting F-shape concrete barrier section (left) and two-sided end treatment system (right).

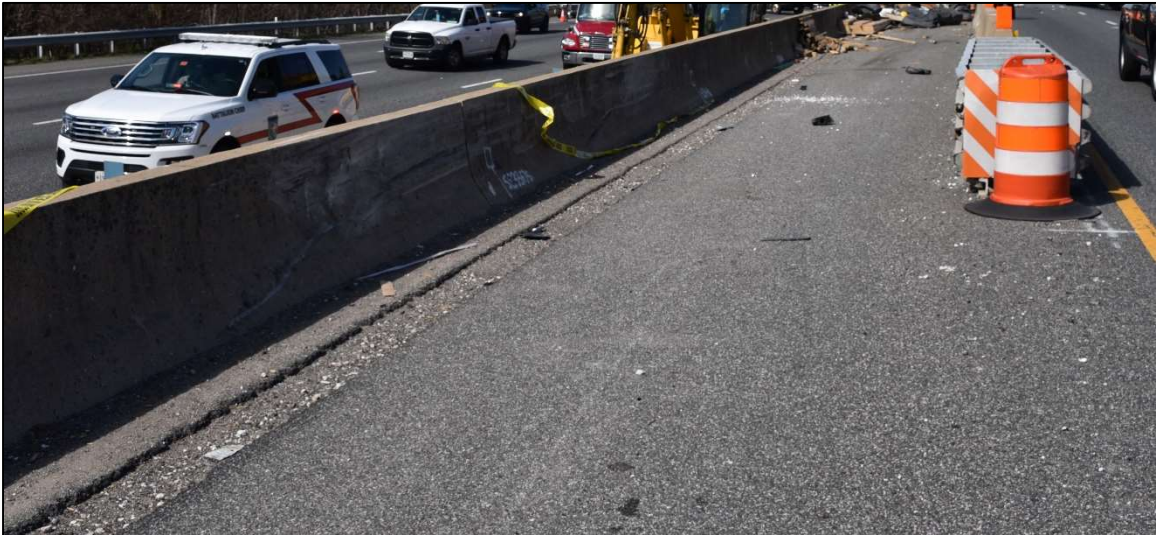
The inner and outer loops of I-695 are divided by a 42-inch-high F-shape rigid concrete barrier system.²⁰ This barrier exhibited superficial surface damage after having been impacted by the Acura after it was redirected through the work zone access opening, as depicted in **Figure 5**. **Figure 6** depicts an aerial photograph

Figure 5: Impact damage to median barrier following Acura contact. (Maryland State Police (cropped))

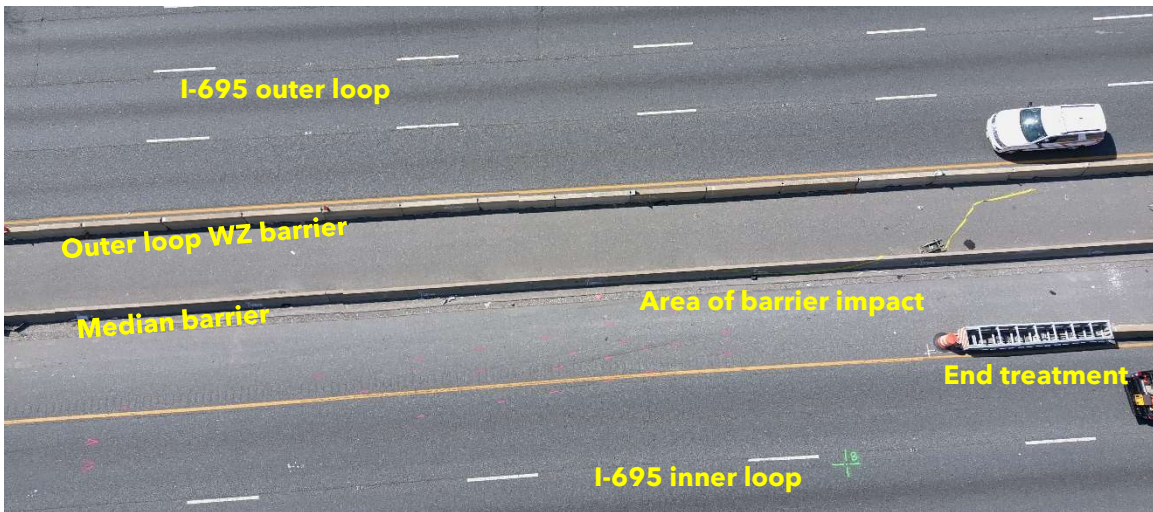
(courtesy MSP sUAS flight) of the northern end of the work zone access opening where the collision occurred. The upstream barrier opening end-treatment is visible.

Figure 6: Aerial photograph depicting the northern end of the barrier opening (Maryland State Police and annotated by NTSB).

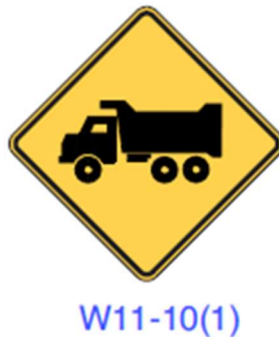
Closed" sign (MDMUTCD W21-5), as designated in the Temporary Traffic Control Plan, had been toppled. This sign was installed adjacent the right shoulder, approximately 1260 feet in advance of the work zone area. CGI responded that the sign had recently been struck by a motorist and was scheduled for reinstallation. The TTCP also indicated the placement of "Trucks Entering Highway" signs (MDMUTCD W11-10(1) as optional) in advance of, and at the work zone openings.²¹ While these signs were not present at the time of the crash, CGI responded that the proximity of the travel lane and limited clearance of any sign erected on the barrier necessitated that the signs be displayed using *Windmaster*[®] portable sign stands when the openings were being accessed by vehicles. MDSHA similarly responded that the signs were displayed on portable stands when the access openings were to be used. The TTCP provided guidance stating that the "location of temporary traffic control signs and other temporary traffic control devices may be adjusted by the contractor to account for unforeseen field conditions" (TTCP Note 15).²² **Figure 7** depicts an illustration of the W11-10 "Trucks Entering Highway" sign.

Figure 7: MD MUTCD Trucks Entering Highway sign.

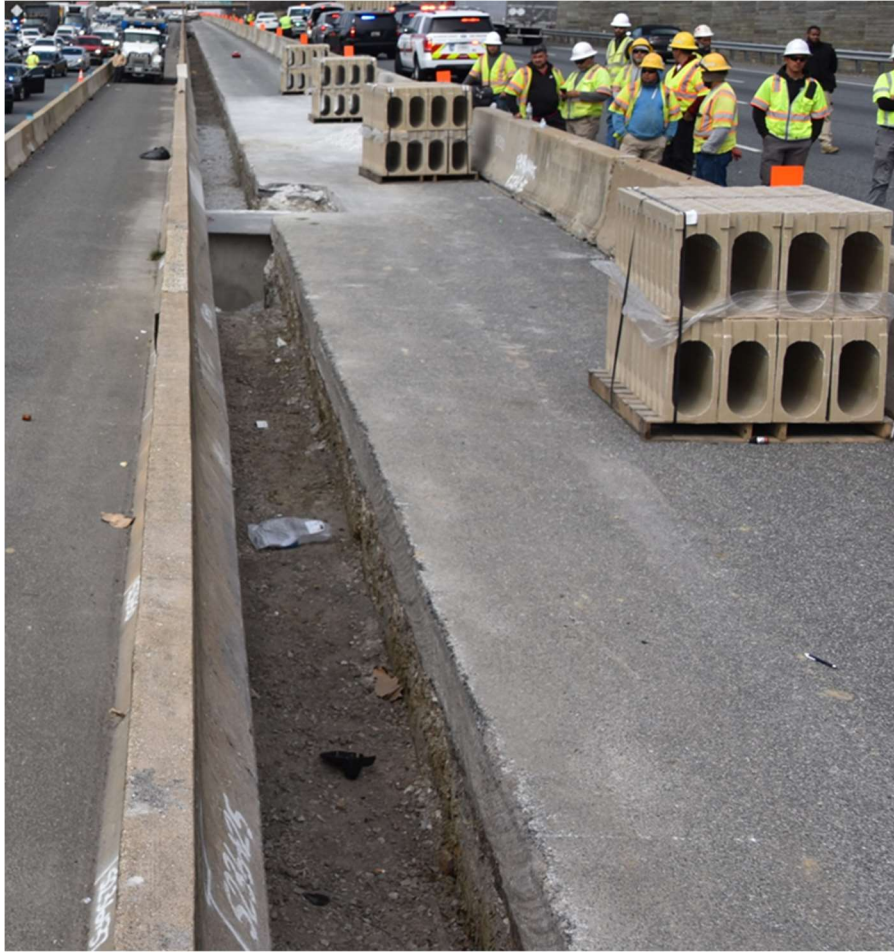
At the time of the crash the current phase of work involved trenching and installation of pre-cast concrete drains along the outer edge of the median shoulder. At the time of the crash the workers were located within the work zone and had been further separated from the access opening by construction material stored within work zone. As noted by CGI and observed in MSP photographs, three pallets of prefabricated polymer concrete trench drain, each weighing approximately 2,240 pounds were linearly positioned between the opening and the likely location of the workers. Other material including lumber and steel rebar were also stacked within about 150 feet from the upstream barrier end treatment. The three pallets were located at distances of about 147, 177, and 201 north of the barrier end treatment. Movement of the Acura through the work zone displaced these pallets and destroyed many of the drains. In addition, a large steel job box, measuring approximately three by three by five feet was also struck and destroyed. Steel rebar rods were displaced into the outer loop shoulder work zone and adjacent travel lanes. At their positions of final rest, the Acura and Volkswagen were approximately 218 and 387 feet north of the upstream barrier end treatment.

Figure 8 is a photograph depicting exemplar pallets of the drain segments positioned within the work zone in a manner similar to that near the access opening.

Figure 8: Photograph depicting exemplar storage of drain pallets within the work zone. (Maryland State Police - cropped)
