SEASTREAK COMMODORE (RR-42230)

Order Number
KR1030463

Work Period
14.07.21 - 19.07.21

Service Type
Warranty

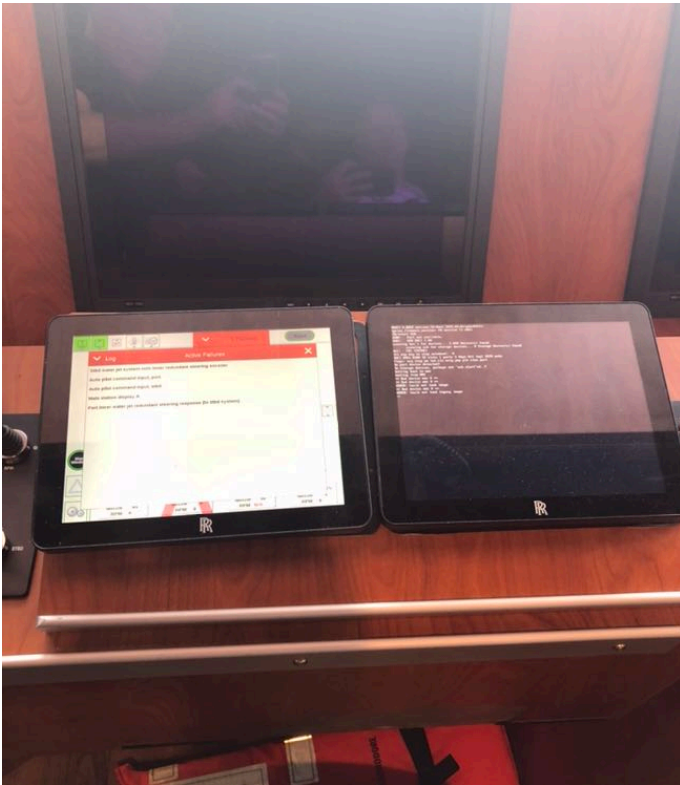
> We removed SD card from Main Screen A and Main Screen B. The cards were swapped into the other screen. The screen which was A booted up without issue using the SD card from Screen B.

The screen which was screen B would not boot up using the SD card from Screen A.

Screen A with SD card from B, and Screen B with SD card from A. Rebooting issue has followed the SD card.
