**Photo 3 - N153SA, a Bell OH-58A, at the accident site (FAA photo)**

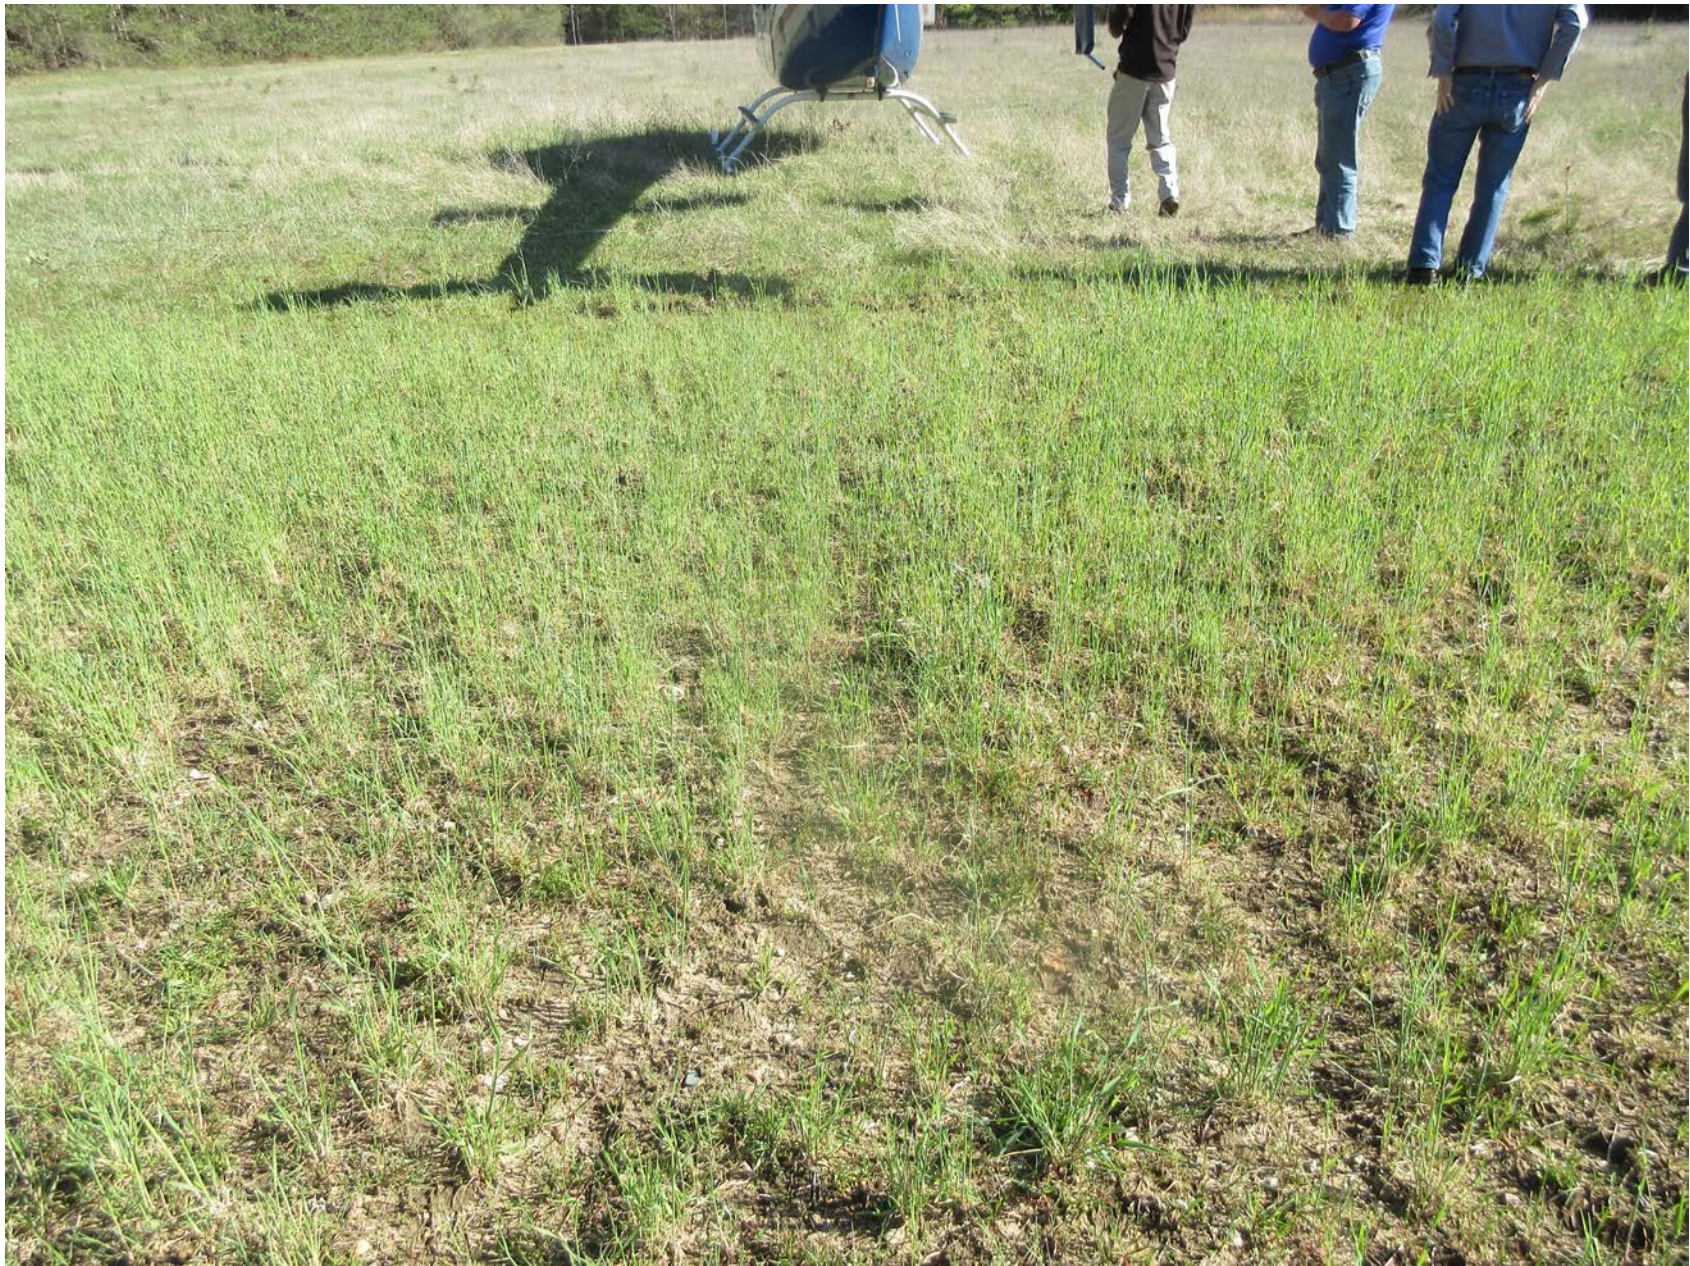
**Photo 1 – Skid marks in the grass depict where the helicopter touched down and slid (FAA photo)**

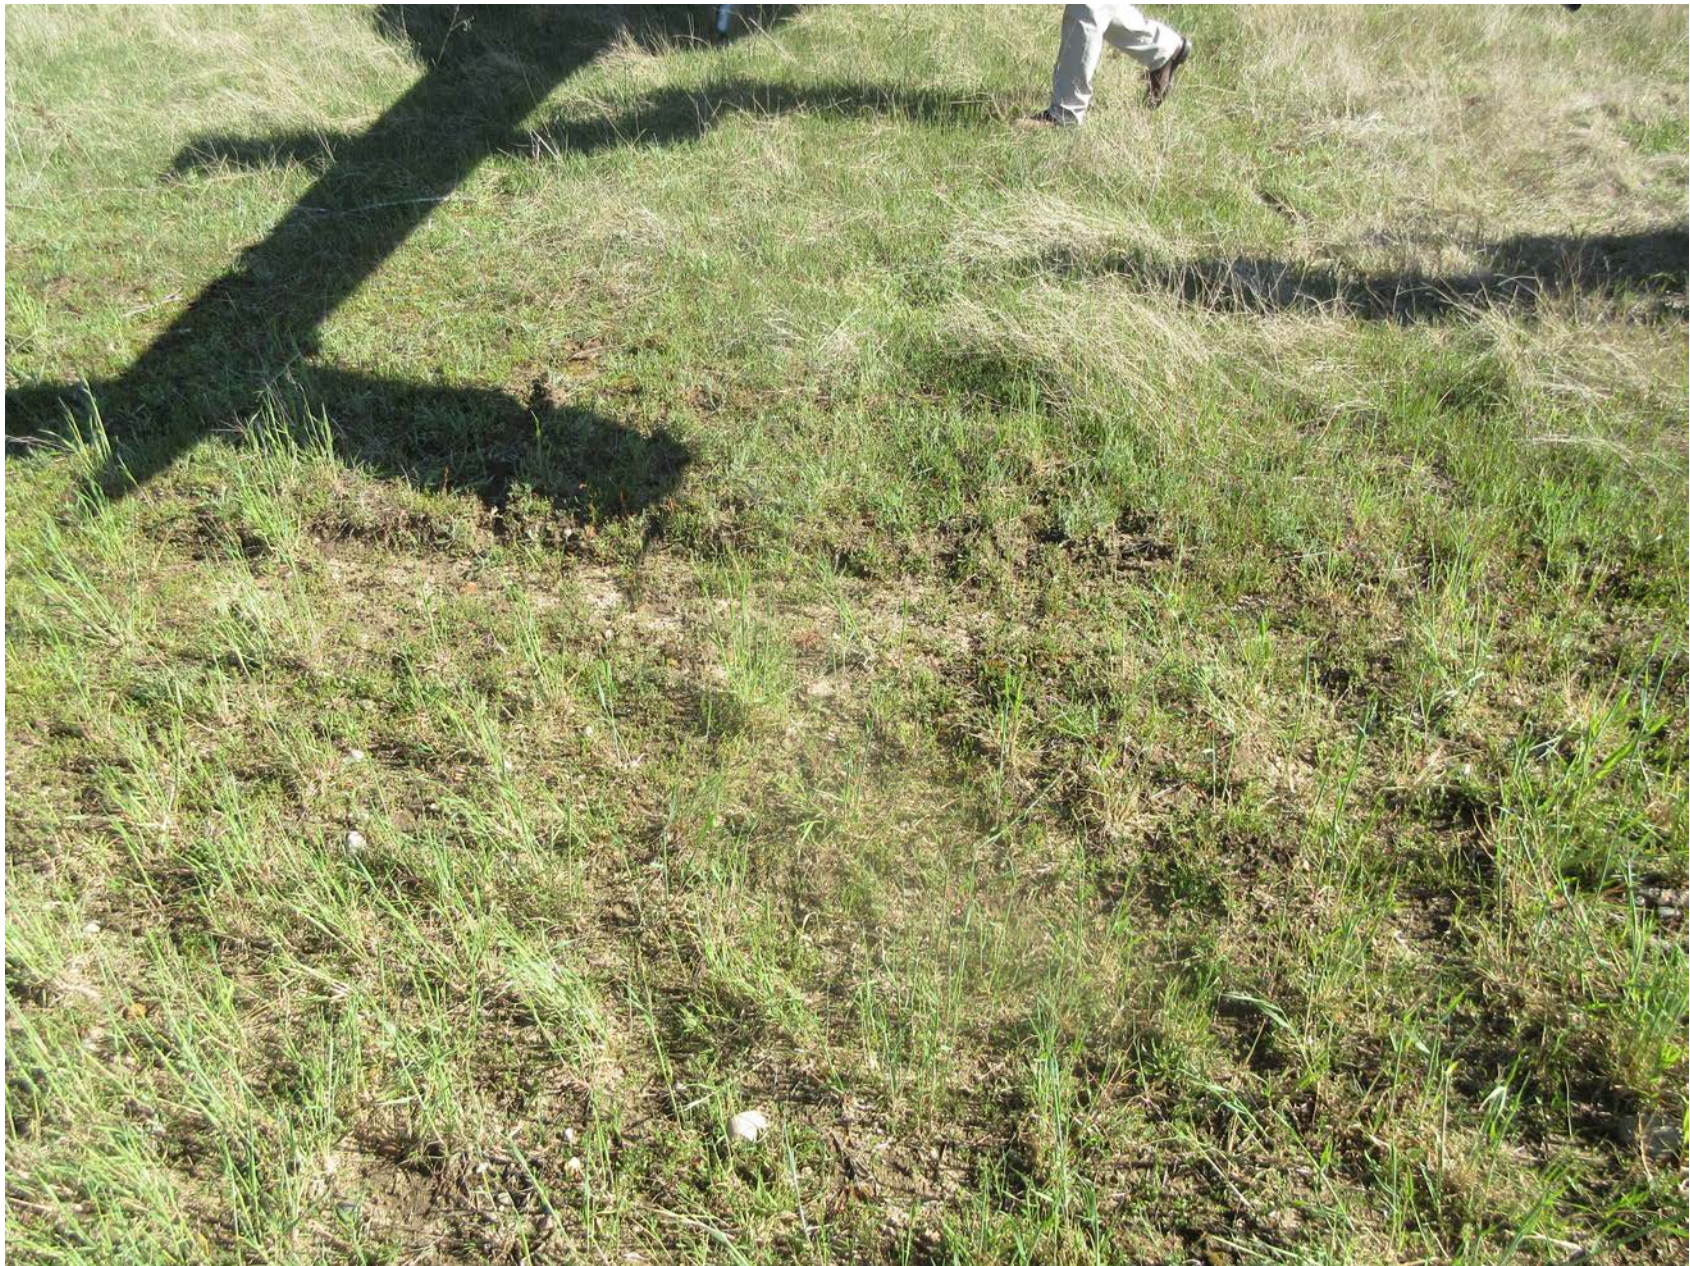
**Photo 2 - Ground furrows consistent with a hard landing (FAA photo)**

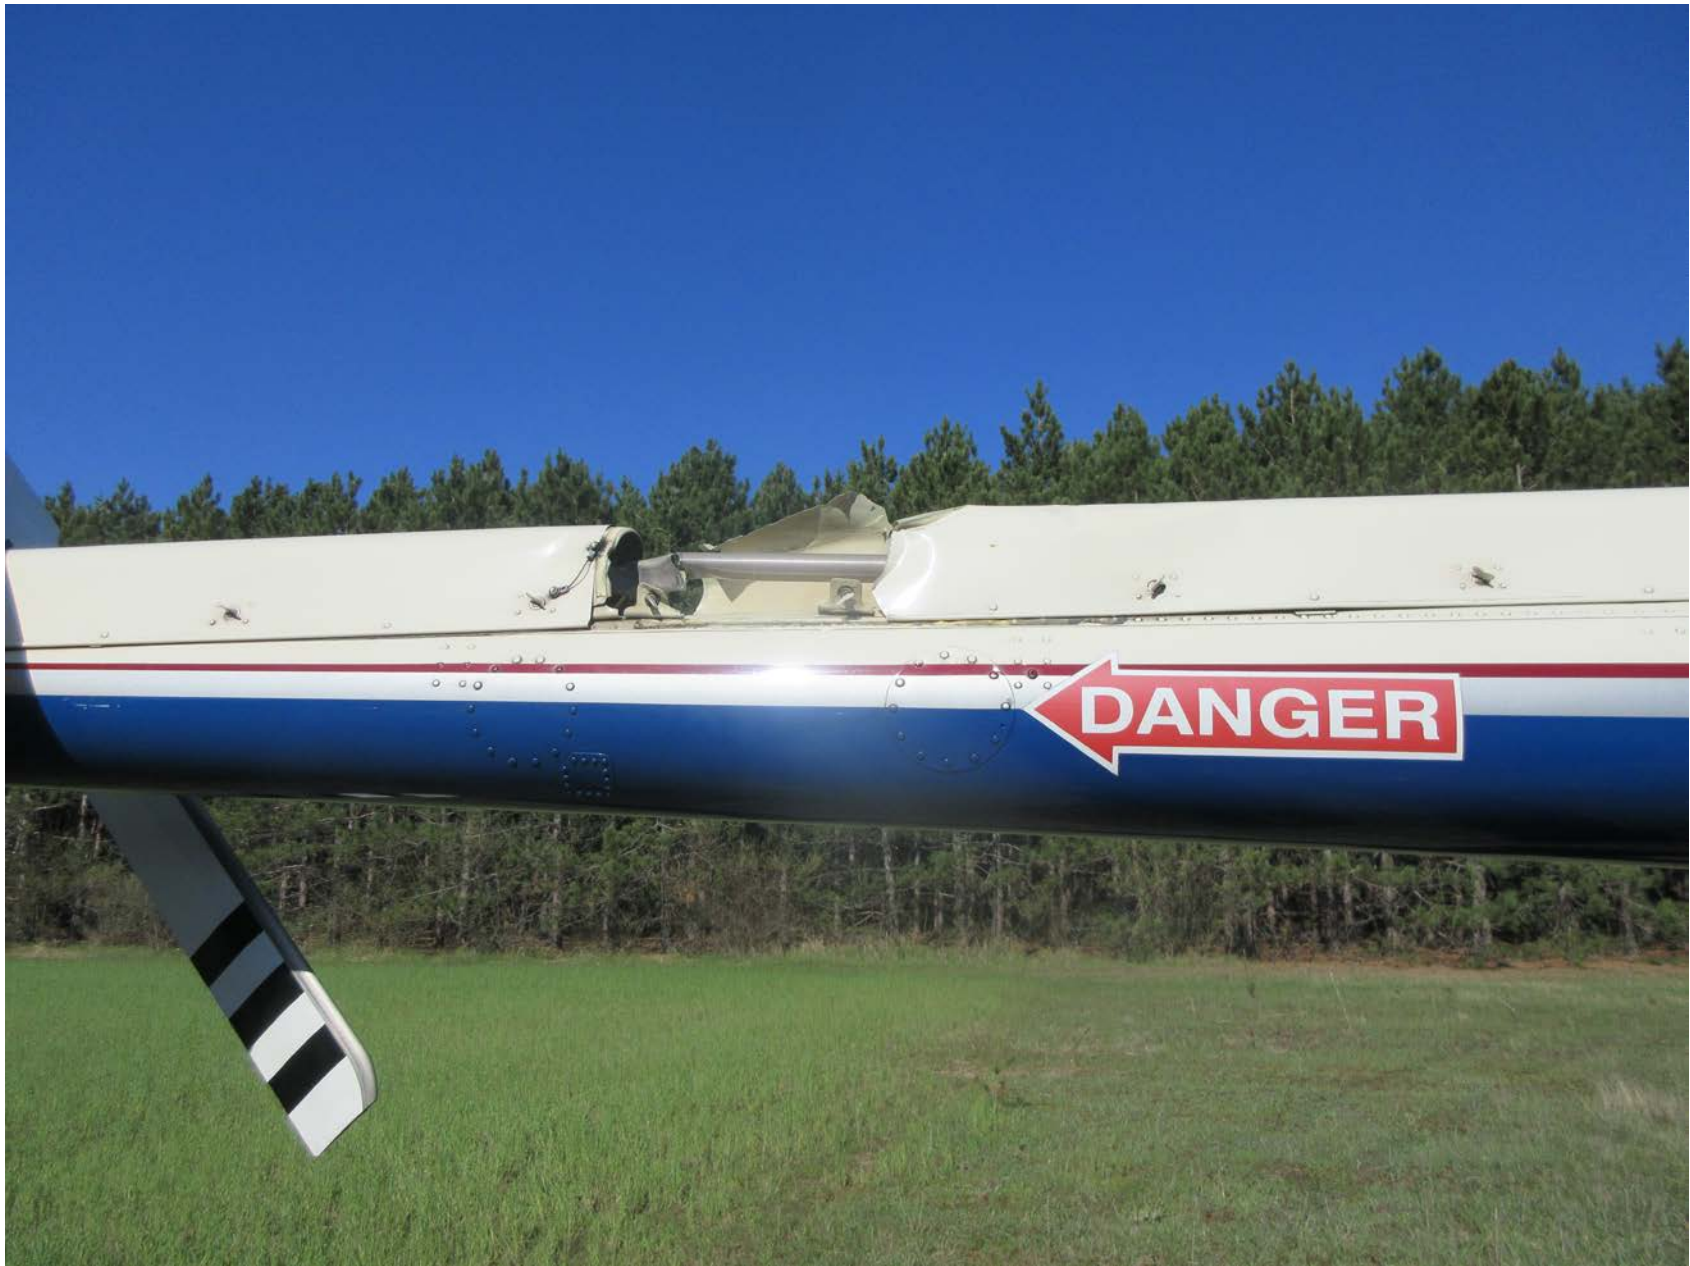
**Photo 4 - Tail boom covering torn away, exposing severed tail rotor driveshaft (FAA photo)**

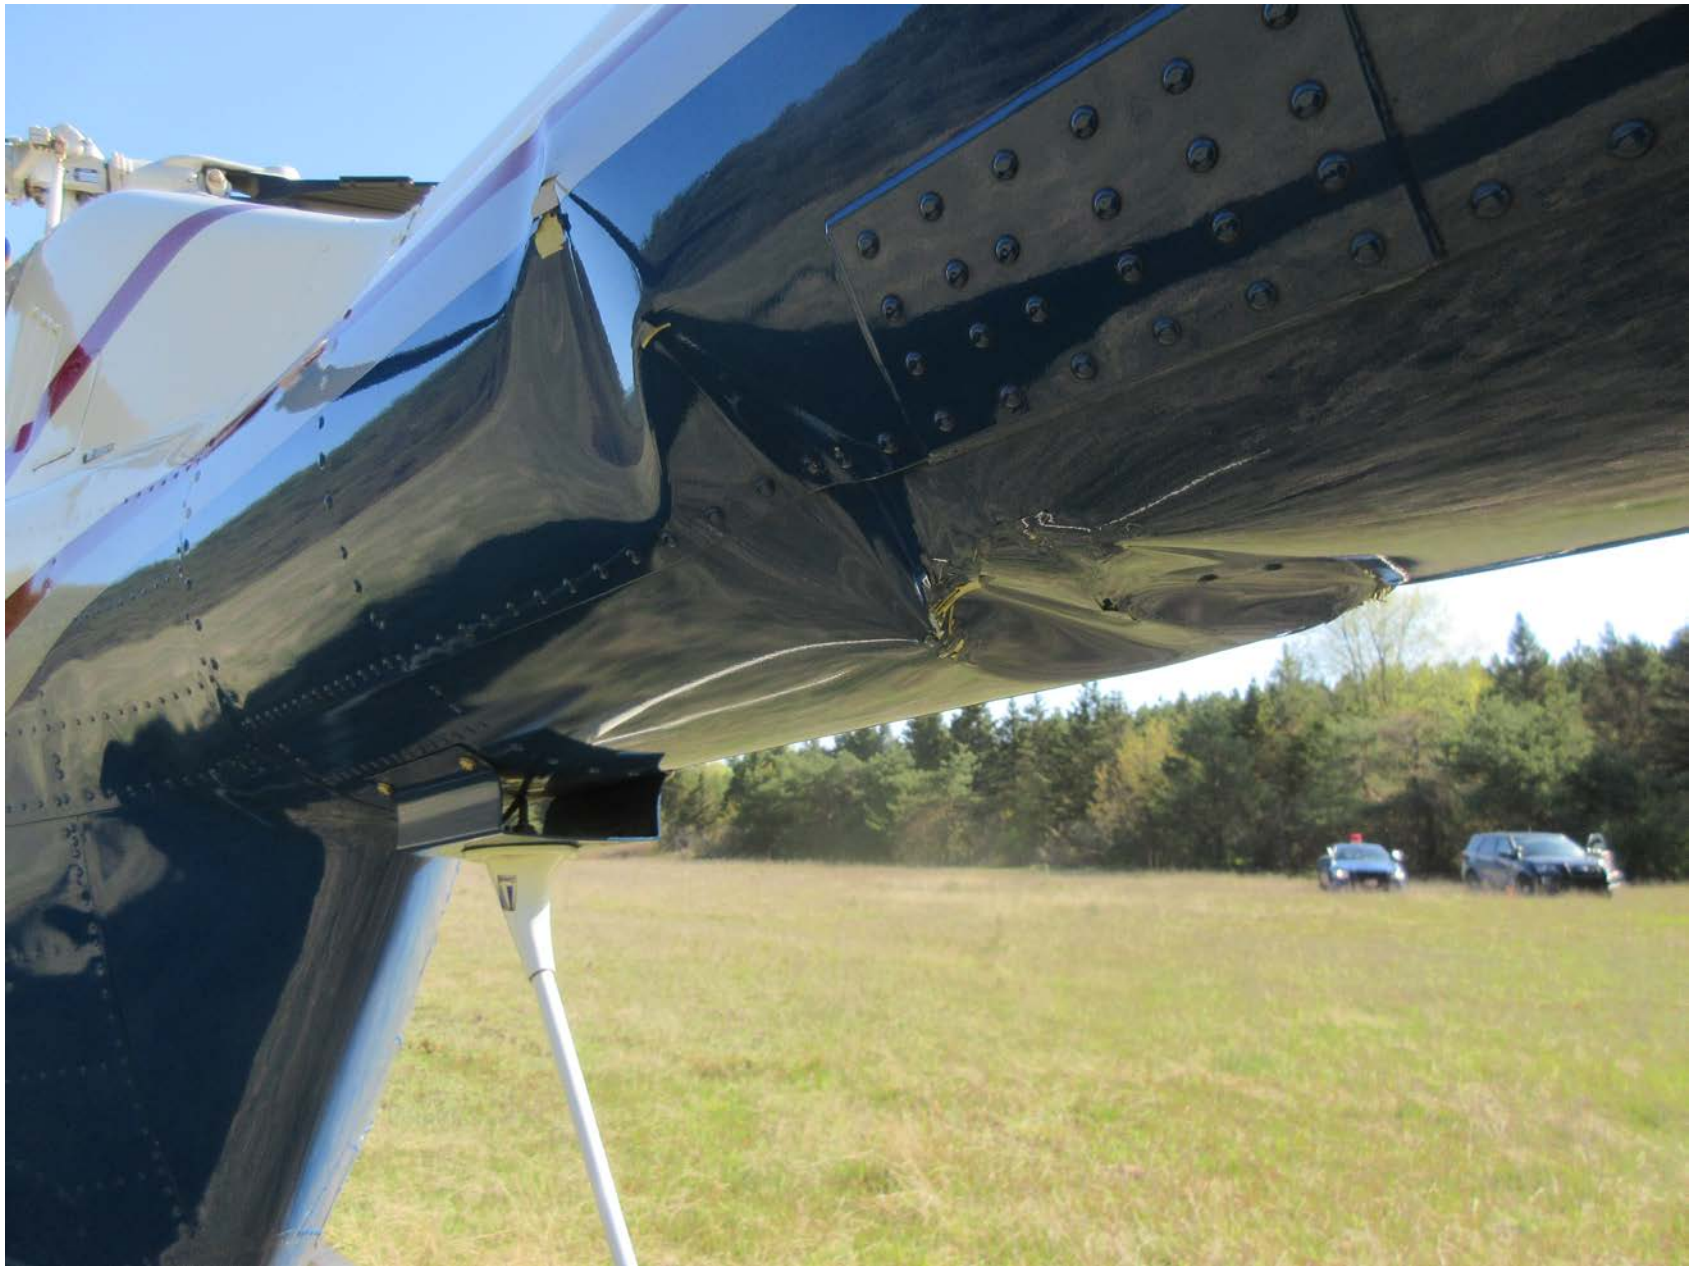
**Photo 5 – Impact Buckling on bottom of tail boom (FAA photo)**

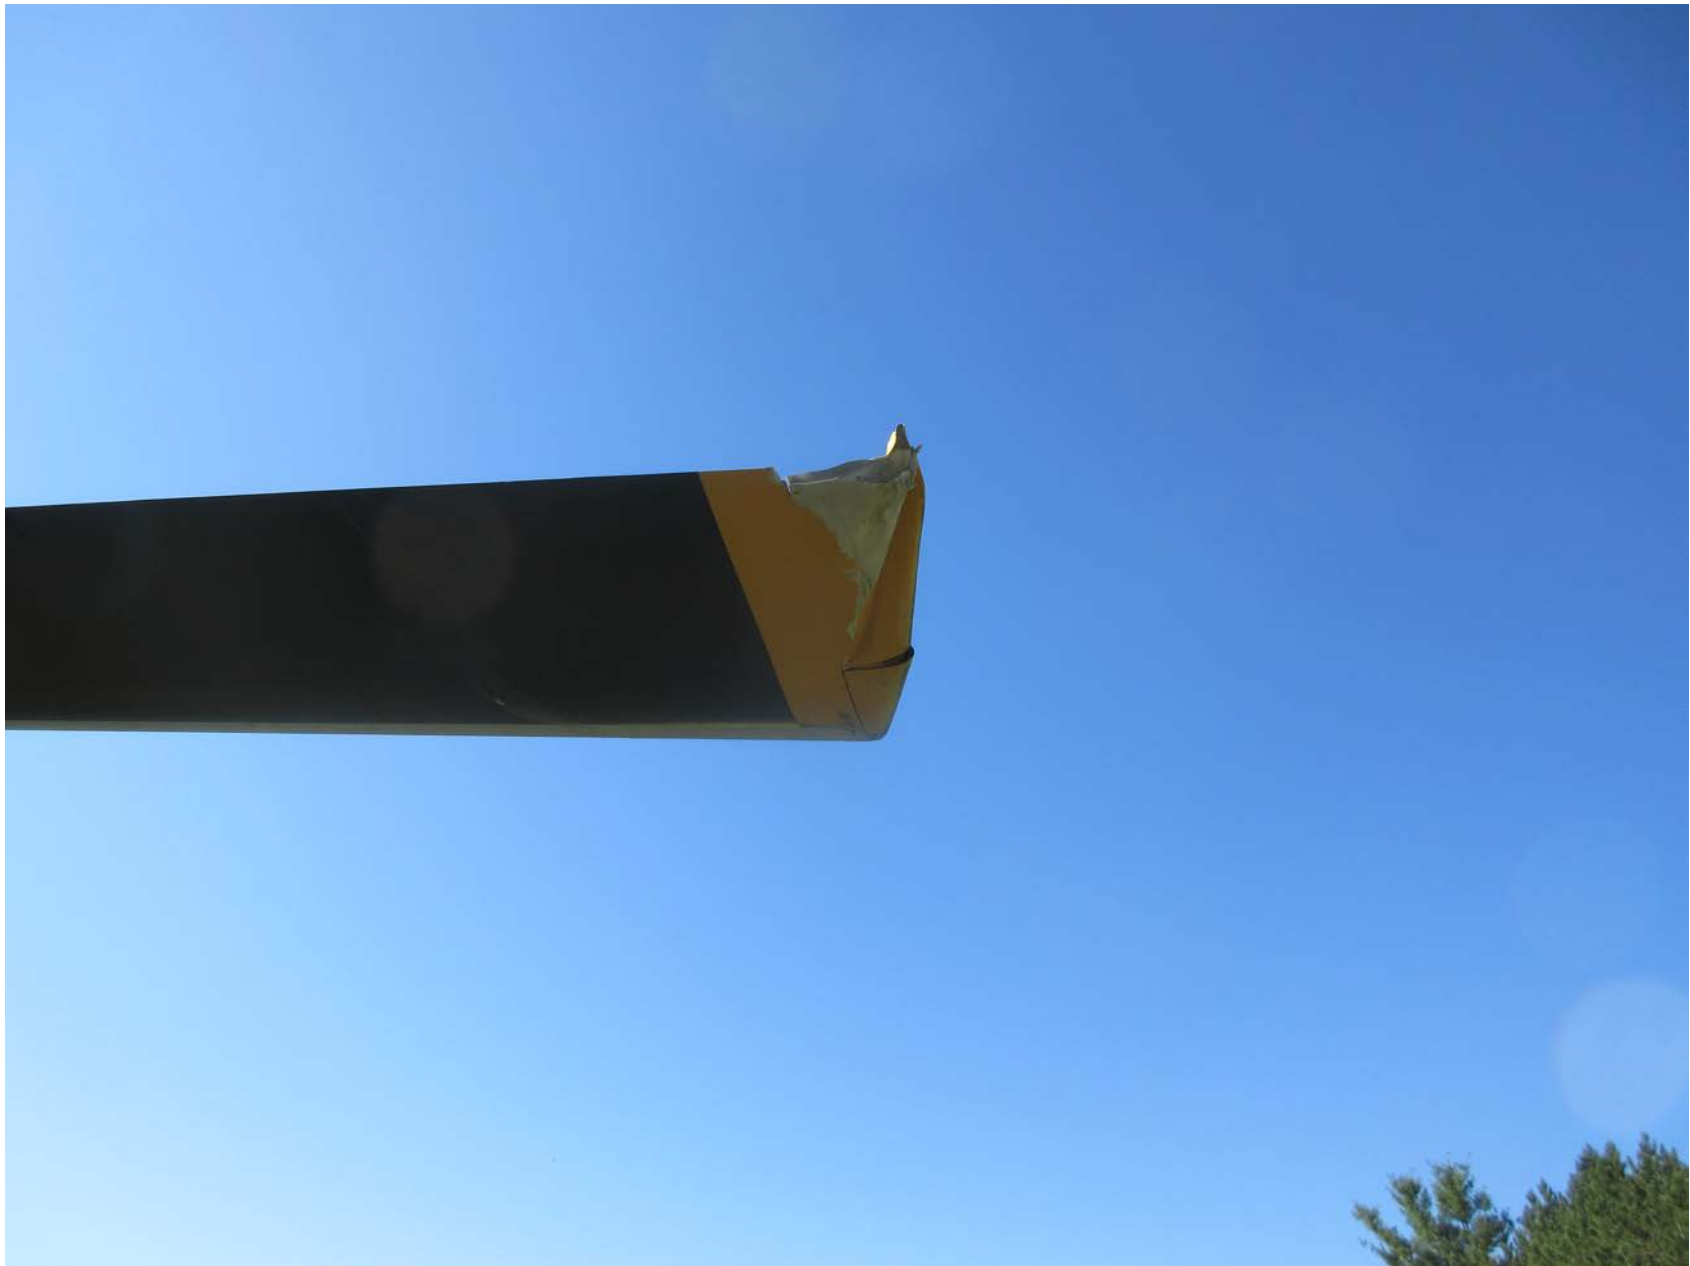
**Photo 6 – Damaged main rotor blade tip (FAA photo)**
