National Transportation Safety Board

HWY23FH014

HIGHWAY, VEHICLE, AND TECHNICAL RECONSTRUCTION

Group Chair's Factual Report

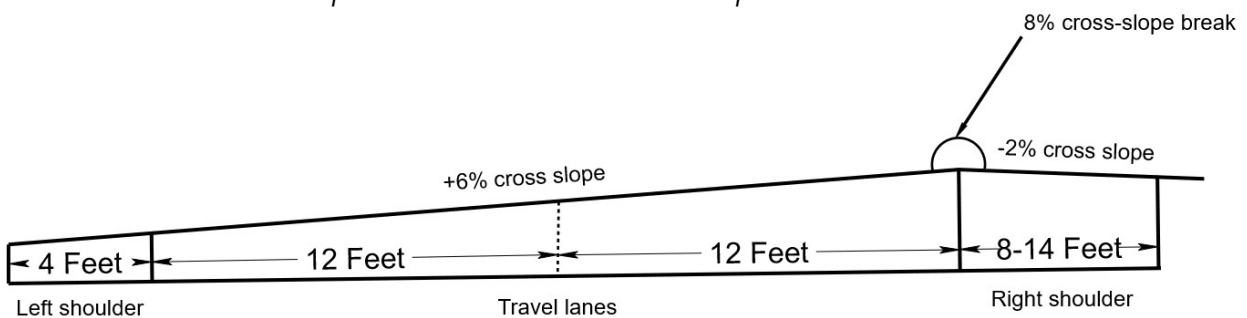
break as measured at the edge of the paved traveled way and paved shoulder was determined by finding the algebraic difference in the grades between the travel lane and shoulder. As can be seen in **Figure 2** the cross-slope break along Cottman Avenue was 8%.

“Within a superelevated roadway section, the maximum algebraic difference of cross slope break should not exceed 8 percent between the traveled way and usable shoulder. Edge line or shoulder rumble strips placed on or close to the edge line are desirable to reduce the potential for full traversal departures onto the shoulder.”

Figure 2. Graphic showing the cross slope of the travel lanes, the right shoulder, and the cross-slope break.

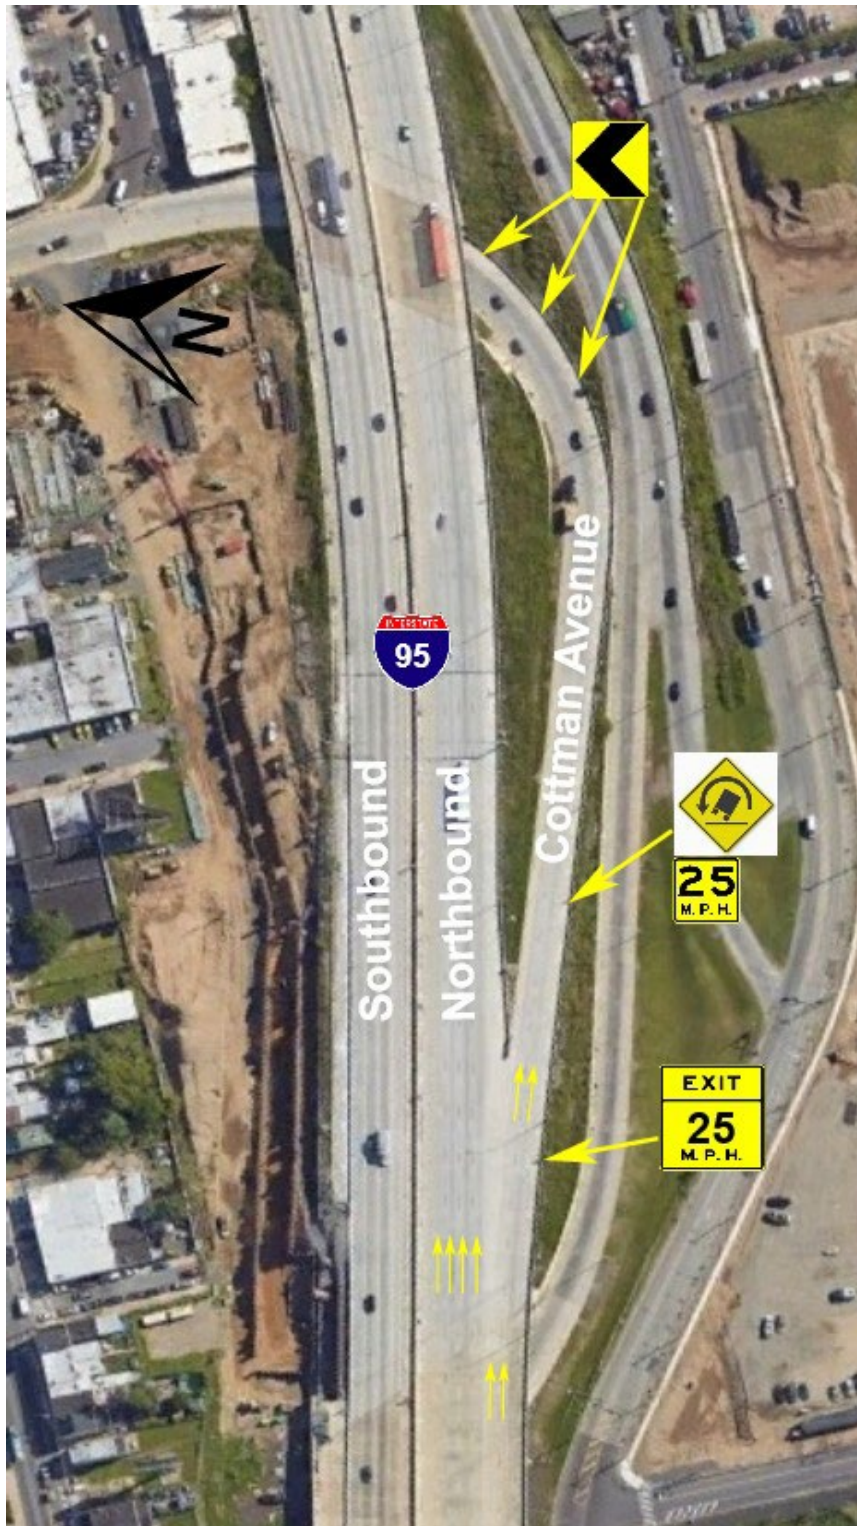
Approximately 733-feet south of the collision area was an advisory exit speed sign advising motorists to travel 25 miles per hour. About 500-feet south of the area of the collision was a truck rollover warning sign accompanied by an advisory speed plaque indicating the recommended speed of 25 miles per hour. There were three chevron alignment signs placed along the outside of the horizontal curve providing emphasis of the change in the horizontal alignment.¹⁰ The collision resulted in two of the three chevron signs being damaged. **Table 4** summarizes the signage prior to the crash on the Cottman Avenue off-ramp.

Figure 3. Google Earth image depicting Interstate 95 and the Cottman Avenue off-ramp. The signage discussed above is identified. Revised by NTSB.

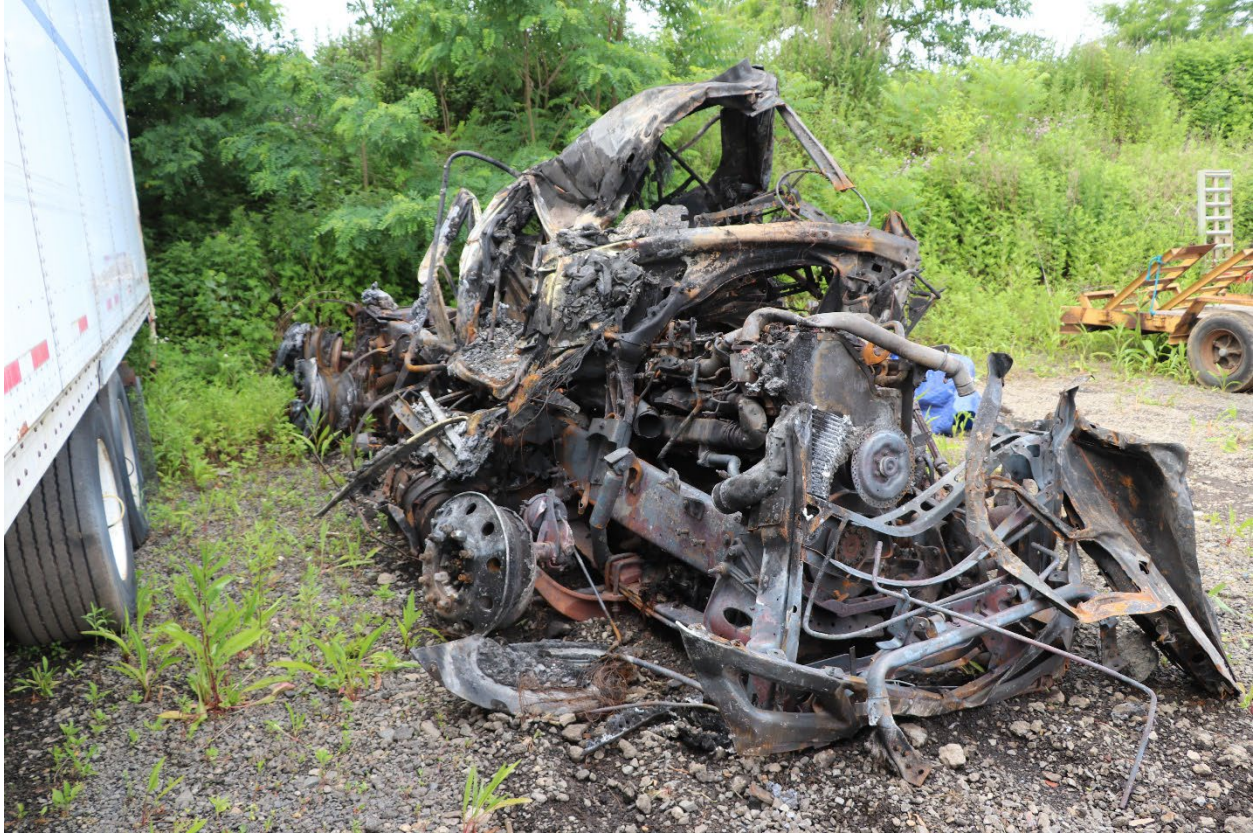
Figure 4. Photograph of 2017 International truck-tractor involved in the collision.

The truck sustained crash damage to the right and left side of the vehicle. The damage included severe fire damage to all areas affecting all major mechanical systems. Figure 4 above shows the truck looking from the front right.

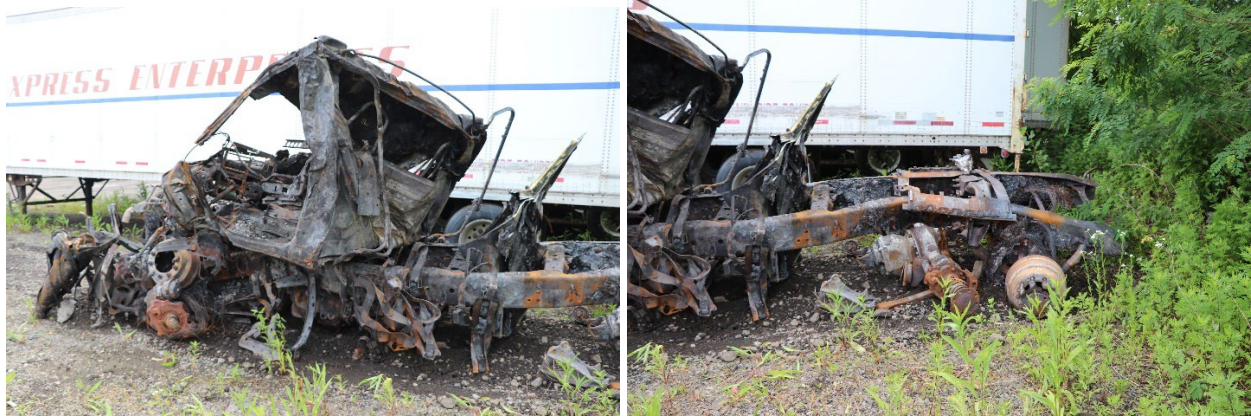
The right side of the cab was displaced inwards to the left and rearwards. The right side "A" pillar and right side of the firewall were displaced rearward and downward. The combustible materials within the cab were completely consumed with only wire visible. The engine and right front frame rail were displaced leftward. The radiator, air conditioning condenser, accessory drive belts, engine cooling fan, and hood were all consumed by fire. The wiring harness casings were consumed by fire exposing bare wires. The exhaust particulate filter on the right side was damaged but still in place. Both the left and right-side saddle fuel tanks were consumed by fire and the straps were still in place. The lower fifth wheel plate was missing; the fifth wheel slider bracket was in place however damaged. Axle two drive had separated from the frame and was hanging down and the short drive line between axles two and three was separated. The right-side rear of the truck was displaced upward. The left-side frame of the truck, under the driver's door and in front of axle two was displaced inward. Figure 5 below shows the damage to the right side of the truck.

Figure 5. Photographs showing the damage to the left side of the tractor.

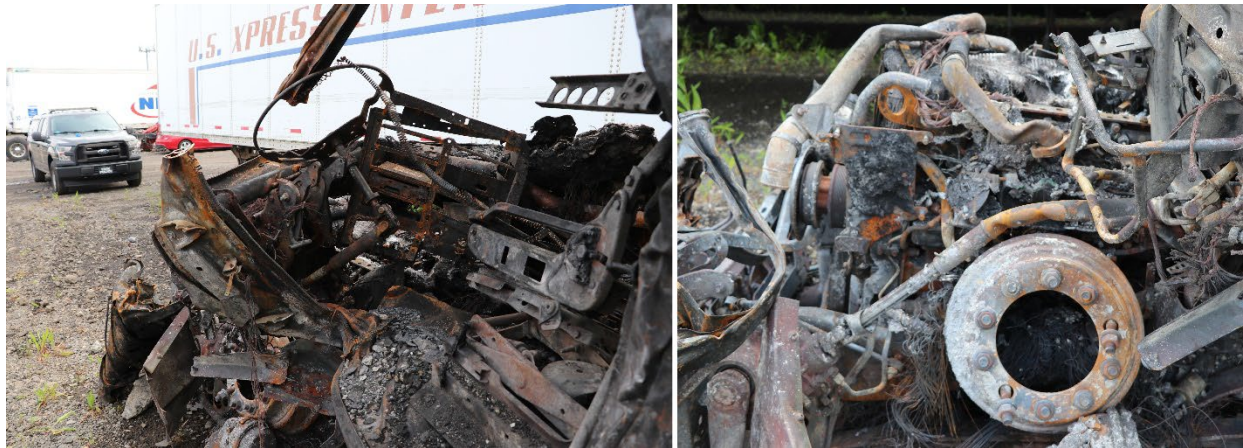
Due to the extensive crash and fire damage, a functional check of the steering system was not able to be performed. A visual examination of the remaining steering components showed a bent upper portion of the steering arm that was still intact and connected to the steering shaft. The hydraulic fluid reservoir that contained the steering fluid was consumed by fire. The pitman arm and drag link were intact. The steering column was intact, and the outer steel hoop that made up the steering wheel was undamaged. Figure 6 is two photographs showing the components of the steering system as they were during the vehicle inspection.

Figure 6. Two photographs each depicting a section of the steering components as observed during the vehicle inspection.

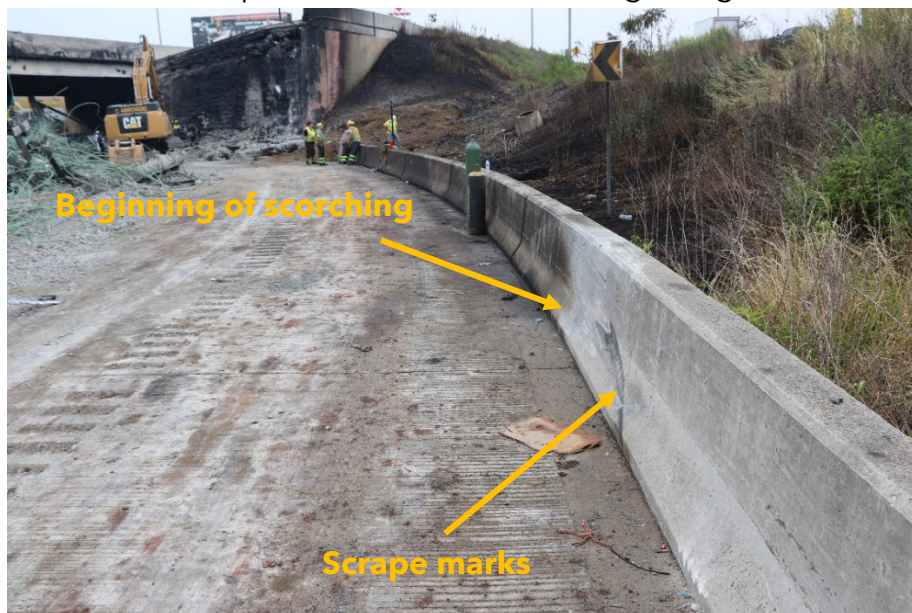
On-scene observations gleaned scrape marks located on the vertical portion of the concrete barrier. Also observed were black scorched areas on the concrete barrier, roadway, bridge structure, and the grass area along the opposite side of the concrete barrier. Recovery operations were underway during the evidence documentation and any roadway evidence had been covered up by debris or destroyed by heavy equipment being utilized to cleanup and remove the collapsed bridge. Figure 7 depicts the first area of scrape marks and the scorching along the concrete barrier.

Figure 7. Photograph depicting the impact marks and scorching on the concrete barrier.

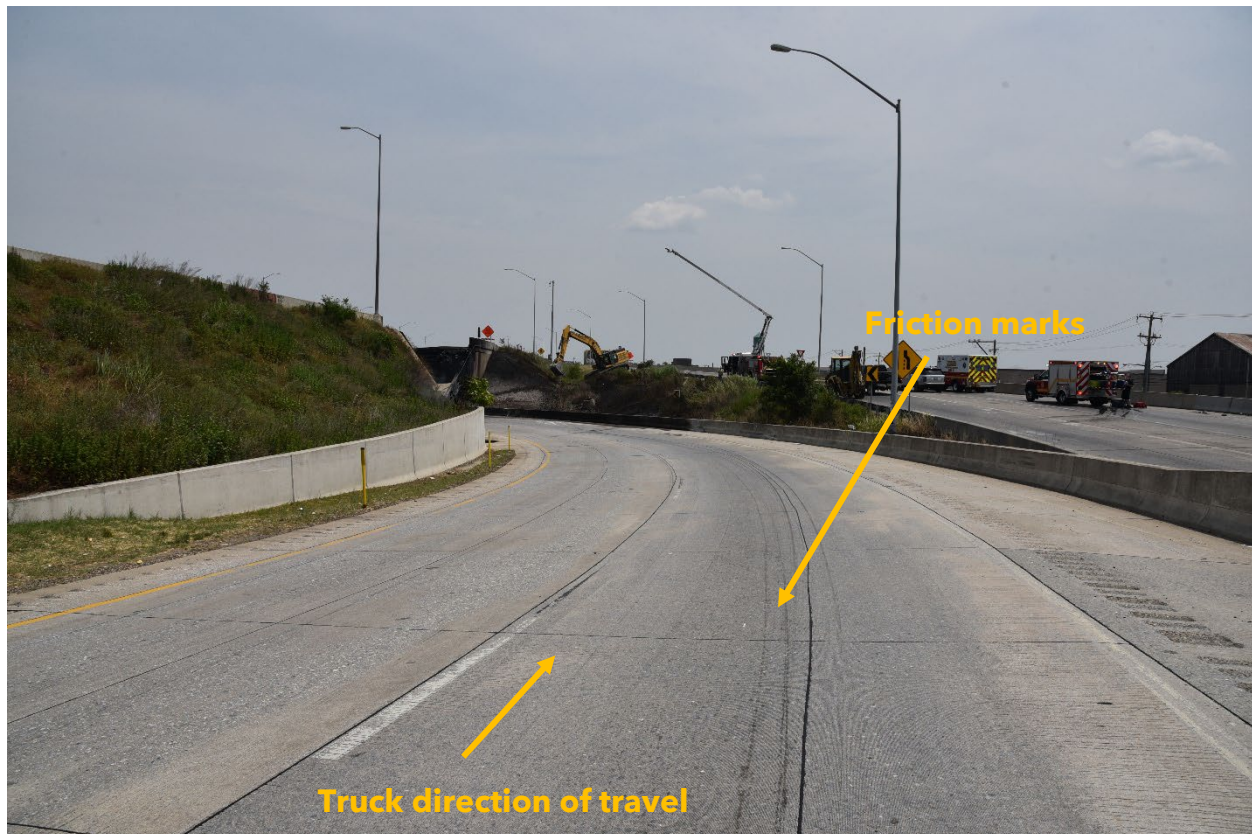
Figure 8. Photograph looking north along the Cottman Avenue off-ramp. In the photograph evidentiary marks are visible along the roadway, and concrete barrier. (Photograph courtesy of PSP)

Figure 8 above is a photograph looking north along the Cottman Avenue off-ramp. The combination vehicle's direction of travel is noted on the photograph. The two parallel friction marks, noted on the image, were light at the beginning and became darker as the marks continued. The friction marks began approximately 170 feet south of the first strike on the concrete barrier, they were straight and transitioned to curvilinear as the combination negotiated the left horizontal curve. The marks were parallel to one another and measured approximately 6 feet 4 inches from the white edge line to the center of the marks which extended approximately 176 feet.

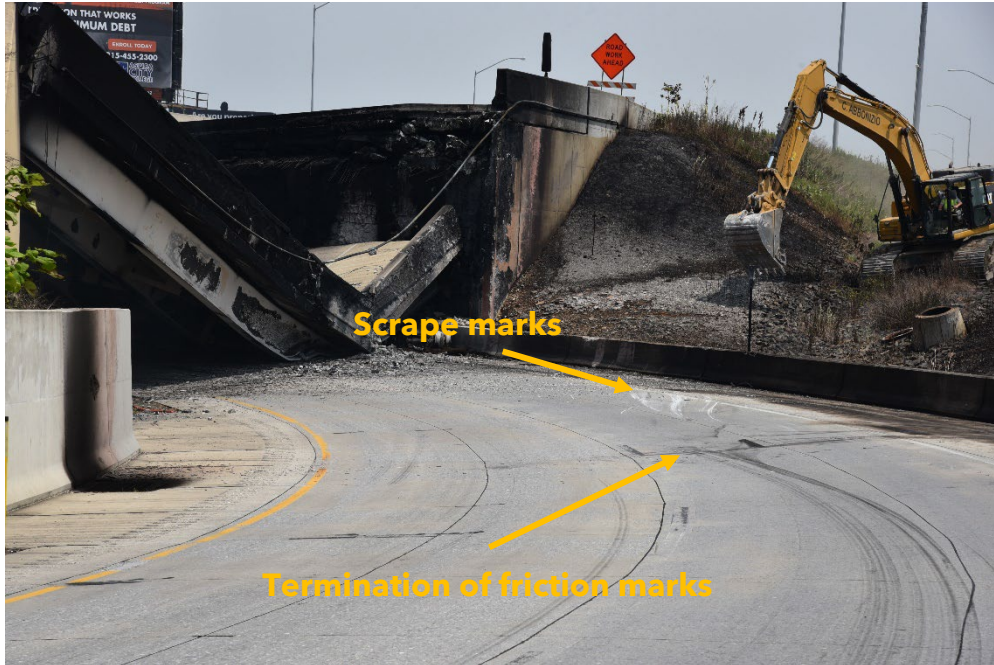
Figure 9. Photograph looking north along the Cottman Ave. off-ramp. The image shows the termination of the curvilinear friction marks. (Photo courtesy of PSP)

Figure 9 is a photograph depicting the area where the friction marks denoted in Figure 8 terminated. At the termination, the marks were dark, and the right outer

mark widened and traveled north towards the shoulder. In line and approximately 4.5 feet south, of the final friction mark were scrape marks on the roadway surface that continued to the concrete barrier. Associated scrape marks on the concrete barrier were not visible due to the scorching from the post-crash fire. The scrape marks were at an approximate 9° angle relative to the direction of travel for a vehicle negotiating the left horizontal curve.

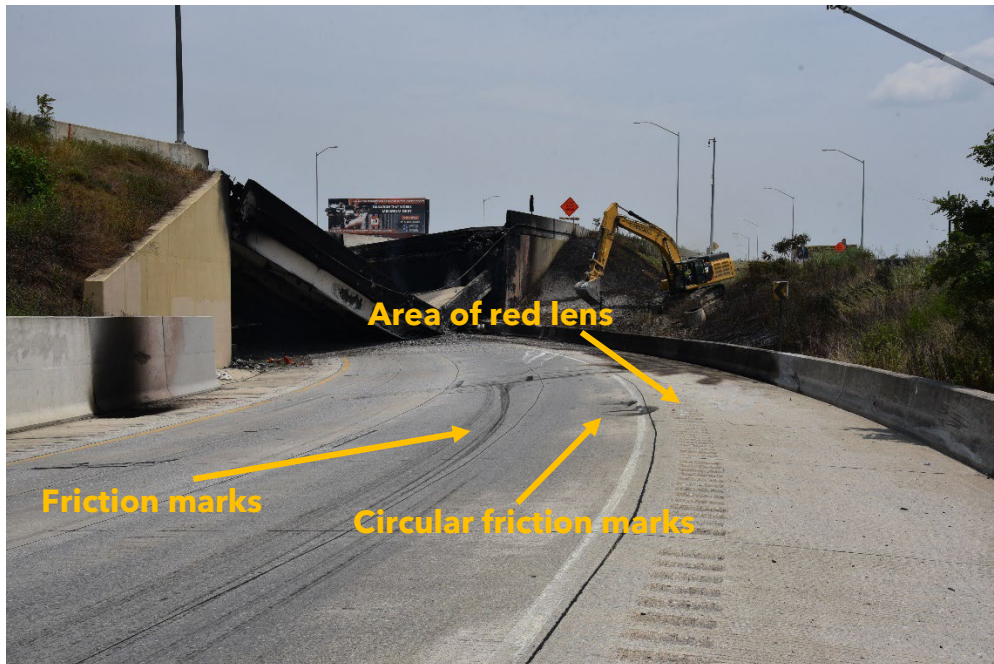
Figure 10. Photograph looking north along Cottman Avenue. In the photograph are the tire friction marks and noted is the area of the red lens and the beginning of the scorched concrete barrier. (Photo courtesy of PSP)

Figure 10 is a photograph depicting the tire friction marks created by the combination as it continued negotiating the leftward curve on Cottman Avenue. Also annotated are the two circular friction marks on the white edge line, east of the circular friction marks, about 5 feet east, on the right shoulder, was a semicircular scrape mark that continued north to the concrete barrier. Observed on the concrete barrier prior to the scorched area, were horizontal scrape marks along the face of the barrier. Observed on the right shoulder, within the rumble strips, between the circular friction marks and scrape marks were fragments of red plastic lens.

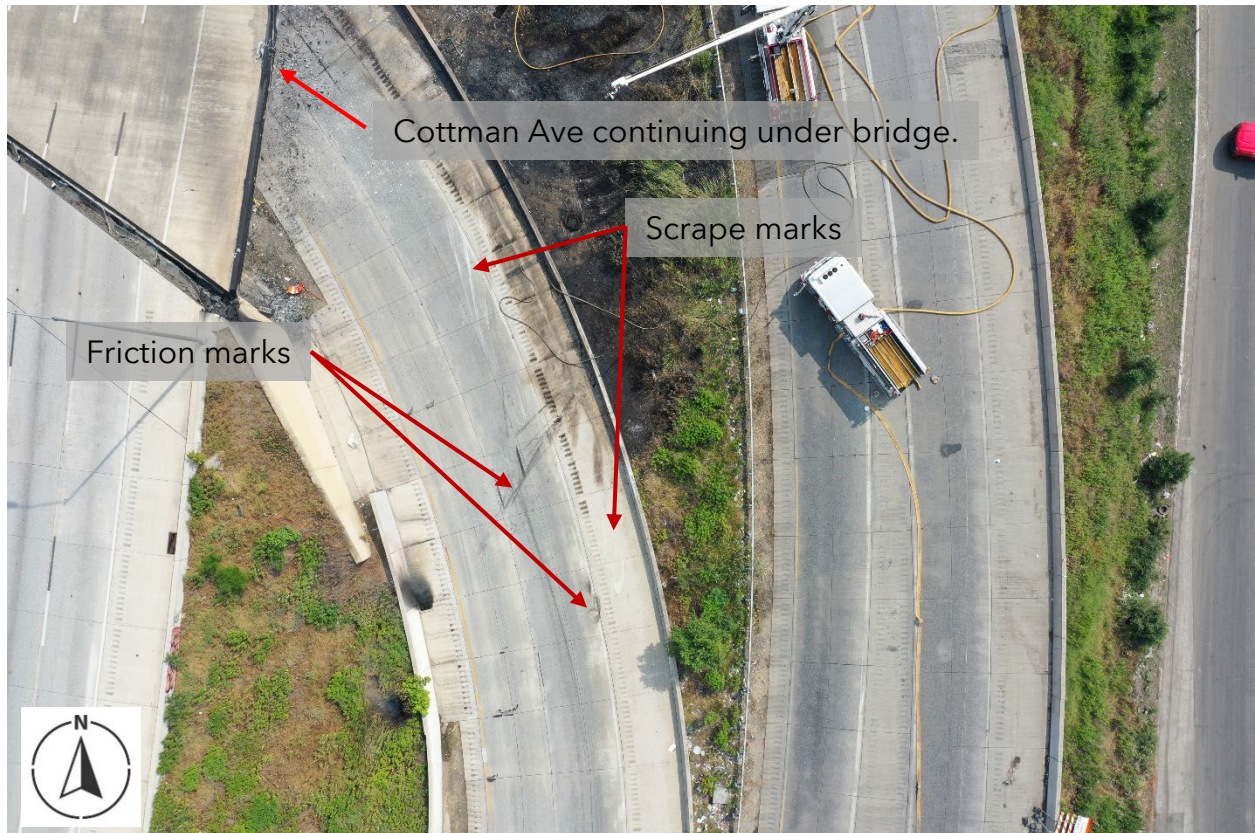
Figure 11 is an aerial image provided to NTSB investigators by PSP. The image shows the Cottman Avenue off-ramp prior to entering underneath the Interstate 95 bridge. Identified in the image are the friction marks and scrape marks associated with the crash.

Figure 11. Overhead aerial photograph showing the friction marks and scrape marks on the roadway surface. (Photo courtesy of PSP)

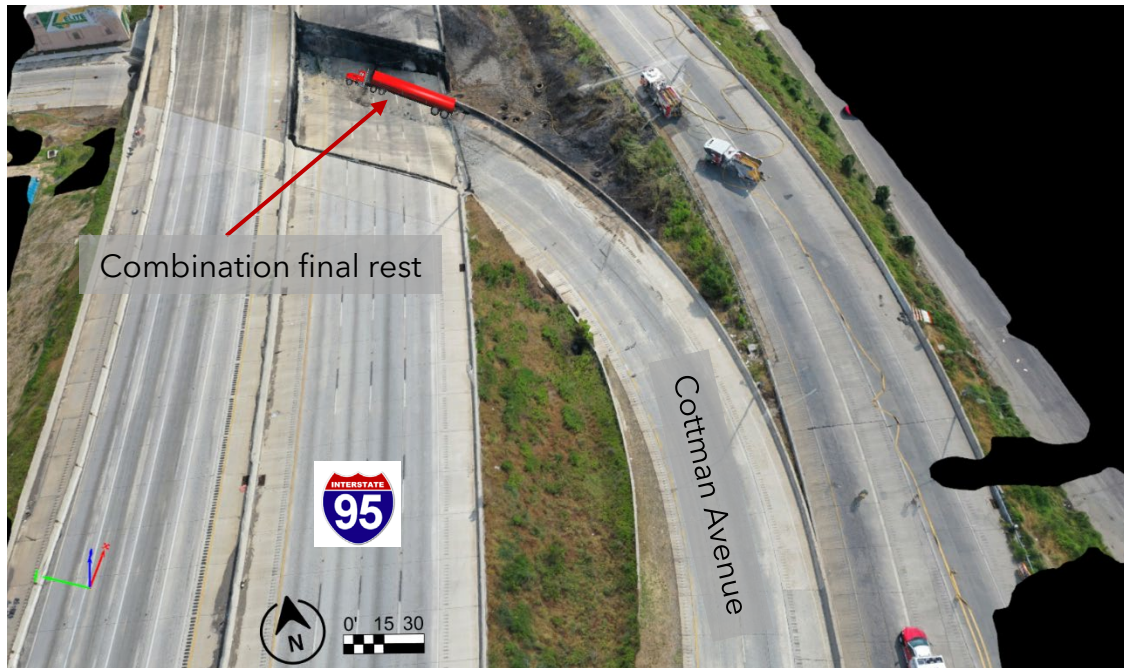
Figure 12 below, is a screen capture of the three-dimensional point cloud generated from the aerial photos collected by PSP. The final rest of the overturned combination unit can be seen. It should be noted that the combination unit was located underneath the collapsed portion of Interstate 95, the trailer portion was found to be at rest with the top down.

Figure 12. Image of the point cloud generated from the aerial photographs. Final rest of the overturned combination unit is noted. (Photos courtesy of PSP)
