Vehicle Attachment – 2004 International Specifications

Clarendon Hills, IL

HWY22MH009

Technical Service Information

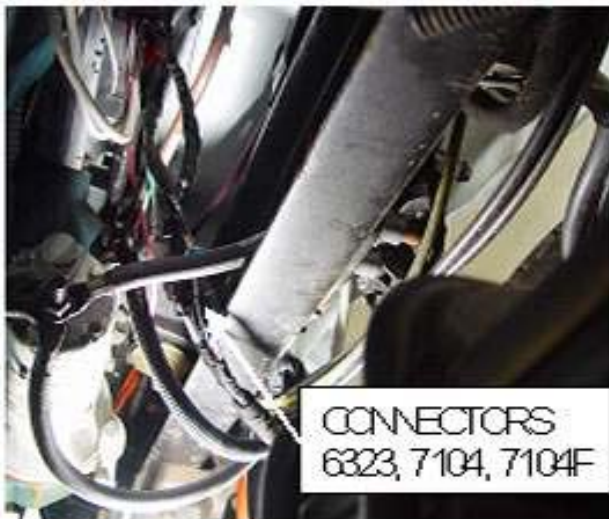
Figure 1 Engine and Transmission Clean Power and Ground Connectors

Intermittent operation of the engine ECM and/or the Allison transmission ECU's can often be caused by poor electrical connections in the Clean Power and Ground Connectors 6323, 7104, or 7104F, or the Chassis/Dash Connector 9700. These poor connections can be caused by "pushed back" pins, loose pins, corroded connectors, or poorly mated connectors because of improperly routed harnesses. The following procedures should be followed to diagnose and repair these connector problems.

1. Locate engine clean power and ground connector near the starter. Refer to Figure 1. Engine harness wires are violet in color.
2. Disconnect the connector and check for corrosion and pushed back pins. If corrosion is present, replace the existing connector and terminals with kit 2587366C91 (See Table 1).
3. Drag test all terminals with a new terminal 1687848C1. Refer to Figure 2. If terminal does not fit securely and have a significant amount of drag, the terminals and connector will need to be replaced with kit 2587366C91 (See Table 1).

4. If the connector/terminals pass the drag test and show no sign of corrosion, apply a small amount of dielectric grease, part number 1831731C1 to the terminals and around the seal and reconnect.
5. Strap lock connector to battery cable so connector is above the bottom of the frame rail. Tie strap should go around the connector body and not the wires. (Caution: connector should not be lower than the bottom flange of the frame rail.)

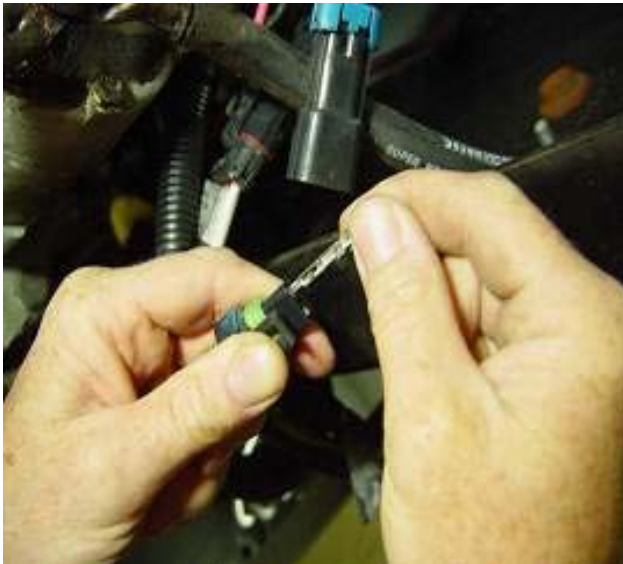
Figure 2 Performing Drag Test

3. Drag test all terminals with a new terminal 2025423C1. Refer to Figure 2. If terminal does not fit securely and have a significant amount of drag, the terminals and connector will need to be replaced with the kit listed in Table 1.

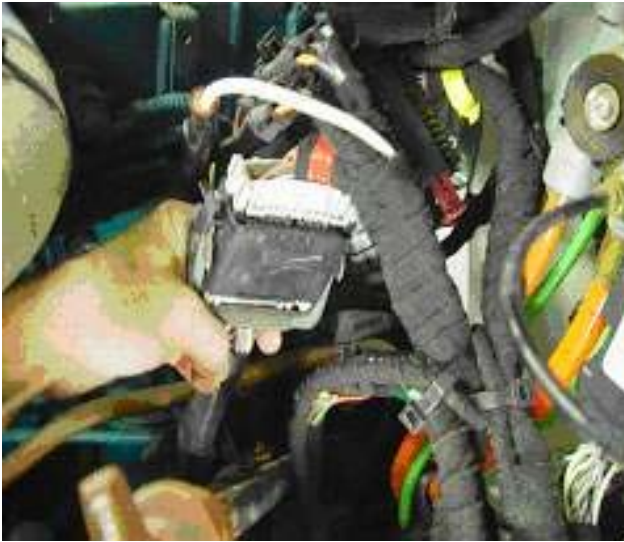
Figure 3 Locate Chassis / Dash Connector

1. Locate the Chassis / Dash connector 9700 in the engine compartment near the wiper motor. Connector 9700 has a gray cam lock lever. Refer to Figure 3.
2. Inspect harness for proper routing and clipping. If harness and connector are tight, remove tie straps and clamps and reposition harness to remove stresses on wires at the connector.

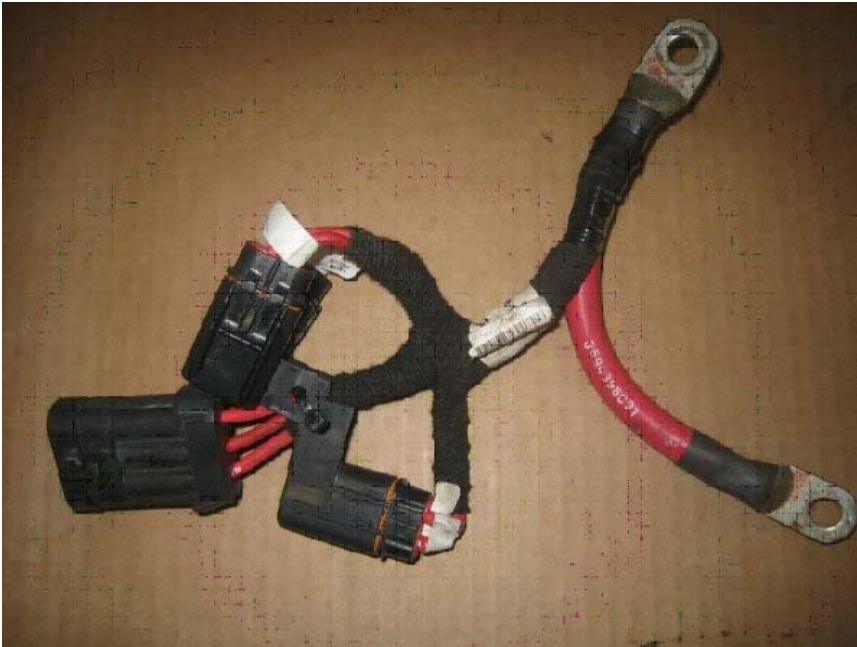
Figure 1 Jumper Cable Assembly — Typical

Subject: Battery Box Located Clean Power Fuses for the IDM (Injector Drive Module), ECM (Engine Control Module), and TCM (Transmission Control Module) Failing, Resulting in Problems with Power to the Associated Module

The following procedure provides guidance if a truck, tractor or bus is experiencing hard start, no start, erratic engine operation, or transmission shifting issues and the engine or transmission fault codes indicate problems with power to the module.

Service replacement part number varies based upon vehicle platform, build date, engine, and transmission configuration. Utilize the VIN parts breakdown inside the Service Parts Catalog. (Figure 1 shows a typical jumper cable assembly).

The newly released jumpers built with copper beryllium terminals have been released in the parts system. All of the old jumper harnesses have been purged from the PDC's. So, if you order a new jumper harness from the PDC, you will receive the updated harness.

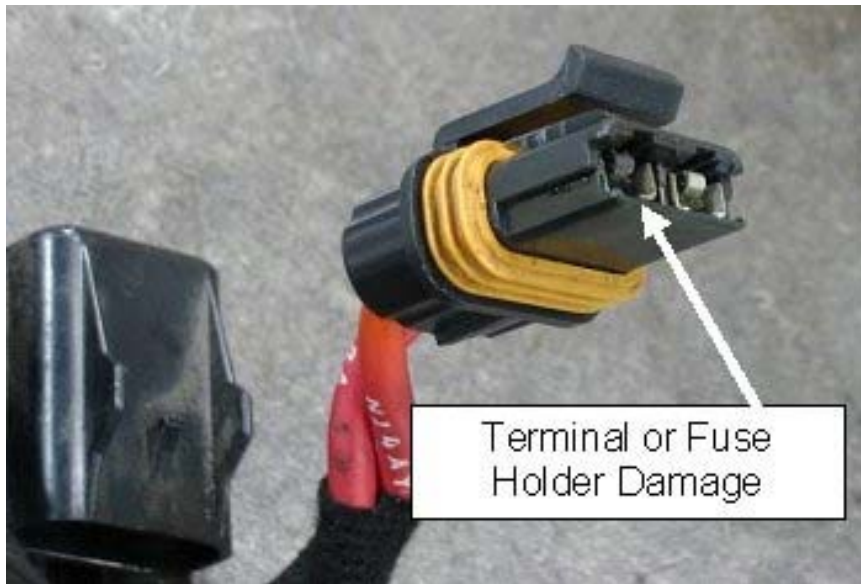
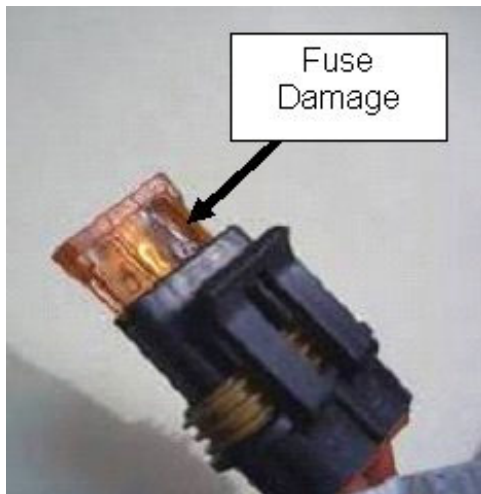
3. If evidence of a damaged jumper cable assembly is found, it will need to be replaced with a new jumper cable assembly as specified in the parts information section. Two improvements have been implemented to insure the integrity of these connections. July 2007: Manufacturing process change to prevent the fuse holder terminals from being spread during the assembly and end of line testing. Dec 2007: The terminals were changed from tin plated copper to copper beryllium. The copper beryllium terminals provide an improvement in their ability to retain spring force on the fuse blades as well as having a higher resistance to thermal cycling.

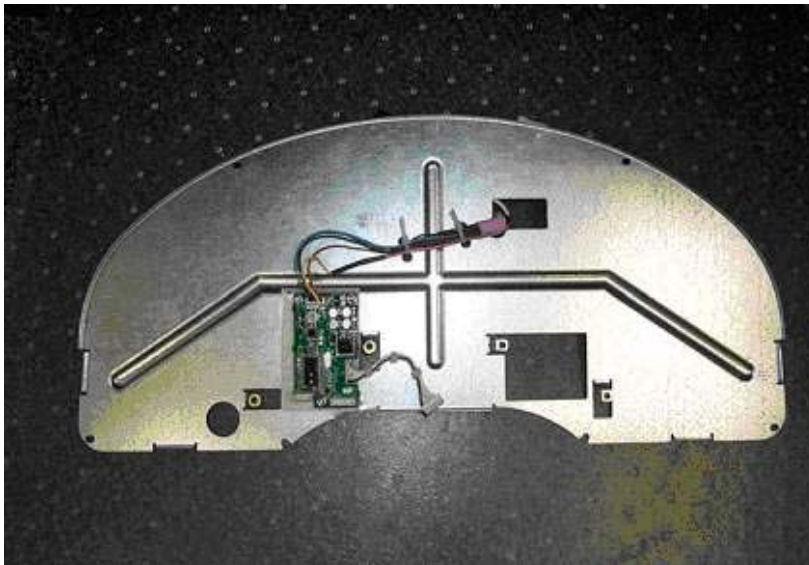
Figure 6 New Rear Cover with Interceptor Circuit

To remedy this , International Truck and Engine Corporation has implemented a program to inspect the current instrument cluster for software version level, and if found to be version 11.0 or 17.0, to replace the instrument cluster rear cover with a new design cover that has an interceptor circuit board attached.

7. Remove new rear cover with interceptor circuit from Kit 8000849R91 (Figure 6).
