**Vehicle Attachment – Vehicle Factors Photographs**

**Andrews, TX**

**HWY22MH006**

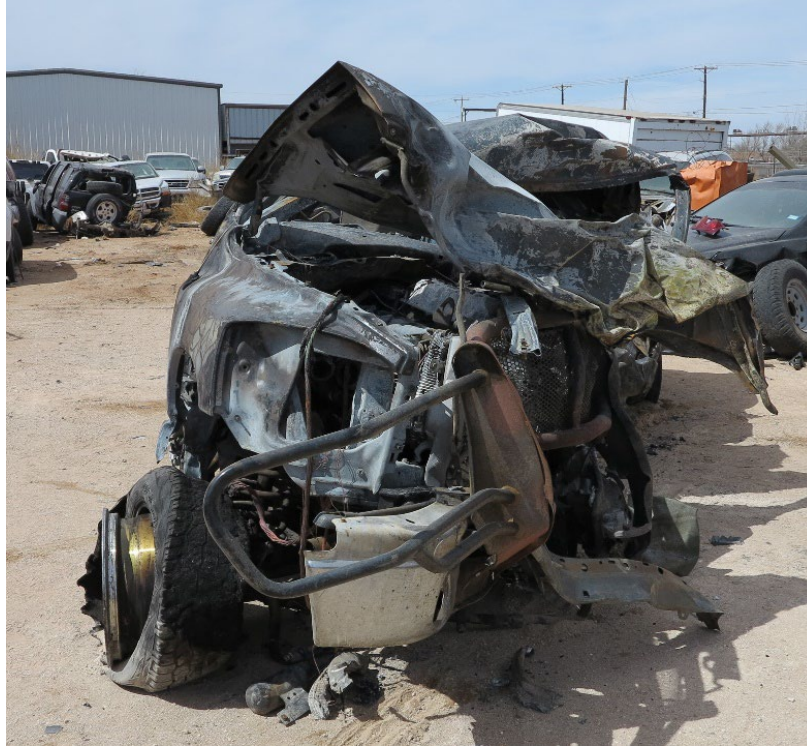
**Photograph 1:** A view of the damage sustained at the front of the pickup

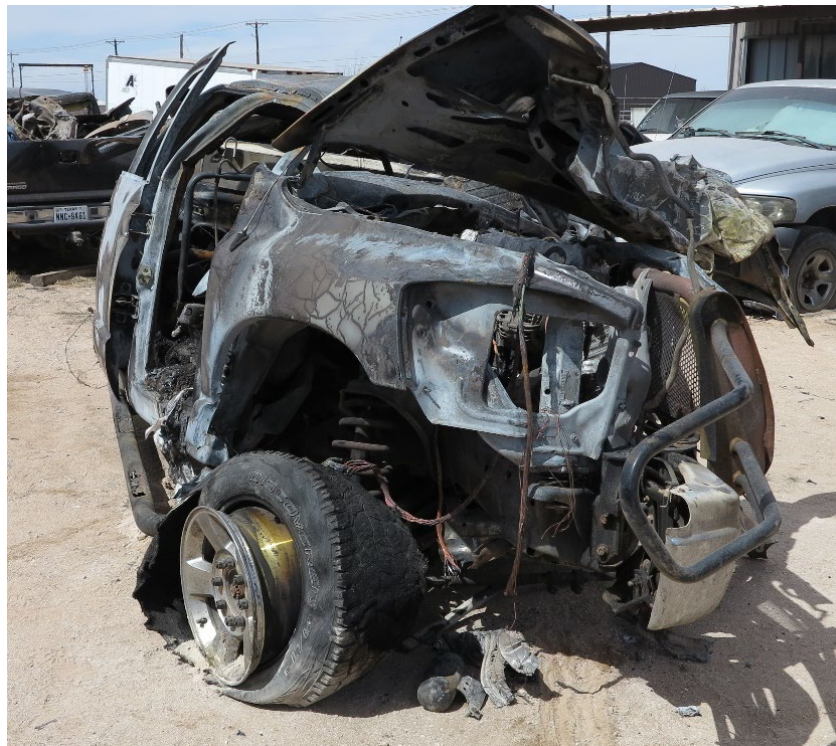
**Photograph 2:** A view of the damage sustained at the right front of the pickup

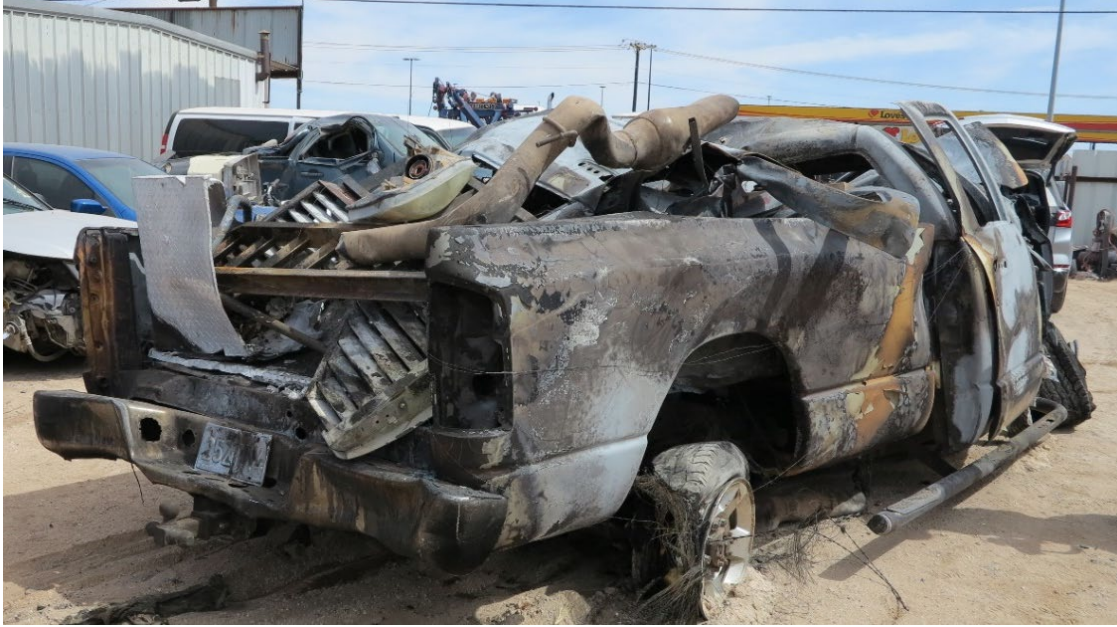
**Photograph 3:** A view of the damage sustained at the right rear of the pickup

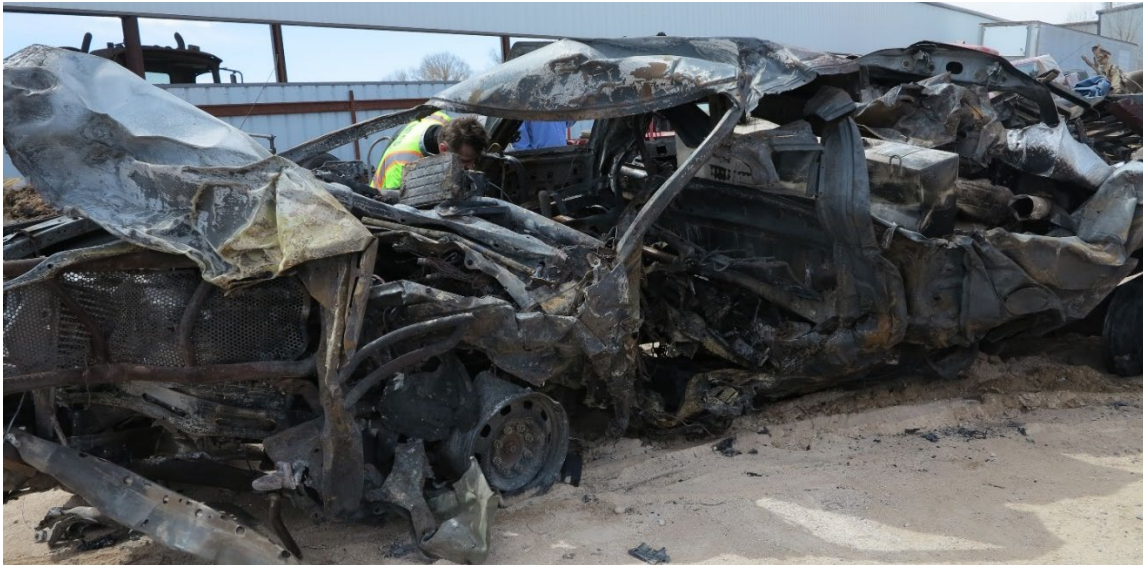
**Photograph 4:** A view of the damage sustained at the left side of the pickup

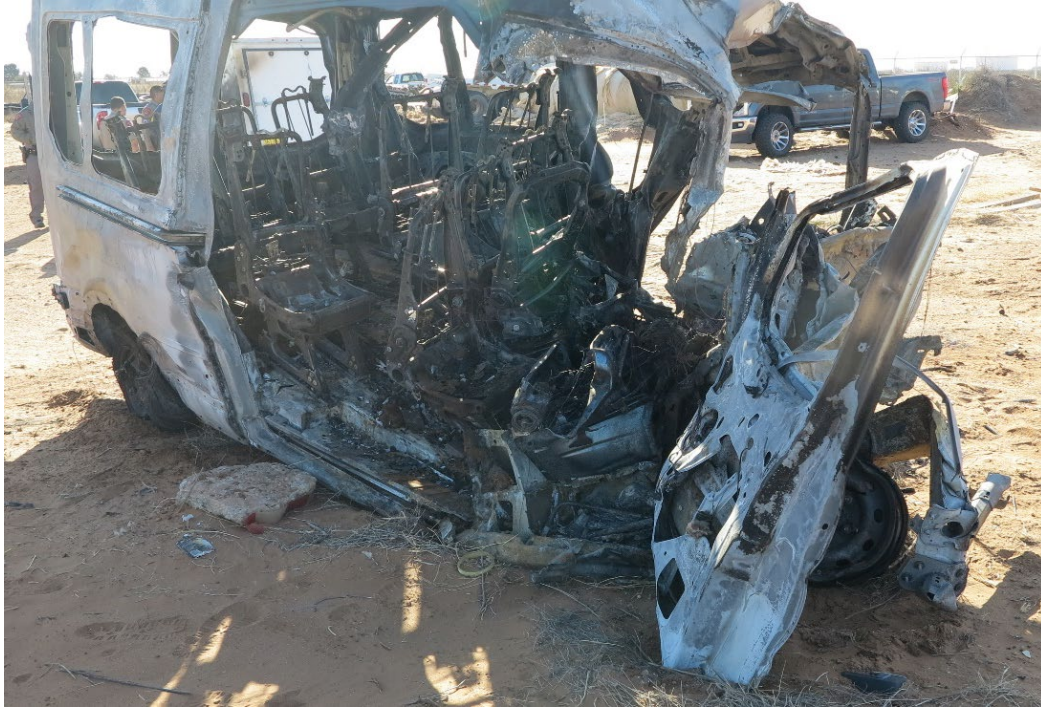
**Photograph 5:** A view of the damage sustained at the right front of the van

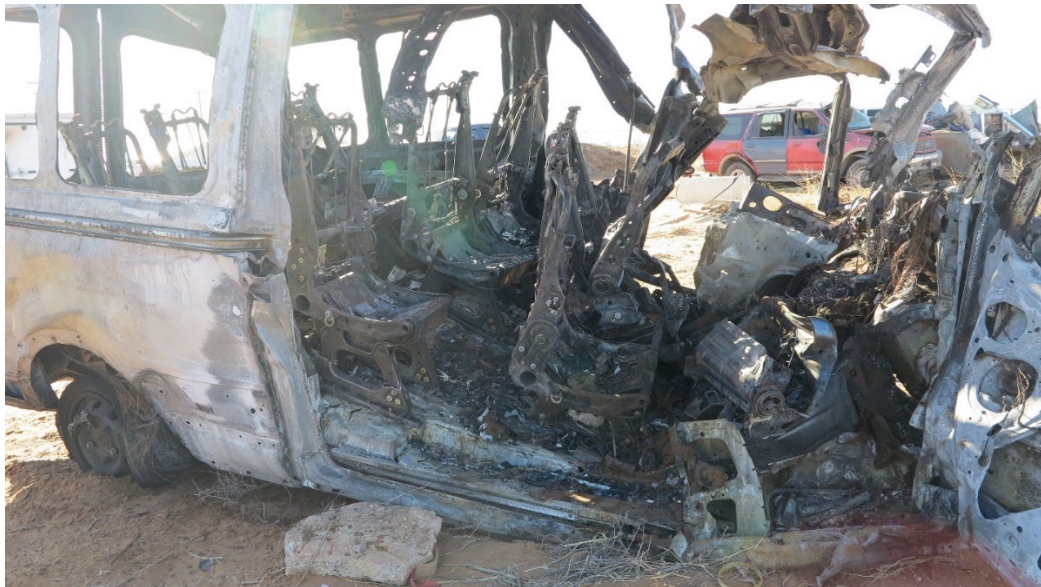
**Photograph 6:** A view of the damage sustained at the right side of the passenger compartment of the van

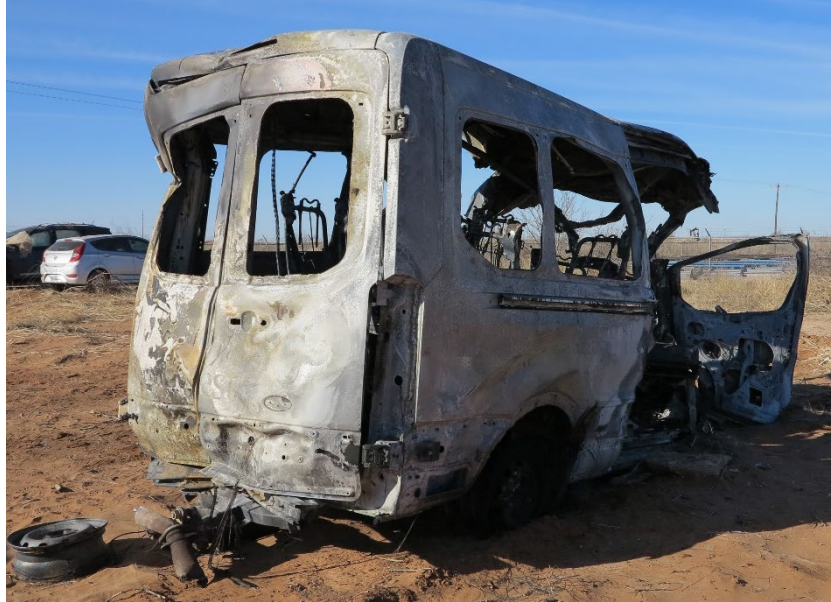
**Photograph 7:** A view of the damage sustained to the right rear of the van

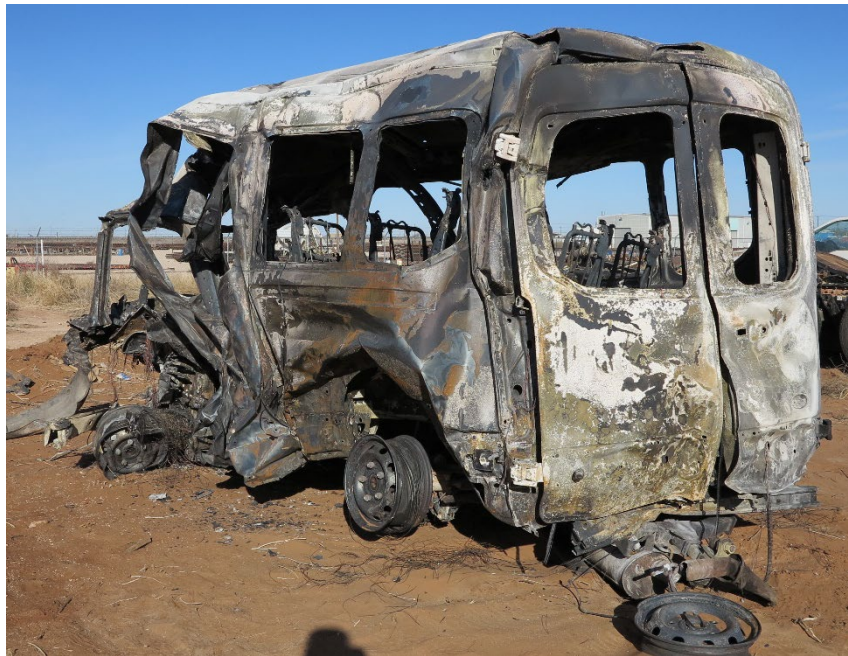
**Photograph 8:** A view of the damage sustained at the left rear of the van
