National Transportation Safety Board

HWY24MH005

HIGHWAY FACTORS

Group Chair's Factual Report

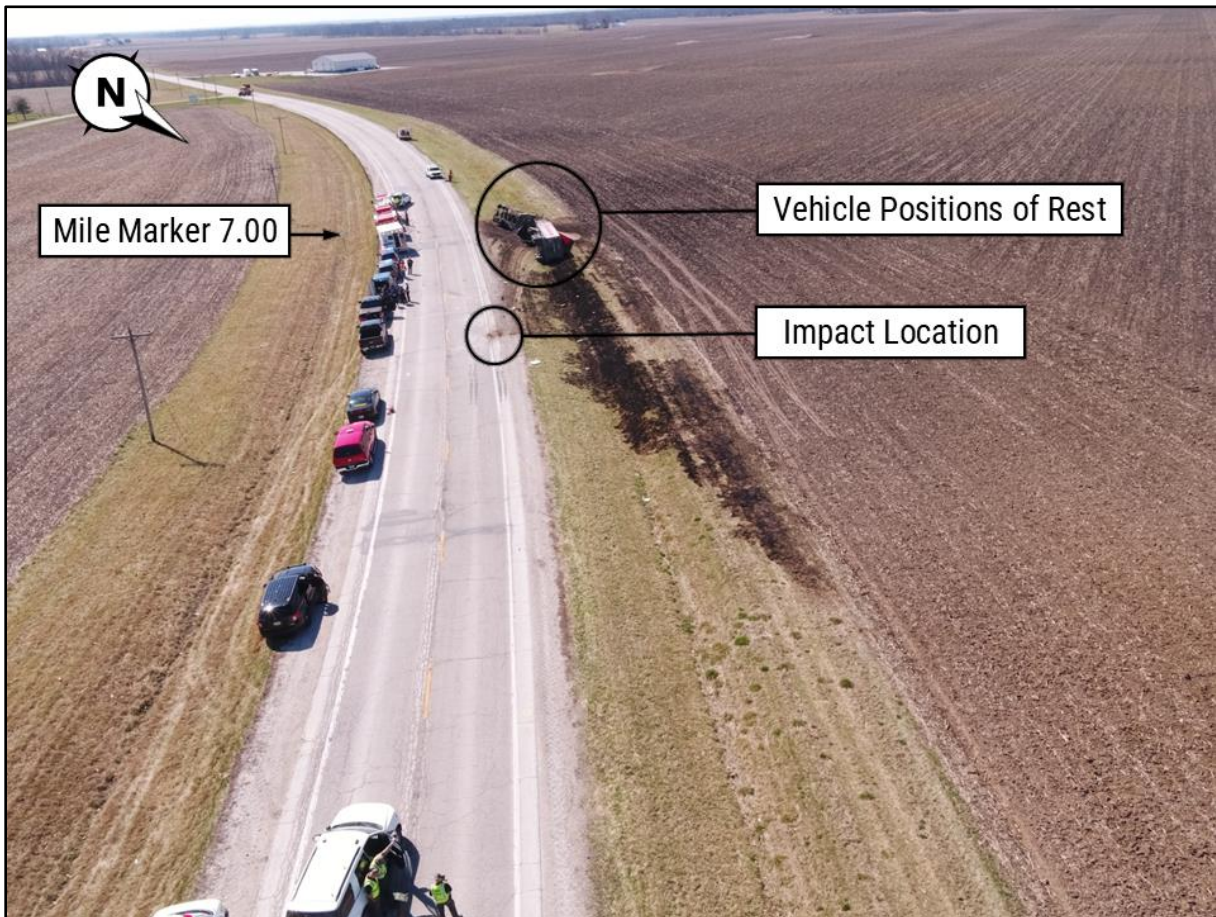
Figure 2. Crash scene from an aerial view looking to the southwest [Source: ISP revised]

Figure 2 illustrates the crash site from an aerial view looking to the southwest.

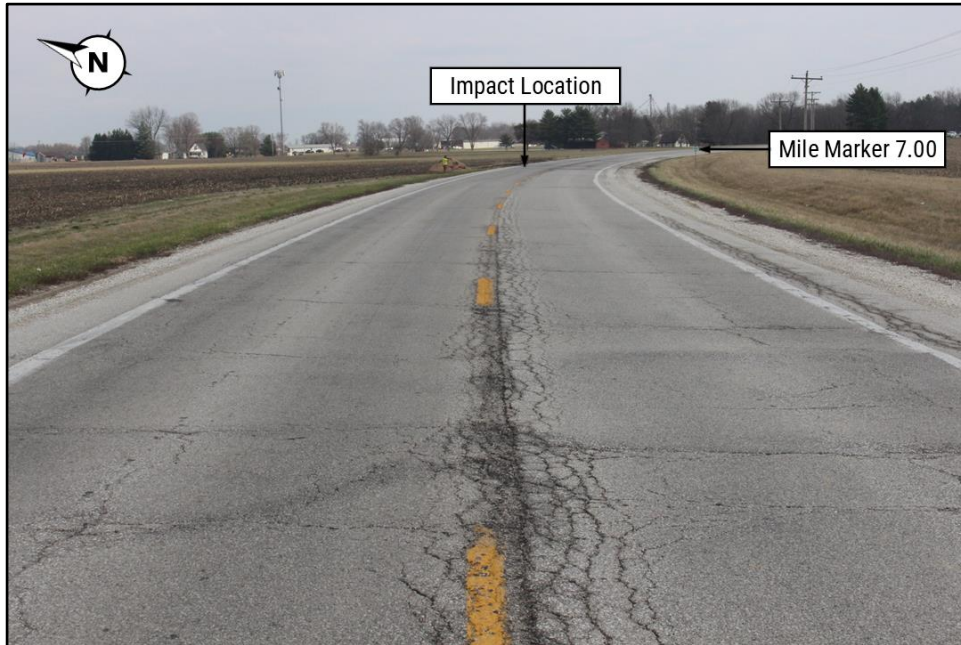
At the crash site, the pavement had varying degrees of longitudinal, transverse, and alligator cracking (see Figure 3 and Figure 4).²

Figure 3. View from the centerline of US-24 facing in an easterly direction.

² Alligator cracking refers to a type of damage on asphalt pavement where a network of interconnected cracks forms, usually caused by repeated traffic loading on a weakened pavement base, significantly impacting its durability and structural integrity.

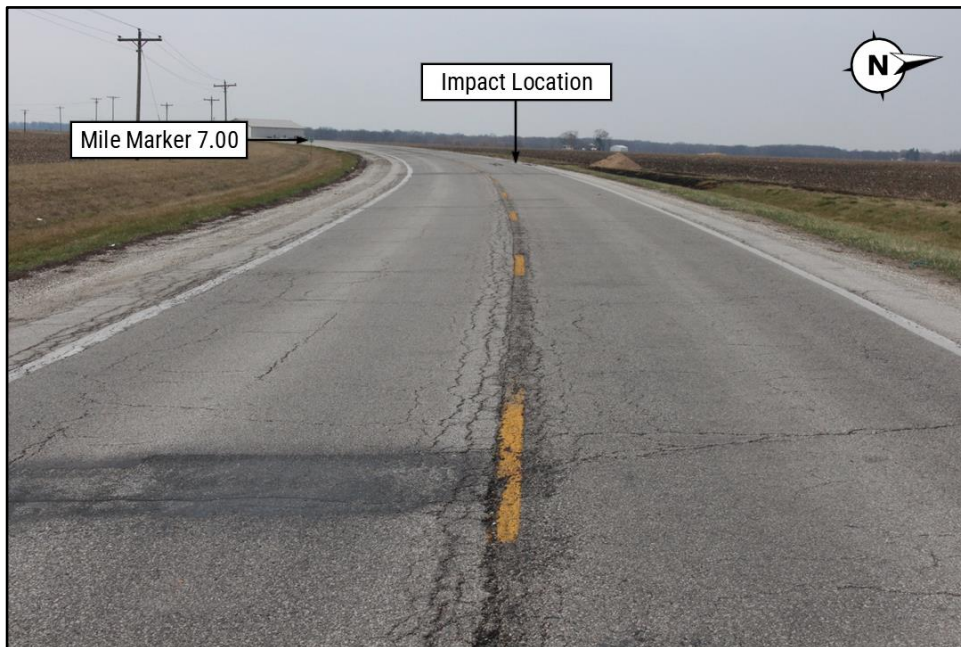
Figure 4. View from the centerline of US-24 facing in a westerly direction.

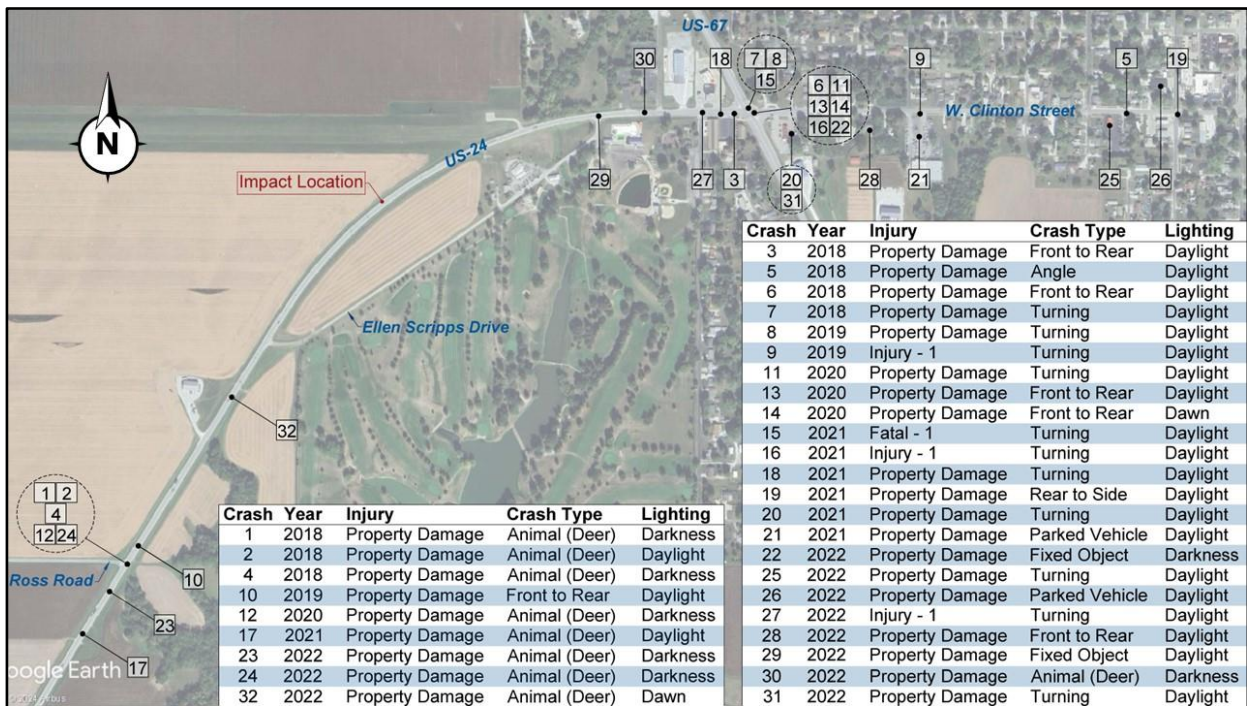
Figure 6. Crashes within one mile of the crash site. Source: Google Earth (revised).

As seen in Figure 6, 28 (88 percent) of the crashes were property damage only, 18 (56 percent) occurred within, or east of the intersection with US-67, and none of the crashes occurred within the horizontal curve where the crash between the school bus and combination vehicle occurred.

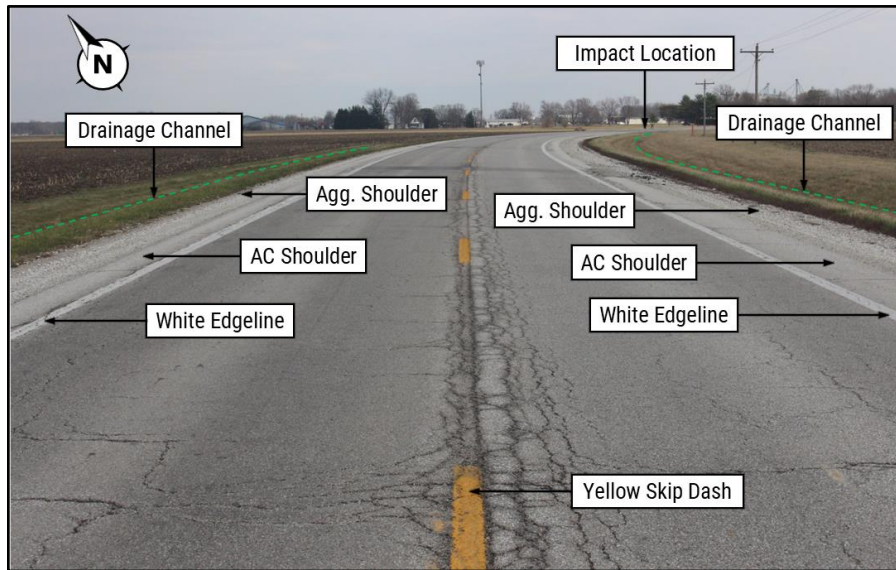
Figure 7 depicts US-24 from a location approximately 100 feet east of Ellen Scripps Drive (near Station 2+00) looking in an easterly direction.

Figure 7. View of US-24 depicting the typical section at the crash site.

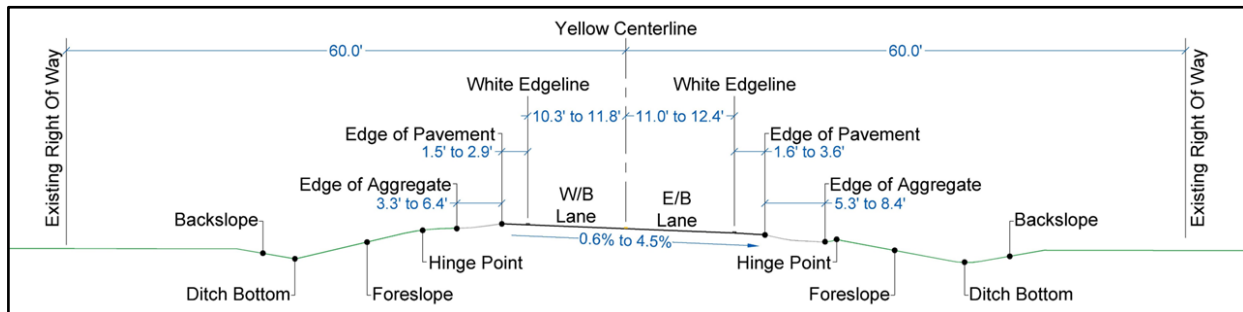
Figure 8 illustrates the typical section of US-24 in the area of the crash site. The roadway was superelevated with the high side of the roadway at the edge of the westbound lane, and cross slopes that varied between 0.6 and 4.5 percent.⁸ The superelevation between Station 11+00 and Station 15+00, near where the vehicles collided and traveled after impact, the superelevation varied between 4.1 and 4.5 percent. Table 4 shows roadway dimensions at each station.

Figure 8. Typical section between Station 1+00 to Station 21+00.

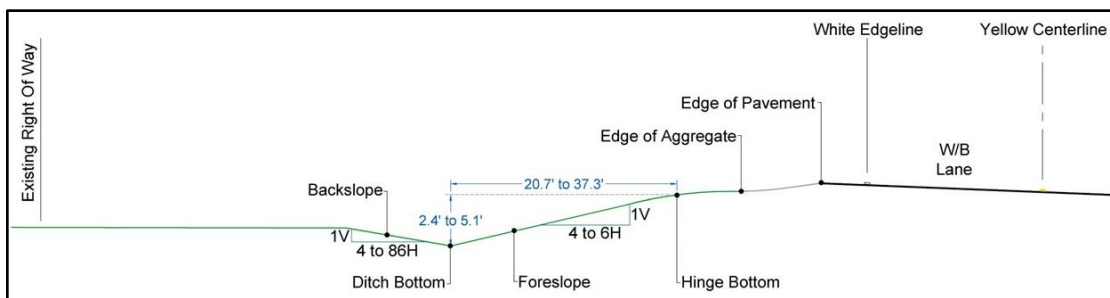
After impact, the combination vehicle and school bus traveled in a westerly direction, entered the drainage channel north of the westbound traffic lane, and came to rest within the same drainage channel. Figure 10 illustrates the typical cross section of the drainage channel north of the traveled way, the channel traversed by the vehicles after impact and as they traveled to their respective positions of rest.

Figure 10. Typical section of the drainage channel (Station 1+00 to Station 21+00).

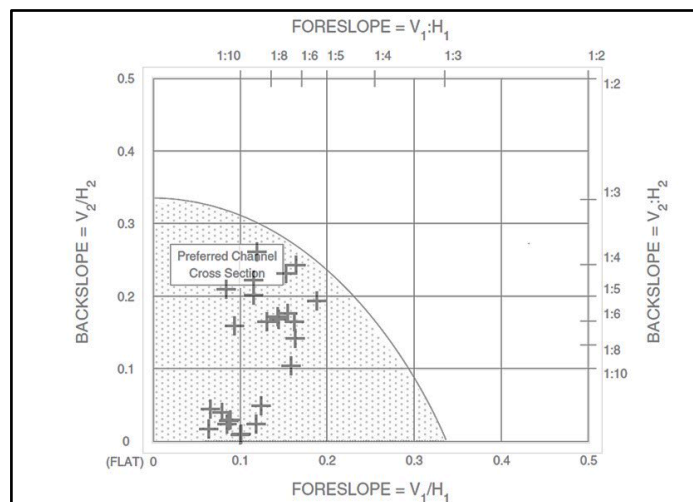
The measured foreslope and backslope ratios were plotted on AASHTO's preferred foreslopes and backslopes chart depicted in Figure 11.

Figure 12 illustrates that all cross sections of the drainage channel were within AASHTO's preferred channel cross section and therefore, need not be constructed at or beyond the suggested clear-zone distance.

Figure 12. Preferred basic channel configurations [source: AASHTO revised].

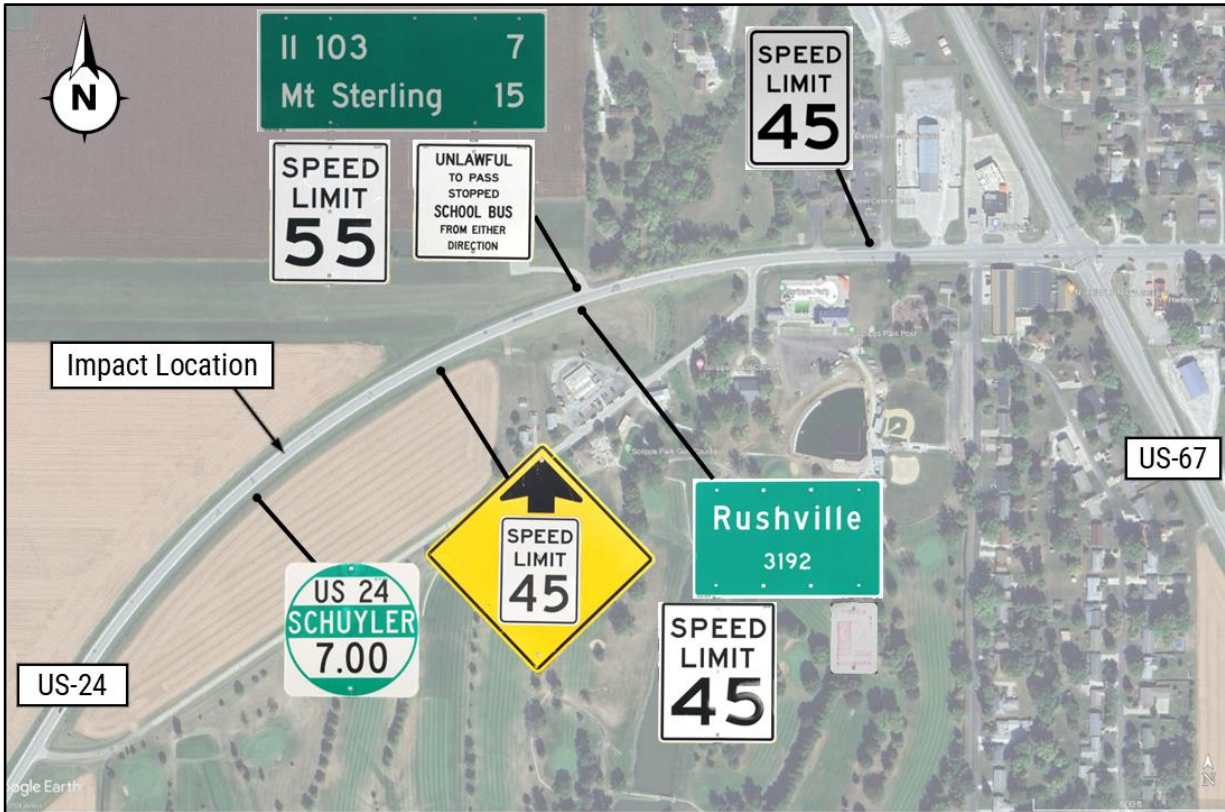
The highway signs on US-24, in the vicinity of the crash site were documented and are depicted in Figure 14.

Figure 14. Signs on US-24 near the crash site [Source: Google Earth revised].
