United States Coast Guard
Witness Statement

Statement of John E. Ward:

As partial owner and Managing Partner of Jackson Creek Marine, LLC (“JCM”), the information provided are the details of the events that occurred on August 8, 2023, involving the tugboat *Jacqueline A* (O.N. 638353) (the “Tug”) to the best of my knowledge.

PLATE THICKNESS/CORROSION SURVEY UT REPORT
For Use with Procedure ASI - NDT- 004

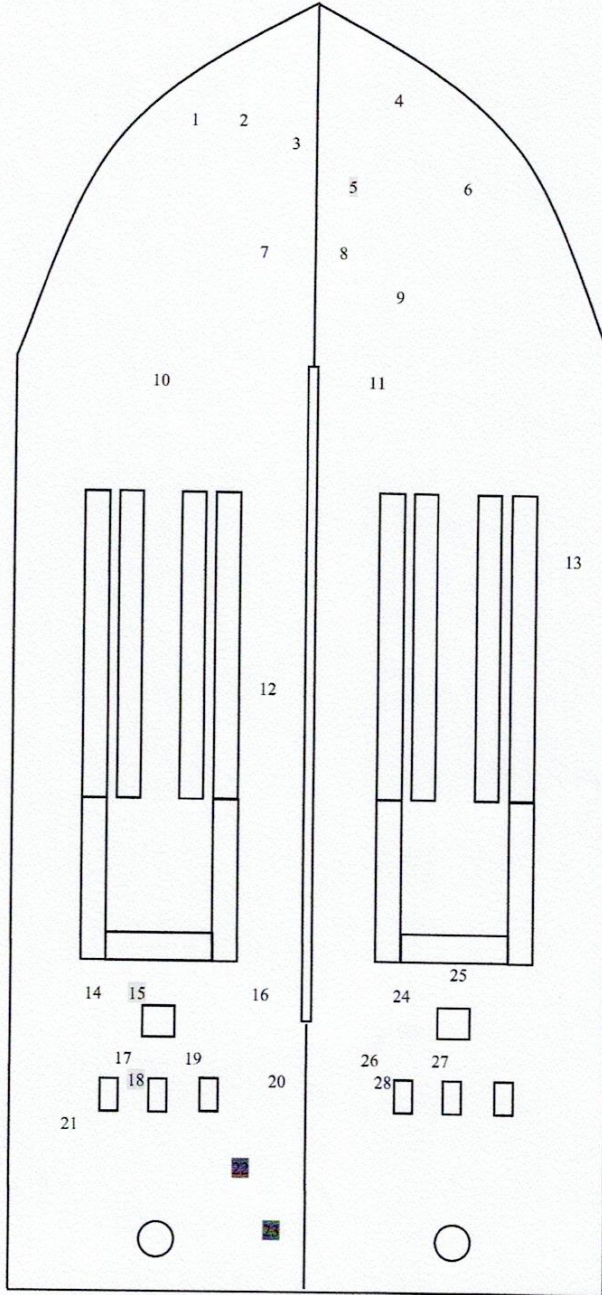
Hull Bottom
SUSPECT AREAS – PITTING
(looking down)

AREA OF INSPECTION	ORIGINAL THICKNESS (in)	ACTUAL THICKNESS (in)	DIM (in)	DIM (%)	MAX ALLOW DIM (in)	MAX ALLOW DIM (%)	COMMENTS
Hull Bottom							
SUSPECT AREAS – PITTING							
1	0.375	0.381	0.000	0.0%	0.094	25%	Hull Bottom – Pitted Area
2	0.375	0.356	0.019	5.1%	0.094	25%	Hull Bottom – Pitted Area
3	0.375	0.325	0.050	13.3%	0.094	25%	Hull Bottom – Pitted Area
4	0.375	0.313	0.062	16.5%	0.094	25%	Hull Bottom – Pitted Area
5	0.375	0.296	0.079	21.1%	0.094	25%	Hull Bottom – Pitted Area
6	0.375	0.381	0.000	0.0%	0.094	25%	Hull Bottom – Pitted Area
7	0.375	0.349	0.026	6.9%	0.094	25%	Hull Bottom – Pitted Area
8	0.375	0.386	0.000	0.0%	0.094	25%	Hull Bottom – Pitted Area
9	0.375	0.353	0.022	5.9%	0.094	25%	Hull Bottom – Pitted Area
10	0.375	0.368	0.007	1.9%	0.094	25%	Hull Bottom – Pitted Area
11	0.375	0.388	0.000	0.0%	0.094	25%	Hull Bottom – Pitted Area
12	0.375	0.356	0.019	5.1%	0.094	25%	Hull Bottom – Pitted Area

13	0.375	0.379	0.000	0.0%	0.094	25%	Hull Bottom – Pitted Area
14	0.500	0.456	0.044	8.8%	0.125	25%	Hull Bottom – Pitted Area
15	0.500	0.376	0.124	24.8%	0.125	25%	Hull Bottom – Pitted Area
16	0.500	0.491	0.009	1.8%	0.125	25%	Hull Bottom
17	0.500	0.461	0.039	7.8%	0.125	25%	Hull Bottom – Pitted Area
18	0.500	0.395	0.105	21.0%	0.125	25%	Hull Bottom – Pitted Area
19	0.500	0.499	0.001	0.2%	0.125	25%	Hull Bottom – Pitted Area
20	0.500	0.441	0.059	11.8%	0.125	25%	Hull Bottom – Pitted Area
21	0.500	0.468	0.032	6.4%	0.125	25%	Hull Bottom – Pitted Area
22	0.500	0.328	0.172	34.4%	0.125	25%	Hull Bottom – Pitted Area
23	0.500	0.351	0.149	29.8%	0.125	25%	Hull Bottom – Pitted Area
24	0.500	0.501	0.000	0.0%	0.125	25%	Hull Bottom
25	0.500	0.419	0.081	16.2%	0.125	25%	Hull Bottom – Pitted Area
26	0.500	0.476	0.024	4.8%	0.125	25%	Hull Bottom – Pitted Area
27	0.500	0.472	0.028	5.6%	0.125	25%	Hull Bottom – Pitted Area
28	0.500	0.447	0.053	10.6%	0.125	25%	Hull Bottom – Pitted Area

March 16, 2023: Auxiliary Systems Incorporated provided a Plate Thickness/Corrosion Survey UT Report. Only some isolated, coin-sized pits were found to exceed the corrosion limits, and these we planned to have ground and clad welded at Harvey, Louisiana. *See* attachment B. Upon simultaneous visual inspection of the hull, we found no basis for concern.

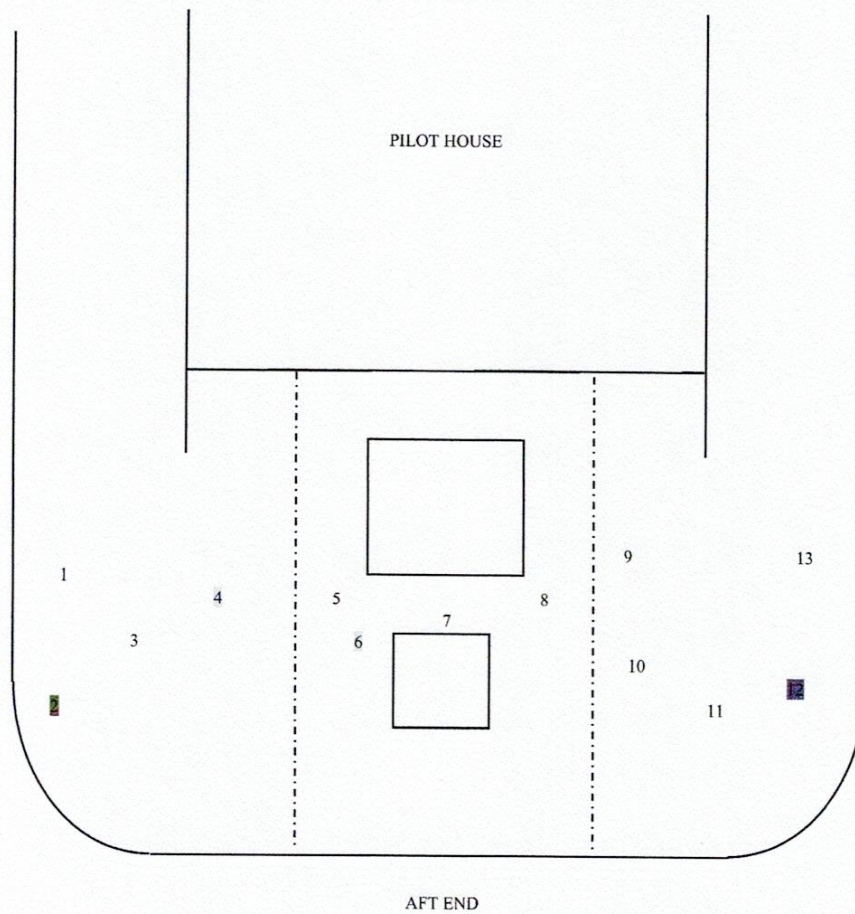
Main Decking
SUSPECT AREAS – PITTING
(looking down)

AREA OF INSPECTION	ORIGINAL THICKNESS (in)	ACTUAL THICKNESS (in)	DIM (in)	DIM (%)	MAX ALLOW DIM (in)	MAX ALLOW DIM (%)	COMMENTS
Main Decking							
SUSPECT AREAS – PITTING							
1	0.313	0.286	0.027	8.6%	0.078	25%	Main Decking – Pitted Area
2	0.313	0.211	0.102	32.6%	0.078	25%	Main Decking – Pitted Area
3	0.313	0.303	0.010	3.2%	0.078	25%	Main Decking
4	0.313	0.237	0.076	24.3%	0.078	25%	Main Decking – Pitted Area
5	0.313	0.279	0.034	10.9%	0.078	25%	Main Decking – Pitted Area
6	0.313	0.243	0.070	22.4%	0.078	25%	Main Decking – Pitted Area
7	0.313	0.261	0.052	16.6%	0.078	25%	Main Decking – Pitted Area
8	0.313	0.276	0.037	11.8%	0.078	25%	Main Decking – Pitted Area
9	0.313	0.264	0.049	15.7%	0.078	25%	Main Decking – Pitted Area
10	0.313	0.264	0.049	15.7%	0.078	25%	Main Decking – Pitted Area
11	0.313	0.317	0.000	0.0%	0.078	25%	Main Decking
12	0.313	0.231	0.082	26.2%	0.078	25%	Main Decking – Pitted Area
13	0.313	0.259	0.054	17.3%	0.078	25%	Main Decking – Pitted Area

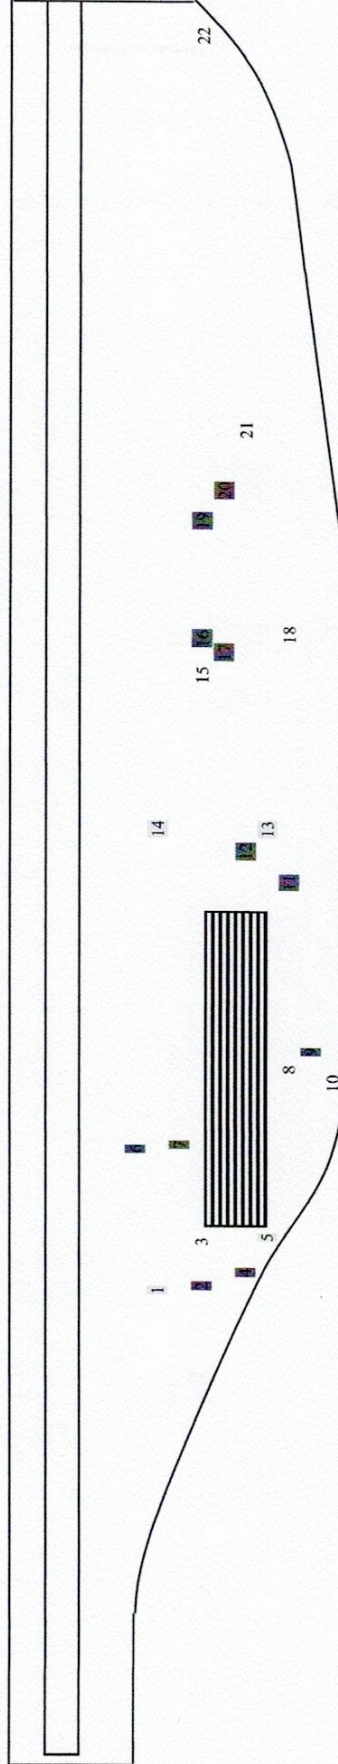
Side Shell Plating
STBD SIDE – PITTED AREAS
 (looking inboard)

AREA OF INSPECTION	ORIGINAL THICKNESS (in)	ACTUAL THICKNESS (in)	DIM (in)	DIM (%)	MAX ALLOW DIM (in)	MAX ALLOW DIM (%)	COMMENTS
Side Shell Plating							
STBD SIDE – PITTED AREAS							
1	0.375	0.301	0.074	19.7%	0.094	25%	Side Shell Plating – Pitted Area
2	0.375	0.265	0.110	29.3%	0.094	25%	Side Shell Plating – Pitted Area
3	0.375	0.336	0.039	10.4%	0.094	25%	Side Shell Plating – Pitted Area
4	0.375	0.255	0.120	32.0%	0.094	25%	Side Shell Plating – Pitted Area
5	0.375	0.290	0.085	22.7%	0.094	25%	Side Shell Plating – Pitted Area
6	0.375	0.221	0.154	41.1%	0.094	25%	Side Shell Plating – Pitted Area
7	0.375	0.255	0.120	32.0%	0.094	25%	Side Shell Plating – Pitted Area
8	0.375	0.341	0.034	9.1%	0.094	25%	Side Shell Plating – Pitted Area
9	0.375	0.262	0.113	30.1%	0.094	25%	Side Shell Plating – Pitted Area
10	0.375	0.315	0.060	16.0%	0.094	25%	Side Shell Plating – Pitted Area
11	0.375	0.263	0.112	29.9%	0.094	25%	Side Shell Plating – Pitted Area

12	0.375	0.258	0.117	31.2%	0.094	25%	Side Shell Plating – Pitted Area
13	0.375	0.300	0.075	20.0%	0.094	25%	Side Shell Plating – Pitted Area
14	0.375	0.284	0.091	24.3%	0.094	25%	Side Shell Plating – Pitted Area
15	0.375	0.334	0.041	10.9%	0.094	25%	Side Shell Plating – Pitted Area
16	0.375	0.251	0.124	33.1%	0.094	25%	Side Shell Plating – Pitted Area
17	0.375	0.201	0.174	46.4%	0.094	25%	Side Shell Plating – Pitted Area
18	0.375	0.361	0.014	3.7%	0.094	25%	Side Shell Plating – Pitted Area
19	0.375	0.249	0.126	33.6%	0.094	25%	Side Shell Plating – Pitted Area
20	0.375	0.225	0.150	40.0%	0.094	25%	Side Shell Plating – Pitted Area
21	0.375	0.305	0.070	18.7%	0.094	25%	Side Shell Plating – Pitted Area
22	0.375	0.316	0.059	15.7%	0.094	25%	Side Shell Plating – Pitted Area

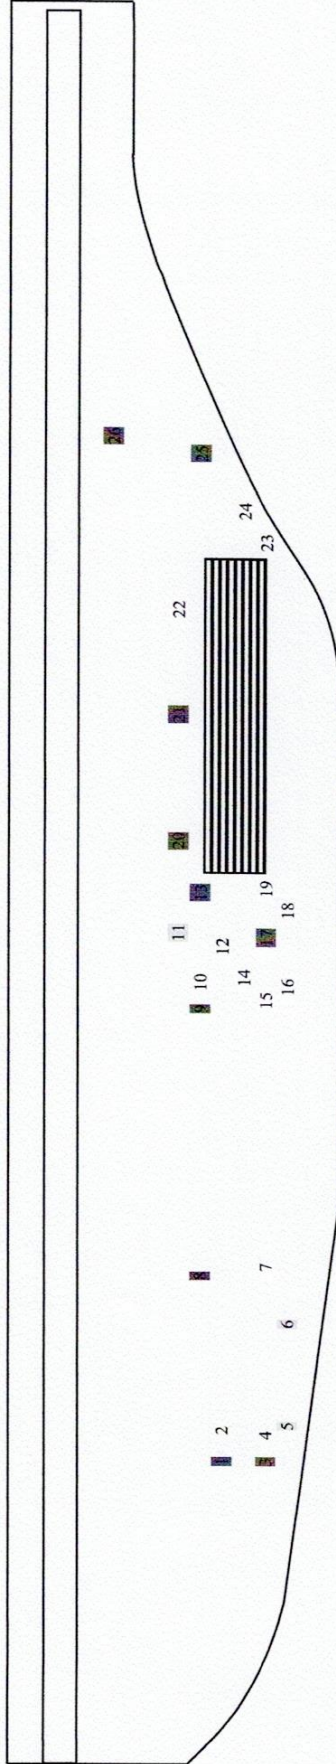
Side Shell Plating
PORT SIDE – PITTED AREAS
 (looking inboard)

AREA OF INSPECTION	ORIGINAL THICKNESS (in)	ACTUAL THICKNESS (in)	DIM (in)	DIM (%)	MAX ALLOW DIM (in)	MAX ALLOW DIM (%)	COMMENTS
Side Shell Plating							
PORT SIDE – PITTED AREAS							
1	0.375	0.216	0.159	42.4%	0.094	25%	Side Shell Plating – Pitted Area
2	0.375	0.314	0.061	16.3%	0.094	25%	Side Shell Plating – Pitted Area
3	0.375	0.251	0.124	33.1%	0.094	25%	Side Shell Plating – Pitted Area
4	0.375	0.318	0.057	15.2%	0.094	25%	Side Shell Plating – Pitted Area
5	0.375	0.283	0.092	24.5%	0.094	25%	Side Shell Plating – Pitted Area
6	0.375	0.300	0.075	20.0%	0.094	25%	Side Shell Plating – Pitted Area
7	0.375	0.381	0.000	0.0%	0.094	25%	Side Shell Plating – Pitted Area
8	0.375	0.281	0.094	25.1%	0.094	25%	Side Shell Plating – Pitted Area
9	0.375	0.281	0.094	25.1%	0.094	25%	Side Shell Plating – Pitted Area
10	0.375	0.308	0.067	17.9%	0.094	25%	Side Shell Plating – Pitted Area
11	0.375	0.284	0.091	24.3%	0.094	25%	Side Shell Plating – Pitted Area

12	0.375	0.318	0.057	15.2%	0.094	25%	Side Shell Plating – Pitted Area
13	0.375	0.278	0.097	25.9%	0.094	25%	Side Shell Plating – Pitted Area
14	0.375	0.315	0.060	16.0%	0.094	25%	Side Shell Plating – Pitted Area
15	0.375	0.366	0.009	2.4%	0.094	25%	Side Shell Plating – Pitted Area
16	0.375	0.384	0.000	0.0%	0.094	25%	Side Shell Plating – Pitted Area
17	0.375	0.269	0.106	28.3%	0.094	25%	Side Shell Plating – Pitted Area
18	0.375	0.312	0.063	16.8%	0.094	25%	Side Shell Plating – Pitted Area
19	0.375	0.306	0.069	18.4%	0.094	25%	Side Shell Plating – Pitted Area
20	0.375	0.264	0.111	29.6%	0.094	25%	Side Shell Plating – Pitted Area
21	0.375	0.279	0.096	25.6%	0.094	25%	Side Shell Plating – Pitted Area
22	0.375	0.305	0.070	18.7%	0.094	25%	Side Shell Plating – Pitted Area
23	0.375	0.317	0.058	15.5%	0.094	25%	Side Shell Plating – Pitted Area
24	0.375	0.328	0.047	12.5%	0.094	25%	Side Shell Plating – Pitted Area
25	0.375	0.267	0.108	28.8%	0.094	25%	Side Shell Plating – Pitted Area

26	0.375	0.245	0.130	34.7%	0.094	25%	Side Shell Plating – Pitted Area
