NATIONAL TRANSPORTATION SAFETY BOARD

Group Chairman's Factual Report

WPR14FA369

**Appendix A – Figures
(4 pages)**

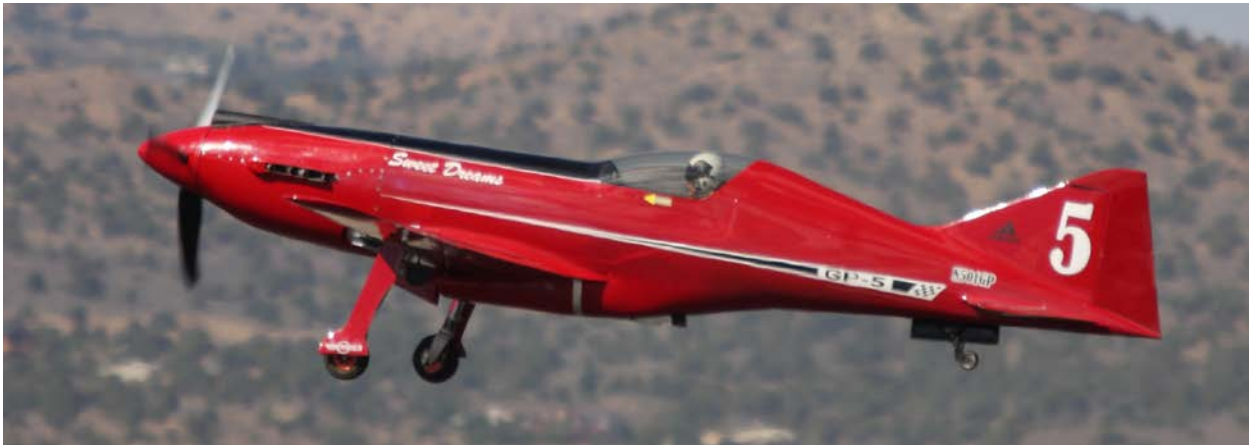
Figure 1 – Backovich GP-5 airplane, N501GP

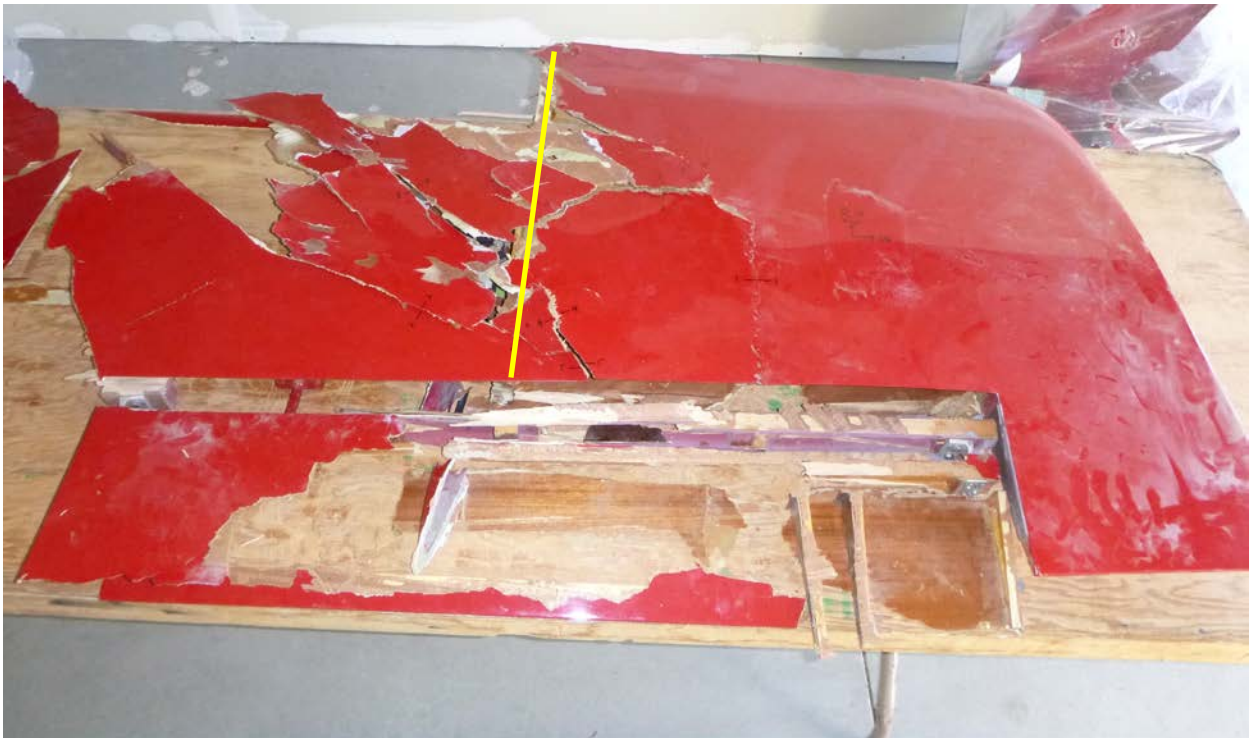
Figure 2 – GP-5 right wing reconstruction, upper surface

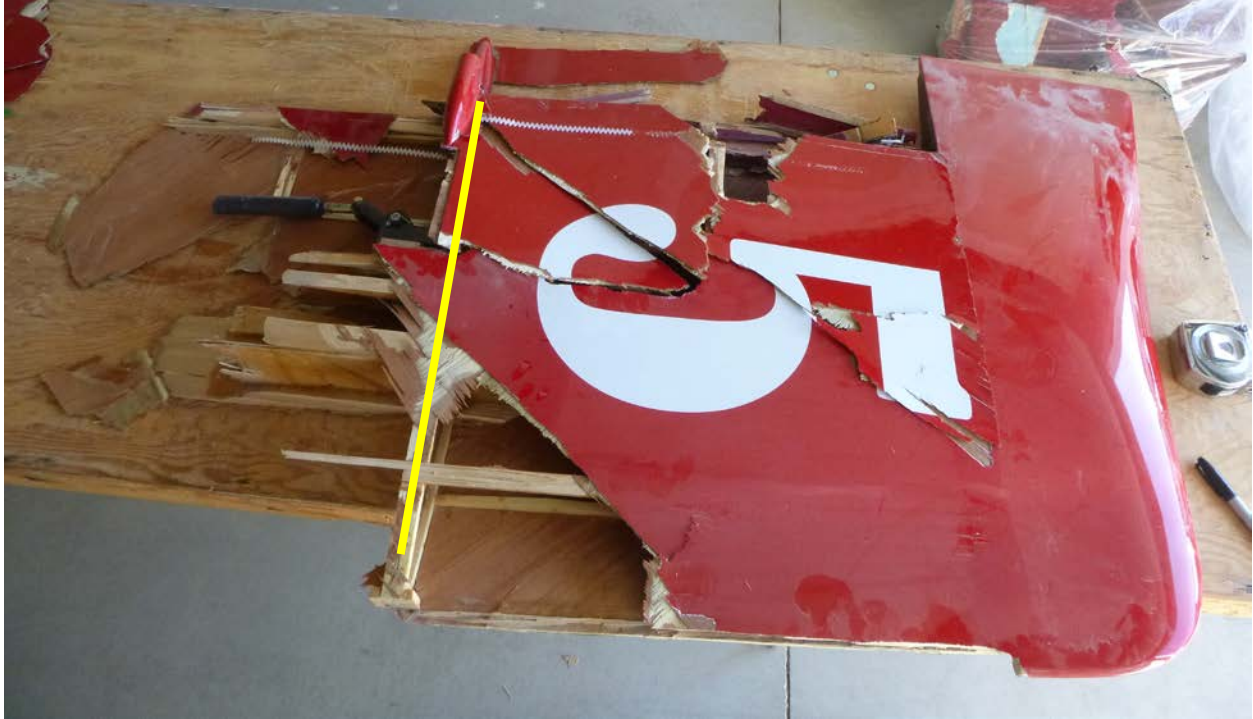
Figure 3 – GP-5 right wing reconstruction, lower surface

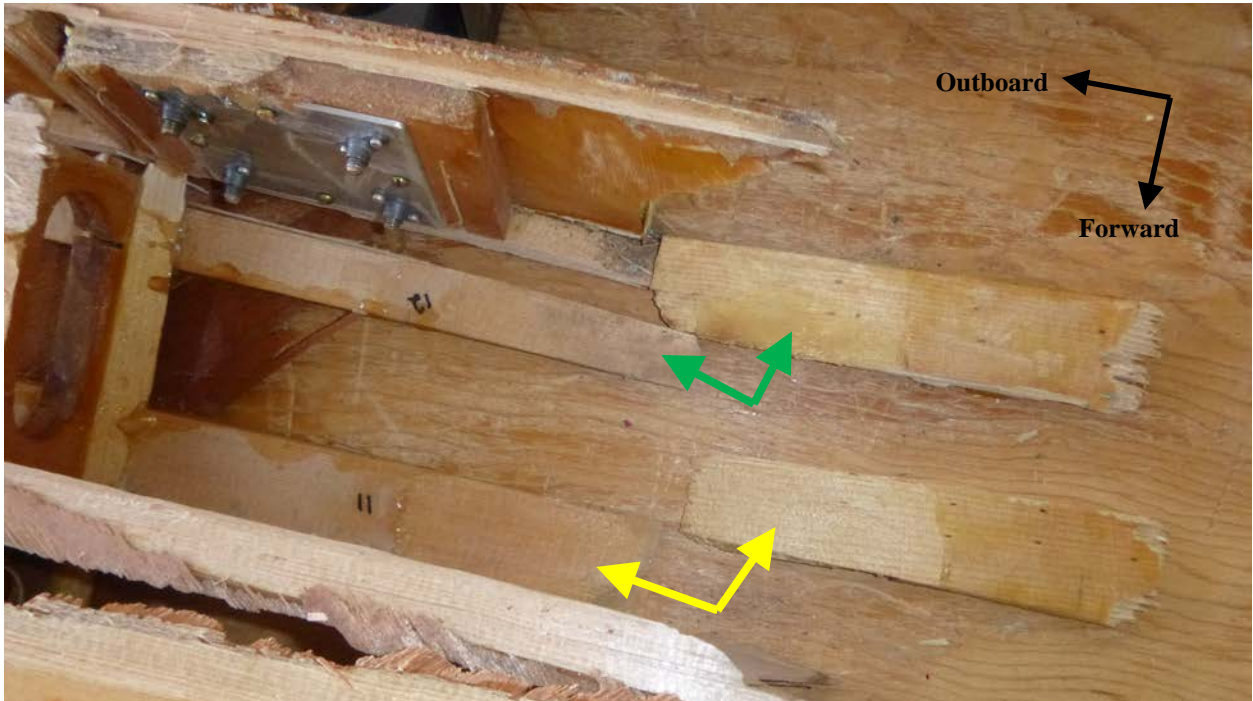
Figure 4 – Forward spar lower spar cap fractures

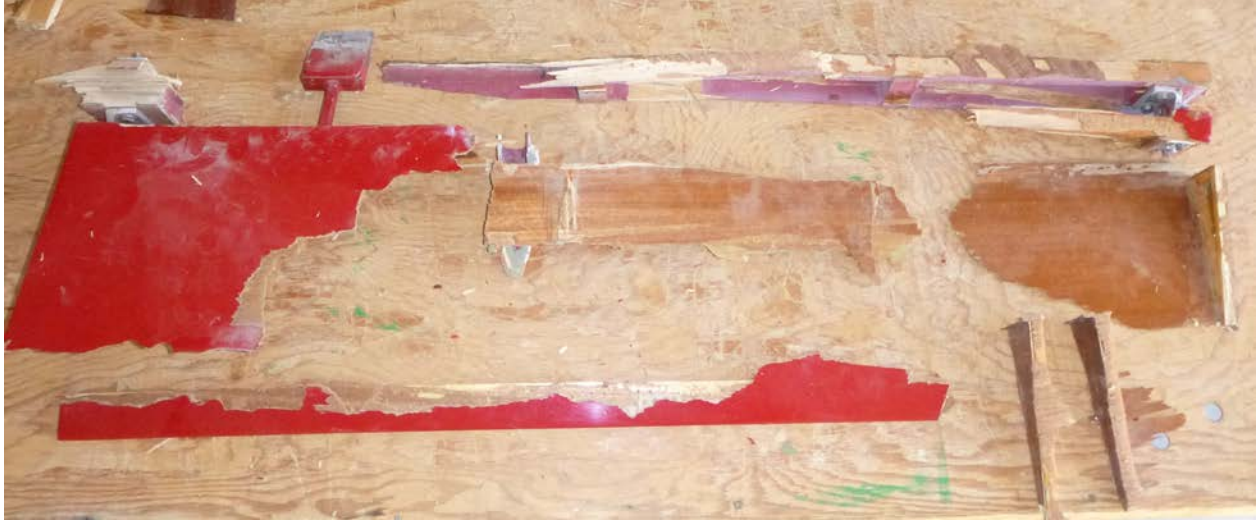
Figure 5 – GP-5 right aileron reconstruction

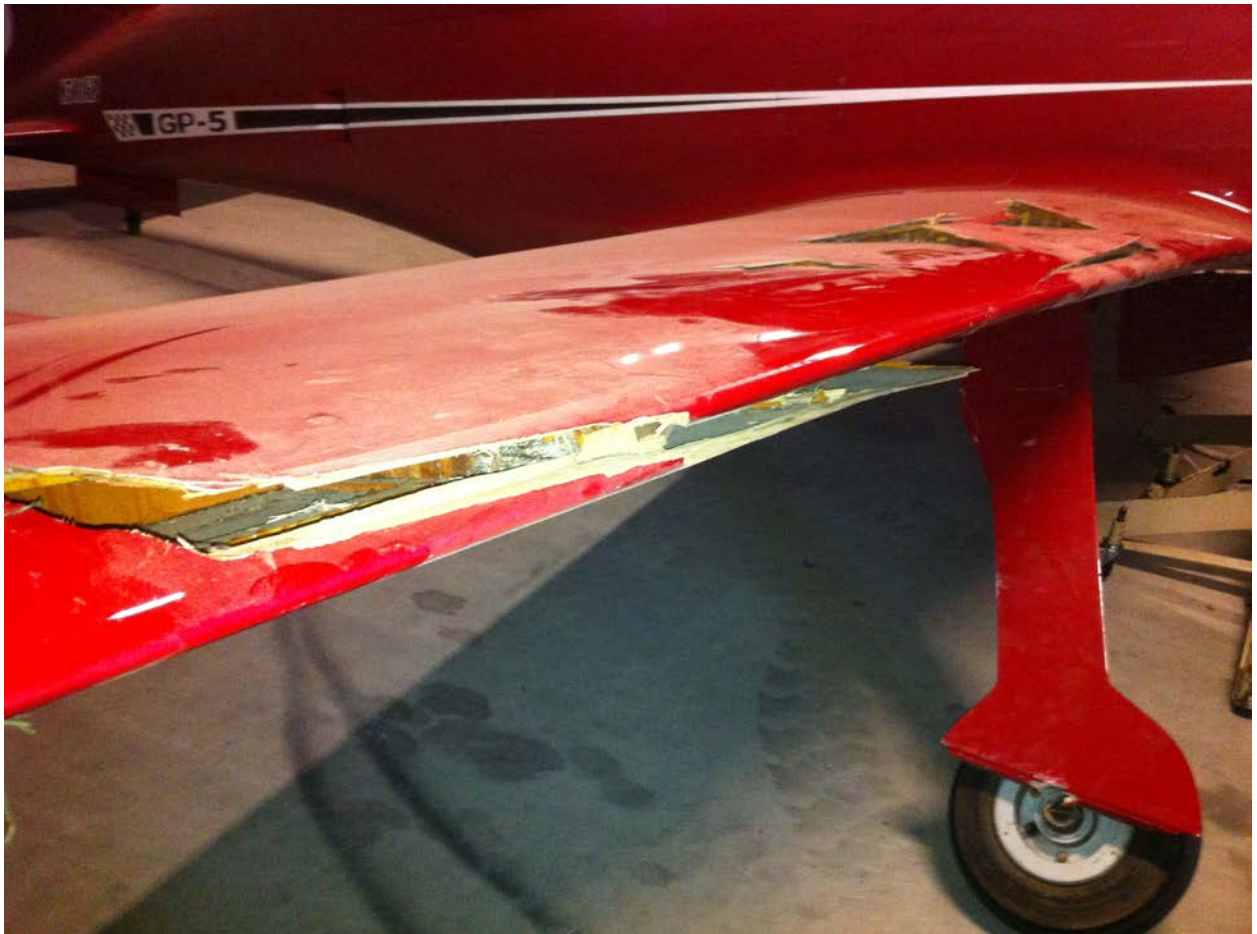
Figure 6 – Right wing upper surface damage following March 11, 2012, landing

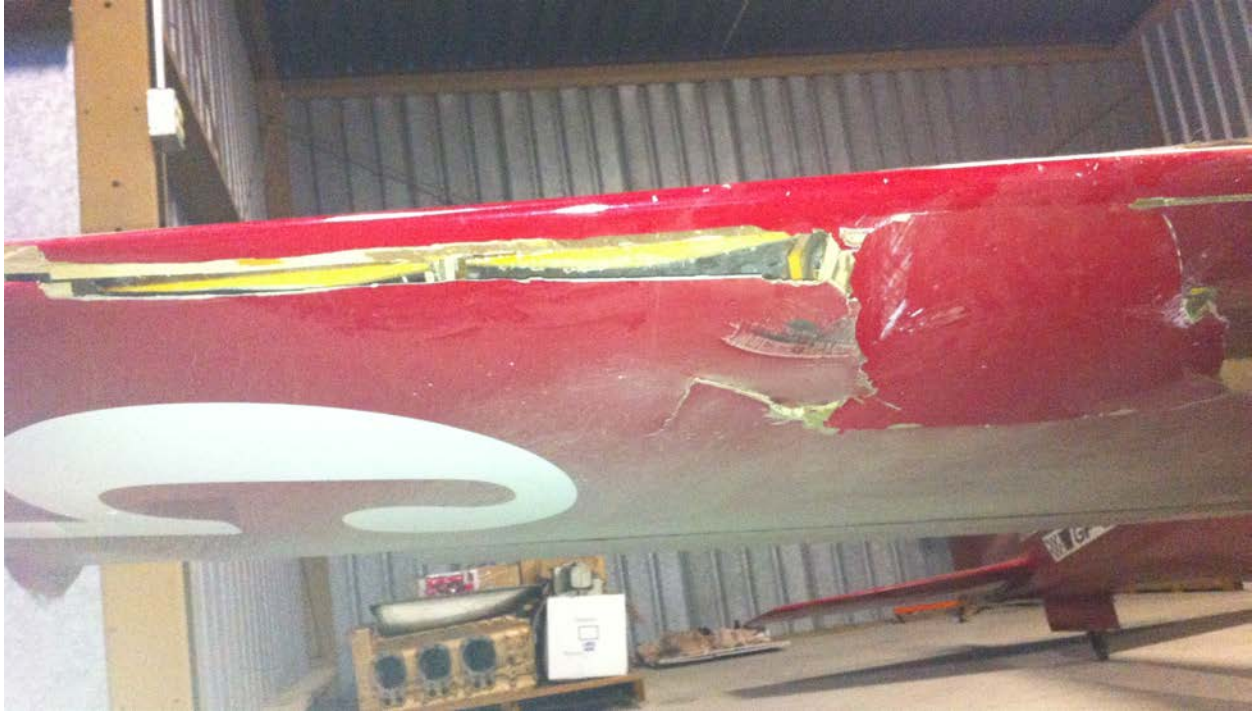
Figure 7 – Right wing lower surface damage following March 11, 2012, landing

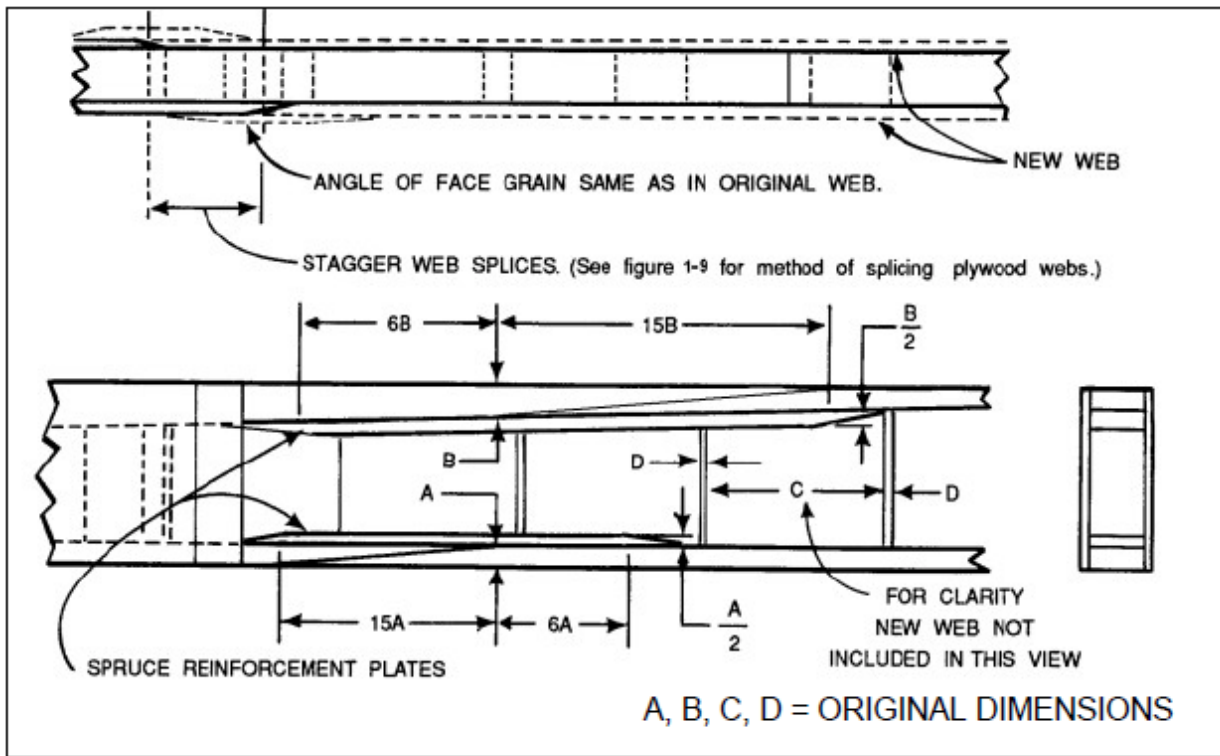
Figure 8 – AC 43.13-1B Figure 1-8, method of splicing box spar flanges.
