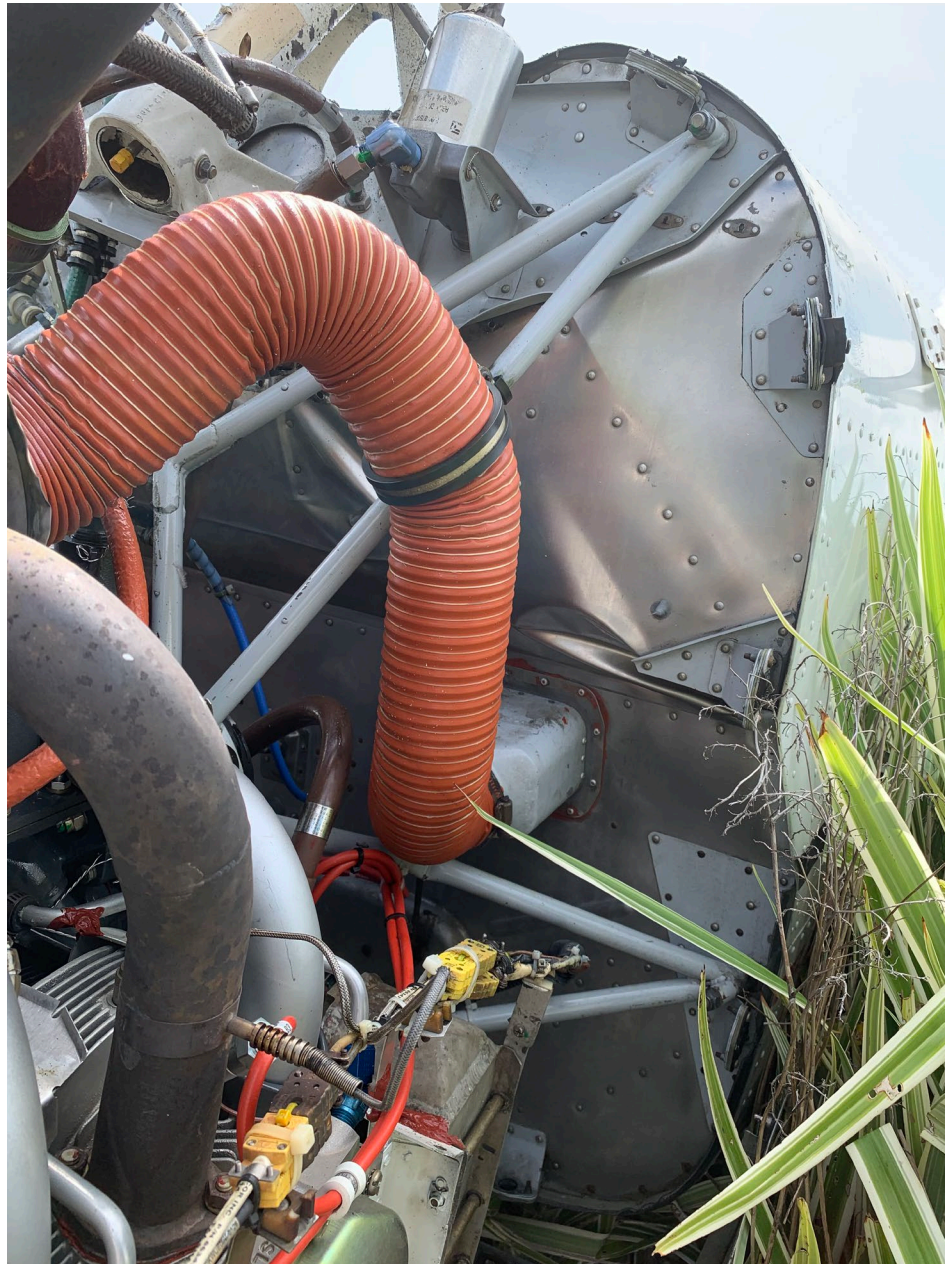
**Photo 4 – Engine Firewall Damage (FAA Photo)**
