Southeastern Marine Surveying Company

RE: **M/V "JACQUELINE A"**
SINKING LOSS
North Myrtle Beach
D.O.L. 08-08-2023
Our File NO.: L-23010

**M/V "JACQUELINE A"
SINKING LOSS**

**D.O.L. 08/08/2023
OUR FILE # L-23010**

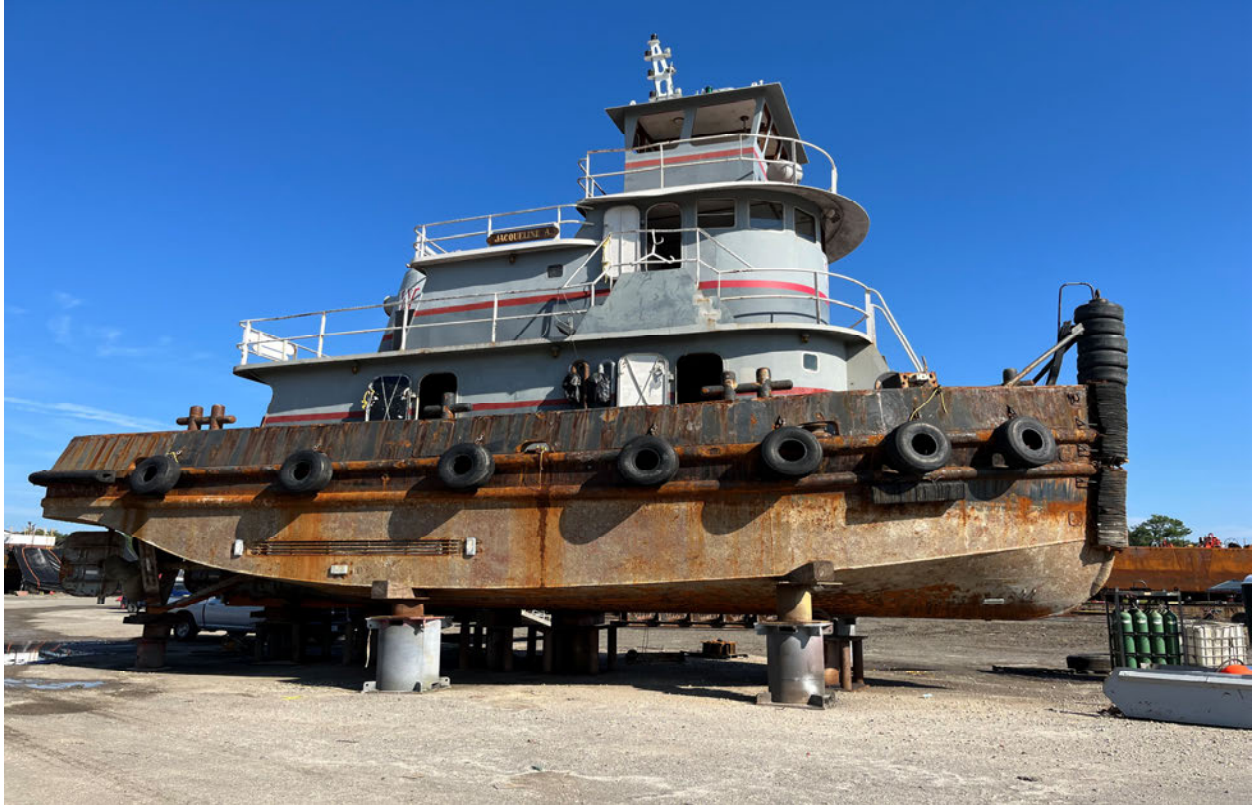
M/V "JACQUELINE A" hauled at Stevens Towing Company following salvage.

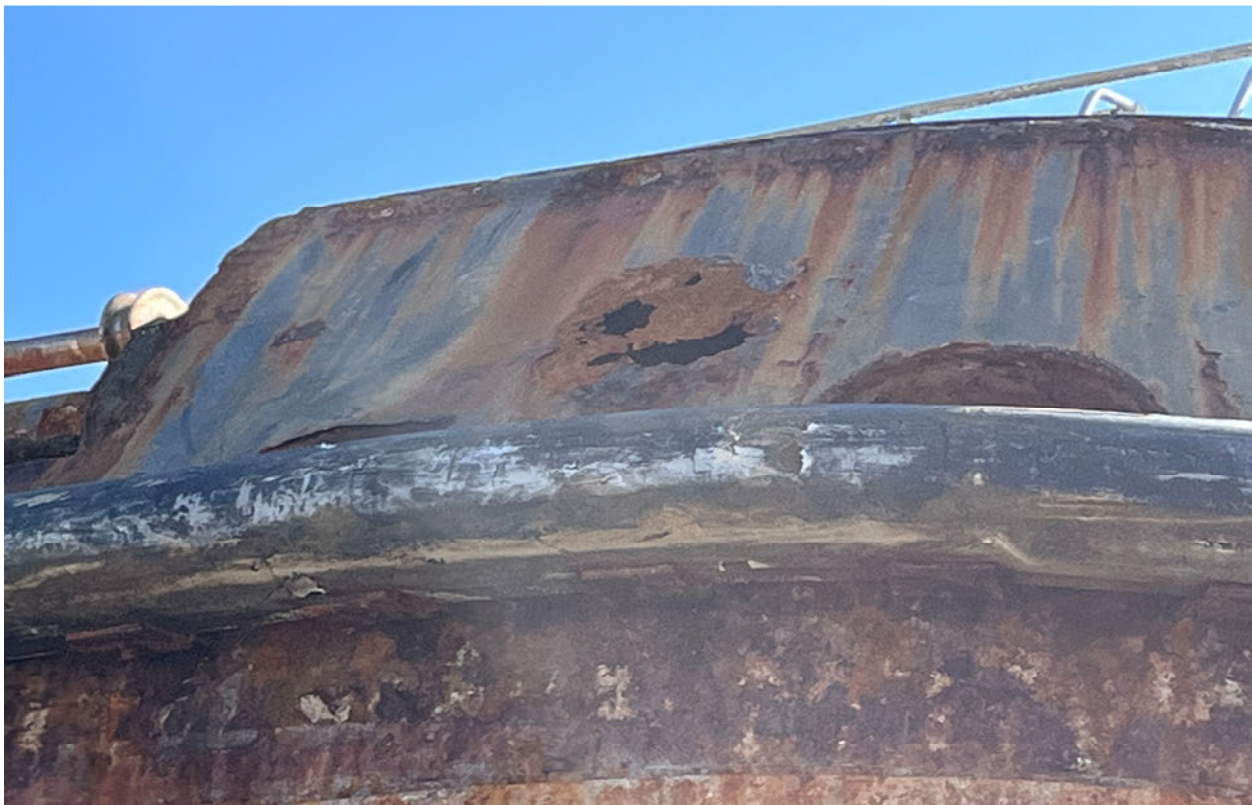
On Tuesday September 19, 2023 the undersigned again proceeded to Stevens Towing Company shipyard and met with the same personnel as before. Inspection of the aft deck revealed a significant amount of rust scale debris had been removed from the lazarette and from the cut-a-way section of the closed bulwark. Inspection of machinery spaces yielded no apparent seawater ingress points, Inspection of port and starboard potable water tanks yielded spaces in apparent good order. Inspection of lazarette yielded a compartment accessed by port and starboard typical single bolt type yoke 18" manholes. Subject manholes inspected and found in apparent good order. Interior inspection yielded a contiguous compartment partially segregated by five (5) longitudinal bulkheads with lightening hole cut outs. Rudder post tubes were noted to port and starboard. An electric bilge pump noted installed on centerline against forward bulkhead. Generally, skeletal members were found moderately to heavily rust scaled with lower portions of longitudinal partial bulkheads heavily wasted. Rudder post tubes found in apparent good order. Significant deck plate wastage was found inside the closed bulwark with holes ranging from 2" to 8" in diameter.

Stern view of closed bulwark with plate wastage.

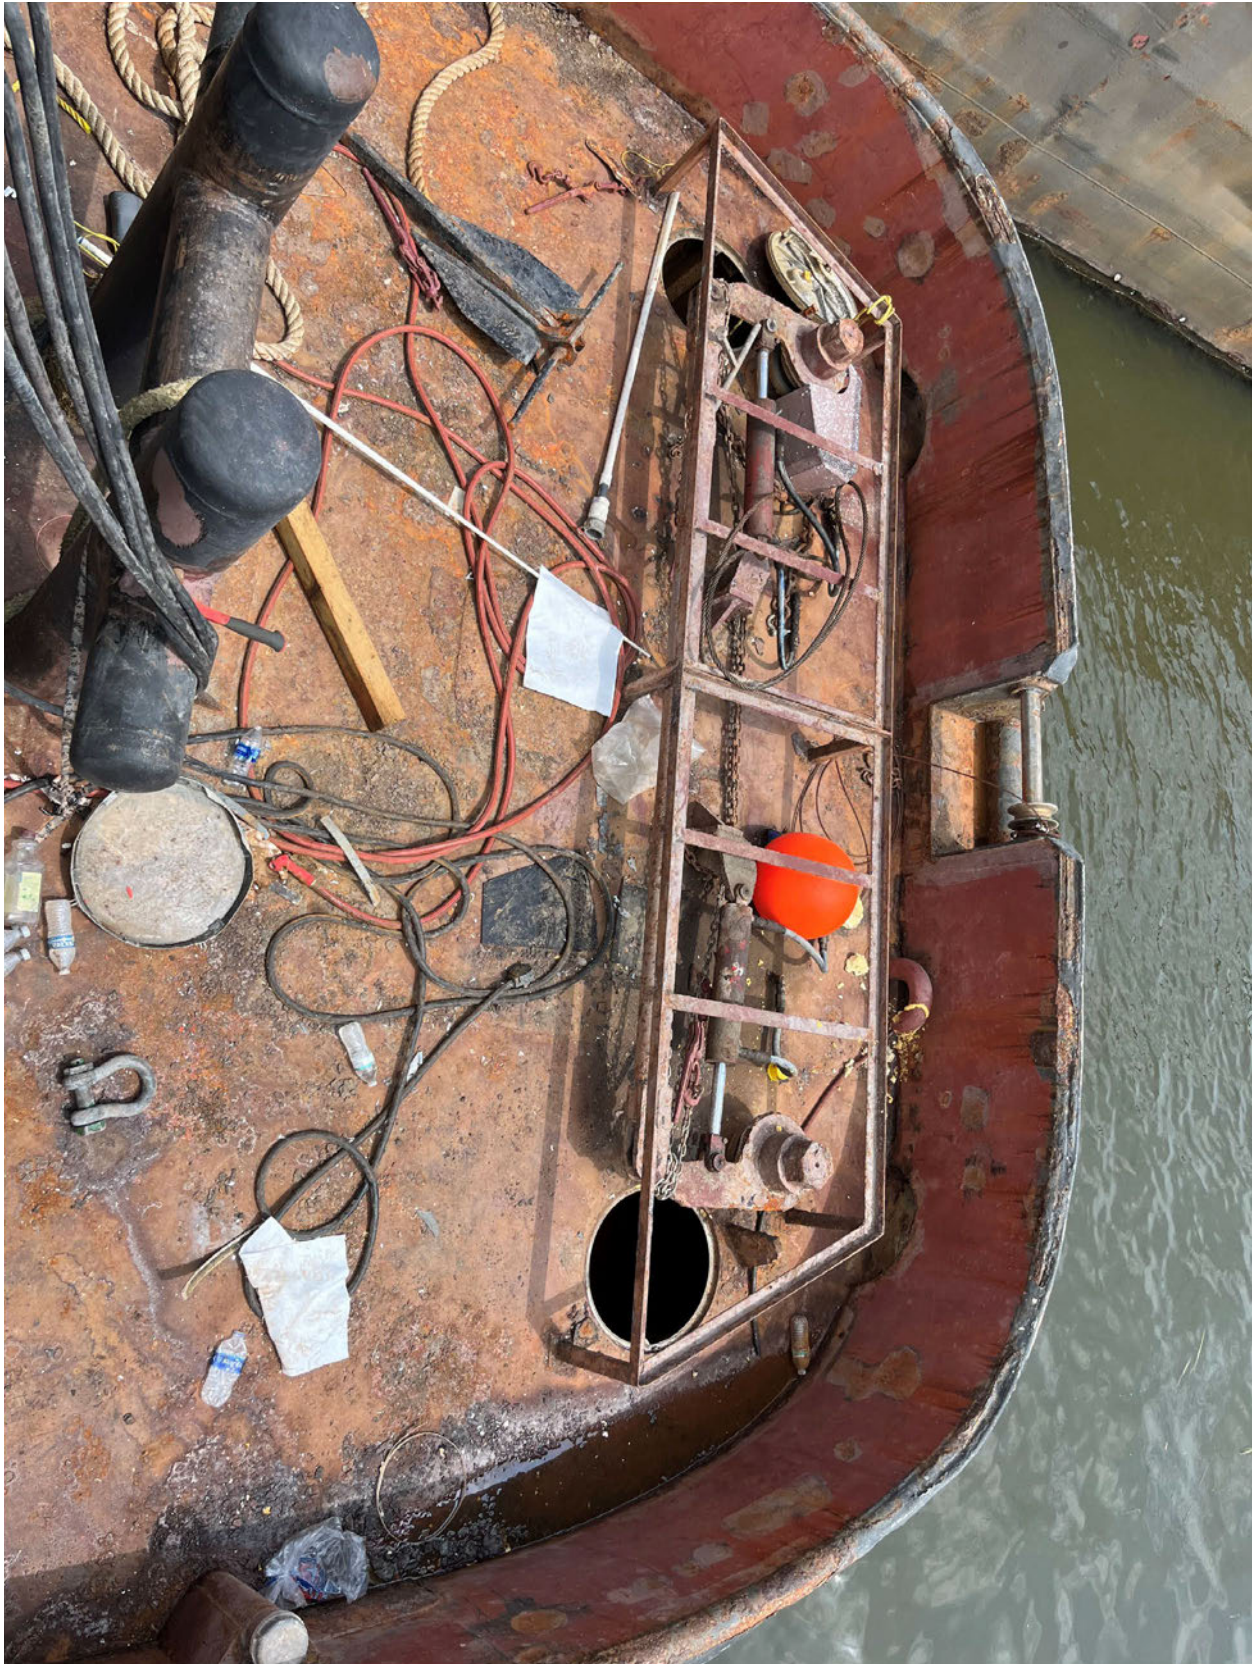
Inboard view of closed bulwark prior to steel being cropped out.

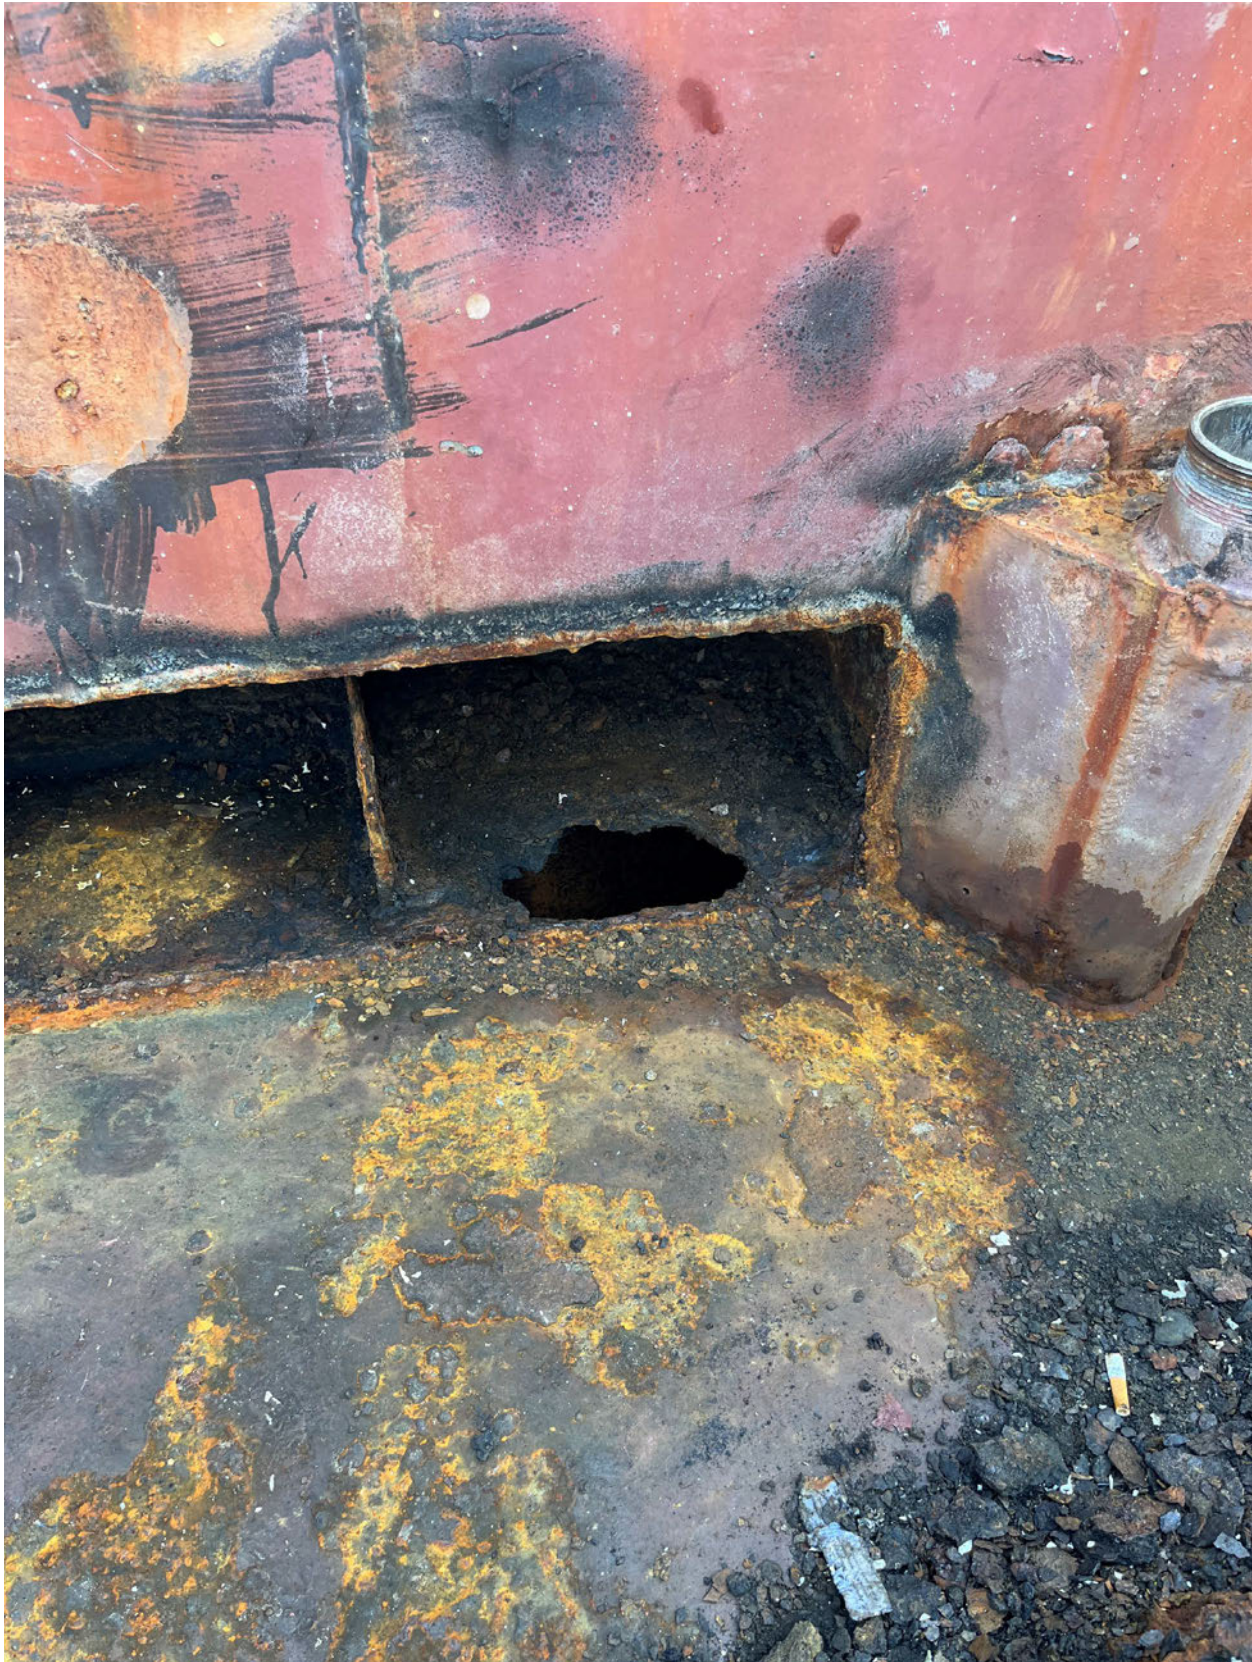
- Hole #1: An 8" diameter hole was found in way of the transverse bulkhead at the #1 frame.
- Hole #2: Found two holes, one with a 6" diameter and another with a 2" diameter, located in way of and forward of #3 frame.
- Hole #3: A slight wasted hole in stern plate positioned approximately 2" below deck plate, in way of and to starboard of centerline. Subject hole measures less than 1" diameter. Hole found hidden beneath stern rubrail.
- Hole #4: A 6" diameter wasted hole was located in way of the longitudinal bulkhead between frames #3 and #4, positioned 14" forward of the transom.
- Hole #5: Found a 2" diameter hole to starboard of longitudinal bulkhead #4, approximately 8" forward of the transom.

Based on a thorough inspection of the **M/V "JACQUELINE A"**, in-water and ashore on blocks, it is the undersigned's opinion that the exact cause of sinking is undetermined. However, based on said inspection it is the undersigned's opinion that the most probable cause was due to sea water ingress filling lazarette and thence machinery spaces through the above

Hole #1 port side adjacent to lazarette forward bulkhead after bulwark steel cropped out. Hole possibly enlarged by scale removal.

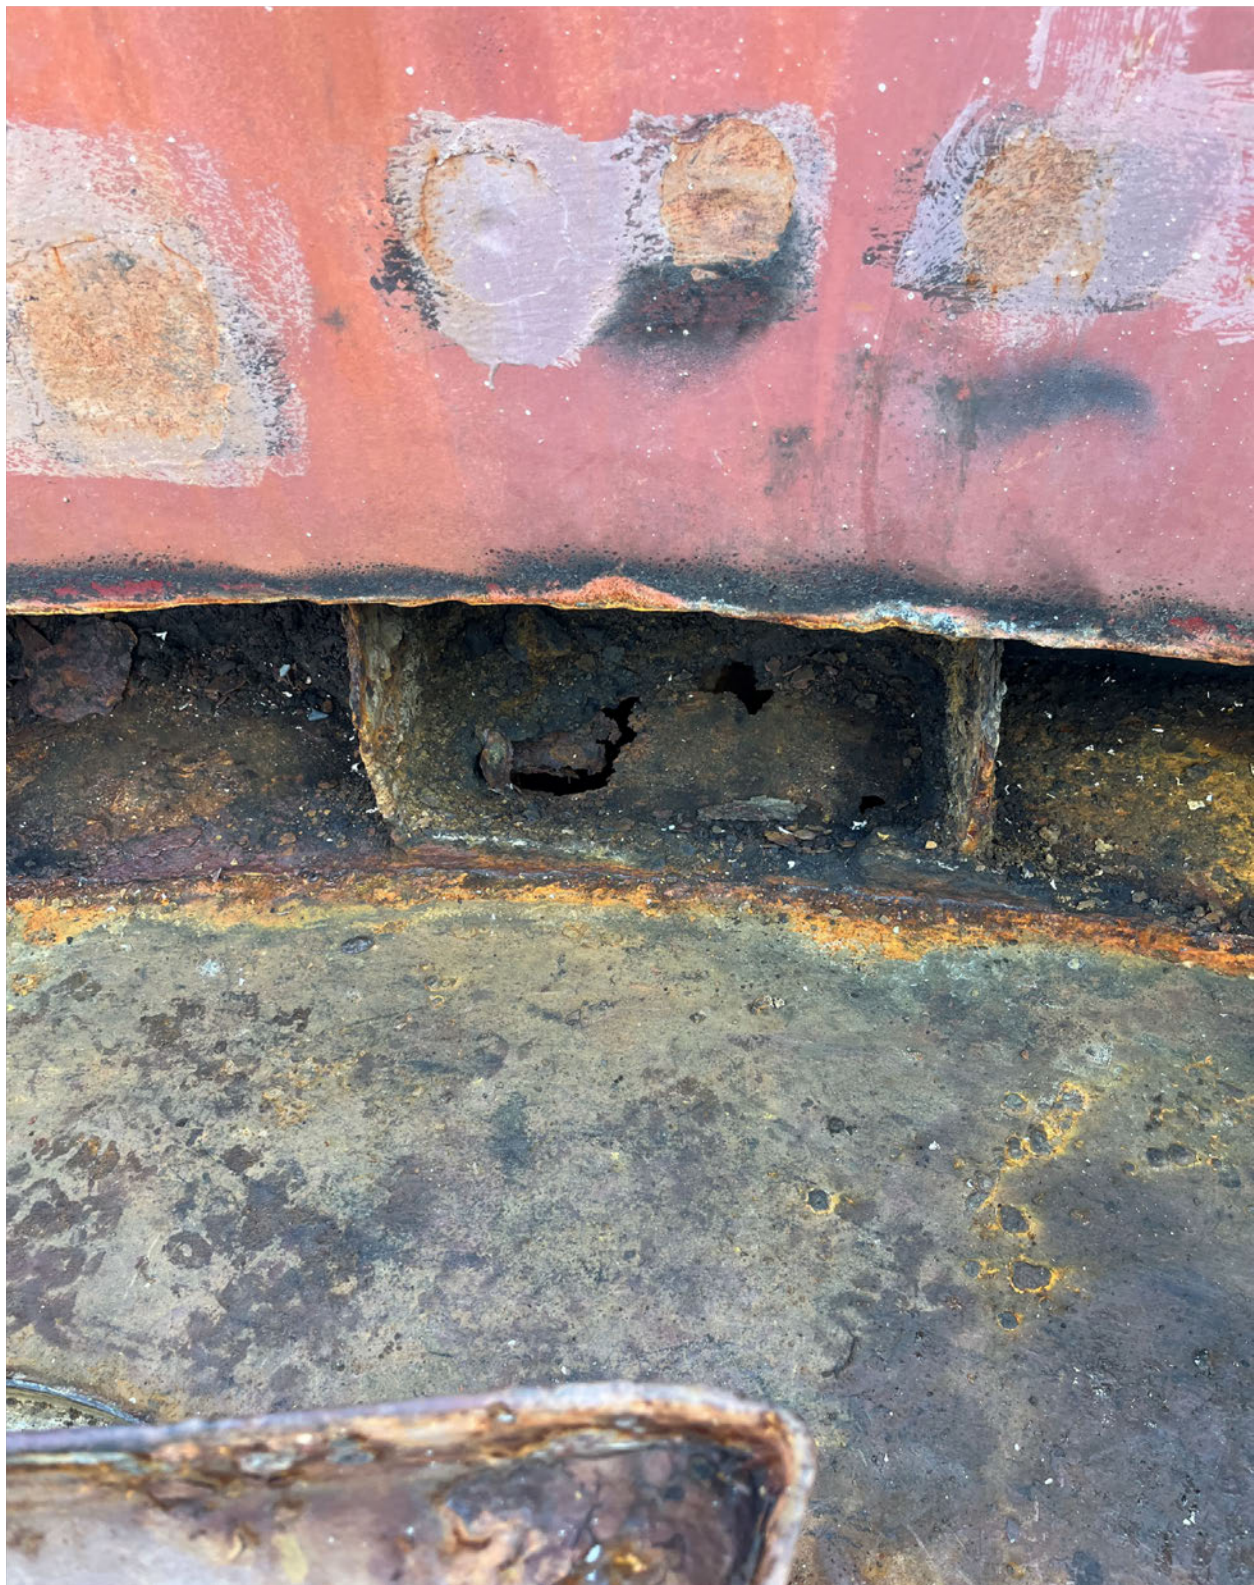
Hole #2 in way of frame #'s 2 and 3 after bulwark steel cropped out. Hole possibly enlarged by scale removal.

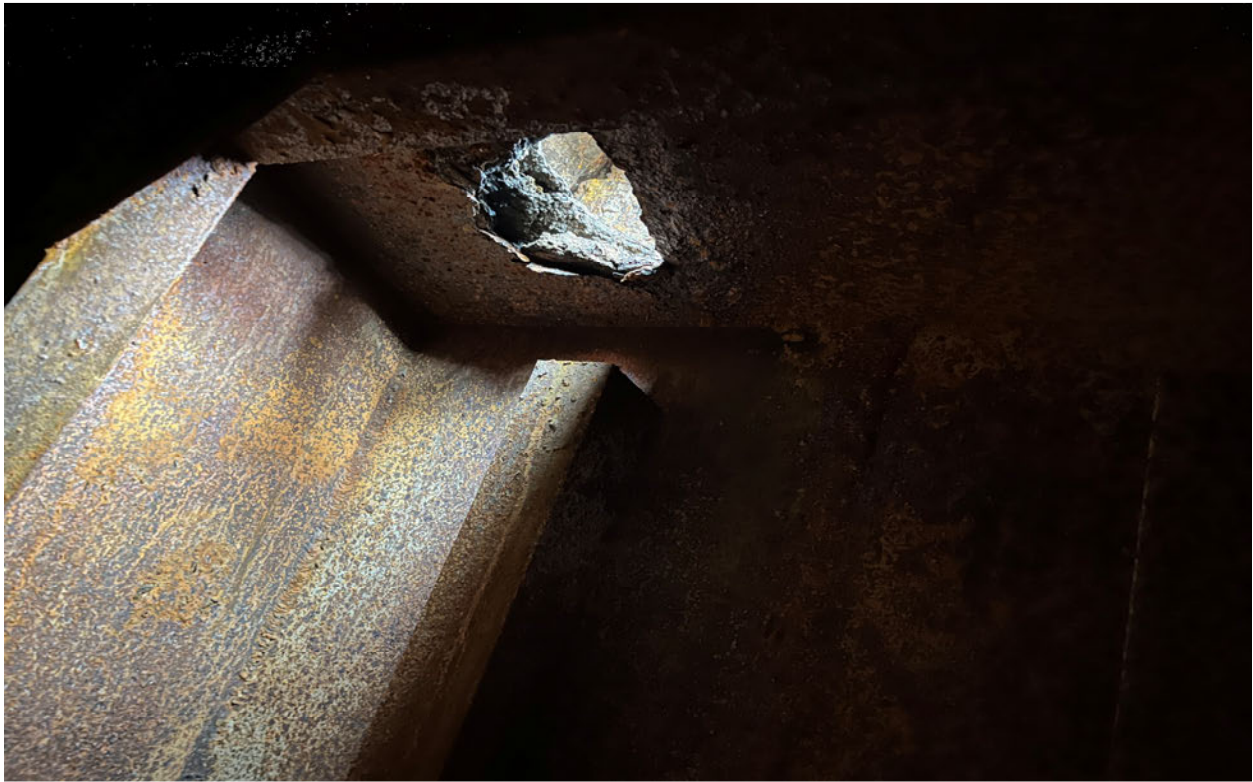
Hole #1 viewed from inside lazarette after bulwark steel cropped out. Hole possibly enlarged by scale removal.

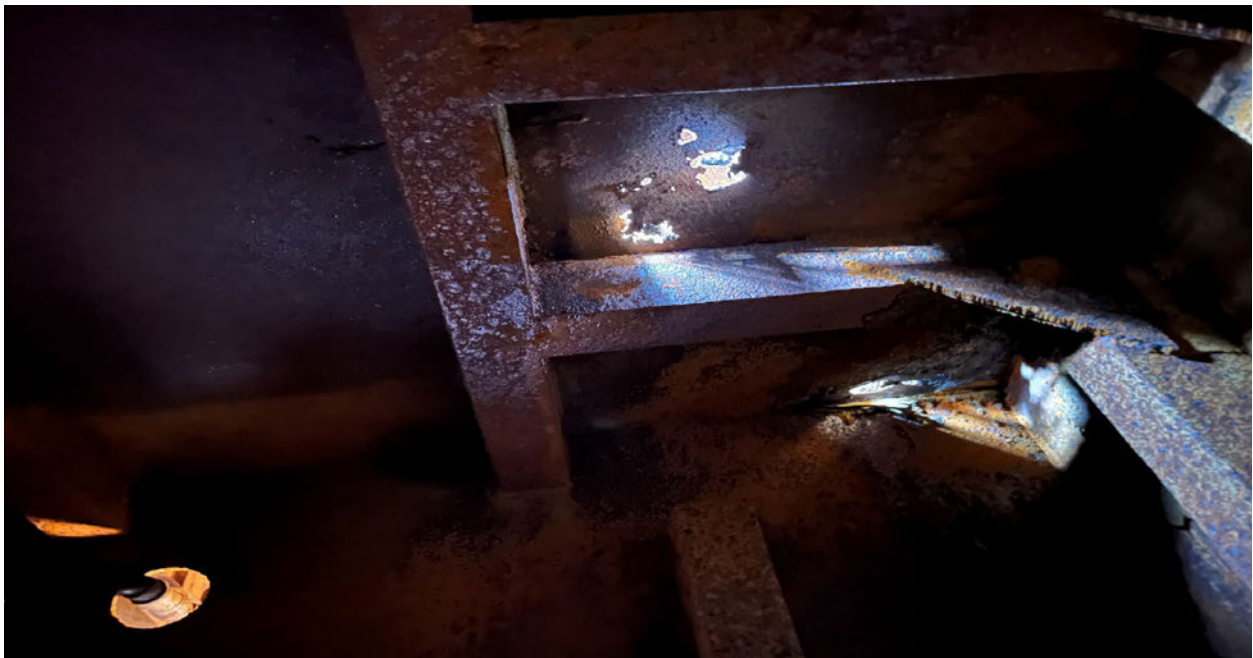
Hole #3 and stern hole viewed from inside lazarette after bulwark steel cropped out. Hole possibly enlarged by scale removal.

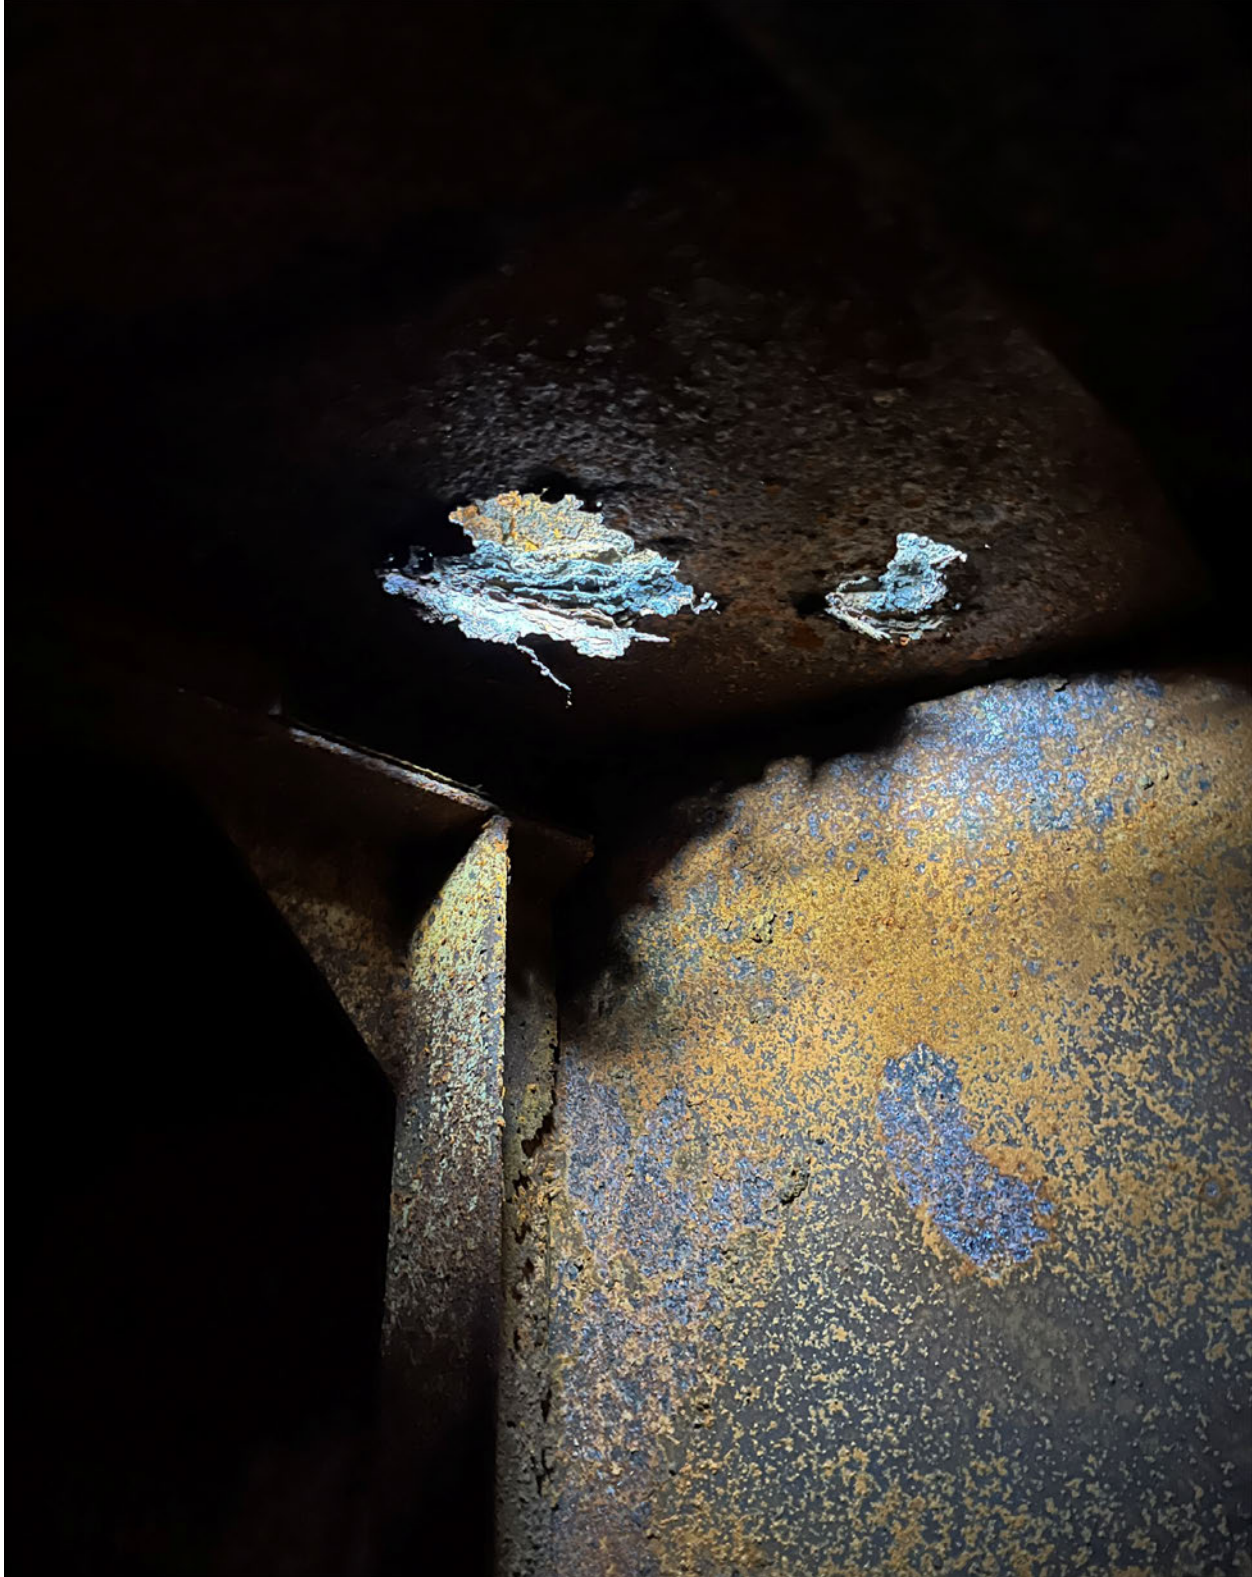
Hole #2 viewed from inside lazarette after bulwark steel cropped out. Hole possibly enlarged by scale removal.
