SURVEY STATEMENT NARRATIVE ANNEX

Name of vessel: **CMA CGM BIANCA**
Owner: **Teucarrier (No. 3) Corp.**
IMO Number: **9436367**

Hull damage Surveys

Narrative Report

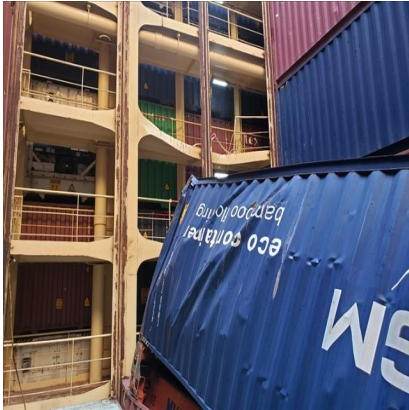
According to the Captain when the vessel began to move off the pier the shore gantry crane spreader in Hold No.5 was in way of row 06 in the cell guides lowering the 4th container, with three (3) containers previously loaded into hold. The spreader was swinging and fell onto a hatch cover guide, puncturing through the container floor, forward spreader bars detached; two forward spreader bars dropped with the container into the hold and remaining spreader pulled out of the hold and impaled a container in position 420588.

CGM CMA BIANCA Container dropped into cargo hold No.5

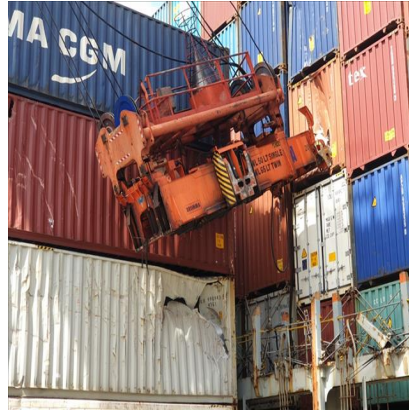
CGM CMA BIANCA Container Spreader impaled into cargo container following wind event.

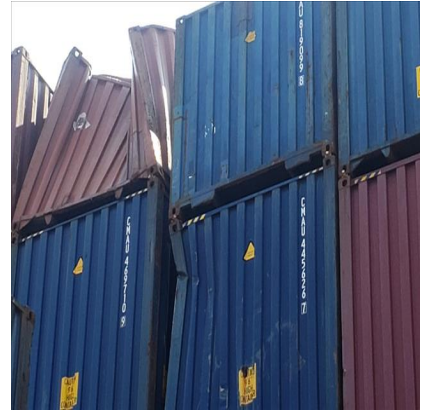
CGM CMA BIANCA Damage to Container in stack
