North American Marine Consultants, LLC

REPORT OF DAMAGE SURVEY

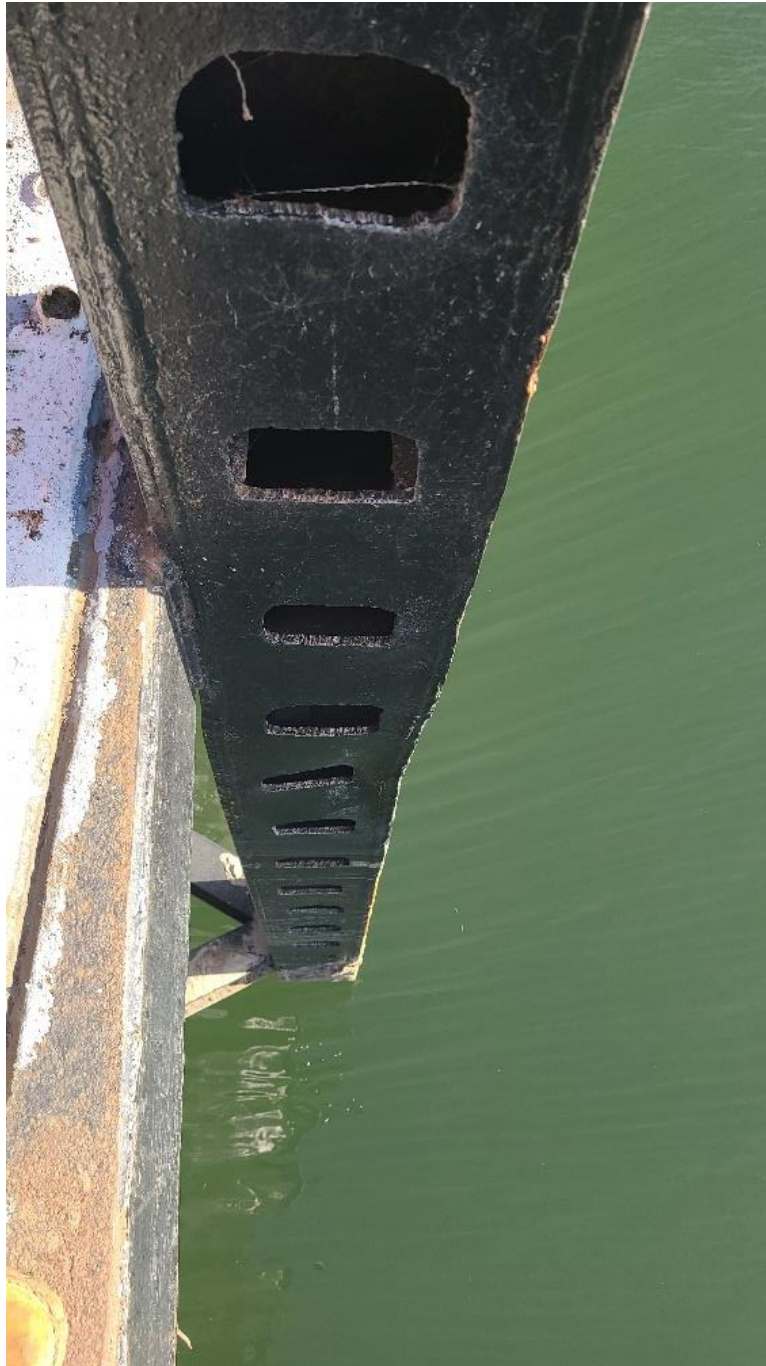
Starboard pushknee damage, looking down from above

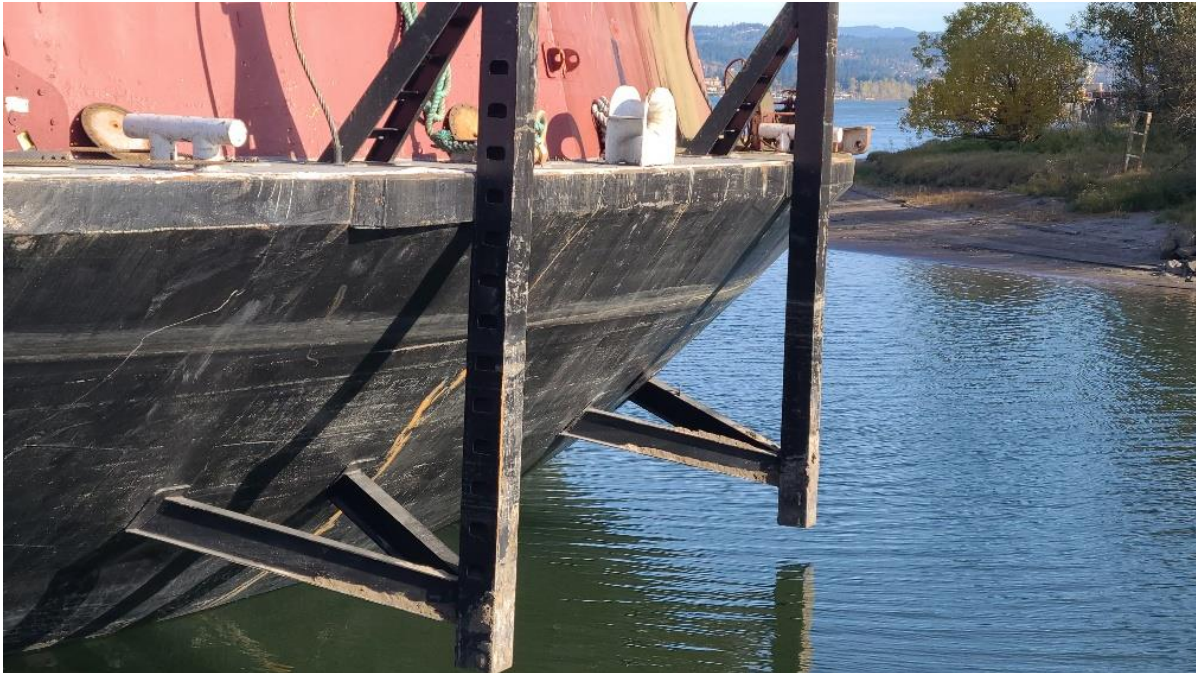
Starboard pushknee, damaged below deck

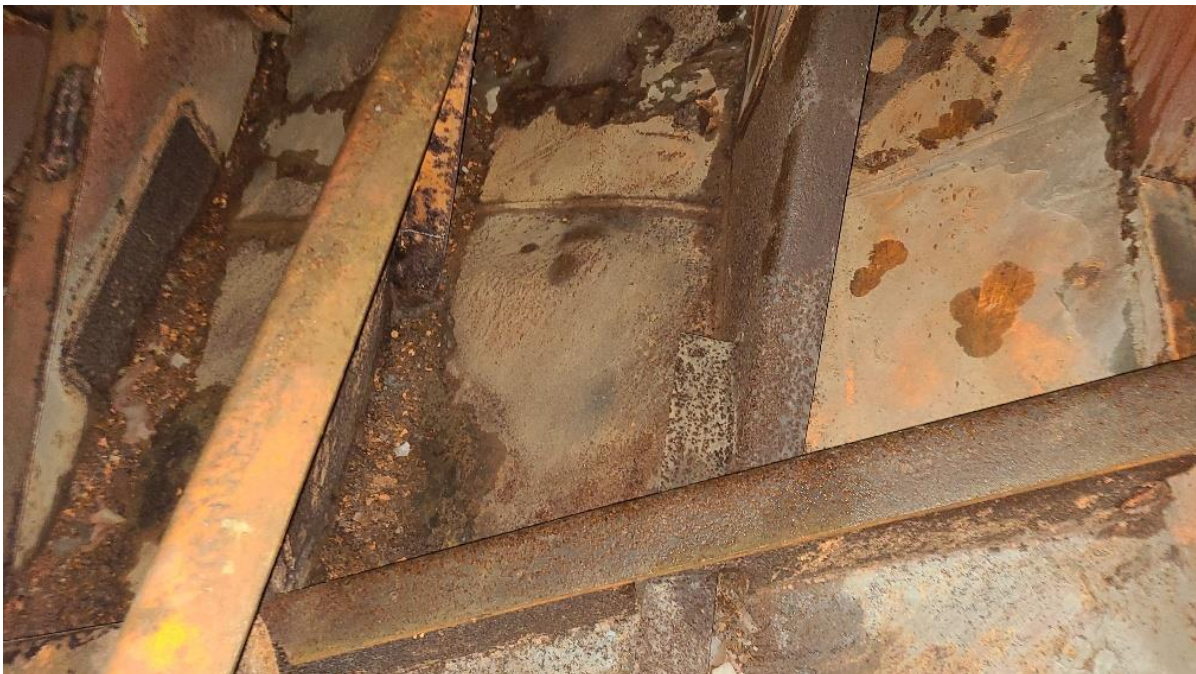
Rake plating set up in port bow rake compartment

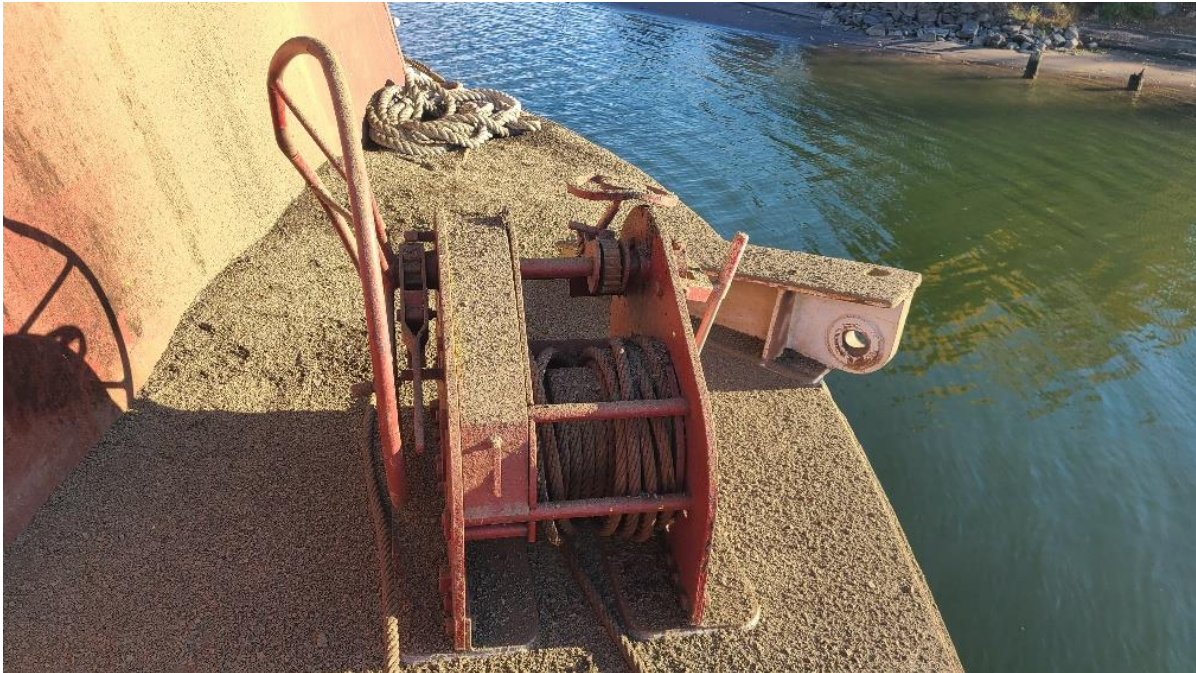
Damaged Patterson deck winch

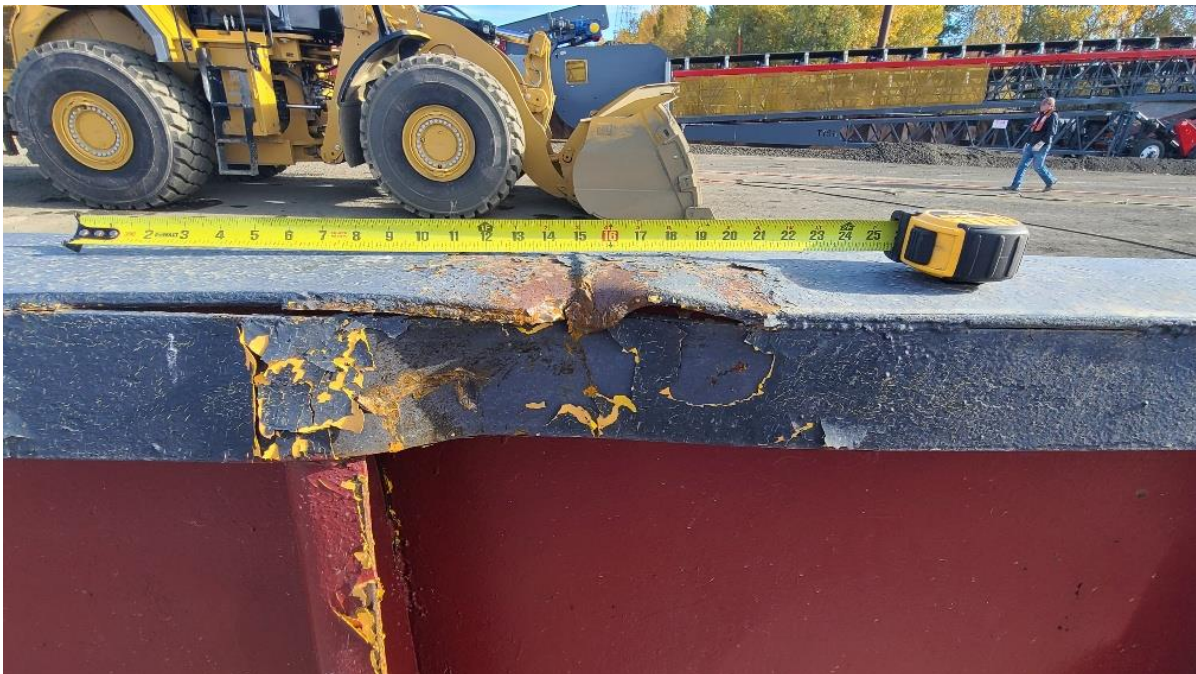
Damage to starboard coaming cap rail
