**Modjeski and Masters Modeling of the Fern Hollow Bridge**

**Pittsburgh, PA**

**HWY22MH003**

DATE: 5/19/2023  
TO: Mr. Dennis Collins, NTSB  
FROM: Modjeski and Masters, Inc.  
RE: Analytical Modeling of the Fern Hollow Bridge

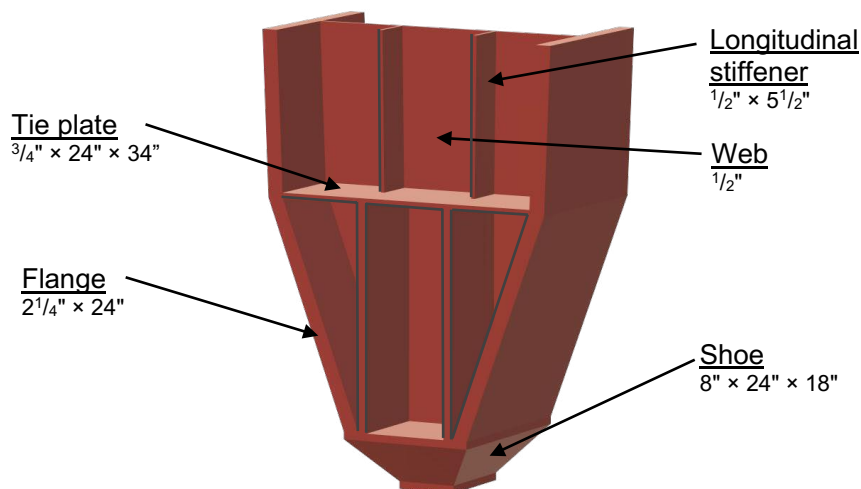
The base of a typical frame leg is shown in Figure 6 [2]. Over most of the frame leg's height, the web depth was tapered, with the flanges inclined at approximately 1.9 degrees from the centerline of the leg. At the base, the flange inclination increased to 22.7 degrees from the centerline of the leg. This local change in inclination of the compression force in the flanges required a tension component to equilibrate the unbalanced force present at this angle change, thus the use of a 3/4-inch-thick tie plate spanning between flanges.

**Figure 6 – Base of typical frame leg (looking at inboard side)**

Because a failure beginning with the connection between the tie and the downhill (span 2 side) flange is consistent with the post-collapse physical evidence [1,3], the local examination focused

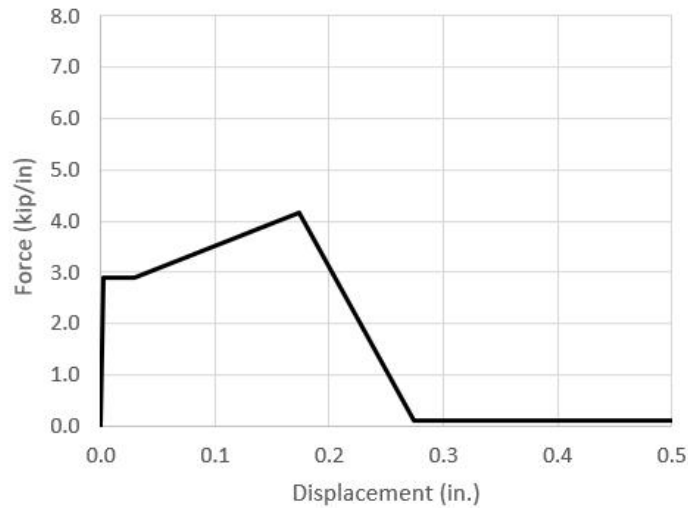
For the inboard downhill (span 2) side of the tie plate, the failure appeared to have occurred through the thinnest remaining section of the tie plate (approximately 0.05 in.), as the weld was still intact. As such, the joint elements at this location were assumed to have elastic-plastic behavior up until the moment of fracture, thereafter the force in the joint element reduces to near zero with increasing displacement. While the force-displacement behavior beyond the peak load is not indicative of actual behavior, where all force would be removed instantaneously upon fracture, a more gradual reduction from peak force and minimum load above zero is required for convergence of the nonlinear structural analysis. The force-displacement behavior is based on the stress-strain test data for the tie plate acting over a length of 1 inch with a thickness of 0.05 inches and assuming a 30% reduction in ductility due to the corrosion present (refer to [7]). The force-displacement behavior for the inboard downhill (span 2) side of the tie plate is shown in Figure 12.

**Figure 12 – Joint element behavior for inboard downhill (span 2) side of tie plate (ductile failure through thinnest remaining section).**

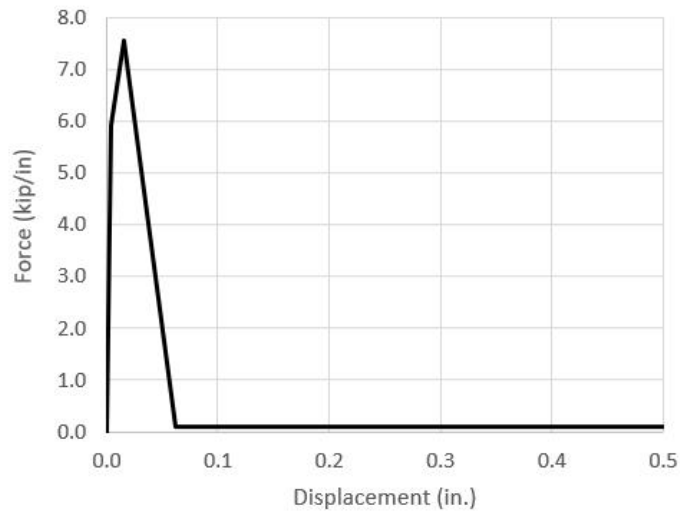
For the outboard downhill (span 2) side of the tie plate, the failure appeared to have occurred through the welded connection. Based on the NTSB’s investigation of the fracture surfaces [6], the welded connection was not full penetration as indicated by the design drawings but was rather a fillet-welded connection or a partial penetration connection with extremely limited penetration into the tie plate and flanges. In addition, the NTSB information revealed that only the weld on the underside of the tie plate was effective, with the weld on the upper side showing signs of limited fusion. Therefore, the joint elements were given similar elastic-plastic-fracture behavior to the inboard side of the tie plate, but the ultimate strength was based on the AASHTO LRFD BDS equations for an assumed weld metal strength of 70 ksi and a minimum throat thickness of the underside fillet weld (approximately 0.36 inches). Yield force was determined as a fraction of this ultimate strength based on tests conducted by Gomez et al. on fillet-welded connections of similar size [8]. Yield and ultimate displacements were also assumed based on tests conducted in the same study [8]. The force-displacement behavior for the outboard downhill side of the tie plate is shown in Figure 13.

**Figure 13 – Joint element behavior for outboard downhill (span 2) side of tie plate (brittle failure through tie plate-to-flange weld).**

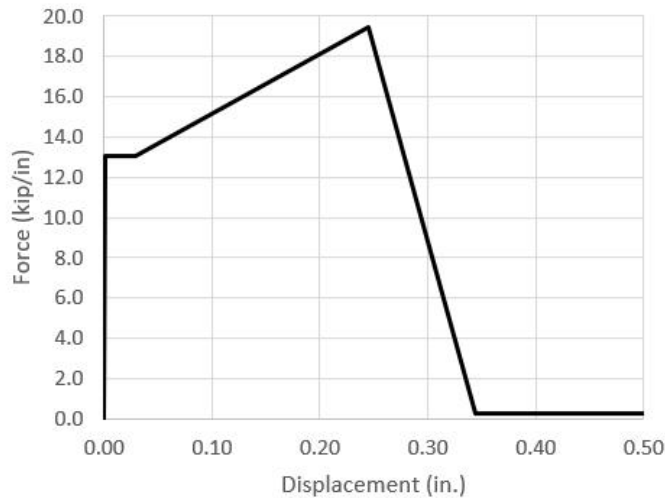
Near the web-to-flange weld on the downhill side of the B1R leg, it appeared that failure occurred through the thinnest remaining section of web plate (approximately 0.25 inches) adjacent to the weld, as the weld was still intact. As such, the joint elements at this location assumed a similar behavior to the inboard downhill side of the tie plate. The force-displacement behavior was based on the stress-strain test data for the web plate acting over a length of 1 inch with a thickness of 0.25 inches and assuming a 30% reduction in ductility due to the corrosion present (refer to [7]). The force-displacement behavior for the web-to-flange joint elements is shown in Figure 14. These web joint elements were included in the model all the way to the boundary between the shell element portion of the model and the beam element upper portion.

**Figure 14 – Joint element behavior for web-to-flange region (ductile failure through thinnest section of web adjacent to flange).**

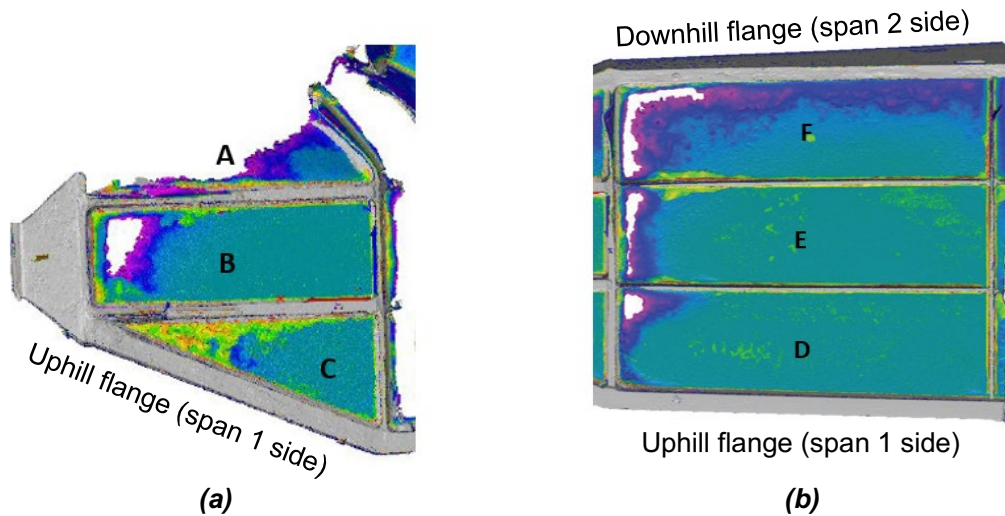
For the web panel directly below the downhill side of the tie plate (labeled “A” in Figure 16(a)), section loss was assumed as 100%, which is consistent with the degree of corrosion noted post-collapse. For the web panels immediately above the tie plate, the section loss of B1L was assumed as a stand-in for the B1R since the B1R web panels in this location were damaged beyond recognition during the collapse. Based on inspection report pictures, it appears that the B1L leg in this region had a similar corrosion pattern and extent to B1R.

**Figure 16 – Elevation view of web looking towards outside of bridge, showing thickness measurements and web plate panel labels A through F for (a) B1R below tie plate and (b) B1L above tie plate (base images taken from [5] with annotation added)**

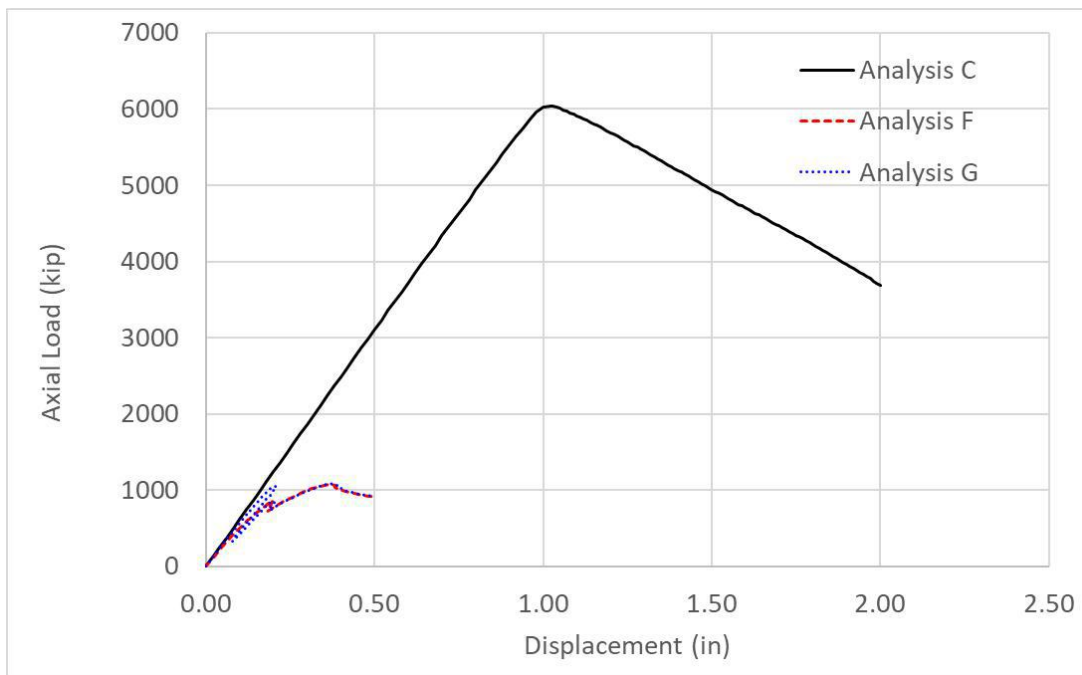
Cases A, B, D, and E are a result of simple hand calculations and therefore a plot of axial load versus displacement along the longitudinal axis of the leg cannot be provided for these analyses. However, the use of the local FEA models for cases C, F, and G allow for the plotting of this type of curve, as shown in Figure 18. Note that case C has a much larger capacity than either of the as-inspected cases and undergoes more displacement prior to ultimate failure. The case C response generally shows linear behavior up until peak load and then the load falls with increasing displacement. The stress state at peak load is shown in Figure 19. Localized yielding in the tie above the lower longitudinal stiffeners leads to the tension load shifting to the web.

**Figure 18 – Axial compression vs. displacement along longitudinal axis of frame leg for all local FEA analyses**

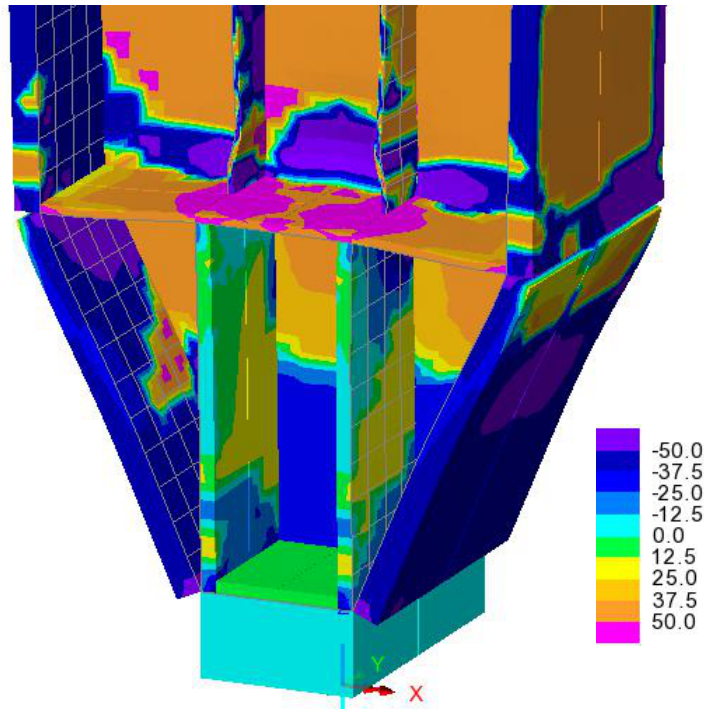
**Figure 19 – Signed largest value of principal stress (in ksi) at peak load for case C**

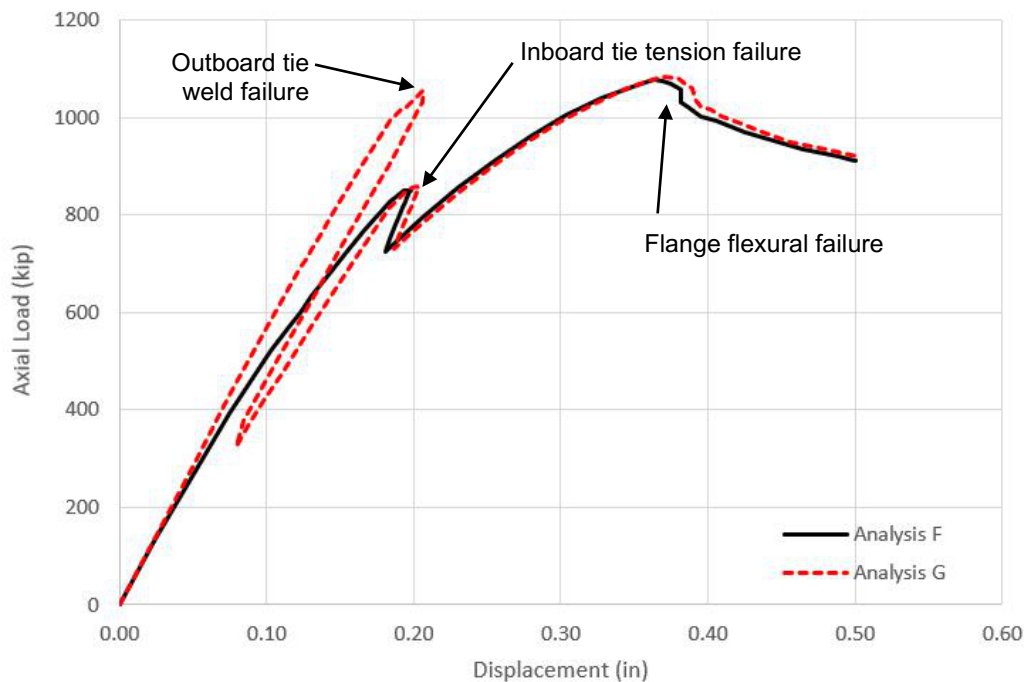
The as-inspected cases are plotted on their own in Figure 20 to show more detail. Each of these responses shows “snap-back” behavior with multiple load peaks, where an initial peak load occurs followed by one or more subsequent peak loads. Each of these peaks correspond to different failure modes, which occur sequentially due to the different stiffnesses required to activate each of the modes and the change in load path as the leg redistributes loads. For example, the initial peak load for case F occurs when the inboard side of the tie plate fails, and the secondary peak occurs when the axial load carried by bending in the downhill flanges reaches its maximum load capacity. The stress states at these peak loads are shown in Figure 21. Note that the plasticity of the tie occurs in the joint elements at the flange-to-tie weld, which is why the stresses appear low in the tie in Figure 21.

The local finite element analyses are performed by formulating static equilibrium and do not account for inertial effects that accrue when a drop in the load deflection curve occurs and additional deformation is necessary to achieve the subsequent peak load. Given the mass of the bridge, once an initial peak is reached and downward acceleration begins, the presence of secondary and later peaks may not arrest the movement resulting in the capacity being defined by the initial peak.

Given the above, it appears likely that case G is the best approximation of the actual capacity of the bridge at the time of collapse among the different cases investigated herein.

**Figure 20 – Axial compression vs. displacement along longitudinal axis of frame leg for as-inspected local FEA analyses**

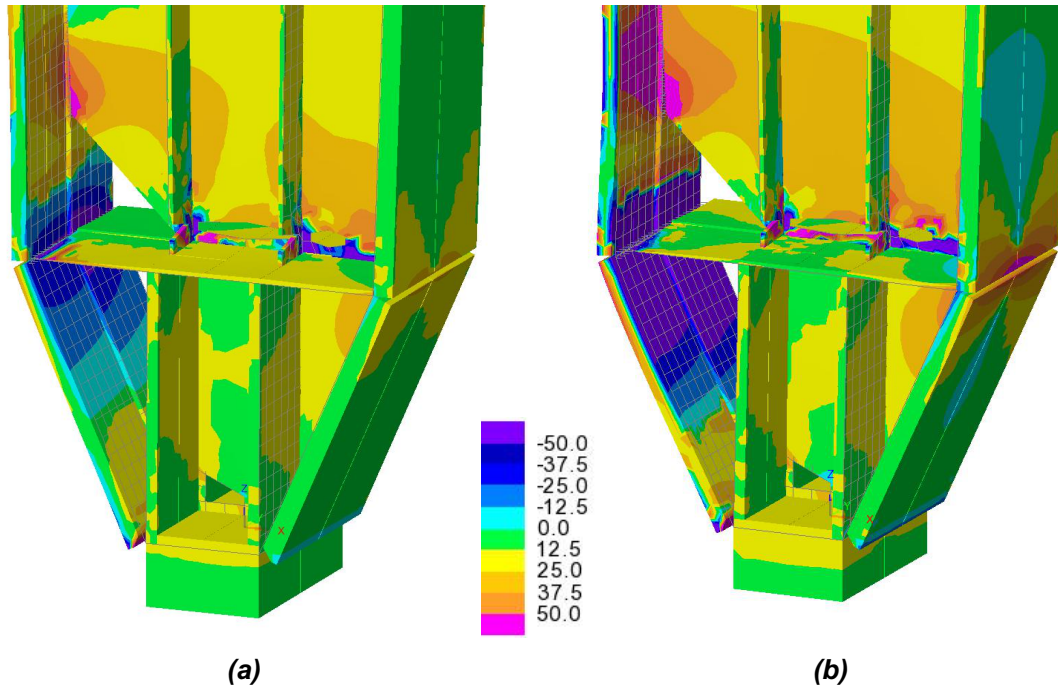
Note that the failures of both cases F and G appear similar to the failure patterns witnessed in the collapsed structure. The failure of the tie along its downhill connection to the flange (where corrosion was largest) side leads to flexure of the flanges. This flexure of the flanges cannot be sustained by the welded connection to the web above the tie nor the welded connection of the flange to the shoe, causing the flange to ultimately separate from both components.

**Figure 21 – Signed largest value of principal stress (in ksi) at (a) initial peak load and (b) secondary peak load, for case F**

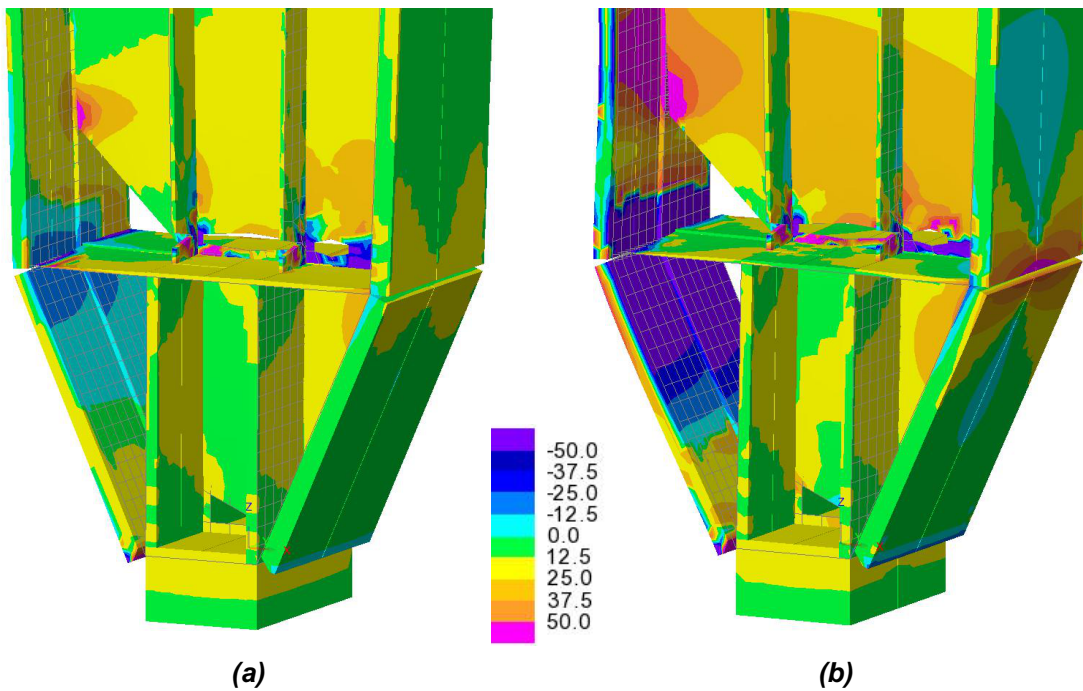
Case G is similar in response to case F but contains an additional peak which occurs prior to the initial peak seen in the case F response. This peak is caused by the loading and failure of the weld at the outboard side of the flange. This is the weld that is assumed to have already failed in case F. The secondary peak occurs due to subsequent failure of the inboard side of the flange, and the tertiary peak occurs when axial load carried by bending in the downhill flanges reaches its maximum load capacity. The stress states at the initial peak and tertiary peak load are presented in Figure 22. These stress states are similar to those of case F.

**Figure 22 – Signed largest value of principal stress (in ksi) at (a) initial peak load and (b) tertiary peak load, for case G**

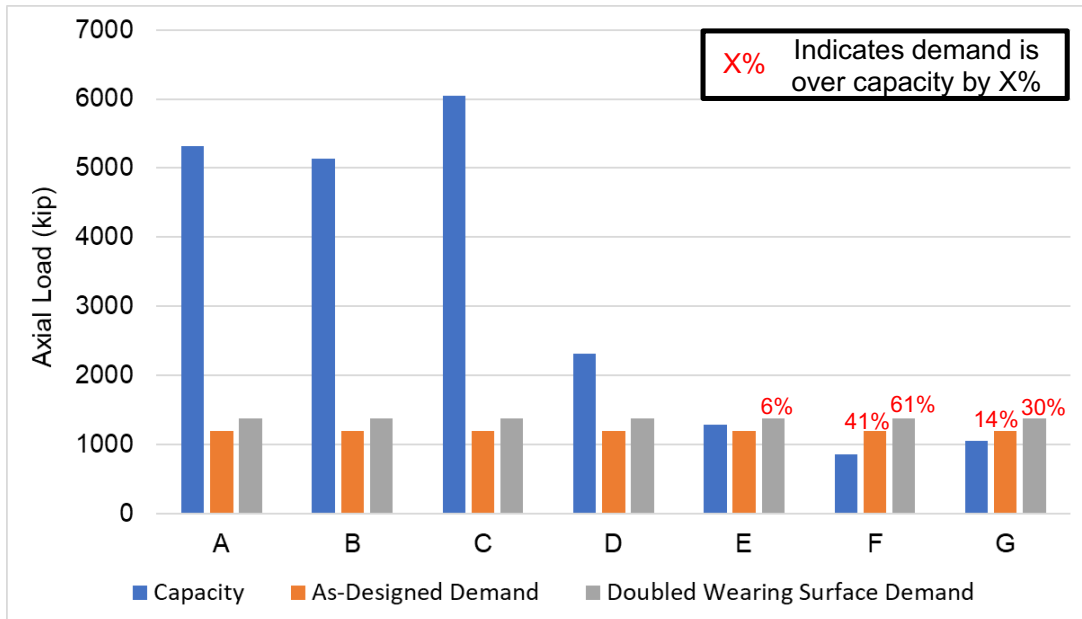
The demand-to-capacity (D/C) ratios for unfactored load and resistance are presented in Table 5 and in Figure 23 for all considered cases. For all as-designed cases, the D/C ratios are less than unity, indicating that the design of the leg for axial failure at its base (neglecting the presence of bending moments) was satisfactory to carry the loads estimated to be present at the time of collapse, even for the case of double the as-designed wearing surface thickness being present.

When significant section loss had occurred throughout the leg and in the cross-bracing between legs, a global-type failure was still not expected as indicated by the case D results. However, the D/C ratios of cases E through G indicate that a localized failure in the tie would have been expected based on the doubled wearing surface loading. For the as-designed wearing surface loading, tie failure would be expected for cases F and G.

**Figure 23 – Graphical summary of demands and capacities for Analyses A through G**
