ECHELON ENGINEERING, INC.

Civil/Marine Consulting Engineers

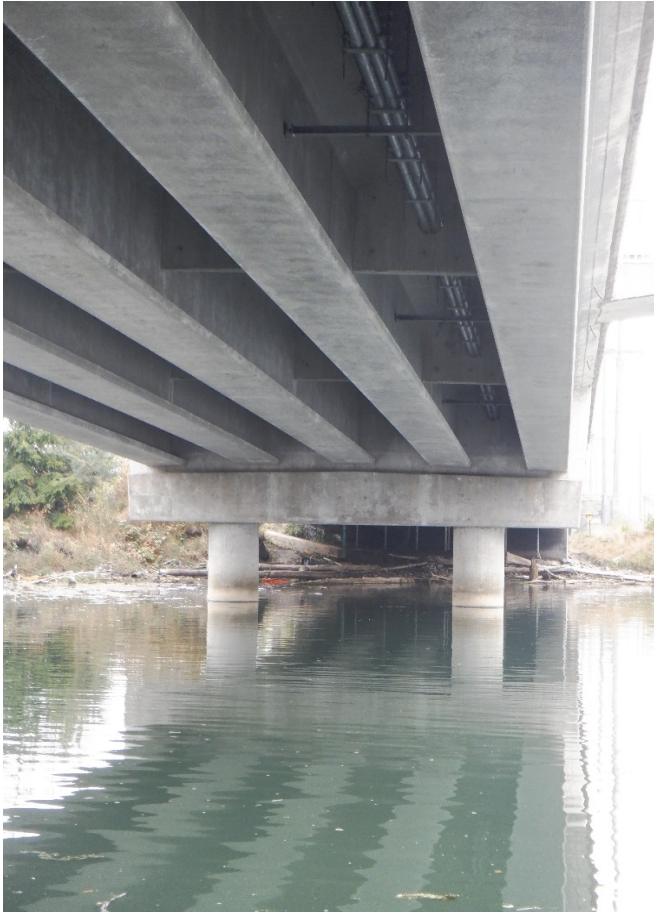
PHOTO No. 3 : Pier 2, Looking Southwest
- Note the overall good condition of the concrete columns, beam and prestressed girders. Inspection of the columns found them to also be in overall good condition below water.

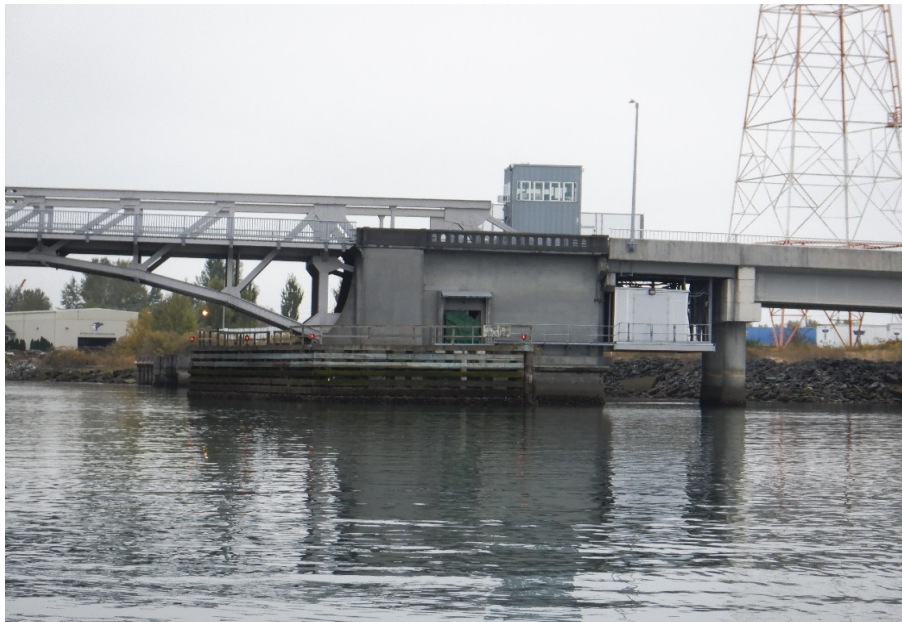
PHOTO No. 4 :
Pier 3 and Pier 4,
Looking Southeast -
Note Pier 3 supported
by two concrete
columns and Pier 4,
the Bascule pier, both
located on the west
side of the channel.
Also note the
protective timber
fender system along
the channel side of
Pier 4.

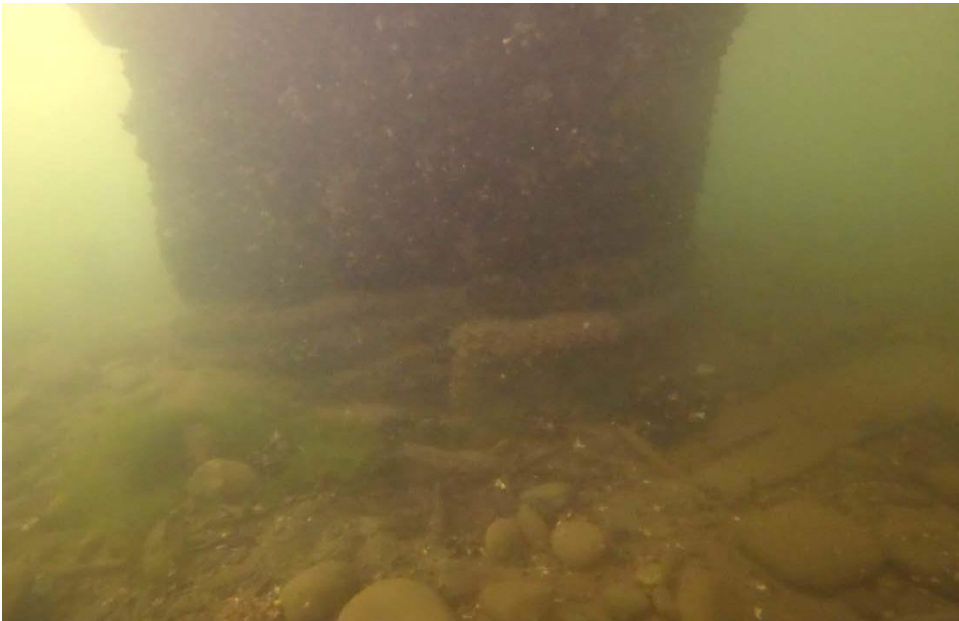
PHOTO No. 6 : Pier 2, North Column - Note the moderate amount of marine fouling located on the concrete column. Inspection found the concrete to be in overall good condition, as well as noting fabric wrapped around the column at the mudline.

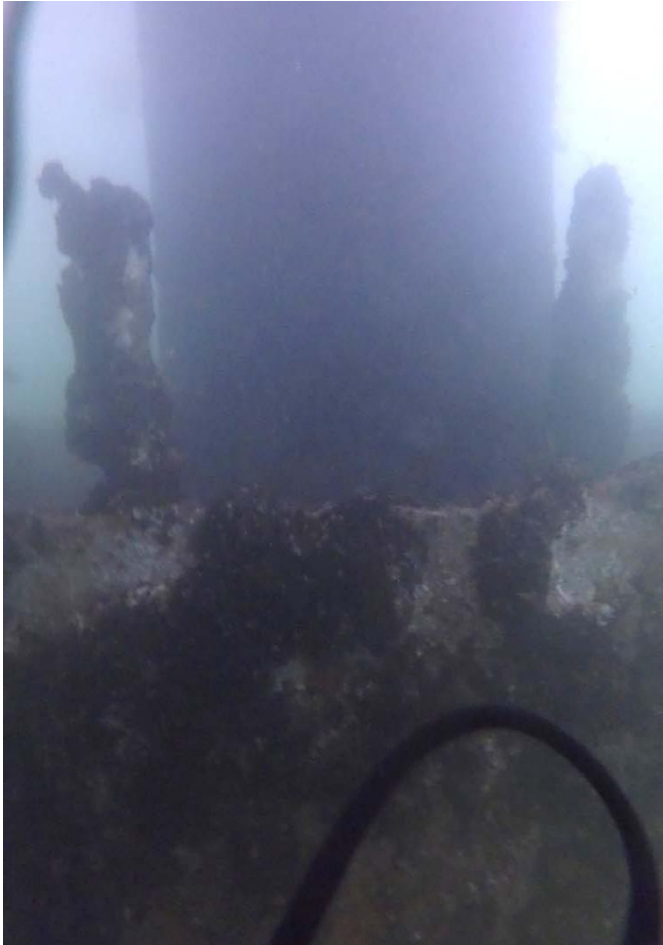
PHOTO No. 7 : Pier 3, North Column - Note the transition between the lower steel shaft and the upper concrete column. Inspection found the column to be in good condition with no significant damage noted to the concrete and minor surface corrosion of the lower steel shaft.

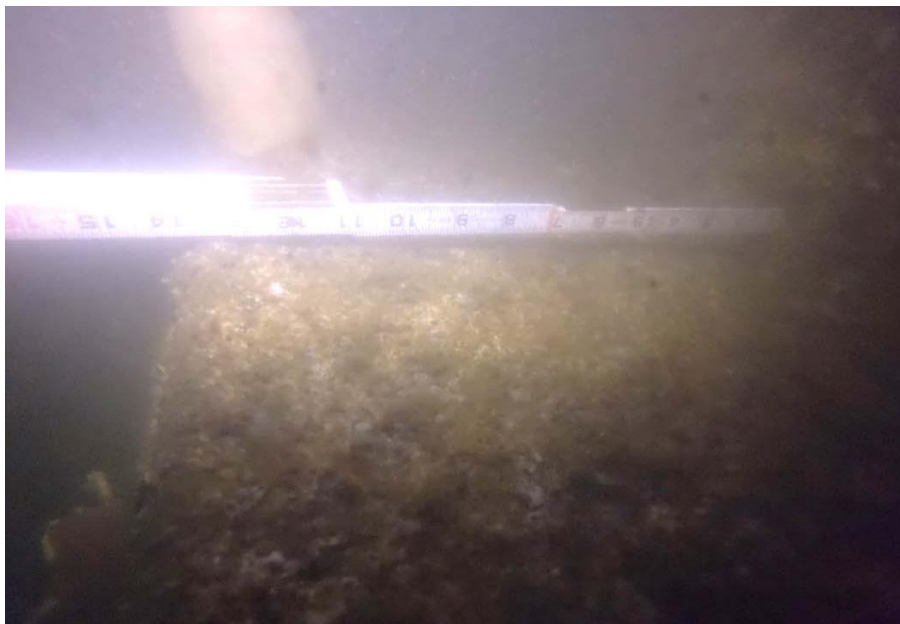
PHOTO No. 8 : Pier 4, Channel Side - Inspection of the bascule along the channel side found exposure of the footing and a portion of the seal pour. Note the overall fair condition of the top of the exposed concrete footing.

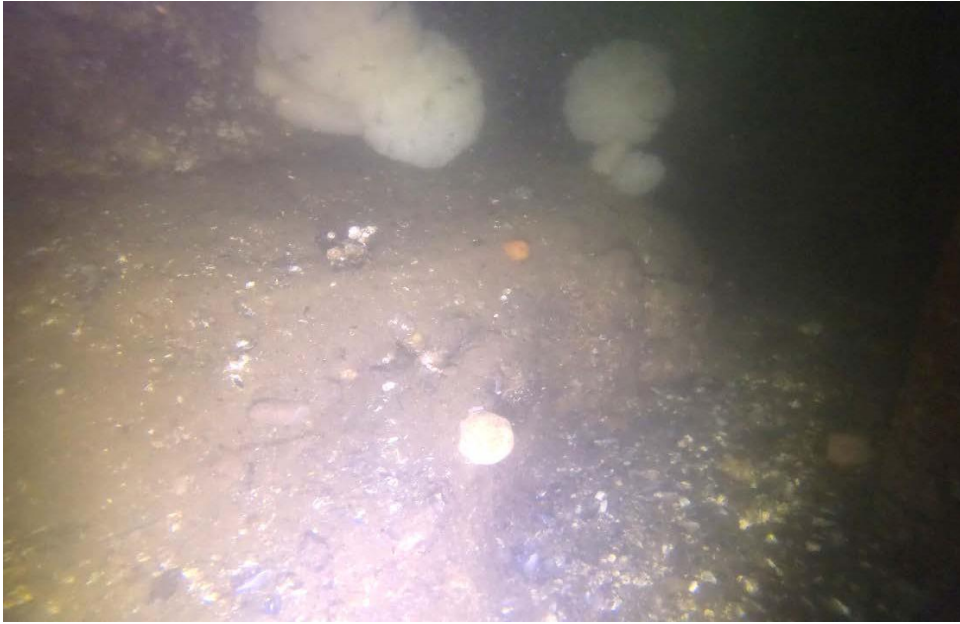
PHOTO No. 9 : Pier 4, Channel Side - Inspection found the top of the seal pour to be exposed along the channel side of the pier. Note the generally good condition of the seal and the silty-sand and shell which comprises the mudline at this location.

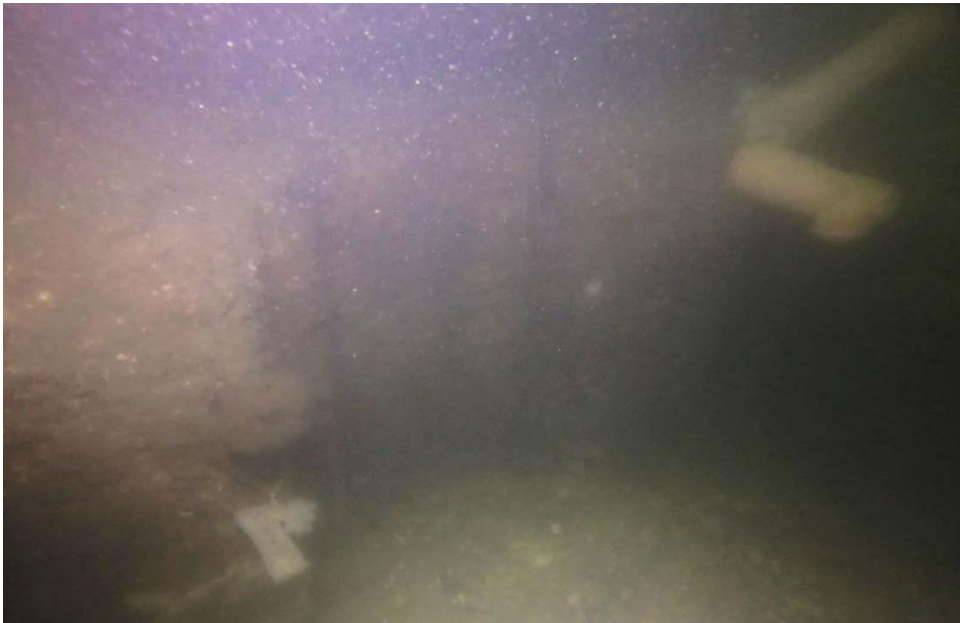
PHOTO No. 10 : Pier 5, Channel Side - Inspection found the top of the seal pour to be exposed along the channel side of this pier also. Note the generally good condition of the seal and the silty-sand which comprises the mudline at this location.

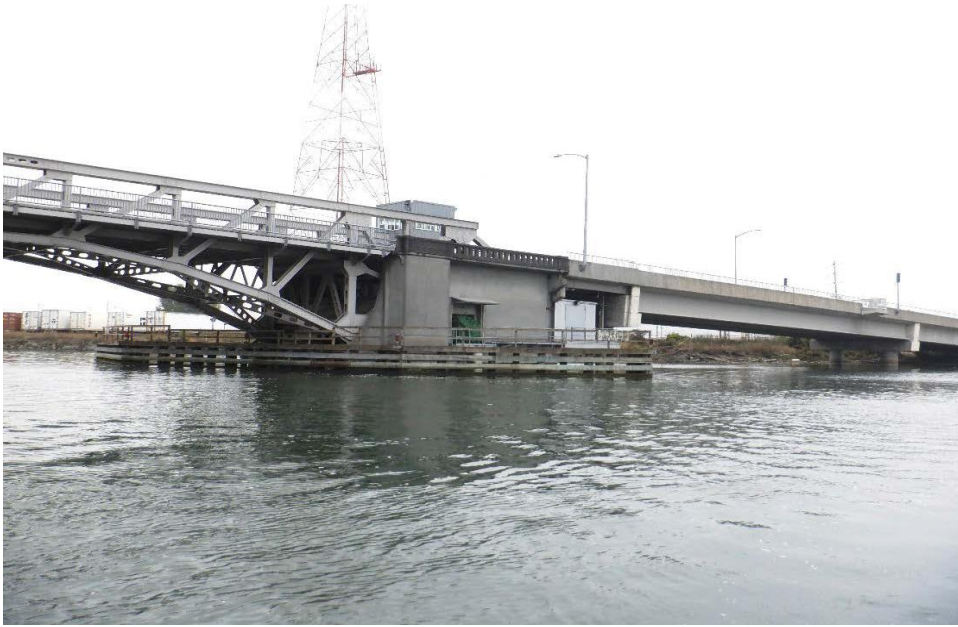
PHOTO No. 11 : Pier 4, Looking South - Note the protective timber fender system located along the channel side of the bascule pier. Although areas of fungal decay and marine borer damage were found, the overall condition of the system was found to be fair to good.

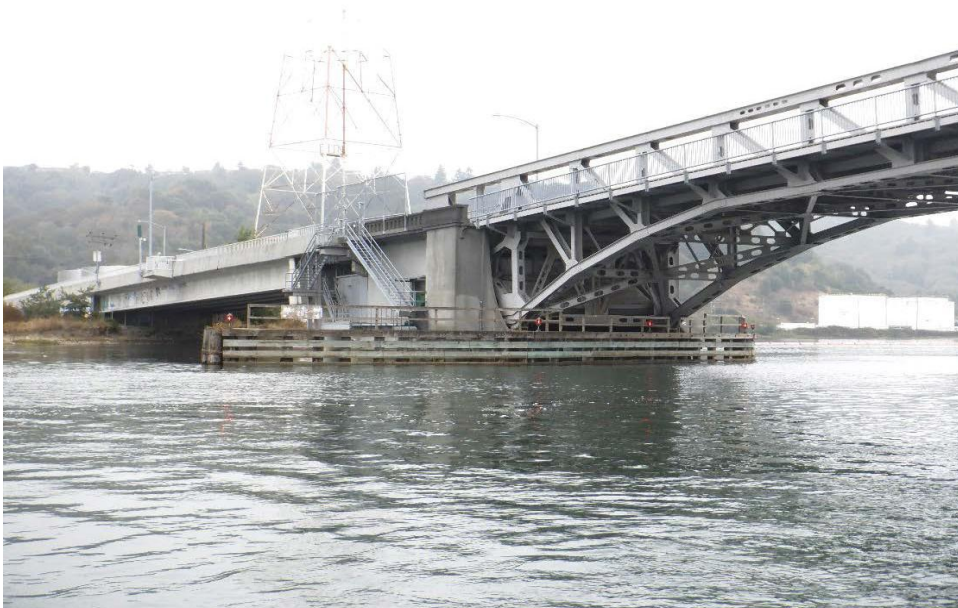
PHOTO No. 12 : Pier 5, Looking East - Note the overall fair to good condition of the protective timber fender system located on the channel side of the bascule pier. Inspection noted areas of fungal decay, as well as marine borer damage to the members.

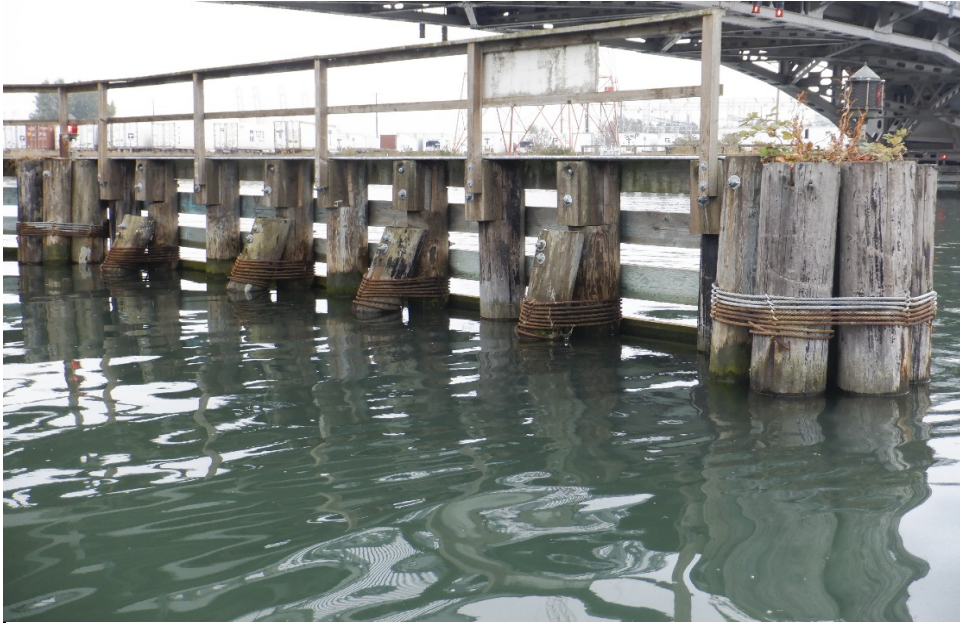
PHOTO No. 13 : Pier 5 Fender System, North End - Note the vegetation located in the tops of the dolphin piles. Also note the fair condition of the wire rope cable connections and the newer Chemonite Treated horizontal lagging.

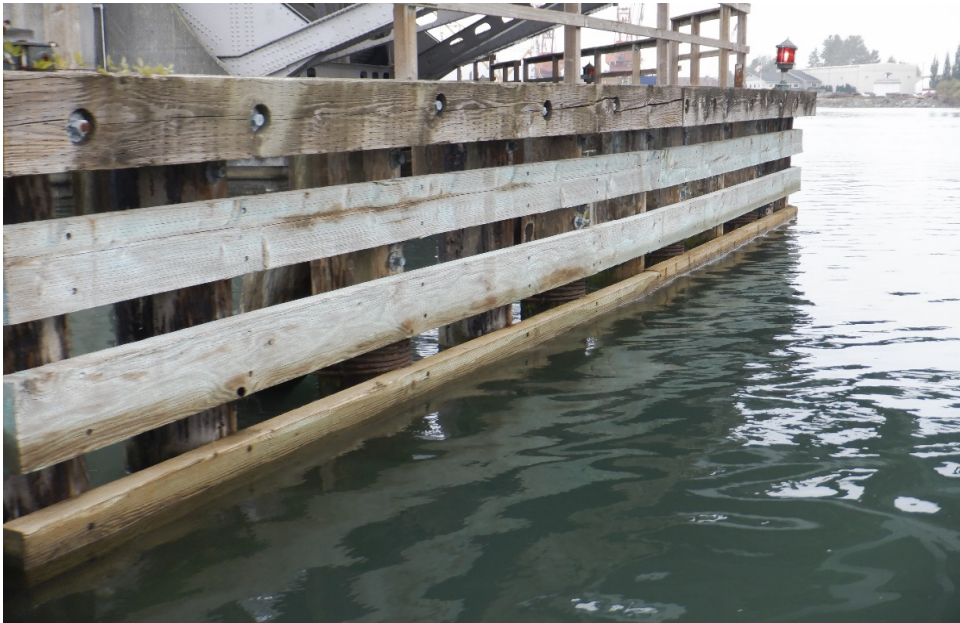
PHOTO No.14: Pier 5, Fender System - Note the overall good condition of the horizontal timber lagging with newer Chemonite treated members located in the intertidal zone.

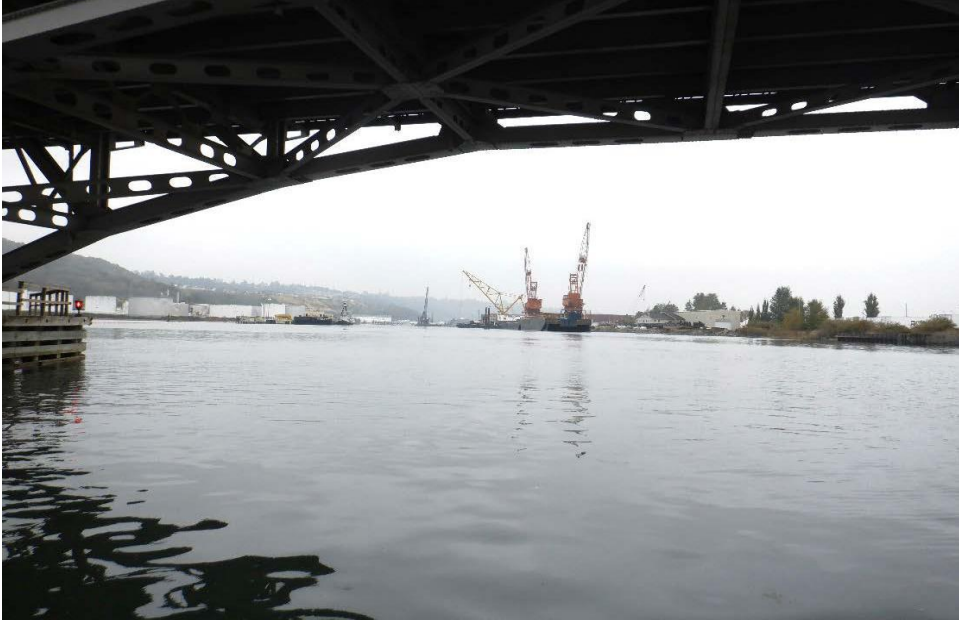
PHOTO No. 15: Hylebos Bridge Edge, Looking Southeast.
