# National Transportation Safety Board

## Response to Petition for Reconsideration

February 26, 2024

In accordance with Title 49 *Code of Federal Regulations (CFR)* 845.32, the National Transportation Safety Board (NTSB) has reviewed the petition for reconsideration and modification of the probable cause of the accident involving a Cessna 525 airplane in Memphis, Indiana, on November 30, 2018 (CEN19FA036). The petitioner has met the requirements for the NTSB's review of his petition; specifically, as the representative of Tamarack Aerospace Group, a party to the investigation, he has a direct interest in the investigation and has claimed that the NTSB's findings were erroneous. On the basis of its review of the petition, dated January 3, 2022, the NTSB grants the petition in part.

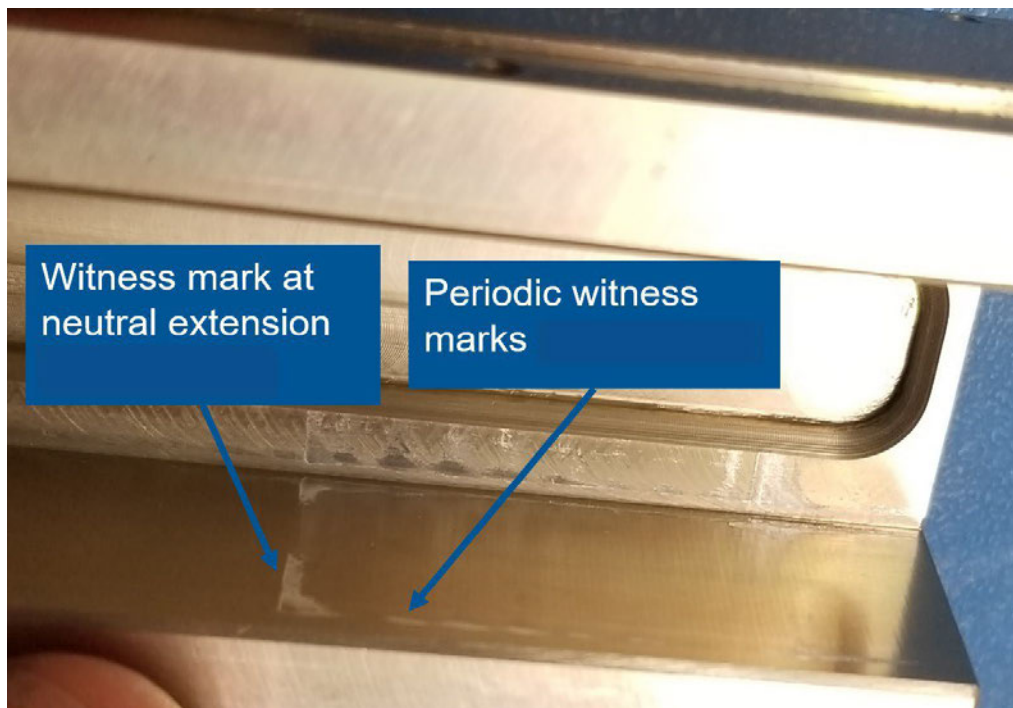
The photographs in figures 1 and 2, which were taken after the grease was removed from the ram guide, show a mark that corresponds to a TACS neutral position of the actuator and periodic marks toward the TCU full-extension position; these marks were not discussed in the original report. The periodic marks were consistently spaced at the approximate distance of the pitch of the ball screw (which positions the TACS). It is possible that the ball screw deformed during impact and that subsequent motion of the ball screw could have caused nonlinear motion of the ball nut and the periodic contact marks on the sides of the ram guide.

**Figure 1.** Witness marks on the side of the ram guide housing.

In summary, the witness marks on the bellcrank and hinge were outside the normal range of travel and were likely not consistent with the TACS position at the time of initial impact. In addition, although the NTSB's original investigation found witness marks on the TCU ram guide at the intermediate- and full-extension positions, the NTSB's re-examination also found witness marks that corresponded to a TACS neutral position and periodic witness marks on the ram guide. As a result, the available evidence for this accident is insufficient to confirm the petitioner's assertion that the actuator was in an intermediate position at the time of initial impact. However, the NTSB agrees with the petitioner that the evidence is also insufficient to conclude that (1) the left actuator was in an extended position at the time of initial impact and (2) the ATLAS caused the left rolling moment; the NTSB has revised the report accordingly.

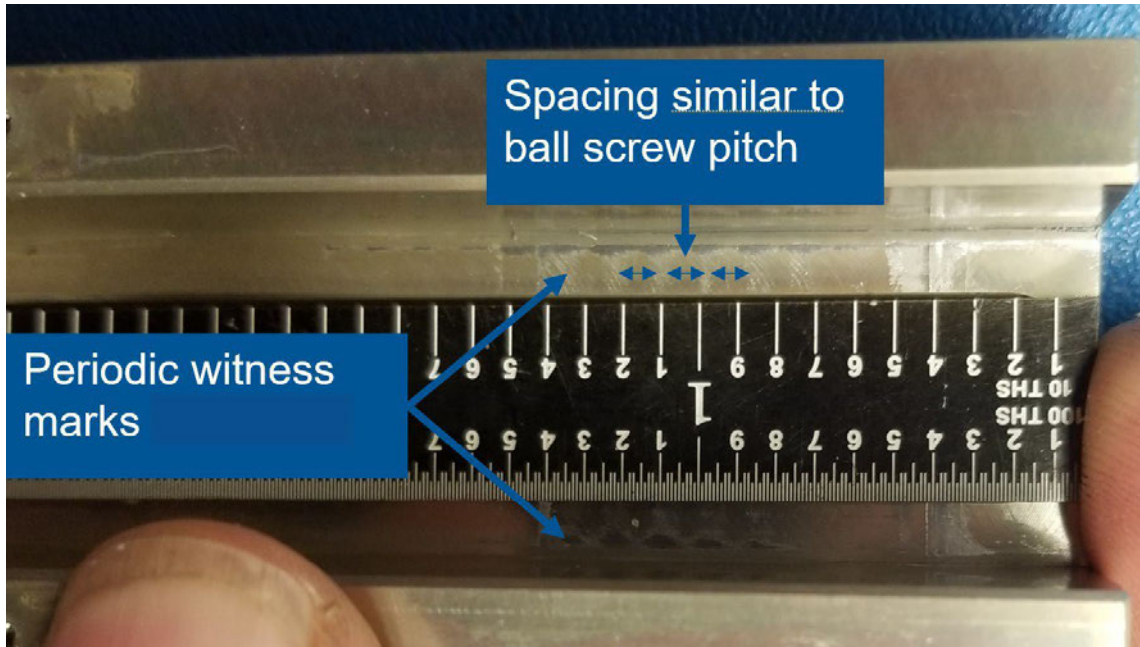
**Figure 2.** Periodic witness marks on the upper surface of the ram guide housing.

In addition, in May 2023, the NTSB compared the wear marks (resulting from normal operations) on an in-service actuator with the witness marks on the accident left TCU ram guide housing.<sup>8</sup> The comparison showed that the witness marks on the accident TCU were different than the normal wear marks.

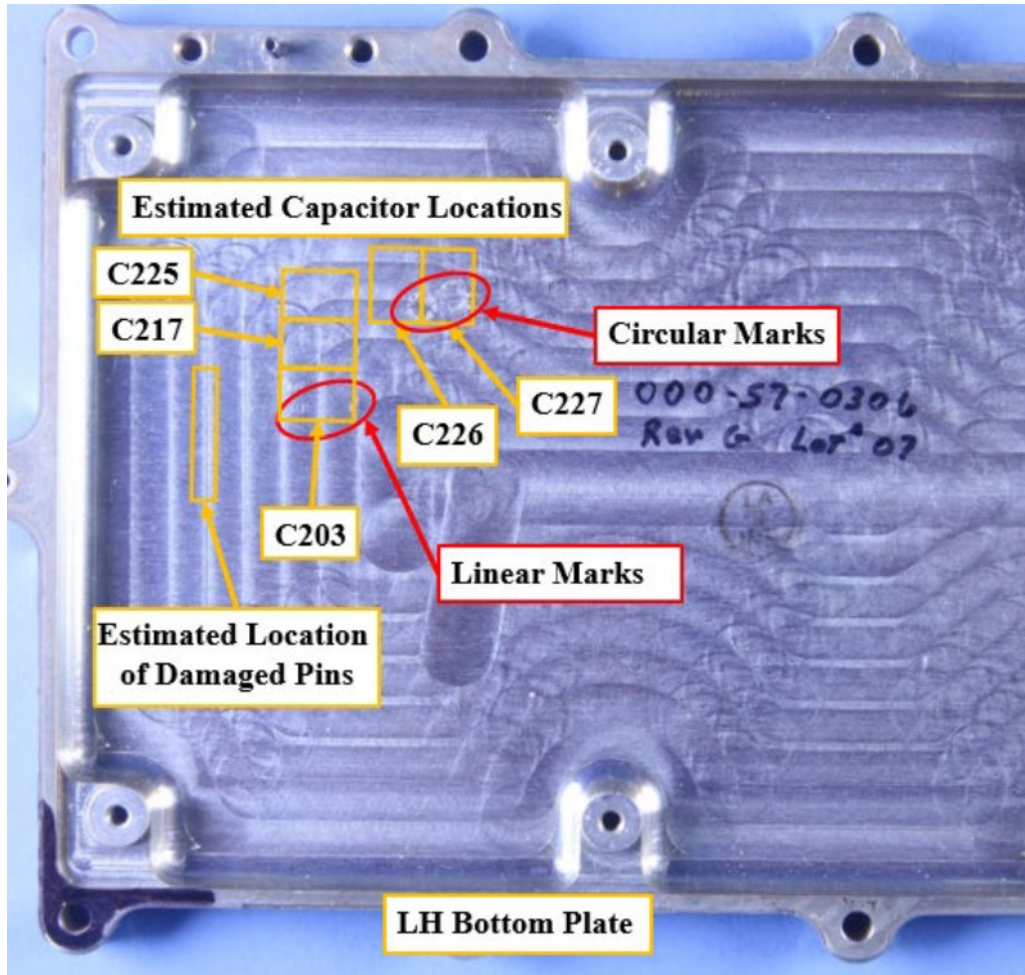
Figure 3 is a photograph (from the original investigation) of the bottom cover of the TCU. The figure shows that witness marks had transferred from the TCU circuit board to the bottom cover, which could have only occurred if the circuit board flexed until it contacted the cover. These marks were not noted in the final report for this accident.

**Figure 3.** TCU bottom cover showing witness marks that corresponded to capacitor locations.

Note: The labels C203, C217, and C225 through C227 indicate specific capacitors. The linear marks, which cannot be readily seen without magnification, were located in the area under capacitor C203.

Dimensional analysis of the circuit board assembly (performed by the NTSB as part of this petition evaluation) showed that, if the circuit board deflected during impact so that it contacted the bottom cover of the actuator, and if the bottom cover deflected slightly, the pins could disengage from the connector.<sup>10</sup> The analysis also showed that the area of maximum deflection of the circuit card was in line with the area of the 6 bent pins, which could explain why only 6 of the 40 pins were affected.

The NTSB found that the additional information from the impact load testing and dimensional analysis supported the possibility that the pins became bent during impact. However, the additional information does not eliminate the possibility that the pins had become bent during manufacture or maintenance given that the pins' pre-accident status is unknown.
