Re: Tamarack Aerospace Group's Petition for Reconsideration and Modification of Findings and Determination of Probable Cause and Request for Oral Presentation — Accident ID CEN19FA036, Memphis, IN – November 30, 2018, Aviation Accident; NTSB Aviation Accident Final Report Published on November 1, 2021

Tamarack Aerospace Group (Tamarack) hereby petitions the National Transportation Safety Board (NTSB) pursuant to 49 CFR § 845.32, to reconsider and modify its findings and determination of probable cause in the above-referenced matter. The basis of this petition is that the NTSB has made erroneous findings that are unsupported by the factual record, inconsistent with engineering principles, or proven to be physically impossible.

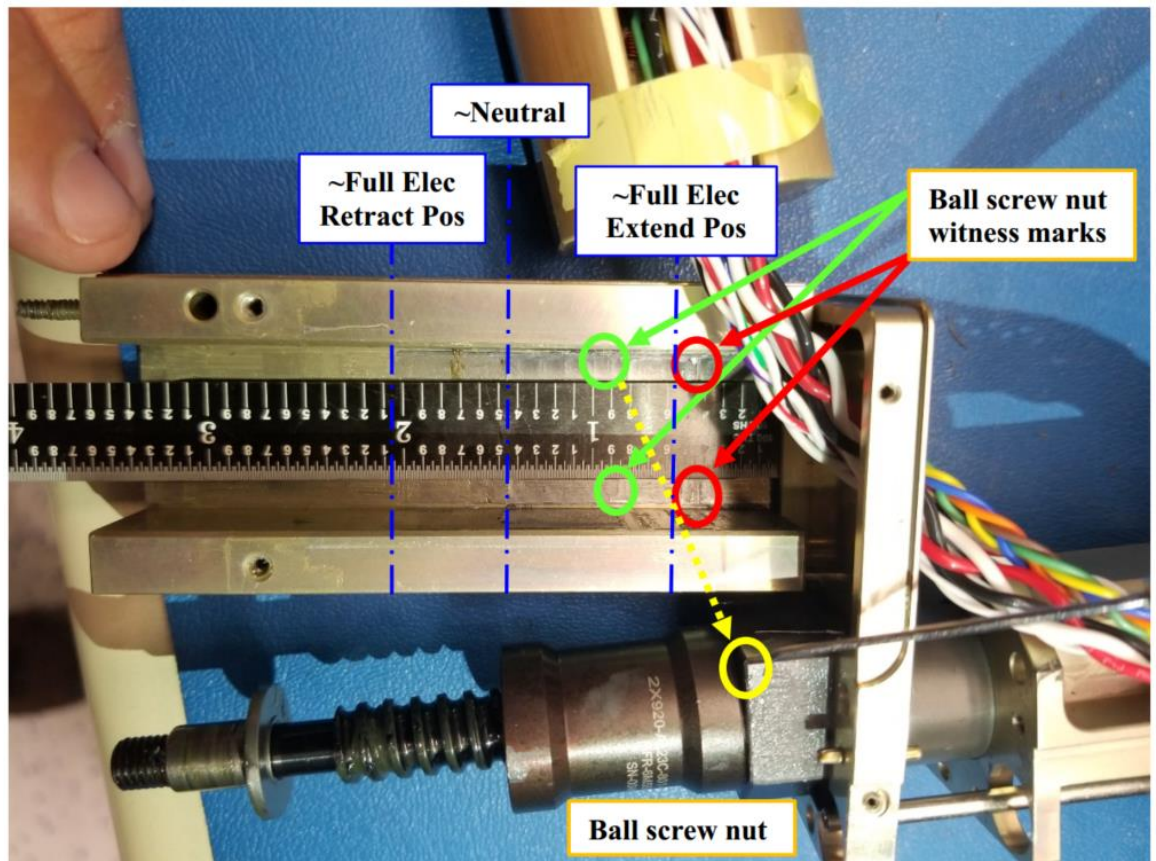
Figure 47 – Upper ram guide housing with witness marks highlighted and estimated travel positions

The ball screw nut was lubricated and free to move by hand with no signs of binding. Two sets witness marks were observed on the ram guide housing, ref Figure 47. **One set of witness marks (green in picture) correspond to a position of intermediate extension. The location of the other set of witness marks (red in picture) corresponds to a position of full extension of the actuator.** [Emphasis added.]

The statements in the Final Report and the Systems Report are inconsistent. The Final Report must be revised to accurately reflect which set of witness marks were found in an intermediate position and which set of witness marks were found in a full extension position.

More fundamentally, the ram guide assembly only contacts the ball nut on two sides, to provide anti-rotation for the ball nut. It is impossible for the ball nut to leave contact marks on the upper or lower surface of the ram guide housing unless the actuator is subjected to a massive acceleration perpendicular to the line of action of

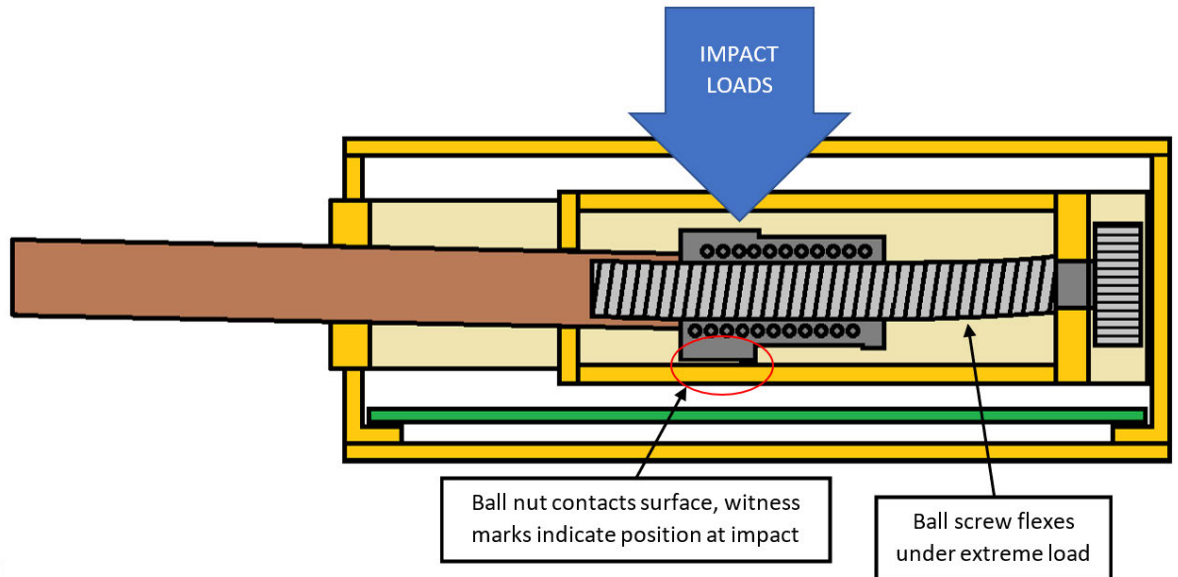
Illustration of ball screw deformation under impact loads

The only explanation for the presence of the contact marks on this part of the ram guide housing is a high velocity impact of the airplane with terrain. The ball nut guide attaches to an end plate within the actuator. The end plate functions as the extension hard stop within the actuator or the hard surface that the ball nut would contact if driven or externally forced past the electronic extension limit. The end of the ball nut guide is approximately 0.15" from the face of the extension hard stop.

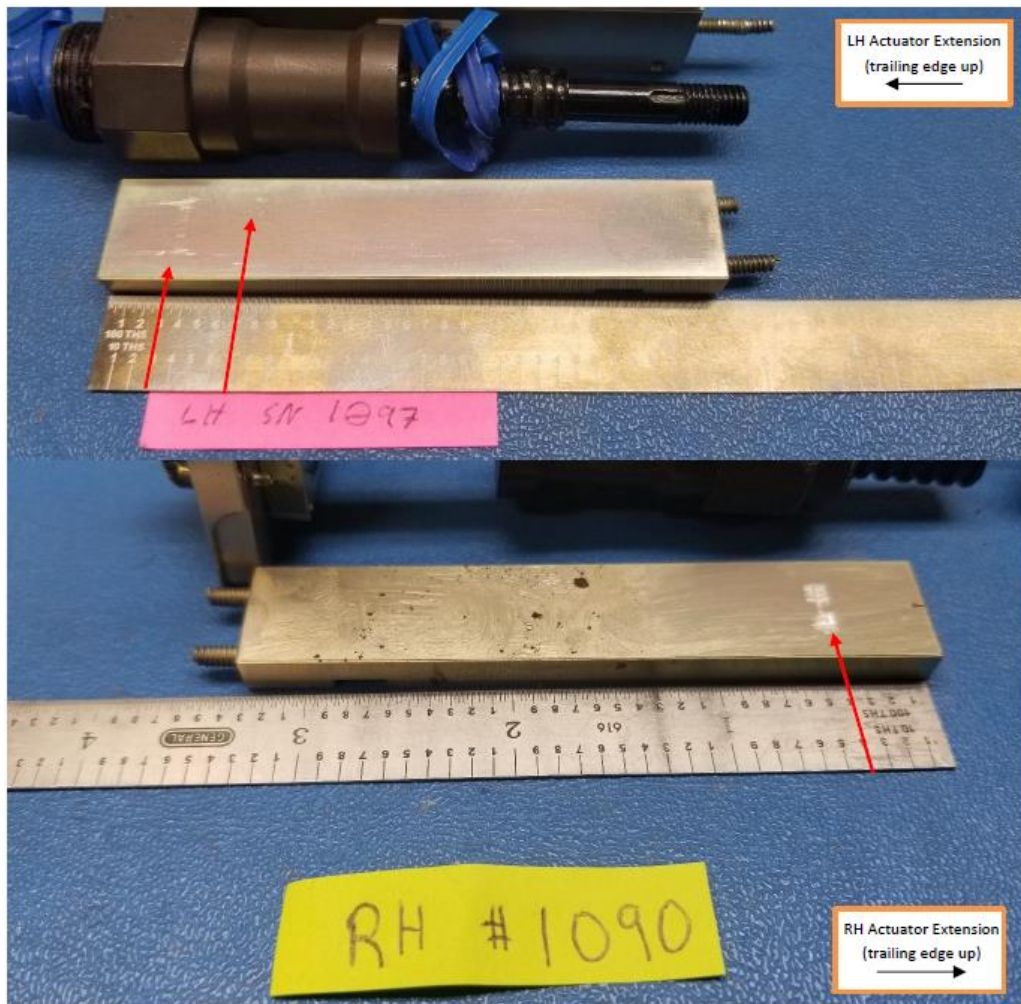
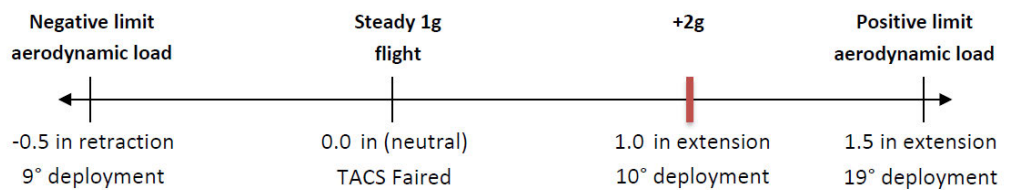
The left-hand actuator has two sets of contact marks. One set is very faint and appears approximately 0.7" from the extension end of the ball nut guide, or 0.85" from the extension hard stop. The other set is more pronounced and appears at approximately 0.30" from the extension end of the ball nut guide, or 0.45" from the extension hard stop. See the Systems Report, at page 42, Figure 48, and the Party Submission, in Figure 2-22. See also Figure 2-23 in the Party Submission for an illustration of actuator position relative to various flight conditions. Both figures from the Party Submission are excerpted below.

As discussed later, the TCUs are mounted in the aircraft asymmetrically— the right hand TCU is mounted upside down relative to the left hand TCU. The intermediate witness marks were found on the lower surface of the ram guide housing, which would be oriented differently on the left and right side relative to the airplane. This is expected, given that the shape of the ball nut makes the lower surface gap smaller.

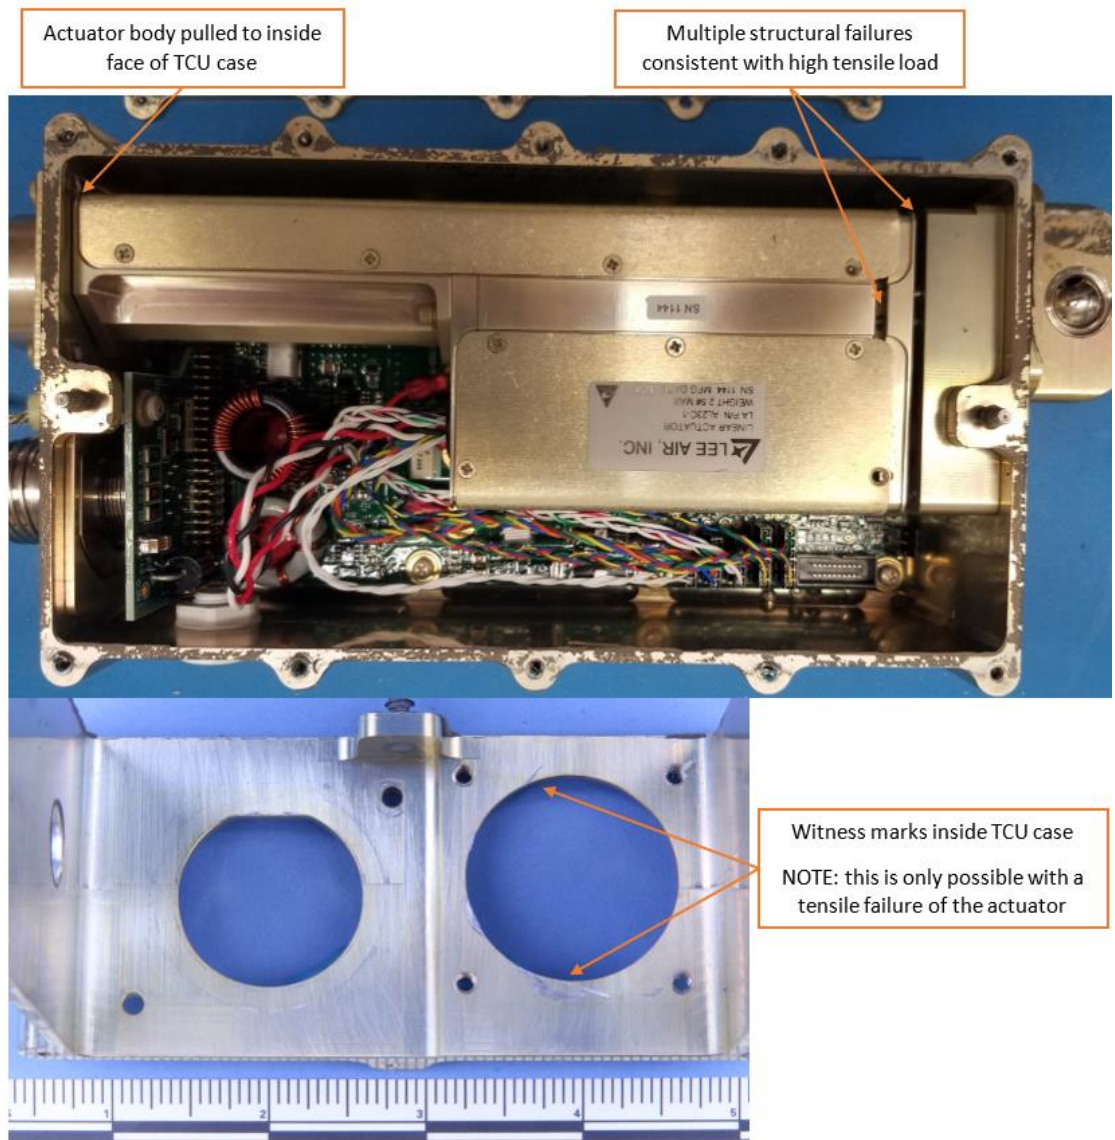
Further, there is internal actuator damage at the TCU/Actuator mount consistent with the TACS being forced trailing edge up. This damage includes tensile failure at the attachment hardware. *If the TCU/Actuator had deployed to drive the TACS to a fully extended position, these fasteners would have been loaded in compression, not in tension.*

When the left-hand TCU was opened for examination by the party members after being recovered from the wreckage, the actuator was discovered with structural failures in the screws connecting the gear train to the rest of the actuator body. Examination of the inner face of the left-hand TCU case revealed a contact mark similar to the mark found inside the actuator on the extension hard stop. This is notable, because the actuator body is static and can only cause that type of mark in the event of a failure. The figure below illustrates the condition of the left-hand TCU as found, noting the relevant witness marks and structural failures.

Condition of left-hand TCU as found

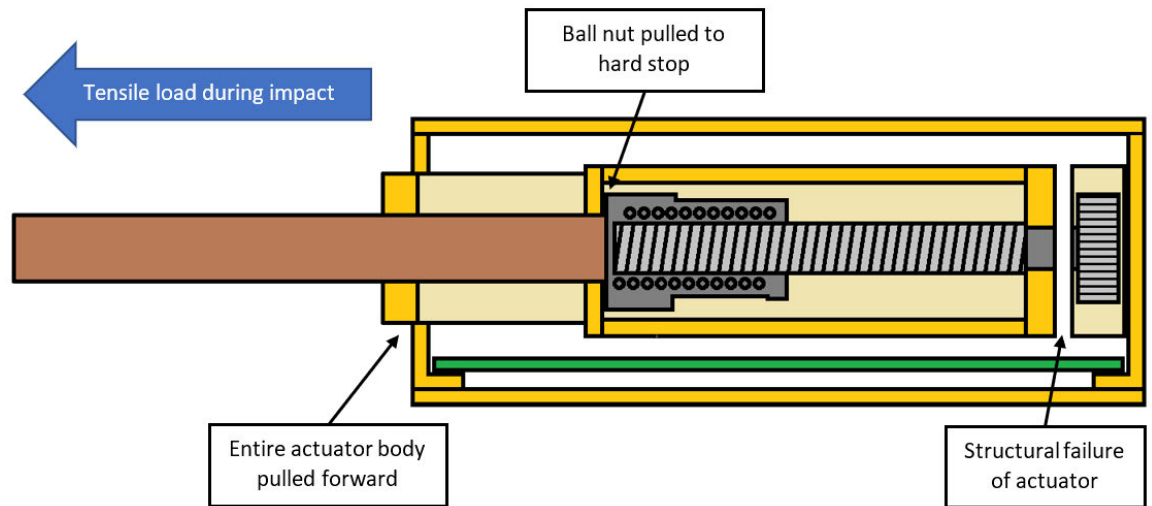
There is one overwhelmingly probable explanation for the simultaneous existence of witness marks showing contact of the ball nut with the internal extension hard stop, witness marks showing contact of the unmoving actuator body with the interior of the TCU case, and structural failures in the fasteners holding the actuator body together. It is probable that a massive tensile force rapidly extended the ram tube of the actuator, causing the ball nut to impact the extension hard stops, then continued to pull the actuator until the fasteners failed and the entire actuator body was pulled forward to the interior wall of the TCU case. This scenario could only have been caused during the impact sequence.

Illustration of impact tensile force and resulting damage to left-hand actuator

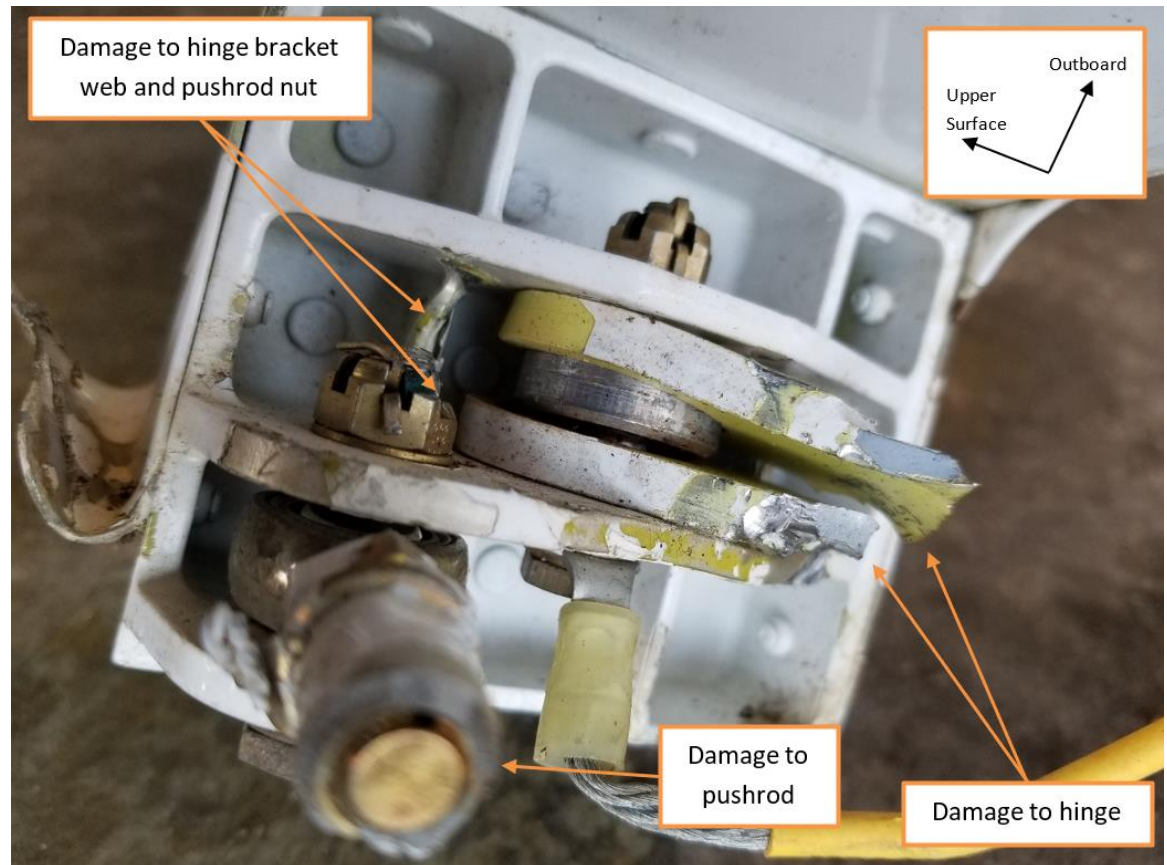
Physical evidence also shows that the TACS were forced to over-deflect beyond the physical limits of the actuator and deployment hardware post impact. During a meeting of the investigation parties to examine the wreckage of the accident aircraft, party members estimated that the damage to the left-hand TACS hinges was consistent with a TACS trailing edge up deflection of 55°, far exceeding the maximum possible deflection of 21°. See Party Submission at p. 22. The following figure from

LH TACS hinge bracket damage

There are two sets of hard stops which limit the deflection of the TACS. One is the extension hard stop within the actuator. The other is a hard stop built into a bell crank connecting the actuator to the TACS. The maximum deflection allowed by either set of hard stops is 21°. The fact that the TACS hinges showed evidence of a TACS deflection to 250% of the maximum deflection indicates that the TACS were forced to

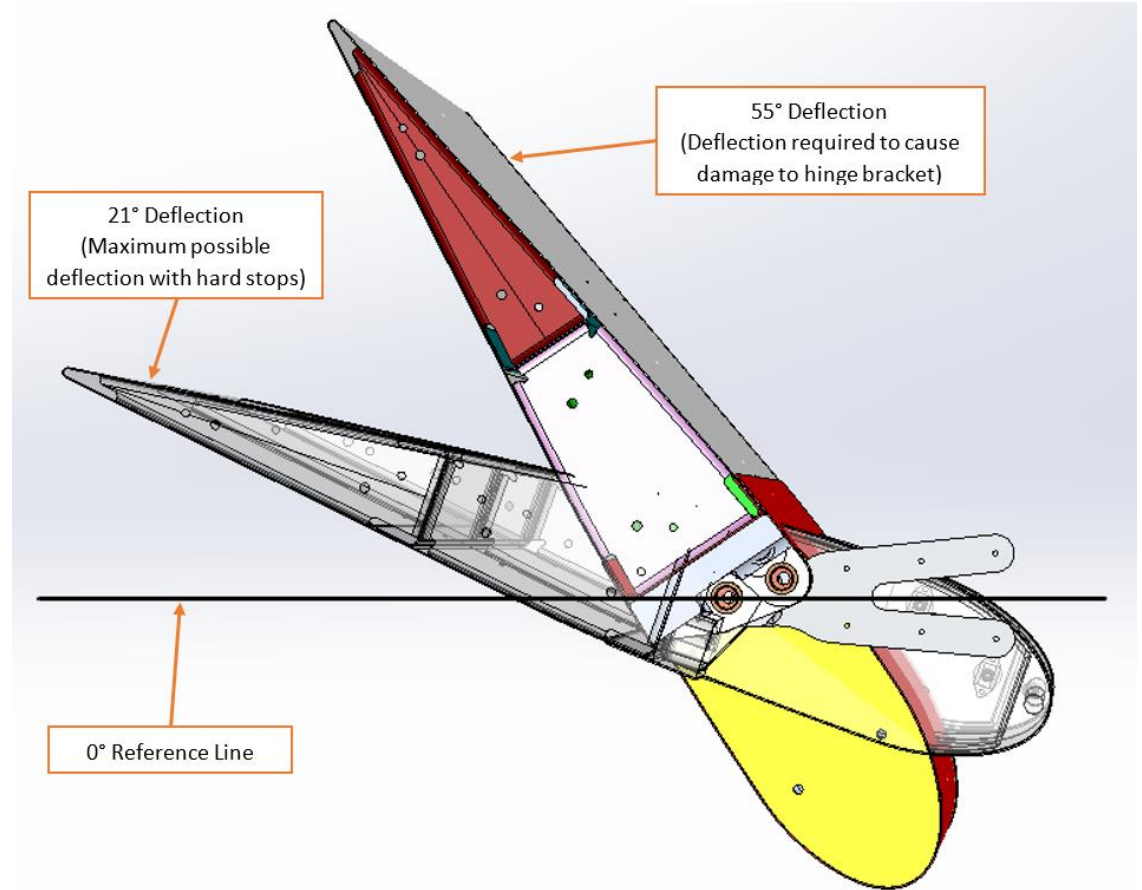
Comparison of LH TACS maximum deflection vs. over-deflection

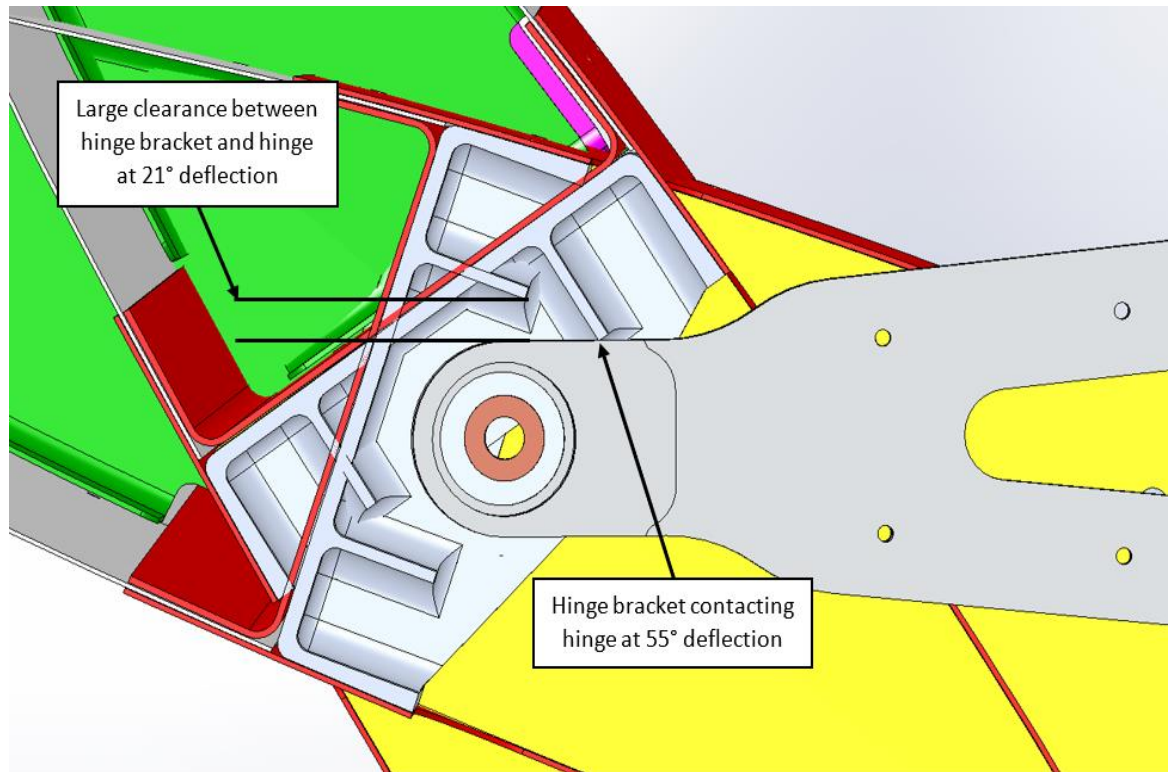
LH TACS hinge bracket detail, maximum deflection vs. over-deflection

There is a walking beam installed between the actuator and the bell crank. The walking beam has three attachment points.¹³ One end of the walking beam attaches to a bearing installed in a bracket mounted on the wing spar. The other end of the walking beam attaches to a bearing in the rod end of the actuator. The middle of the walking beam attaches to a bearing on a pushrod, which is connected to the bell crank that directly drives the TACS.

The walking beam was found fractured into two pieces. The fracture occurred at the point where the pushrod connects the walking beam to the bell crank. The damage to the walking beam was consistent with the middle bearing being torn out of the walking beam in the direction of the bell crank. This is consistent with the TACS being forced to an extreme trailing edge up deflection at high speed and clearly not a malfunction during flight operations.

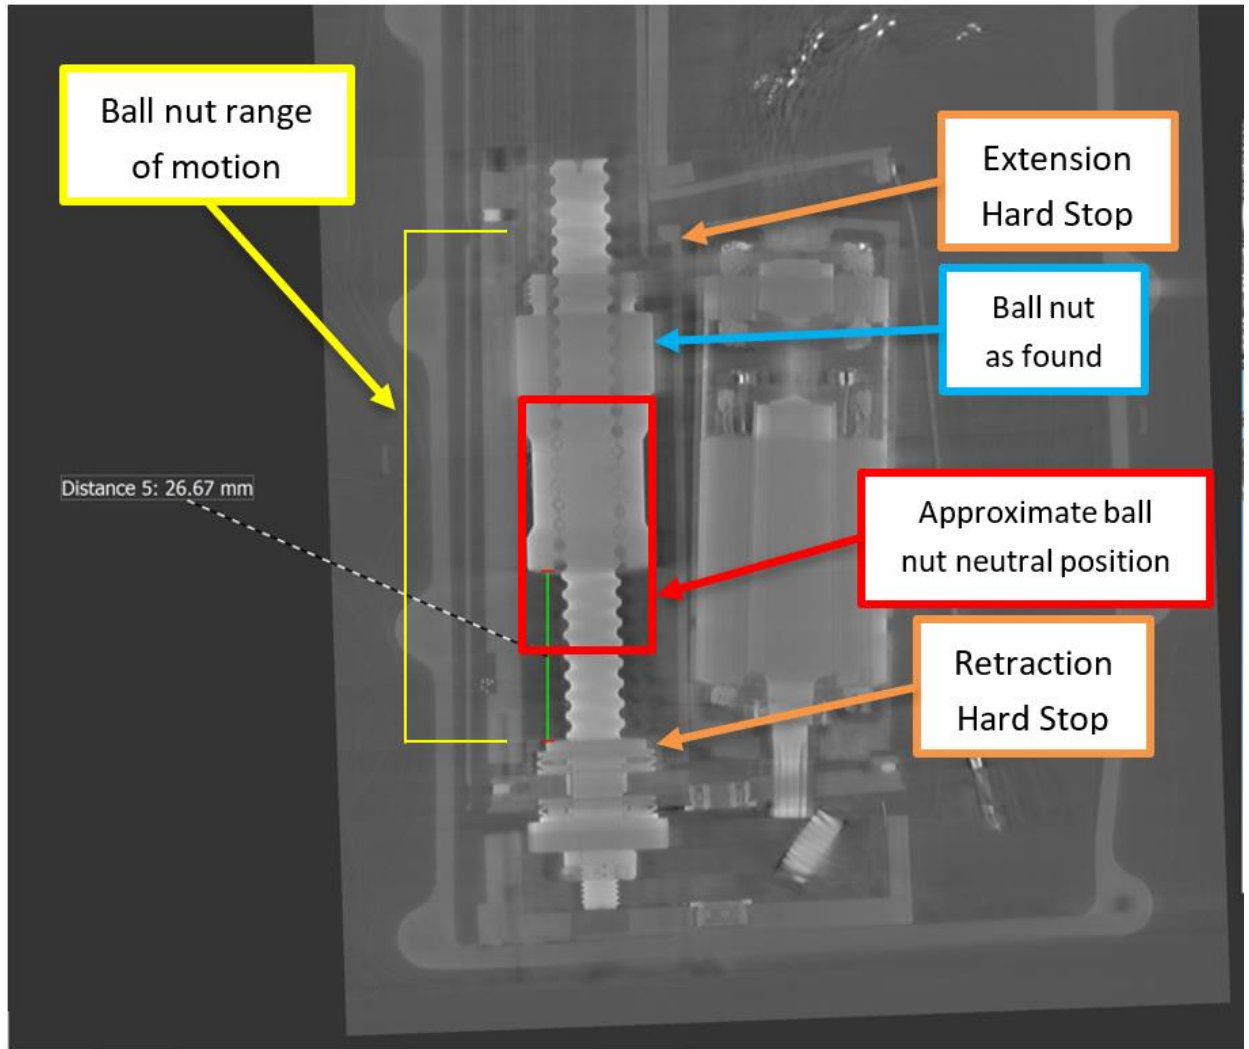
These two statements are inconsistent. An intermediate extension position is not the neutral position. The right-hand actuator contact marks appear approximately 0.40" from the extension end of the lower ball nut guide, or approximately 0.55" from the extension hard stop. This position is close to halfway between the neutral position and the maximum extension position. The right-hand TCU was found with the actuator ram tube broken off at the seal where the ram tube enters the actuator. CT scans of the right-hand actuator confirm that the ball nut was in this position when the right-hand TCU was recovered from the wreckage. See Systems Report, at Page 24, Figures 23 and 24; Party Submission, at page 28, Figure 2-22; and the figure below. As evidenced in the figure below (an image from the CT scan results of the

right-hand TCU)¹⁴, the location of the contact marks on the ram guide housing is direct evidence that the position of the ball nut was caused by the ground impact.

CT image of RH actuator in as-found condition

Damage to the right-hand TACS bell crank and right-hand TACS hinges indicate that the right-hand TACS was forced to an extreme trailing edge down position. This is not consistent with the contact marks within the right-hand actuator. The most probable explanation for the discrepancy is that the damage to the right-hand bell crank and right-hand TACS hinge occurred after the right-hand actuator ram tube was broken off.

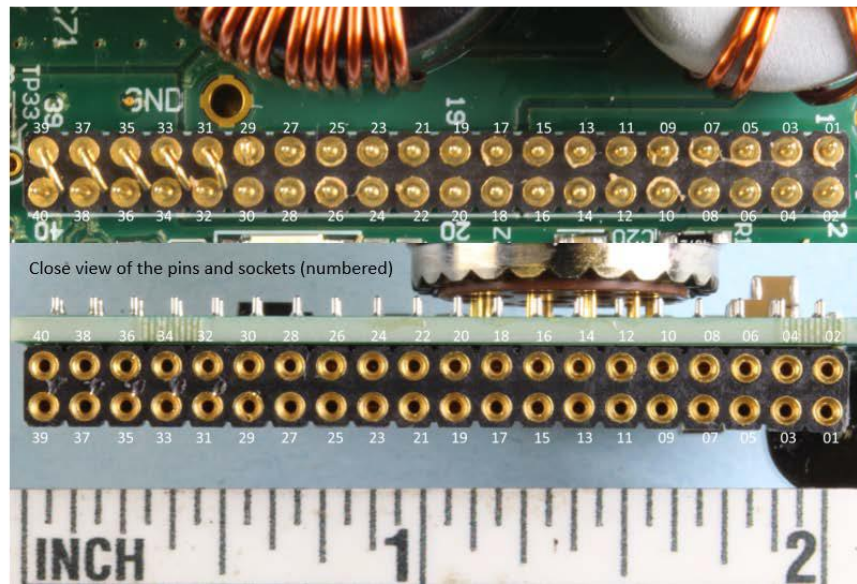
The location of the pins on the Mill-Max connector corroborates this theory. The six pins are located adjacent to each other, in one of the two lines of pins on the TCU main circuit board side of the connection. See the following figure from the Appendix A of the Systems Report, *Material Lab SEM Imagery of [Left-Hand] TCU* (Docket Item # 6, at p. A-2):

The pins are located on the line of pins farther from the front edge of the TCU housing, and on the far end of the connector from the TCU side wall. This is notable, because these pins are located under a less mechanically supported portion of the TCU board. In other words, if the TCU board were to flex, the pins are located in exactly the part of the connector which could be reasonably expected to move the most. The following graphic presents an illustration of how the left and right TCU

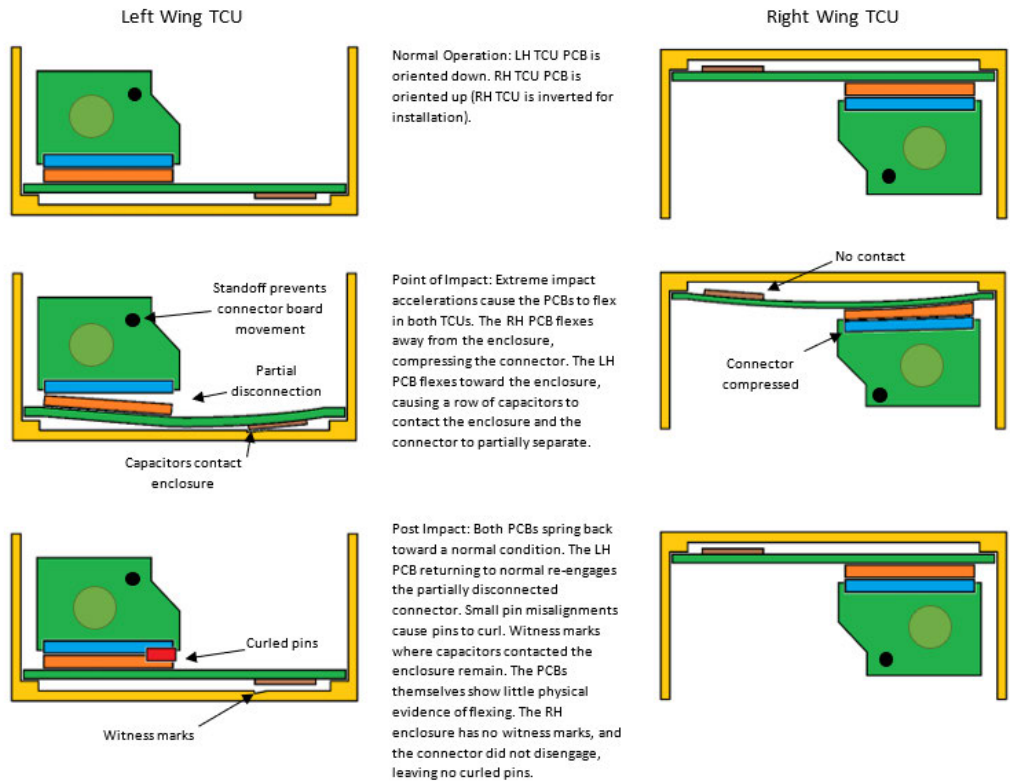
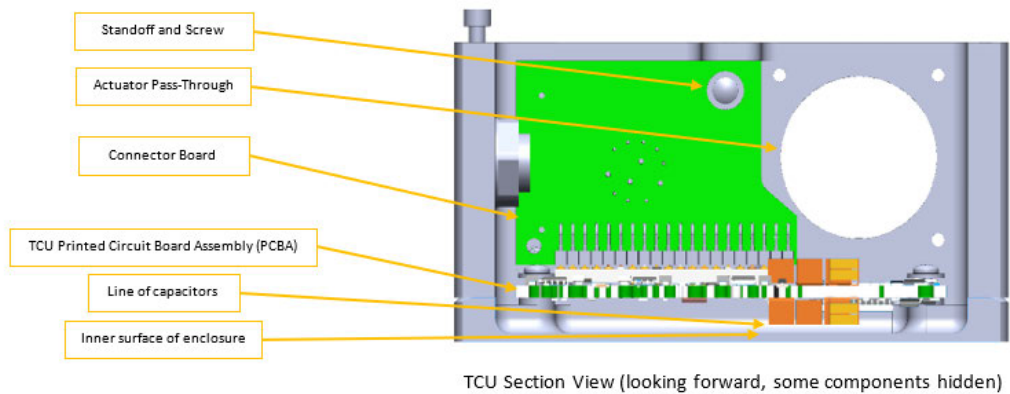
Illustration of TCU printed circuit board flex in response to impact forces

To test the theory, the NTSB sent the lower TCU cover to be imaged with a high magnification optical microscope. During this imaging, witness marks were discovered on the lower TCU cover. Notably, the marks on the lower cover approximately matched the shapes and locations of components on the lower side of the TCU circuit board. For example, a narrow rectangular mark was discovered below a pair of stacked capacitors with narrow, rectangular pieces of metal soldered to the ends to join the two capacitors. These witness marks are not addressed in the Final Report.
