# National Transportation Safety Board

HWY24MH005

## **SURVIVAL FACTORS**

Group Chair's Factual Report

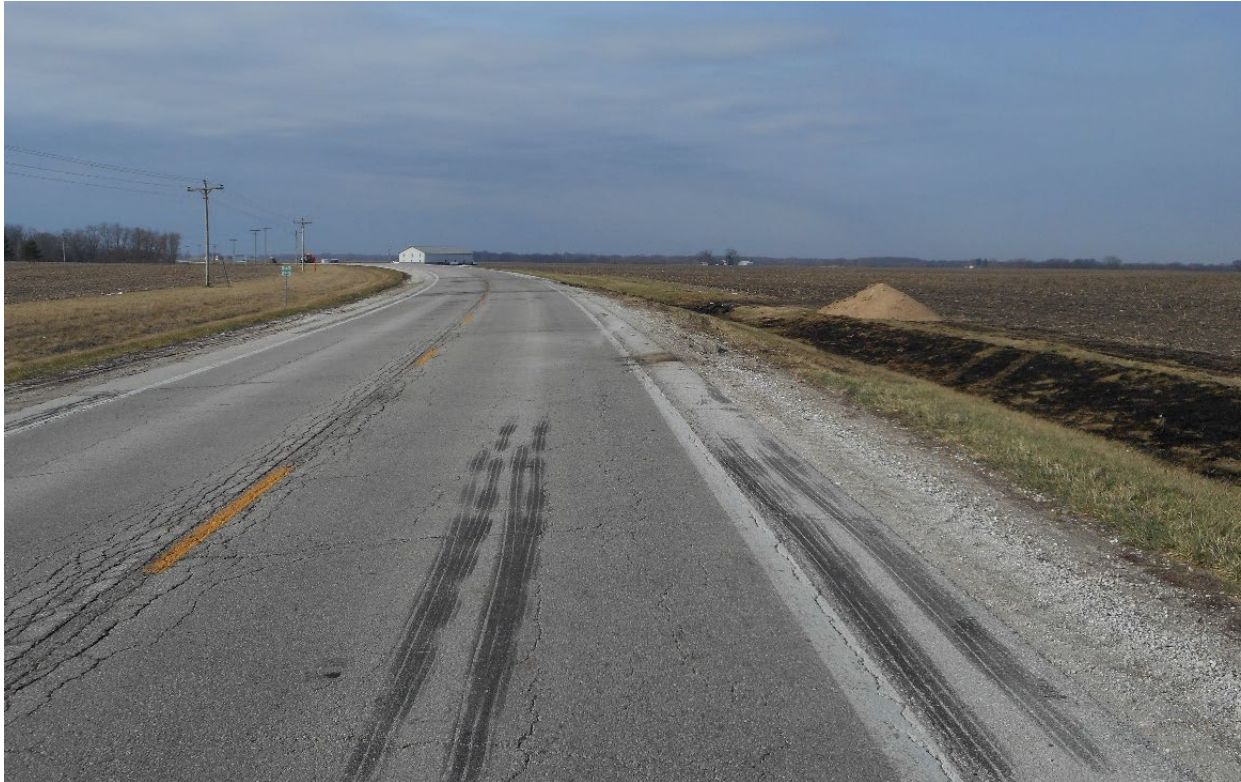
At this location, US-24 was an undivided two-lane rural road with a posted speed limit of 55 miles per hour. Each lane was bordered by an asphalt concrete and aggregate shoulder.<sup>1</sup> Refer to Figure 1 below for a view taken of the scene the day after the crash occurred.

**Figure 1.** View looking west at tire marks leading to the area of impact.

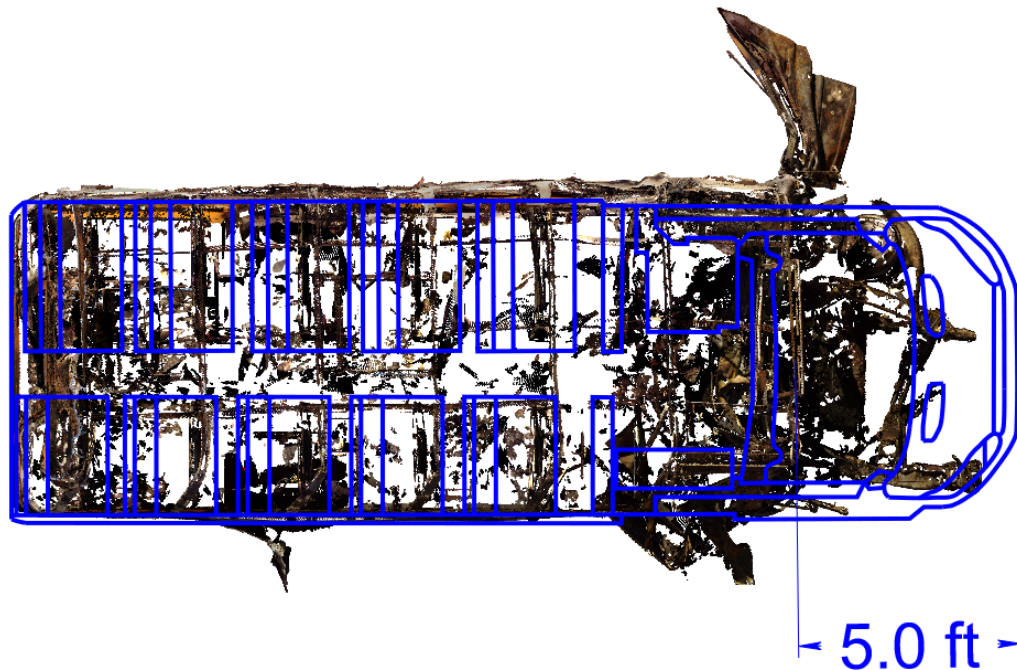
The exterior of the bus sustained heavy front-end damage as a result of the frontal impact with the truck. Figure 2 shows the damaged bus captured from the three-dimensional scan, overlaid with an outline of the undamaged exemplar bus. The front end of the bus, including the engine block, was displaced rearward with the deformed frame rails and other metal components remaining. The bus sustained substantial

front-end crush with a measured 5 feet of engine displacement rearward from the front bumper of an exemplar, as observed in the overlay in Figure 2. The bus engine rearward displacement intruded into the driver seating area and the center console. The post-crash fire consumed the majority of the bus leaving primarily only the metal components, as shown in Figure 3.

**Figure 2. Graphic of the damaged bus overlaid with an outline of undamaged bus.**

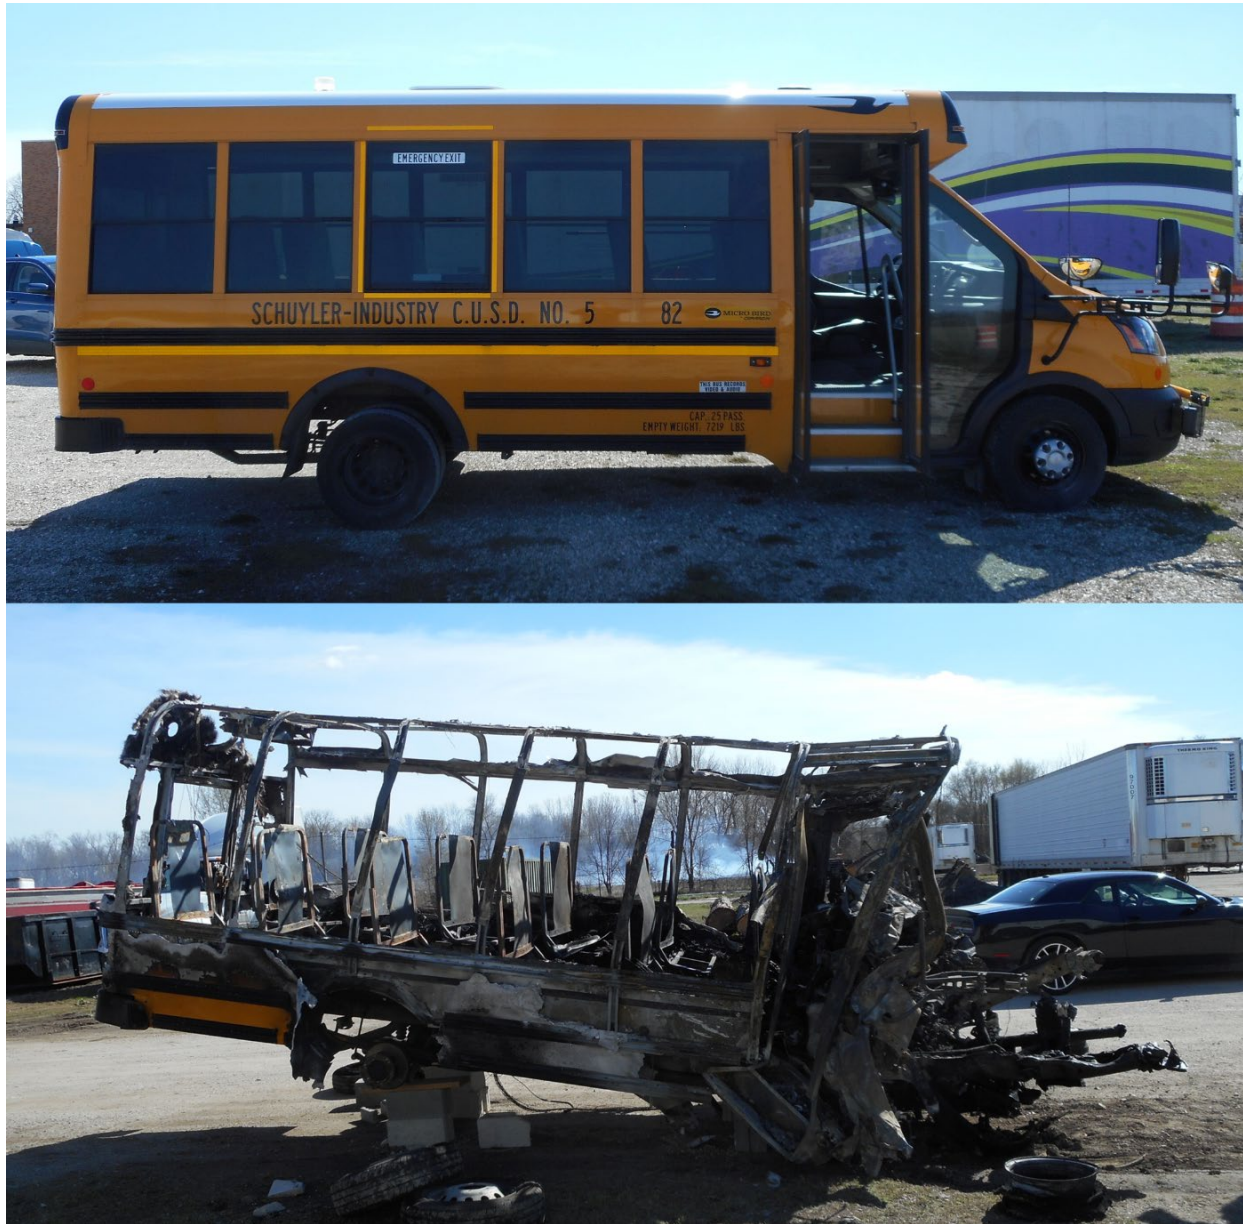
The bus had five 30x35 inch passenger windows on the left side behind the driver's door window. As shown in Figure 3, the right side of the bus was equipped with five 30x35 inch windows behind the bi-fold loading door. Based on the exemplar school bus, the third window from the front on each side of the bus was an emergency exit window, measuring 30x35 inches. Based on the exemplar school bus, the two-emergency exit windows displayed the appropriate signage. The exit signage was printed at the top of the window (Emergency Exit) and at the bottom of the emergency exit window (Lift Handle, Push to Open with a red arrow pointing upwards) on both the inside and outside surfaces of the bus.

The windshield and all the windows disintegrated in the crash and post-crash fire. The bi-fold door was displaced and crushed rearward, as was the loading stairwell. There was an opening in the bus roof where the plastic emergency roof exit hatch was located above the center aisle at Row 3. Examination of the rear emergency exit door showed that it was still operable. All six tires were consumed in the post-crash fire. The high-density polyethylene (HDPE) gas tank that was secured to the bus undercarriage inside the frame rails and under the first and second seat rows, was also consumed in the fire. Refer to Section 3.9 School Bus Fuel Tank Standards.

**Figure 3. Comparison view of right side of exemplar bus and damage to crash bus.**

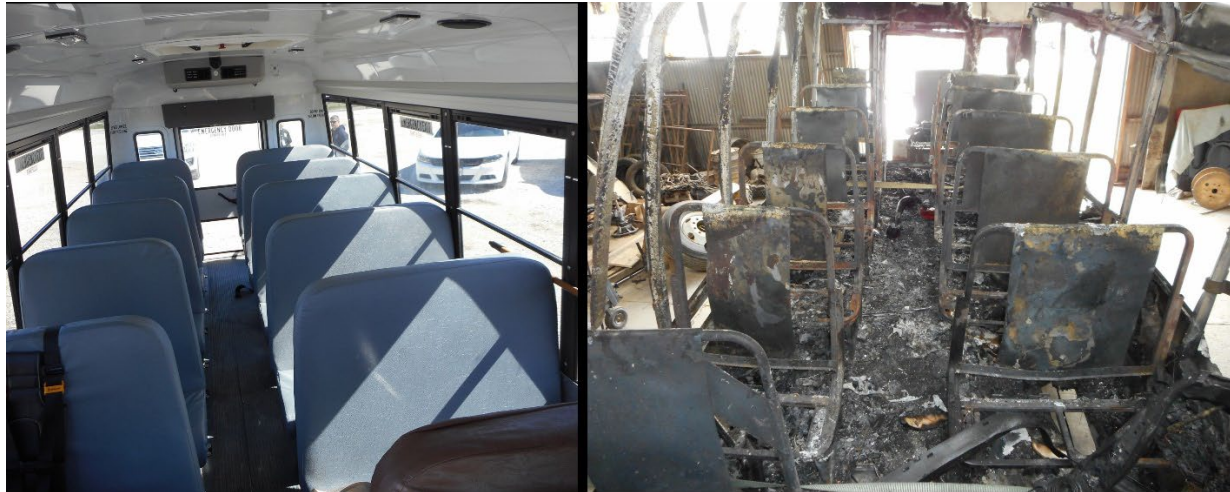
As previously mentioned, the majority of the interior of the bus was consumed in the post-crash fire resulting in thermal damage that left primarily only the metal seat

frames and metal components, as shown in Figure 4. The school district provided an exemplar bus (2021 MB-II) to assist investigators in identifying components and systems in the crash-involved bus.<sup>2</sup>

**Figure 4. View looking from front to rear in exemplar and crash involved buses.**

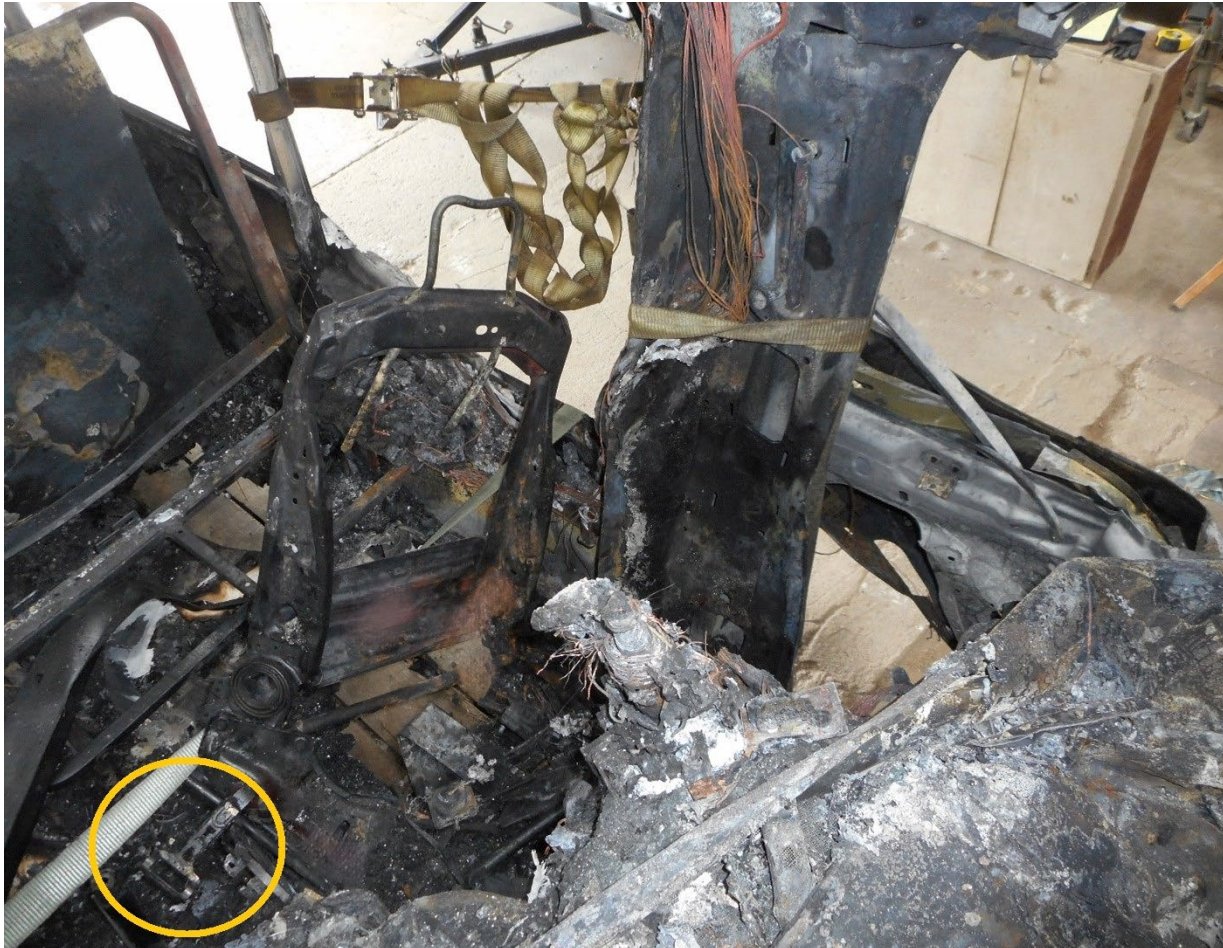
The driver's seating area and loading door area were displaced rearward from the intruding engine block through the firewall, dashboard, and floorboard. The bus was equipped with an adjustable high-back bucket seat with an integral headrest for the driver seat position. The driver seat was still attached but was deformed and shifted rearward and rotated clockwise approximately 30 degrees from its original position as shown in Figure 5. The driver's steering wheel was broken off the steering column. The driver seat was equipped with a lap and shoulder seat belt attached to the B-pillar. The D-ring was in the lowest position. Examination of the driver's lap/shoulder belt showed that the latch plate was still inserted in the buckle, as shown circled in Figure 5. The webbing of the lap and shoulder belt was consumed in the fire.

**Figure 5. Overhead view of deformation to driver's seating area. Note buckled seatbelt (circled).**

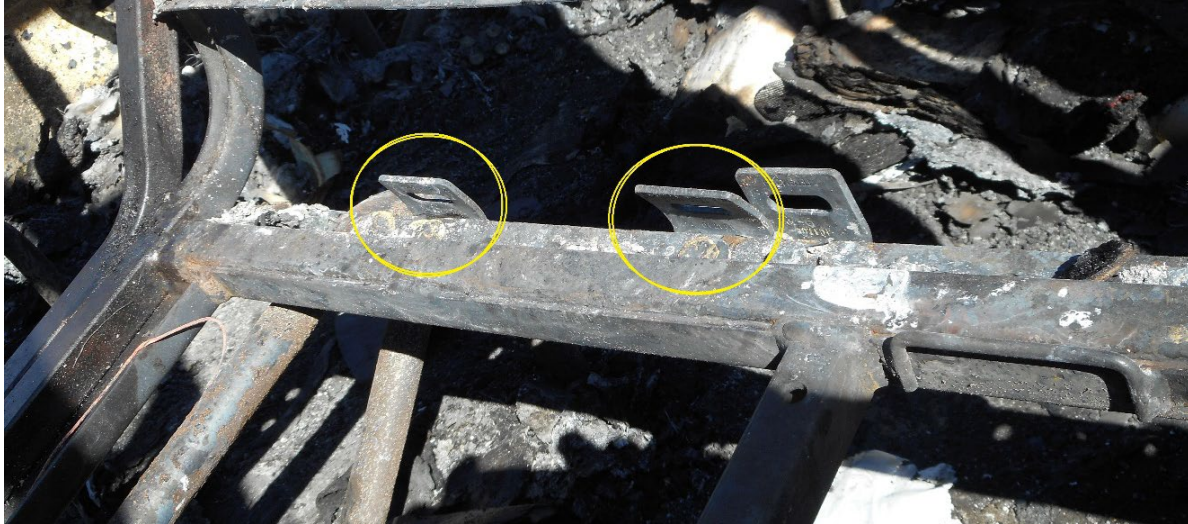
All 25 seat positions were equipped with lap belts, which, except for the latch plates and buckles, were consumed in the post-crash fire. Examination of all 25 lap belt anchors on the bus revealed three lap belt anchors were visibly bent forward. The metal belt anchors for the lap belts for seat positions in Row 1 and 2 on the left side aisle seats and Row 2 on the right-side aisle seat were bent forward as shown in Figure 6. The Illinois State Police (ISP) discovered a single buckled seat belt in the debris on the floor of the bus. A further search was unsuccessful in finding any additional buckled lap belts.

**Figure 6. View of bent lap belt anchors (circled) on the seat frame in Row 1 left side aisle seat.**

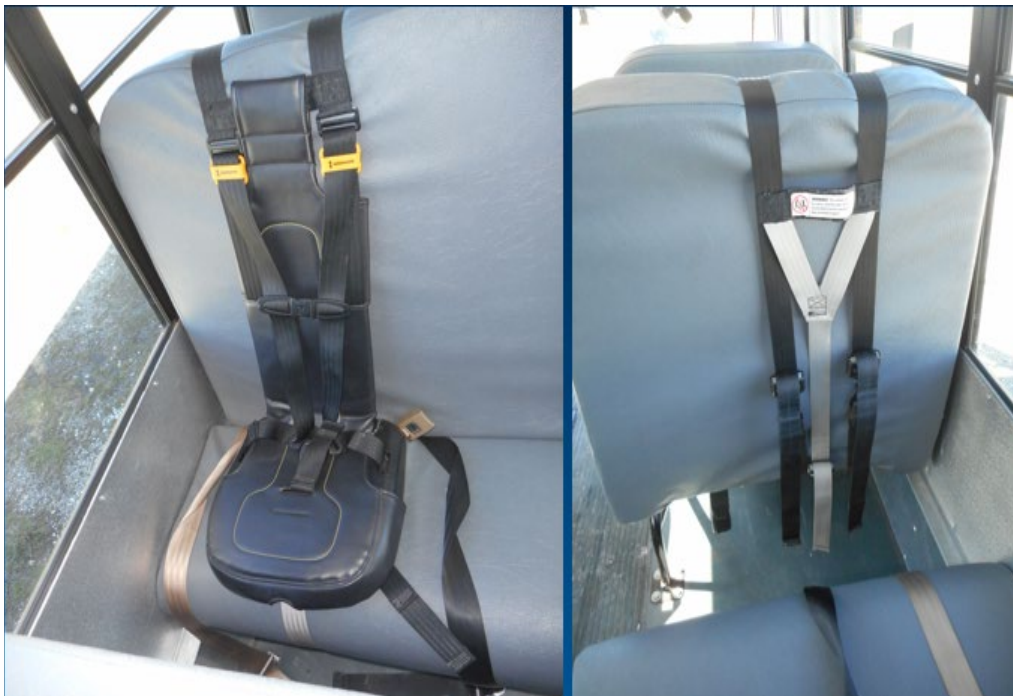
**Figure 7. Front and rear views of installed 5-point CSRS in exemplar school bus.**

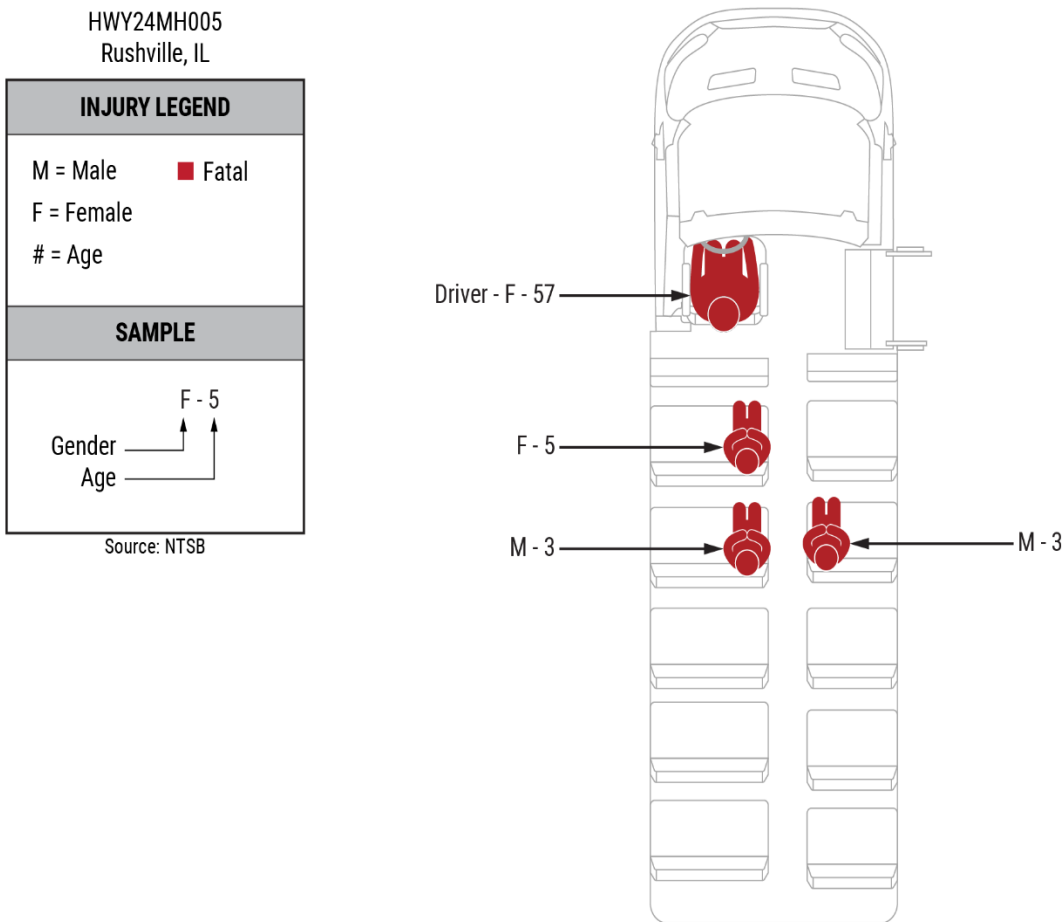
The seating chart shown in Figure 8 is based on documentation obtained from evidence of occupant loading found on the three sets of lap belt seat anchors and EMT descriptions of the final rest positions of the passengers. The seating chart provided by the SICUSD Director of Transportation indicated one of the 3-year-old male students seated in the first row on the right across from the 5-year-old female. Postcrash evidence indicated that the two 3-year-old boys were seated across from each other in the second row.

**Figure 8.** Seating chart of occupied seats.

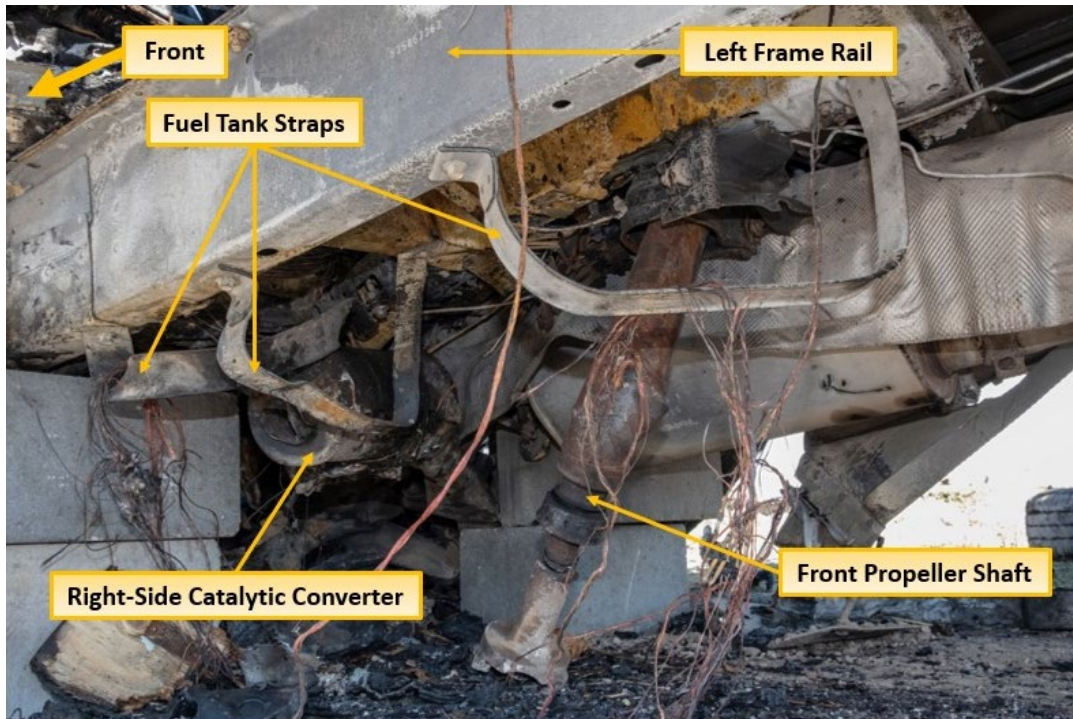
Based on witness accounts, the post-crash fire ignited almost instantly after the impact between the bus and the truck. Both vehicles were consumed in the post-crash fire. As shown in Figure 9, the HDPE fuel tank was consumed in the post-crash fire.

**Figure 9.** Undercarriage view of area adjacent to fuel tank location (Annotated).

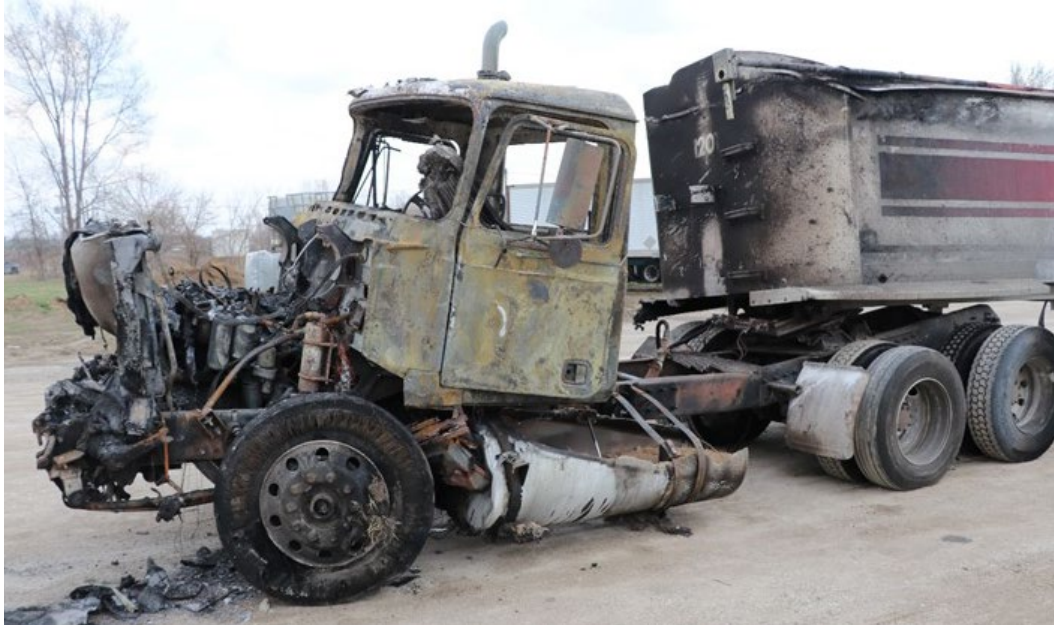
The Mack truck sustained extensive damage to the front end, as shown in Figure 10 from the impact and post-crash fire. The front end sustained approximately 3 feet of crush, displacing the engine rearward. All that remained were primarily the metal components and partially burnt front tires. The truck's left-side saddle gas tank was

compromised while the right-side saddle gas tank had melted in the post-crash fire. The 2001 Vantage 39-foot dump trailer sustained minor damage from the 90-degree rollover to the right side and minor damage from the post-crash fire and resultant brush fire.

**Figure 10.** Front-left angle view of front-end damage to Mack truck.

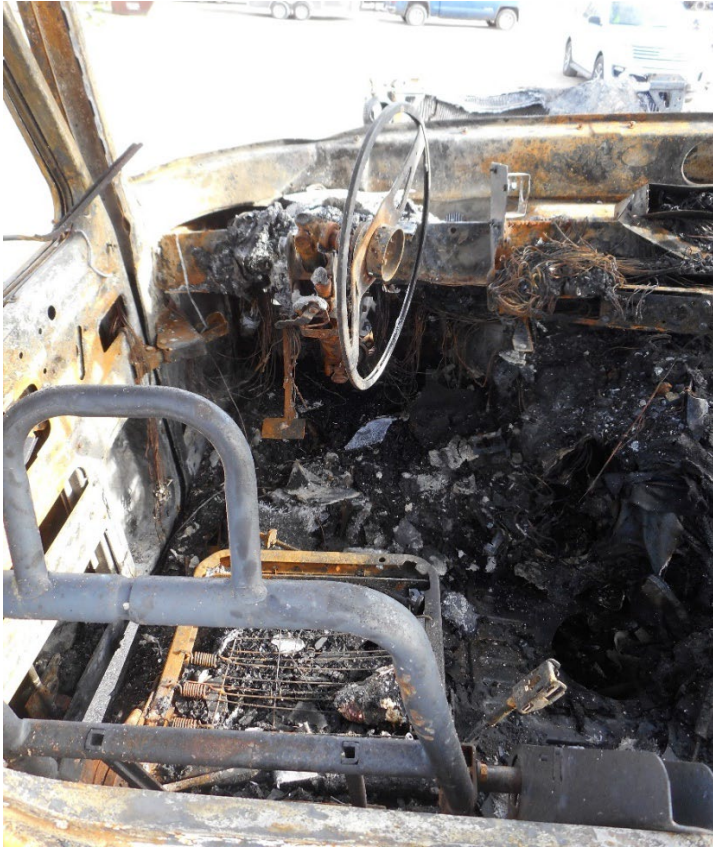
The cab of the truck was totally consumed in the post-crash fire as shown in Figure 10. All that remained was the metal seat frames, dash and steering wheel. The driver seat was equipped with an integral headrest. There did not appear to be any seat deformation to the metal frame. The entire steering wheel was rotated almost 90-degrees to the right as shown in Figure 11.

The truck was equipped with a lap/shoulder restraint. Examination of the interior showed that the latchplate was not inserted in the buckle and was not found on floor amongst the other debris. EMT's commented the driver was found with his legs against the center dash and his right shoulder stuck behind the front passenger seatback and his left shoulder against the driver seatback.

**Figure 11.** Interior view of Mack truck driver seating area.
