SURVEY REPORT

Report No. 23101344

ALLISION BETWEEN ASSIST TUG "OLYMPIC SCOUT"

AND THE "HYLEBOS RIVER BRIDGE WEST BASCULE FENDERING"

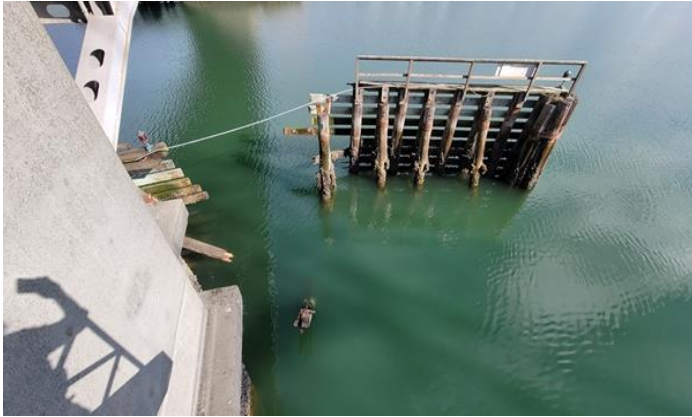
Damage was sighted to the centre and northern section of the sheer wall, with the center section being disconnected from the southern section and heavily pushed out of position, to the north, by approximately 45~50’. The supporting fender piles and batter piles for these sections have been pushed over at various angles of up to 30°~40°. The three (3) affected timber pile dolphins were also sighted as pushed over and moderately to heavily damaged.

The horizontal wooden beams comprising the face of the sheer-wall, where visible, were variously moderately to heavily damaged over the full length of the affected area.

19. Damaged sheer wall

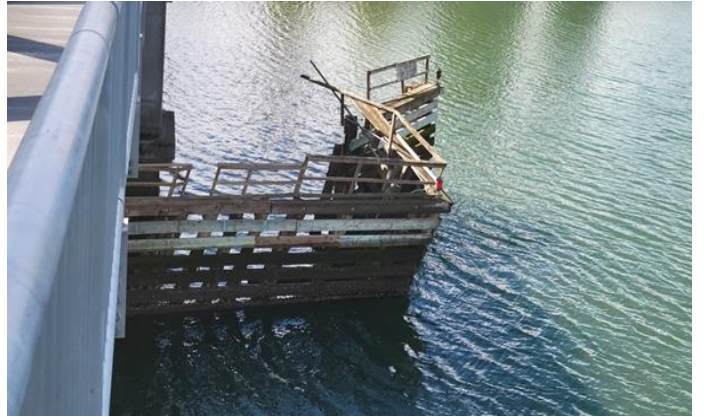
20. Damaged sheer wall

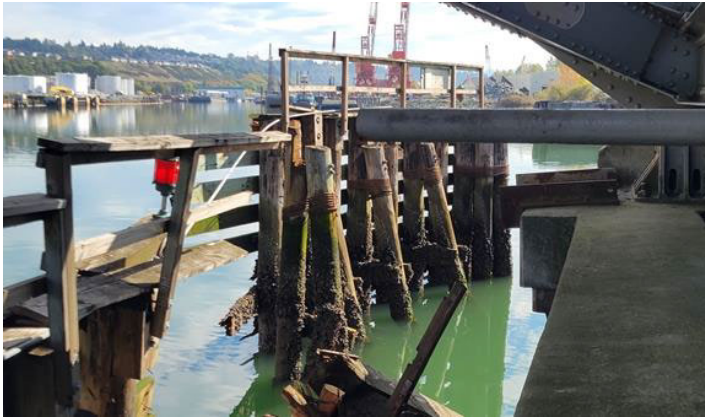
21. Damaged sheer wall

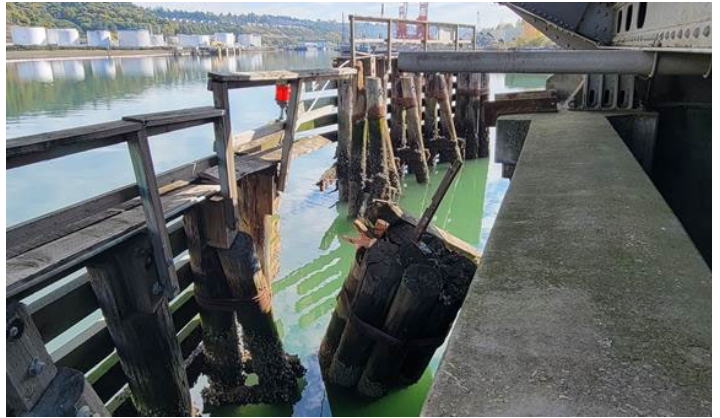
22. Damaged sheer wall

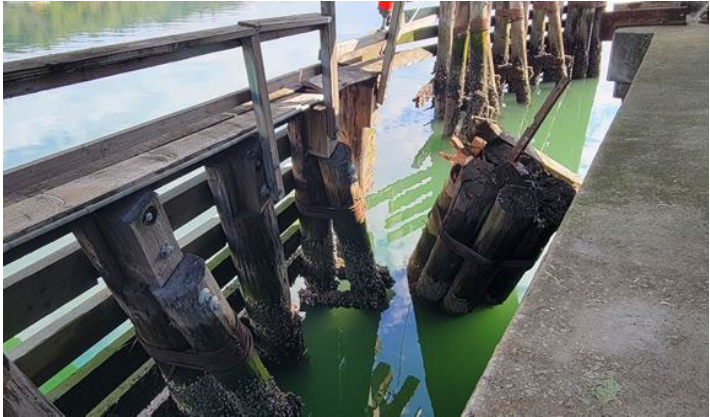
23. Damaged sheer wall

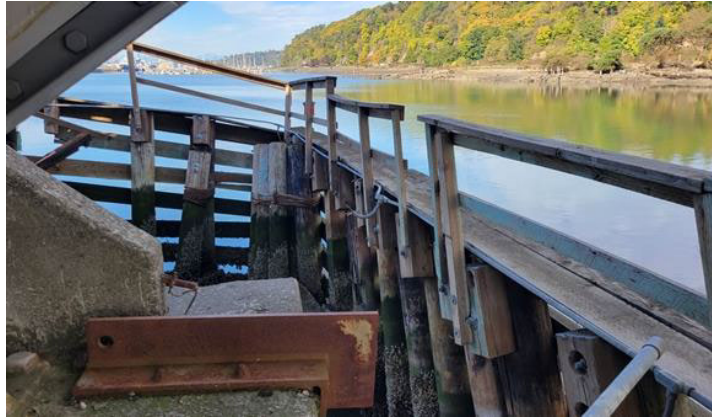
24. Damaged sheer wall

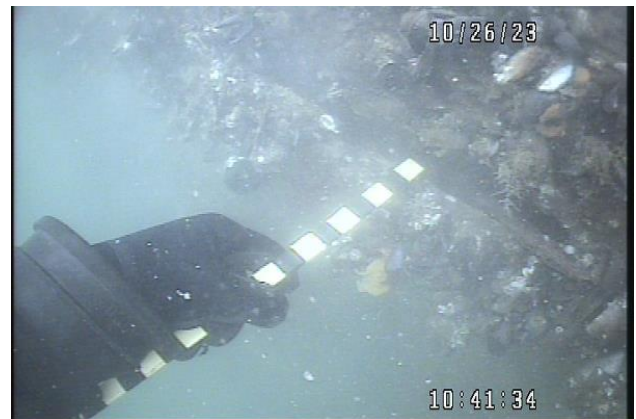
- No. 1 Batten – A end – end rot with approximately 90% loss over 6’.

26. No 1 Batten with end rot and loss

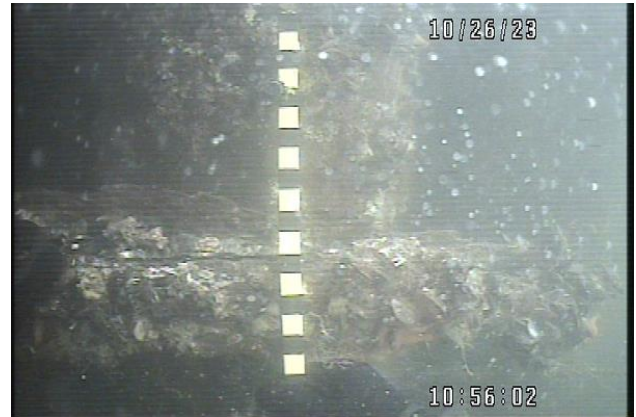
28. No 1 C batten failed over 20'

- No. 1 Batten – B to C interface – No C board section at interface.
- No. 1 Batten – C end – board completely failed over length of 20'. The South end in visually satisfactory condition.

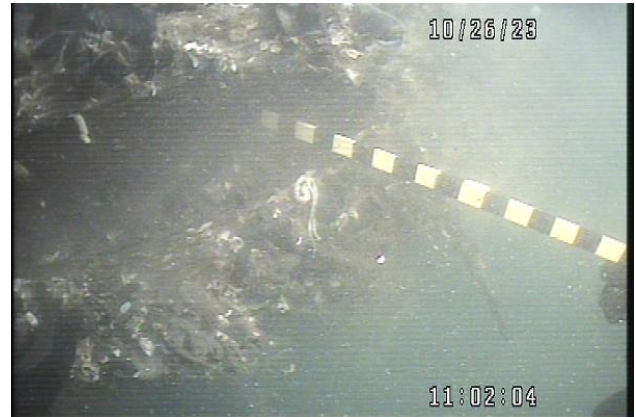
32. No 1 D batten complete core loss

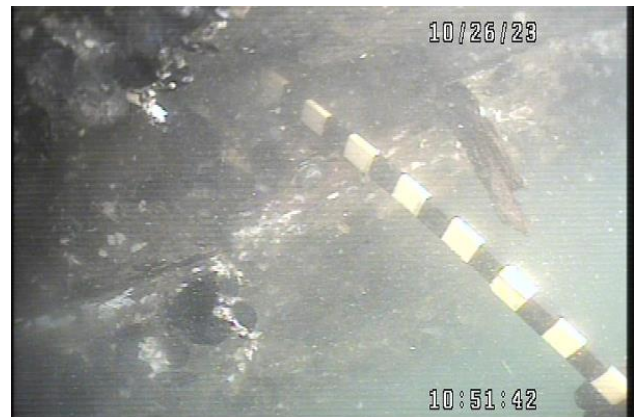
34. No 2 Batten B end – carriage bolt loss

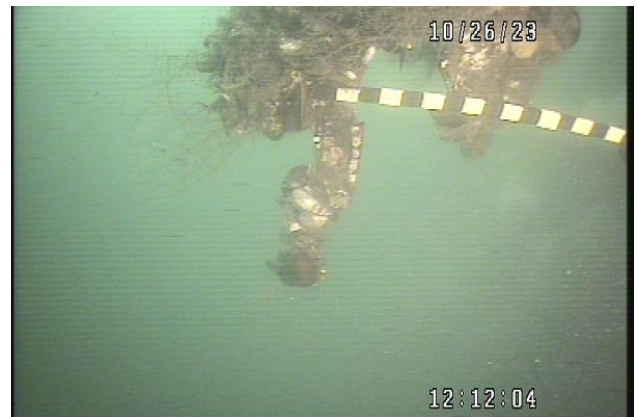
- No. 17 pile – Fender pile – lower 16' missing.

48. No 17 pile – lower section missing

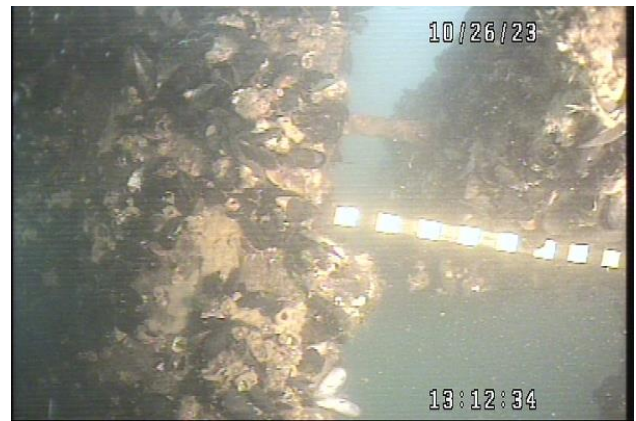
- No. 24 pile – Square vertical pile – gap of 7” between pile and cap timber. Visually satisfactory condition.

50. No 24 pile – gap between pile cap and timber

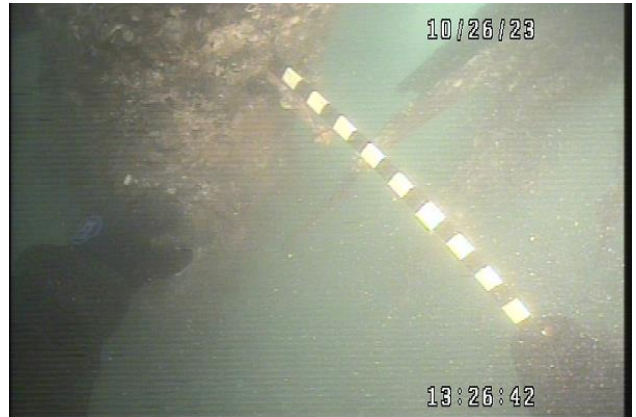
- No. 25 pile - Fender cluster No. 3 – seven (7) surrounding and one (1) center pile – pile closest to channel completely deteriorated with approximately 19’ lost.
- SE pile – approximately 70% section loss from mudline extending up over 10’. Remainder of piles visually satisfactory.

52. No 25 pile – pile deteriorated with bottom section loss

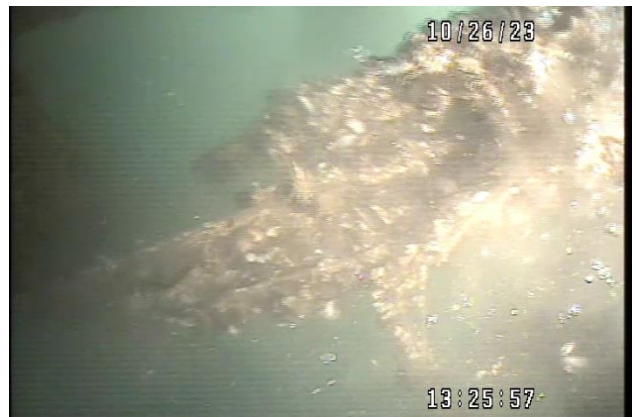
54. No 27 pile – north horizontal support end rot

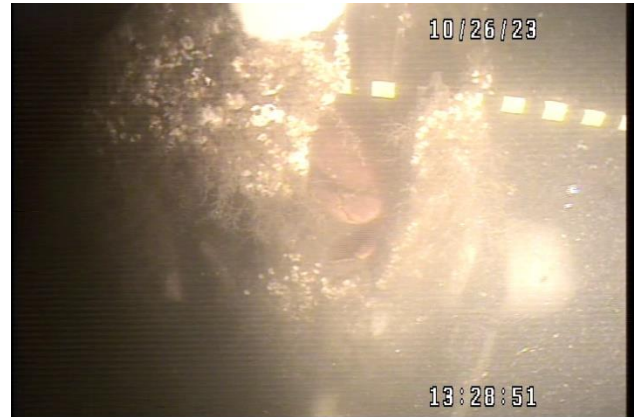
56. No 27 batter pile – fractured at mudline

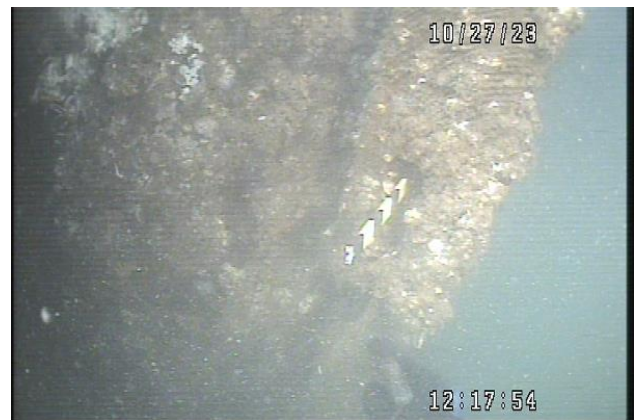
58. Batten 2G – end rot sighted – 50% core loss over 2’.

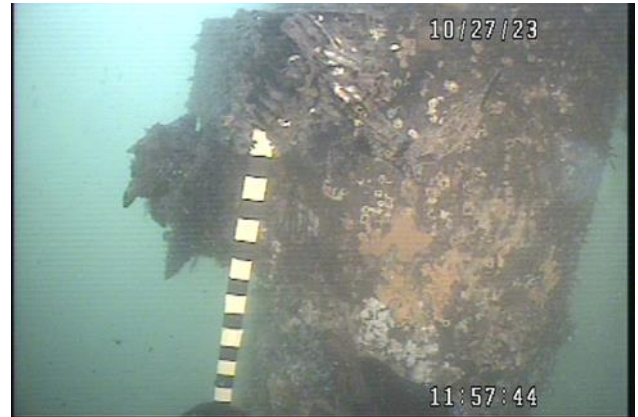
60. Batters at section G to F displaying heavy end rot. South section of G missing.

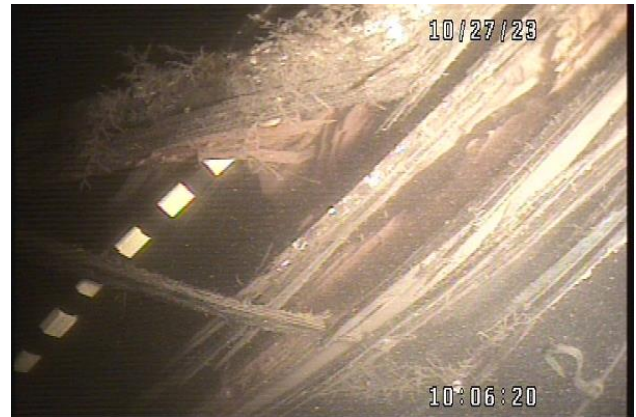
66. No. 8 batter pile – core rotten

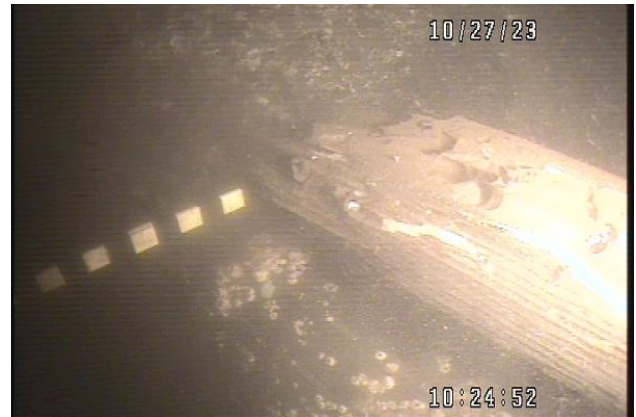
72. No. 2 pile cluster – SE pile – flowering at base

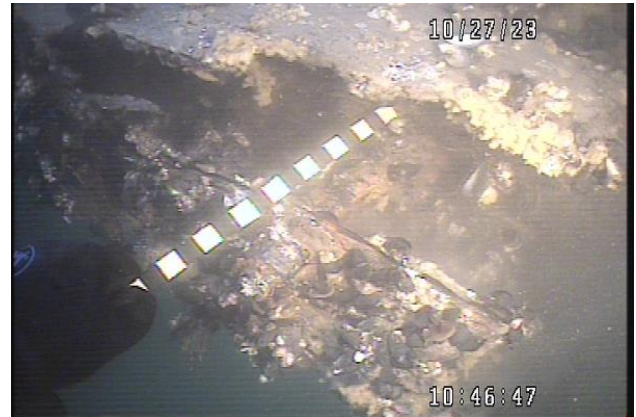
74. No. 10 pile – securing hardware degraded and heavy core rot

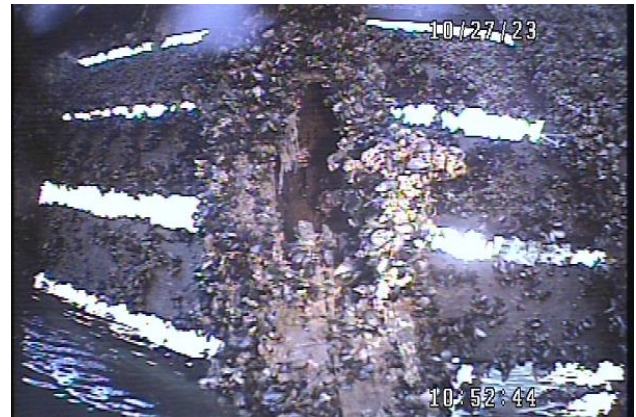
76. No. 10 pile – heavy core rot sighted above waterline

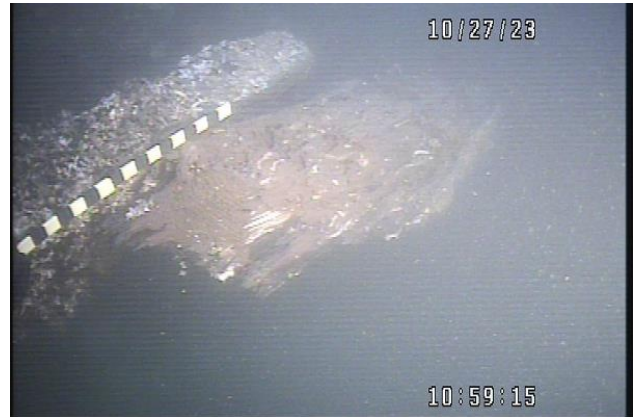
78. No. 12 pile – strut to pier connection
– end and core rot

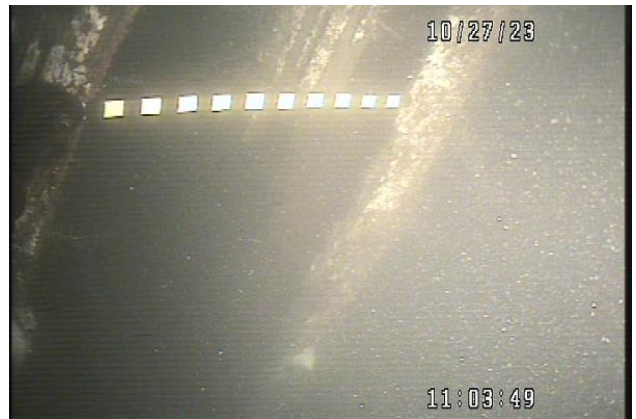
80. No. 14 pile – severed at 19' with 90%
section loss

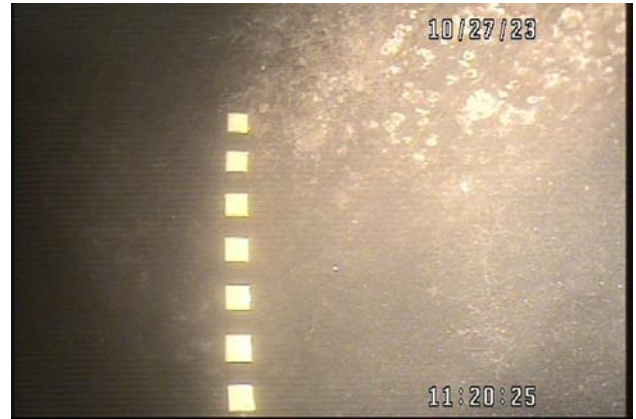
82. No. 19 pile – pressure flowering at mudline interface

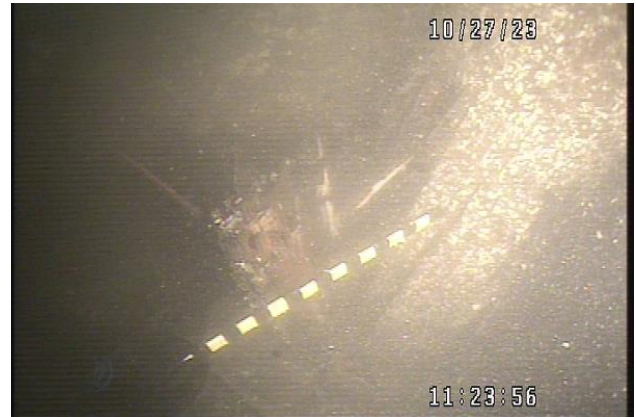
84. No. 20 batter pile – completely separated at 27’ with core rot observed.

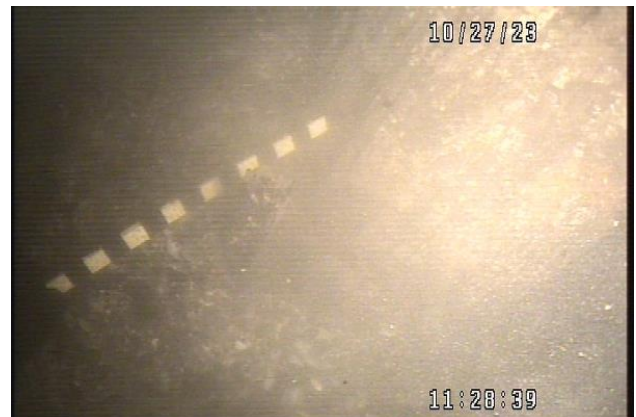
86. No. 21 pile – fractured at mudline interface with checks and stress flowering sighted on surface.

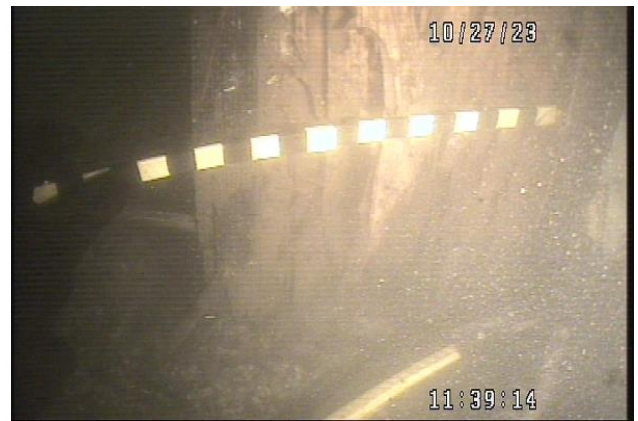
88. Fender Cluster 3 SE pile – broken with heavy rot

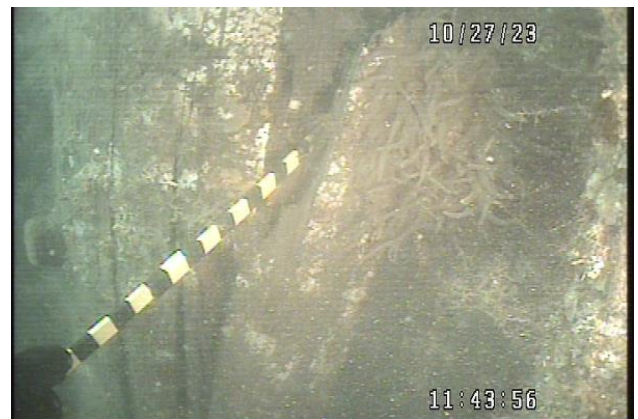
90. Fender Cluster 3 SW pile – wood sighted as rotten

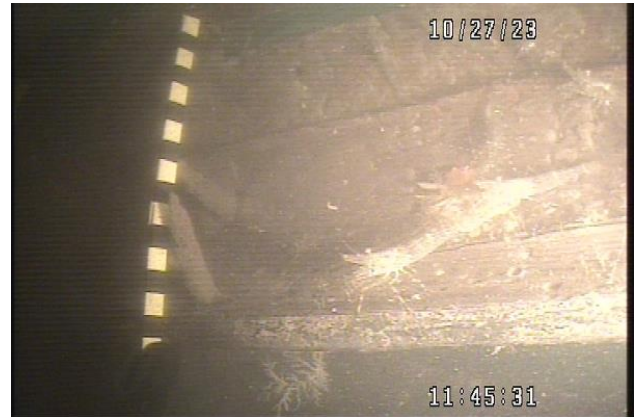
92. Fender cluster 3 SW pile – severed above mudline and core hollowed out.

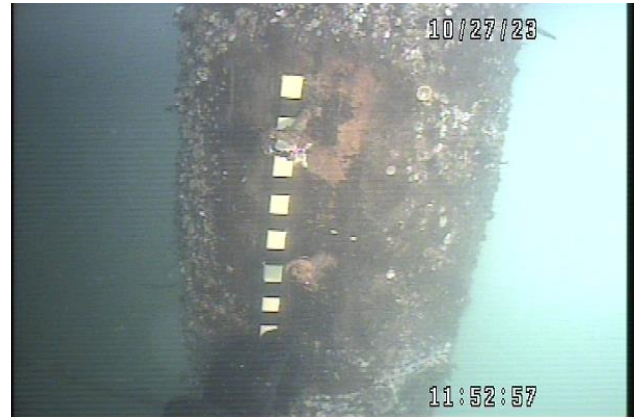
96. No. 24 pile – north and south horizontal supports missing

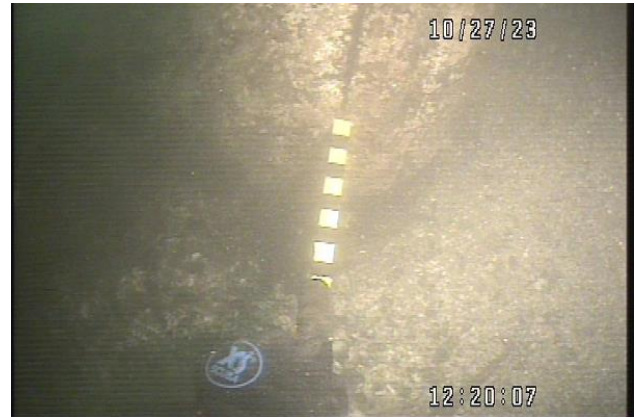
101. Fender cluster 4 – S pile – core rot measured at 11” at base with rot extending up to half of pile height

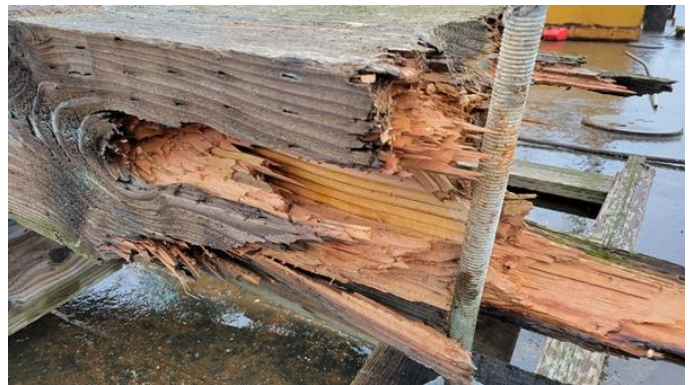
119. Catwalk condition of timber

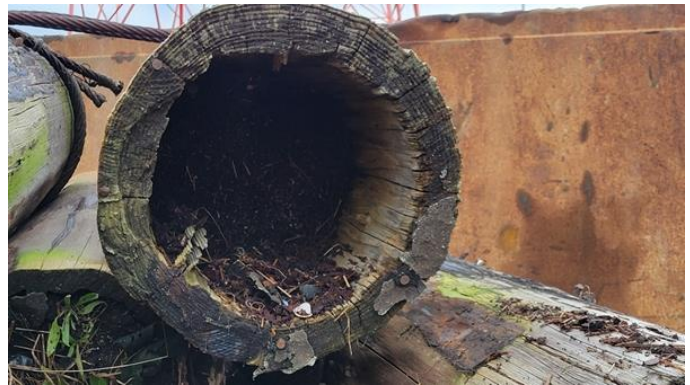
133. Top of No 4 cluster – extensive core deterioration observed

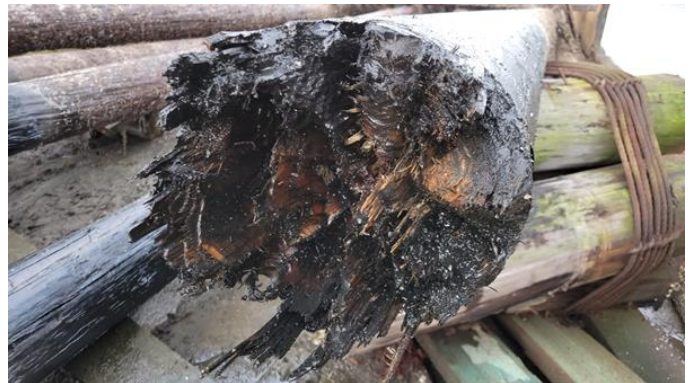
137. Pile No 18 – lower section – interior core wasted and soft to touch.

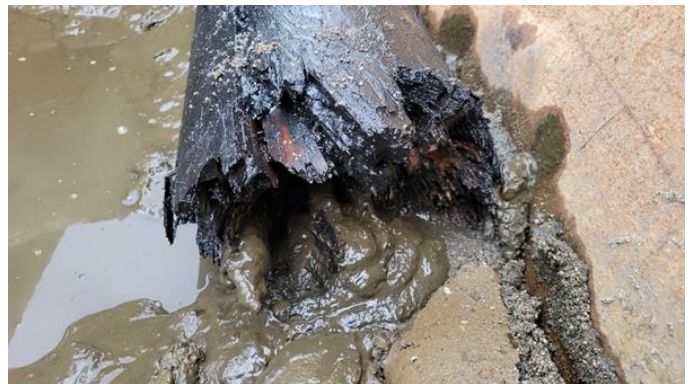
139. Pile No 18 batter pile – lower section – interior core heavily wasted

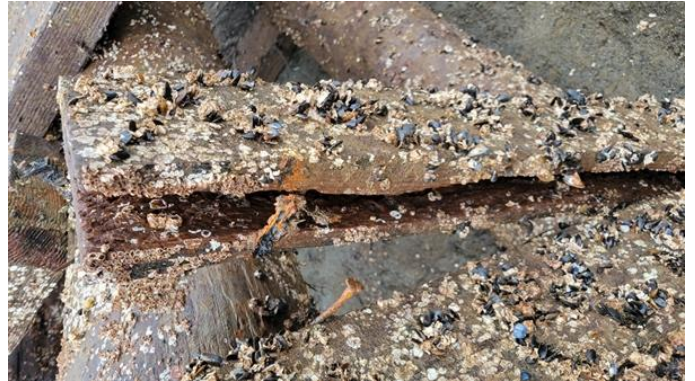
141. Pile No 18 lower horizontal support
– extensive core wastage noted.

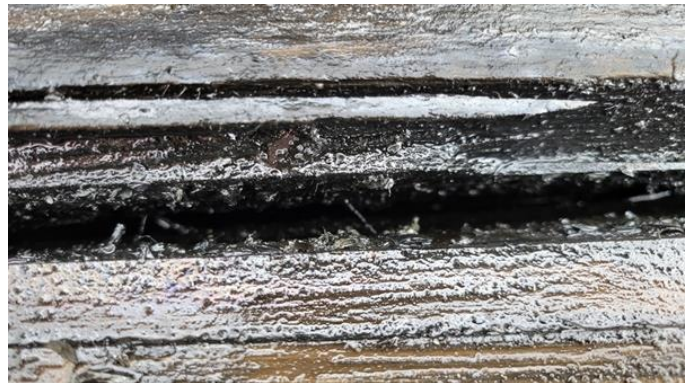
143. Pile No 19 – cracks observed over
length of pile

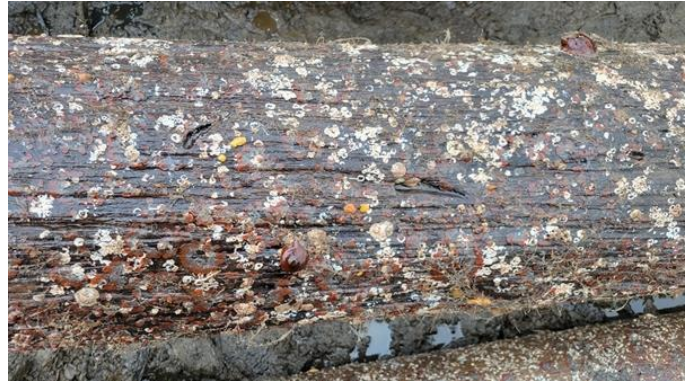
145. Pile No. 20 – worm tracks observed

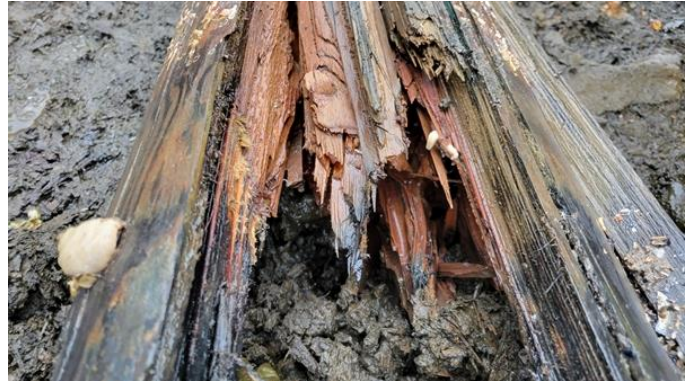
149. Pile No 20 batter pile – broken off at mudline – wastage of core and heavy worm tracks noted

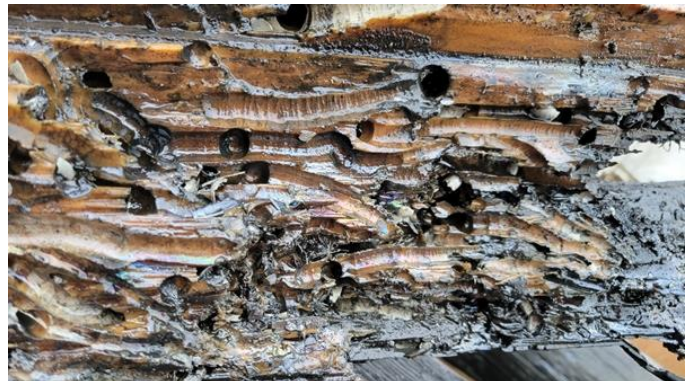
151. Pile No 21 – extensive wastage of core with worm tracks noted

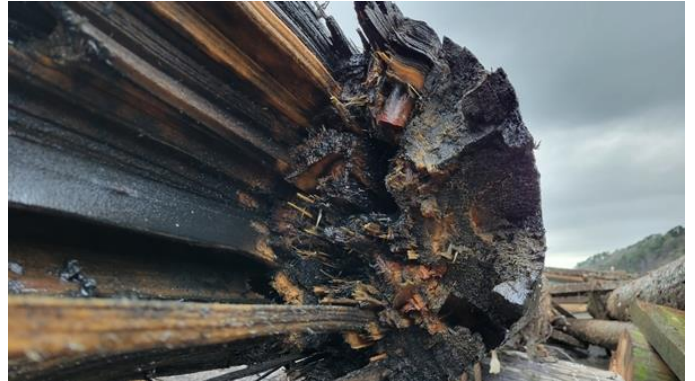
153. Pile No 22 – broken off at mudline –
wastage of core observed

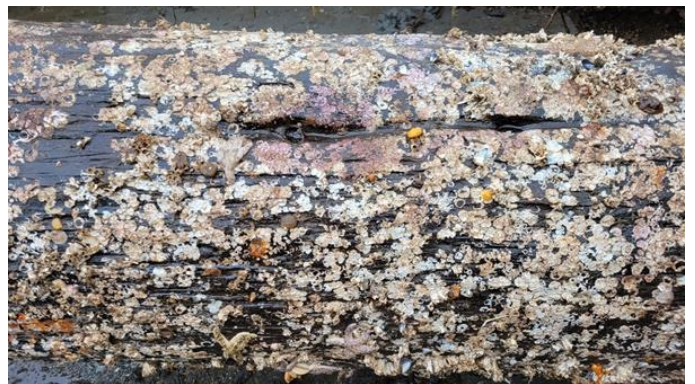
157. Pile No 22 batter pile – wastage of
core and surface checking

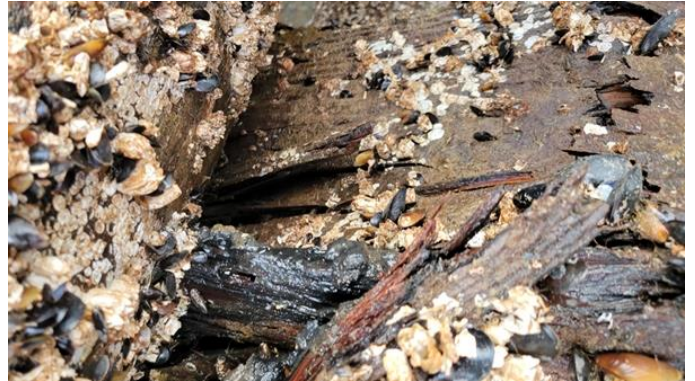
163. Pile No 9 – fender pile with core degradation

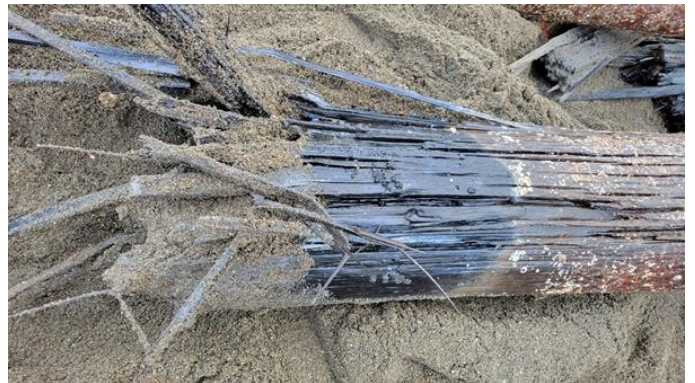
165. Pile No 10 – fender pile with surface checking and core rot

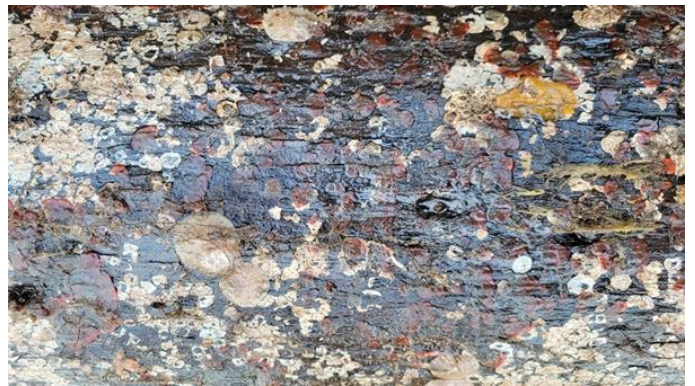
169. No 12 fender pile – core degradation
due to borer worms

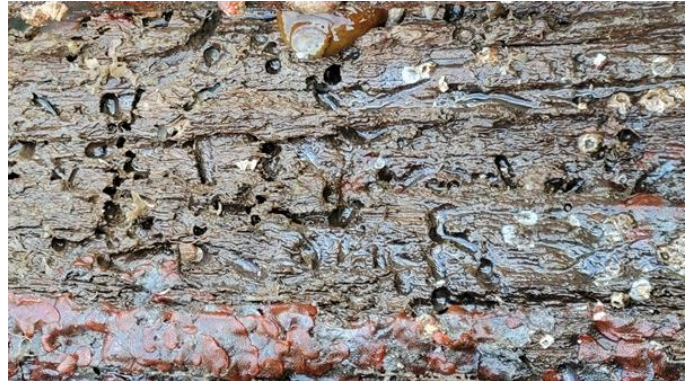
173. No 14 fender pile – surface degraded and with worm tracks

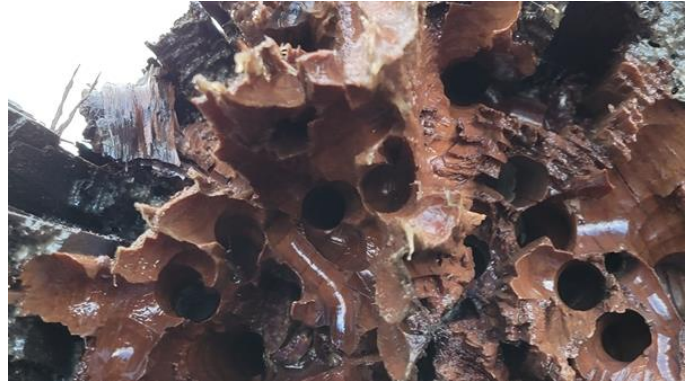
177. No 15 fender pile – broken with heavy core loss and worm tracks

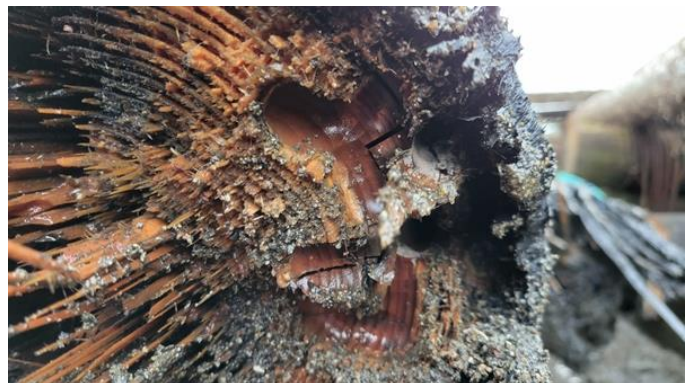
181. No 17 fender pile – core degradation and worm tracks observed

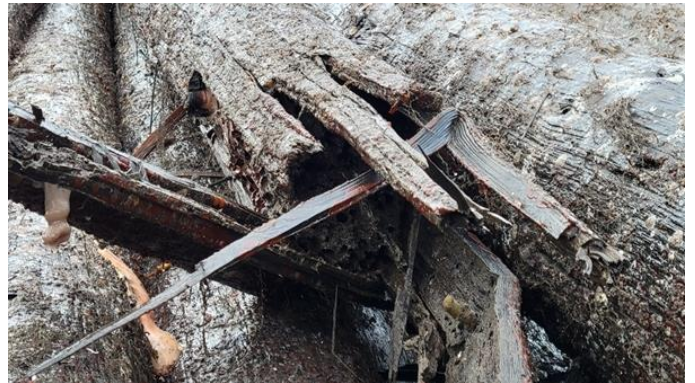
185. No 3 pile cluster – heavy degradation

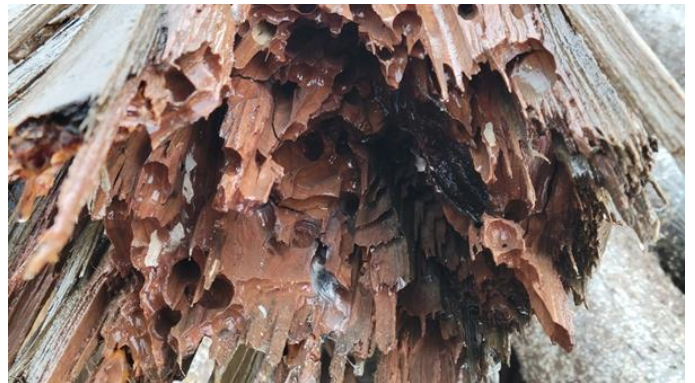
195. No 2 pile cluster – core degradation and worm tracks

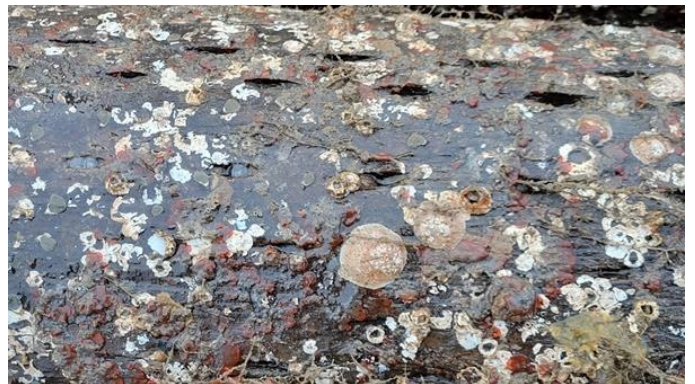
197. No 2 pile cluster – surface checks due to internal core rot

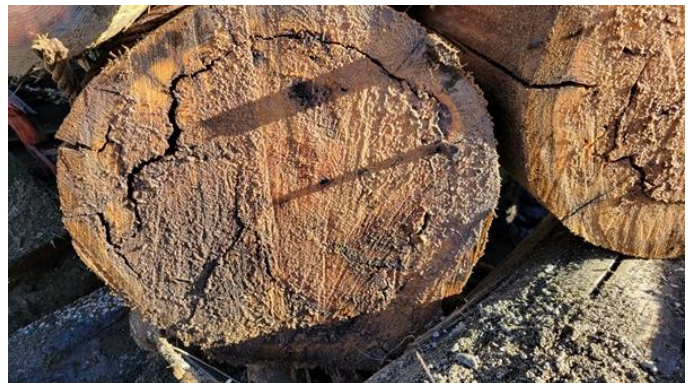
203. Degraded core of top section

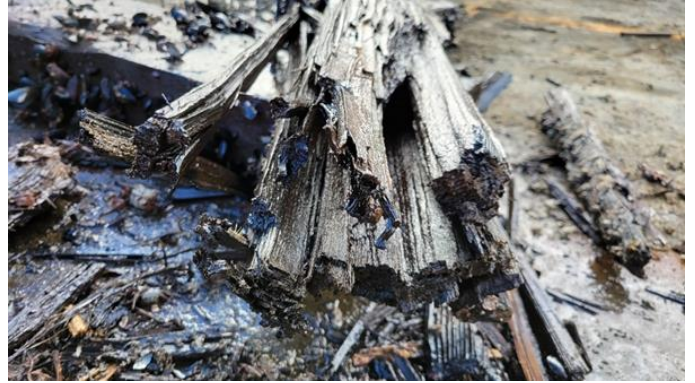
205. Pile cluster No 1 top – timber deteriorated

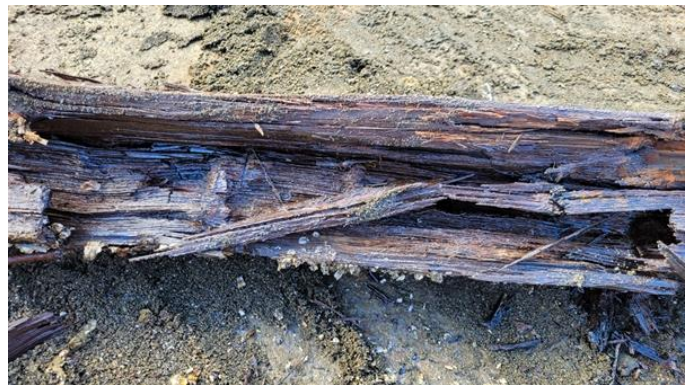
207. Pile cluster No 1 top – timber deteriorated

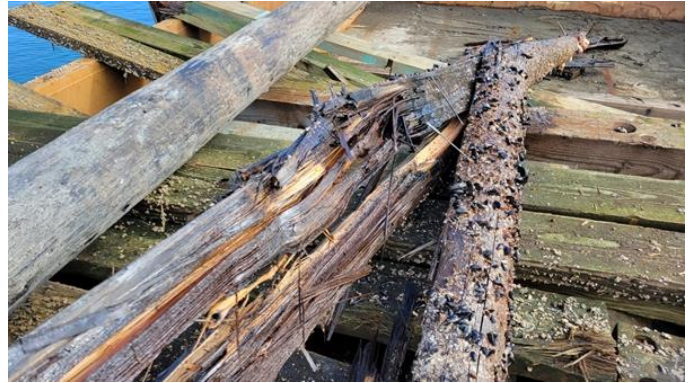
209. No 4 batter pile – checking over surface area and core deteriorated

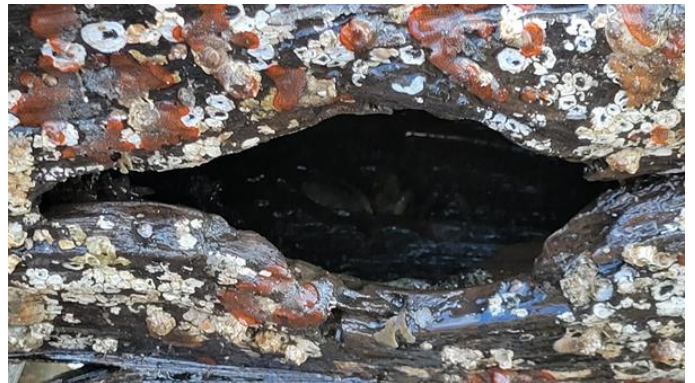
215. No 1 cluster pile – hollow core

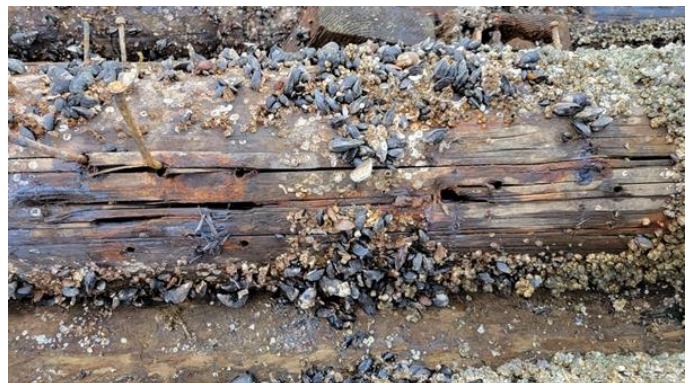
221. Surface checking and worm tracks

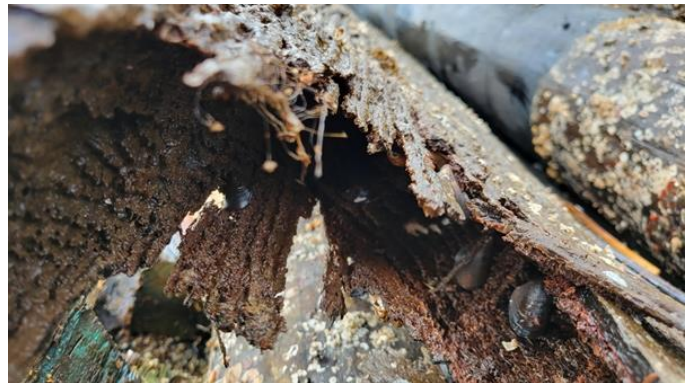
225. Horizontal support - core deterioration

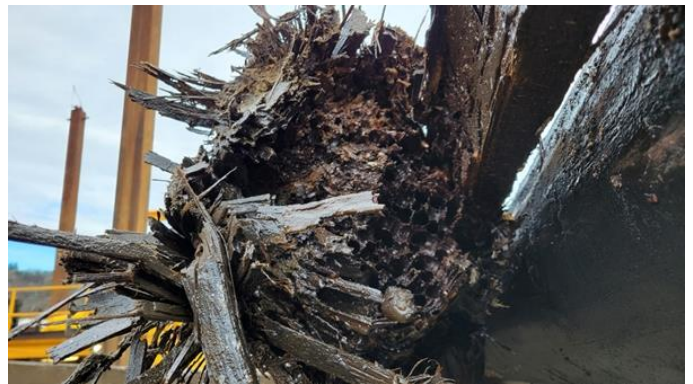
227. No 28 batter pile – core degradation and worm tracks

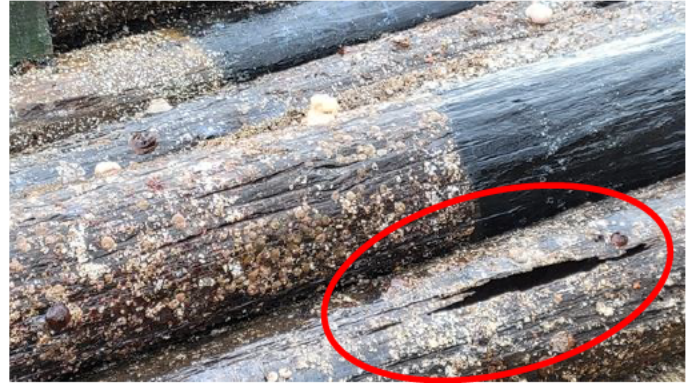
233. No 3 pile 4th cluster – hollow core

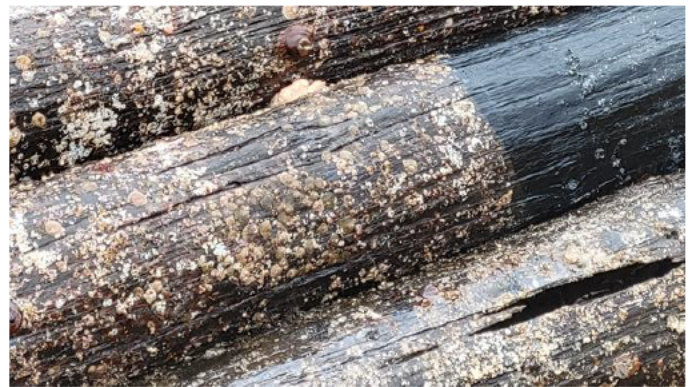
235. No 31 fender pile – pressure flowering at mudline interface

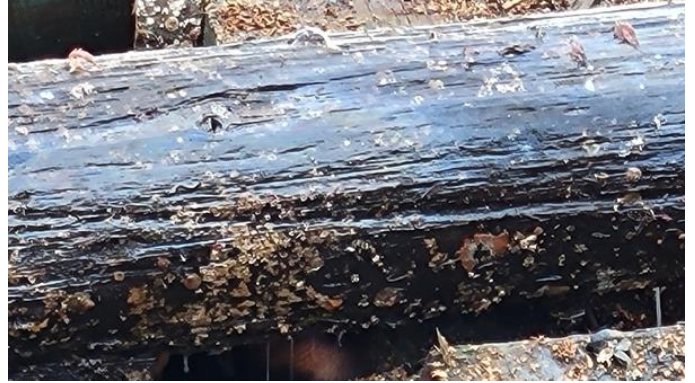
237. No 30 fender pile – section loss due to borers.

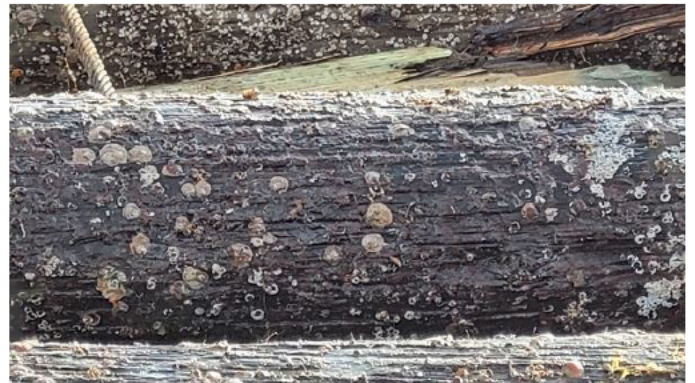
243. No 26 fender pile – visually generally satisfactory with light surface checking

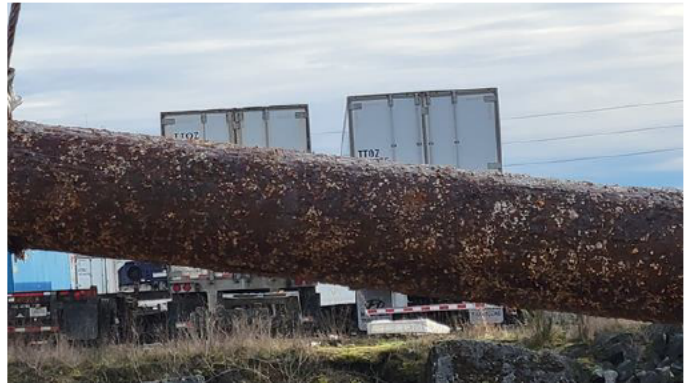
245. No 24 fender pile – visually generally satisfactory
