United States
Coast Guard

Commanding Officer
United States Coast Guard
Marine Safety Center

Subj: POST-SINKING STABILITY ANALYSIS OF TUG JACQUELINE A (O.N. 638353)

Enclosure: (1) Explanation of Analysis & Assumptions
(2) MSC GHS Output, 31 Jan 2024

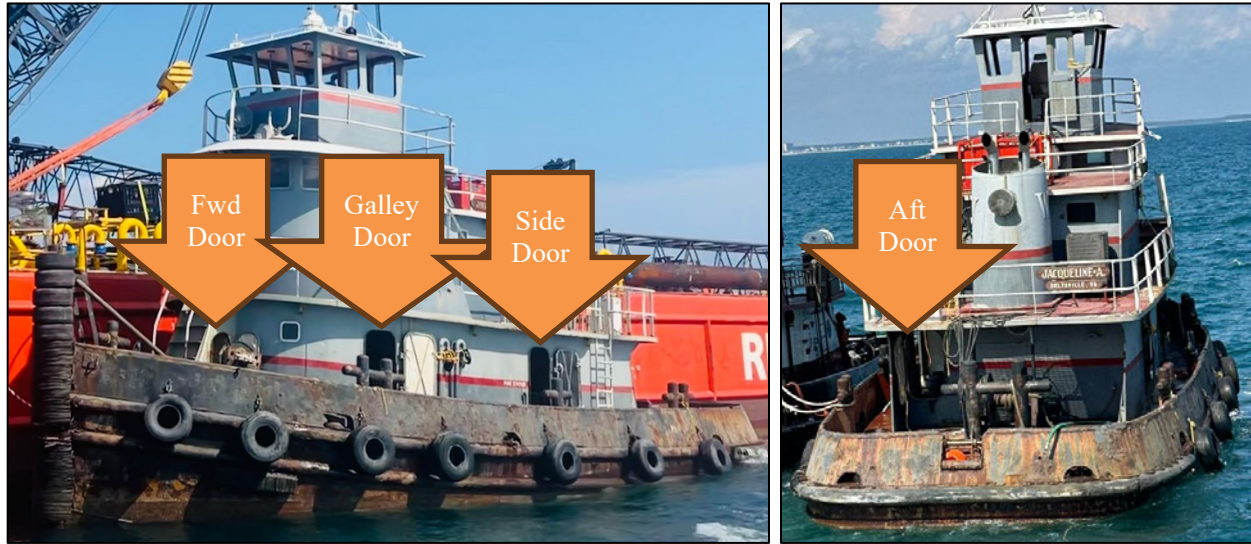
A downflooding point is an opening in the vessel that permits the ingress of water to the buoyant hull. Downflooding points include weathertight openings (such as doors that are not fully watertight). Based on our examination of the JACQUELINE A, the lowest intact downflooding points are the doors to the house. These doors were typical weathertight doors with gaskets and two dogs opposite of the hinges. These downflooding points are shown in Figure 6 and Table 1.

Figure 6: Refloated Condition Pictures with Downflooding Points Indicated

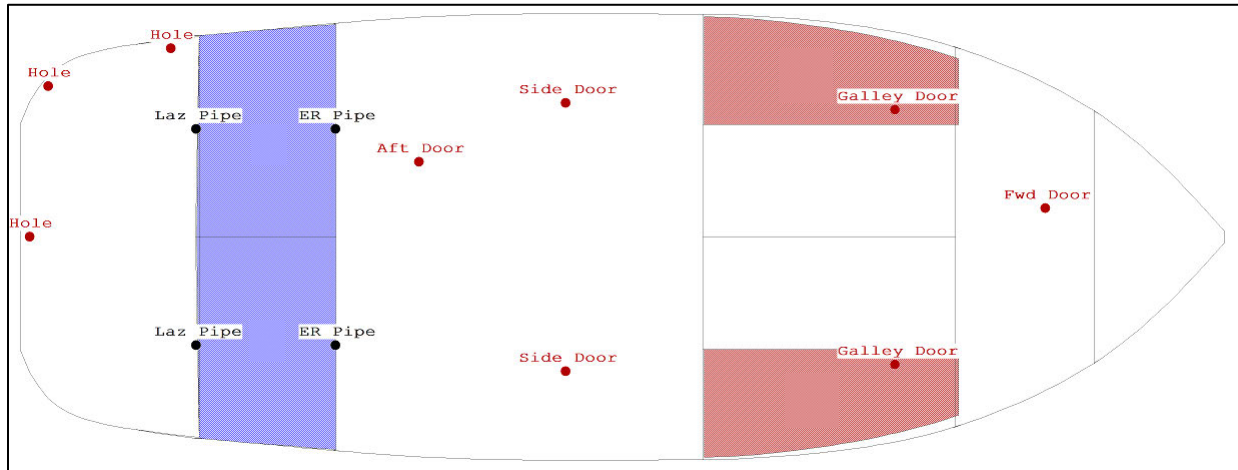
In addition to normal downflooding points, JACQUELINE A had deck wastage near the stern that would allow downflooding into the lazarette. Three large holes were observed and measured. These holes are considered in our downflooding/sinking analysis but not in the intact stability analysis. Hole location is shown in Figure 7 and Table 2.

Figure 7: Plan View Sketch of Downflooding Points, Holes, and Tanks

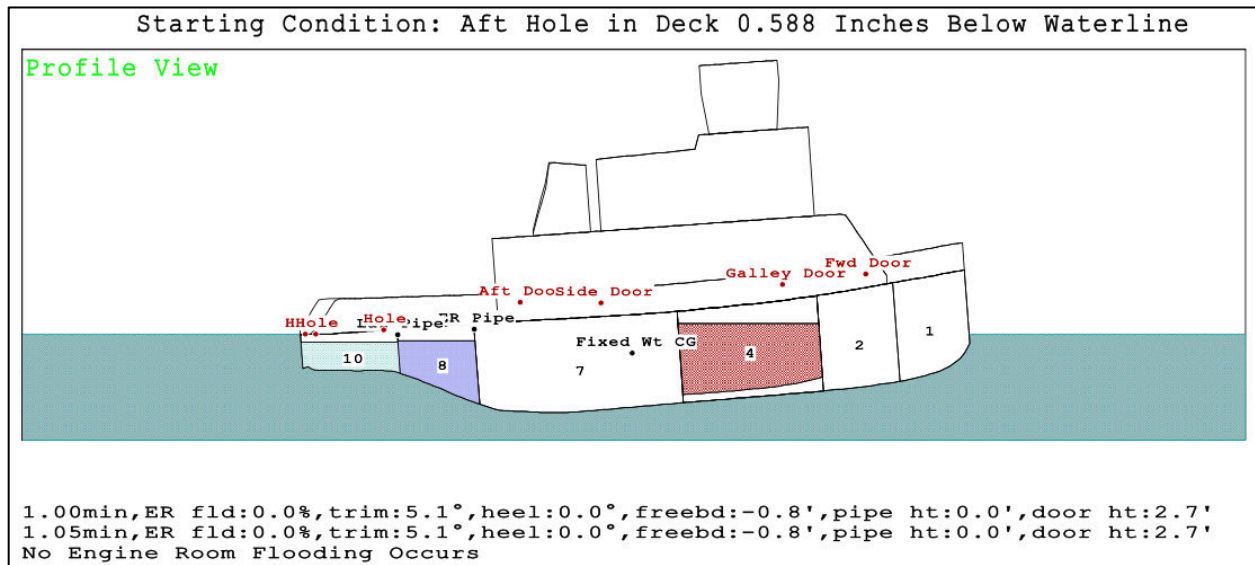
Because of the aft trim in all conditions, no engine room flooding occurs until the lazarette is 100% full. This is because the wire runs are near the top forward bulkhead of the lazarette. This is the last location of the lazarette to fill when the vessel has aft trim. Additionally, the wire runs, normally level with no trim, are angled upward to the engine room with aft trim. This requires the lazarette to be fully submerged to have external head pressure forcing water up the wire runs into the engine room.

Figure 8: Timestep Analysis Showing Initial Lazarette Flooding Resulting in No Flooding of the Engine Room (Fixed VCG 5.25', Variable LCG 25')
