## 7219 WHEEL MOVEMENT INVESTIGATION

Revision: 2

July 27<sup>TH</sup>, 2023

**HATCH LTK**

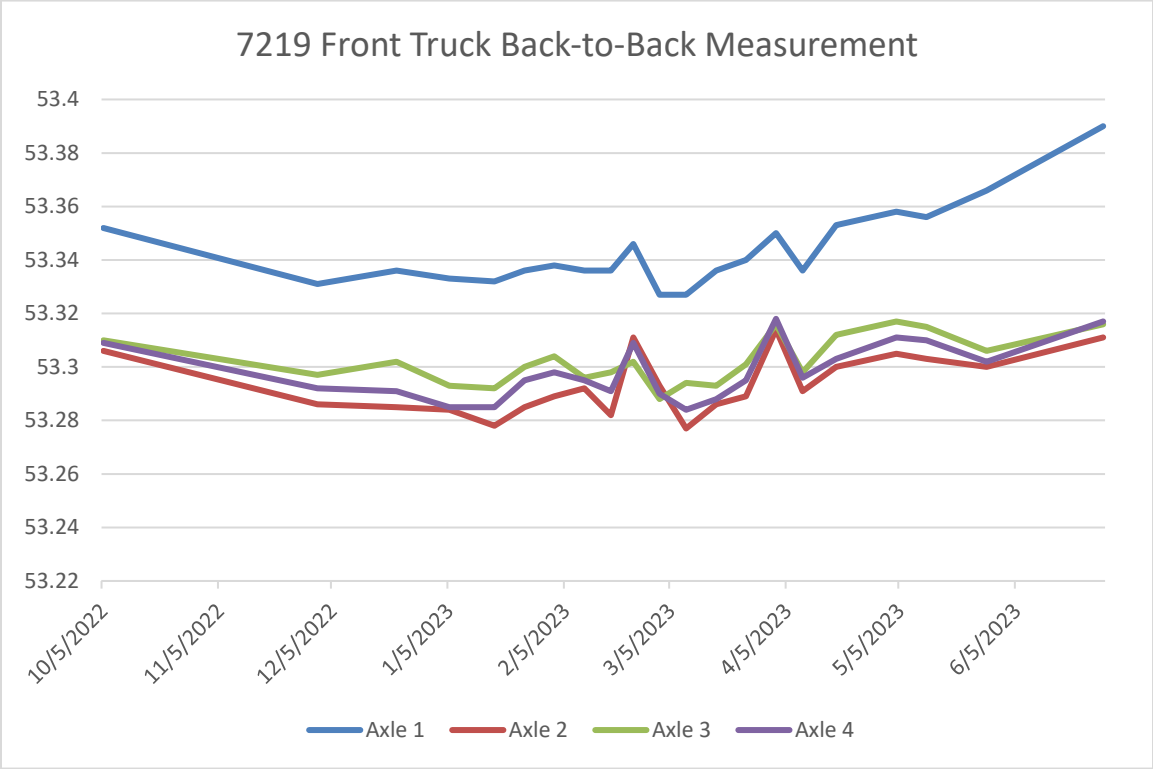
Figure 1: 7219 Front Truck Back-to-Back Measurement History

Axle 1 measured 53.390” in both positions 1 and 2. The Gear Side Journal Bearing gap was measured at 0.027” using a feeler gauge. Table 2 below shows the measurement history from the October 2022 baseline to the time of the failure. Figures 1, and 2 are visual representations of the historical axle back-to-back, and journal bearing gap measurements respectively. The car mileage delta from baseline to failure, was 24,016 miles. The delta measurement from failure to baseline is 0.038”.

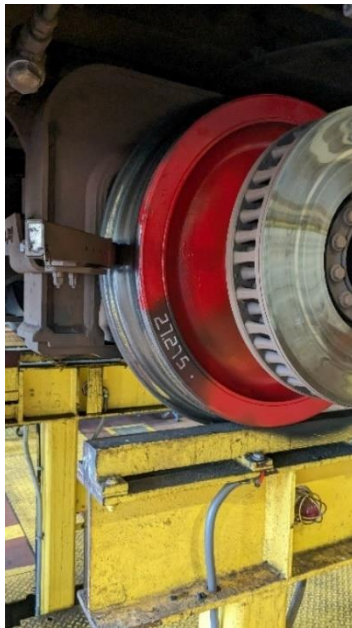
Figure 3: Axle 1 Painted Red to be Removed

WMATA conducted a complete truck C-Inspection on the front truck of 7219 on July 7<sup>th</sup>, 2023. During the C-Inspection, it was verified that the back-to-back and Gear Side Journal Bearing Gap measurements of Axle 1 did exceed the allowable limit. Table 3 below shows the measurements taken at the time of the C-Inspection in comparison with the Baseline and failed Periodic measurement. Prior to the inspection, the wheels of Axle 1 were painted red in accordance with Service Bulletin 110 (SBF-110), the back-to-back out of compliant wheelset procedure, as shown in Figure 3.

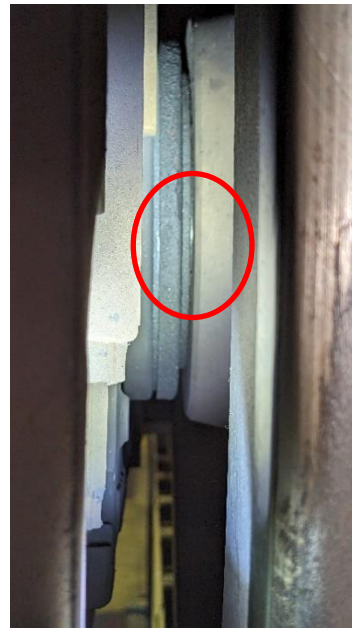
Figure 4: Gear Side Journal Bearing Gap

The red circle in Figure 4 shows the gap at the Gear Side Journal Bearing. The C-Inspection did not identify any other anomalies with the truck or wheelset assembly. The truck C-Inspection for SN 70442 can be found in Appendix B.

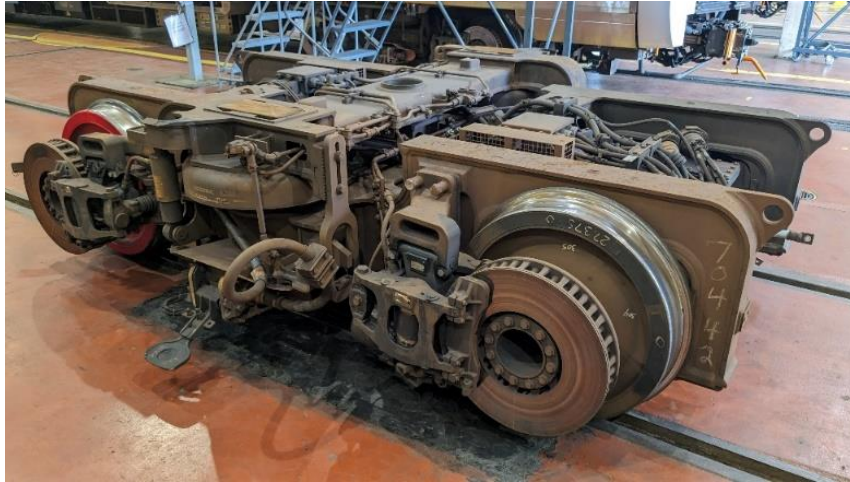
Figure 5: Removed Front Truck SN 70442

After the inspection was completed, and the measurements were verified, truck shop personnel removed and replaced the front truck. The installed truck was original to car 7014 (SN 70027). The truck was removed from 7014 due to a wheel size issue (WO 17960826). Axles 1 and 2 in truck SN 70027 are both original. The axle information can be found in Table 4.

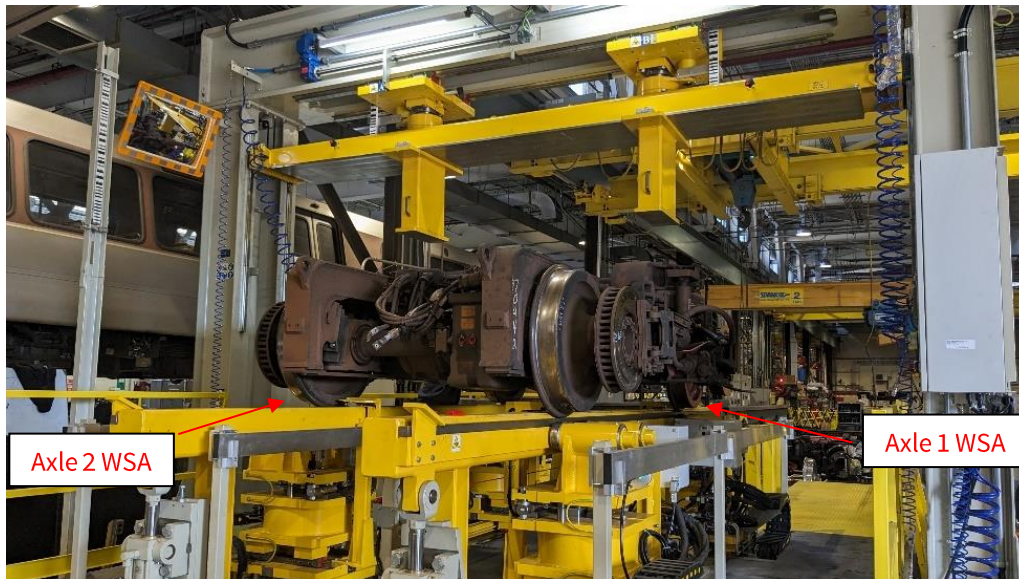
Figure 7: SN 70442

Truck SN 70442 was trammed at Greenbelt on the BBM Truck Stand on July 14<sup>h</sup>. Axle 1 which failed for back-to-back, is further away from the operator’s stand.

The results of the tramming conclude that the truck is within specification both in parallel and diagonal.

The BBM Truck Stand was able to measure the back-to-back distance of Axle 1 and confirmed the exceeded limit.

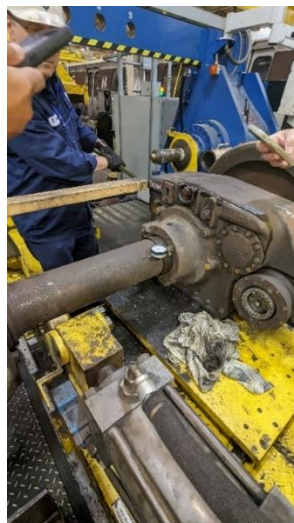
Figure 9: Gearbox Lateral Movement

The gearbox lateral movement was measured using a dial gauge. The measurement was performed against the Gearbox, and Motor Side Wheels, and both times the readings were 0.002". This can be found in the Appendix F.

GBX Seat	GBX Lateral Play <b>.002 → (NOT ENOUGH)</b>
----------	--

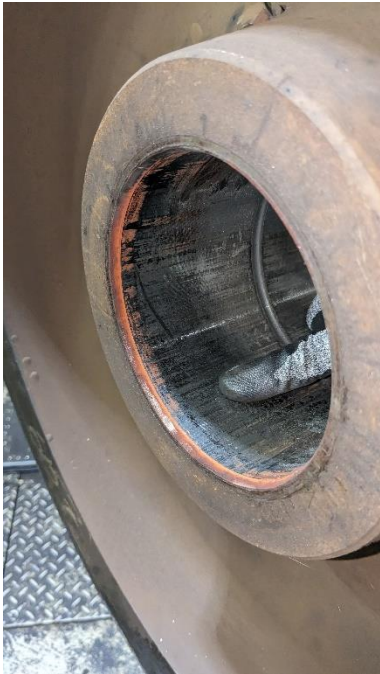
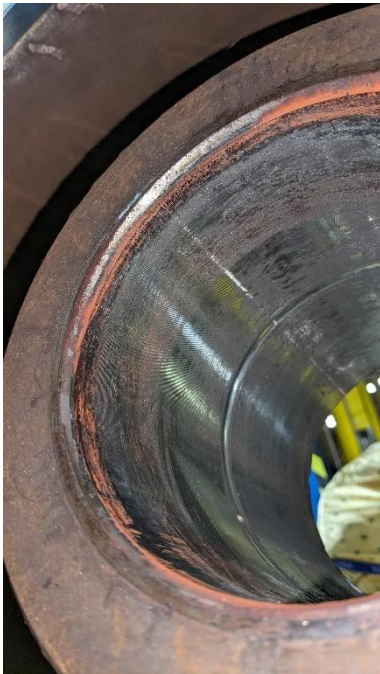
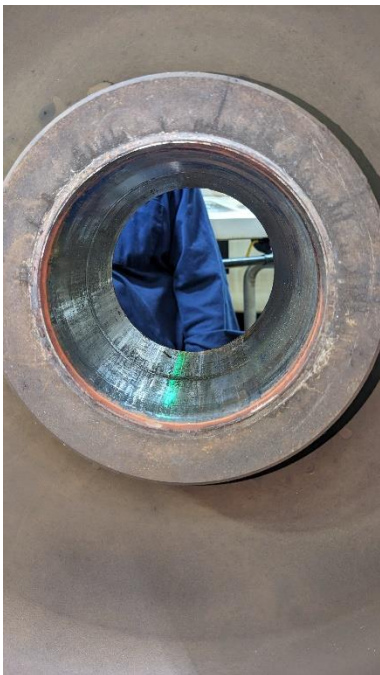
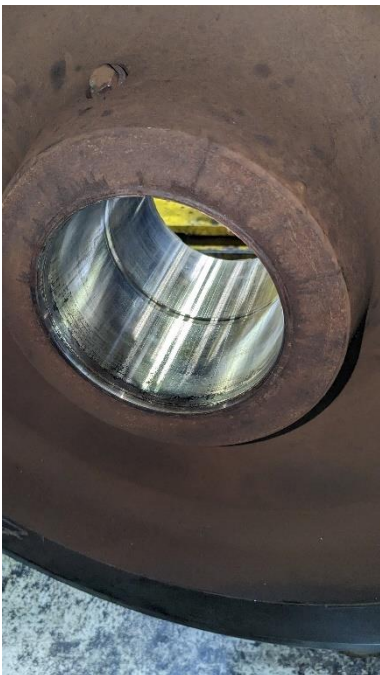
The visual inspection of the Gearbox Side Wheel showed a larger rust band along the inboard side of the wheel bore compared to the Motor Side Wheel seen in Figures 11 through 13 below. After the bore was cleaned, black bands indicating fretting and wheel movement remained on the inboard side of the wheel bore in Figure 14. This fretting is consistent with other wheelset assemblies which have failed for out-of-tolerance back-to-back measurements.

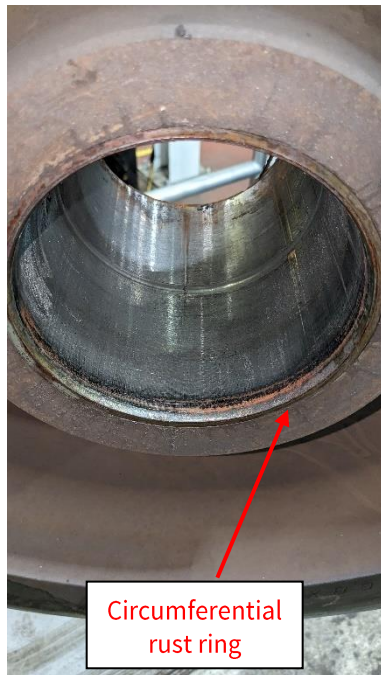
Figure 15: Motor Side Inboard

The visual inspection of the Motor Side Wheel showed rust on the inboard taper similar to the Gear Side Wheel as seen in Figure 15. This rust is along the circumference of the edge. The lateral lines in the bore are from the residual Molykote used during the wheel press on at ORX. After the bore was cleaned, these lines were not present as seen in Figure 16. Black bands remained at the inboard side of the wheel bore. Similar to the Gearbox Side Wheel.

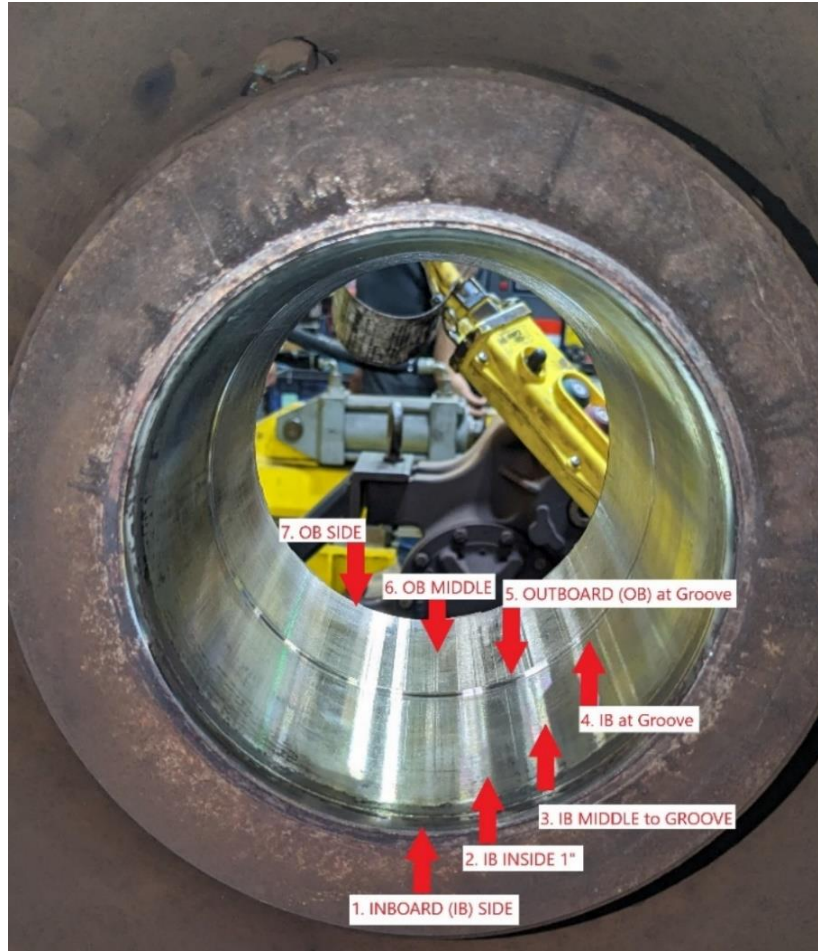
Figure 18: Inside Bore Measurement Points

Table 9 lists the dimensions, along with the referenced measurement points. From the results it is seen that starting at the Inboard Side (Position 1), to the Outboard Side (Position 7) there is an overall decreasing taper through the wheel bore.

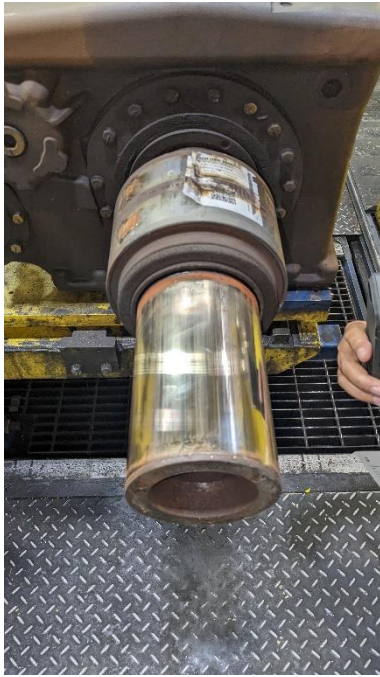
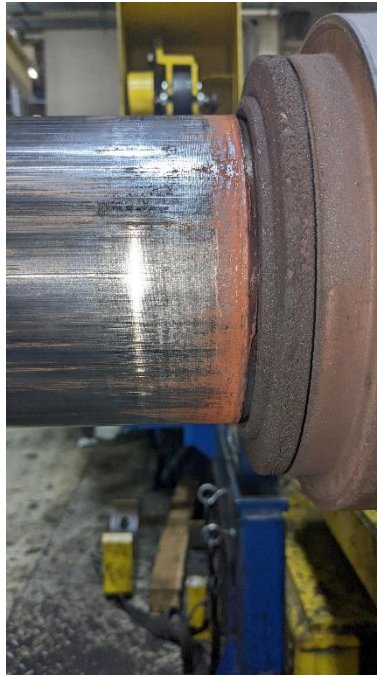
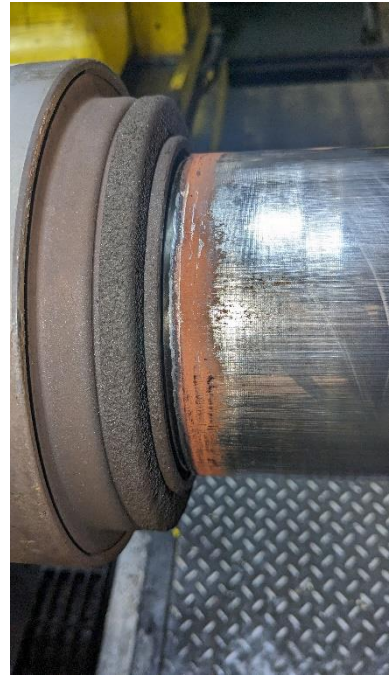
Figures 19 through 21 of the Gearbox Side Wheelseat visual inspection showed no signs of metal tears from the dismount. A consistent pattern of fretting was seen, similar to other wheelseats which have failed due to the axle back-to-back exceeding tolerance. This ring thickness is alike to that of the inner bore of the respective wheel found in Section 2.3.3.1.

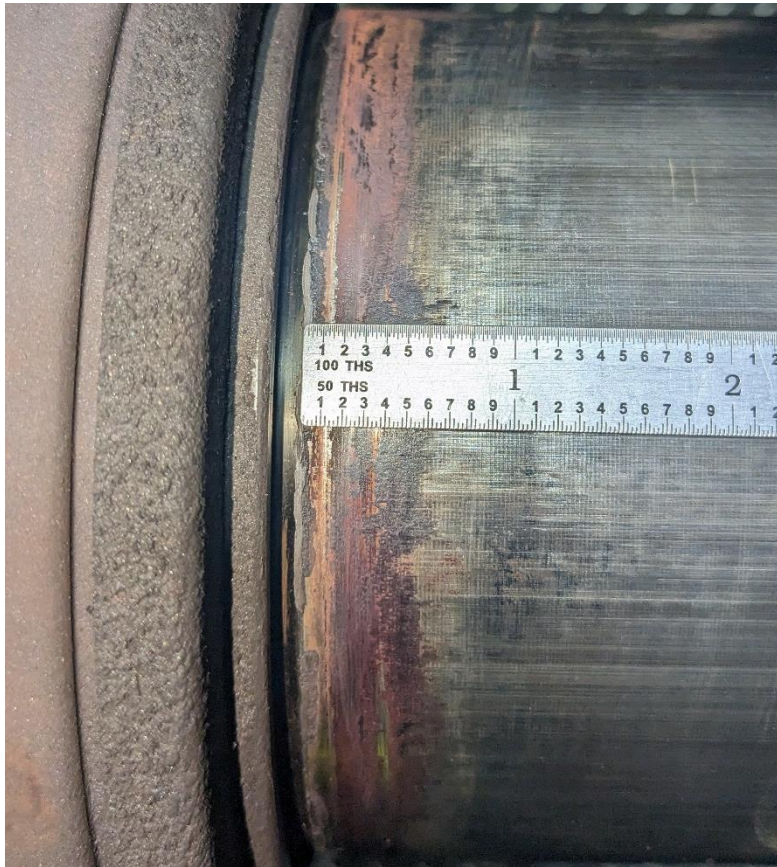
*Figure 22: Gear Side Wheel Fretting with Scale*

A scale was placed at the relief groove to measure the overall length of the fretting band. The band length was 0.400", as shown in Figure 22 below.

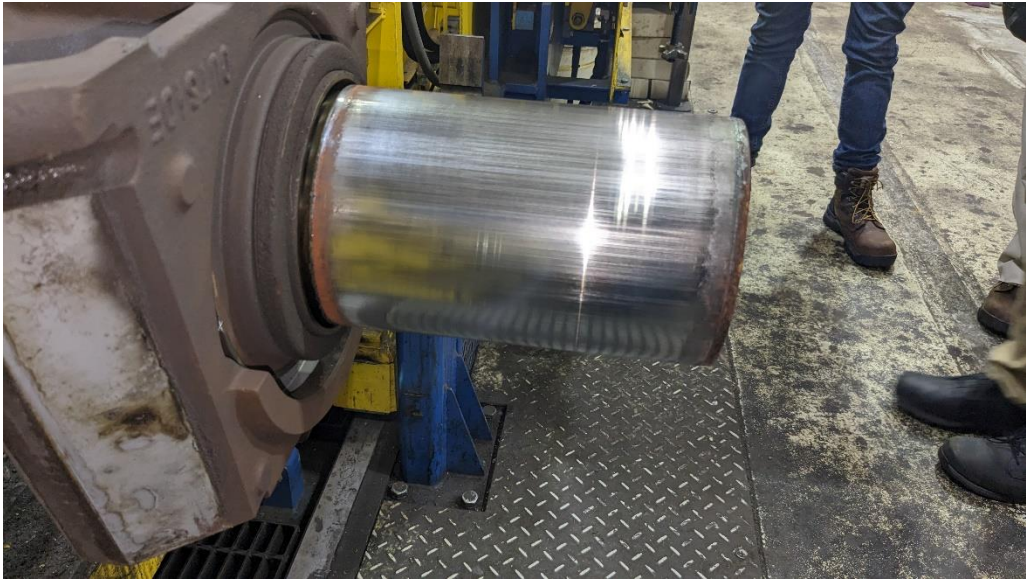
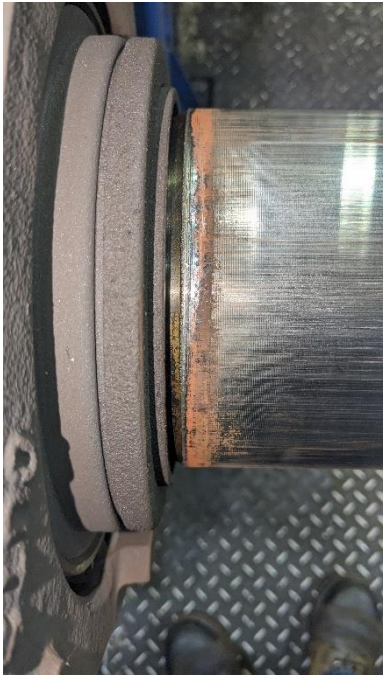
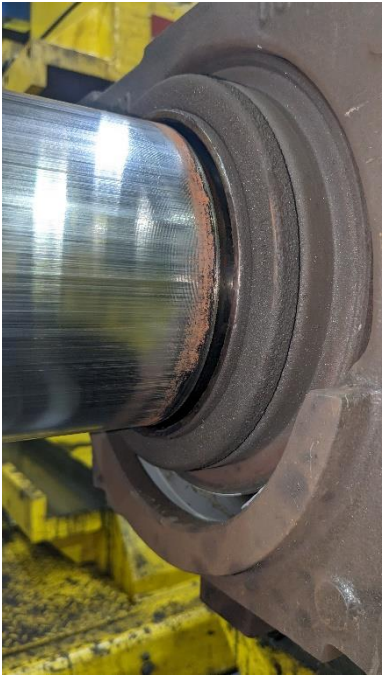
Figures 23 through 25 are of the Motor Side Wheelseat. No tears were found during the inspection. It was observed that there was a rust band along the outside circumference of the axle by the relief groove much like the Gearbox Side Wheelseat. This was expected as the inner bore of the Motor Side Wheel had a similar pattern.

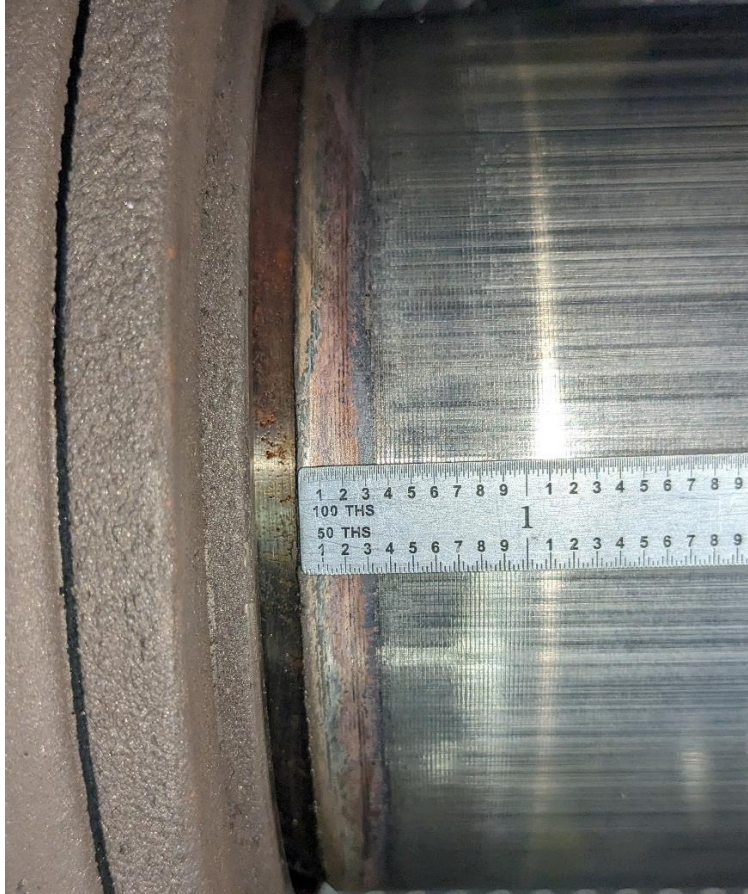
*Figure 26: Motor Side Wheelseat Fretting with Scale*

A scale was placed at the relief groove to measure the overall length of the fretting band. The band was 0.350", as shown in Figure 26 below.

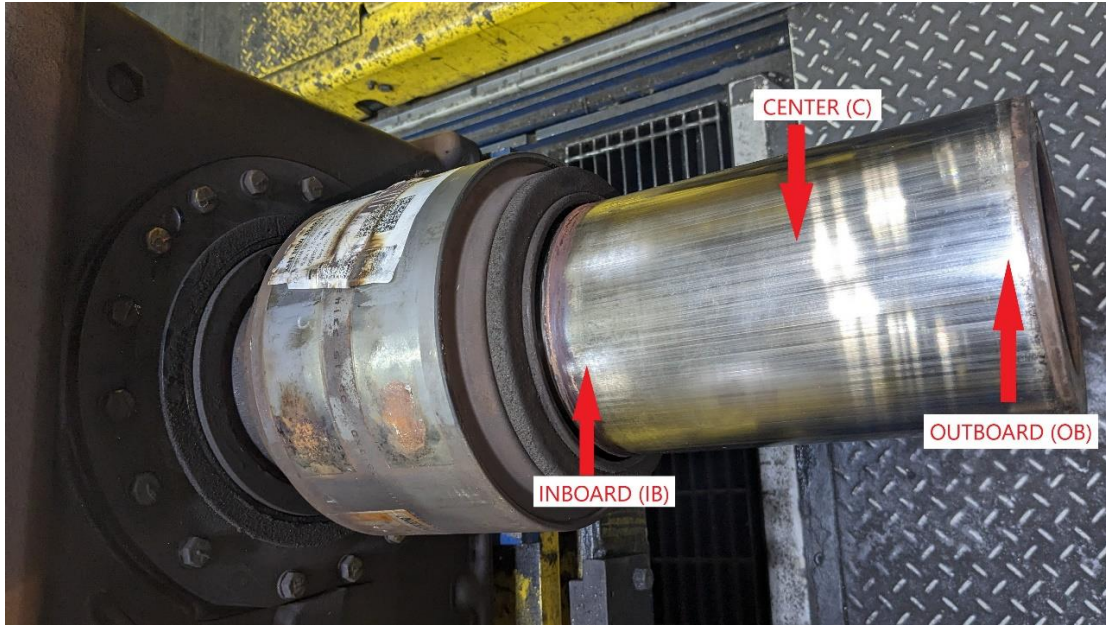
Figure 27: Wheelseat Measurement Points

Both wheelseat diameters were measured in three locations using a Large-Diameter Micrometer. Outboard (OB), Center (C), and Inboard (IB) as shown in Figure 27. A second set of measurements were taken at each location by rotating the axle 90°. Table 10 below lists results of the measurements.

The wheelseat diameter tolerance for a used axle is 5.618" to 5.621". All of the measured points were within this specification.
